# **Summary Building Condition Survey Report**

**Alves Primary School  
1 Main Road, Alves IV30 8UR**

**9<sup>th</sup> and 10<sup>th</sup> of May 2022**

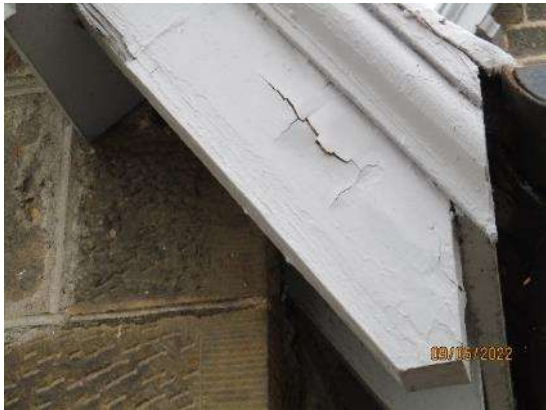
27. Wet rot to rafter feet

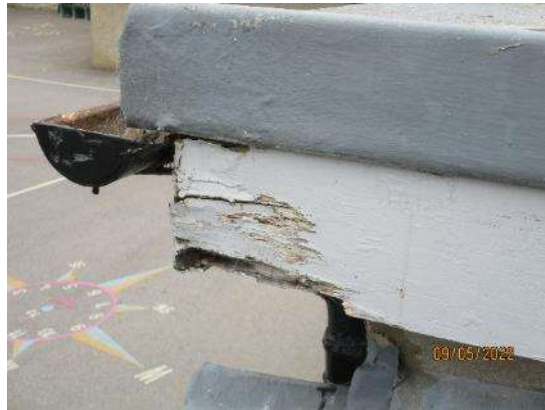
28. Wet rot to fascia boards

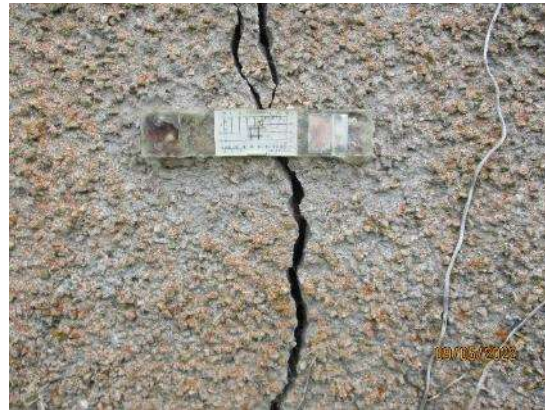
- Asbestos tiles have extensive moss growth to the East aspect.
- The GRP roof above the staff toilet has a significant hole and extensive blistering.
- External walls to classrooms 1 and 2 have extensive, significant cracking.
- Plaster and plasterboard ceilings have significant cracking.
- Internal walls also have significant cracking.
- Concrete floors to classrooms 1 and 2 have dropped by approx. 25mm.
- Internal doors are dated, glazing is single glazed and ironmongery is defective.

40. Extensive, significant cracking

- Replacement of asbestos cement tiles.
- Underpinning of classrooms 1 & 2 to prevent further movement.
- Expansion of the field of CCTV cameras to increase security.
- Installation of an intruder alarm system in the dining block to increase security.
- Review of requirement for mechanical ventilation in toilet rooms.
- Upgrade of controls for mechanical fans and lighting for energy saving purposes.
- Upgrade of lighting in both buildings due to age and condition.
- Upgrade of heating and associated plumbing systems in both buildings due to age and condition and for energy saving and reduction of carbon emission purposes.
- Installation of a sump pump system within the dining room block basement boiler house, as it is below ground level and has potential to flood.

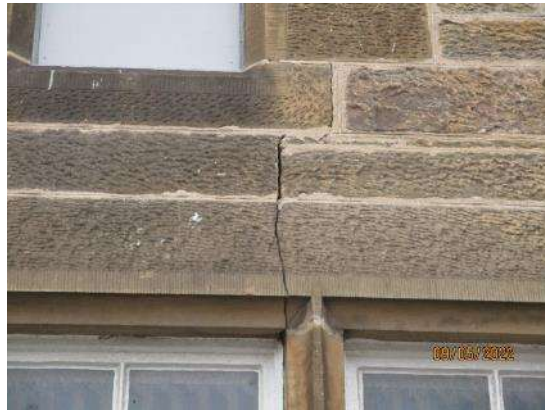
46. Isolated cracking

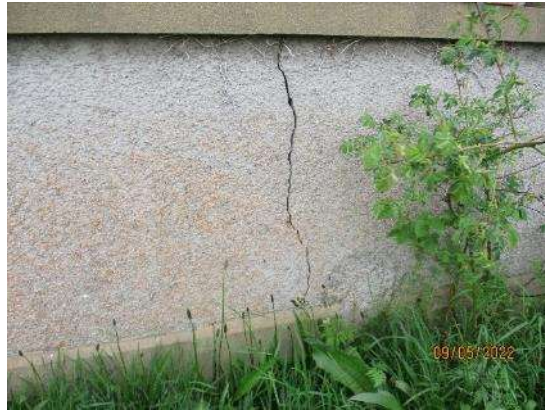
50. Cracked roughcast – Teaching north

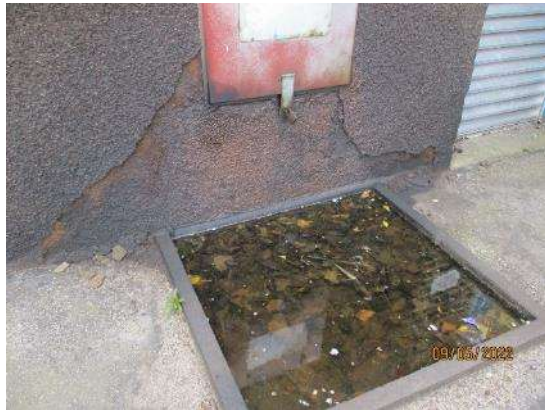
51. Damaged roughcast – Plant room

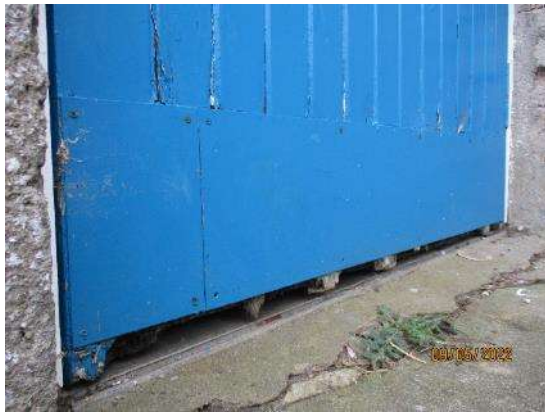
- The GRP roof is punctured in several places and has extensive blistering.
- Cast iron gutters, hopper heads and downpipes are partially blocked with vegetation.
- Timber sliding sash windows are in poor condition and largely painted shut.
- External timber doors have wet rot at the bottom edge.

55. Wet rot in bottom rail

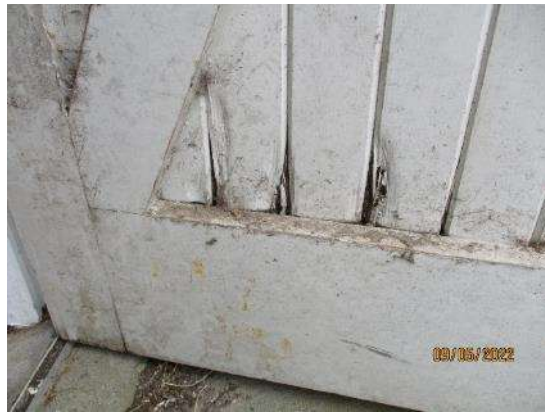
56. Wet rot in lining boards

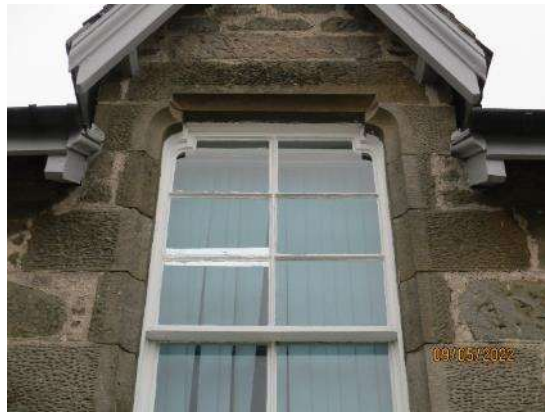
62. Previous repairs

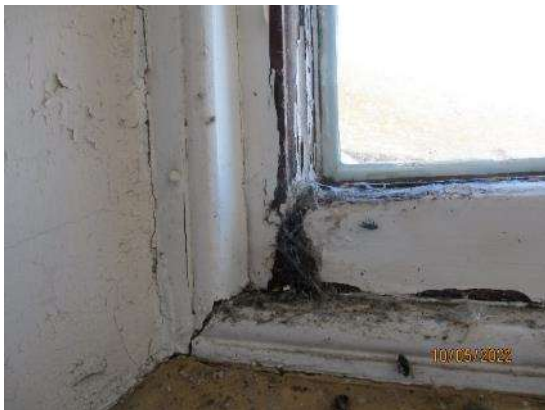
63. Wet rot in sashes and frames

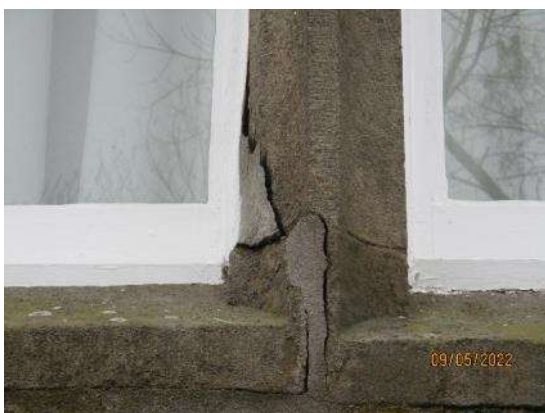
65. Damage/repairs to stone mullions

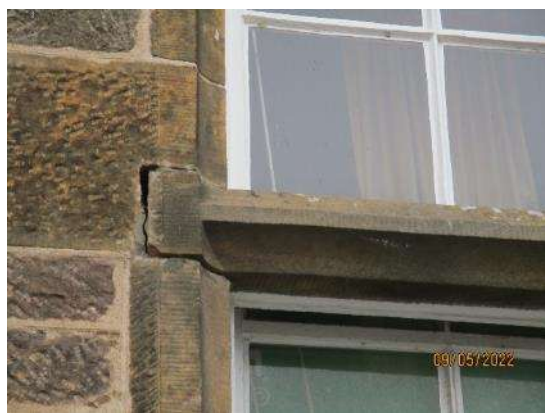
66. Movement at stone transoms

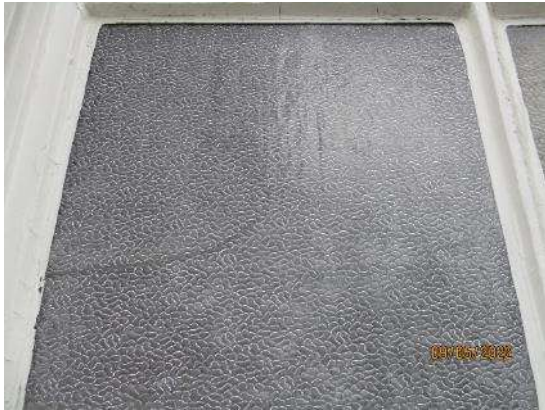
67. Cracked glazing

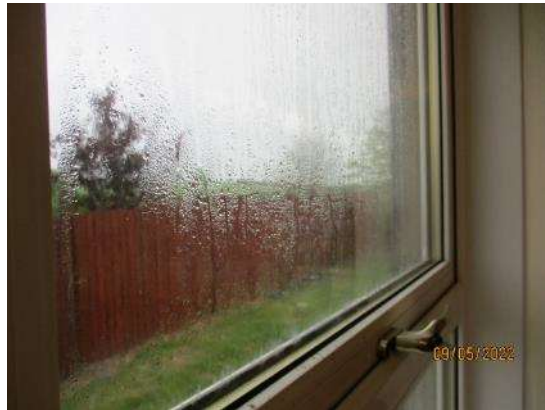
70. Failed double glazed units

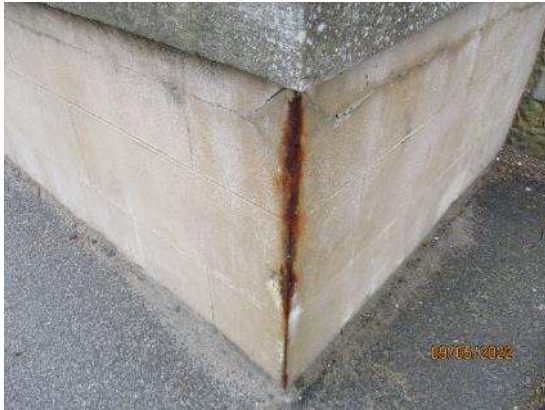
78. Corcor bead corrosion

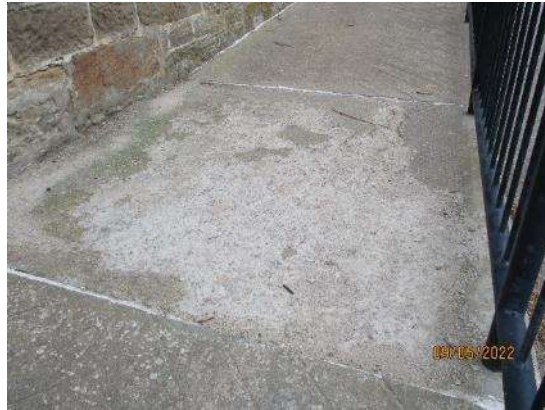
79. Eroded concrete surface

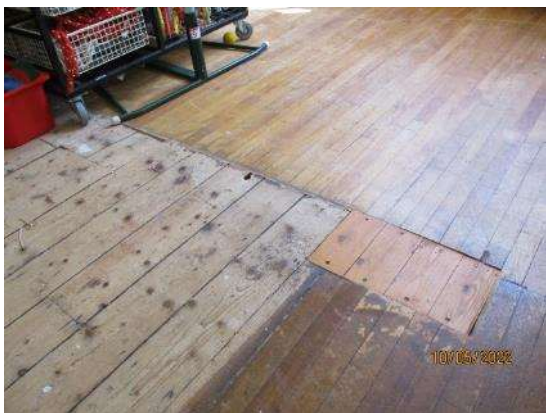
88. Patch repaired timber boards

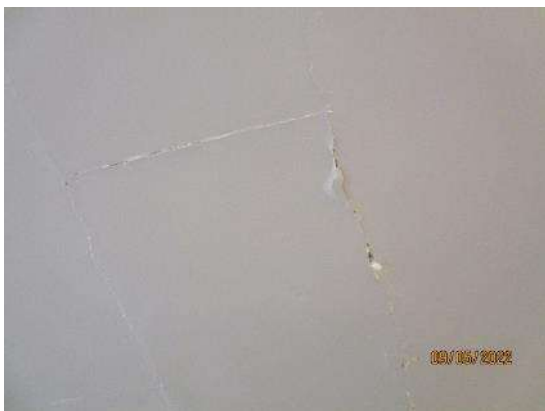
99. Plaster ceilings - cracked

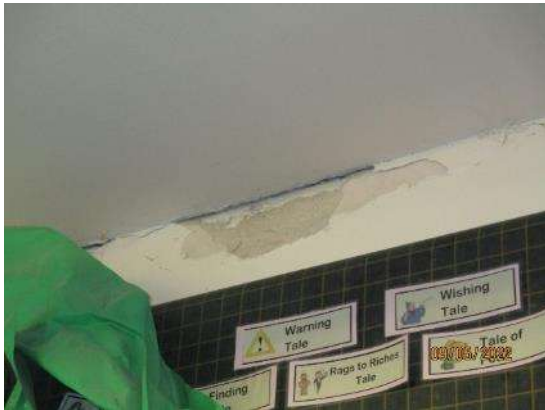
103. Plastered walls - spalling

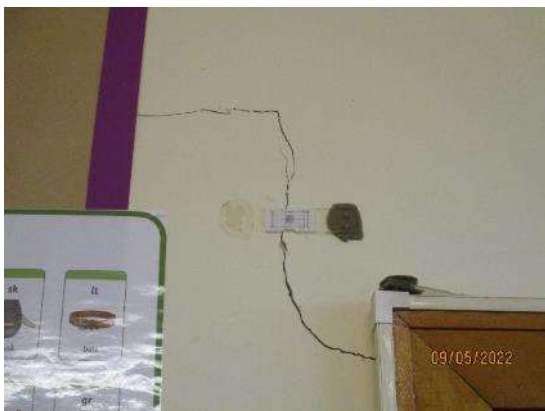
105. Plastered walls - cracked

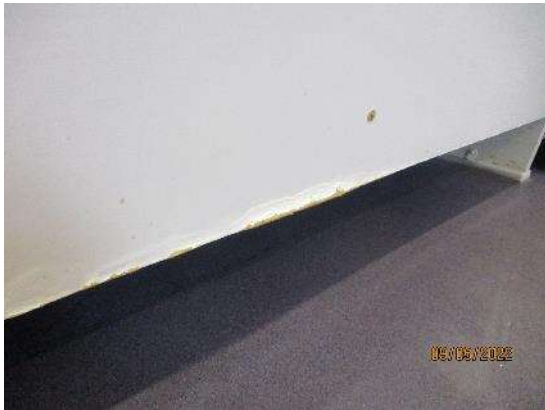
127. Water damage to bottom edge

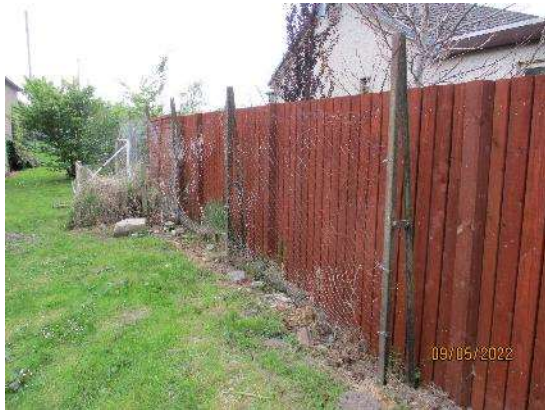
208. Damaged chain link fencing

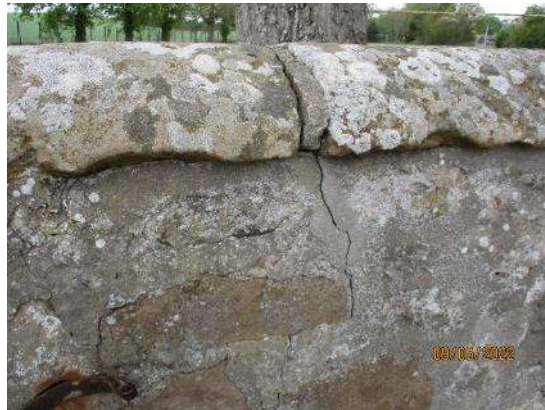
215. Cracks and movement adjacent to trees

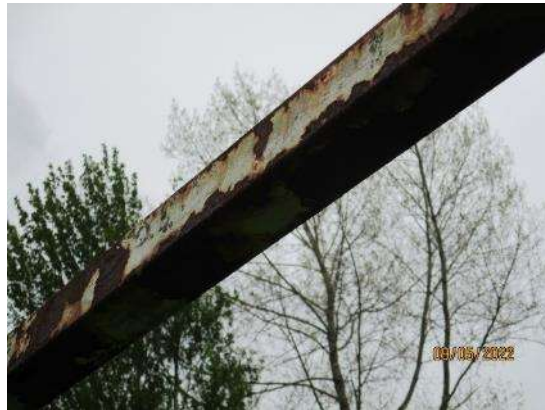
232. Surface corrosion
