# **Summary Building Condition Survey Report**

**Andersons Primary School  
High Street, Forres IV36 1DB**

**31<sup>st</sup> January & 1<sup>st</sup> February 2022**

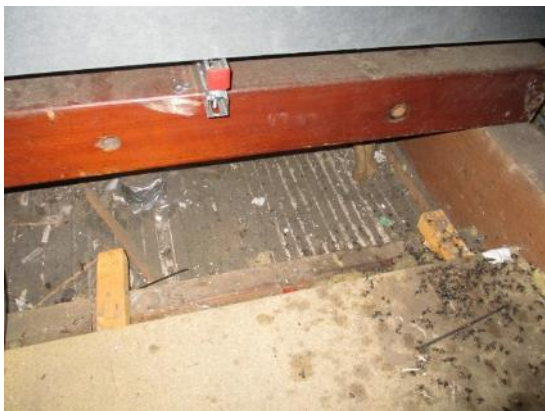
11. Disturbed/missing mineral insulation

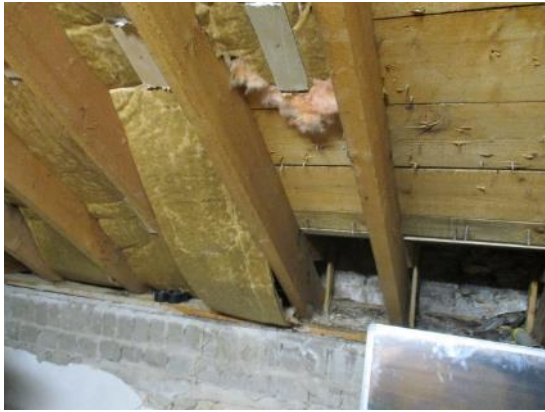
13. Damaged/missing insulation to north roof

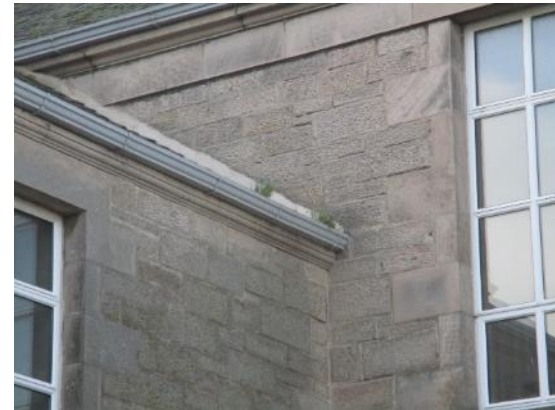
16. Vegetation in gutters

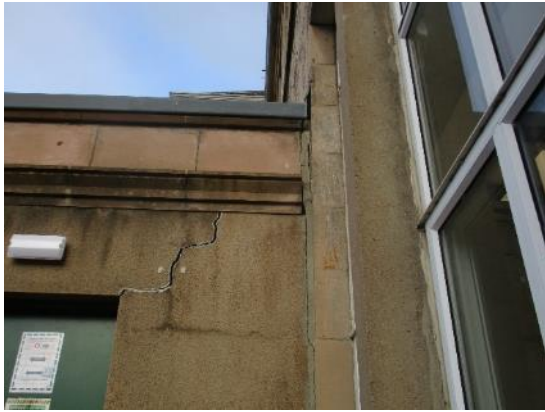
32. Movement and cracking of external walls

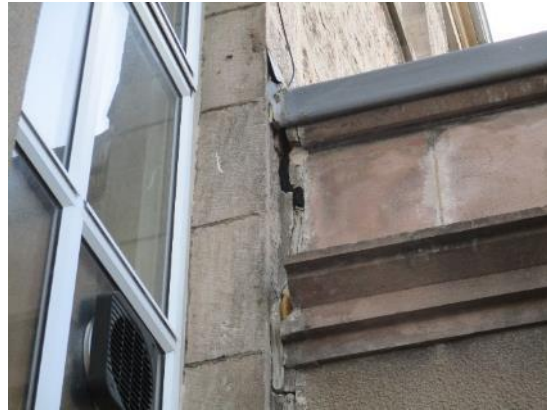
33. Gap between the extension and the main building

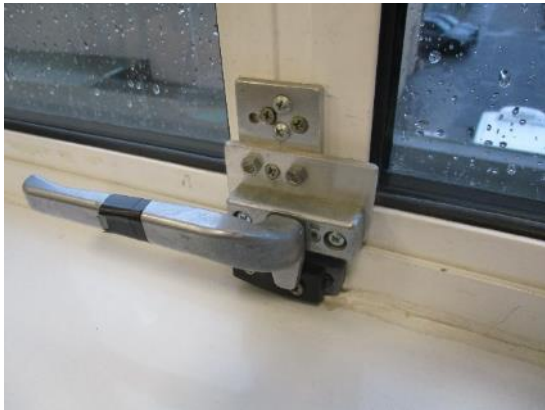
52. Lever ironmongery in very poor condition

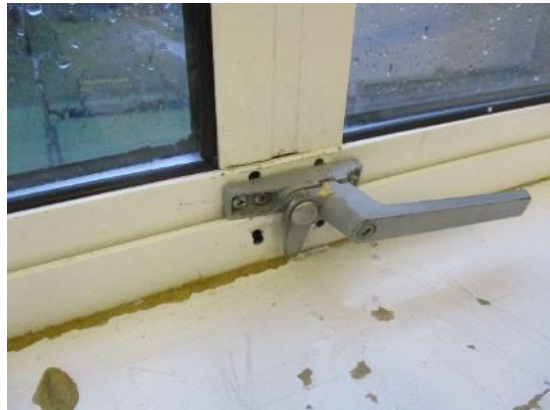
53. Lever ironmongery in very poor condition

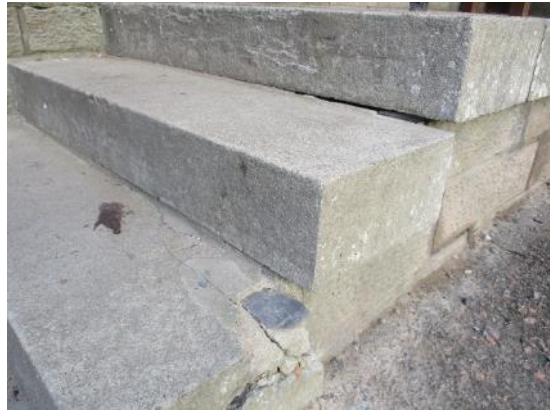
59. Damaged steps to Kitchen side door

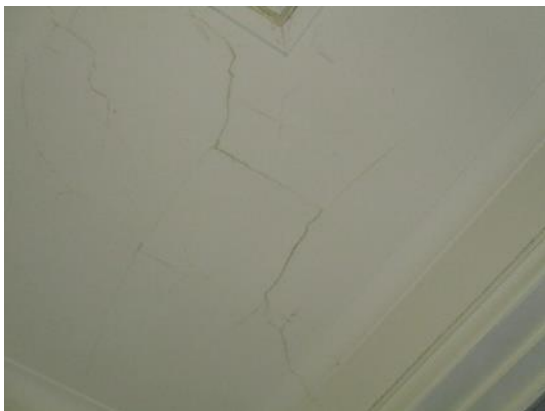
62. Cracked lath & plaster ceilings

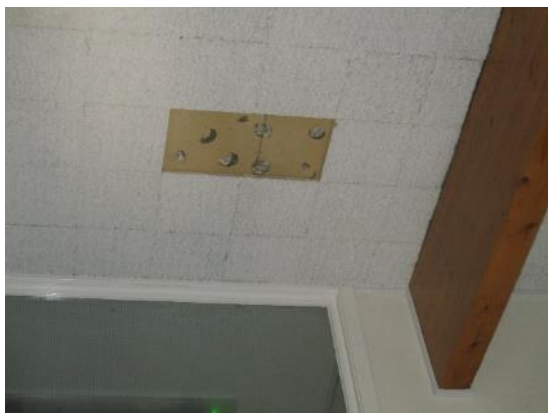
69. Ceiling tiles failing

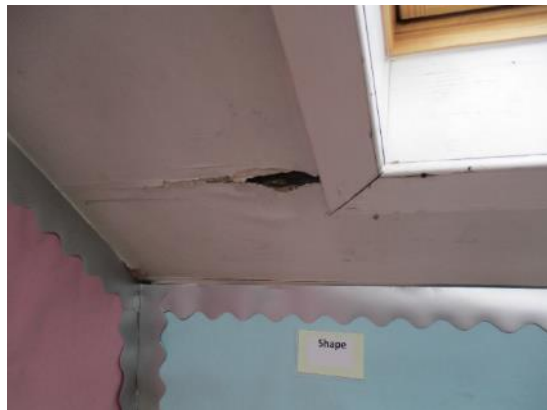
73. Plasterboard walls - Water damage

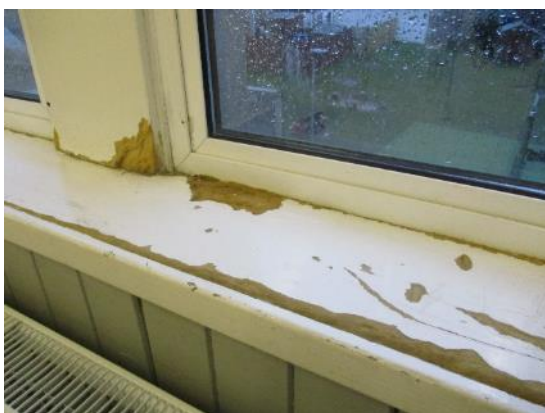
80. Water damaged MDF window linings

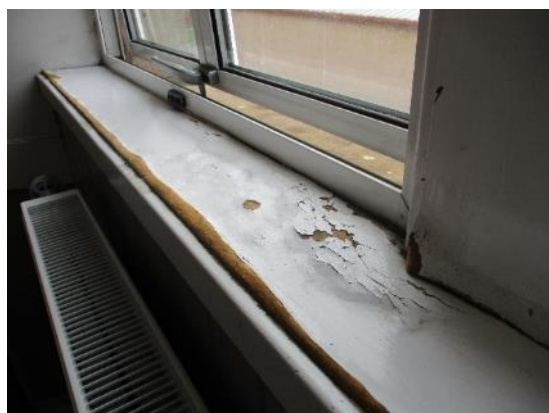
81. Water damaged MDF window linings

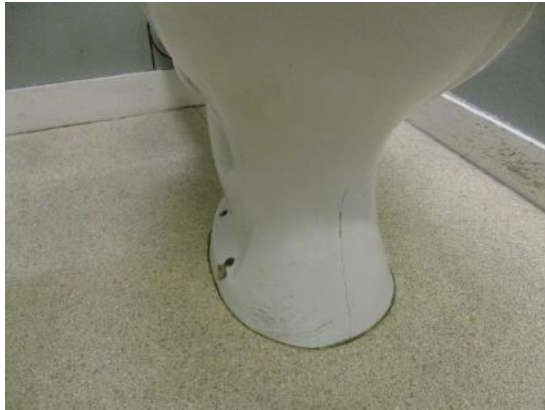
94. Cracked and chipped WC

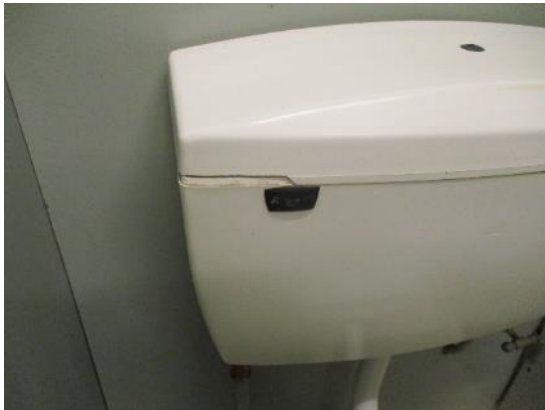
95. Damaged plastic cisterns

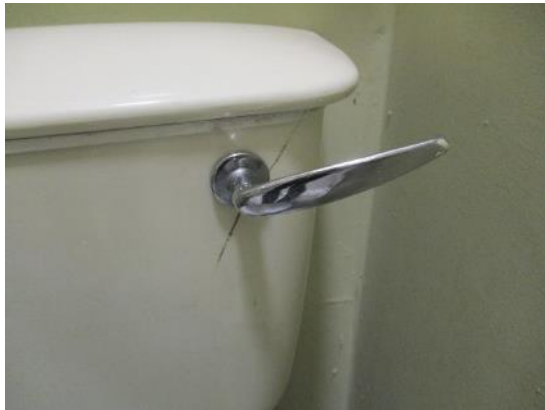
96. Cracked vitreous china cisterns

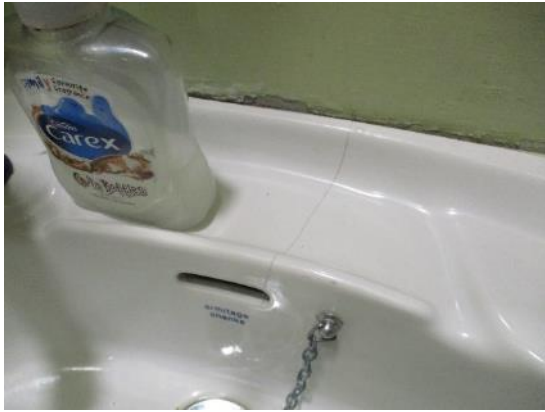
99. Cracked wash hand basins

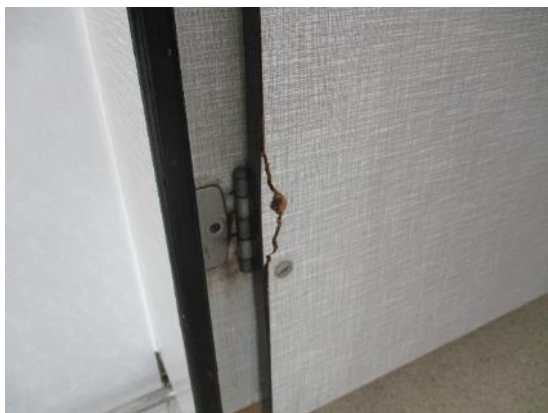
104. Damage to doors

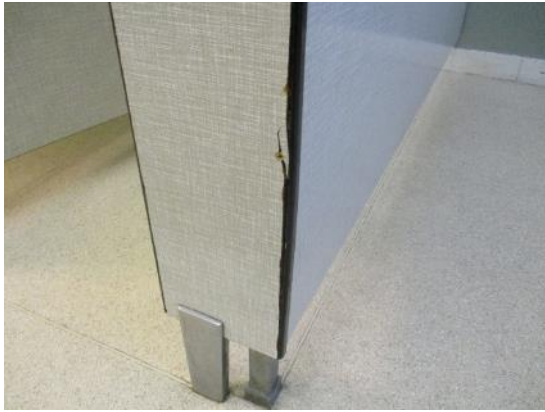
105. Damage to partitions

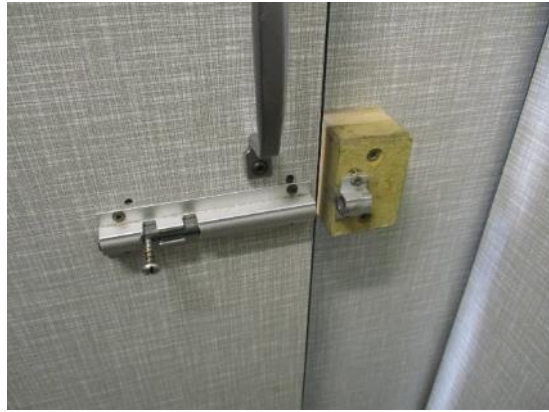
106. Failed and repaired ironmongery

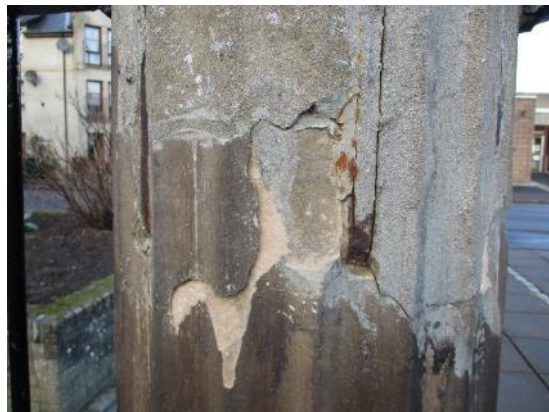
- Gate piers have exposed reinforcement and require repair (Cat B Listed).
- Perimeter wall surface cracking and efflorescence, cracked and broken coping stones.
- Gas supply pipe exiting the main gas meter has no mechanical protection and has evidence of being used to climb on.

170. Exposed reinforcement

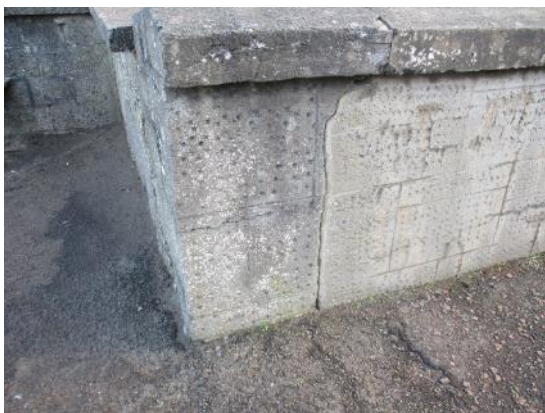
171. Perimeter wall cracking
