# **Summary Building Condition Survey Report**

**Applegrove Primary School  
Orchard Road, Forres IV36 1PJ**

**21<sup>st</sup> & 22<sup>nd</sup> February 2022**

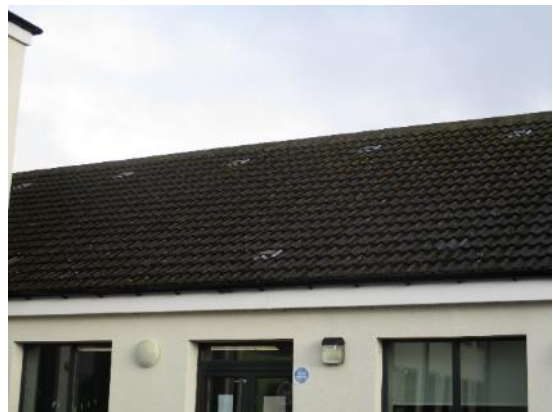
5. Extensive moss growth

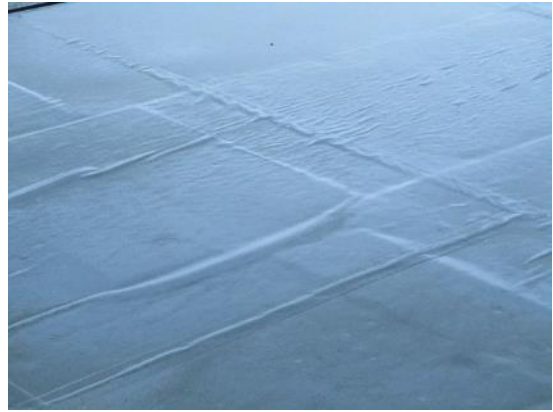
8. Wrinkled single ply membrane

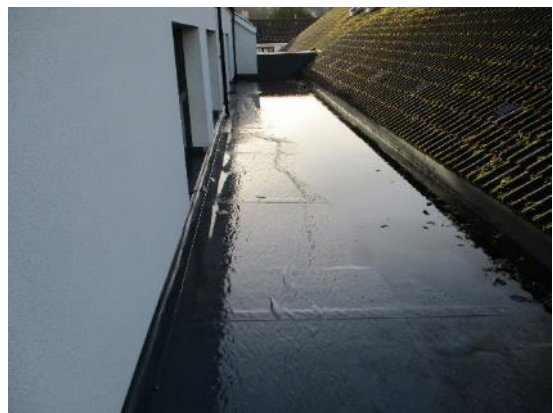
11. Flooding in isolated areas

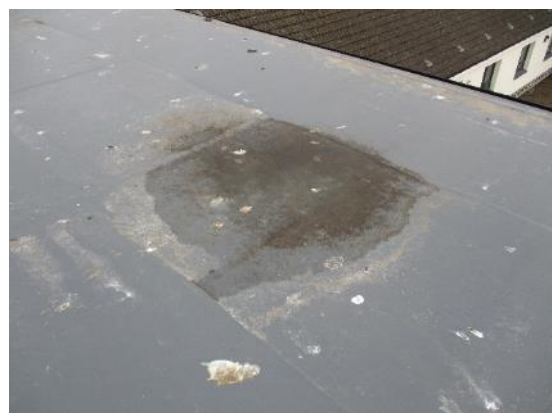
17. Isolated ponding

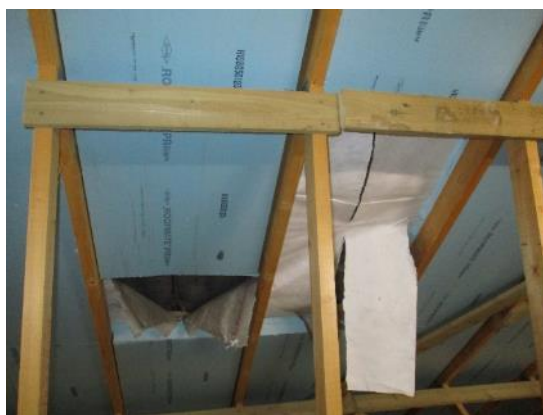
20. Damaged insulation below tiles

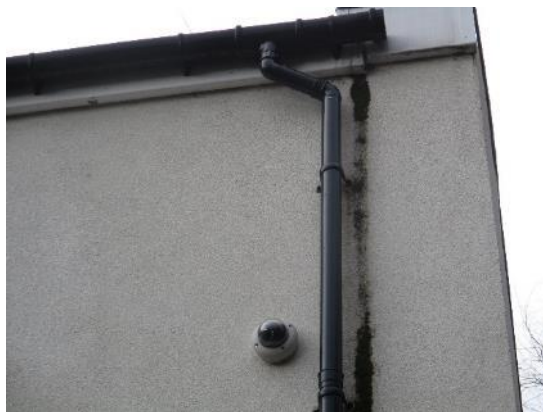
22. Leaking gutters

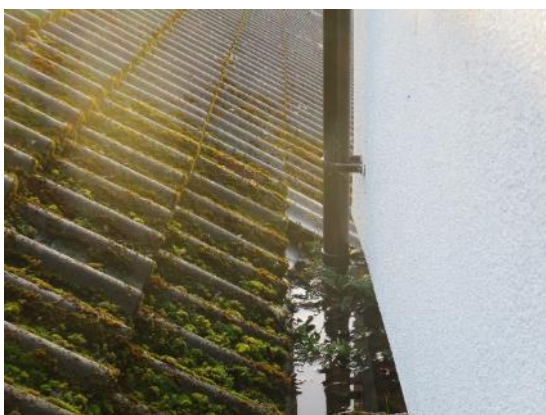
23. Blocked abutment gutters

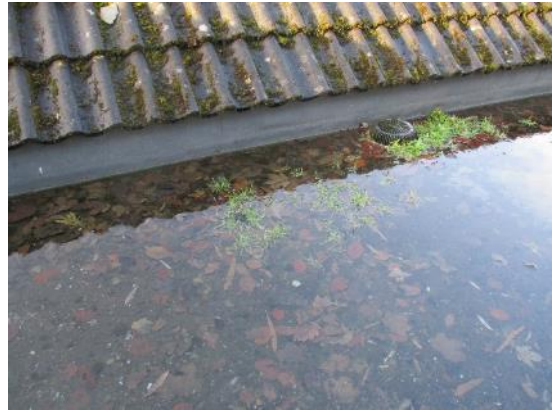
26. Flooding

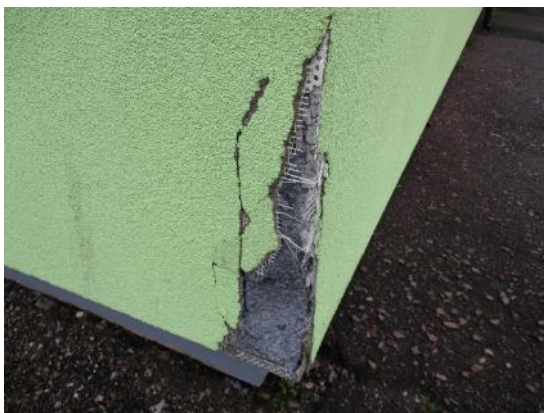
35. Damage to external insulation

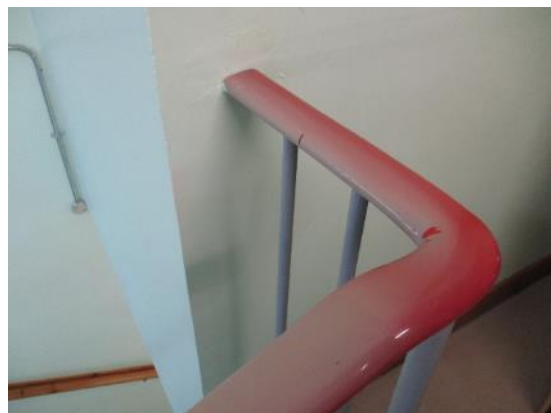
66. Faded PVC handrail covers

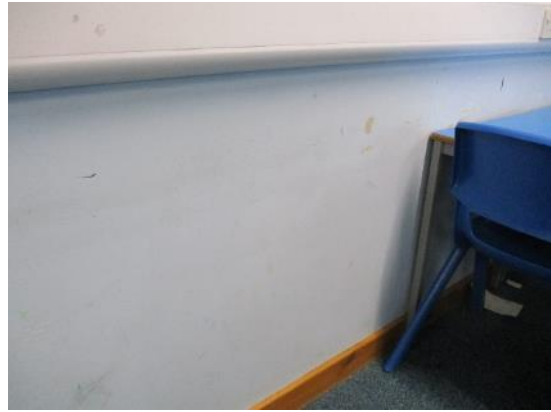
74. Damaged plastered walls

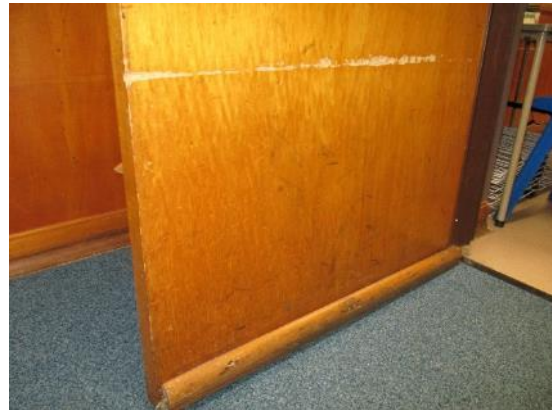
82. Surface damage

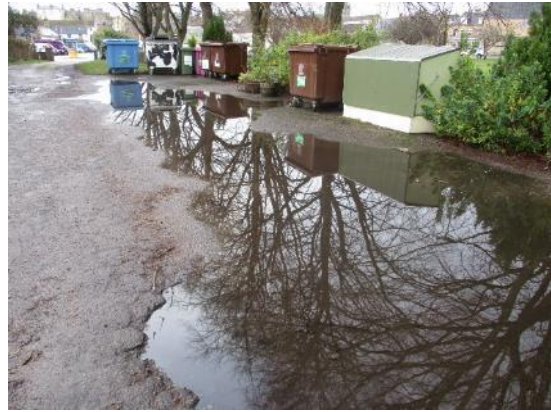
160. Surface damage and flooding

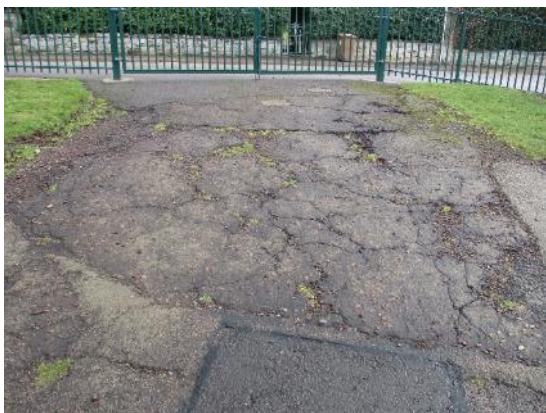
163. Damaged tarmacadam at gates

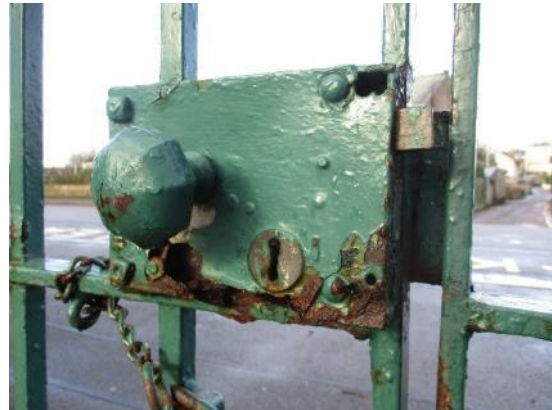
168. Extensive corrosion
