# Summary Building Condition Survey Report

**Dallas Primary School**  
**Knockando Road, Dallas IV36 2SA**

**24<sup>th</sup> May 2022**

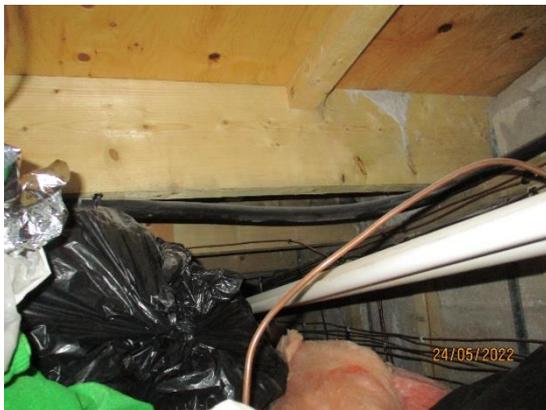
2. Slight sag in roof structure

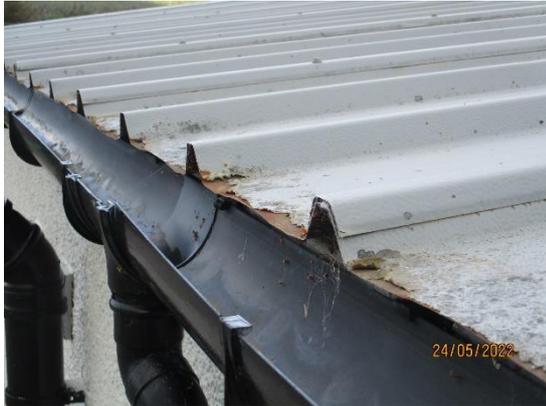
9. Cut edge corrosion

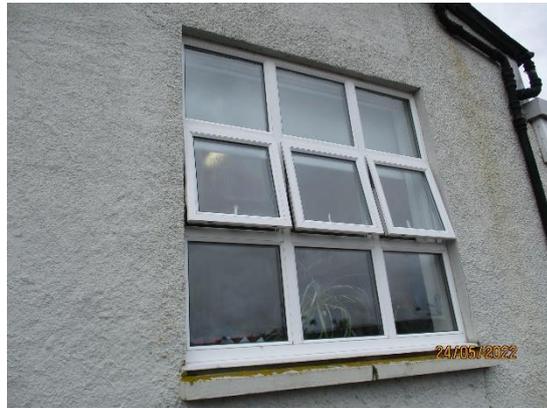
33. Rot in timber frame

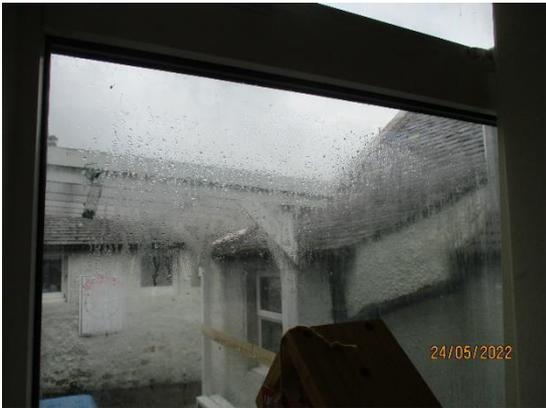
38. Failed double glazing unit

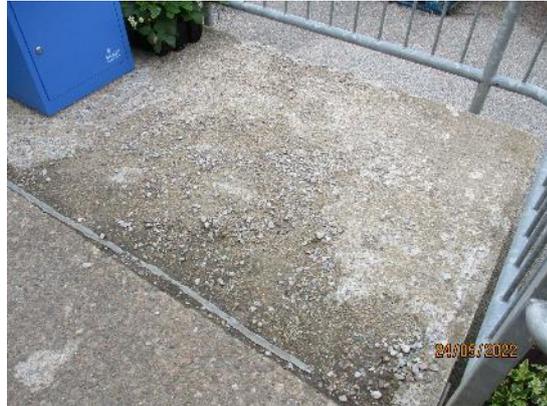
44. Cracked ramp

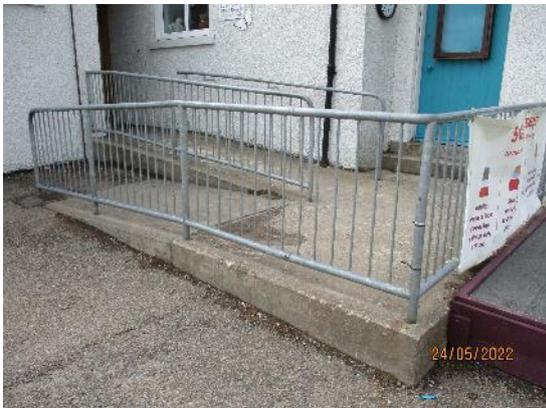
45. Spalling concrete surface

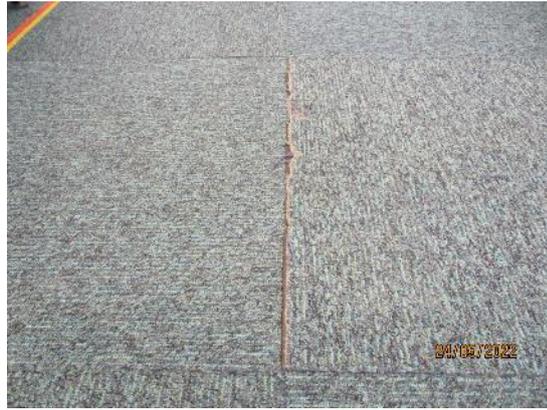
48. Soiled carpet

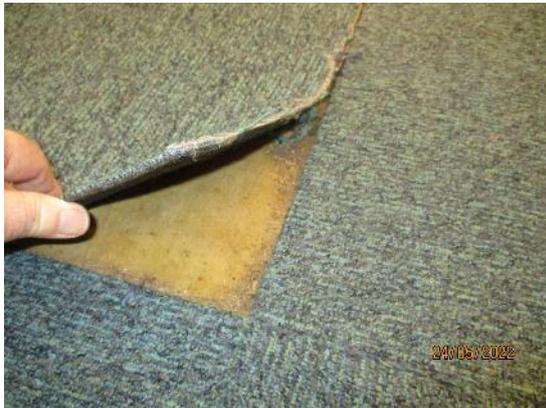
49. Worn carpet tiles

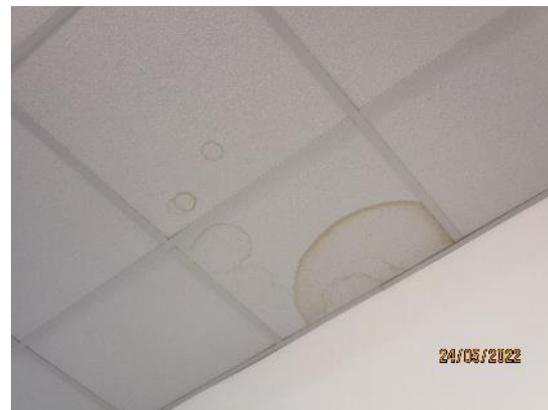
59. Watermarked ceiling tiles

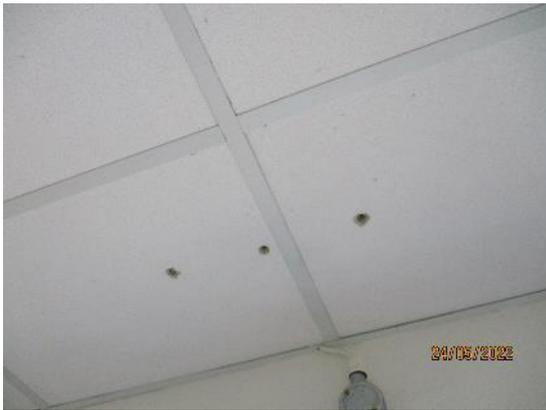
60. Damaged ceiling tiles

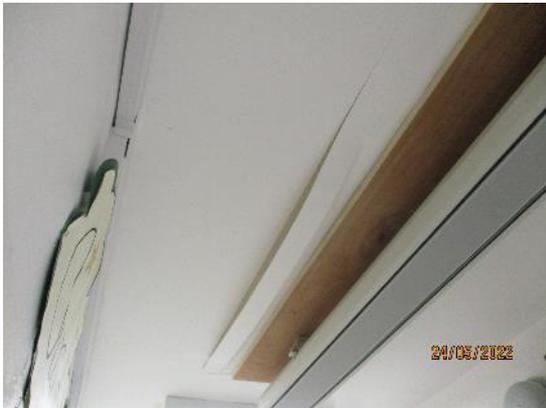
62. Failed taped joints

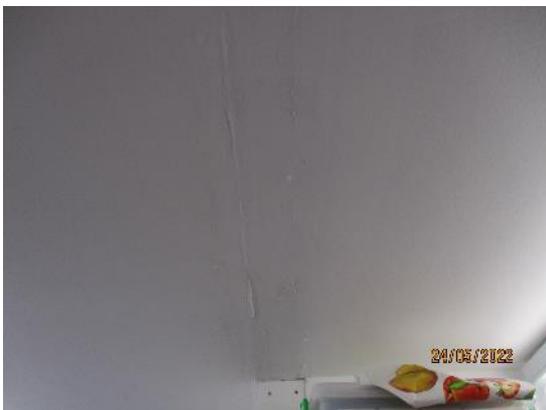
64. Damaged taped joint

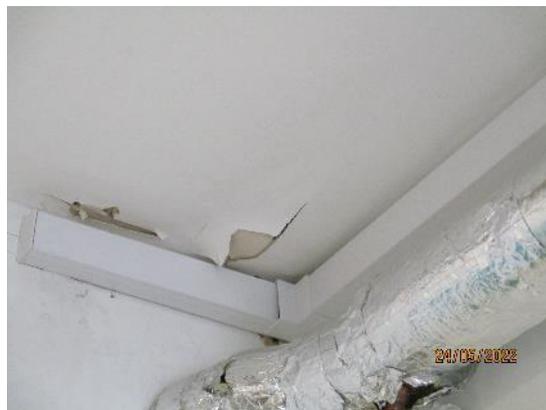
65. Damaged plasterboard

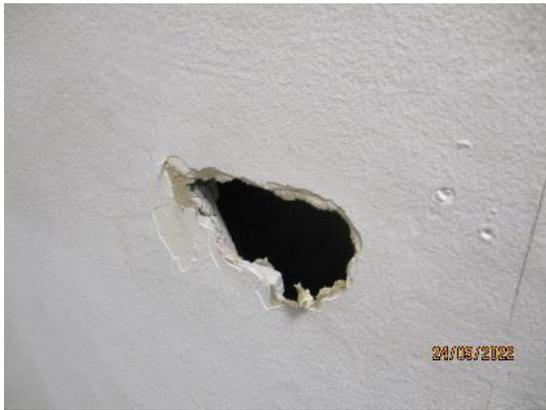
66. Damaged plasterboard walls

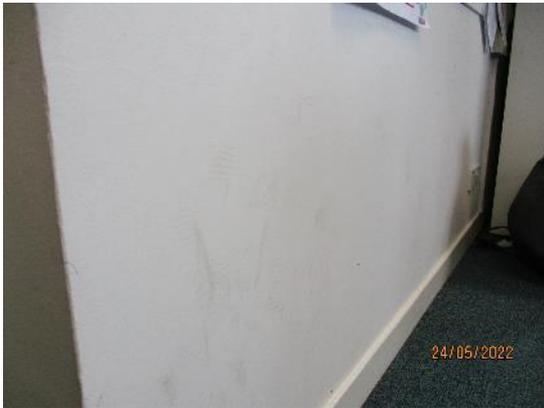
85. Scuffed walls

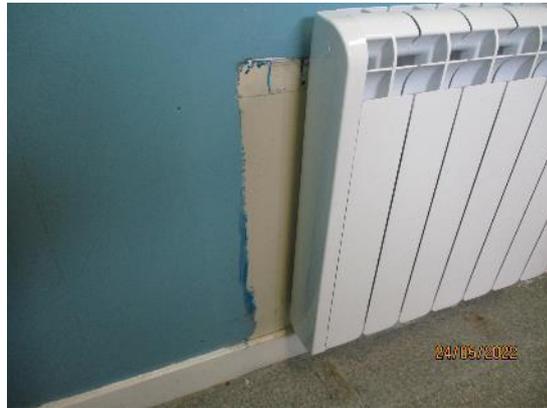
86. Missing decoration (replacement radiators)

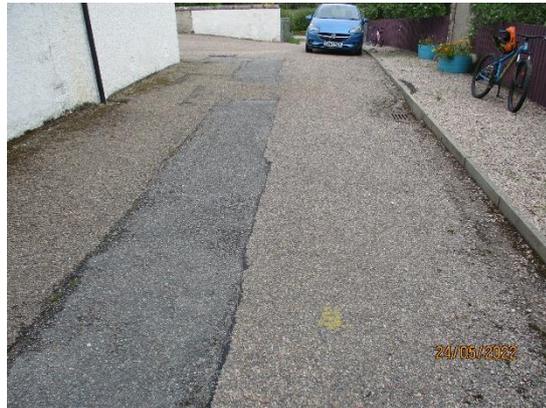
130. Cracked surface

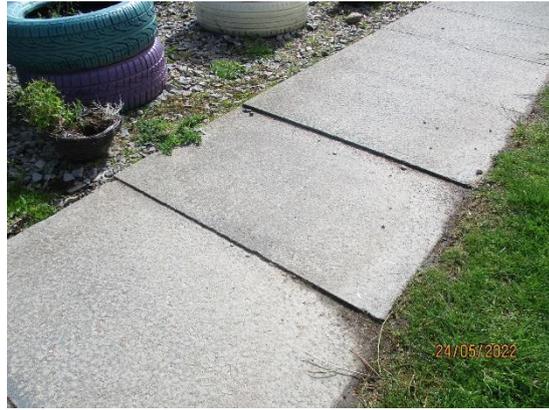
135. Uneven surface

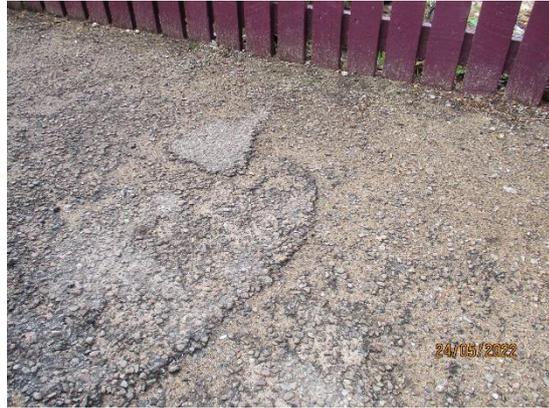
137. Uneven surface
