# **Summary Building Condition Survey Report**

**Dyke Primary School**

**Dyke IV36 2TF**

**5<sup>th</sup> October 2021**

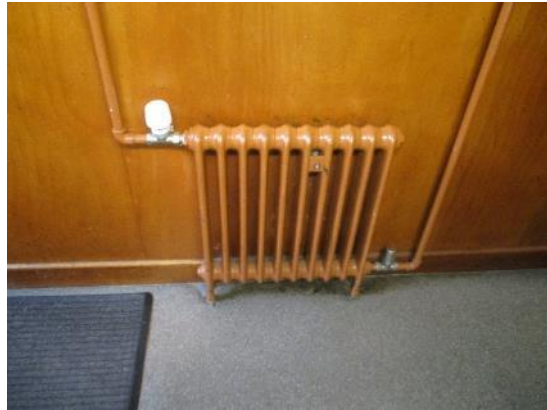
32. Cast iron radiator main school

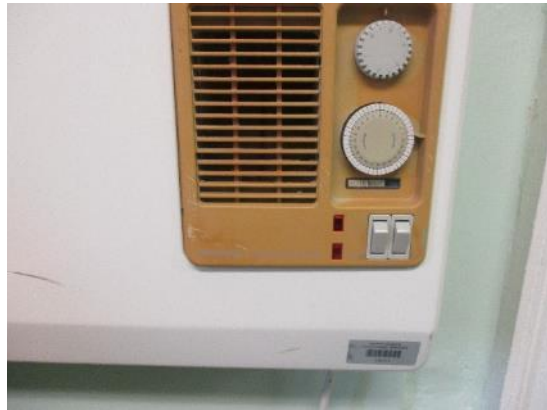
34. Kitchen block electric convector heater

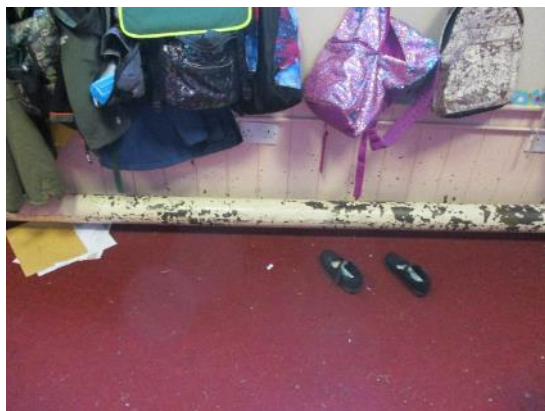
35. Heating pipe main school

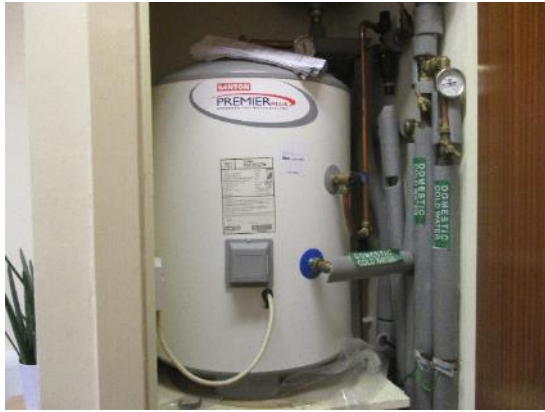
37. Hot water cylinder main school

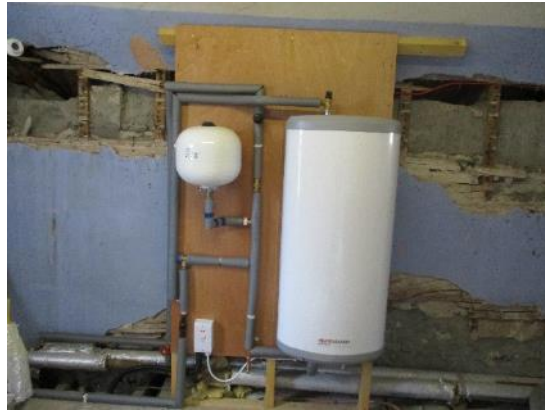
38. Multipoint hot water storage heater - kitchen

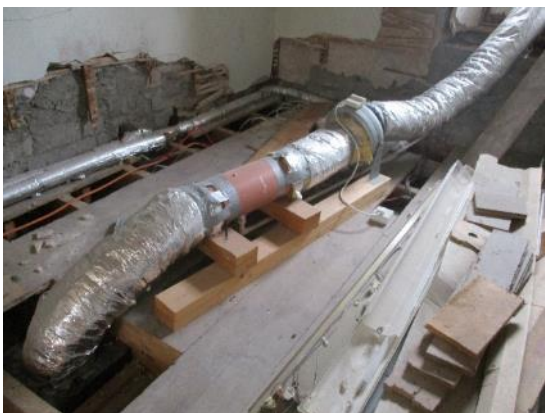
41. Specialist extract ventilation – Kitchen

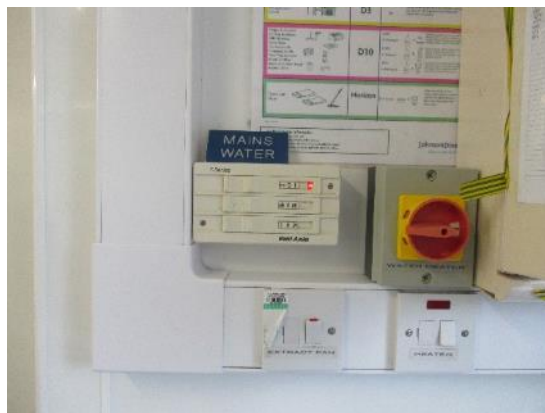
42. Specialist ventilation controls - Kitchen

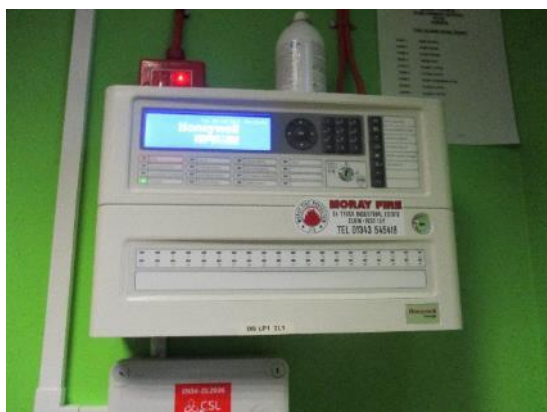
43. Fire alarm panel. Main school

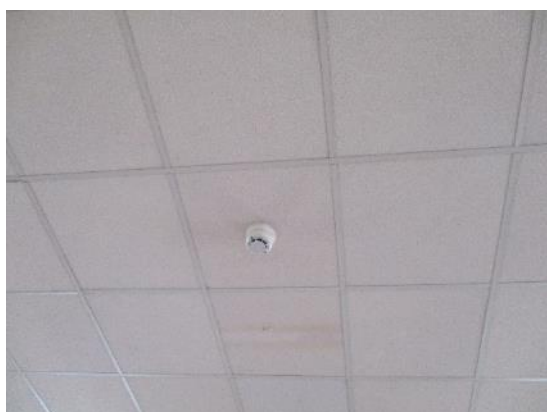
45. Fire alarm system detector head.

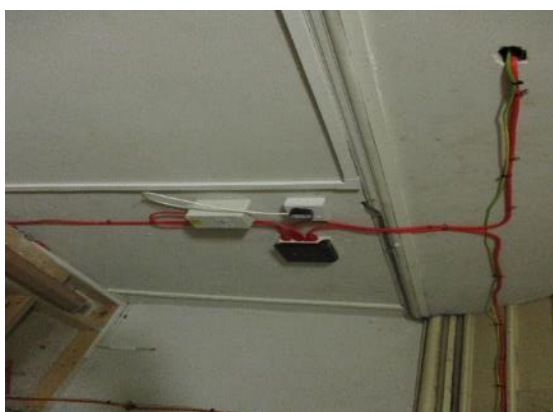
46. Fire alarm system wiring attic main school.

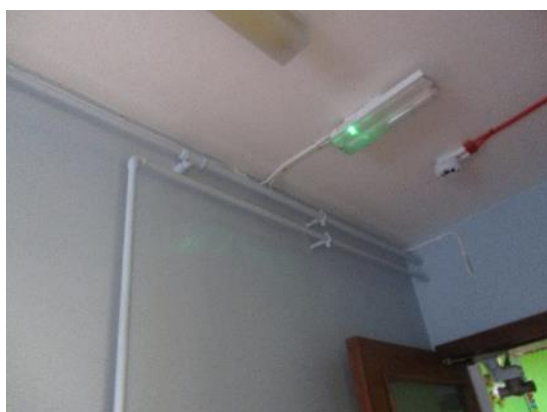
47. Emergency lights main school.

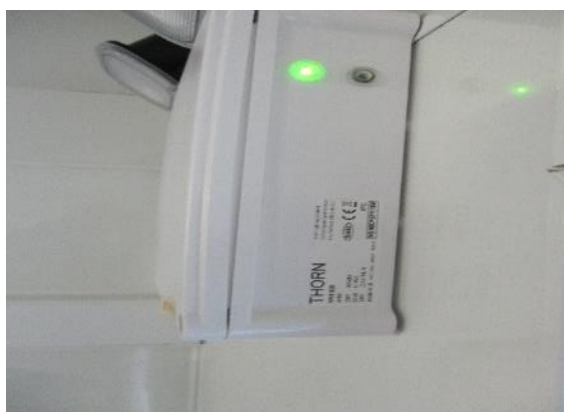
48. Emergency lights kitchen.

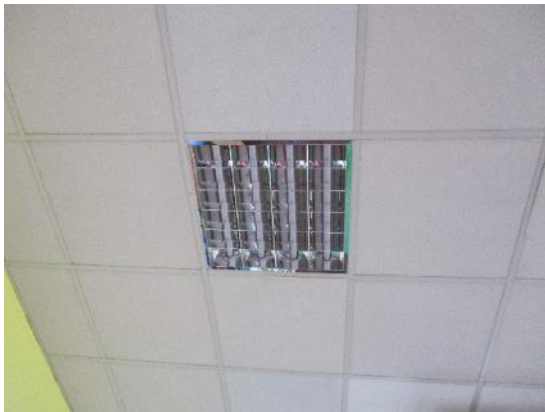
50. Classroom light main school.

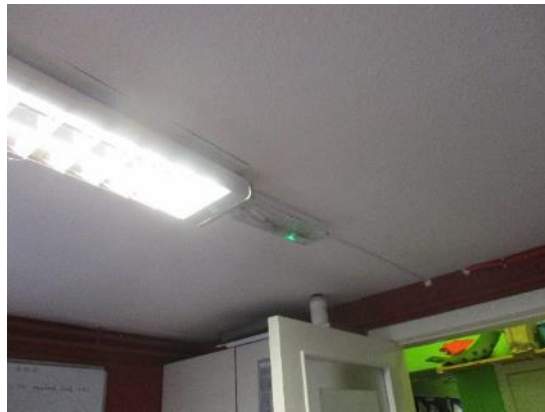
51. Main school class light.

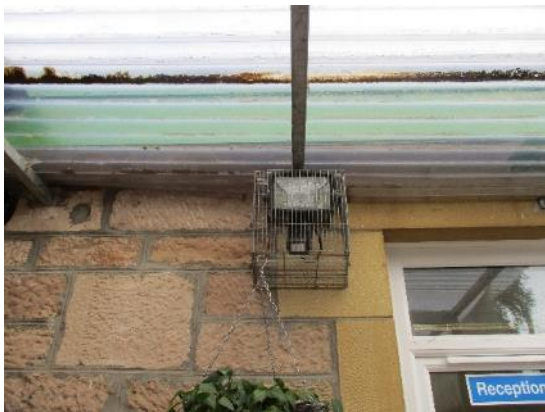
52. Main school external flood light.

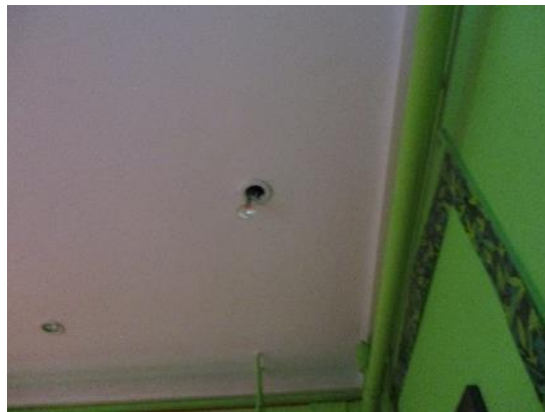
53. Main school corridor downlight.

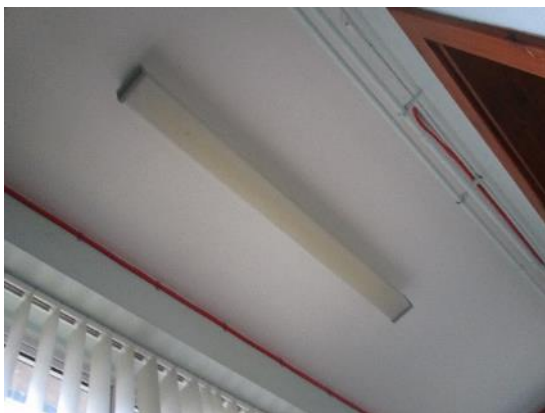
54. Main school reception batten light.

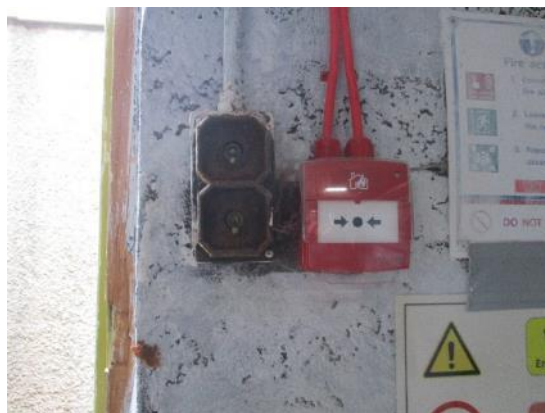
55. Main school plant room light switches.

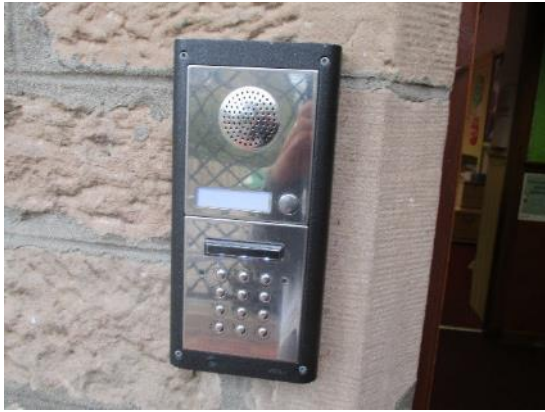
56. Main entrance door entry system call.

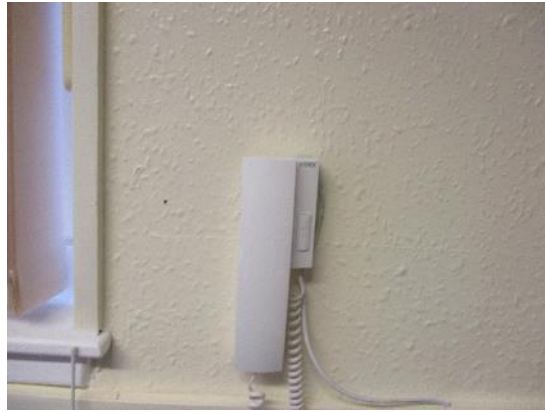
57. Main entrance door entry receiver.

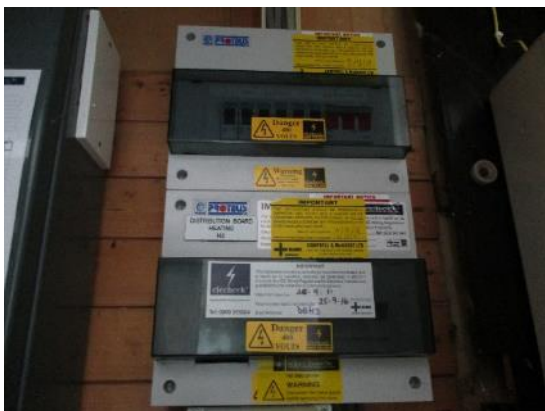
60. Kitchen block distribution boards.

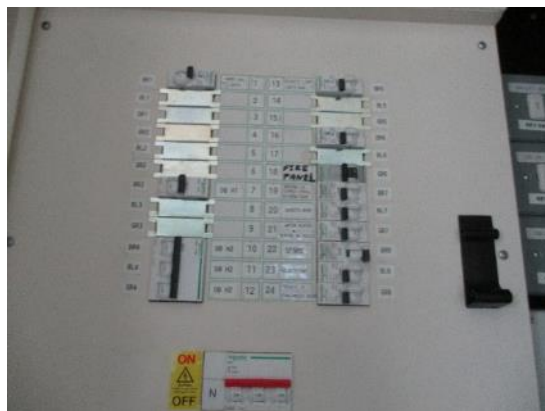
61. Main school distribution board.
