Summary Building Condition Survey Report

Kinloss Primary School
Burghead Road, Kinloss IV36 3SX

14th & 15th March 2022

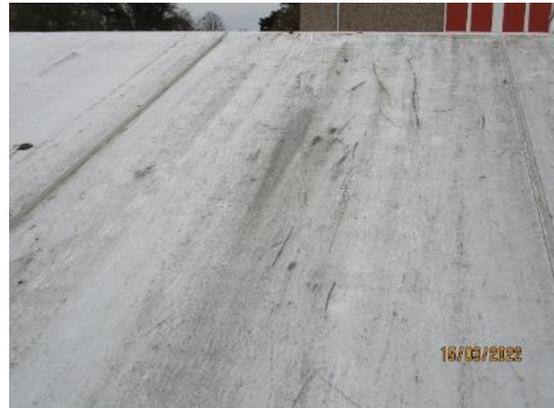
16. Surface damage

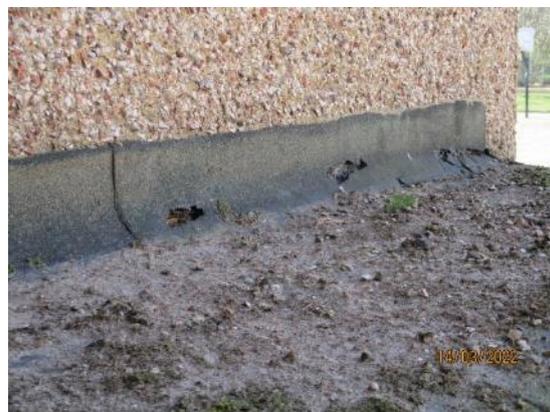
18. Felt flashing damaged

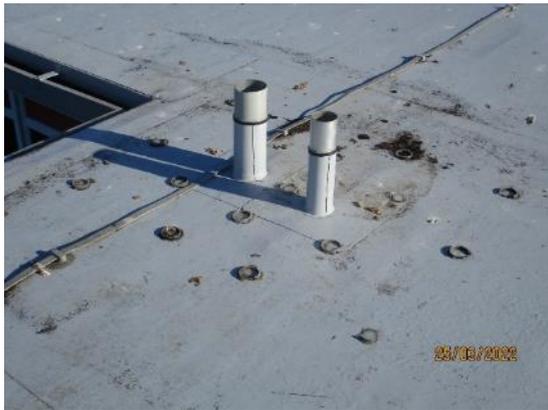
19. Bird deterrents missing

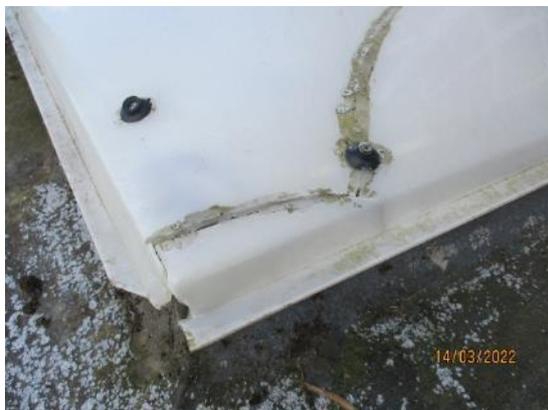
23. Damage to rooflight

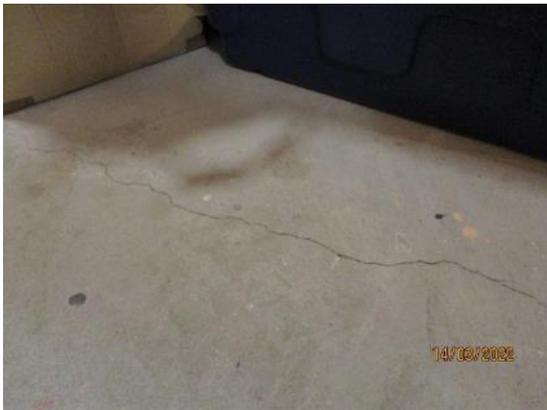
50. Hairline cracking

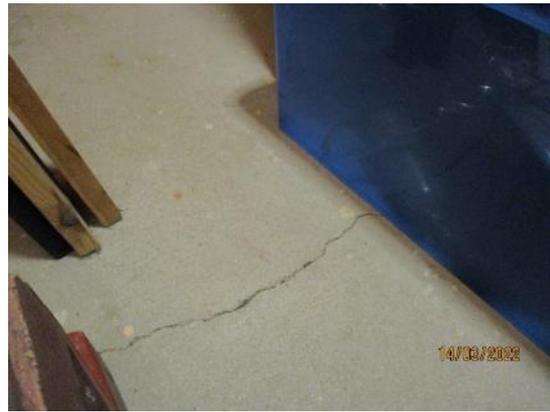
61. Isolated cracking

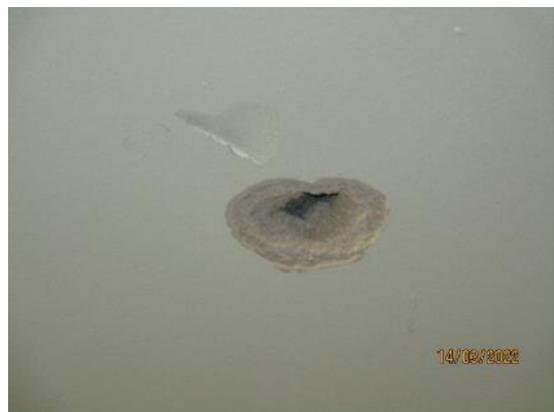
76. Isolated plaster damage

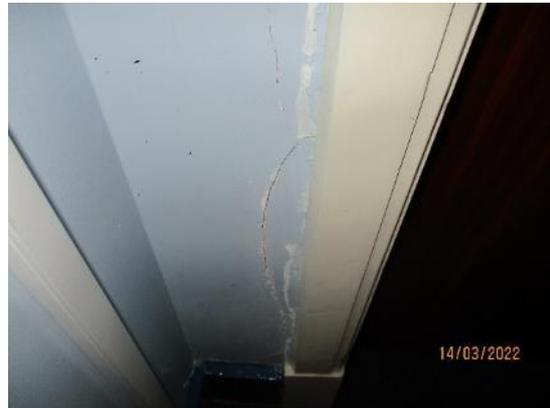
80. Cracking at door frames

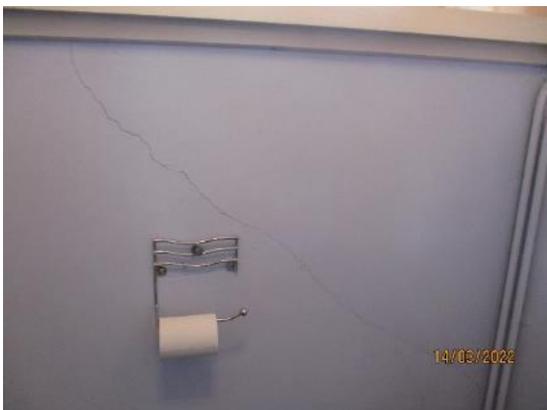
81. Cracking

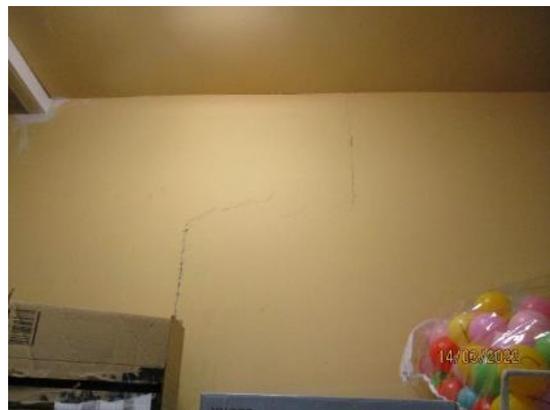
82. Cracking

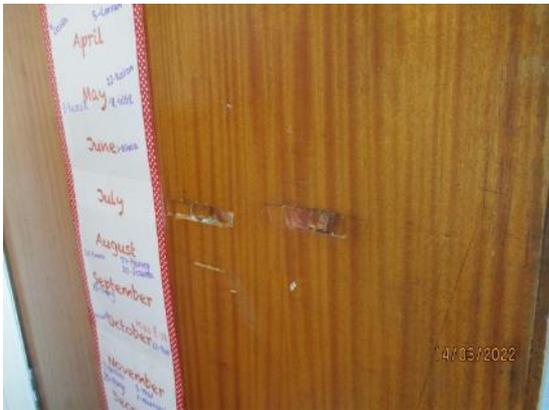
85. Surface damage

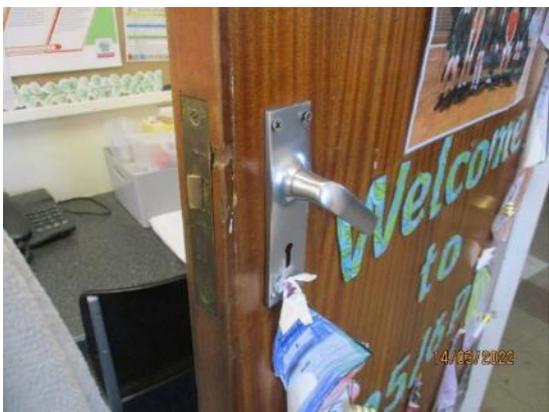
87. Ironmongery failing

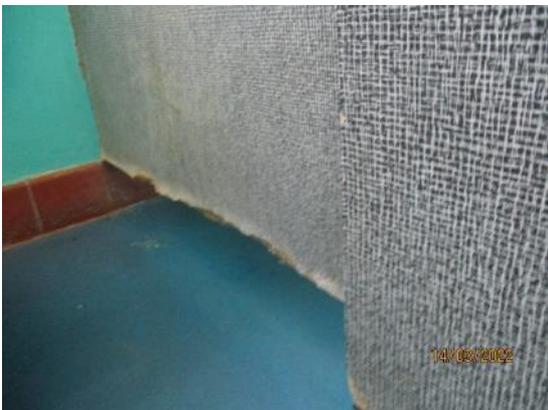
105. Partitions degrading

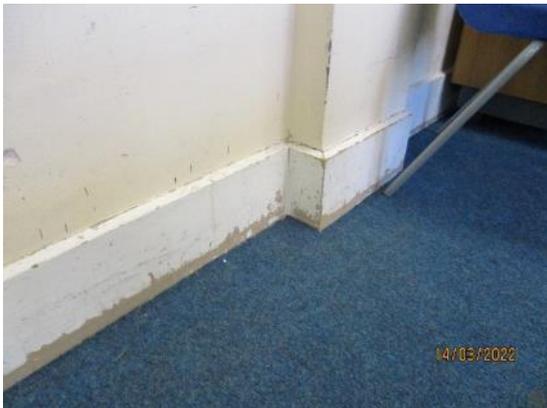
108. Chipped and peeling paint

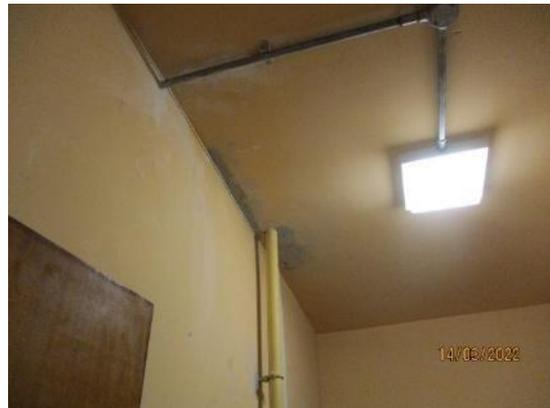
109. Spalling paint to walls and ceilings

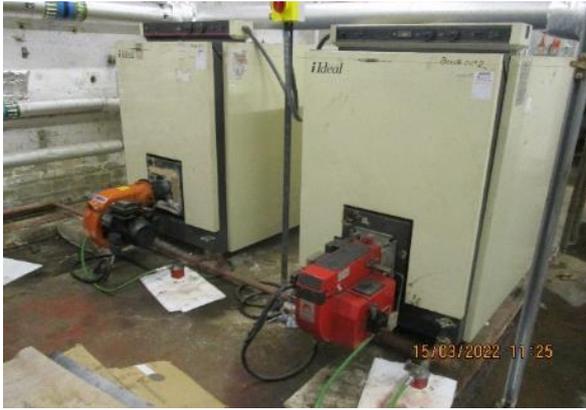
- Oil boilers are reaching the end of their useful life, in poor condition and should be considered for replacement.
- The Hot water calorifier is life expired and should be considered for replacement within part of scope of heating upgrades.

116. Oil fired cast iron boilers.

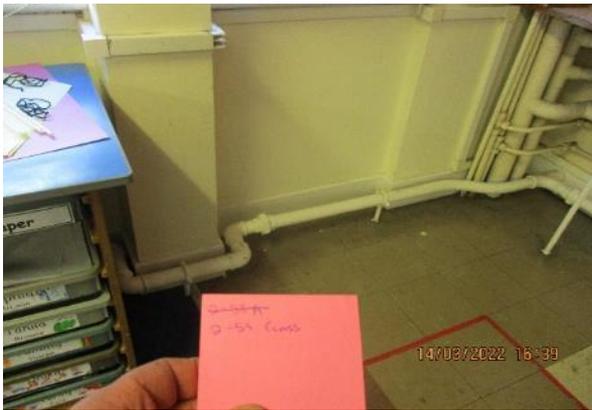
- The original heating system pipework not replaced in the 1st phase of upgrades is in poor condition and should be considered for replacement.
- The existing heating system heat emitters throughout the whole building are in poor condition and should be considered for replacement.

124. Pipework existing heating.

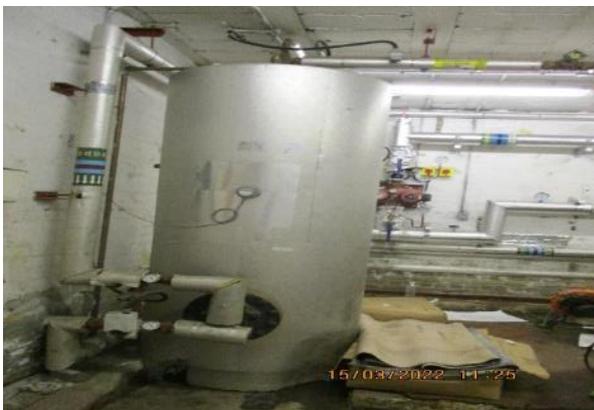
126. Hot water storage calorifer.

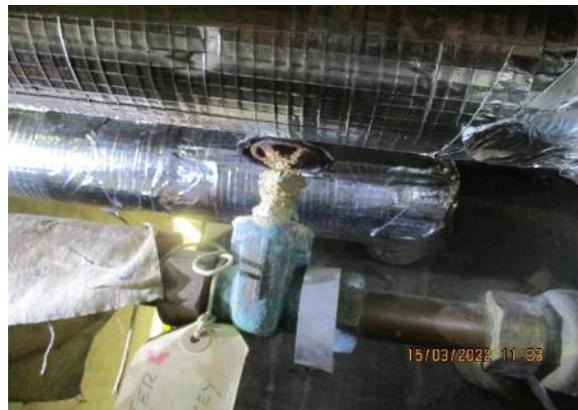
- Hot water distribution pipework is life expired, in poor condition and poorly insulated and should be considered for replacement.
- Cold water distribution pipework is life expired, in poor condition, poorly insulated and should be considered for replacement.

127. Hot water pipework basement service duct.

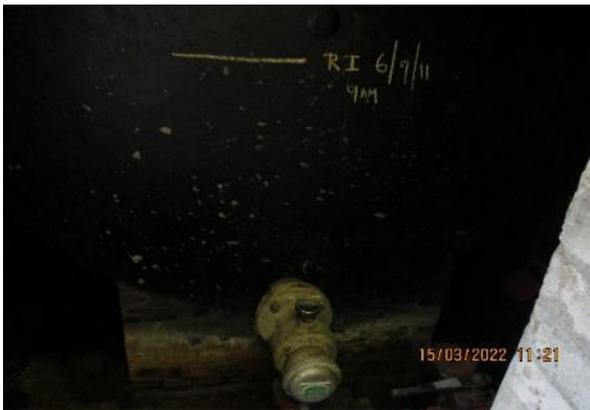
- Oil storage tank and distribution pipework is life expired, in poor condition and should be considered for replacement within part of scope of heating upgrades.

130. Oil storage tank – basement bunded room.

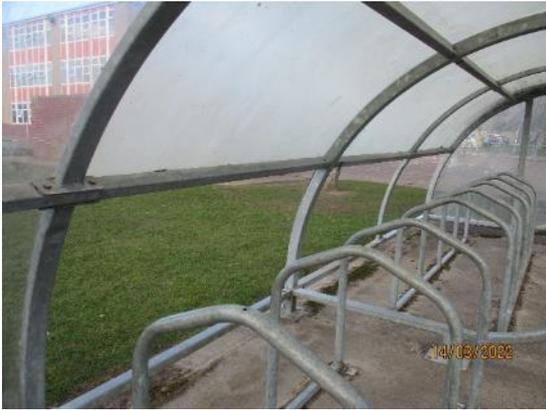
- Access road and car park, surface erosion, cracking and pot holed.
- Investigate sunken drainage routes in the playground.
- Missing and damaged Perspex cladding to the Bike Shelters.

188. Broken and missing Perspex panels
