# **Summary Building Condition Survey Report**

**Logie Primary School**

**Dunphail IV36 2QG**

**7<sup>th</sup> October 2021**

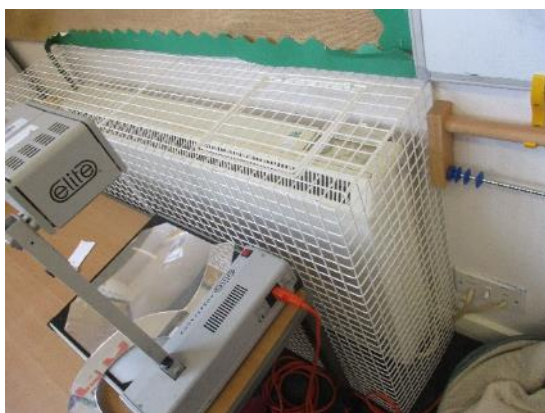
23. Main school off peak storage heater

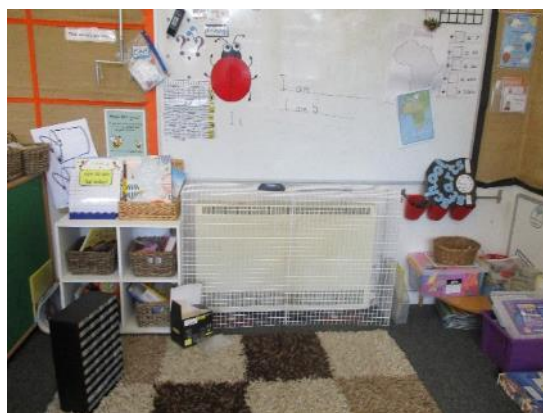
24. Main school class off peak storage heater

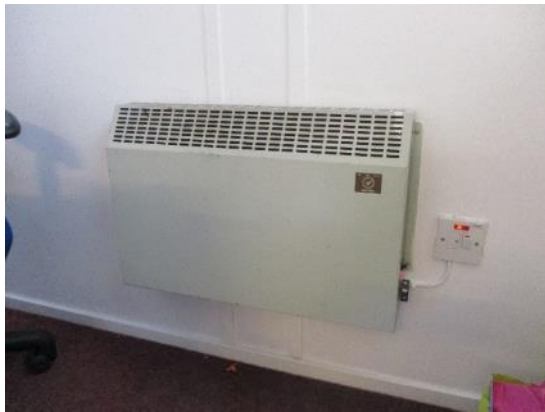
25. Portacabin electric convector

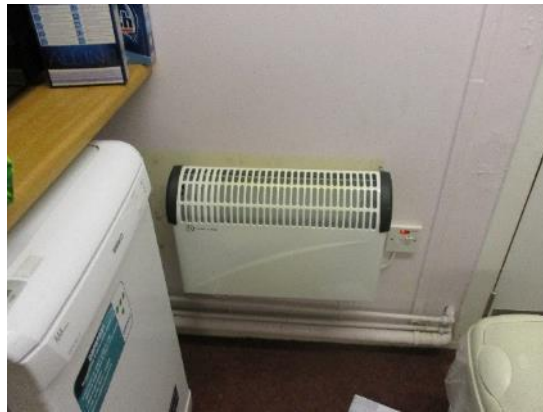
26. Portacabin staffroom convector

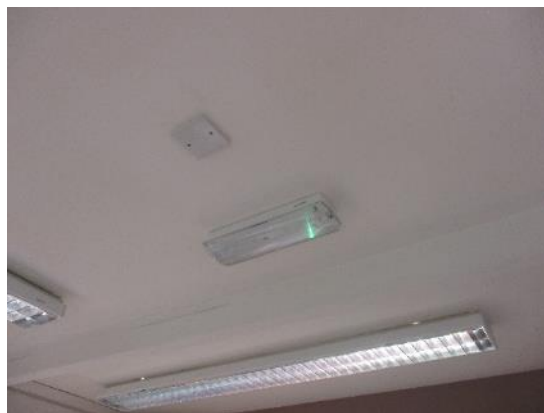
30. Main school lighting and emergency lights

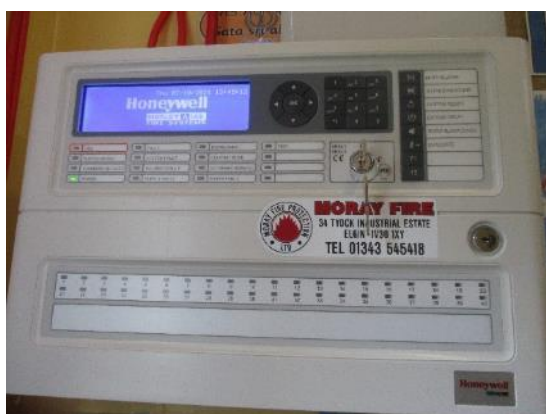
31. Main school fire alarm panel

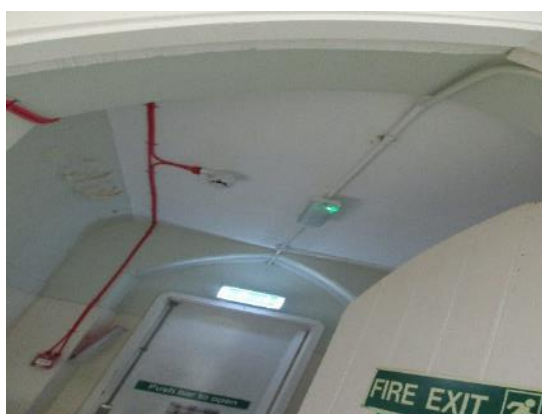
32. Fire alarm system wiring and devices.

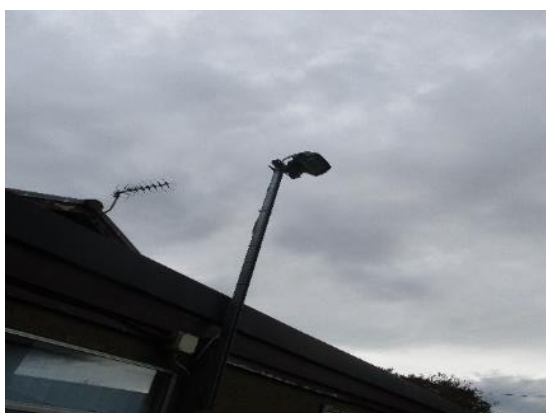
35. Main school external floodlight

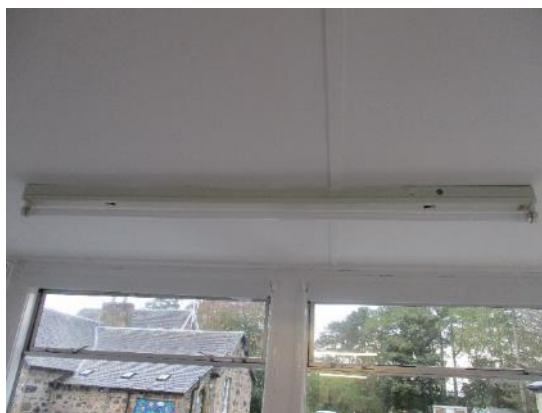
36. Main school Portacabin lighting

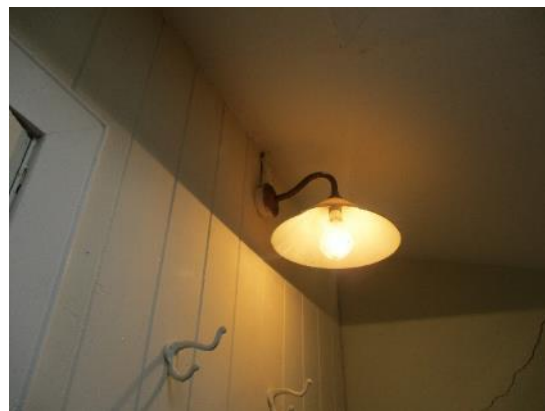
54. Lantern light – WC.

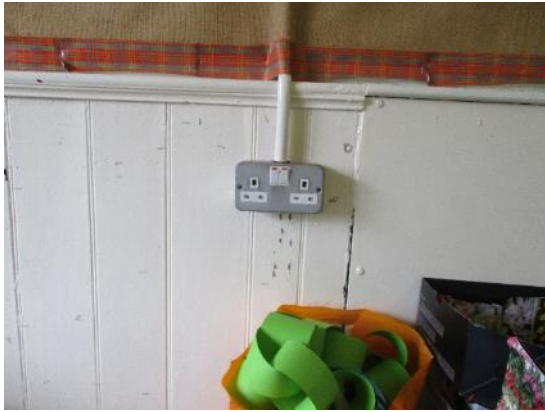
55. Double socket – hall.

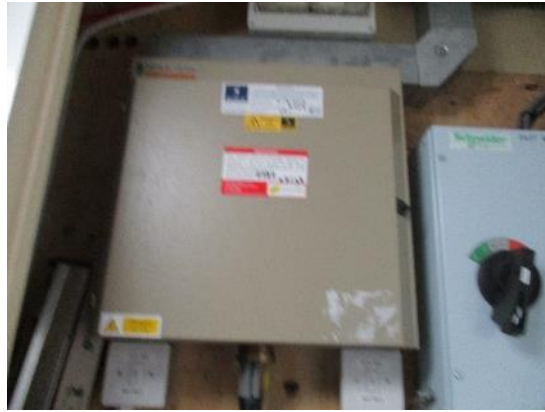
56. Distribution board.

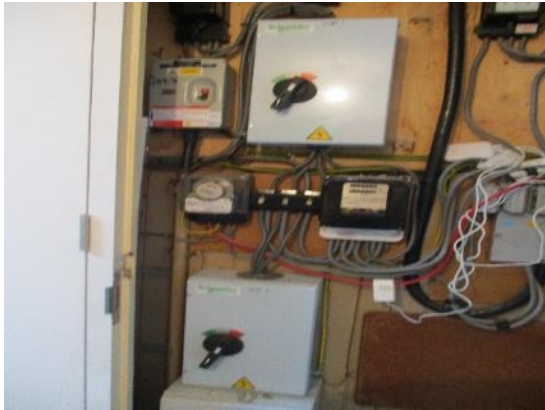
57. Switchgear and LV wiring.

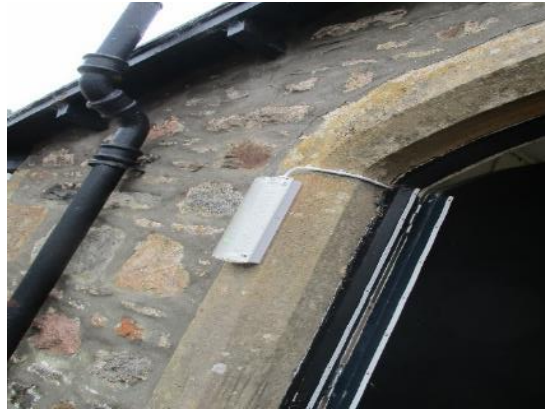
58. External emergency light.

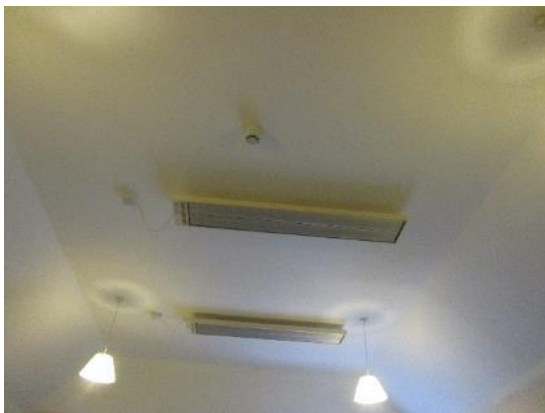
59. Hall store radiant panel heaters and lights.

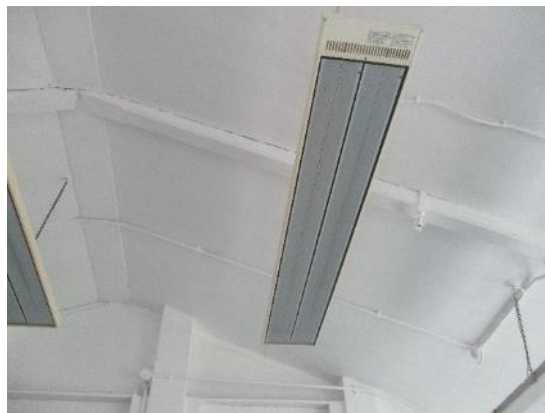
60. Hall radiant panel heaters

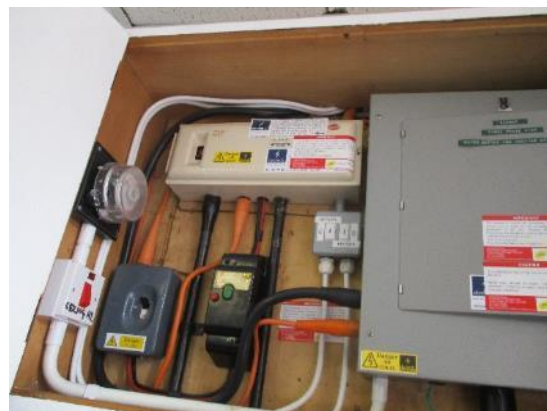
72. Dining hall boards and devices.

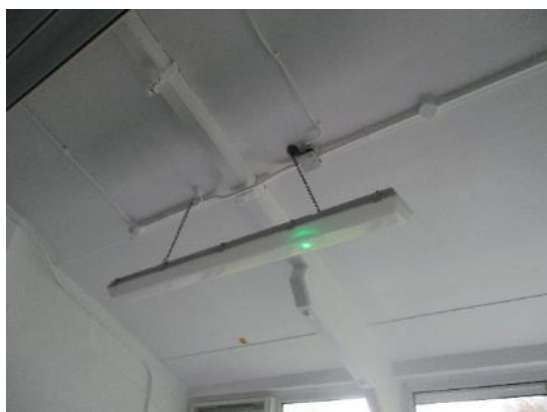
73. Kitchen Light

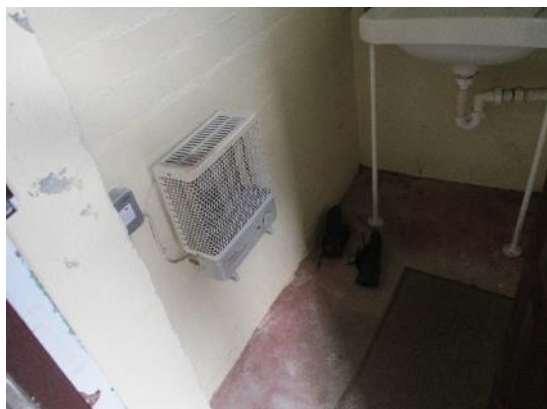
75. WC Frost heater

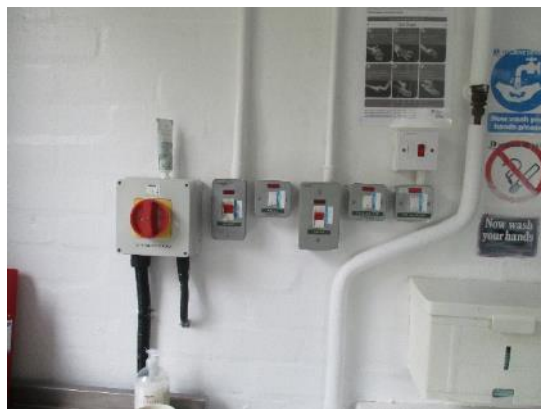
76. Kitchen isolators and switches

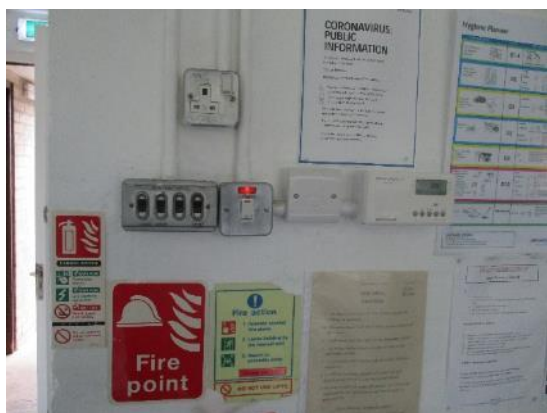
77. Kitchen switches.

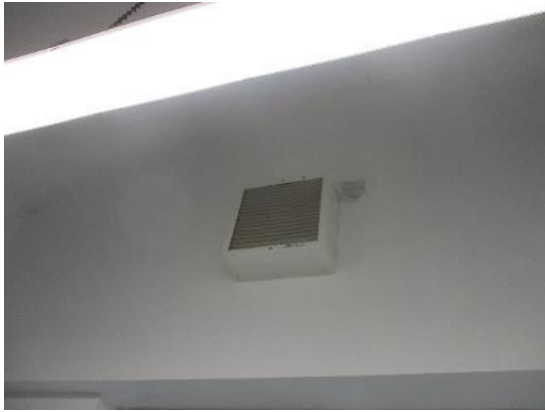
79. Kitchen extract fan.
