# **Summary Building Condition Survey Report**

**Pilmuir Primary School  
Pilmuir Road, Forres IV36 1HD**

**30<sup>th</sup> & 31<sup>st</sup> March 2022**

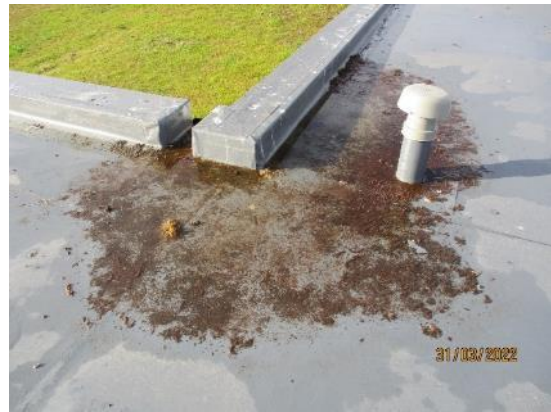
7. Part blocked rainwater outlets

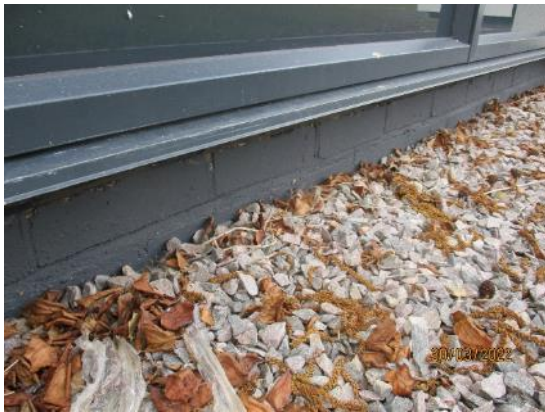
- External walls cracked and roughcast boss in a number of areas.
- Windows, glazing and ironmongery in poor condition.
- Inadequate roofspace insulation.

18. Cracks in masonry

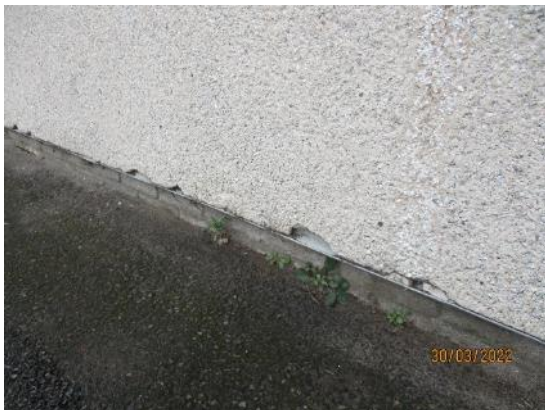
20. Roughcast repairs

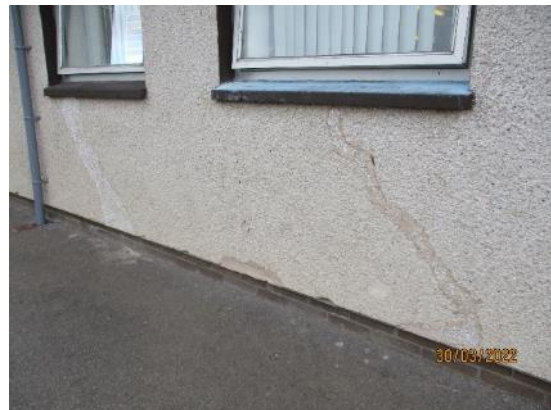
21. Spalling at bellcast bead

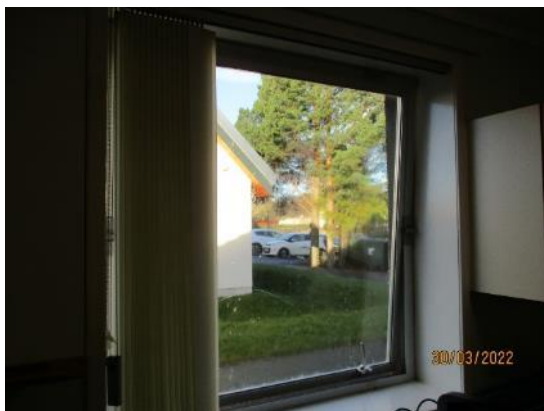
34. Failing seals

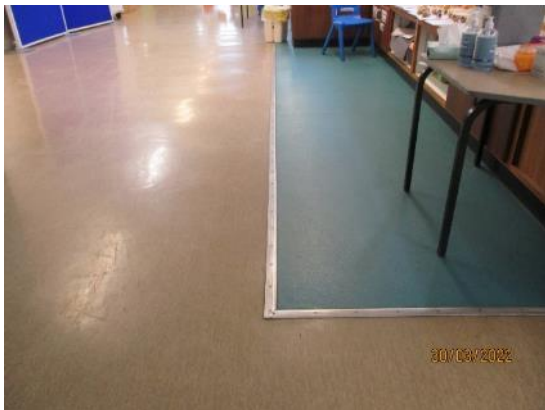
50. Sheet vinyl, scuffed and worn

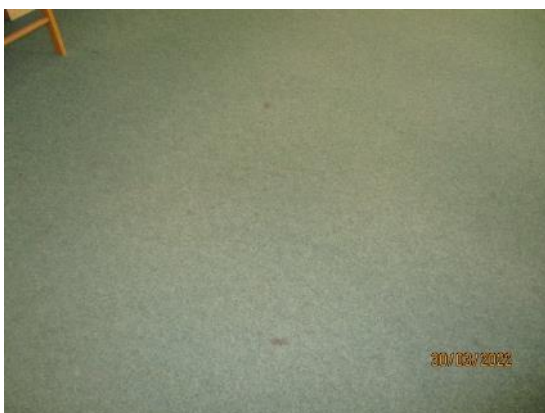
52. Carpet soiled and worn

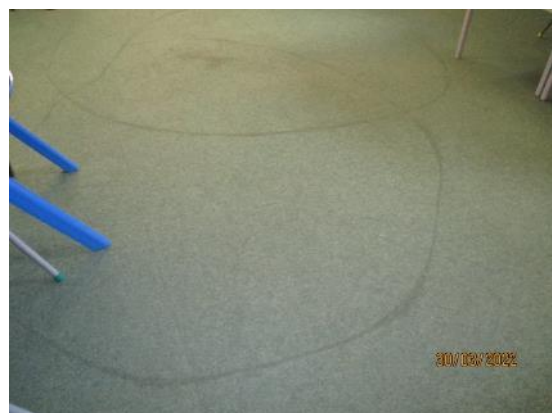
53. Carpet soiled and stained

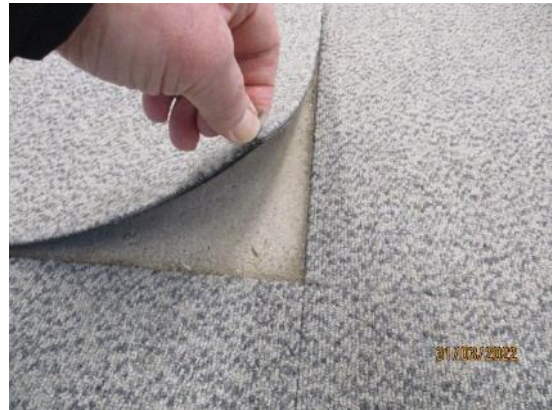
- Roof insulation loose and moving below single ply membrane.
- Rainwater ponding on flat roof.
- Silt and debris blocking rainwater downpipes.
- Carpet tiles lifting in Classroom 3.

57. Carpet tiles loose and lifting

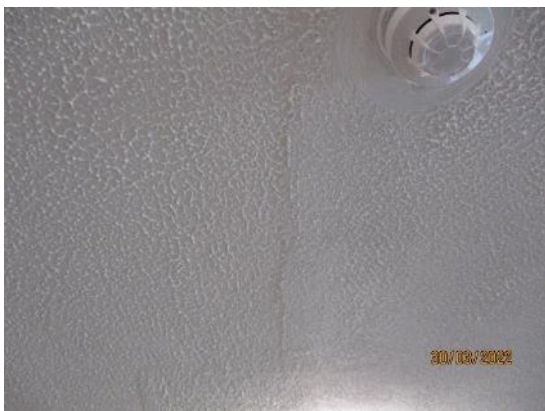
58. Textured ceilings – cracking at taped joints

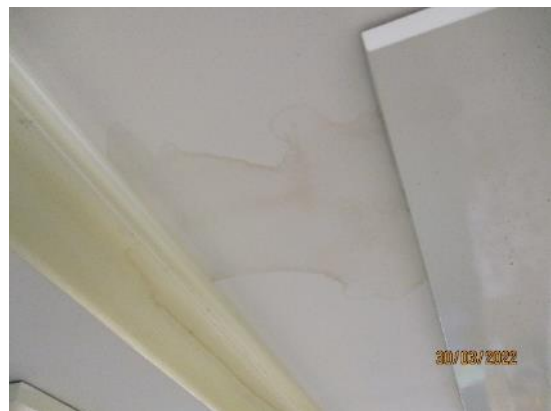
59. Flat ceilings - watermarked

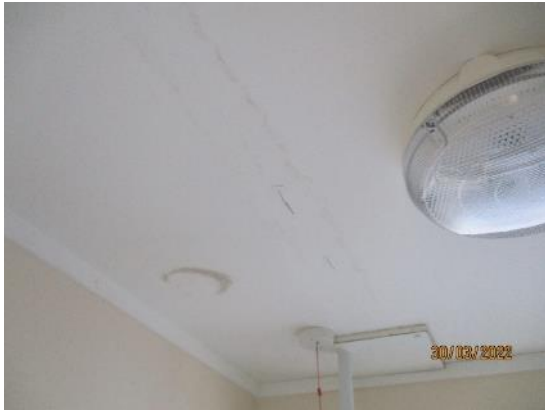
60. Failed taped joints

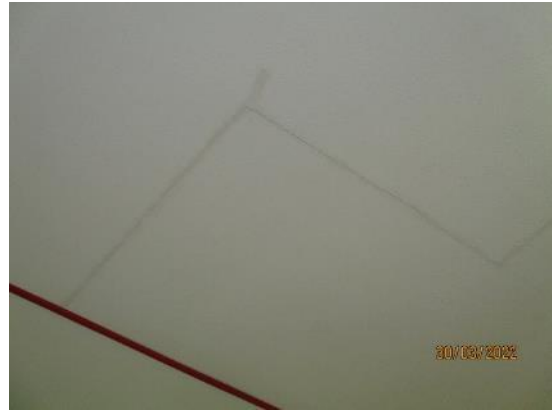
61. Plasterboard open joints

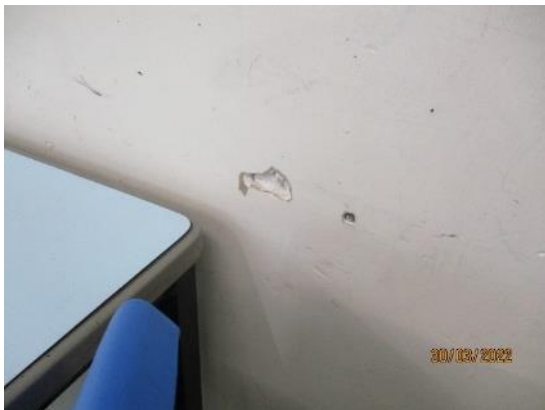
62. Isolated areas of surface damage

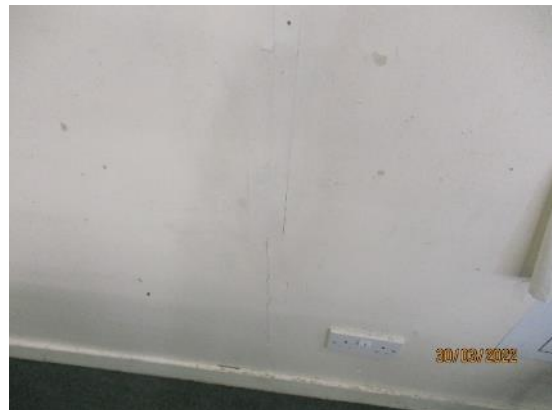
63. Plasterboard taped joints failing

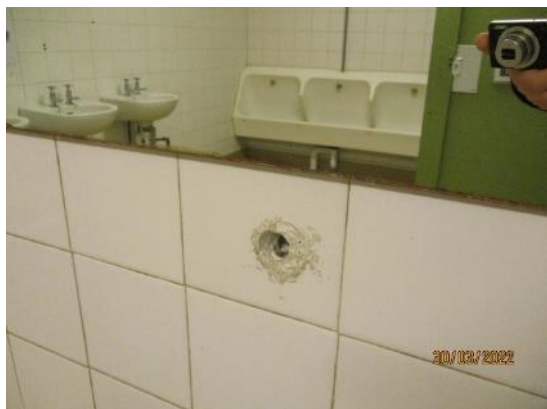
68. Damaged wall tiles

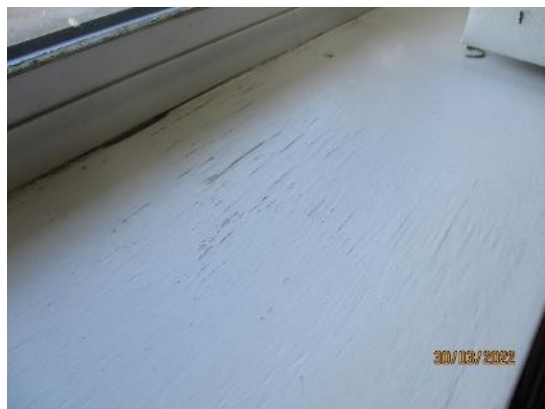
69. Timber window sills, cracking and peeling

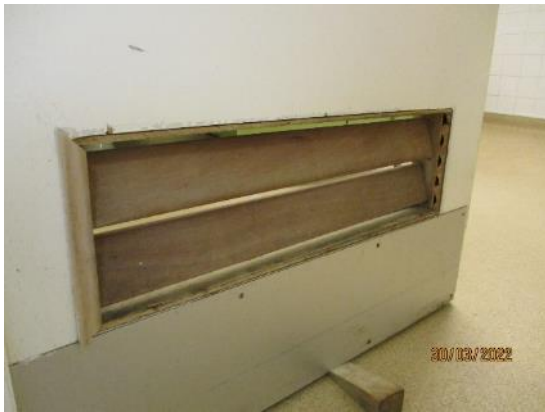
72. Isolated areas of damage to timber doors

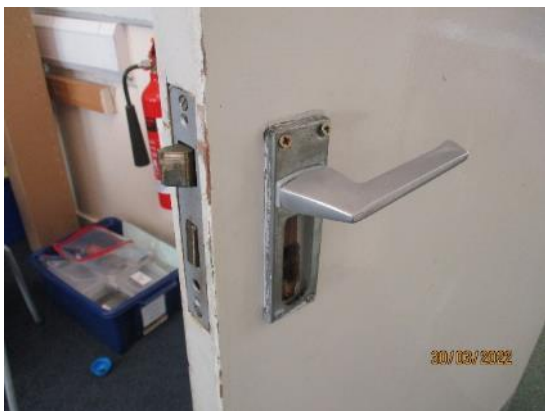
76. Ironmongery – repairs required

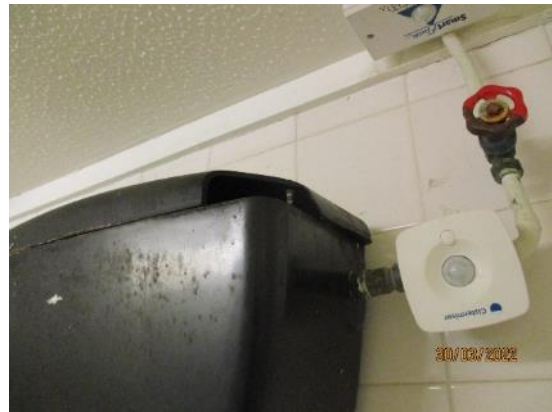
79. Damage to high level cisterns

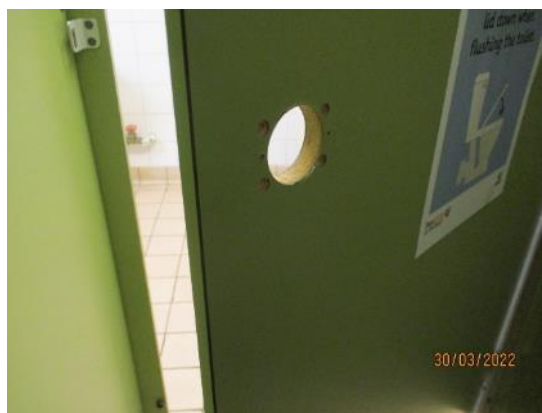
89. Missing ironmongery

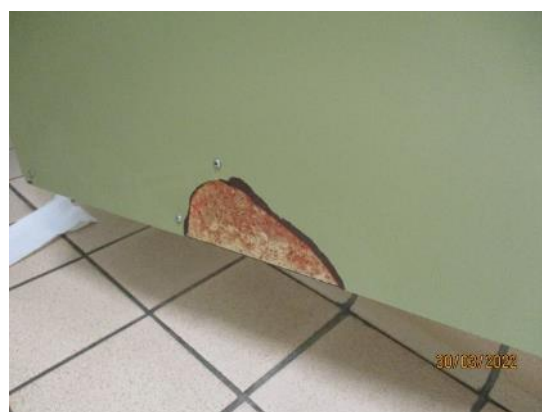
91. Chipped and broken surface

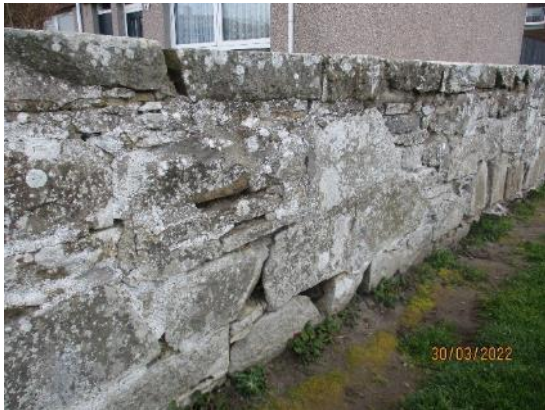
- Stone wall to East boundary crumbling, requires repair and repointing.
- Concrete posts to chain link fence leaning and require stabilised.
- Access road and car park, tarmacadam breaking up and potholed.

181. Stone wall repairs and repointing required
