# **Summary Building Condition Survey Report**

**Cluny Primary School  
South Pringle Street, Buckie AB56 1PX**

**25<sup>th</sup> and 26<sup>th</sup> April 2022**

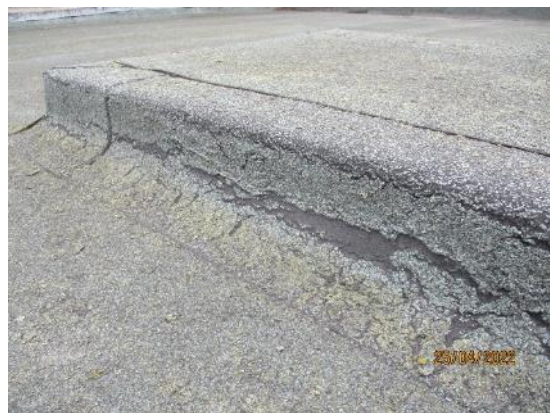
11. Felt surface crazing

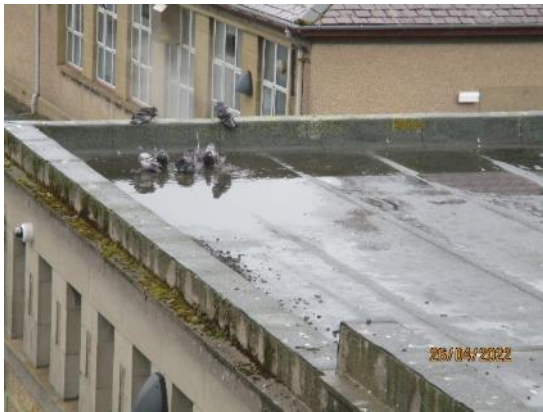
12. Felt surface cracking

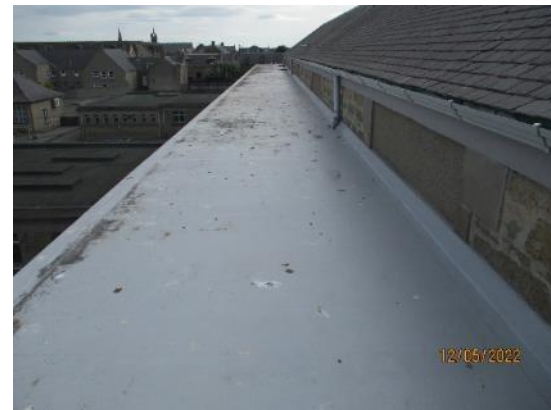
15. Felt cracking and crazing

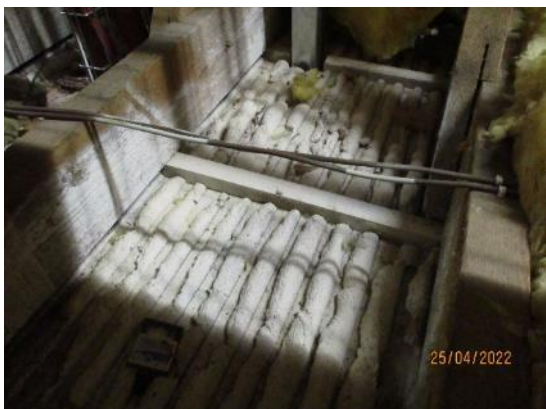
20. Insulation disturbed in main school roof

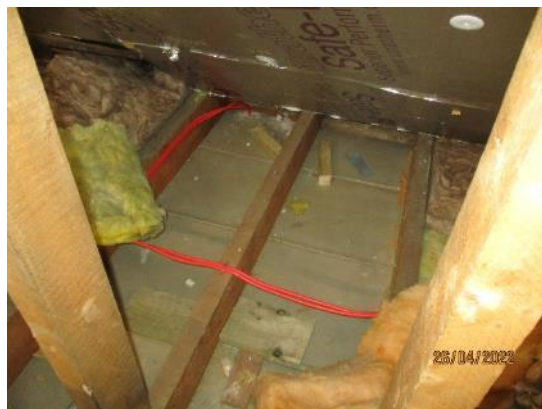
21. Insulation missing in main school roof

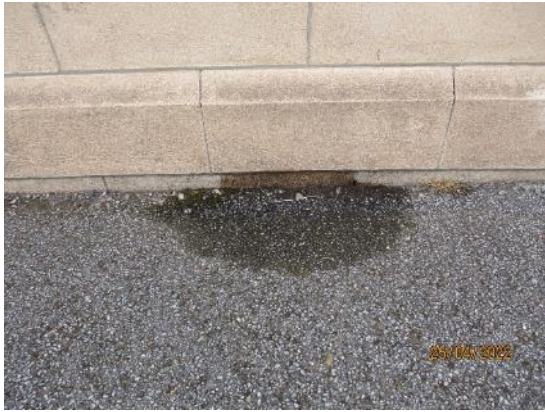
24. Leaking gutter joints

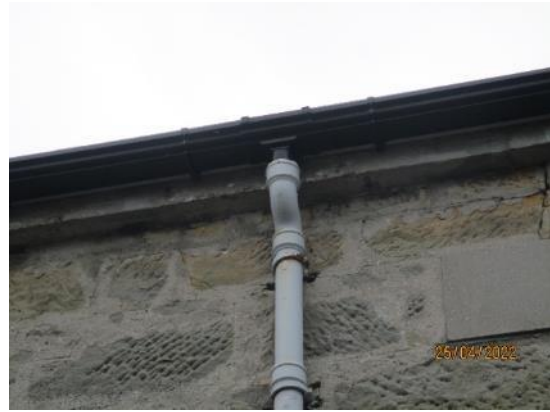
25. Leaking gutter joints

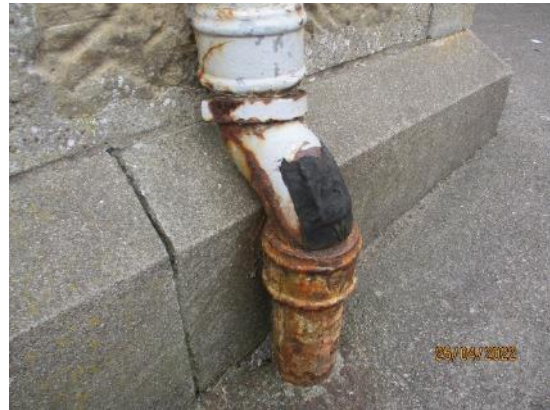
33. Damage to cast iron rainwater downpipes

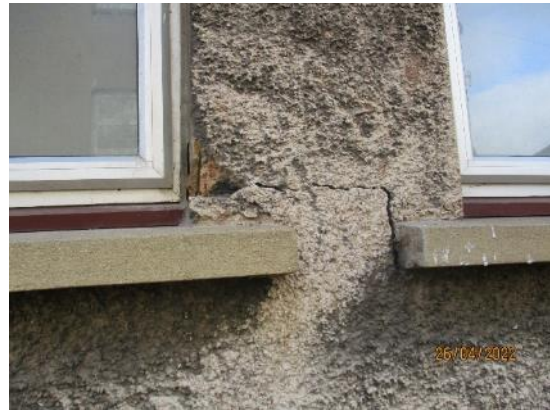
39. Isolated cracking, pointing required

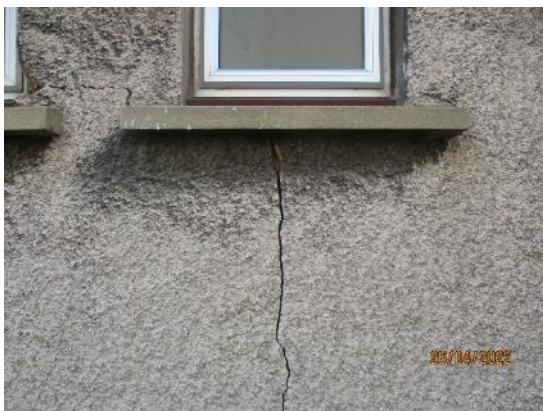
40. Cracking to Dining Hall walls

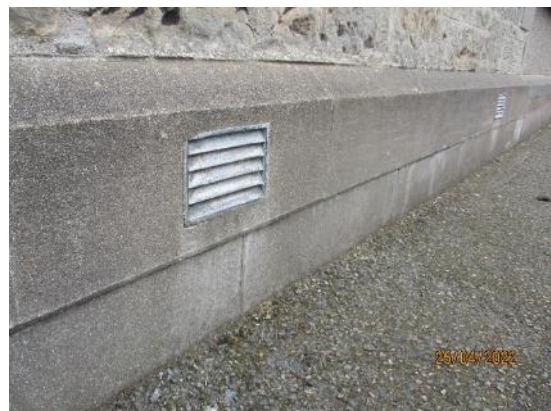
41. Cracking to Dining Hall walls

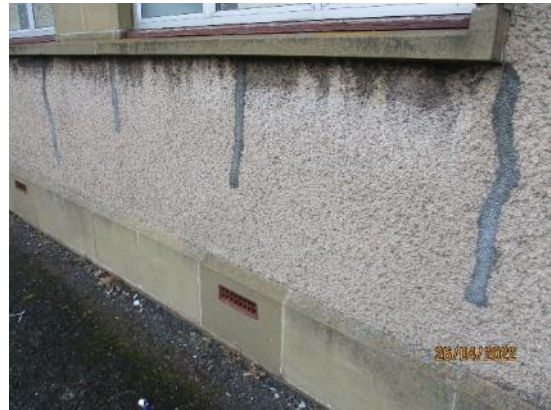
45. Isolated spalling of render panels

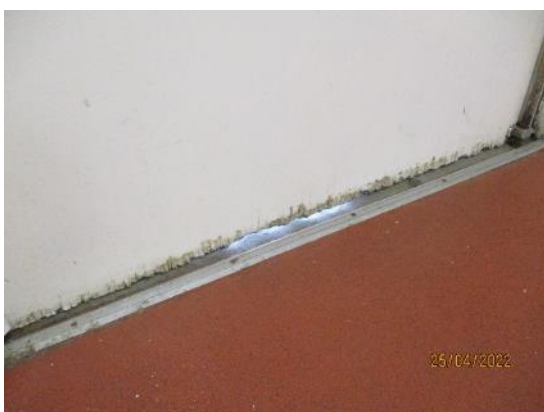
50. Timber wet rot

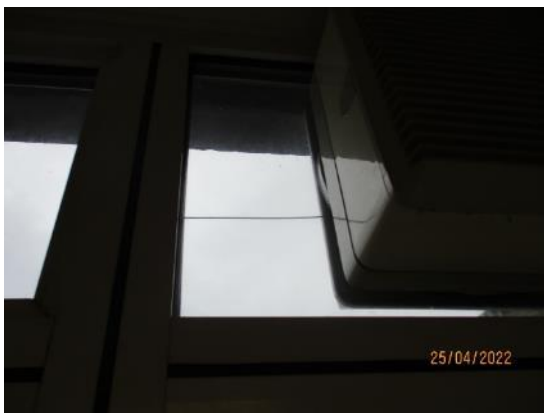
58. Defective double glazed units

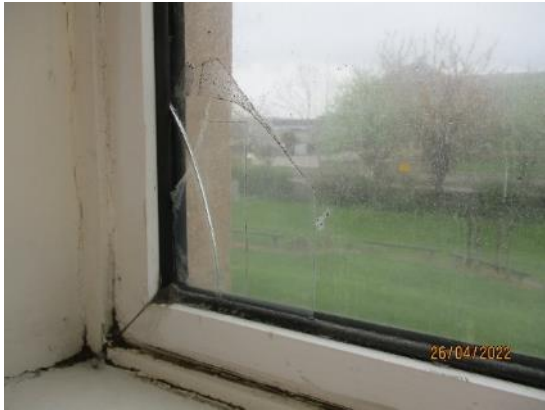
60. Defective double glazed units

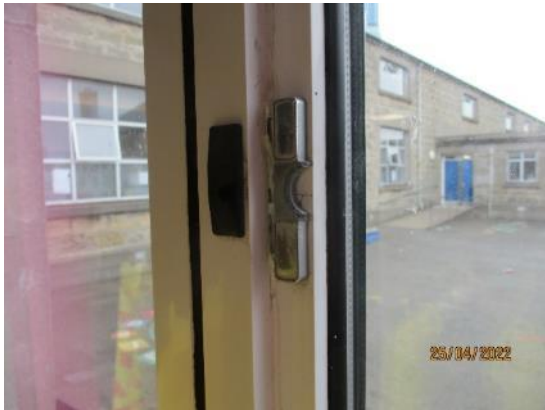
62. Defective/missing ironmongery

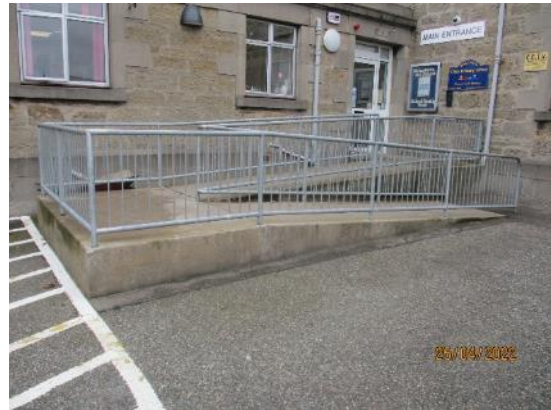
74. Cracked concrete ramps

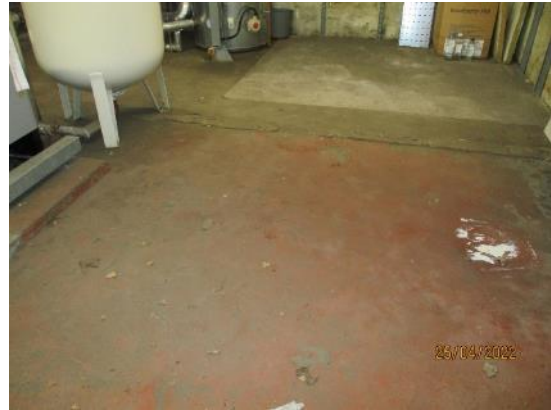
84. Timber flooring repairs

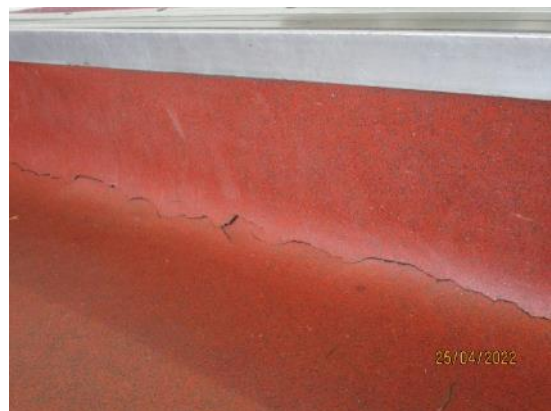
88. Vinyl taped repairs

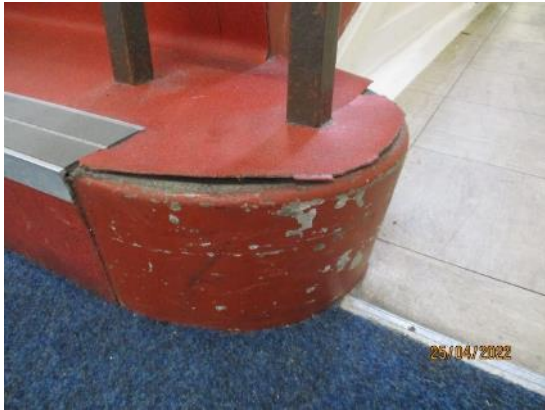
89. Vinyl cracked

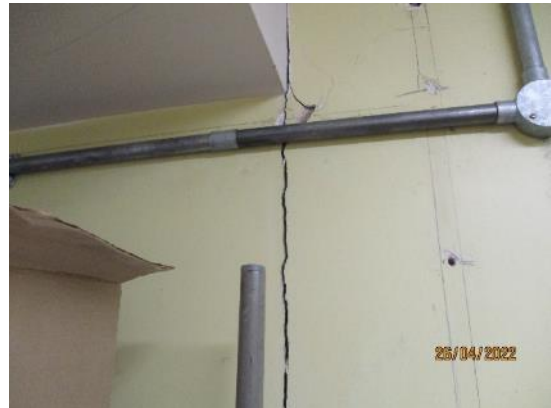
98. Dining Hall cracked walls

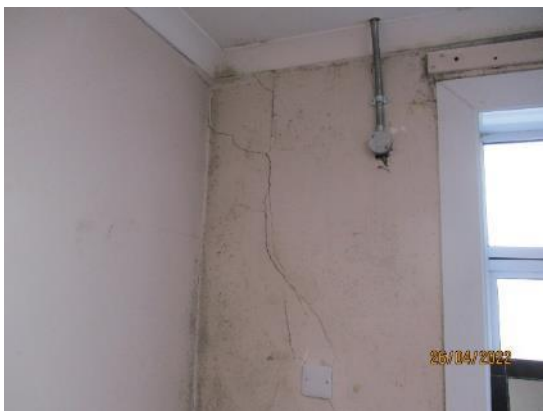
99. Cracking to masonry walls

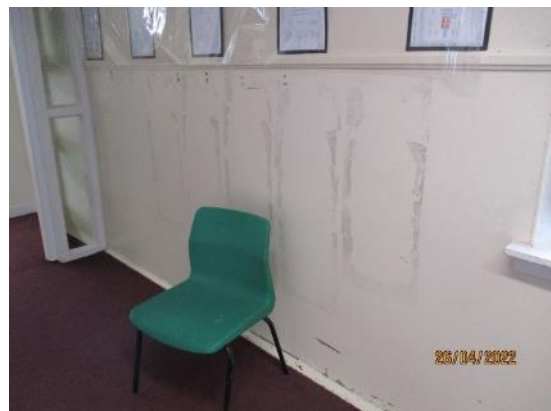
100. Damaged fibreboard linings

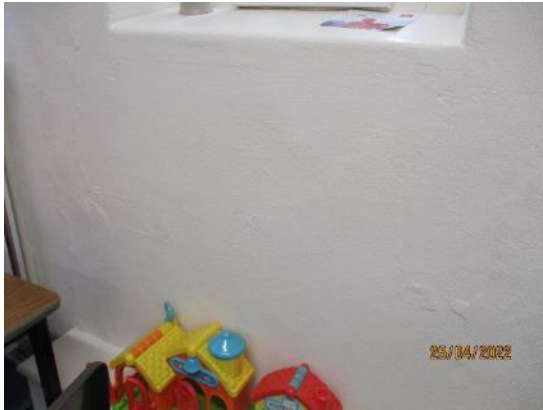
101. Damaged plastered walls

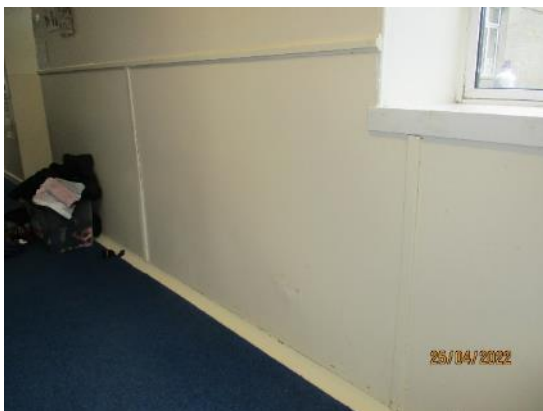
104. Damaged plasterboard walls

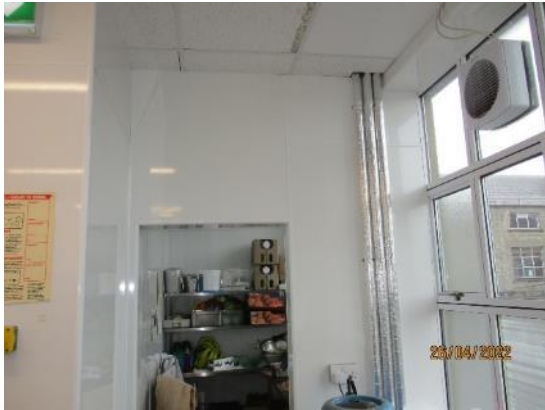
106. Fibreboard linings damaged

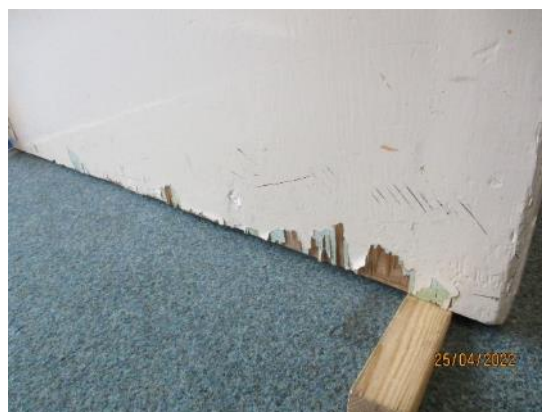
113. Damaged timber doors

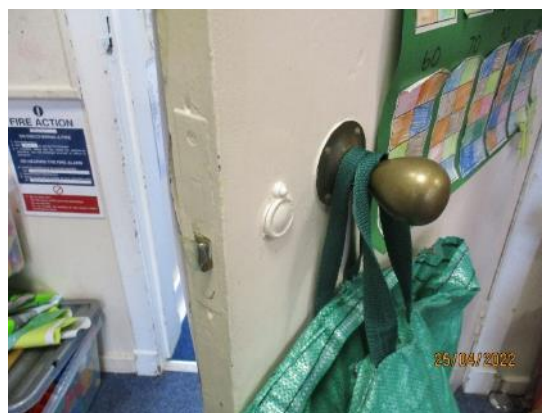
117. Defective ironmongery

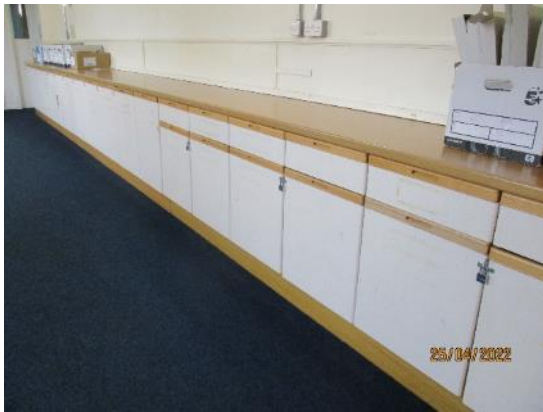
130. Damage to base units

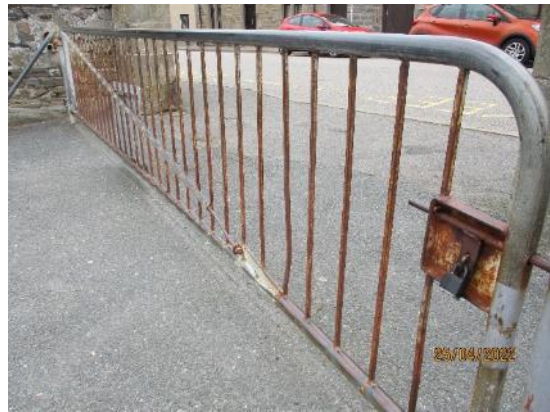
231. Corrosion of tubular gates

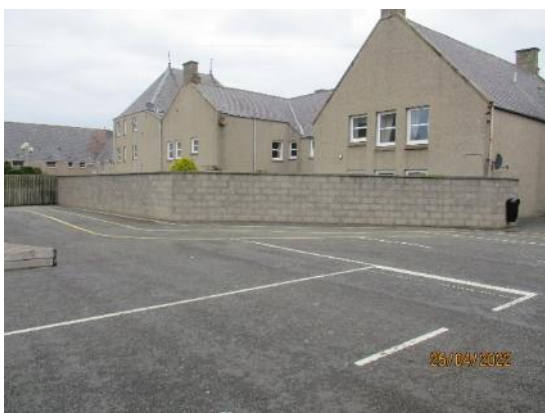
234. Damage to blockwork walls

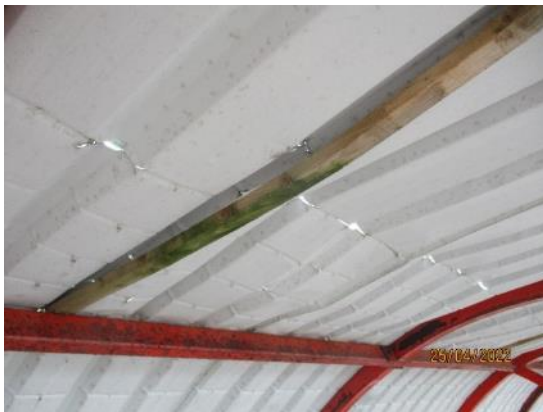
244. Corrosion of the steel frame
