# **Summary Building Condition Survey Report**

**Cullen Primary School  
Old Church Road, Cullen AB56 4UZ**

**7<sup>th</sup> June 2022**

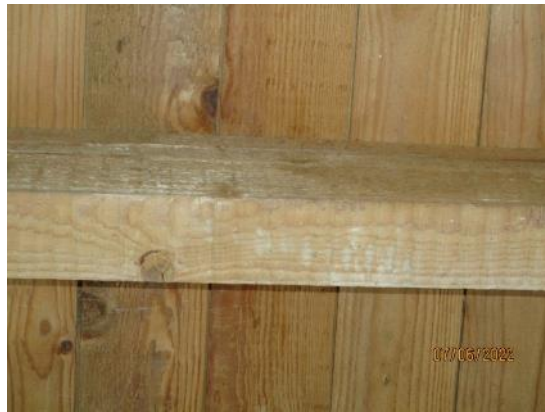
2. Woodworm in joists

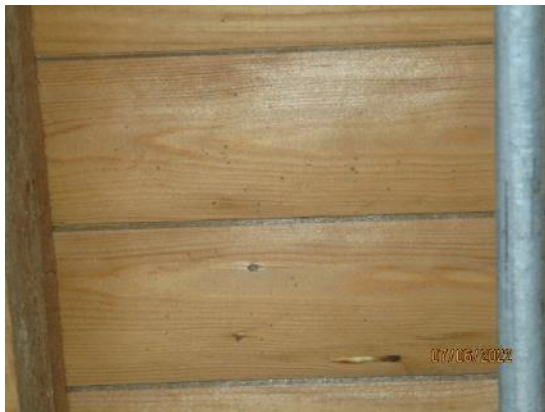
3. Woodworm in boards

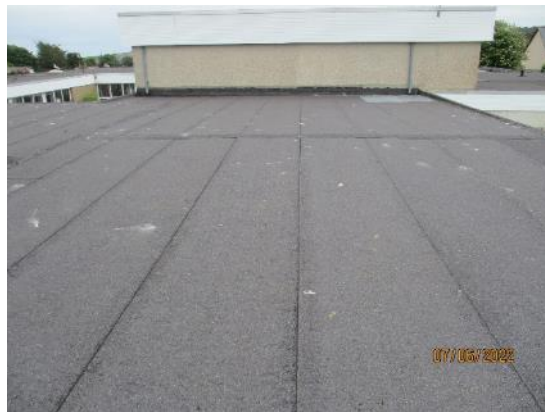
4. Felt roofing

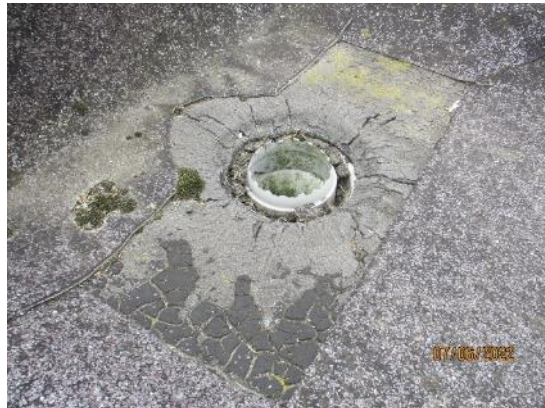
10. Cracking of surface

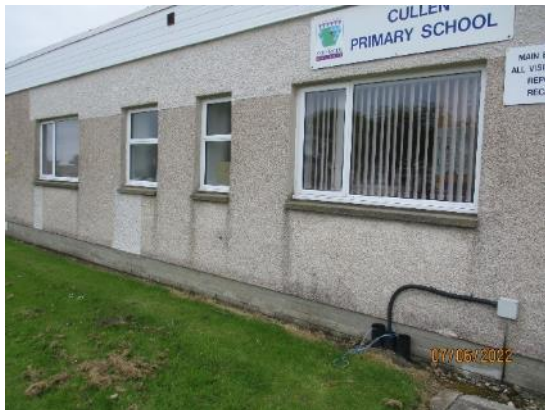
15. Patch repairs to roughcast

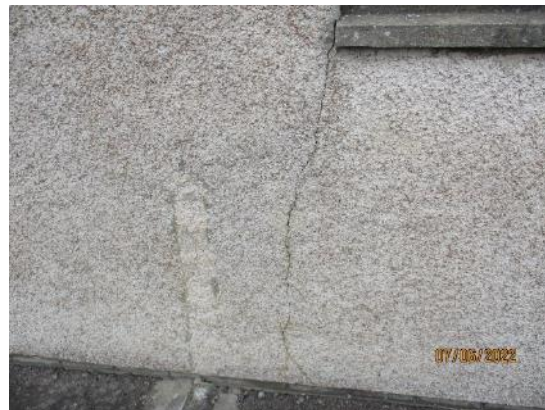
16. Isolated hairline cracking

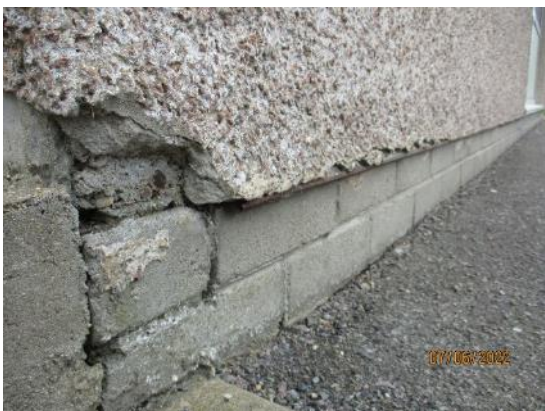
17. Damage to bellcast bead

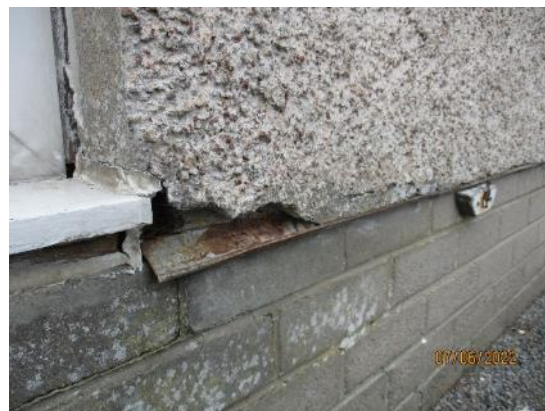
18. Corrosion and damage

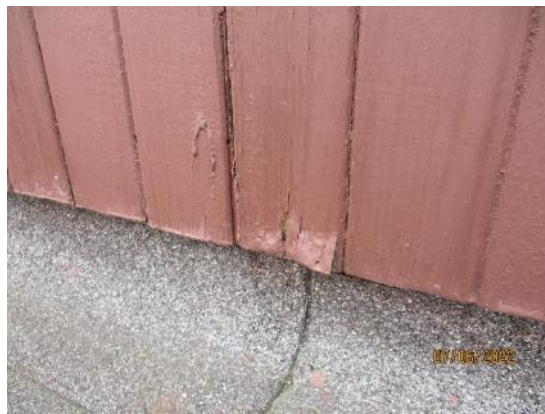
20. Rot in timber boards

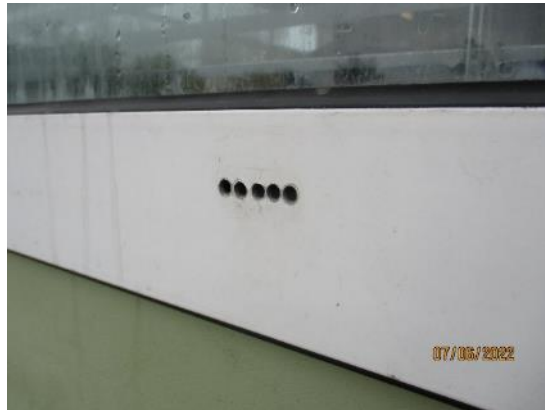
28. Missing weep hole covers

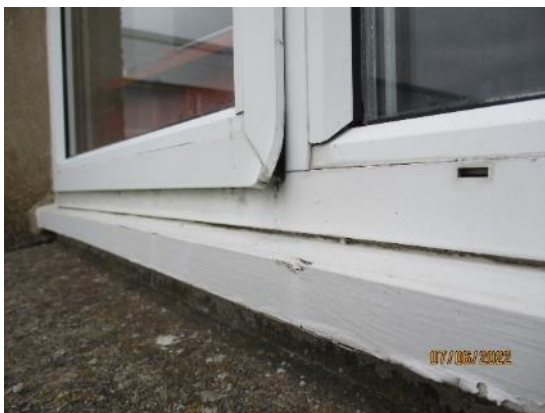
29. Damaged window casement

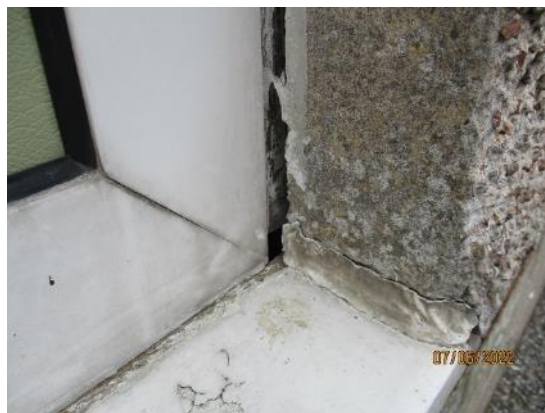
30. Missing sealant to window frames

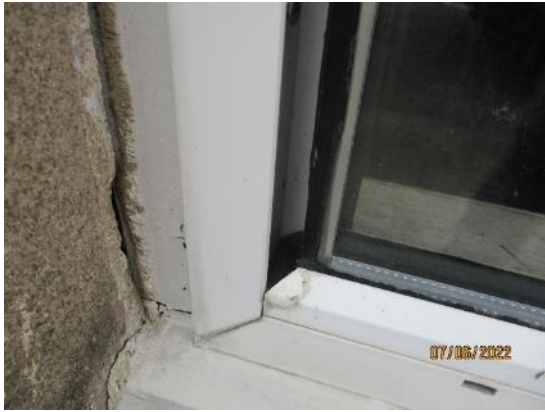
31. Missing glazing bead to boiler room

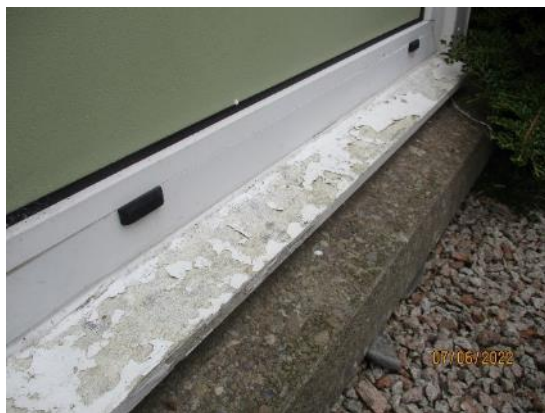
35. Paint peeling on sills

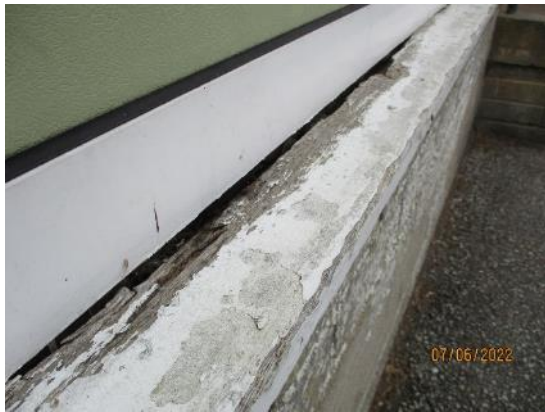
37. Rot and missing sealant

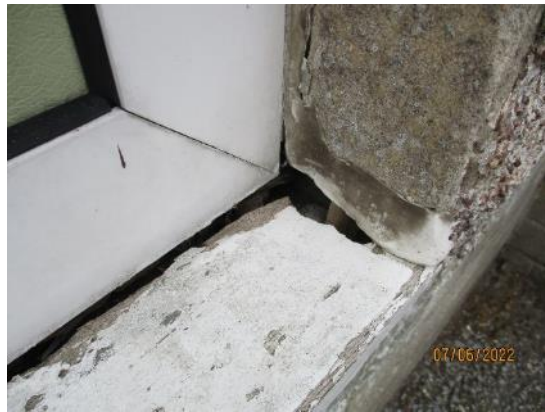
38. Rotten timber sills

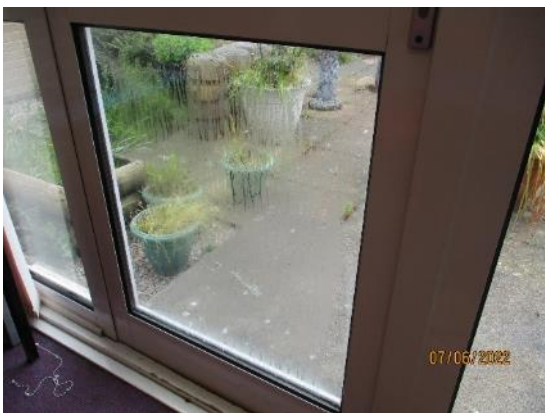
41. Blown double glazing units

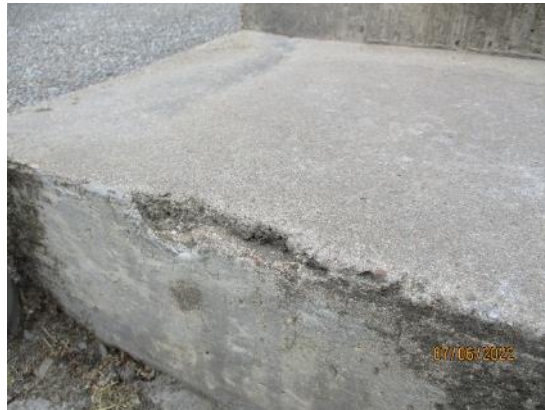
46. Damage to nosings

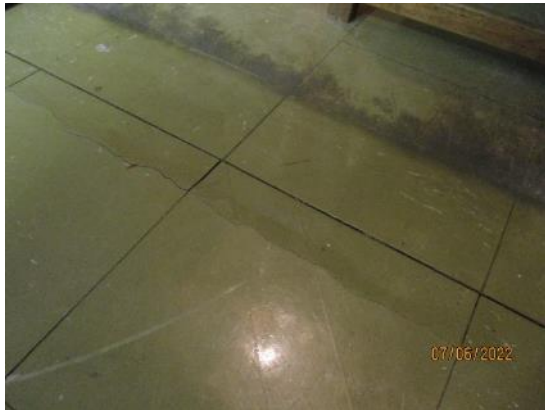
51. Damaged vinyl tiles

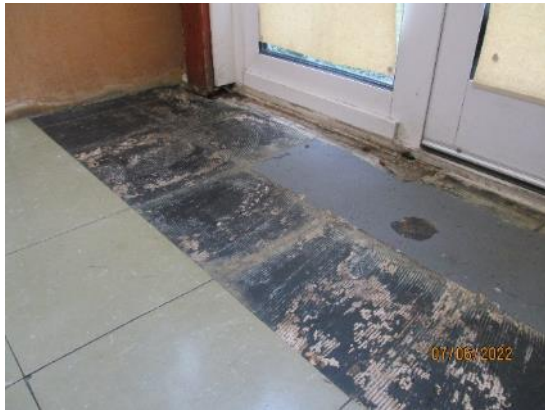
52. Missing vinyl tiles

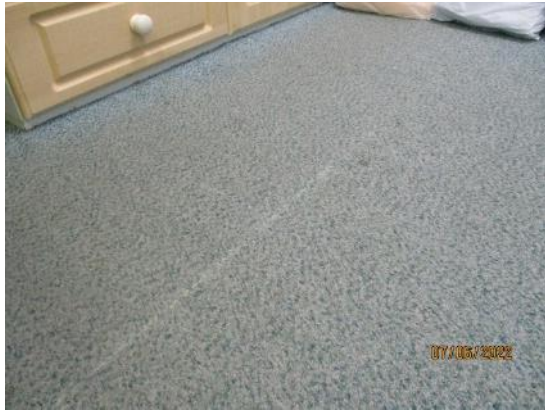
55. Worn carpet

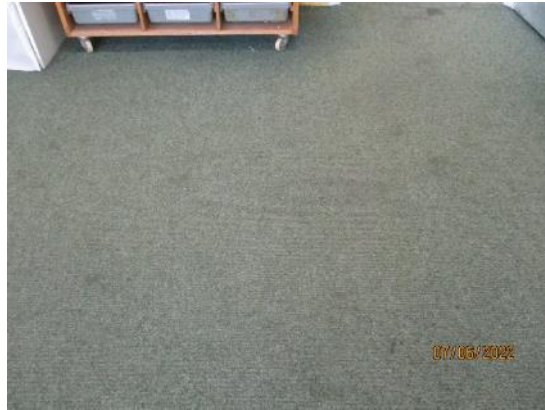
56. Soiled carpet

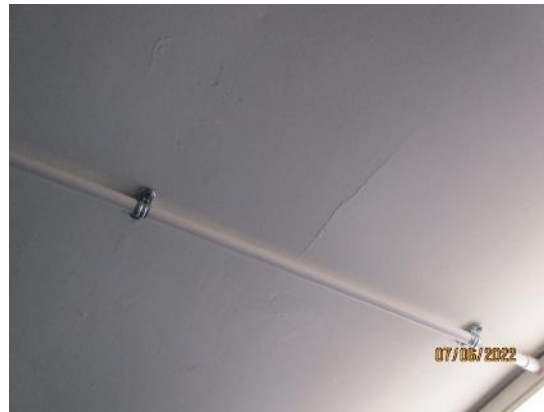
61. Plasterboard with hairline cracking

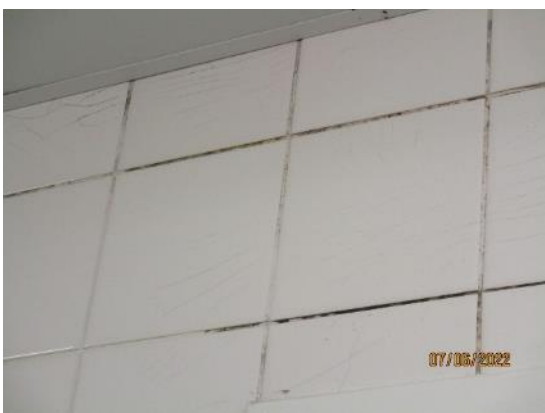
70. Soiled grouting to tiles

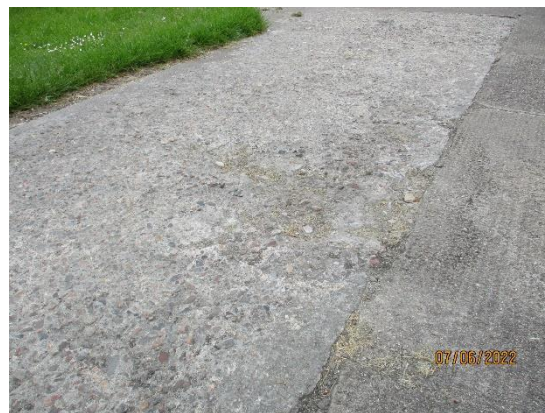
166. Surface erosion

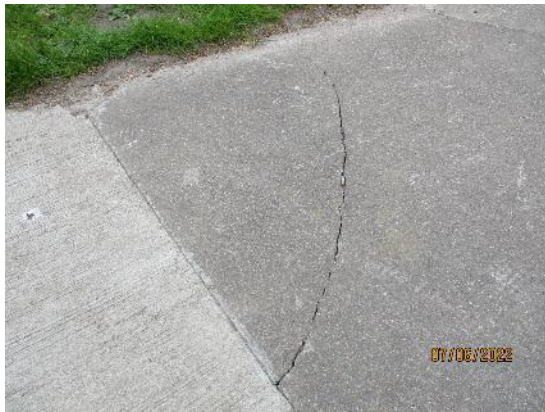
167. Cracked concrete paths

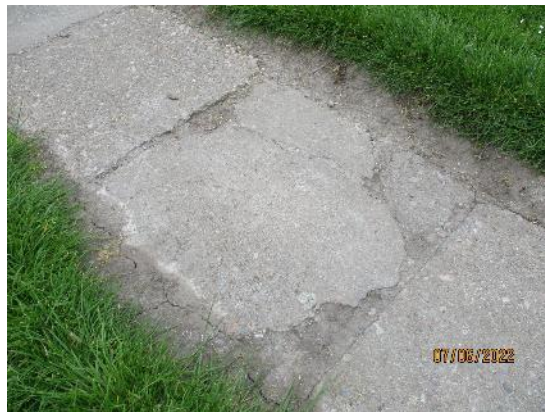
170. Cracked and uneven

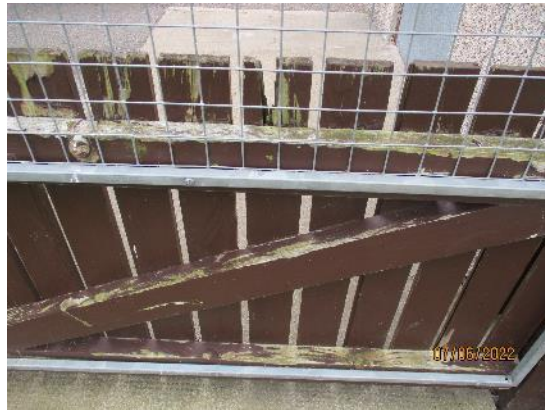
176. Timber rot and flaking paint

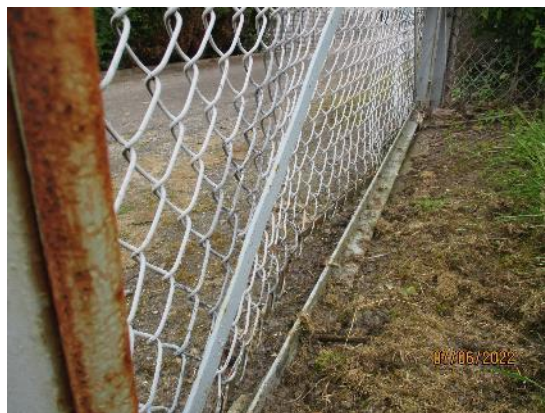
178. Damage and surface corrosion

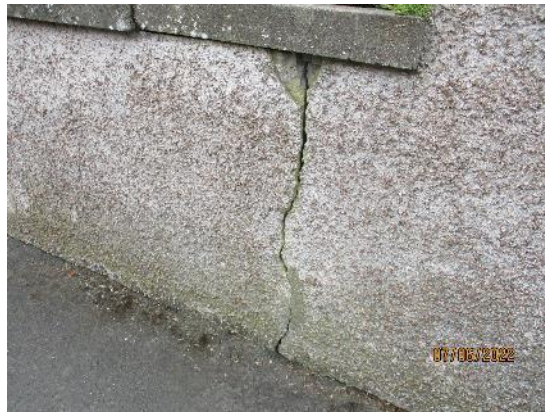
180. Cracks in boundary wall

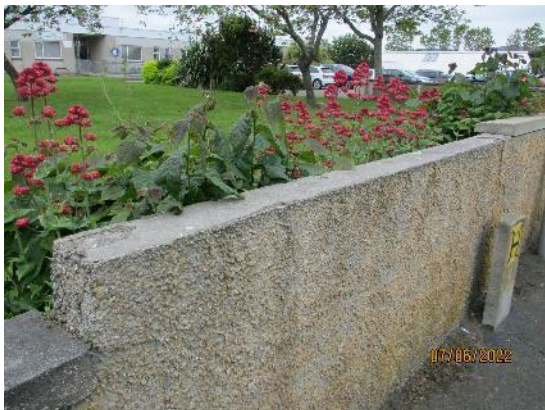
181. Missing coping stones

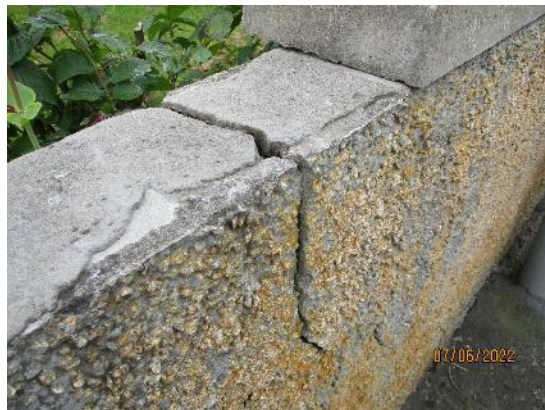
182. Significant movement

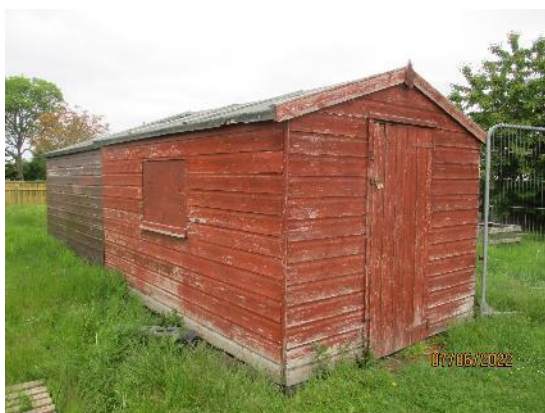
184. Timber sheds
