# **Summary Building Condition Survey Report**

**Findochty Primary School  
Burnside Street, Findochty AB56 4QW**

**11<sup>th</sup> & 12<sup>th</sup> July 2022**

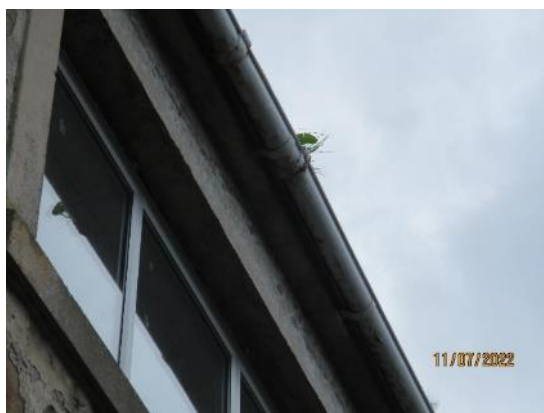
17. Extensive surface corrosion

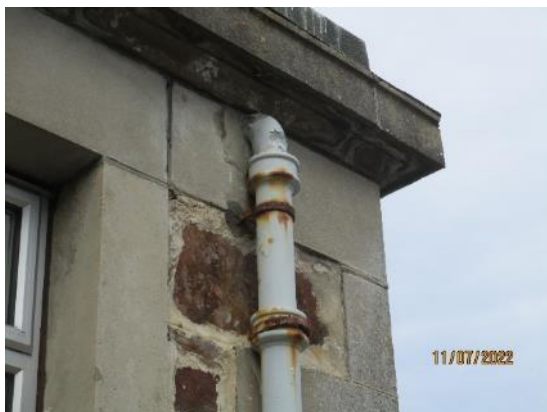
20. Outlets blocked with nesting material

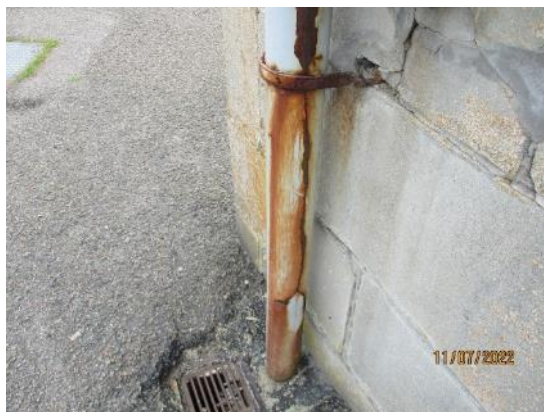
21. Corrosion to cast iron downpipes

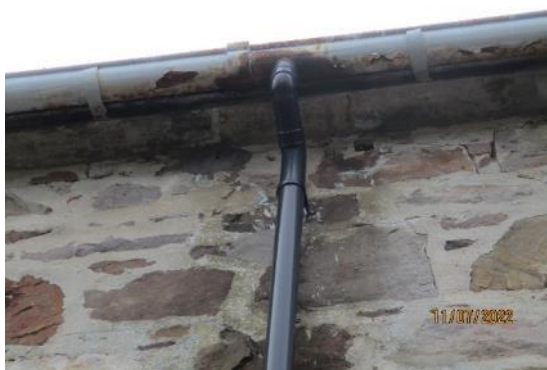
22. Cracked and leaking cast iron downpipes

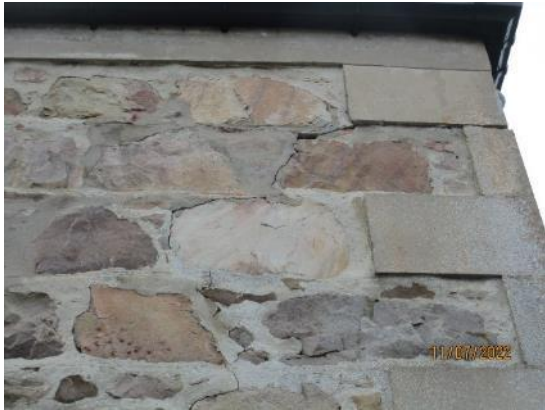
29. Vertical cracking

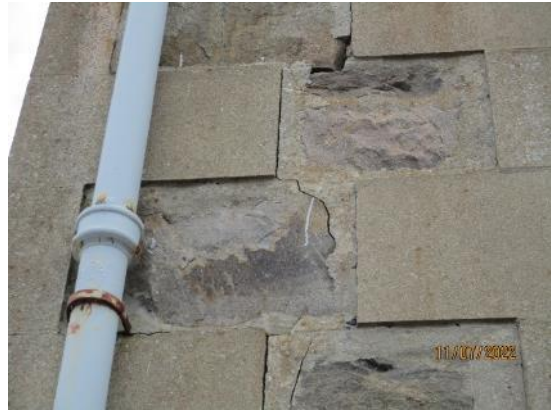
30. Isolated cracking

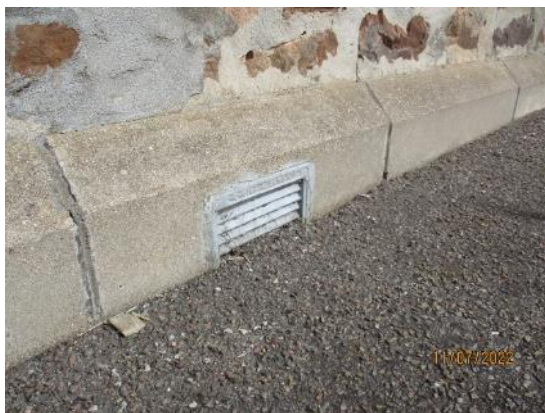
33. Damaged vents

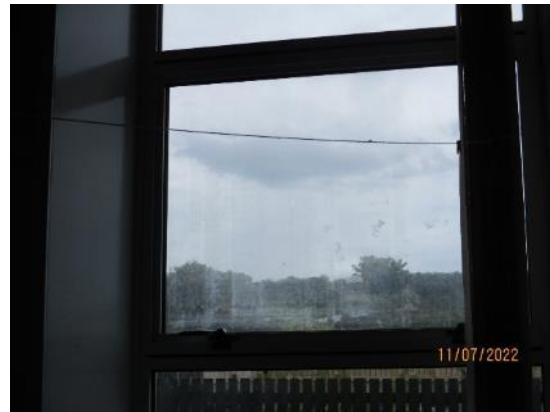
48. Broken double glazing unit

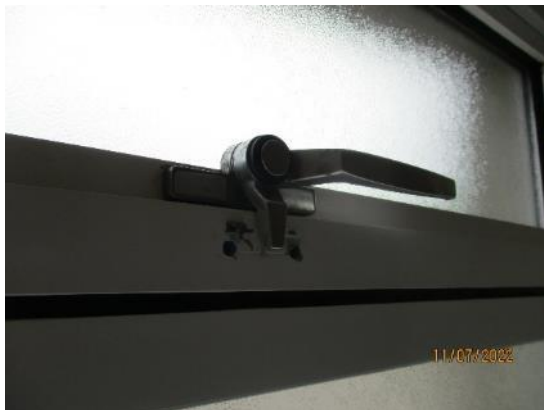
49. Fogged double glazing

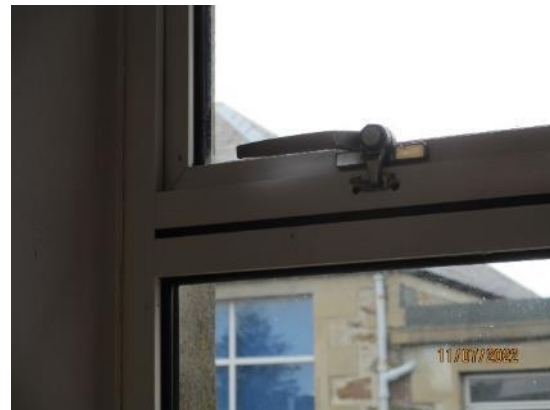
50. Window handles and missing friction wedges

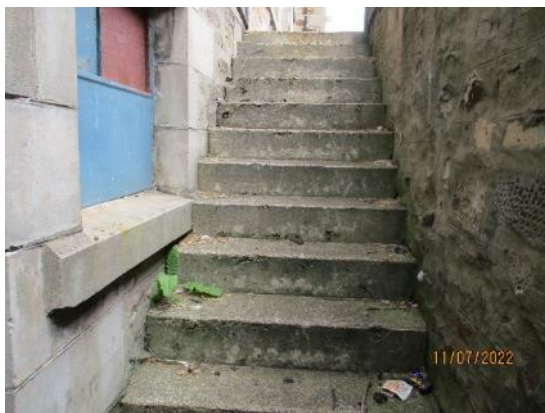
57. Cracked steps

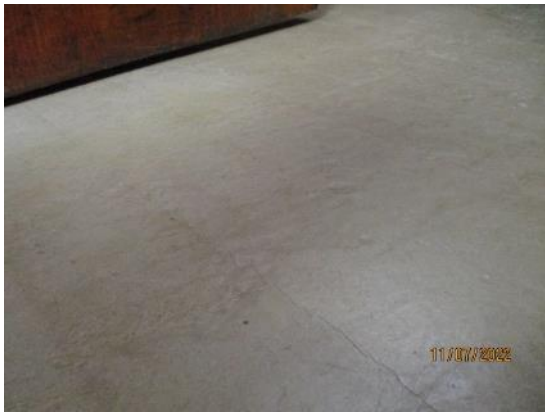
65. Sheet vinyl flooring, worn

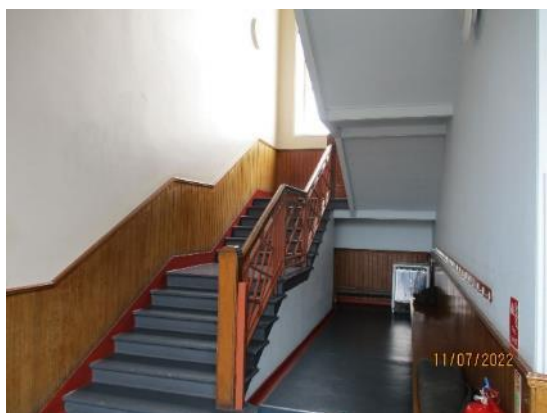
75. Extensive woodworm damage

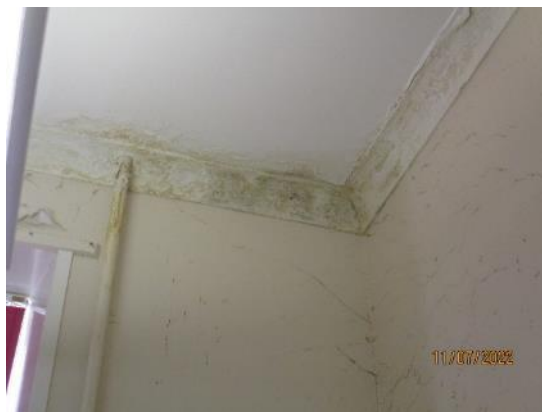
86. Cracked lath & plaster ceilings

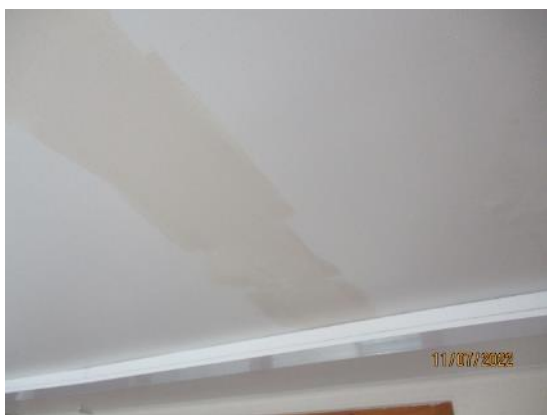
87. Damp ceiling and cornice

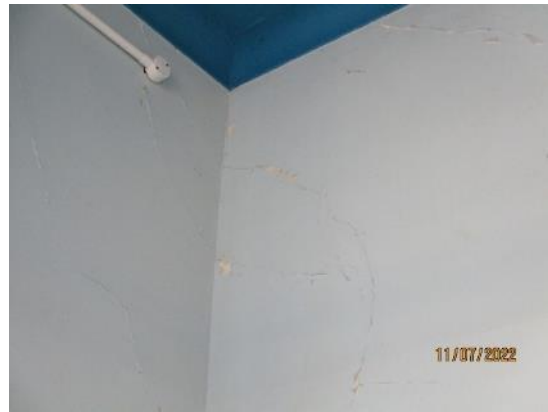
90. Repairs to plasterboard walls

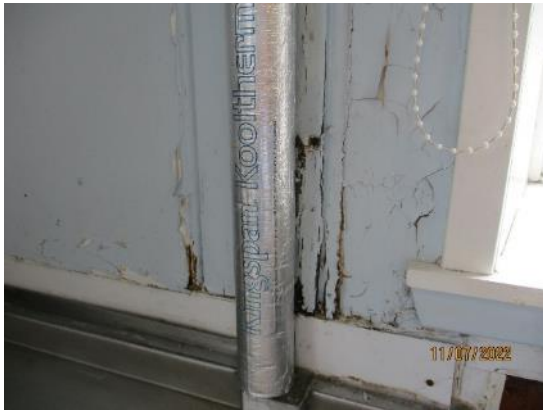
91. Cracking to lath & plaster walls

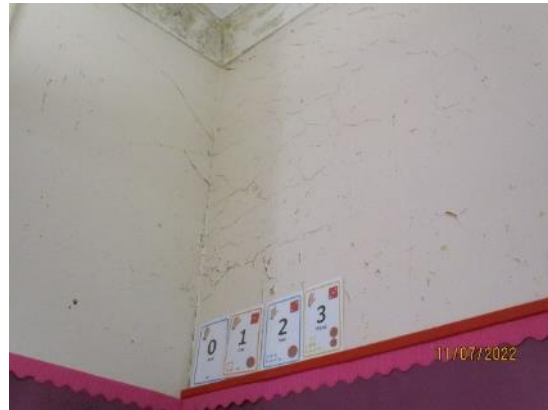
92. Damage to lath & plaster walls

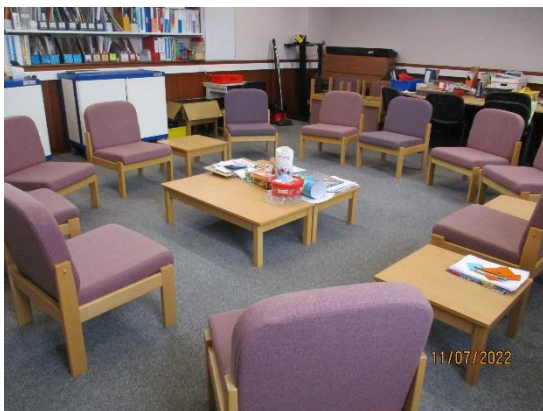
135. Typical damage to desks

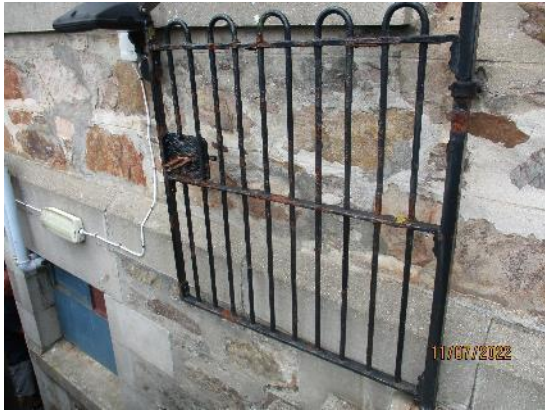
196. Surface corrosion and damage

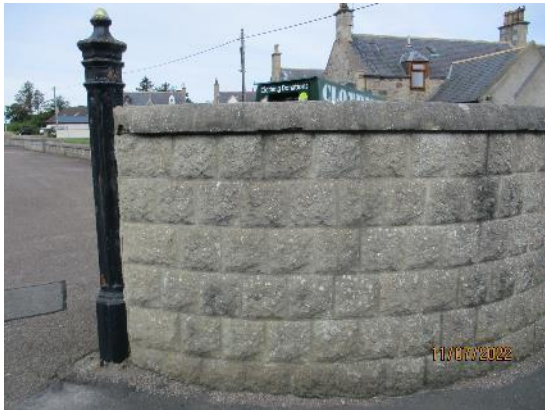
200. Extensive penetrating corrosion

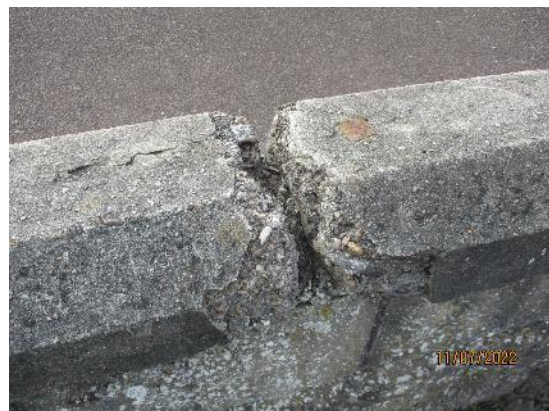
203. Damage to concrete coping

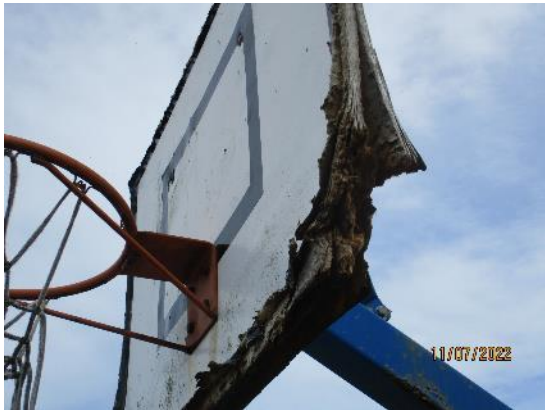
218. Steel stands with surface corrosion
