# **Summary Building Condition Survey Report**

**Millbank Primary School  
McWilliam Crescent, Buckie AB56 1LU**

**18<sup>th</sup> & 19<sup>th</sup> July 2022**

Z00445 / ADC & NS

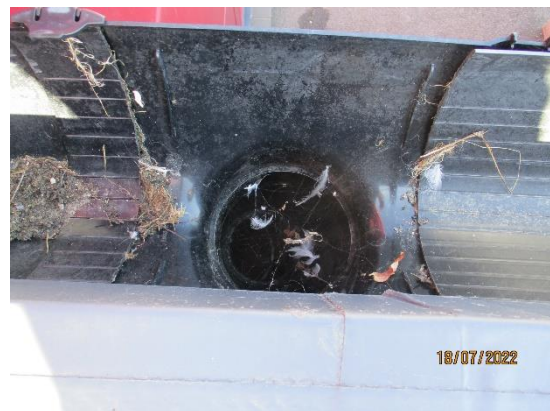
17. Boiler house downpipes – broken brackets

- Improved sub-floor ventilation below timber suspended floors.
- Improved sill detail at bottom of metal wall cladding.
- Strengthen downpipe brackets to metal box downpipes.
- Investigate sunken tarmacadam in Nursery playground.

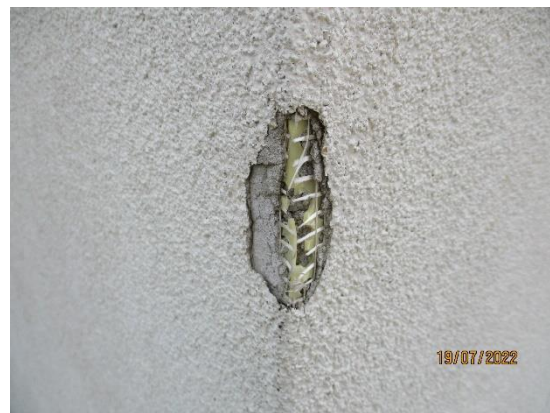
23. Damage to external insulation

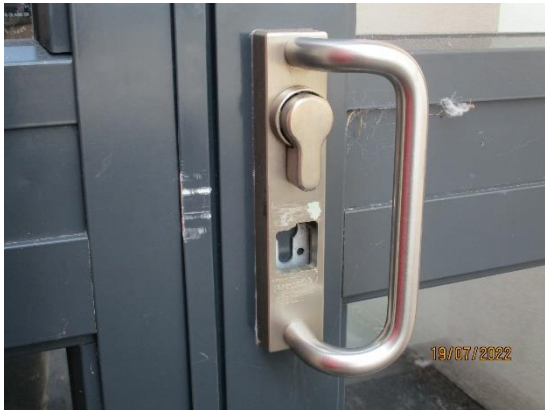
32. Poor fitting fire escape doors

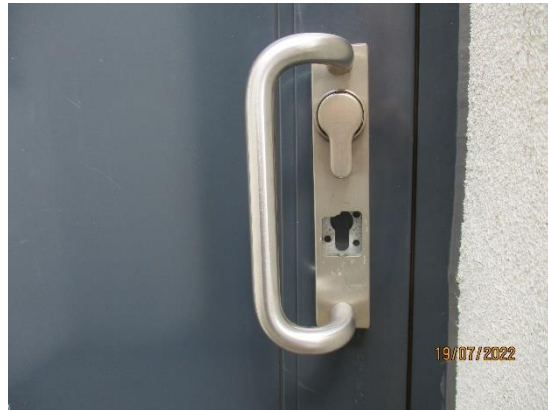
33. Damage to fire escape doors

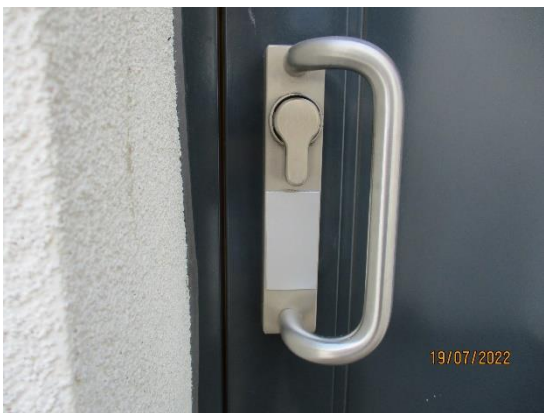
34. Damage to fire escape door ironmongery

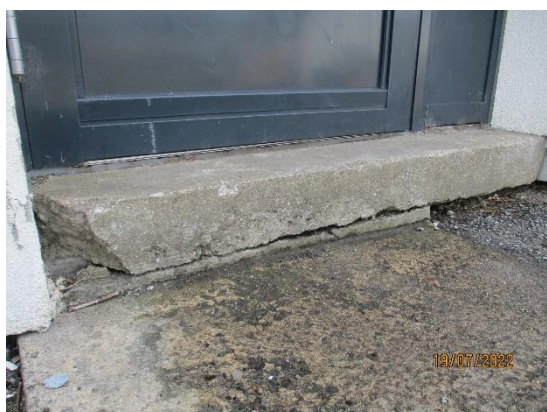
44. Concrete step to main entrance

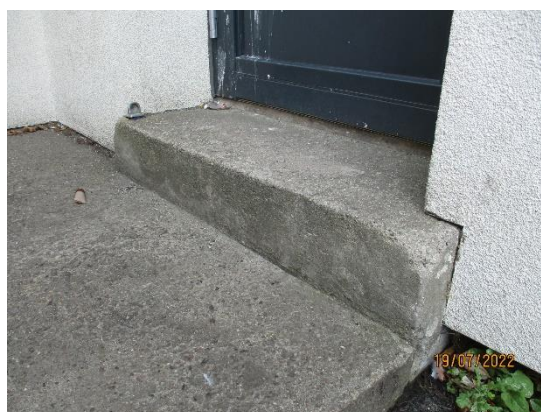
45. Broken concrete step to fire exit

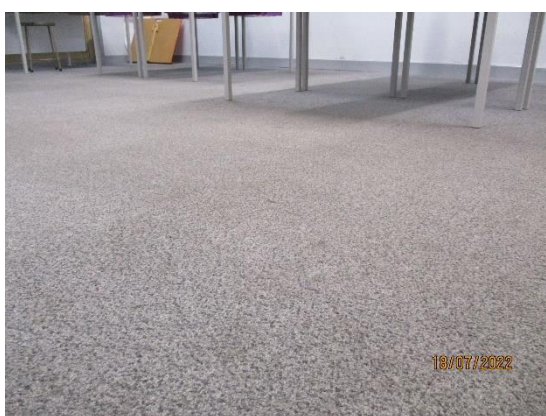
52. Ridges in concrete floor

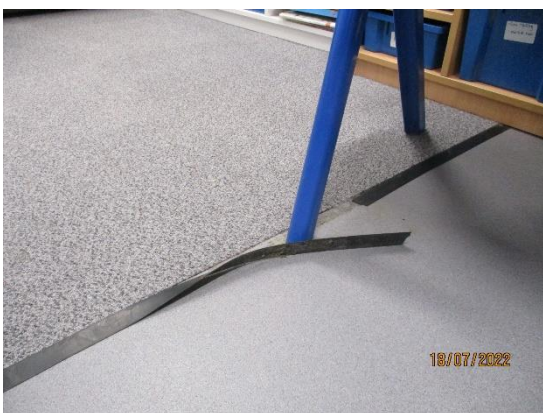
58. Loose edging strip to vinyl flooring

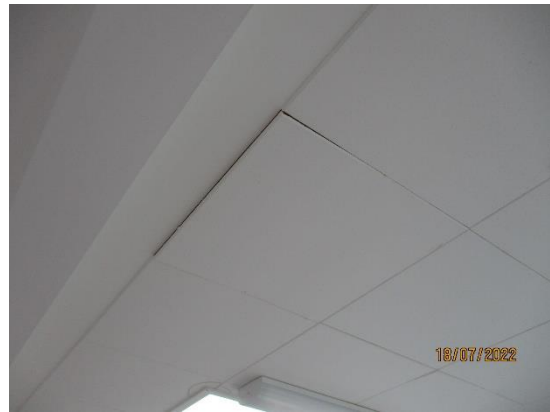
66. Loose fibre tiles

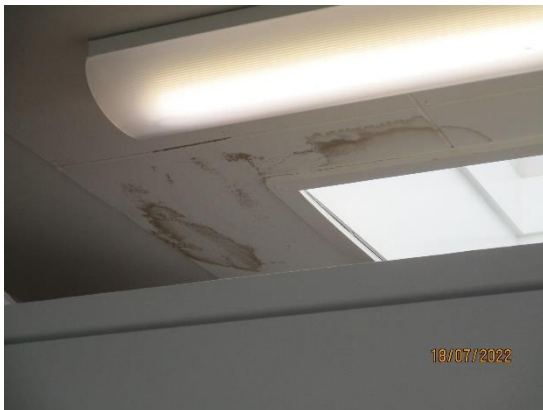
67. Watermarked fibre tiles

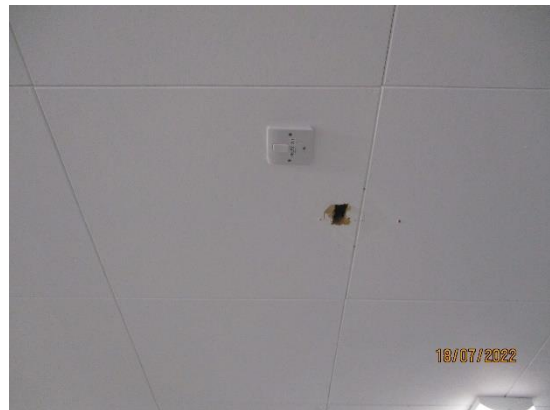
68. Damaged fibre tiles

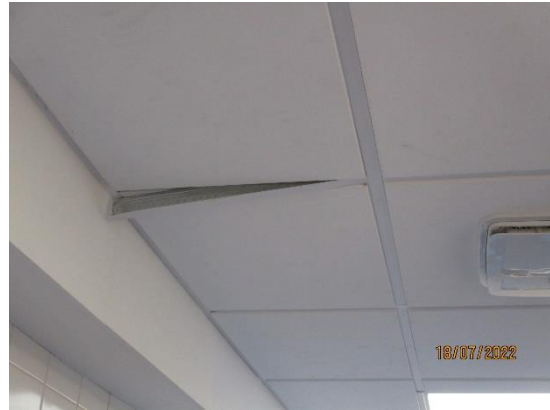
72. Damaged suspended ceiling tiles

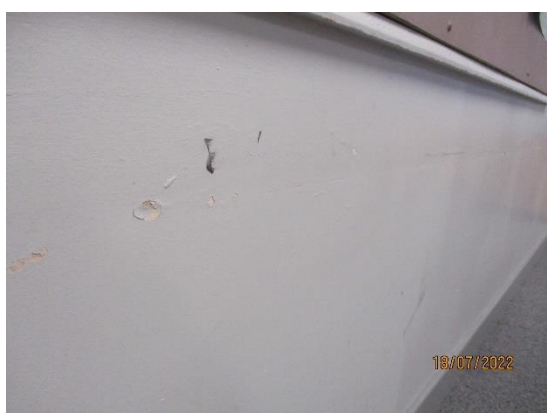
80. Damage to plasterboard

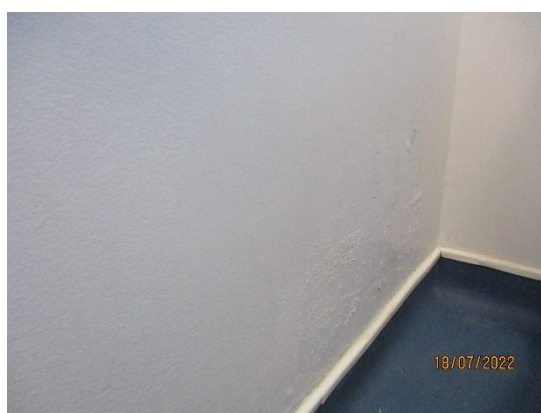
81. Damaged plasterboard surface

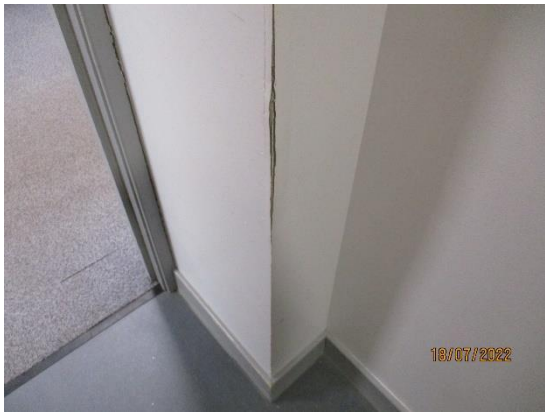
82. Damaged corner tape

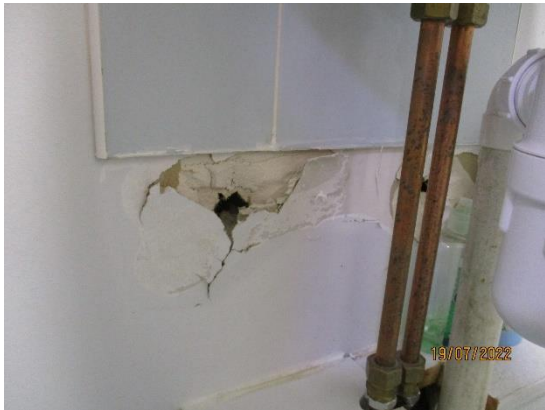
84. Damaged plasterboard walls

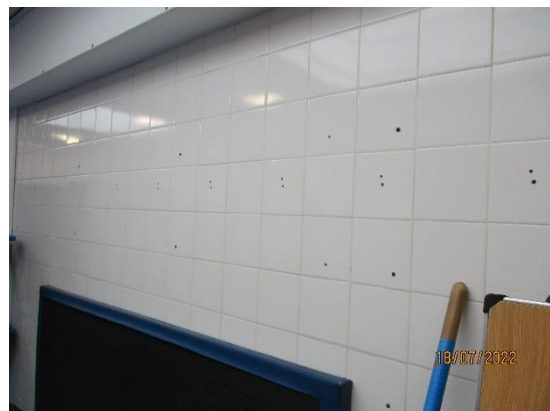
87. Damaged ceramic tiled walls

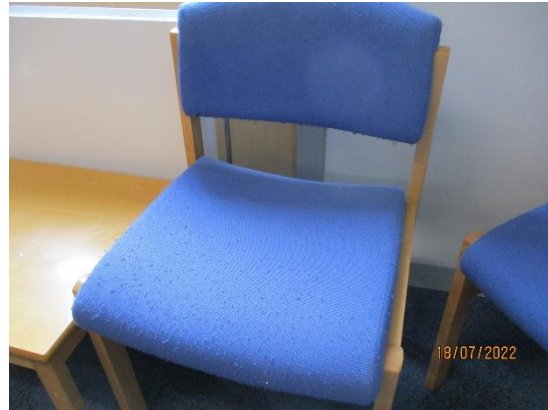
122. Worn seats

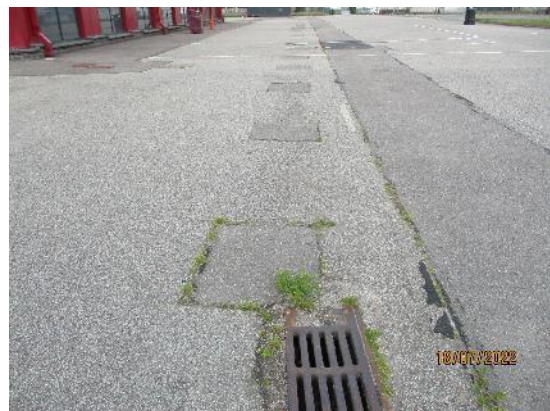
201. Cracked, patched playground

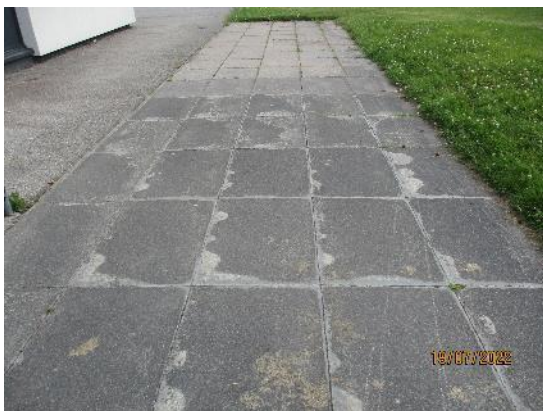
206. Cracked / damaged PCC slabs

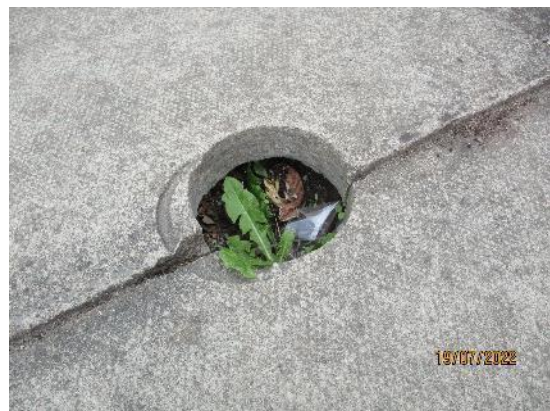
207. Holes in Nursery playground

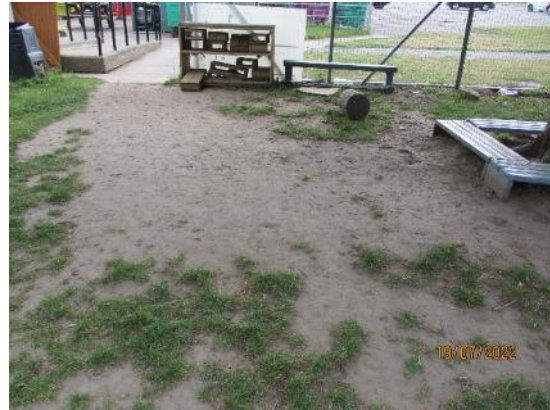
227. Worn and missing grass
