# **Summary Building Condition Survey Report**

**Portessie Primary School  
School Road, Portessie AB56 1TN**

**24<sup>th</sup> & 25<sup>th</sup> August 2022**

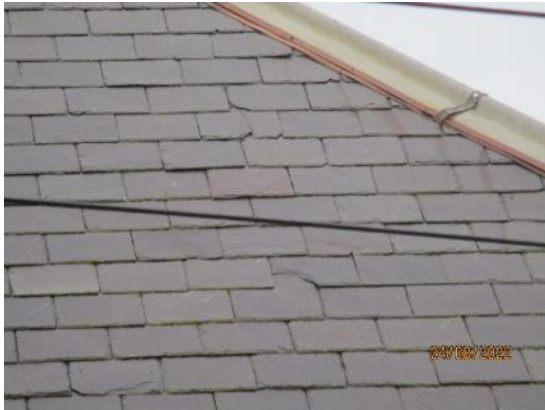
7. Isolated slipped and broken slates

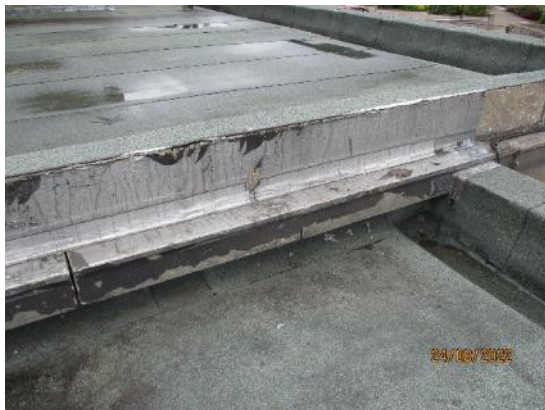
10. Previous poor quality repairs

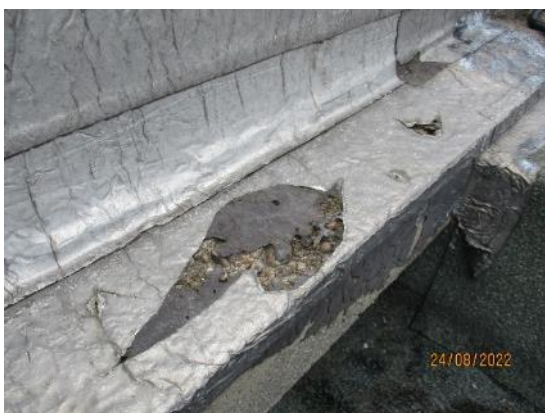
11. Perforated previous repairs

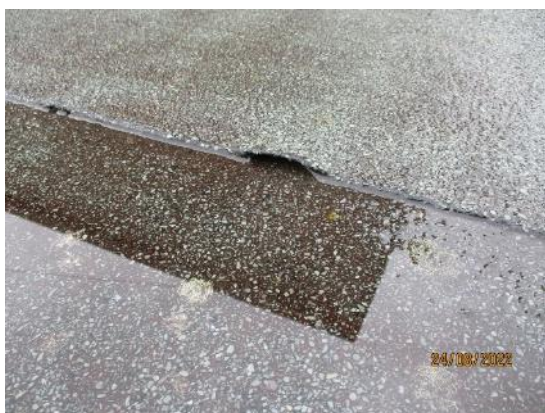
12. Open felt joints

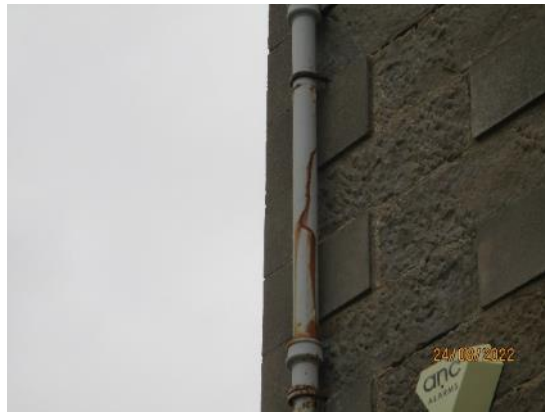
20. Cracked cast iron downpipes

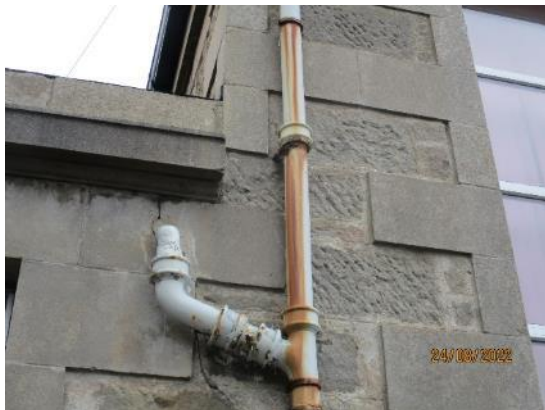
21. Corroded cast iron downpipes

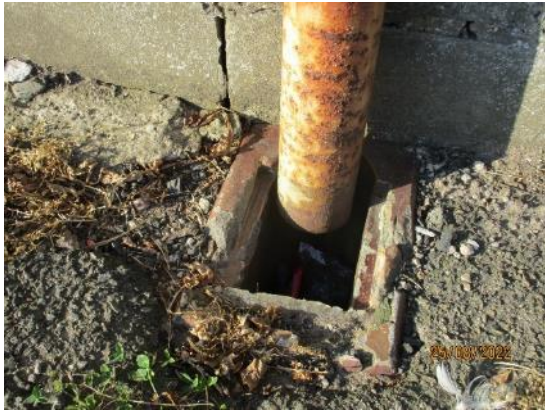
25. Back inlet gullies with missing gratings

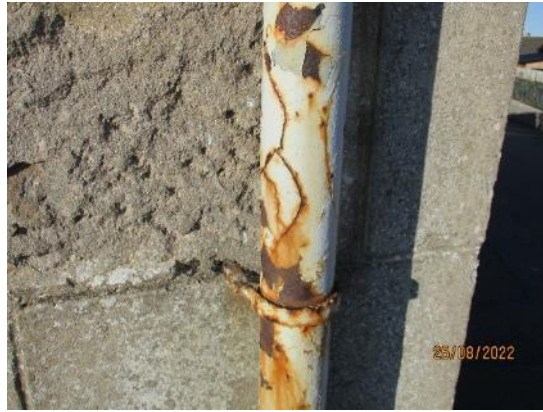
26. Cracked cast iron downpipes

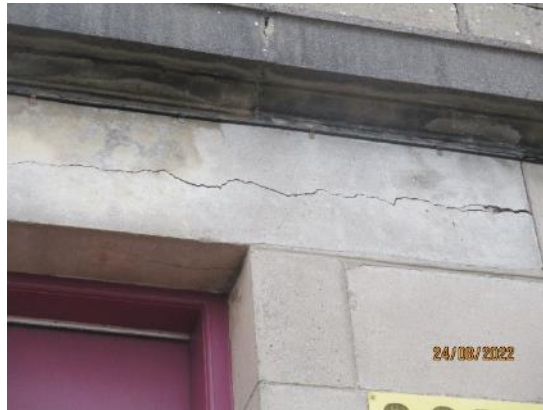
28. Cracked lintol above main entrance

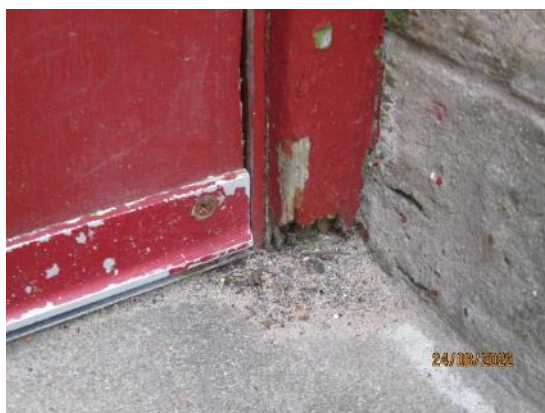
35. Wet rot in timber frame

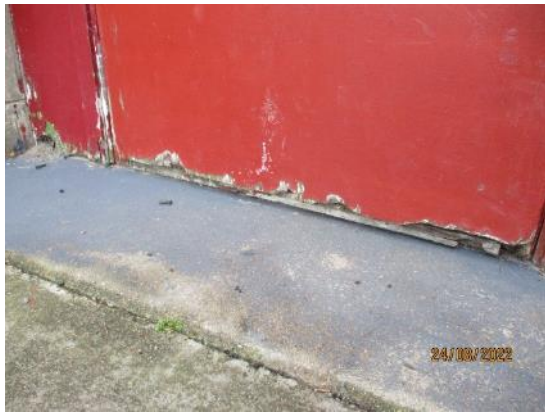
37. Rot in bottom of timber doors

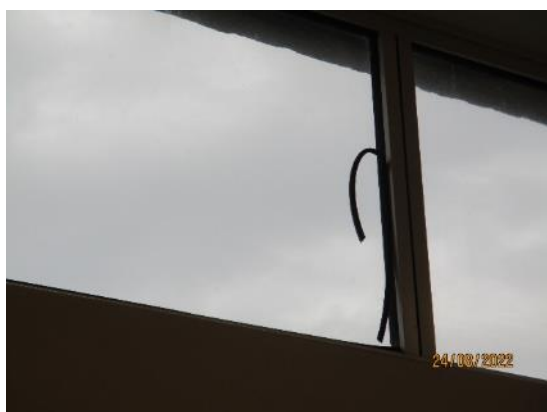
45. Failed window seals

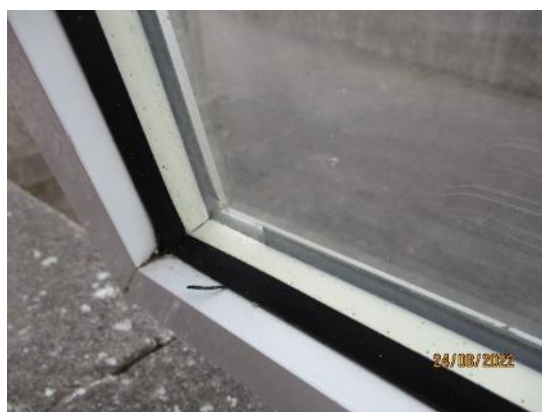
46. Double glazing – missing seals

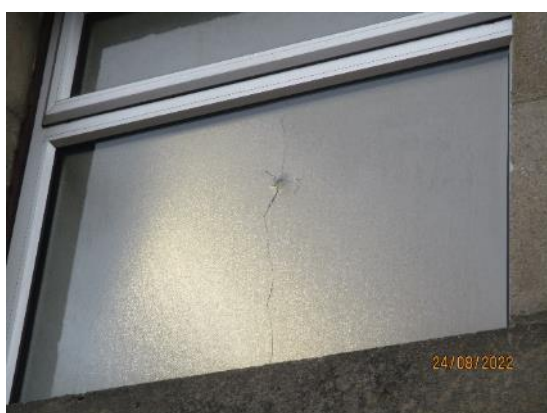
47. Broken glazing

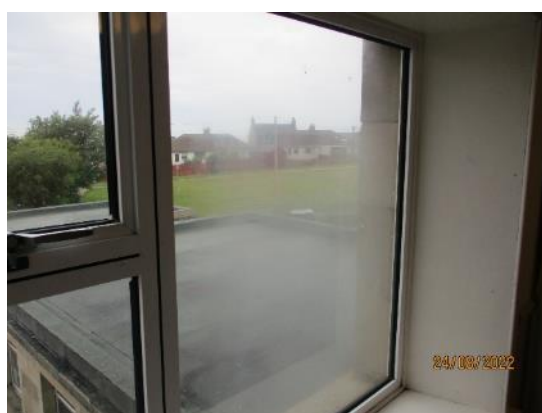
48. Fogged double glazing

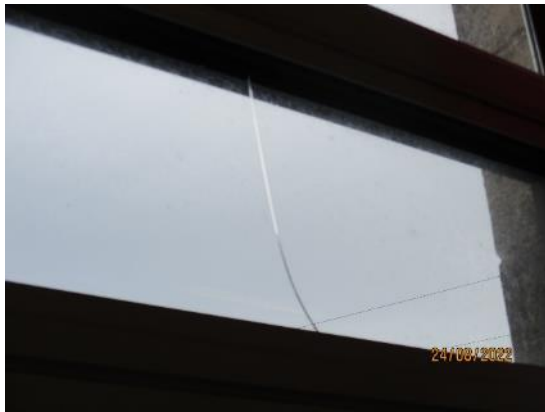
49. Cracked glass

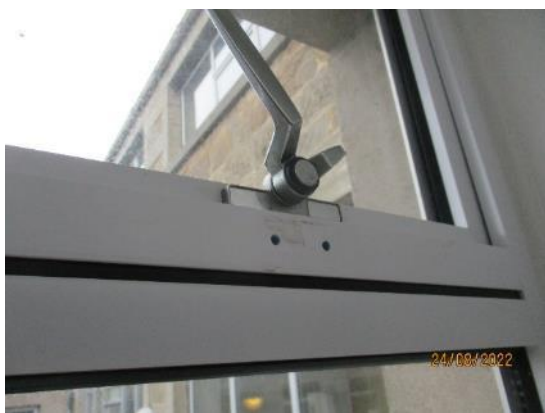
53. Lever handles and missing keepers

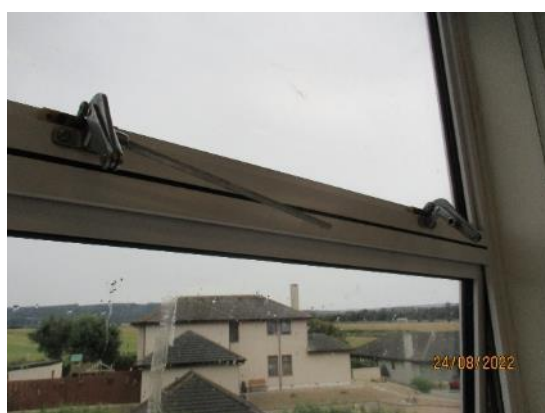
54. Broken handle stays

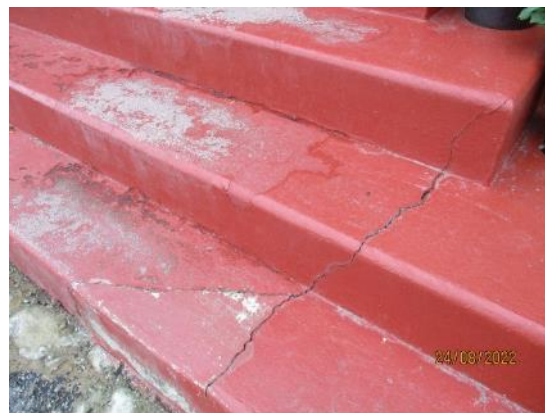
61. Cracked steps to front door

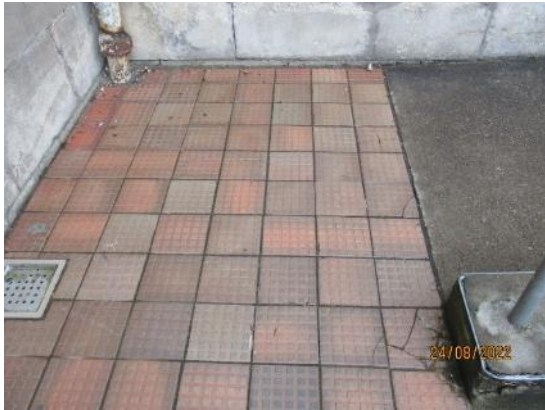
68. Quarry tiles loose and broken

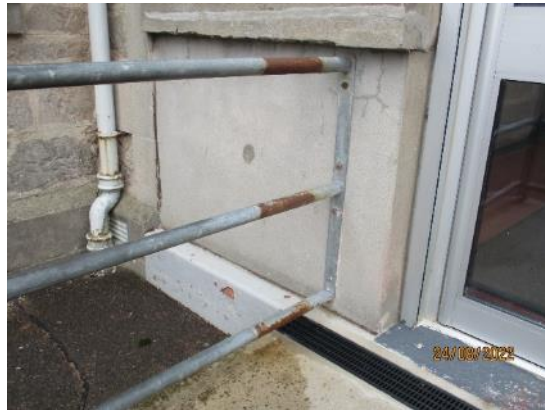
71. Surface corrosion

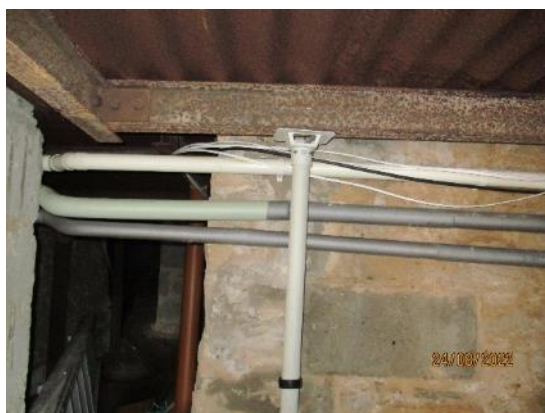
72. Cellar steel frame with temporary support

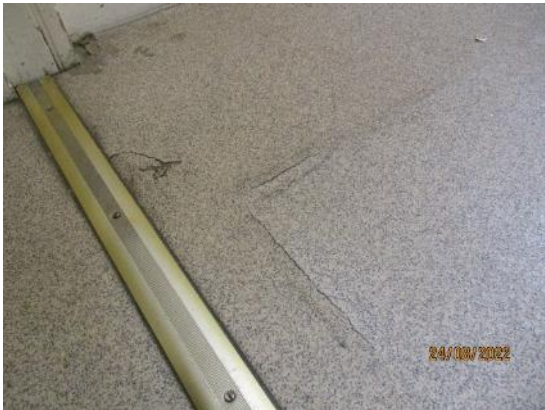
76. Damaged sheet vinyl

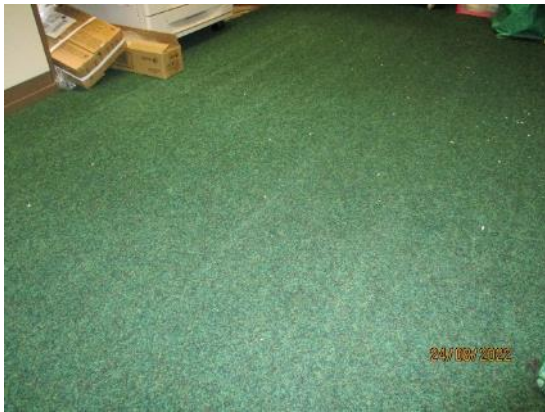
80. Wrinkled, loose carpet

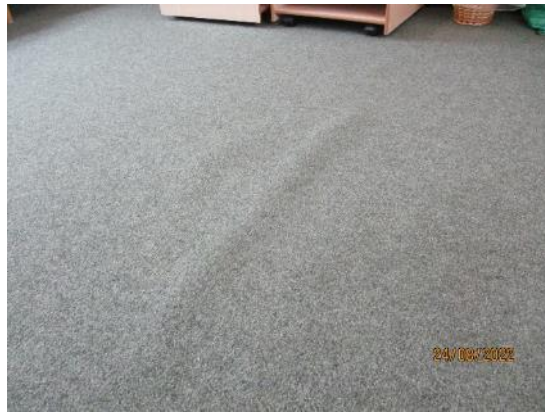
81. Stretched, wrinkled carpet

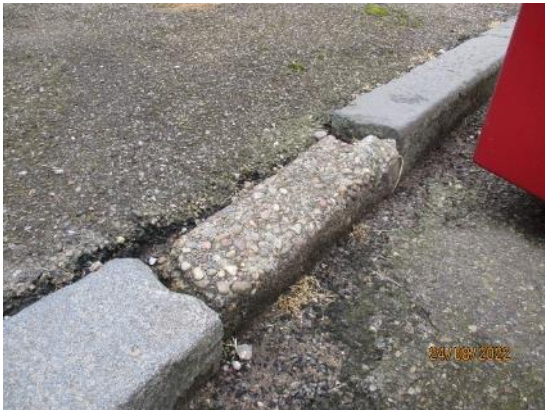
94. Broken steps

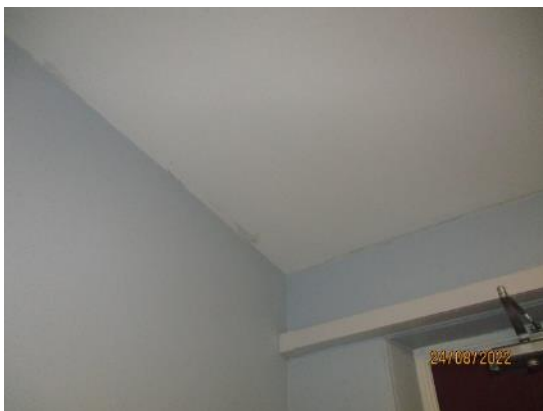
101. Damaged plaster ceilings

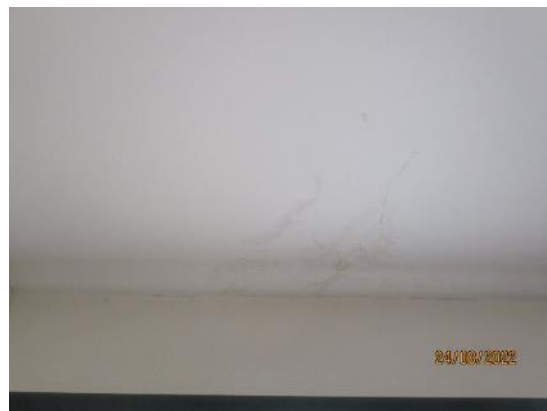
102. Damaged lath & plaster ceilings

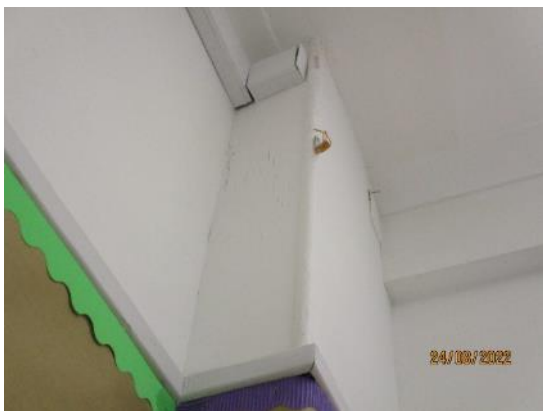
113. Damage to lath & plaster walls

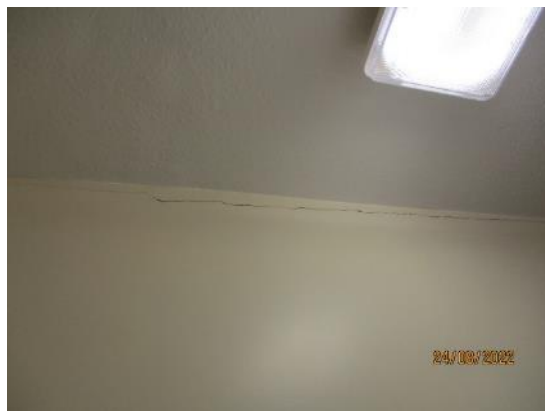
114. Failing taped joints

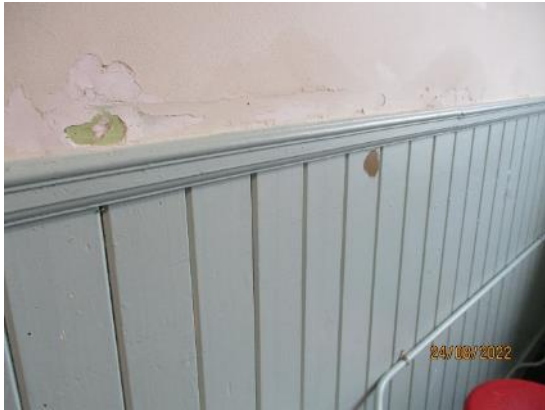
115. Spalling plaster walls

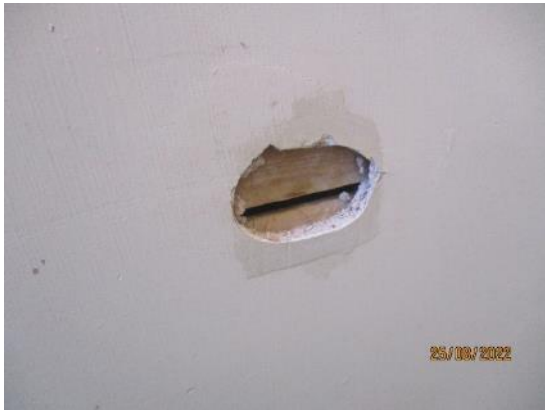
117. Damage to lath & plaster walls

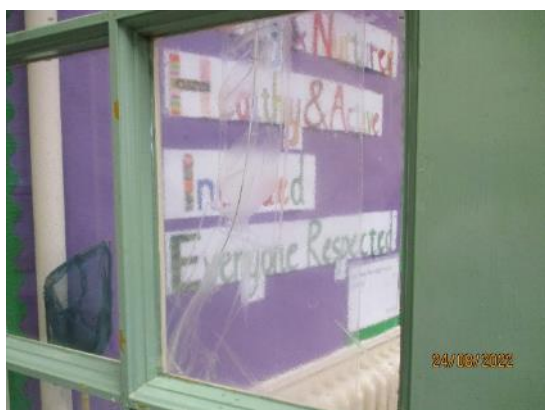
141. Broken glass in doors

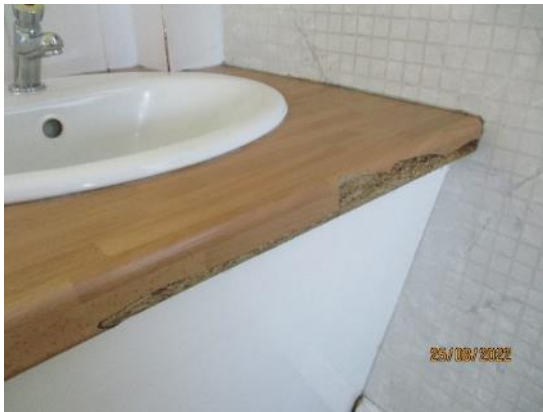
157. Damaged worktops

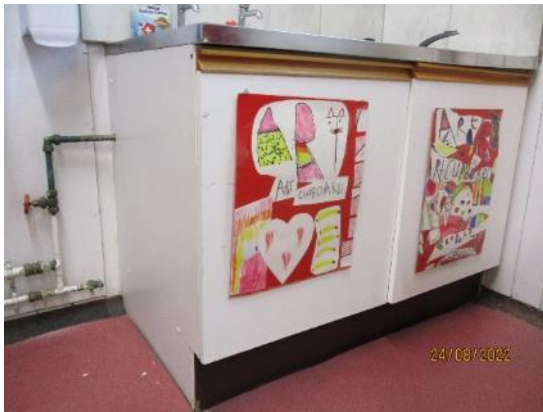
163. Base units in poor condition

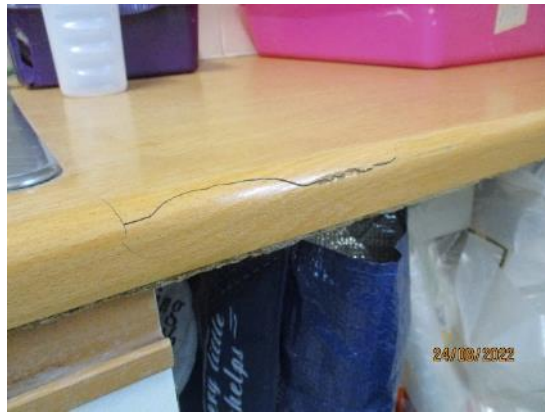
164. Damaged worktops

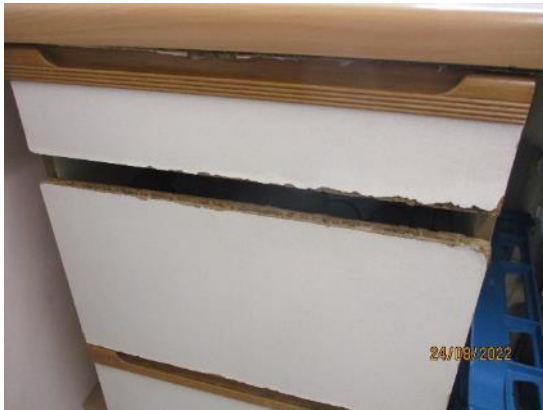
165. Damaged base units

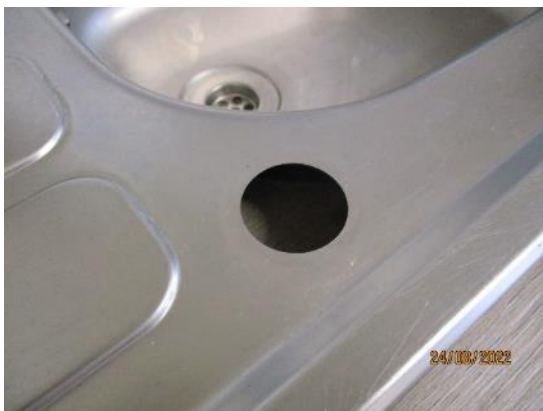
167. Broken blanking plates

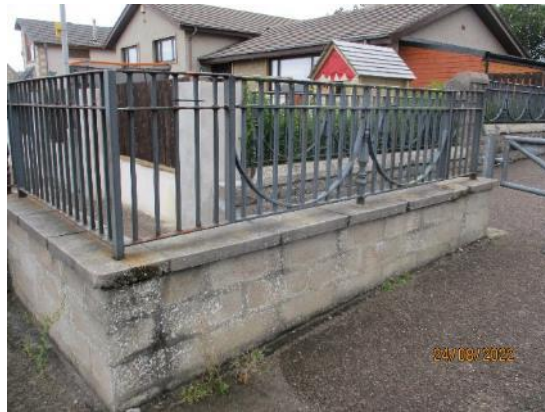
244. Missing wire fence
