# **Summary Building Condition Survey Report**

**Portgordon Primary School  
Richmond Terrace, Portgordon AB56 5RA**

**13<sup>th</sup> September 2022**

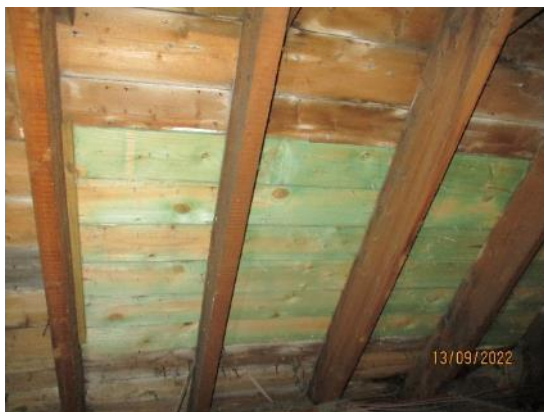
5. Replacement sarking boards

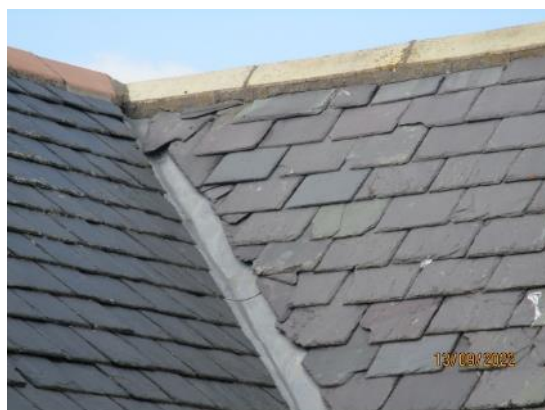
11. Slipped and broken slates

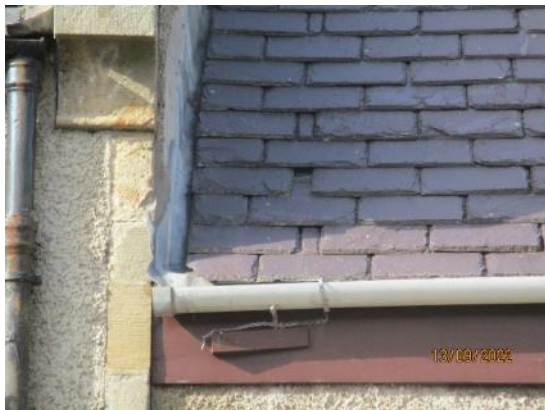
15. Missing slate piece

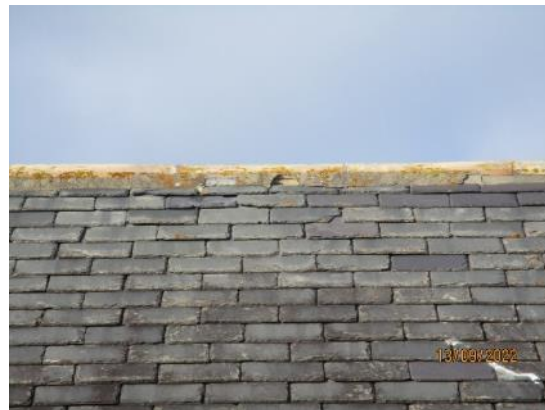
16. Damaged clay ridge tiles

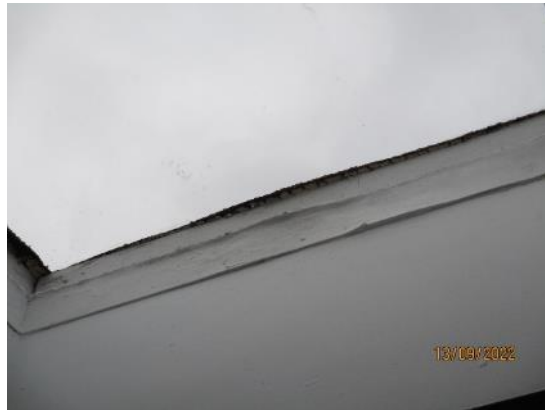
28. Distorted seals to rooflights

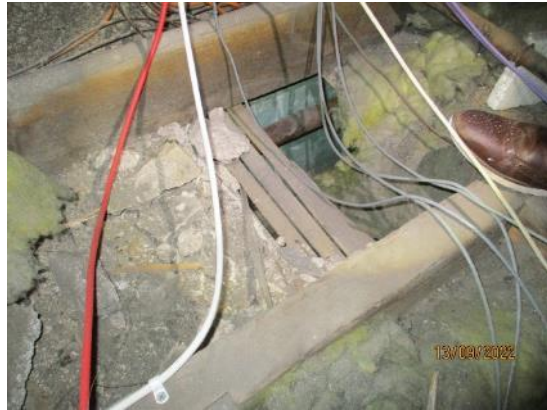
32. Missing insulation, damaged lath & plaster

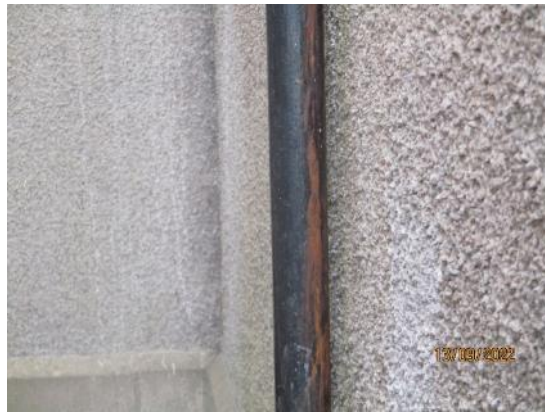
38. Cracked, corroded downpipes

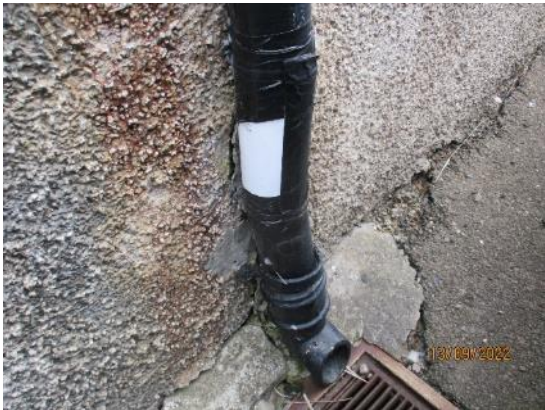
39. Impact damaged cast iron

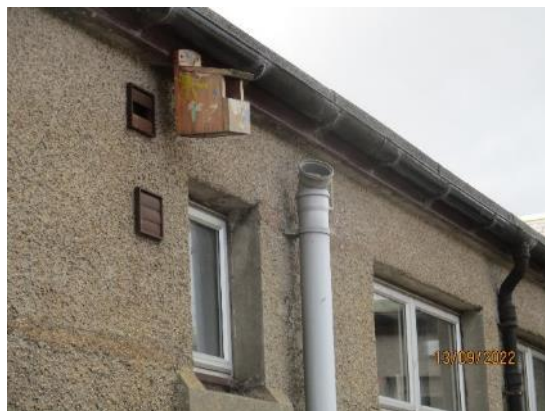
42. Damaged UPVC SVP's

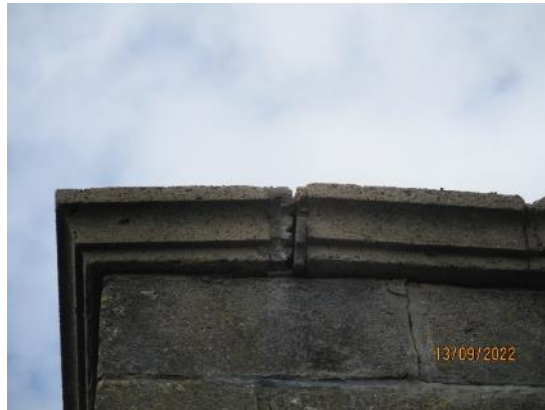
46. Missing pointing to copes

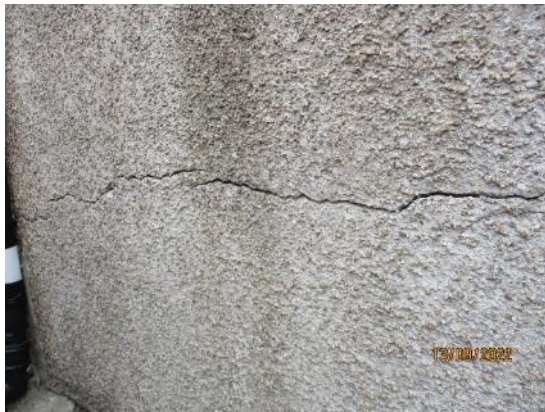
49. Cracking to external walls

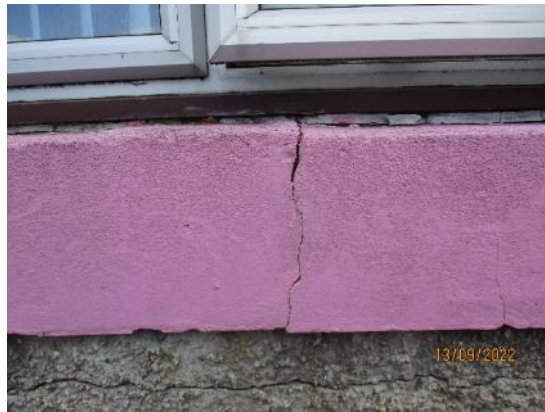
50. Cracked concrete window sills

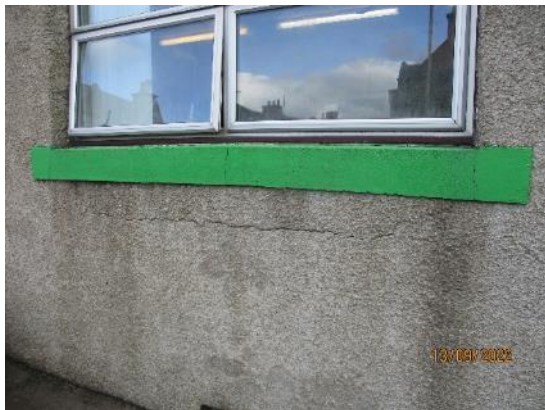
51. Cracking to external walls

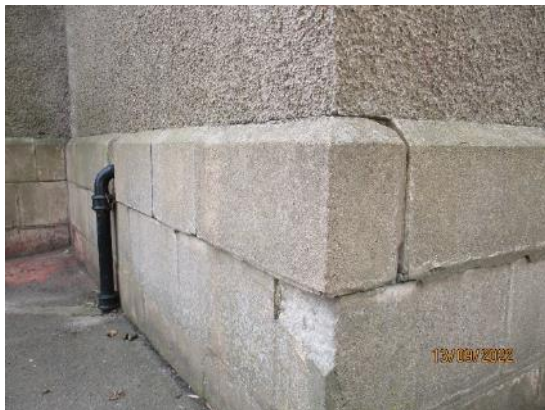
52. Slipped masonry above DPC

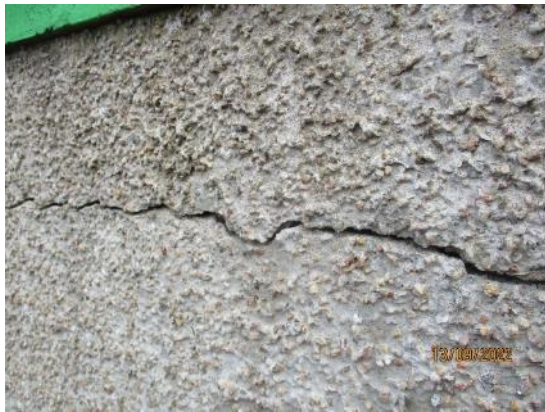
55. Cracking of roughcast finish

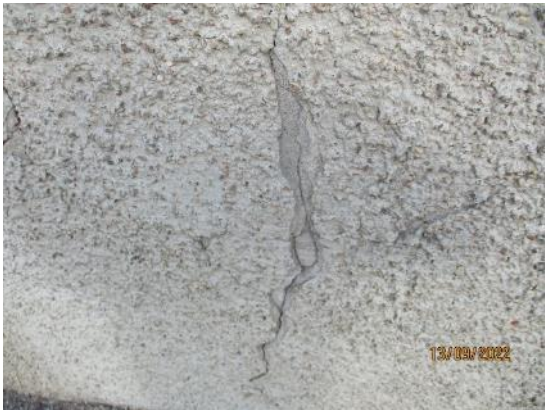
57. Cracked, spalling roughcast finish

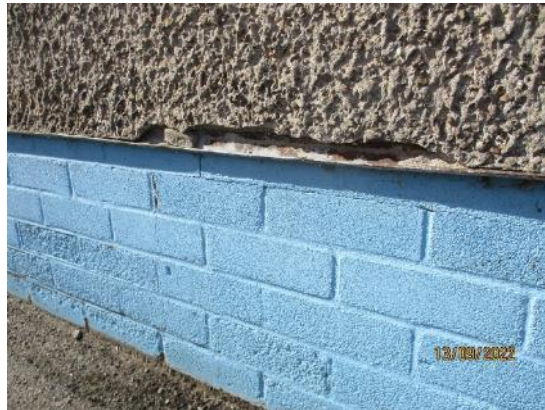
58. Missing roughcast at bellcast bead

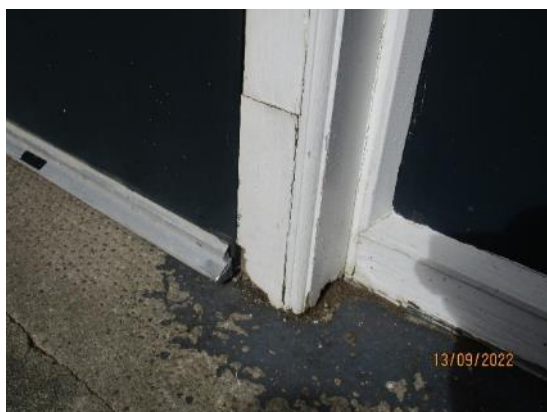
61. Previous repairs to timber door frame

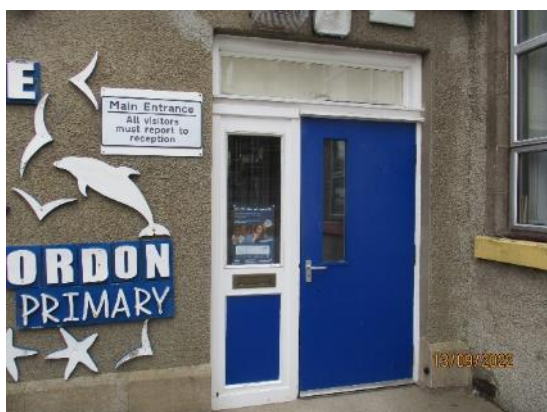
62. Rot in timber door frames

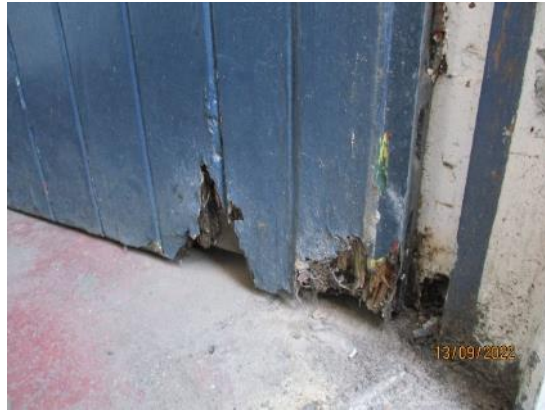
68. Rot at bottom of door

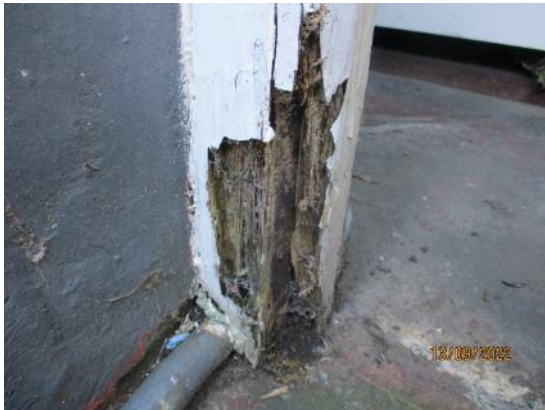
69. Rot in door frame

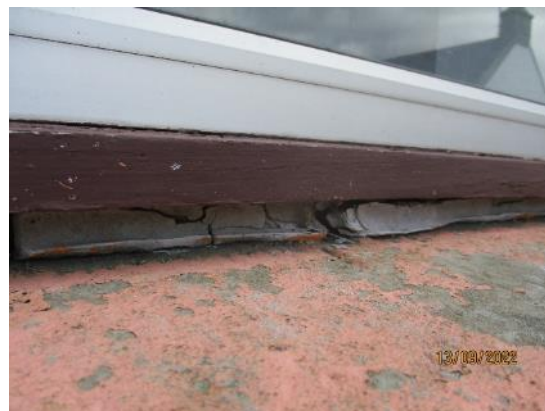
72. Failed sealant below window sills

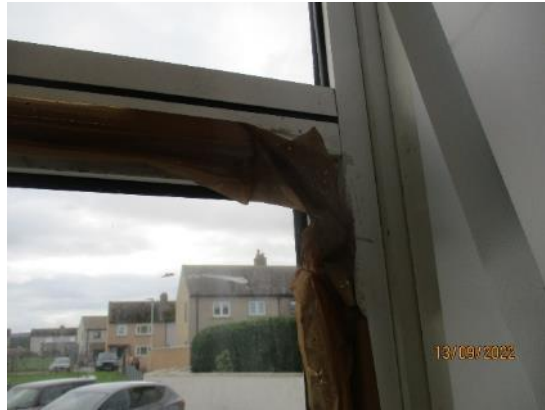
74. Windows taped where seals have failed

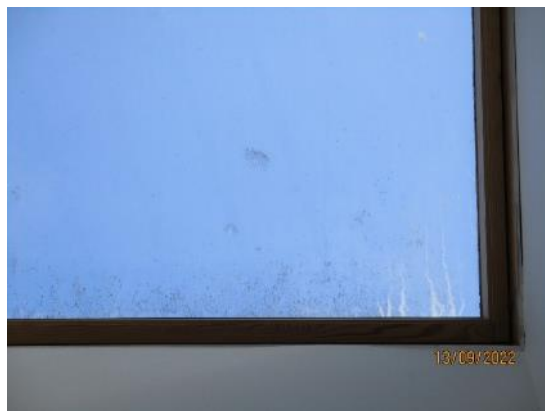
78. Failing solar film

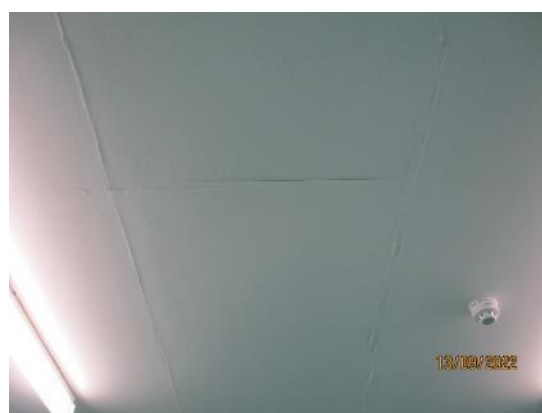
119. Plasterboard ceilings – failed taped joints

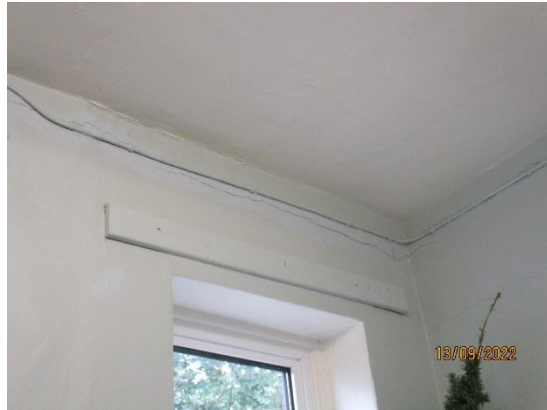
133. Cracks at high level

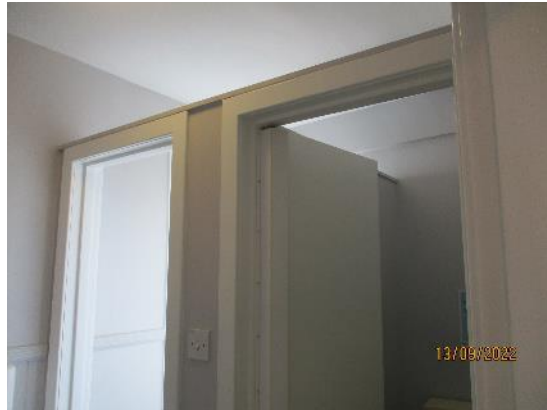
157. Wear and damage to classroom doors

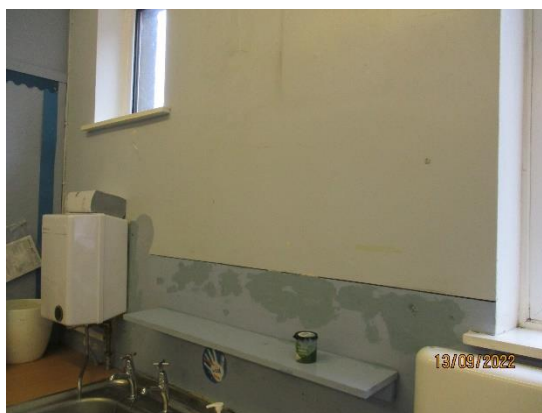
191. Peeling paint

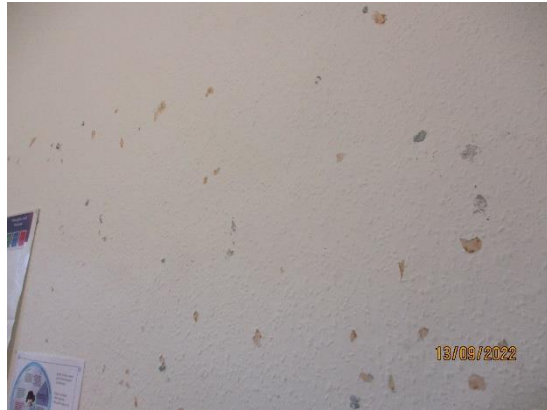
193. Damaged decoration

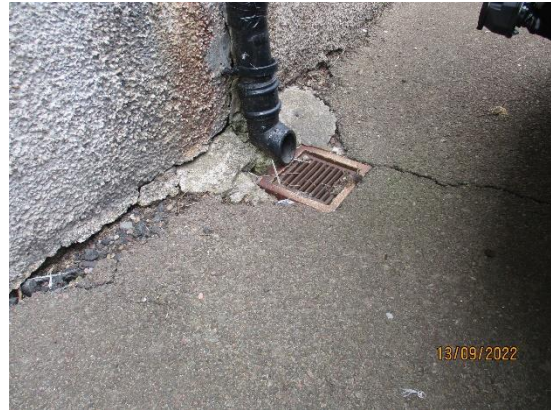
253. Surface cracking

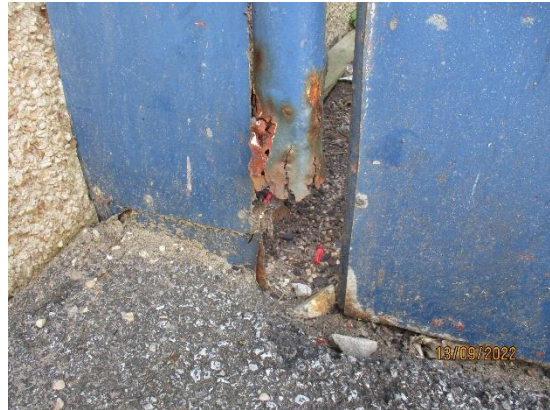
271. Corroded, broken post

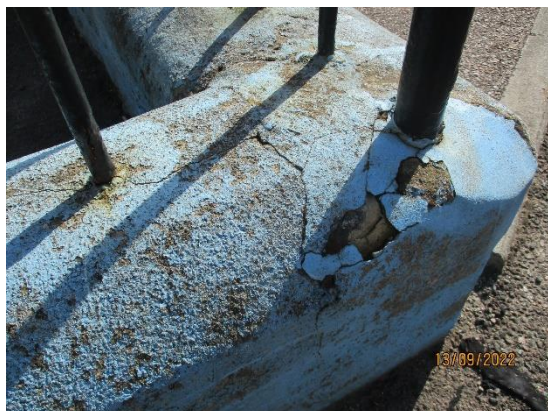
275. Coping to low level wall - cracked

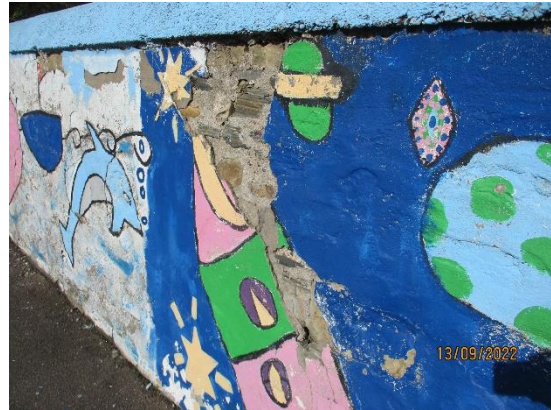
277. Render spalling

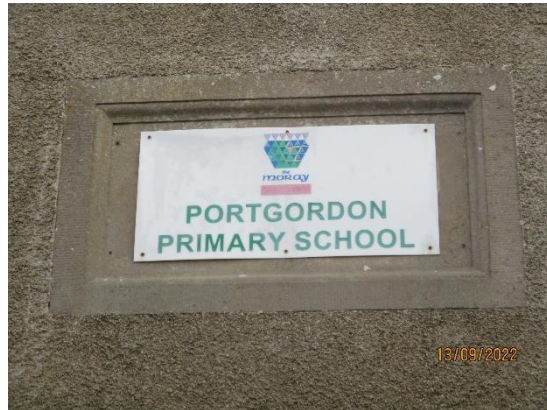
278. Missing pointing

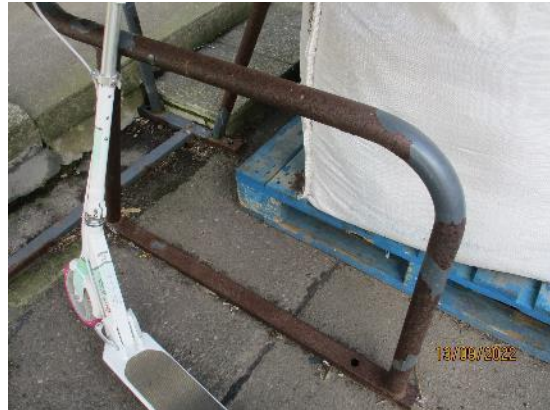
289. Corroded metal frame
