# **Summary Building Condition Survey Report**

**Portknockie Primary School**  
**King Edward Terrace, Portknockie AB56 4NX**

**3<sup>rd</sup> & 4<sup>th</sup> October 2022**

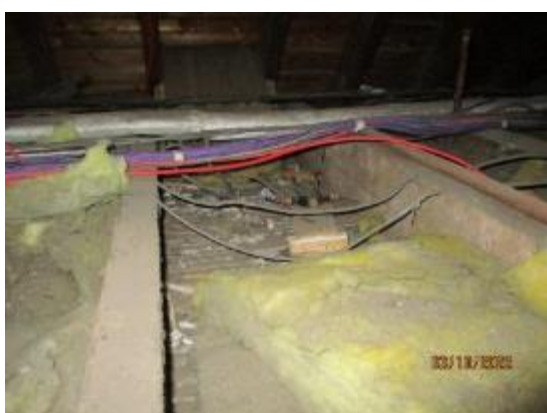
22. Thin mineral fibre insulation

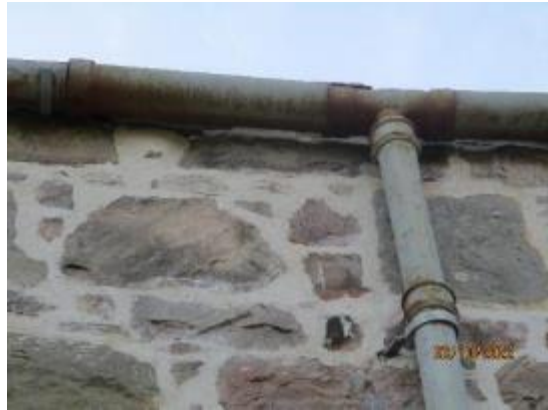
31. Damaged rainwater outlets

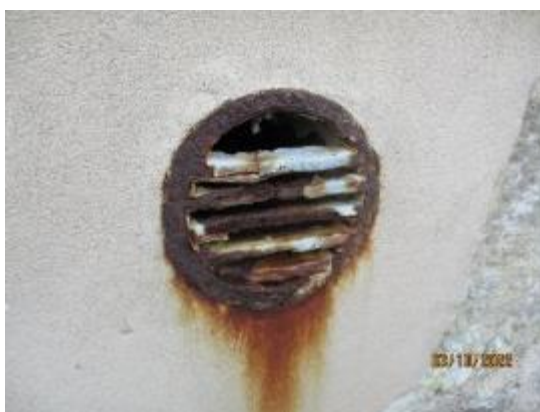
51. Corroded sub-floor vents

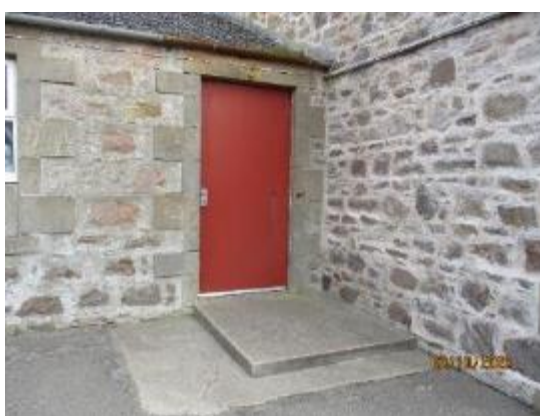
53. Pointing required to isolated cracking

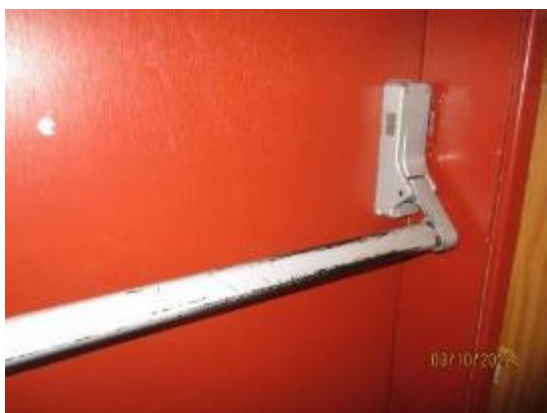
58. Wet rot in timber door to Nursery

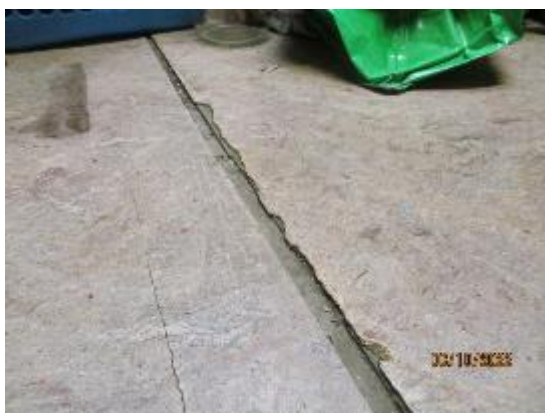
88. Linoleum cracked and worn

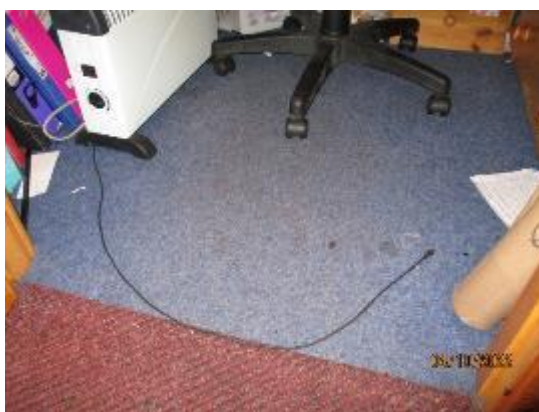
92. Carpets are worn and soiled

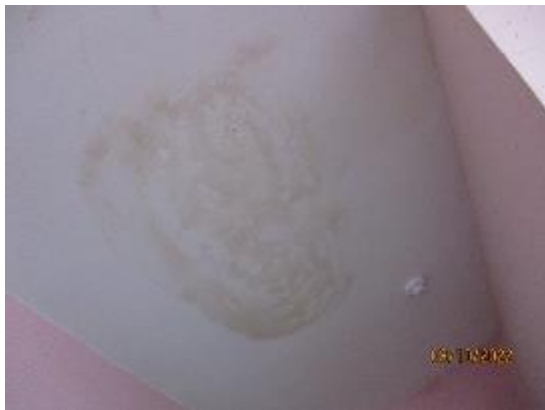
98. Lath & plaster ceilings – cracking

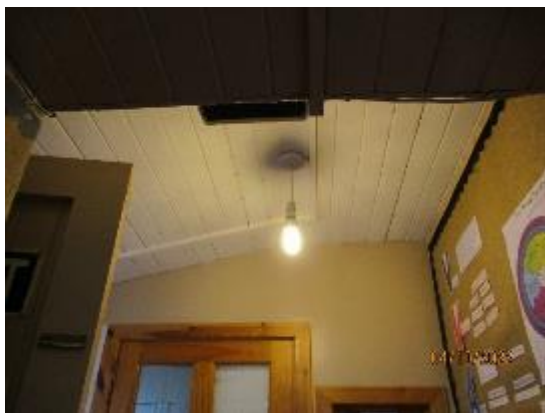
105. Cracked lath & plaster ceilings

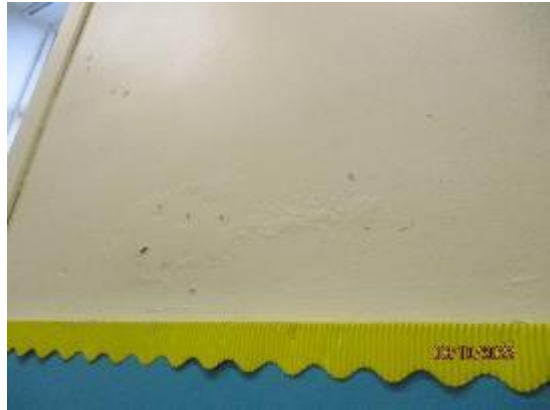
107. Lath & plaster walls cracked

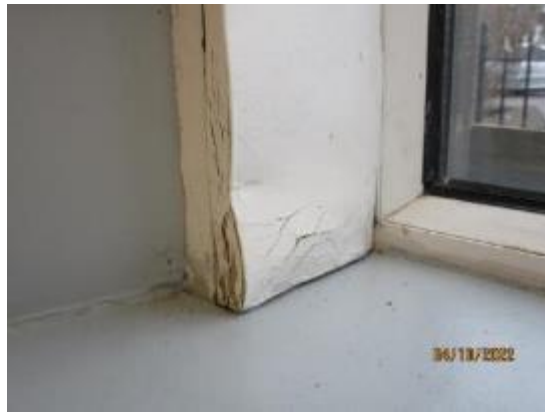
119. Damage to window linings

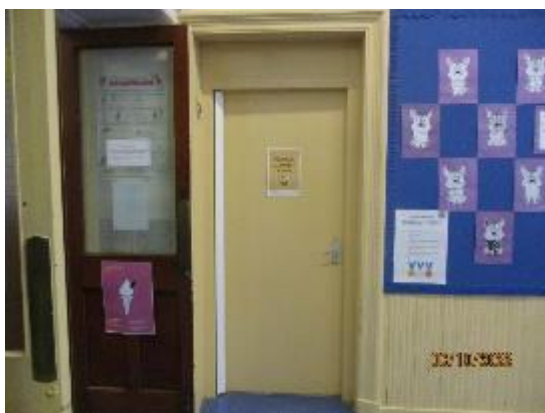
123. Damaged timber doors

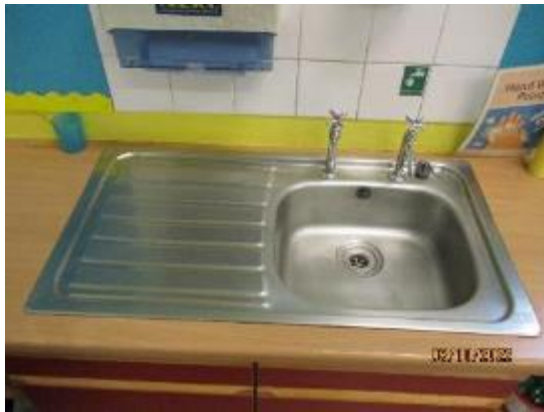
157. Worn worktops

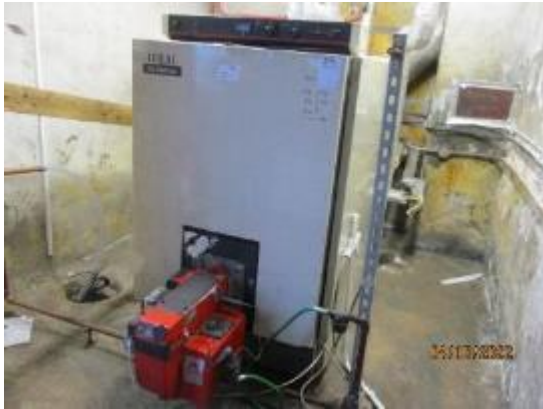
- Main school heating system and boiler are in poor condition and have exceeded their useful life.
- General wiring and accessories have exceeded their useful life.

176. Boiler and burner. – Oil fired. Plant room 0/26

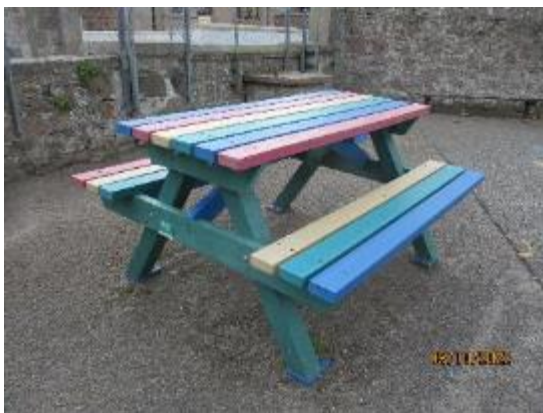
245. Patch repairs to playground surface

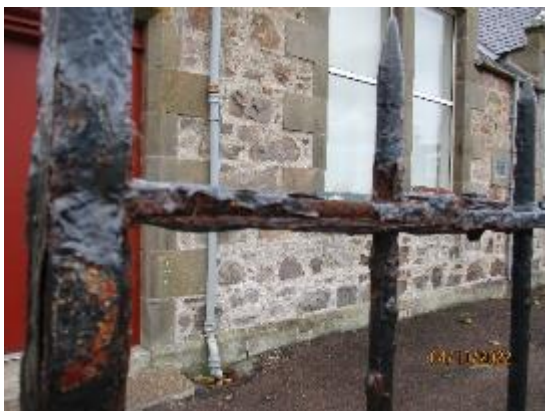
- Natural stone walls require repointing.
- Metal railings have considerable surface corrosion.
- Boiler House gate – corroded with sharp edges.
- Surface water drainage to the west playground is poor.

251. Railing corrosion

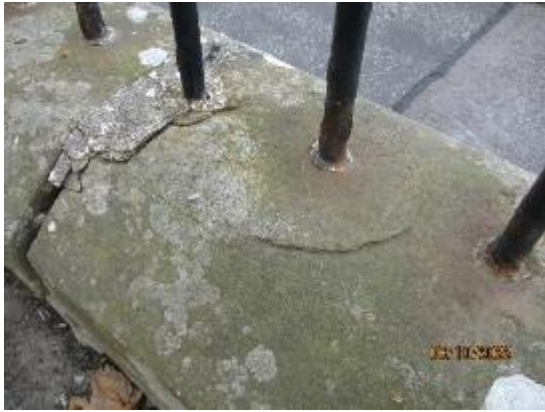
265. Missing pointing

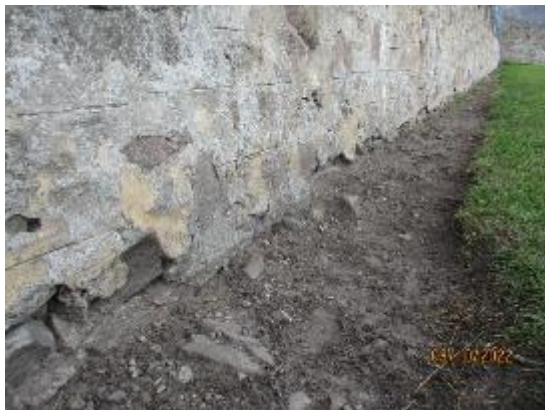
273. Cracks to perimeter wall

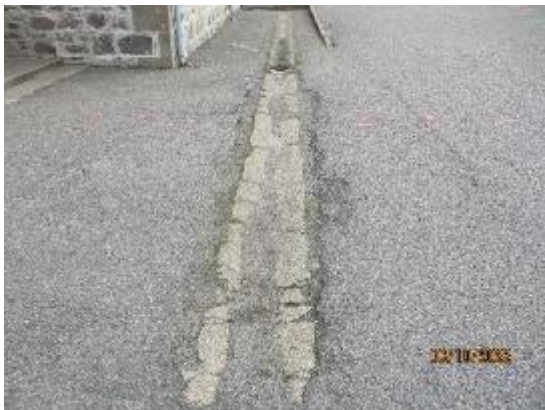
279. Cracked surround to drainage gully
