# **Summary Building Condition Survey Report**

**St Peter's Primary School  
37 St Peter's Terrace, Buckie AB56 1QN**

**13<sup>th</sup> December 2022**

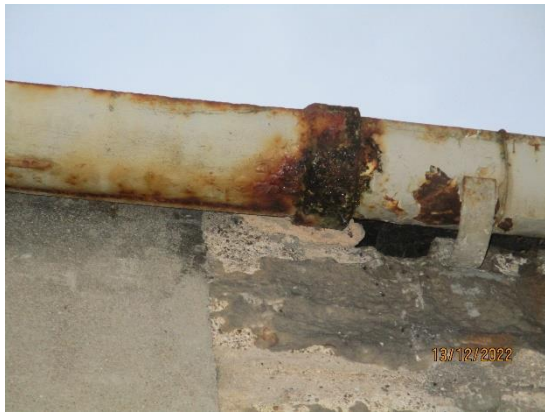
- Isolated slipped and broken slates.
- Cast iron gutters are corroded and leaking.
- UPVC gutters are distorted and collapsing.
- Stone lintols are cracked and spalling.
- Significant condensation on plastered ceilings below flat roofs.
- Lath & plaster ceilings are cracked.
- Lath & plaster walls are cracked.
- Plastered walls, peeling and spalling.
- Some wall linings have identified asbestos content.
- Timber floor boards are uneven and creek.
- Carpets are soiled and worn.
- Sheet vinyl has holes cut in it and cracked in several locations.
- Vinyl tiles are damaged and lifting.
- Internal timber doors are twisted and cracked.
- Internal decoration is overdue.

19. Leaking gutter joints

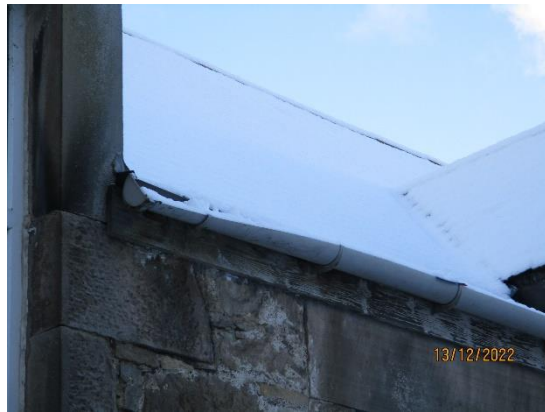
20. Collapsing UPVC gutters

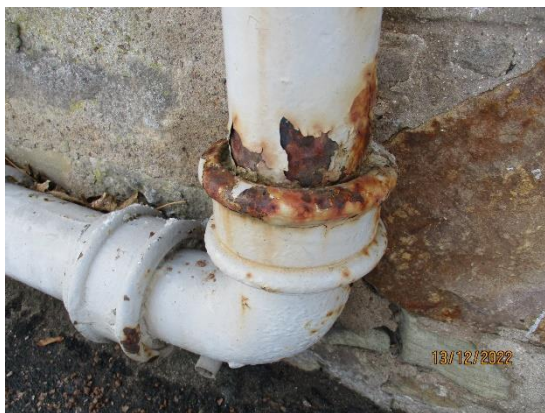
23. Downpipe corrosion

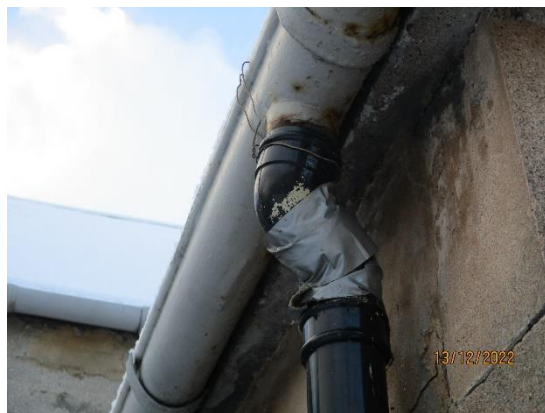
24. Damaged UPVC downpipes

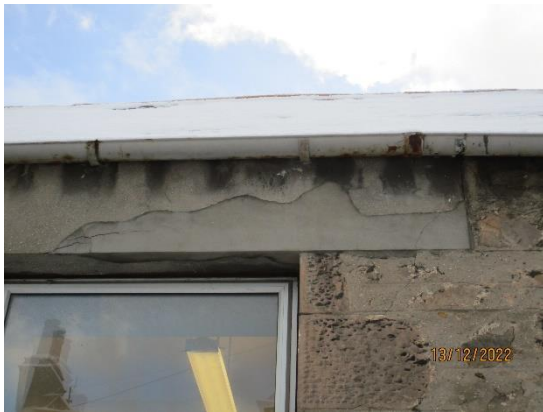
31. Previous repairs to concrete lintols

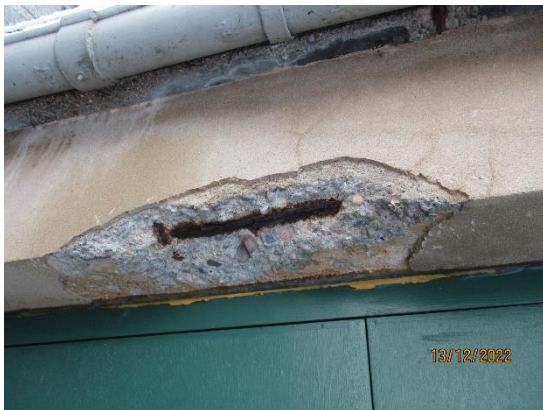
33. Spalling lintols, exposing reinforcement

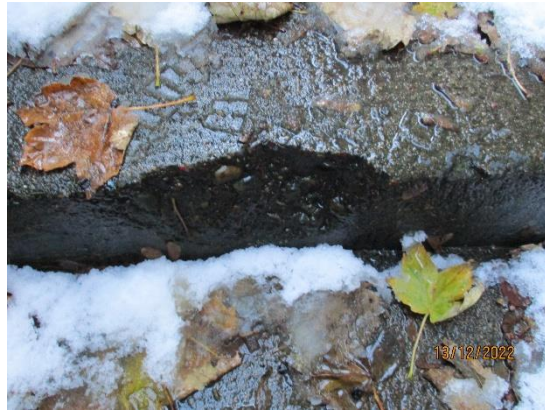
62. Broken steps

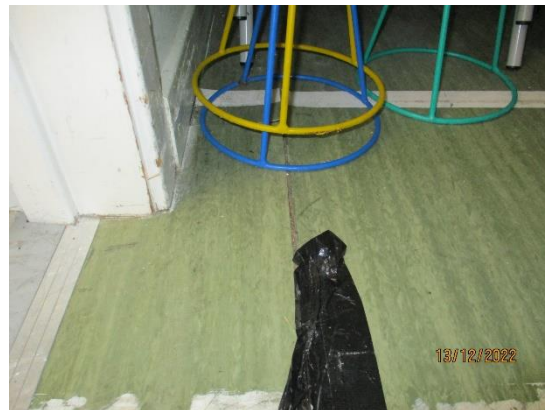
70. Tape repairs to vinyl flooring

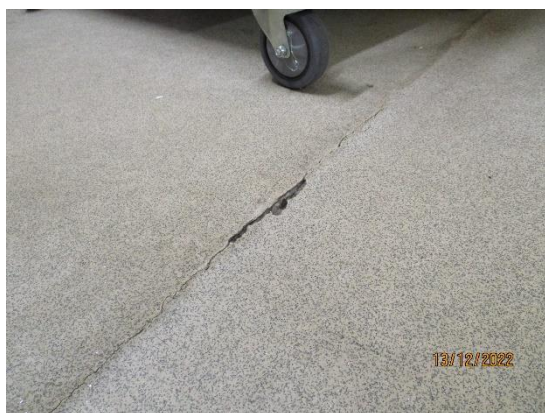
71. Cracked vinyl flooring

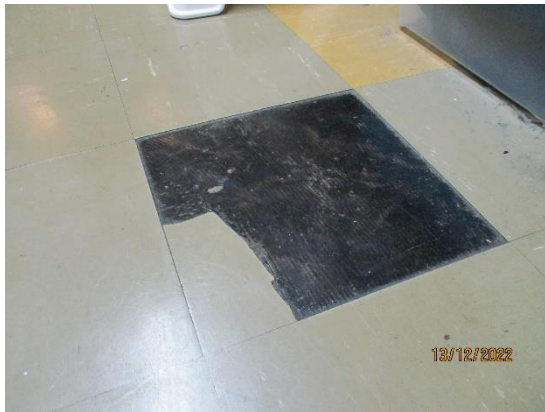
73. Missing and broken vinyo tiles

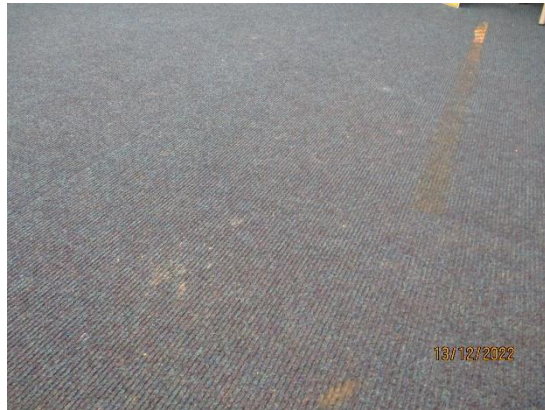
76. Soiled and worn carpet

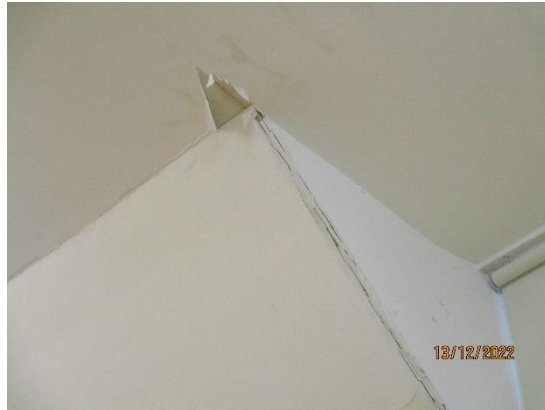
86. Cracked and damaged lath & plaster

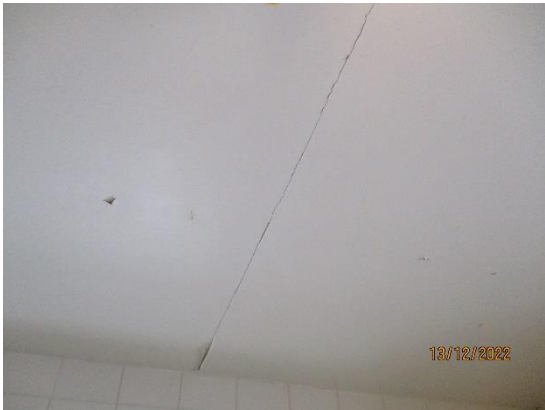
87. Cracked ceilings

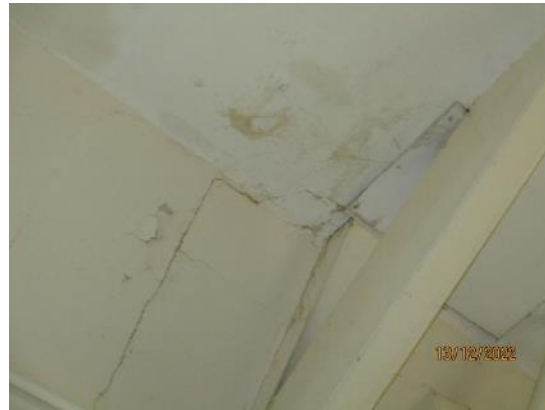
88. Water damaged ceilings

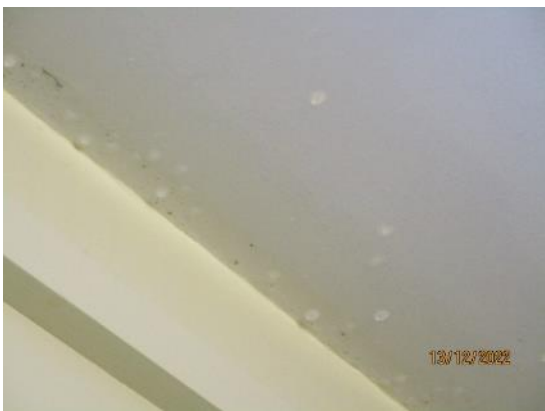
89. Condensation on underside of flat roofs

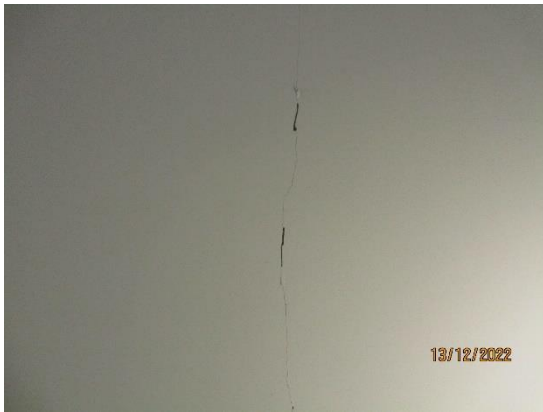
91. Cracked ceilings

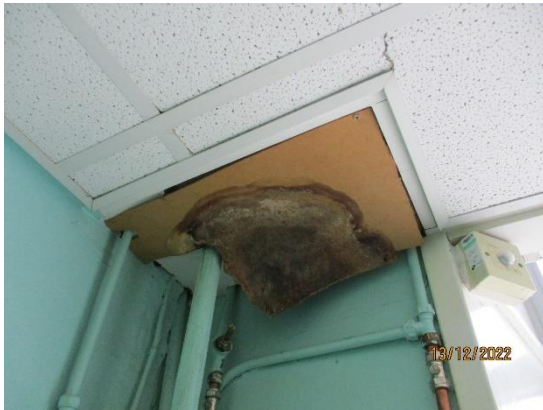
93. Water damaged suspended ceilings

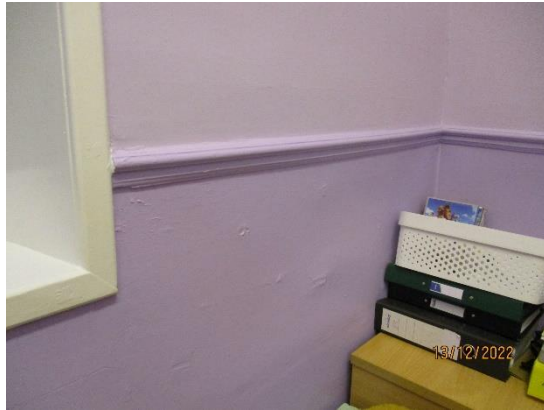
97. Spalling plaster

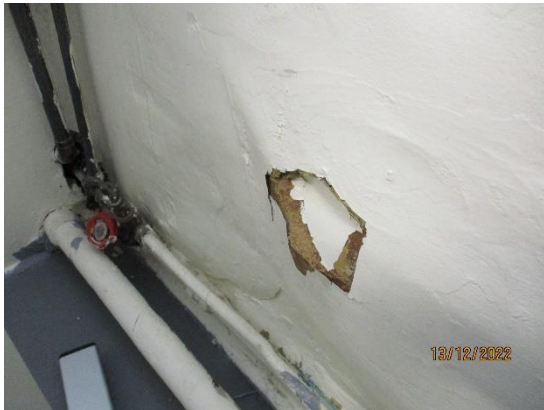
99. Damaged fibreboard walls

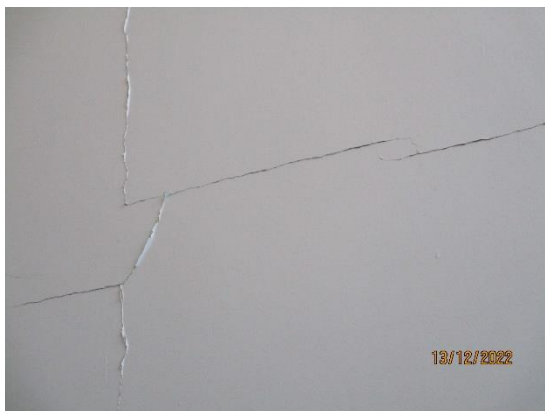
100. Cracked plastered walls

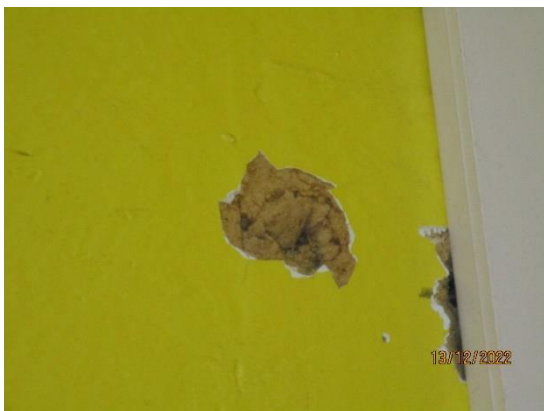
101. Damaged fibreboard walls

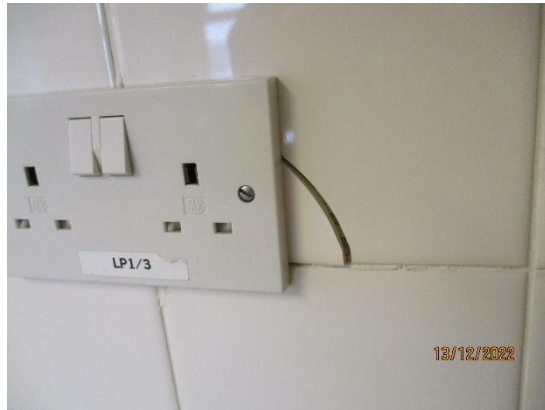
105. Damaged ceramic tiles

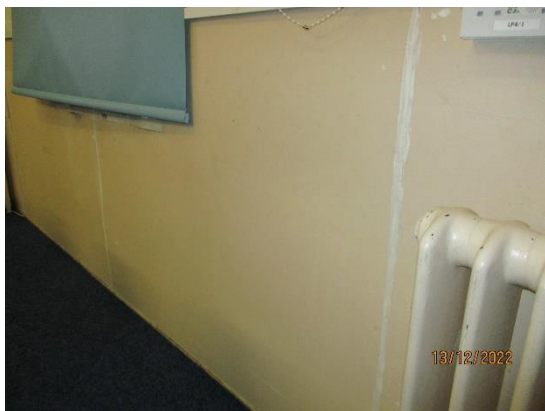
106. Wall linings – suspected asbestos

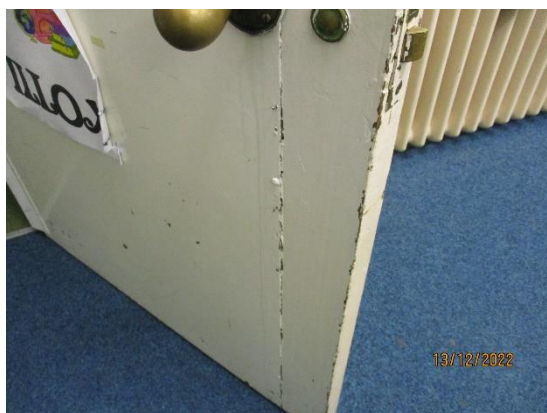
112. Cracked door framing

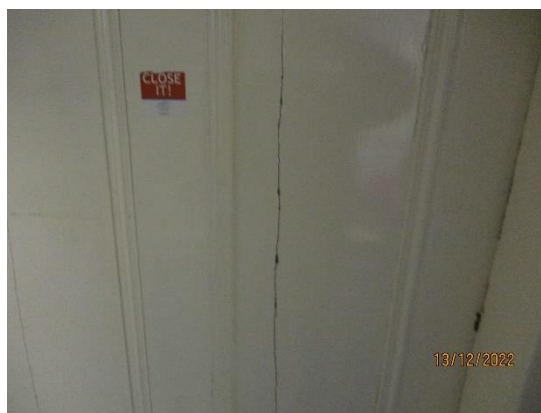
113. Cracked door panels

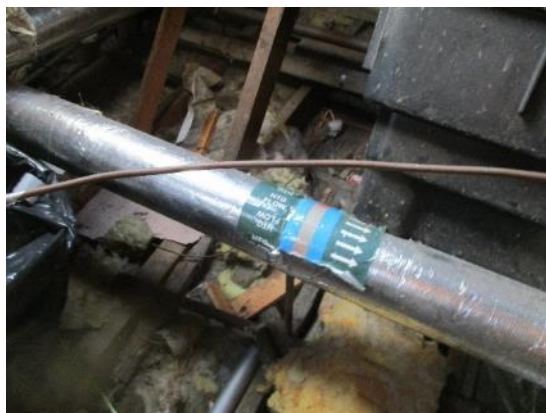
- Gas boilers are life expired as per CIBSE Guide M and in poor condition.
- Heating distribution pipework and heat emitters are life expired as per CIBSE guide M and in poor condition.

165. Pipework – heating distribution. Attic space.

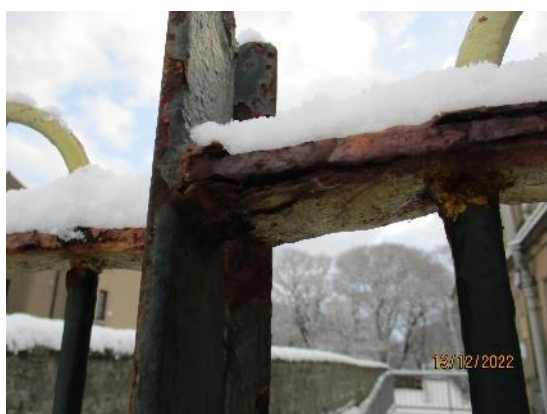
- Isolated cracking of stone perimeter walls.
- Corrosion of metal entrance gates.

227. Corrosion of metal gates

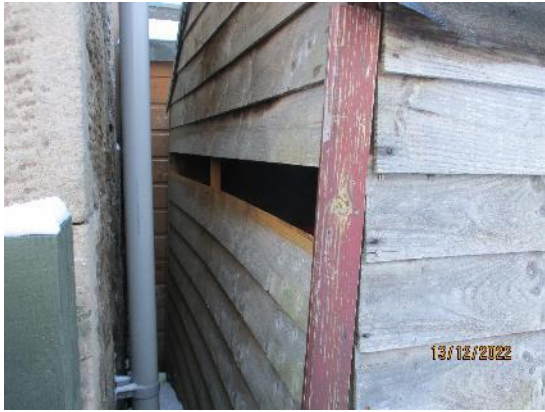
239. Timber shed – missing cladding
