# **Summary Building Condition Survey Report**

**Bishopmill Primary School  
Morrison Road, Elgin IV30 4DY**

**8<sup>th</sup> & 10<sup>th</sup> August 2023**

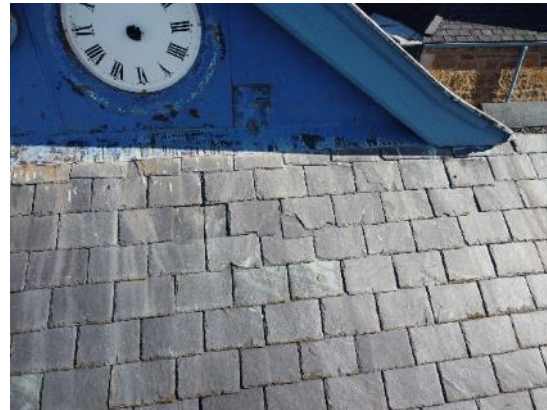
16. Isolated broken and slipped slates

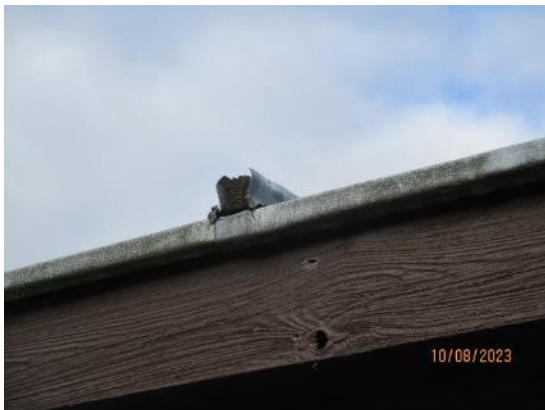
33. Missing sections of zinc

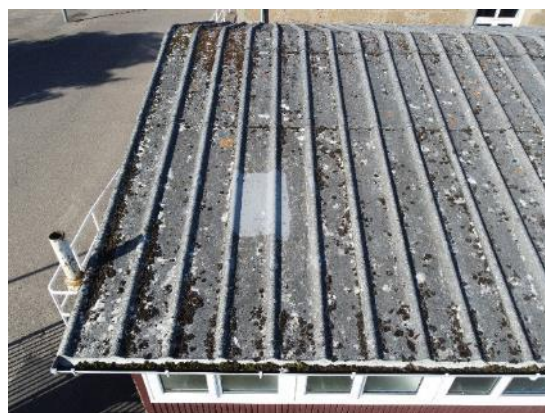
35. Surface erosion and previous repairs

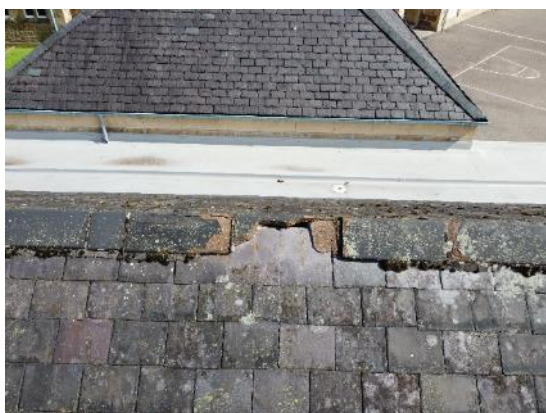
36. Damaged clay ridge tiles

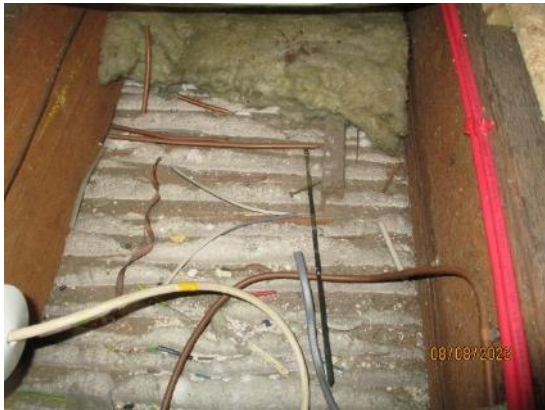
45. Insulation missing in isolated areas

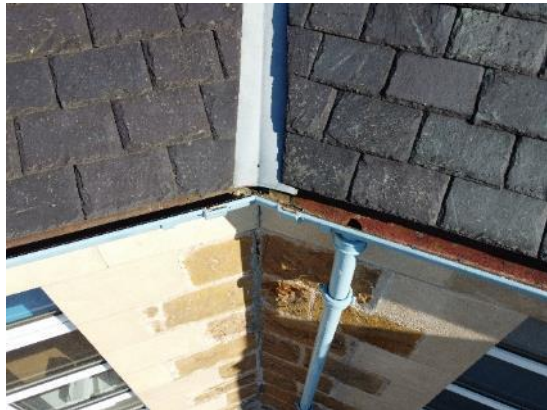
46. Surface corrosion in cast iron gutters

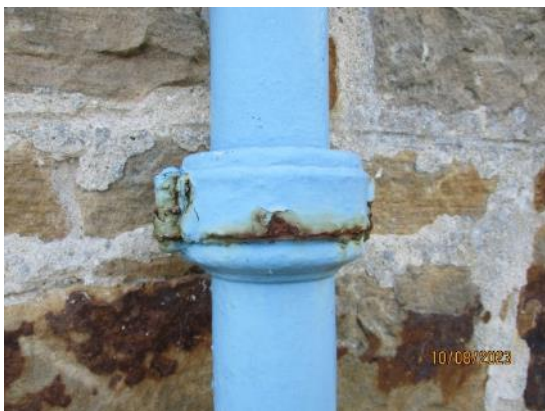
59. Surface corrosion

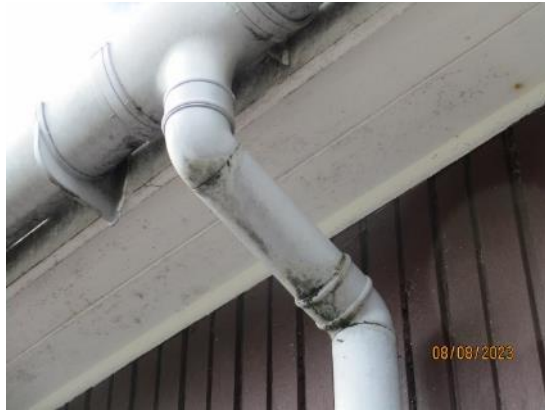
62. UPVC downpipes leaking at joints

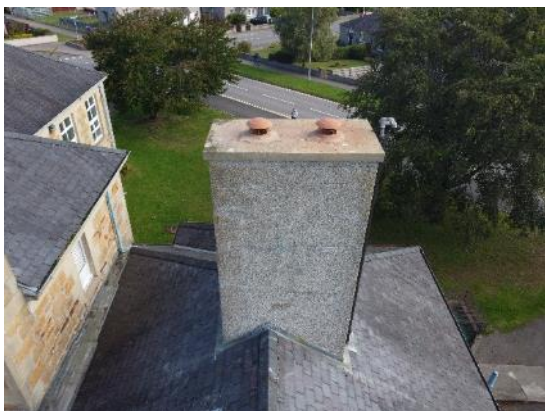
65. Cracked roughcast to boiler flue

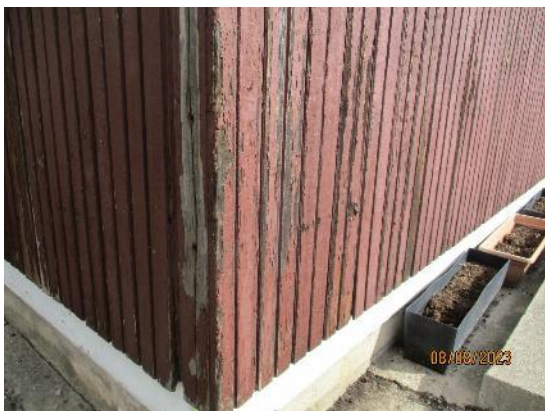
83. Rot and damage to timber cladding

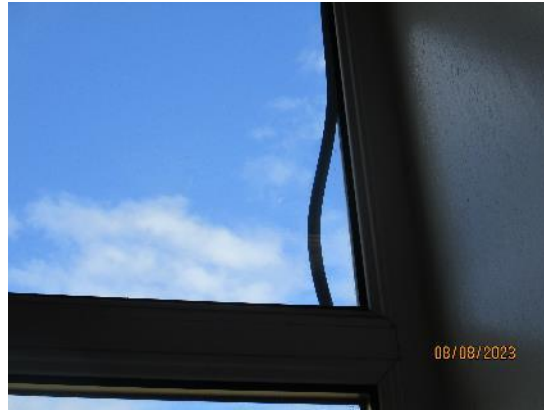
110. Failed window seals

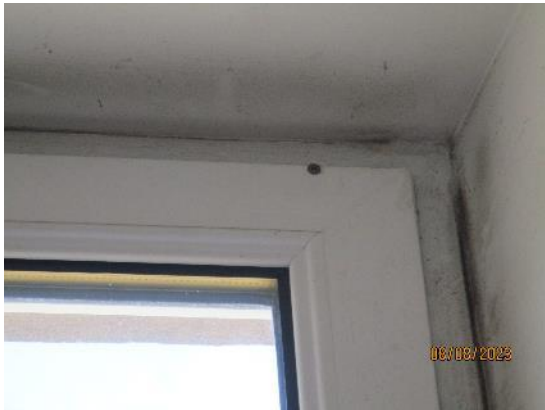
111. Windows screwed shut

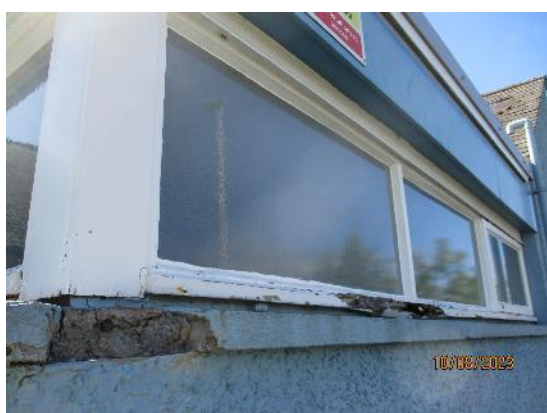
119. Rot in timber window frames

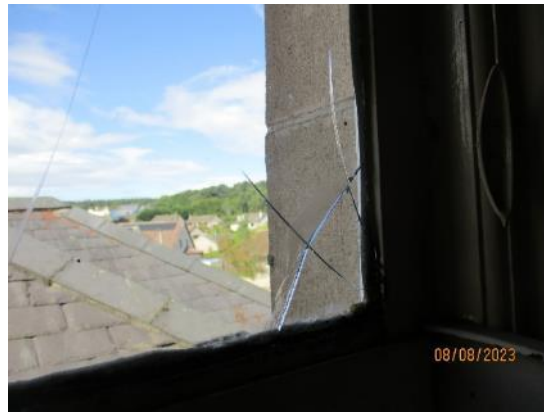
128. Broken single glazed windows

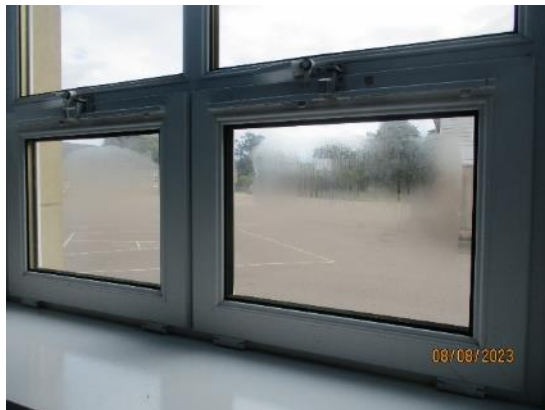
129. Failed double glazing units

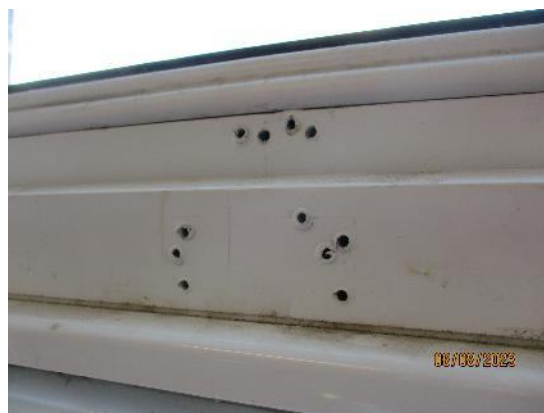
132. Missing window ironmongery

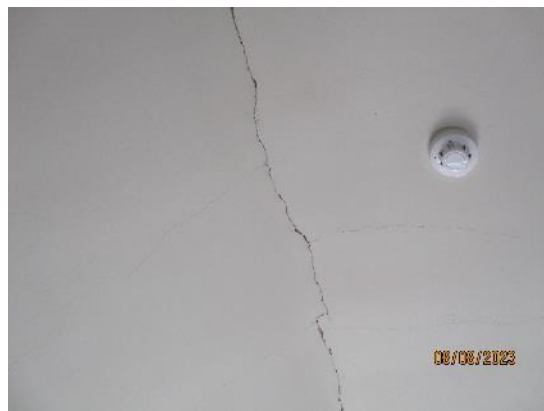
179. Cracked lath & plaster

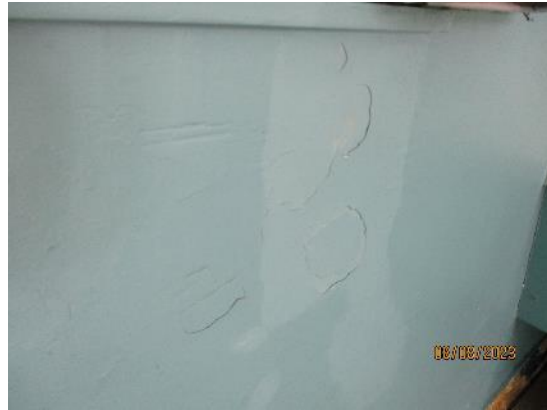
186. Cracked plaster walls

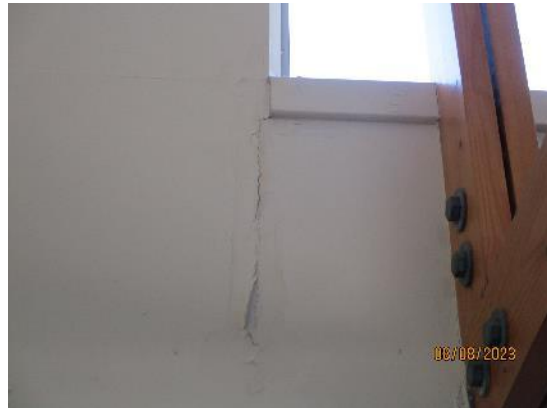
188. Water damaged plasterboard

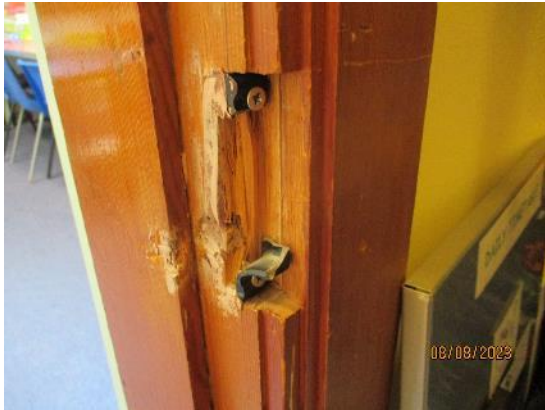
203. Damage to door frames

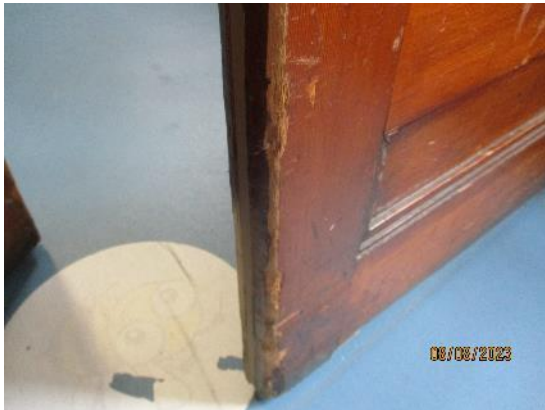
205. Damage to doors

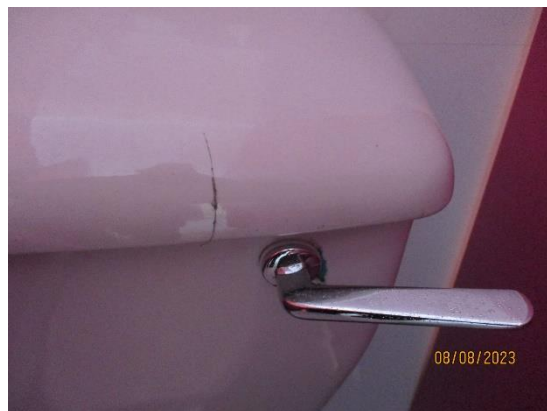
226. Cracked cistern

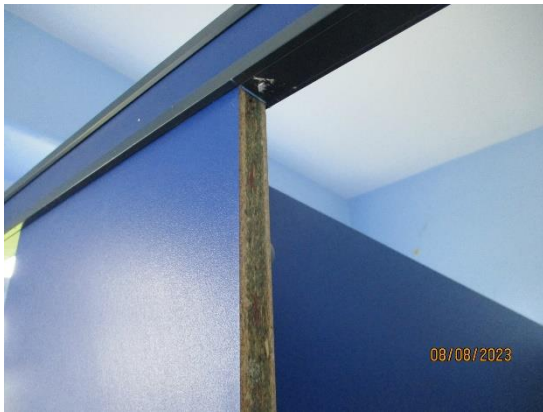
239. Missing edging strips

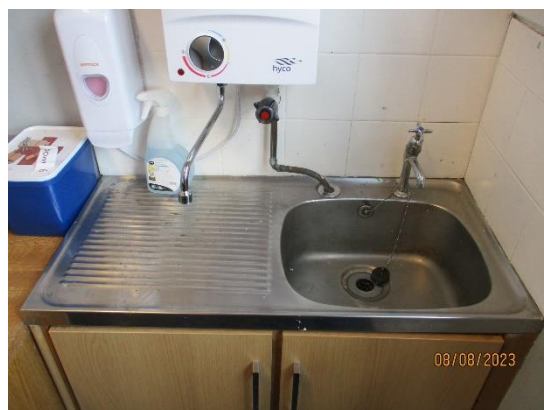
244. Dated classroom stainless steel sinks

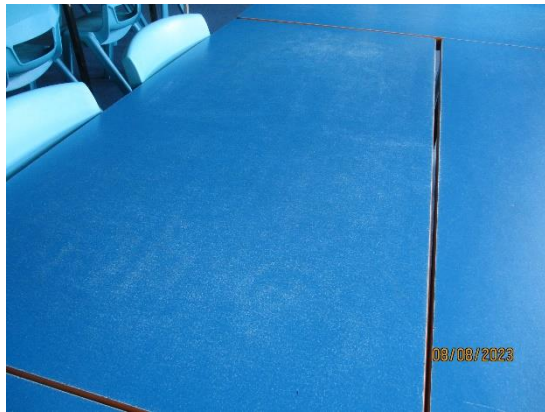
263. Worn desk tops

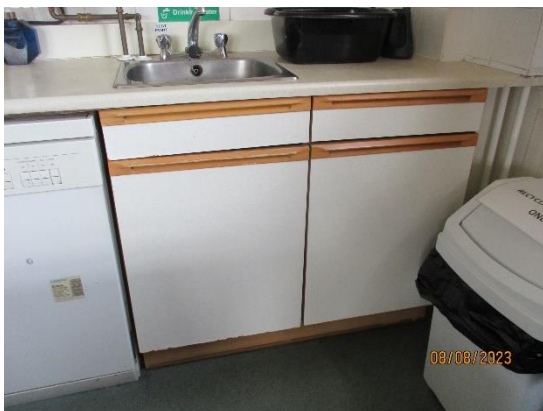
266. Worn sink base units

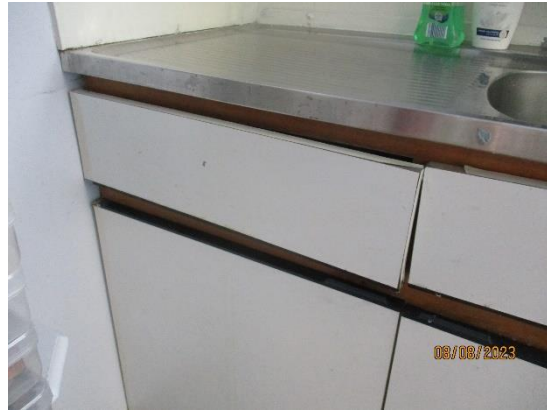
269. Loose drawers and lamination materials

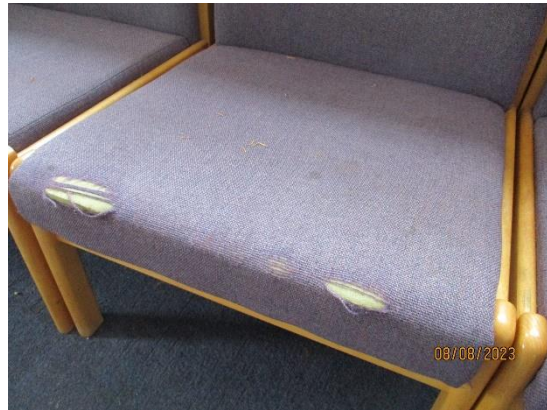
271. Worn fabric material

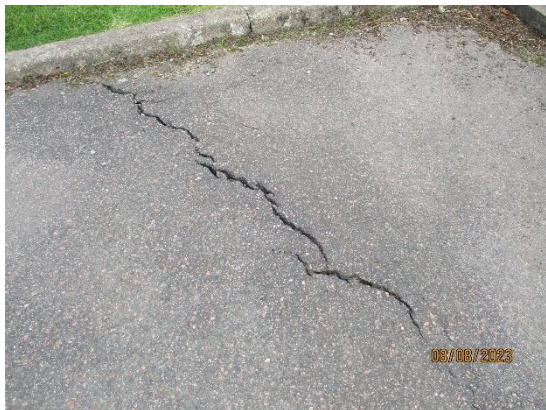
371. Tarmacadam paths cracked by tree roots

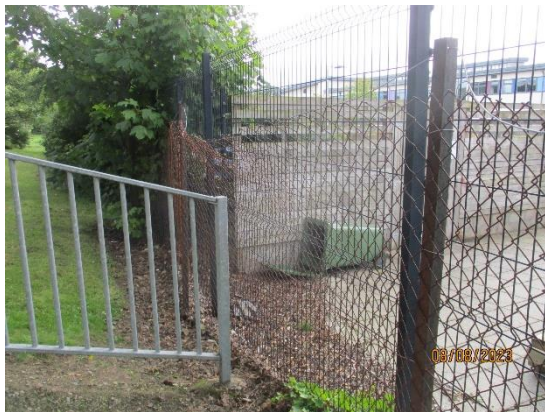
376. Corroded chain link fence

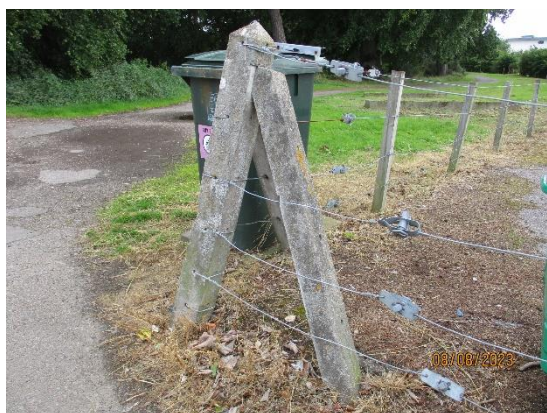
385. Impact damage to concrete posts

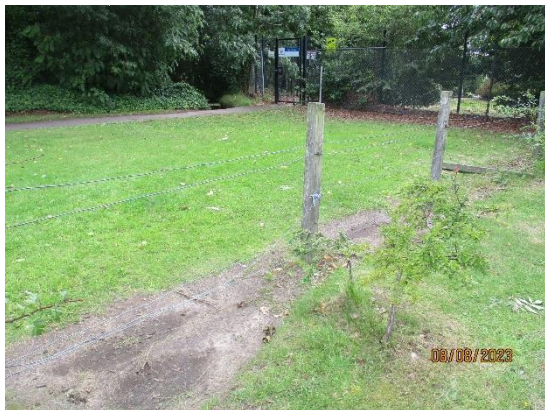
388. Missing wire

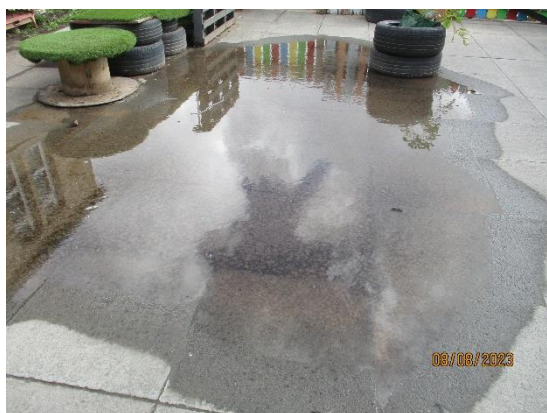
403. Inadequate drainage causing flooding

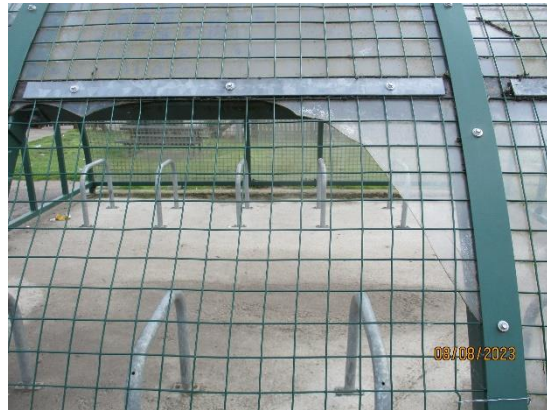
407. Broken plexiglass

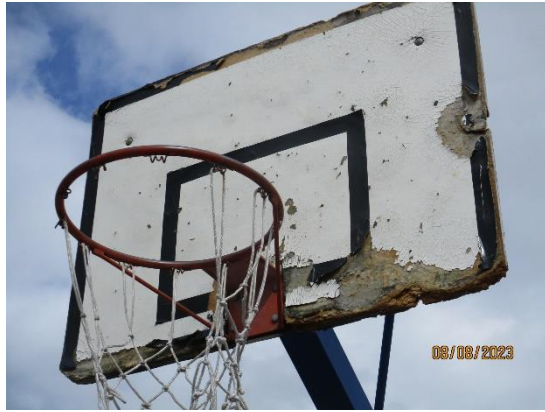
417. Backboards in poor condition
