# **Summary Building Condition Survey Report**

**East End Primary School  
Institution Road, Elgin IV30 1PR**

**10<sup>th</sup> & 11<sup>th</sup> April 2023**

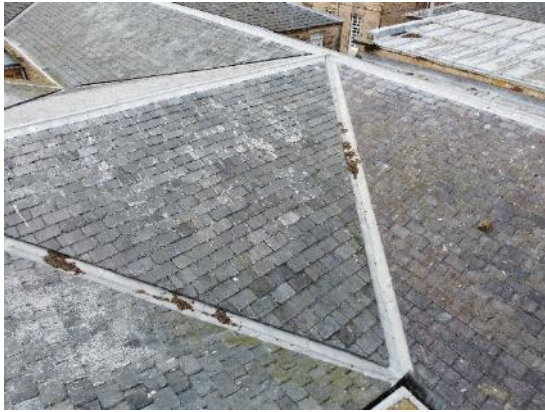
6. Debris in lead valleys

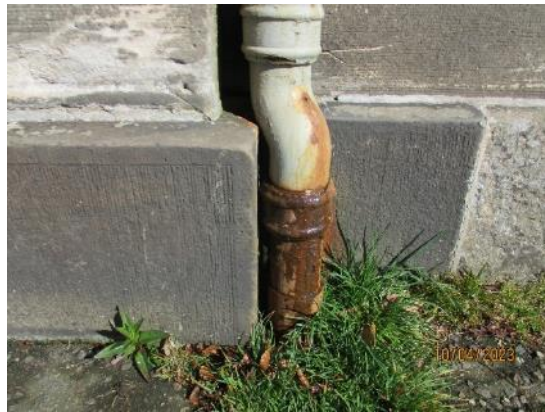
37. Block 1 – downpipes and overflows

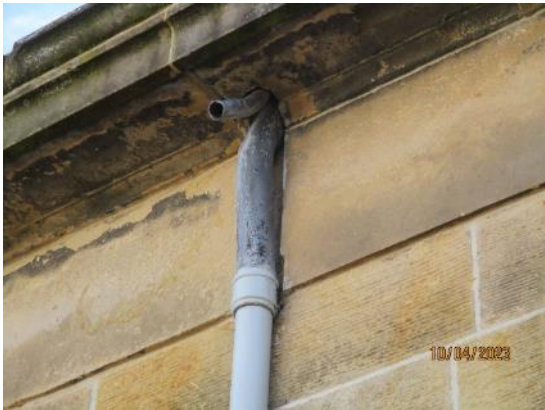
- Cast iron gutters and downpipes are damaged and partially blocked.
- Evidence of rainwater penetration to be investigated.
- Timber suspended floors to first floor have sagged and slope, investigate condition.
- Timber panelled doors are life expired.

38. Cracked, leaking, corroded cast iron

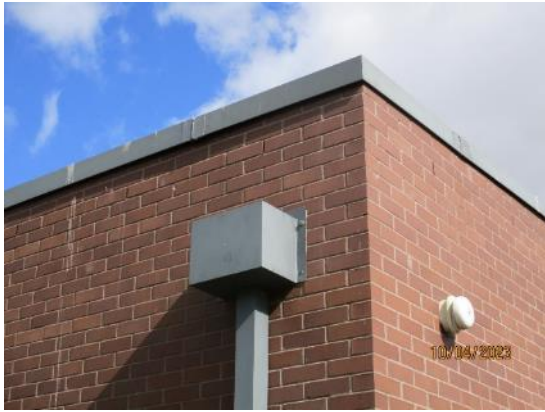
42. Poor condition downpipes

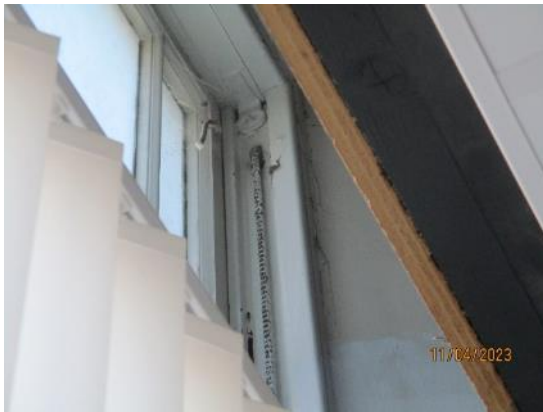
73. Gaps around windows

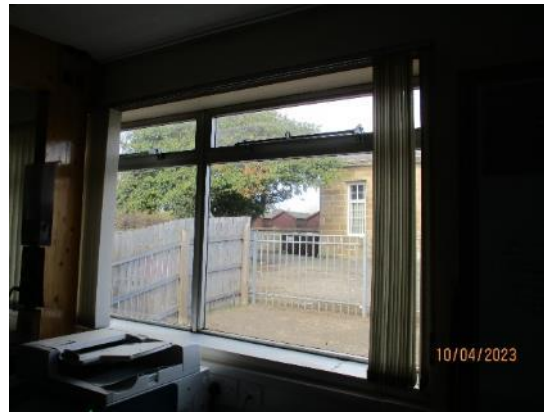
74. Broken chords

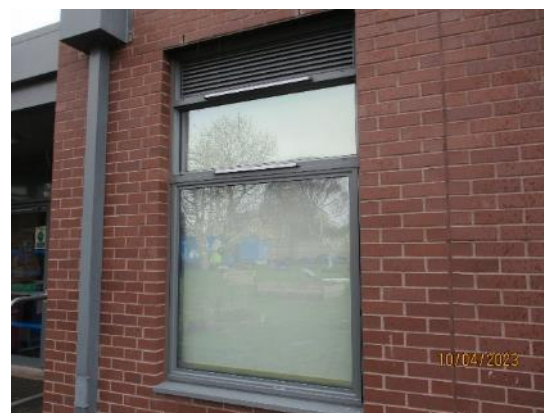
78. Defective panel below windows

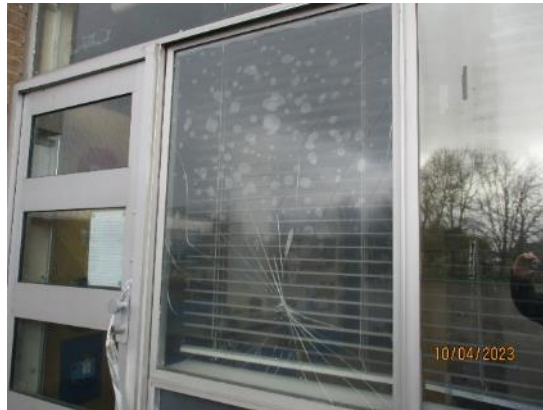
83. Broken glass

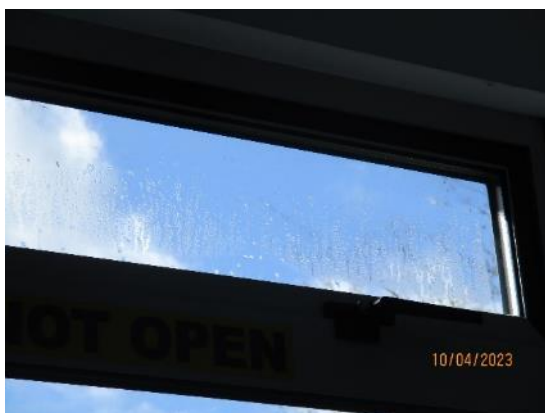
84. Blown double glazed unit

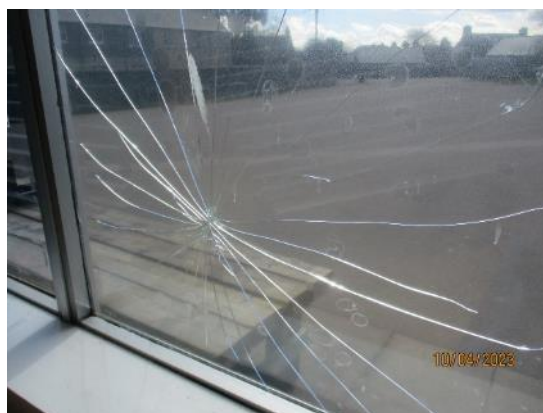
85. Broken glass

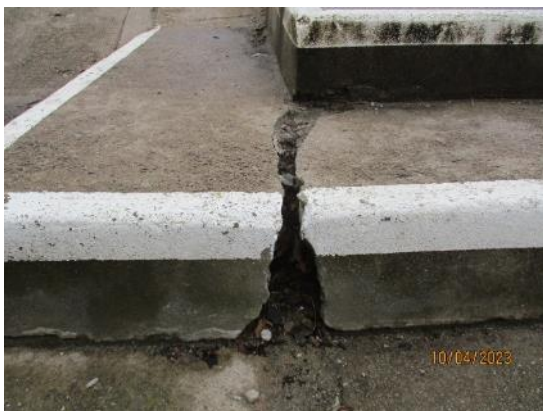
- Roof covering missing from Games Store.
- Aluminium windows and doors are life expired and single glazed.
- Concrete steps to west playground are broken.
- Internal doors and ironmongery are reaching the end of their useful life.
- Sanitary ware is functional although dated and life expired.

100. Broken concrete steps

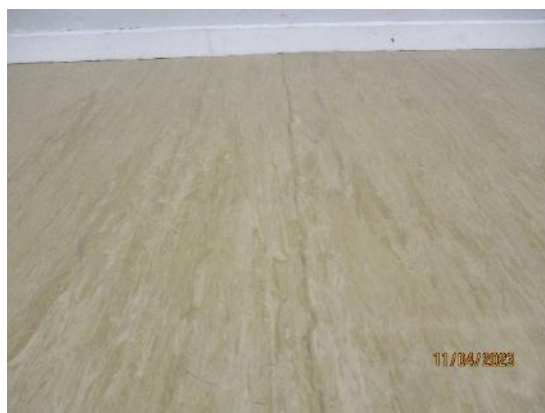
107. Linoleum cracked

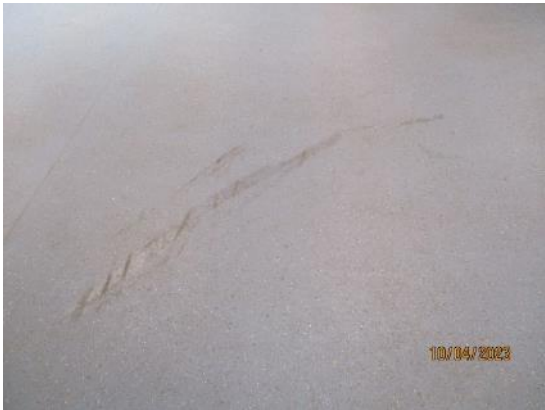
110. Damaged sheet vinyl

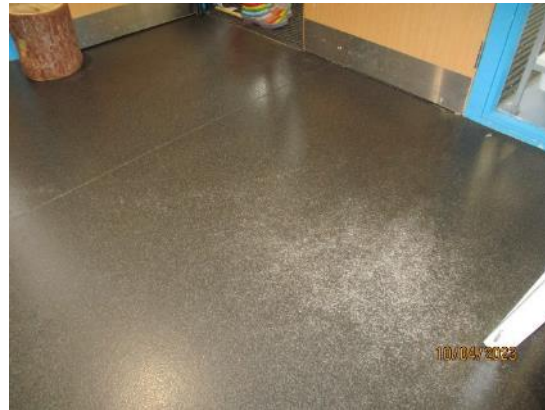
111. Worn sheet vinyl

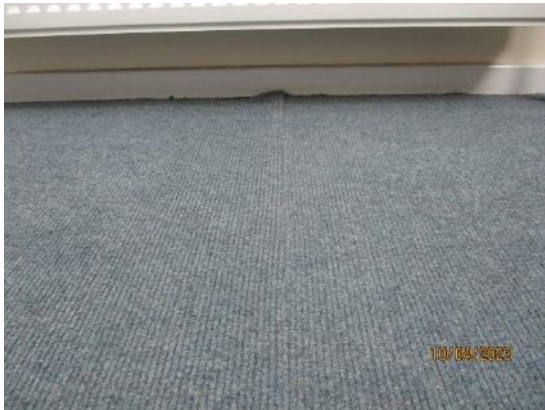
116. Loose carpet edges

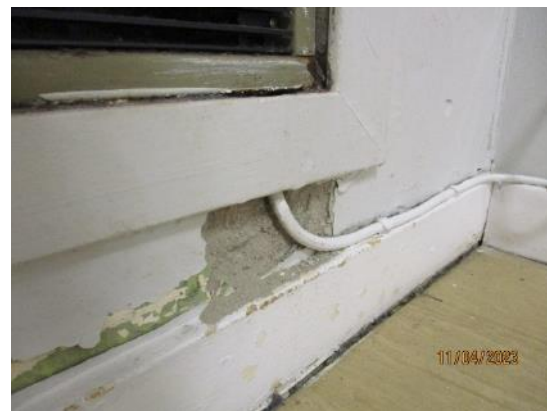
142. Damaged plaster walls

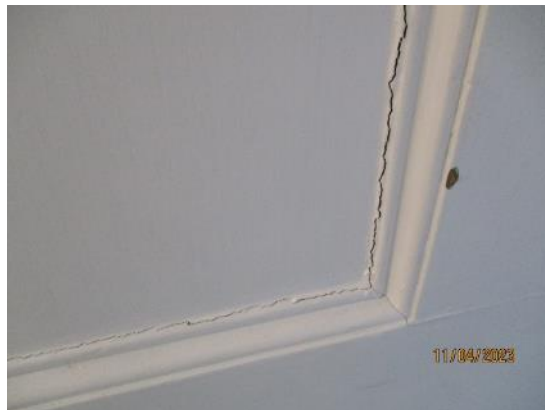
152. Damaged doors

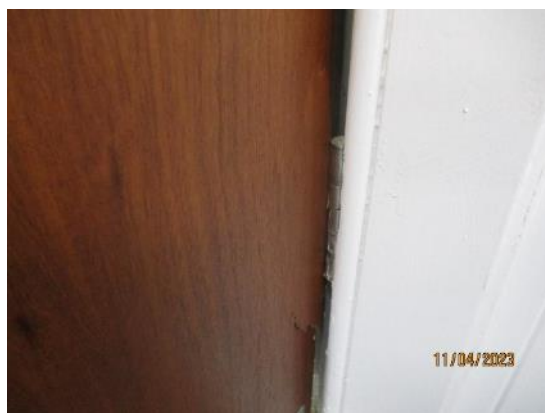
154. Isolated damage

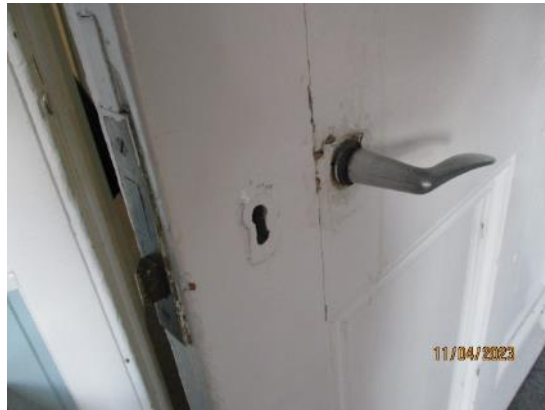
164. Missing aluminium ironmongery

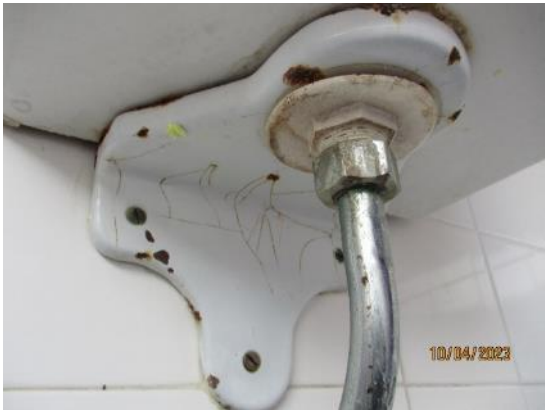
169. Cracked wall brackets

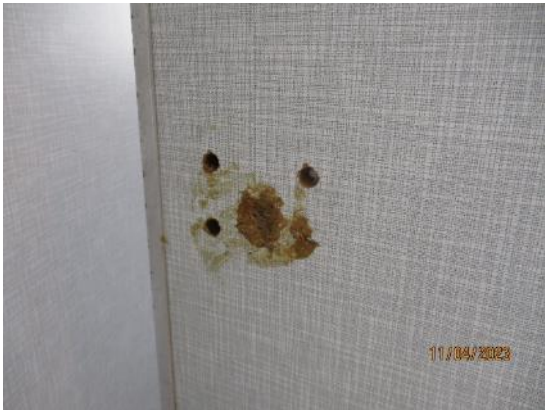
187. Damaged cubicle partitions

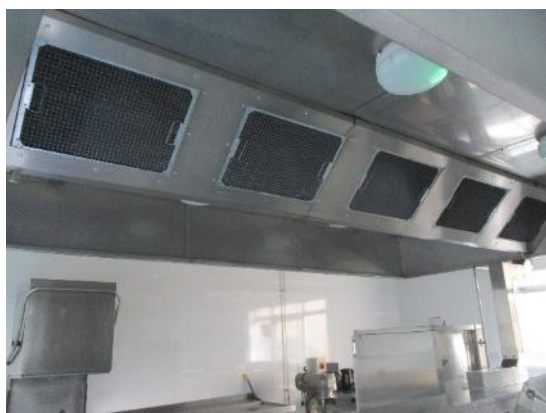
242. Extract canopy kitchen 1/3 block 2.

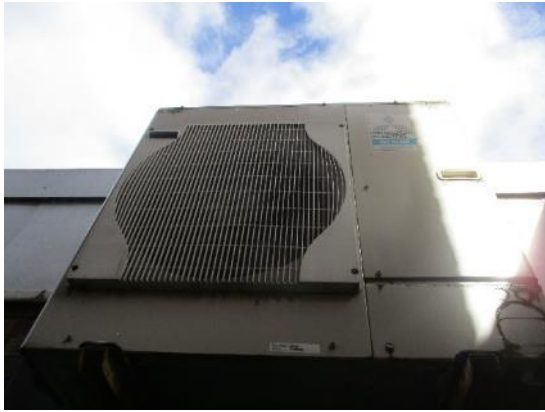
- The air conditioning systems in rooms kitchen 1/3, classes 1/13 and 1/15 are in poor condition and approaching the end of their useful life.
- Smoke and heat detectors in block 2 are assumed to be greater than 10 years old and therefore life expired as per CIBSE Guide M.

244. Air conditioning outdoor unit - kitchen 1/3 block 2.

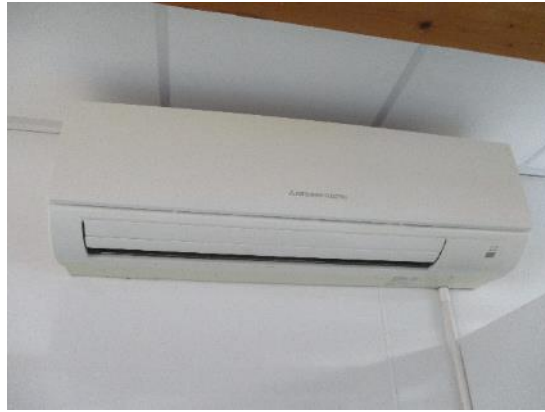
245. Air conditioning indoor unit - kitchen 1/3 block 2.

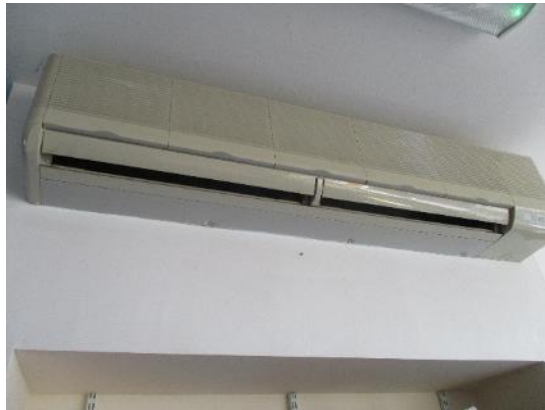
246. Air conditioning indoor unit class 1/13 (P5)

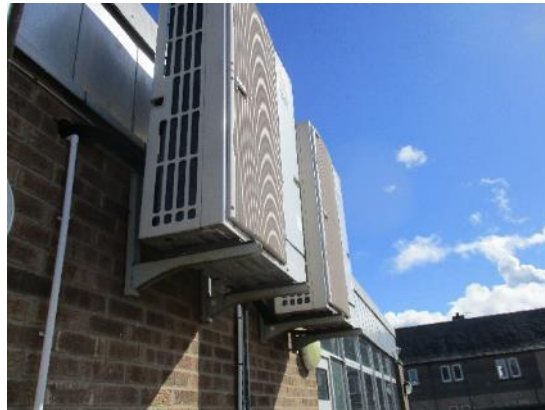
247. Air conditioning outdoor units classes 1/13 + 1/15.

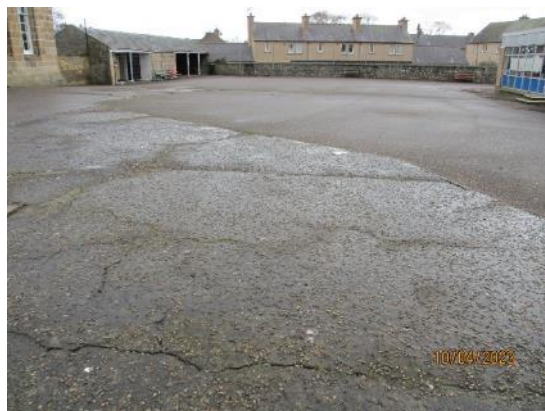
- Tarmacadam access road and car park, sunken and potholed.
- Tarmacadam playground cracked and uneven.
- Timber benches have timber rot and sections missing.
- Precast slab footpaths are broken and uneven.
- Fencing above stone walls is damaged.
- All pedestrian and vehicle entrance gates are seized.
- Stone perimeter walls are cracked, eroded and damaged.
- All surface water drainage to the car park and playground are blocked.
- The roof of the playground shelter is in poor condition, woodworm, slipped slates, water ingress etc.

303. Tarmacadam playground cracking

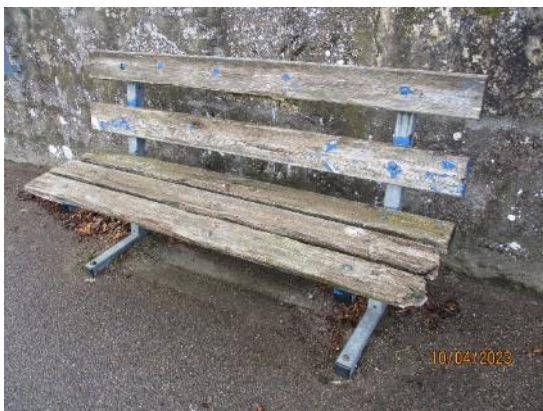
308. Timber benches with timber rot

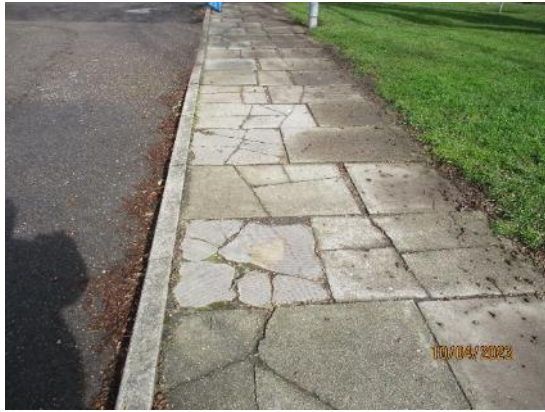
310. Extensively cracked paving slab footpaths

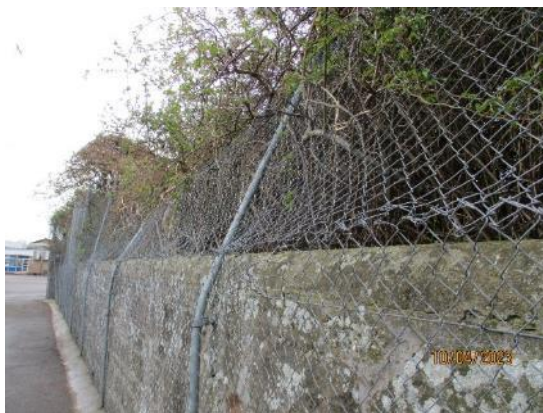
315. Damage to chain link fencing

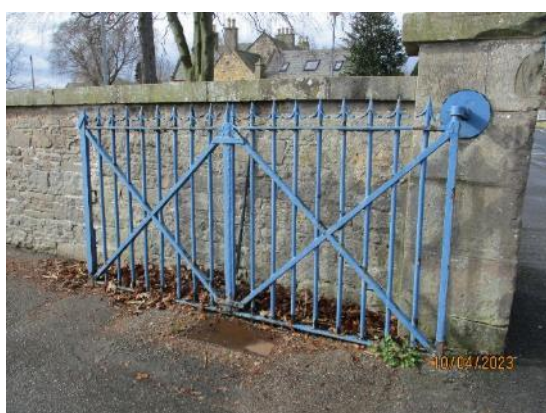
320. Vehicle gates (seized)

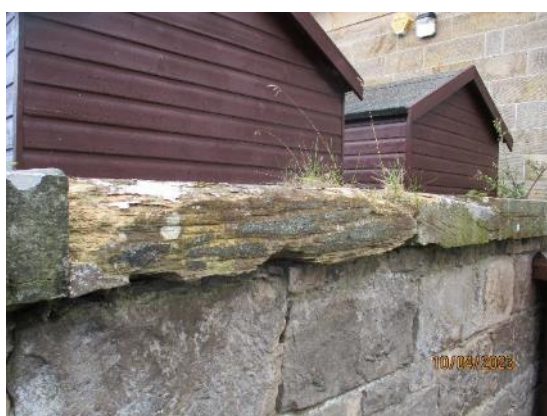
326. Eroded coping stones

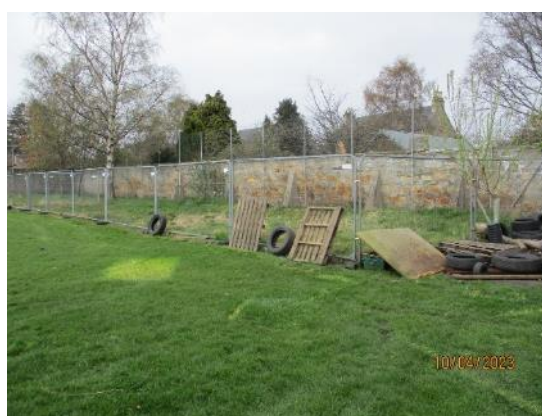
327. Damage to perimeter wall

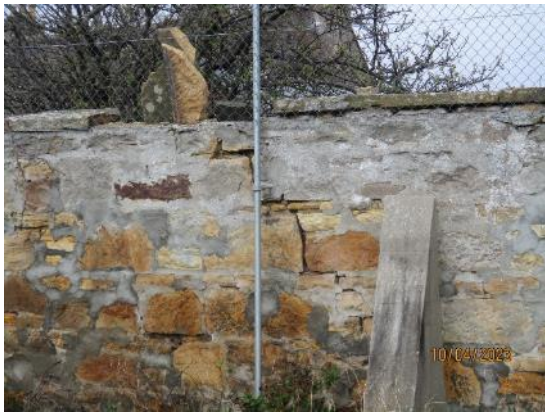
328. Significant damage to stone walls

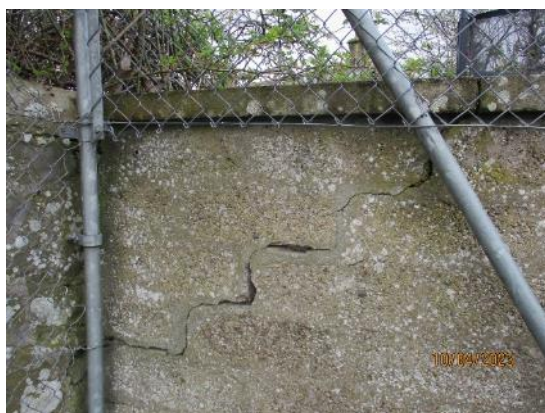
332. Cracked blockwork walls

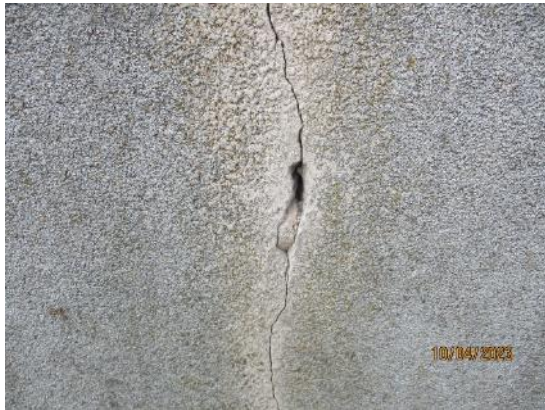
342. Cracked external wall and roughcast
