# **Summary Building Condition Survey Report**

**Seafield Primary School  
Deanshaugh Terrace, Elgin IV30 4ES**

**24<sup>th</sup> to 26<sup>th</sup> May 2023**

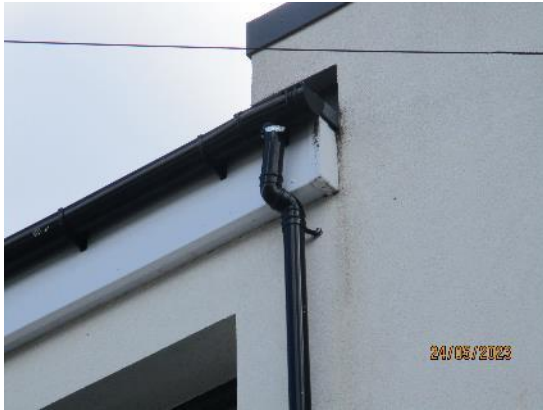
25. UPVC downpipes (isolated defects)

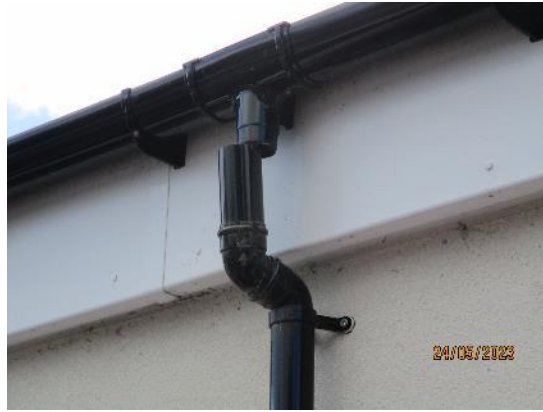
32. UPVC downpipes (isolated defects)

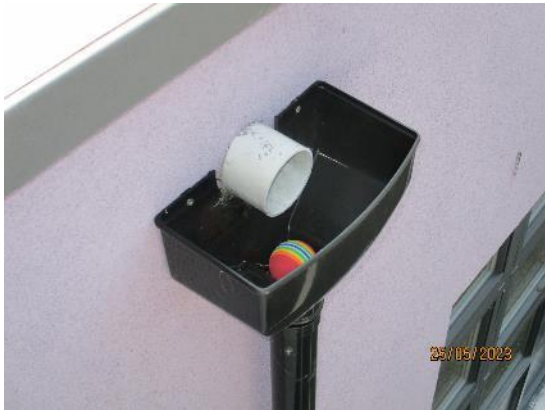
33. Hopper heads with blockages

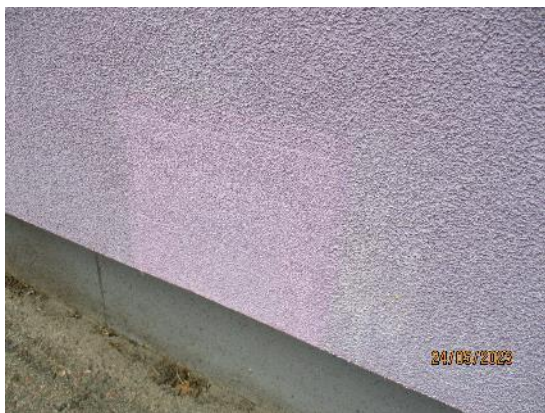
54. Isolated areas of previous repair

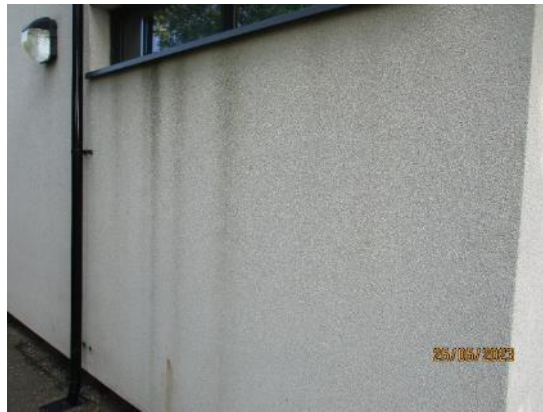
74. Staining to external insulation

- Protection of the external insulation is recommended in the car park area.
- Consider additional bird deterrents, 4 gull nests found on roofs.
- Confirm operational condition of bird scarer on nursery roof.

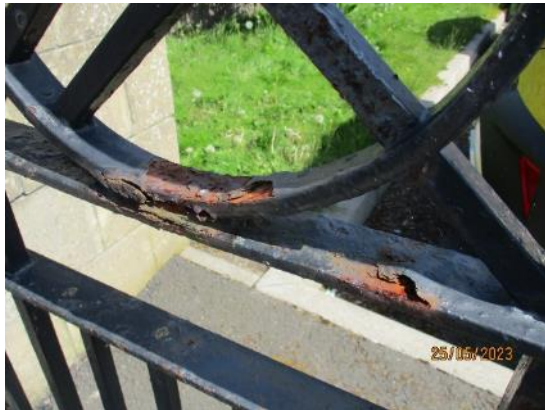
- Tarmacadam car park and access road are breaking up and pot holed.
- External concrete steps and ramps are cracked and eroded.
- Tarmacadam and paving slab footpaths are cracked and uneven.
- Damage and corrosion to metal gates and chain link fencing.

75. Surface corrosion to metal gates

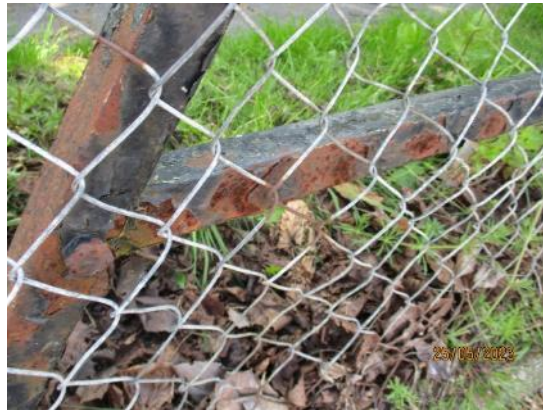
76. Surface corrosion to fence framework

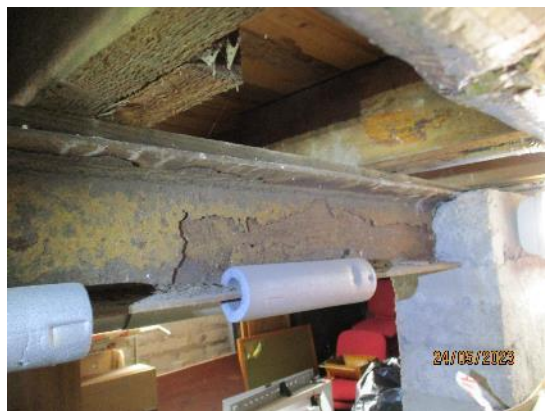
- The original timber internal doors are reaching the end of their useful life.
- Steel structure below the stage has considerable surface corrosion.
- Several carpets are soiled and stained.

84. Corroded steel beams

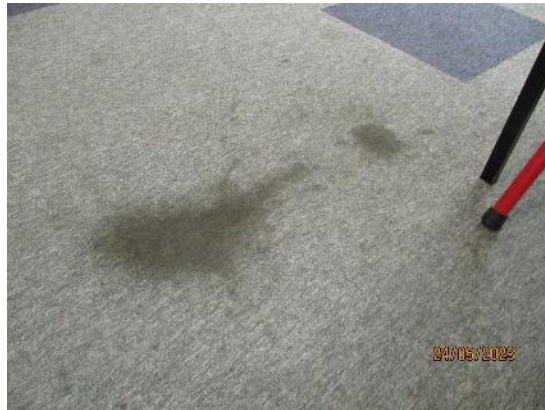
88. Soiled and stained carpets

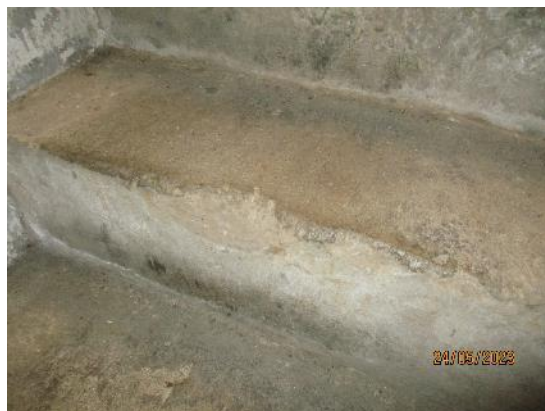
102. Damaged stair nosings

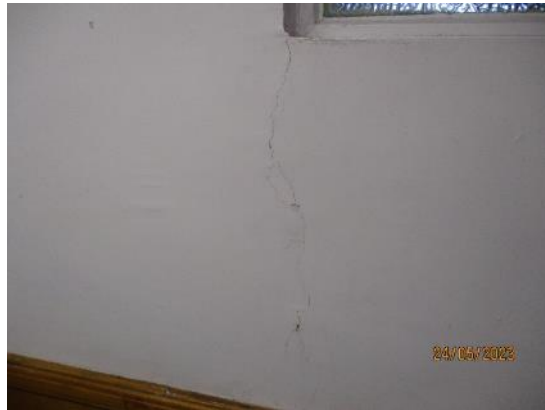
111. Plastered walls (isolated hairline cracking)

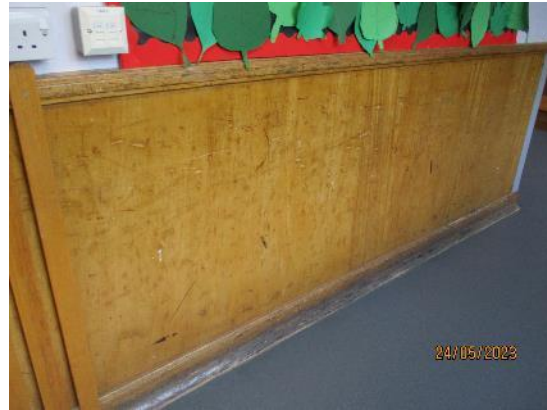
115. Minor surface damage

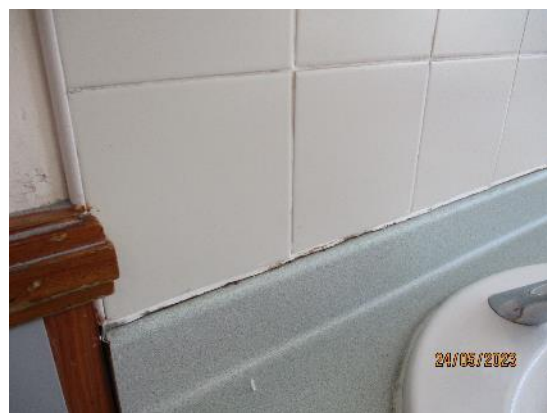
119. Isolated missing grout

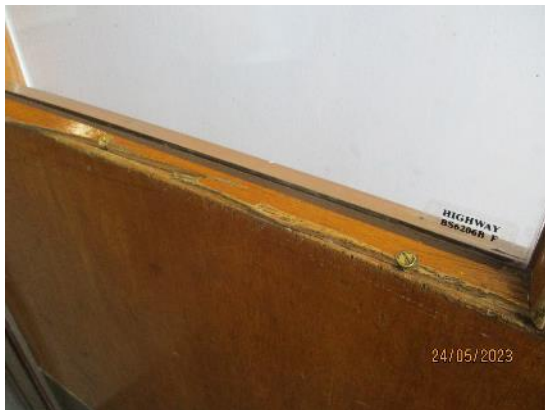
122. Broken glazing beads

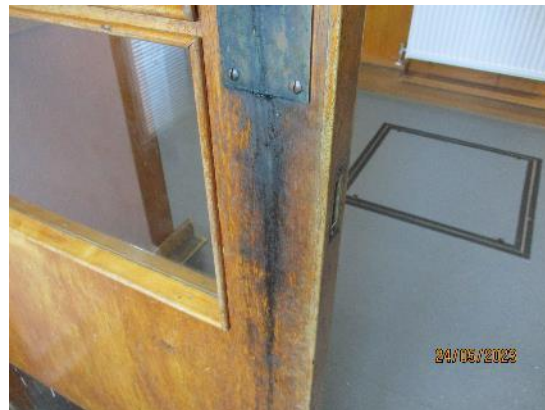
123. Damage to the surface of doors

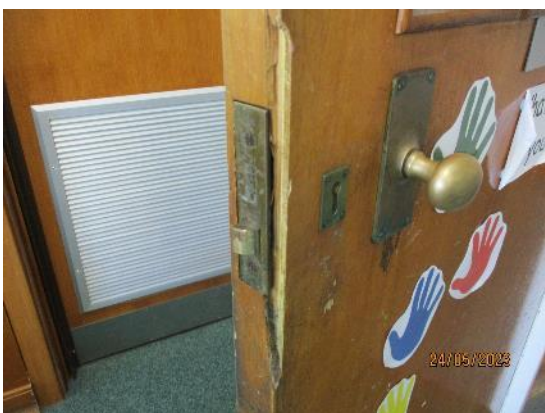
124. Damage to door edges

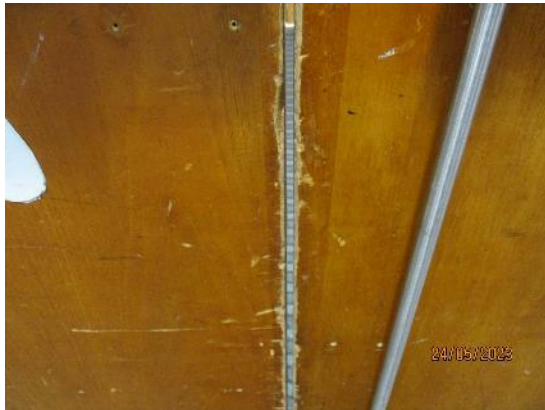
128. Gaps with damage to edges

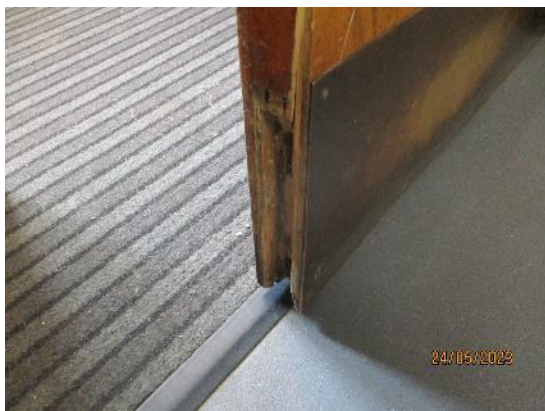
130. Damage to styles and bottom rails

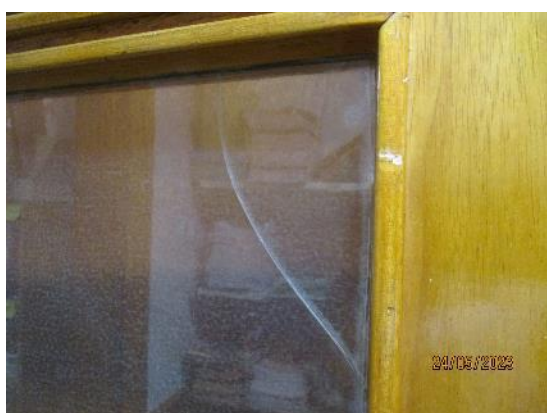
136. Isolated broken glass

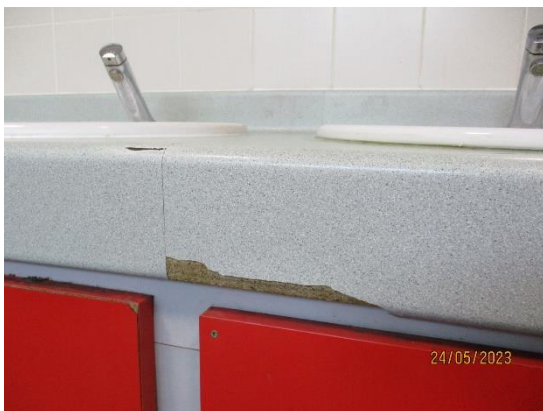
154. Isolated surface damage

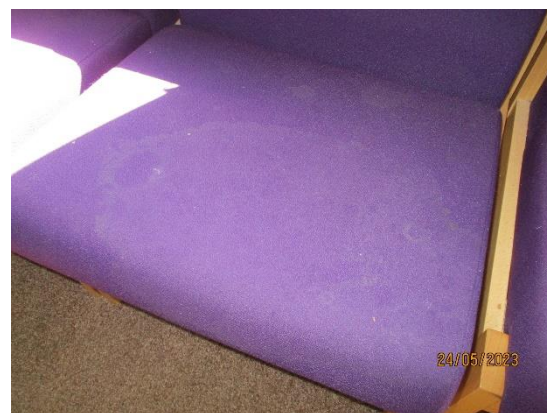
177. Stained seats

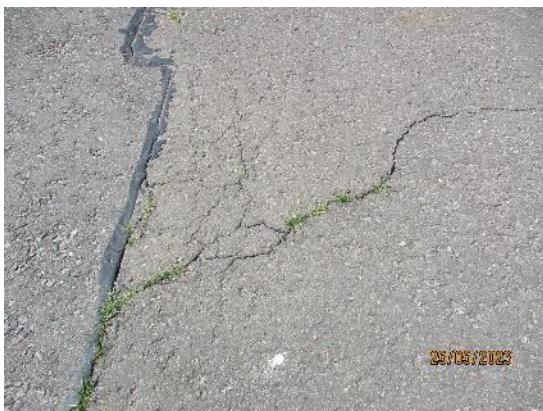
242. Tarmacadam cracking

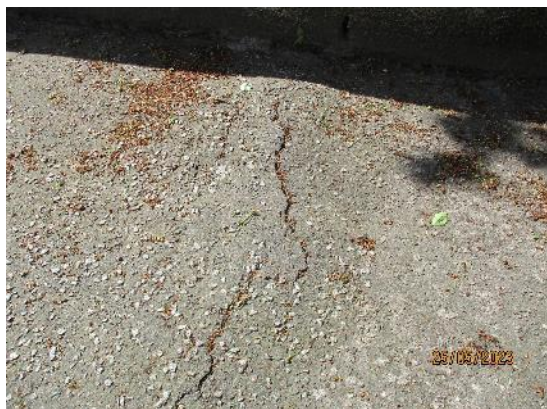
246. Cracking due to tree roots

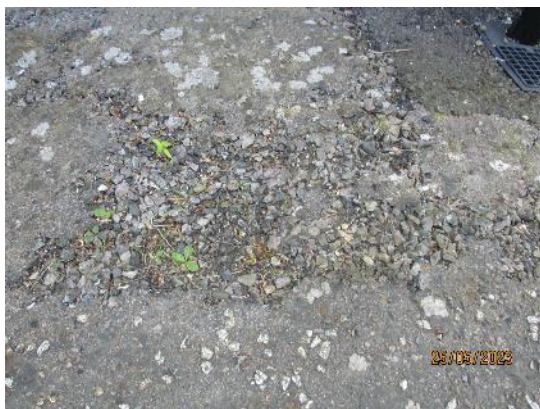
247. Surface erosion

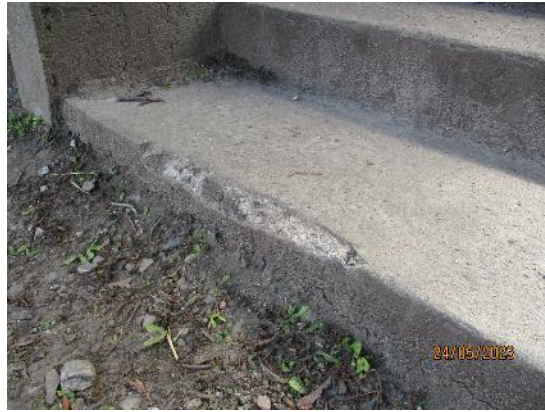
251. Broken nosings

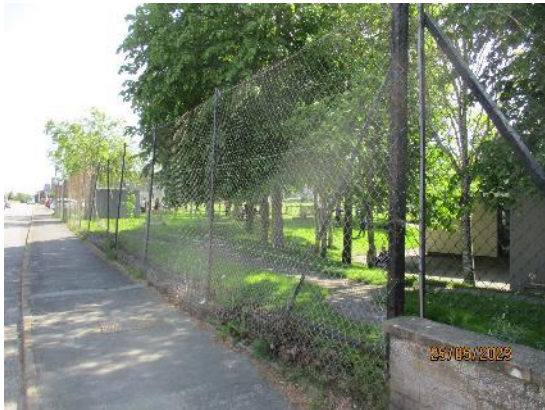
252. Chain link fence leaning

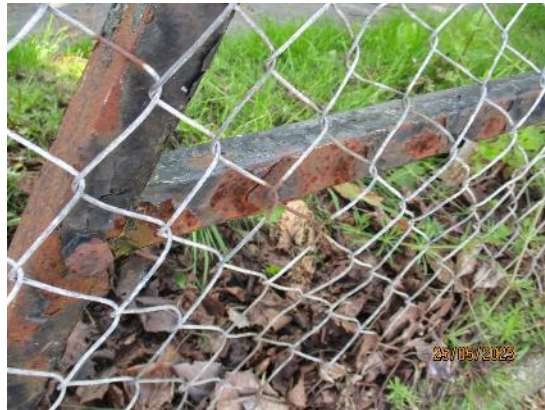
253. Corroded steel frame

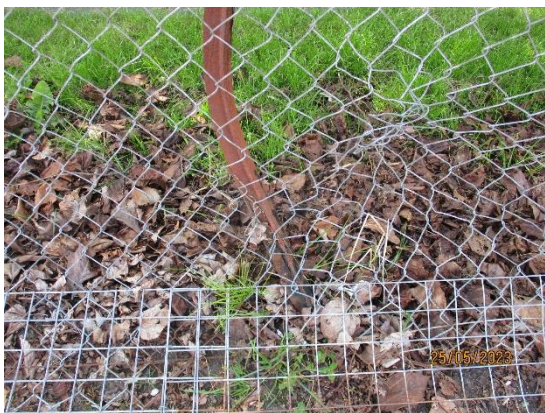
254. Impact damage to steel frame

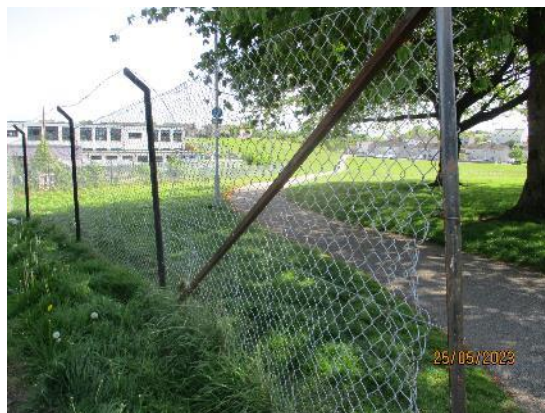
255. Loose chain link fencing

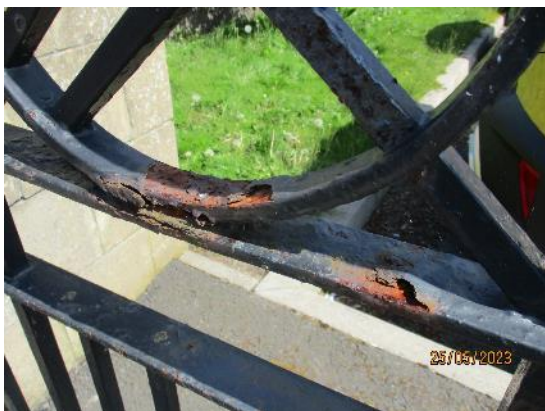
260. Peeling paint and surface corrosion

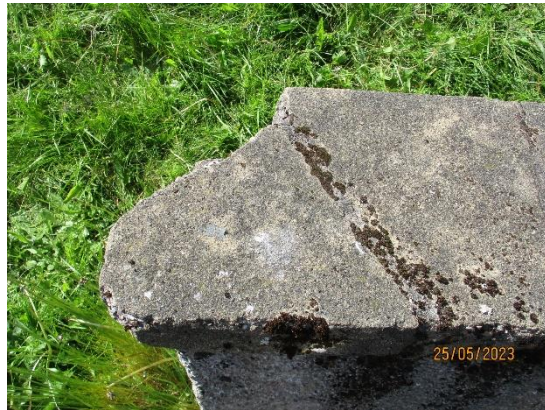
271. Broken coping stones

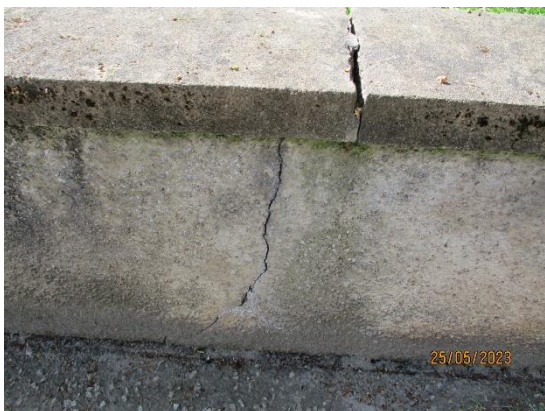
272. Cracks to brick walls
