# **Summary Building Condition Survey Report**

**St Sylvesters Primary School  
Abbey Street, Elgin IV30 1DA**

**26<sup>th</sup> & 27<sup>th</sup> June 2023**

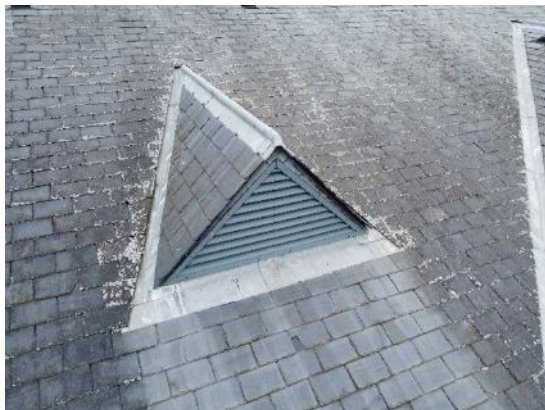
10. Isolated broken slates

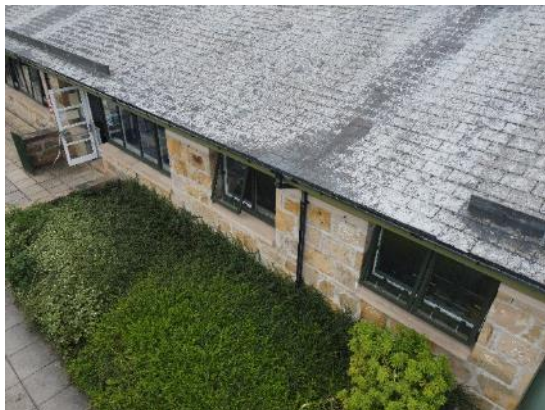
21. Missing section of snow boards

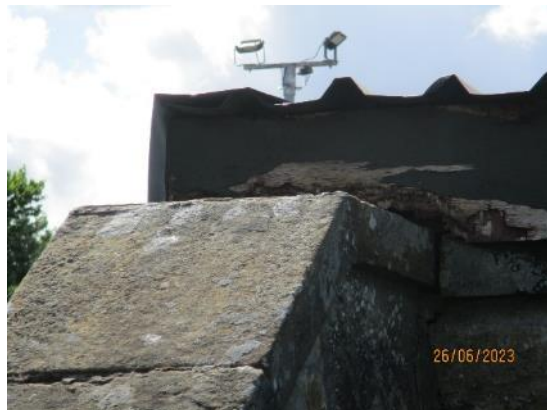
22. Rotten fascia board to external store

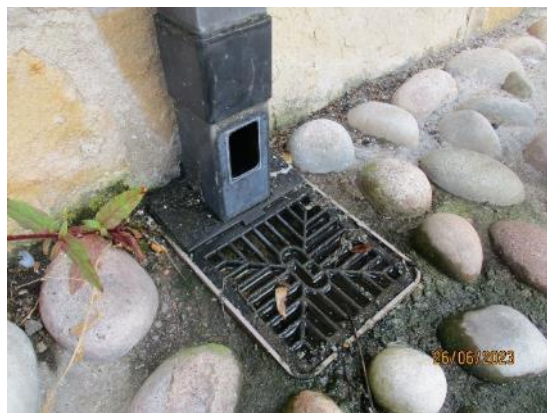
30. Below ground drainage blocked

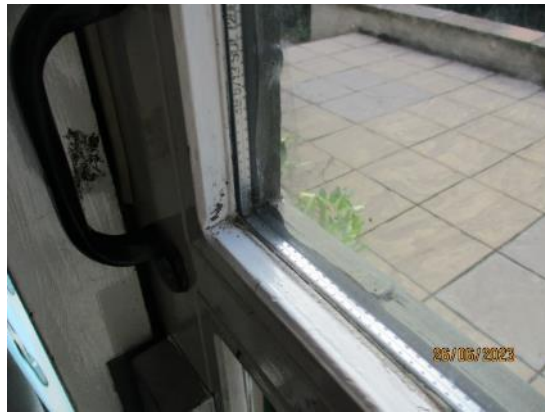
37. Damage to face of doors

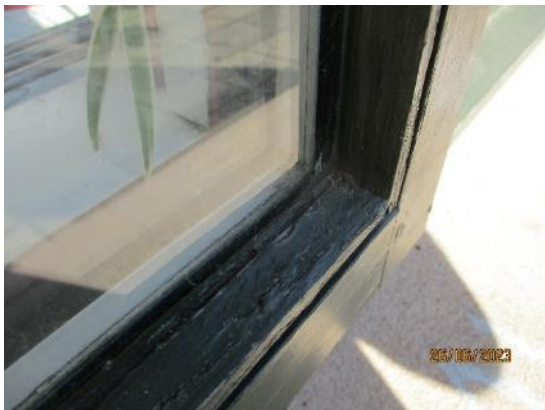
44. Seals to frames failing

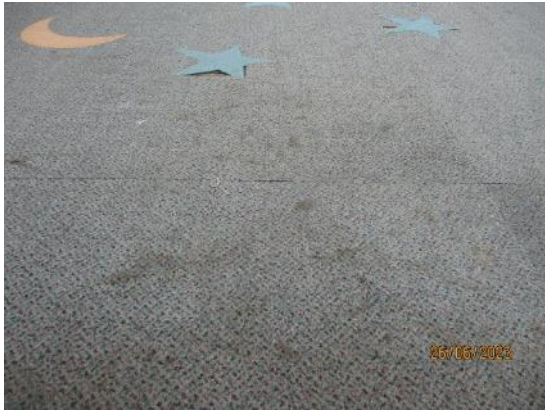
59. Edges lifting, seam joints failed

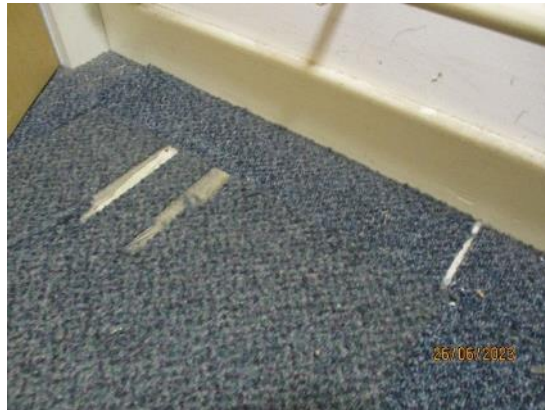
63. Carpet tiles damaged

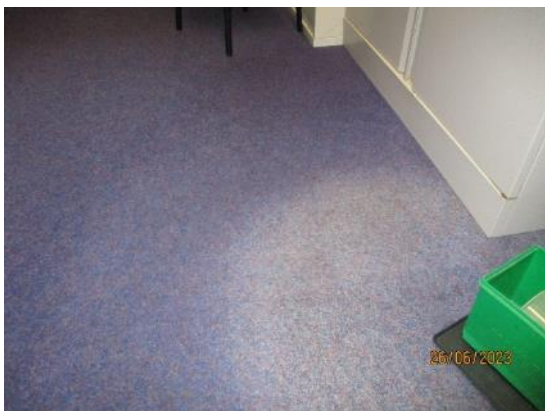
64. Carpet worn

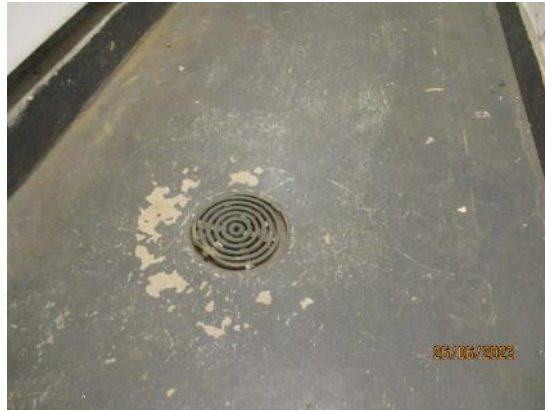
66. Timber boards worn

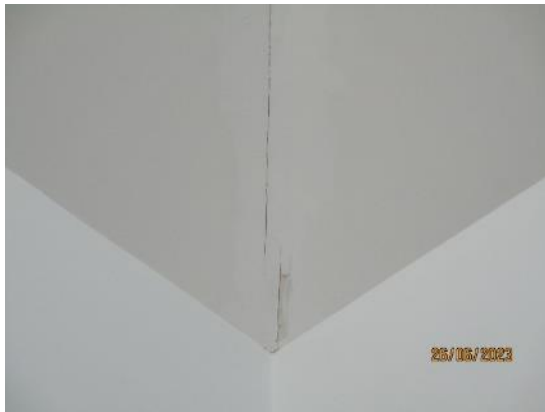
71. Cracking at taped joints

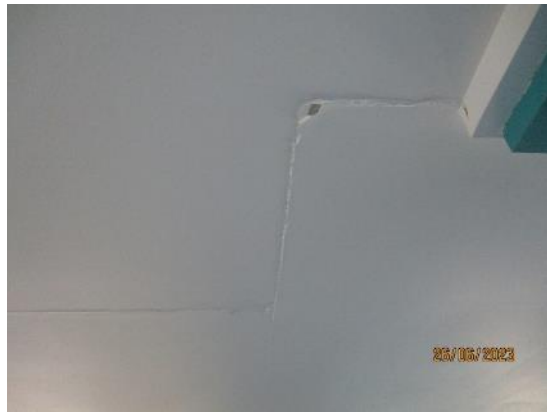
72. Cracking at joints

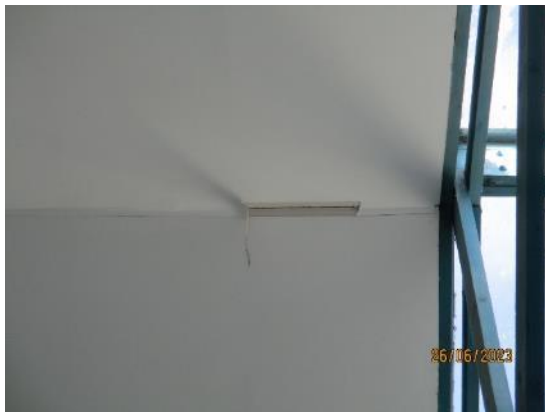
73. Failed taped joints

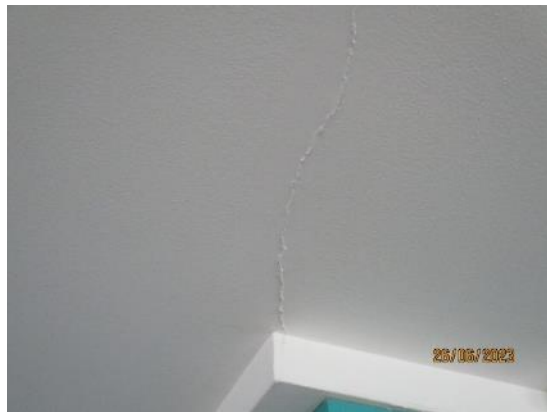
74. Cracking at steel columns

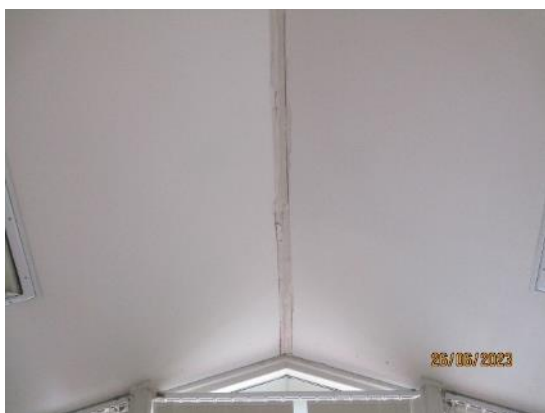
75. Failed taped joints

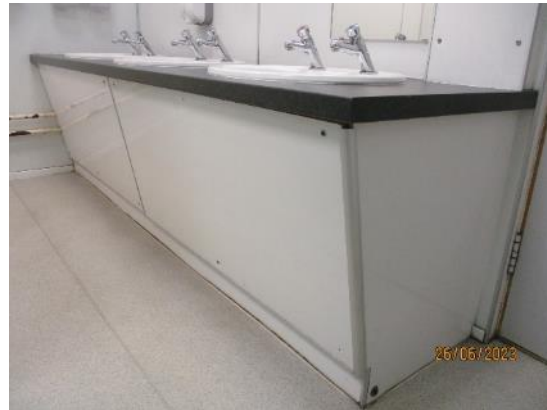
112. Edging coming loose

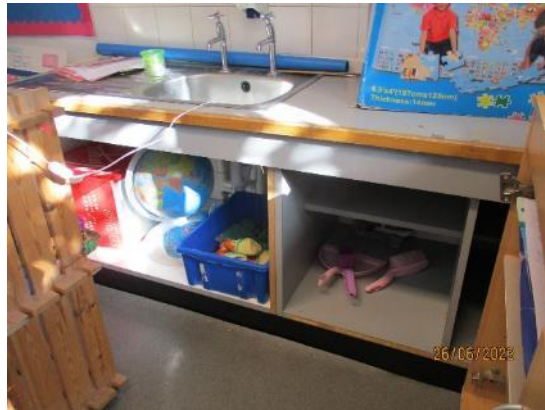
129. Worn worktops

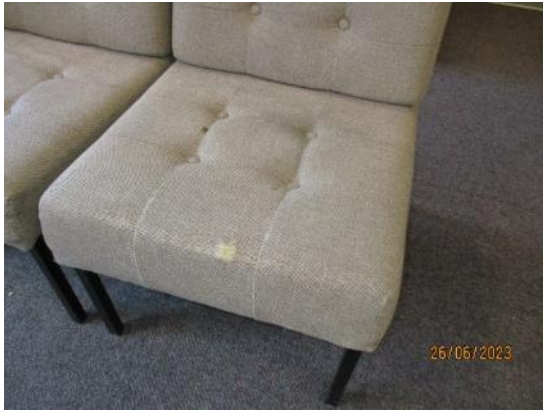
133. Chair fabric damage

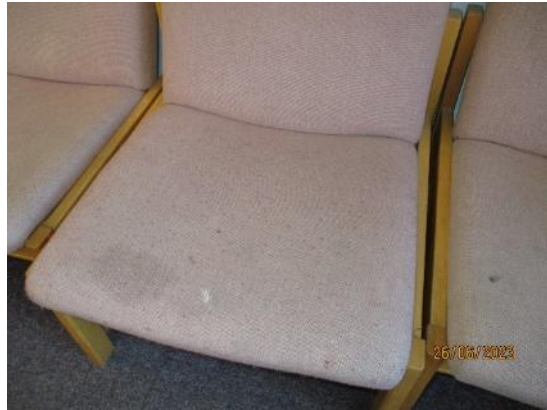
134. Chairs soiled and stained

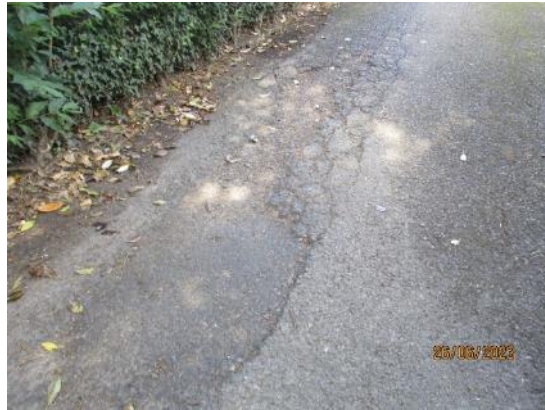
190. Cracked and pot holed

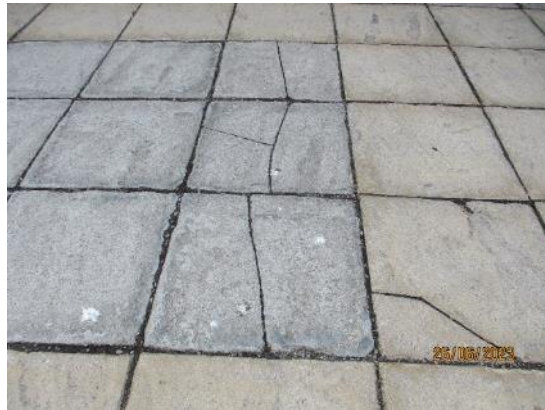
198. Cracked, loose and uneven slabs

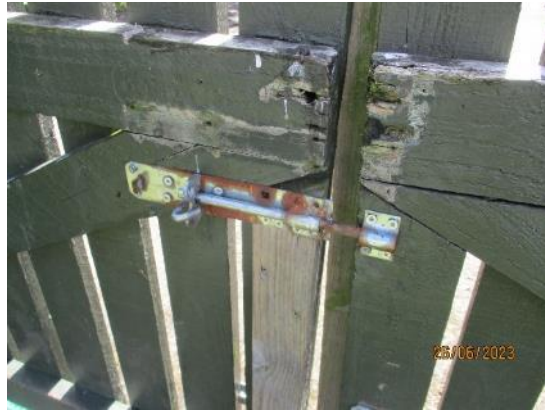
208. Damage and rot to timber gates

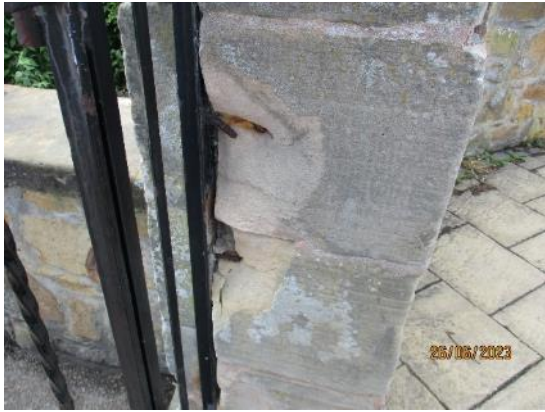
213. Masonry damage and erosion

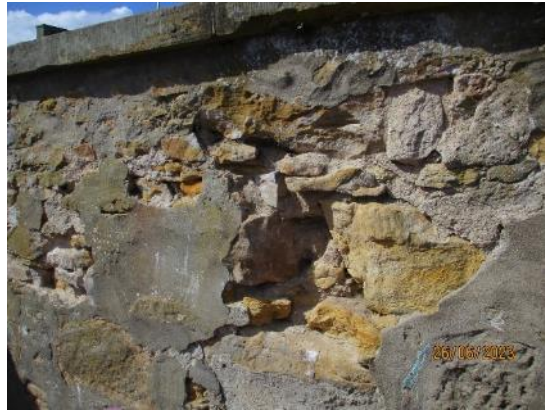
214. Eroded, crumbling masonry

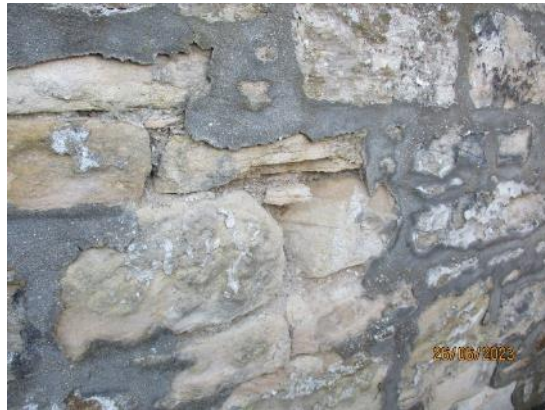
216. Spalling cement mortar pointing

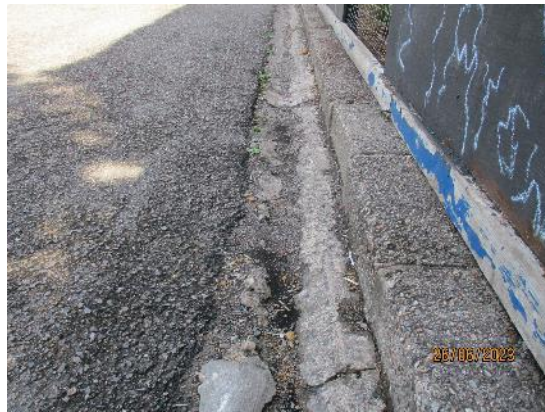
220. Concrete channel drain cracked and broken

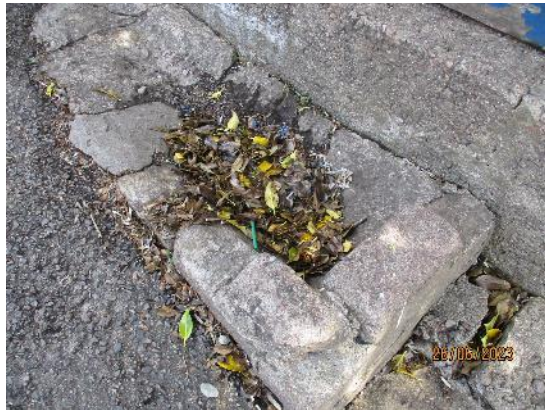
221. Drainage gully broken and blocked

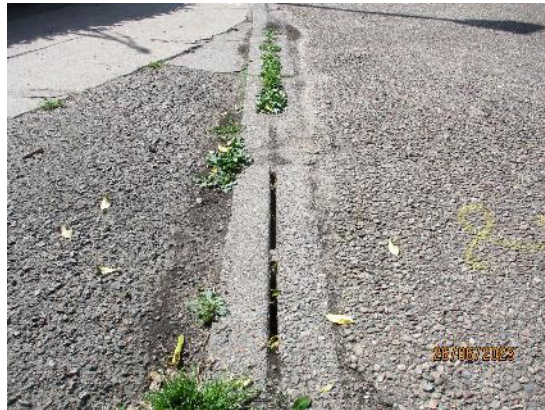
222. Concrete channel drain blocked
