# **Summary Building Condition Survey Report**

**West End Primary School  
Mayne Road, Elgin IV30 1PA**

**12<sup>th</sup> & 13<sup>th</sup> July 2023**

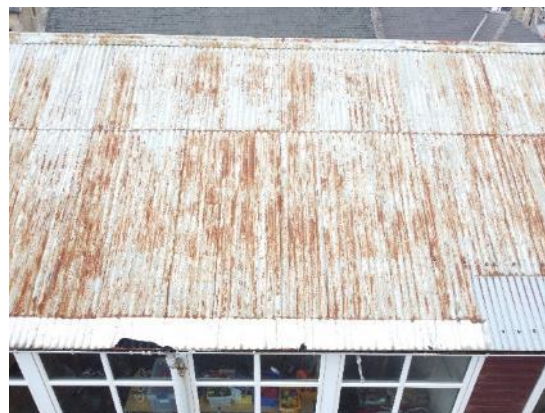
17. Corroded and damaged corrugated iron

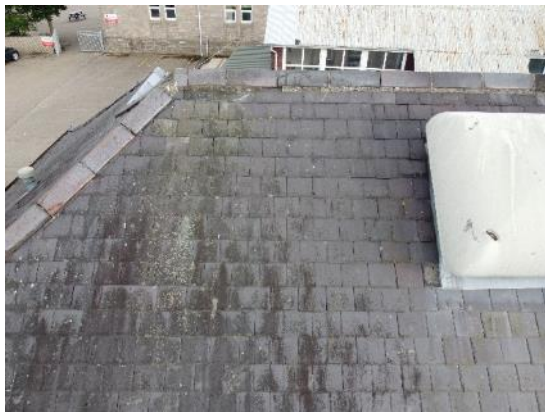
20. Chipped and broken slates

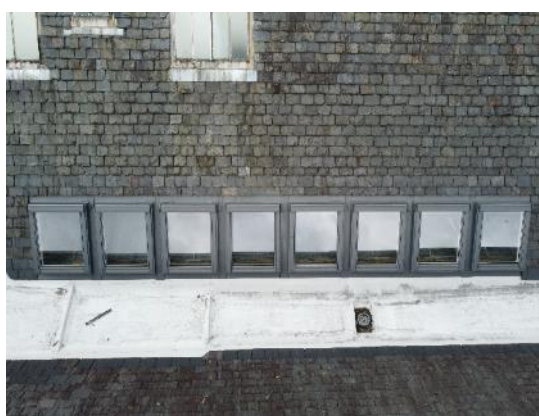
29. Metal skylights with broken glass

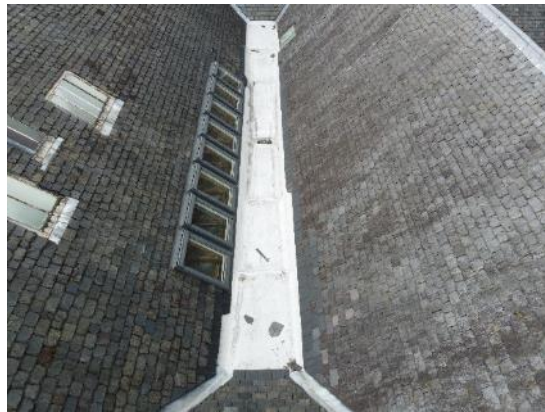
37. Leaking cast iron gutters

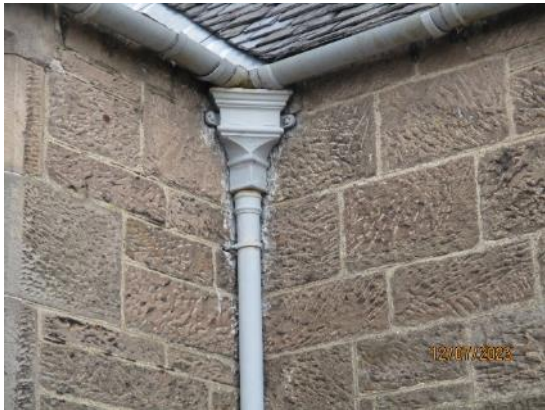
44. Broken upvc gutter

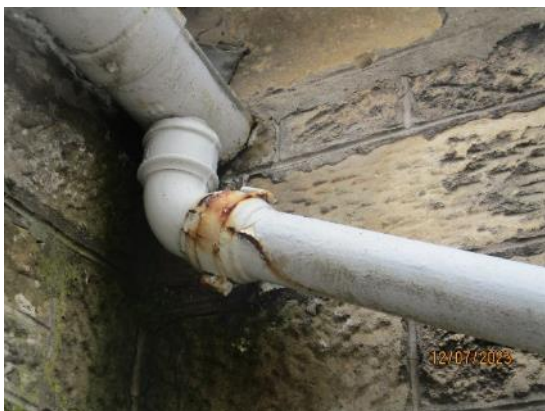
46. Cracked, leaking cast iron downpipes

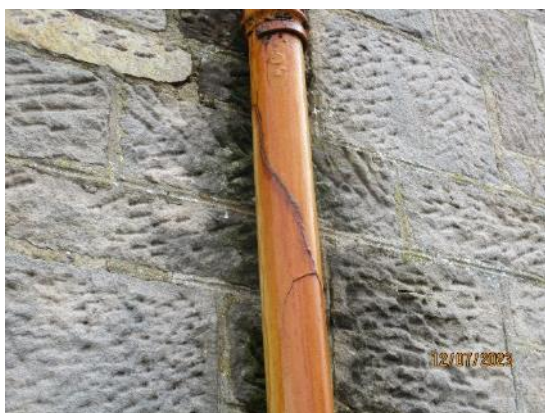
52. Cracked, leaking downpipes

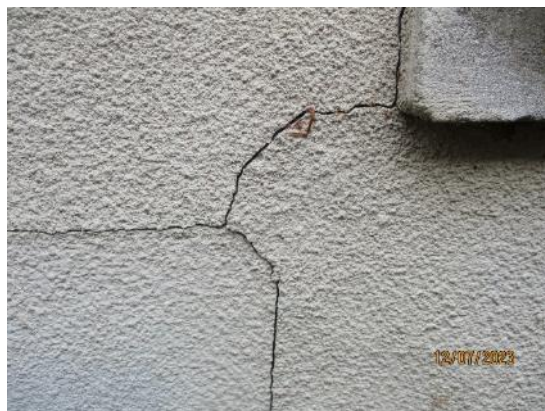
65. Cracked masonry walls

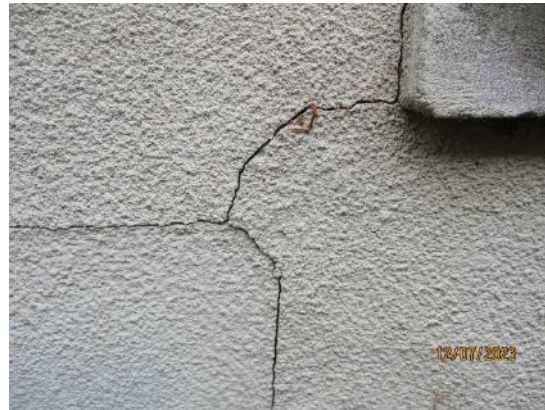
81. Cracked roughcast to school

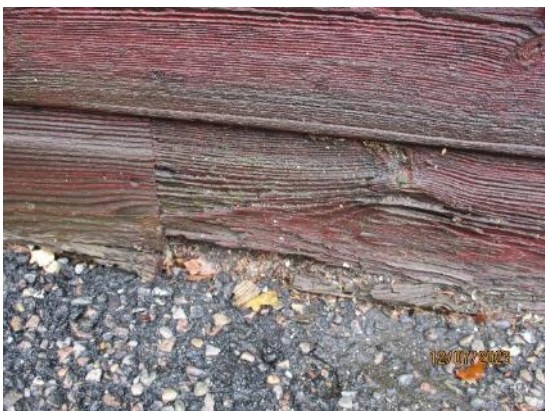
82. Saturated timber linings to Hut

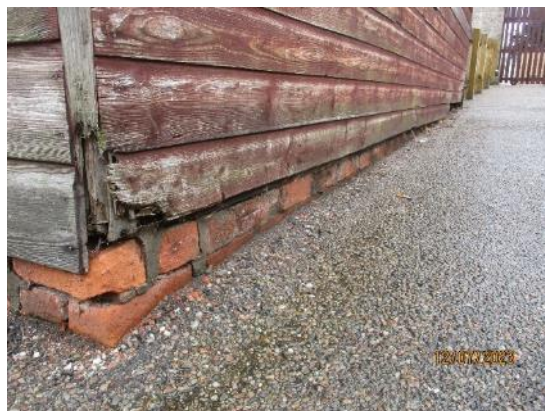
83. Rot and damage to timber linings

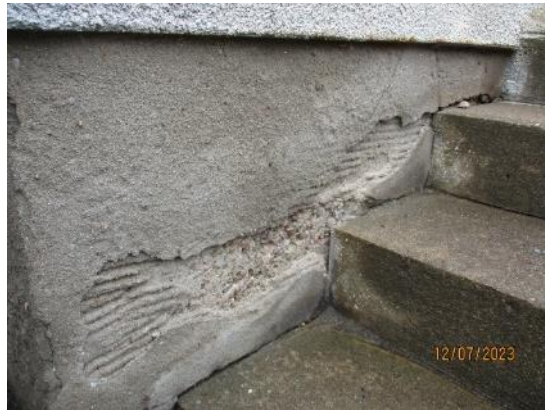
87. Spalling smooth render to Dining Hall

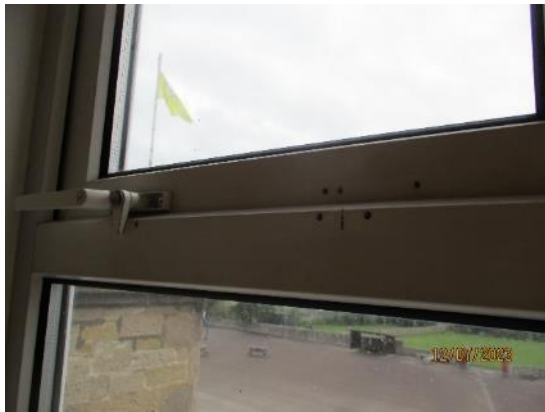
102. Missing ironmongery

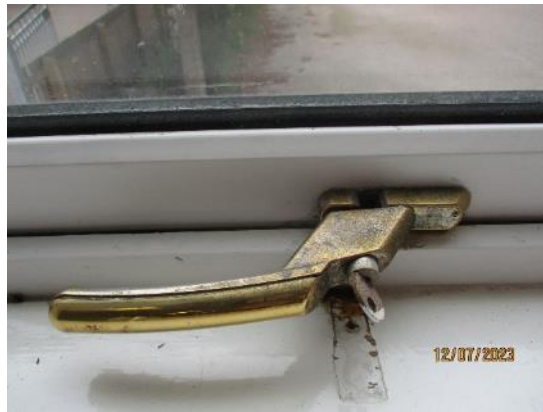
103. Surface damage to ironmongery

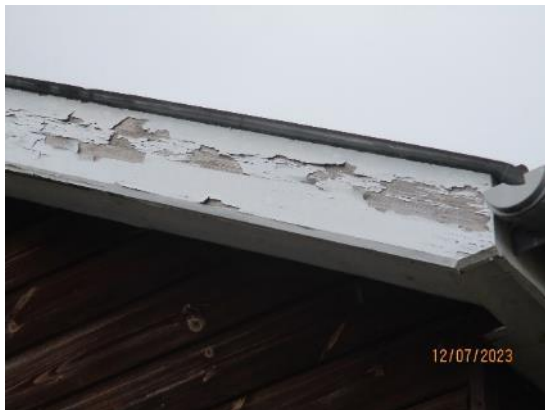
104. Peeling paint to barge boards

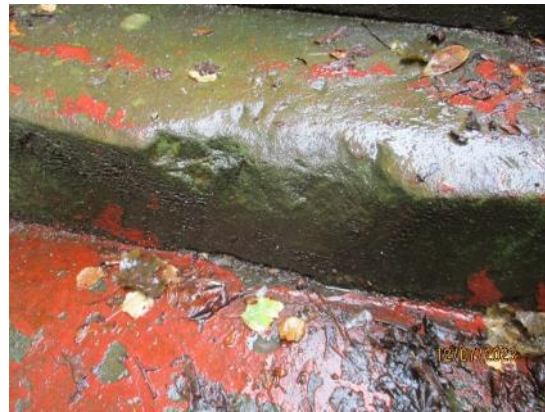
115. Damage to stone steps

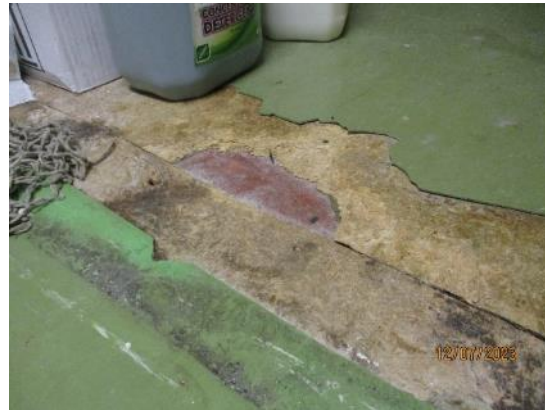
123. Cracked and lifting

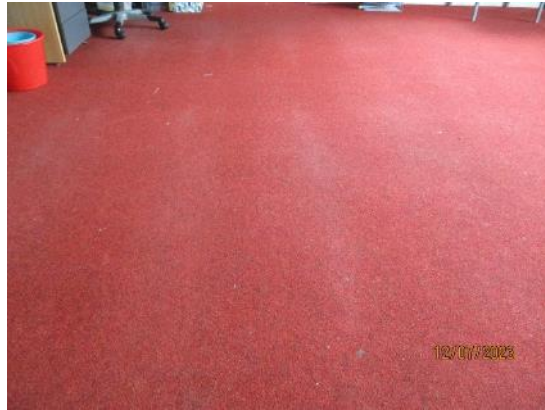
127. Faded and worn

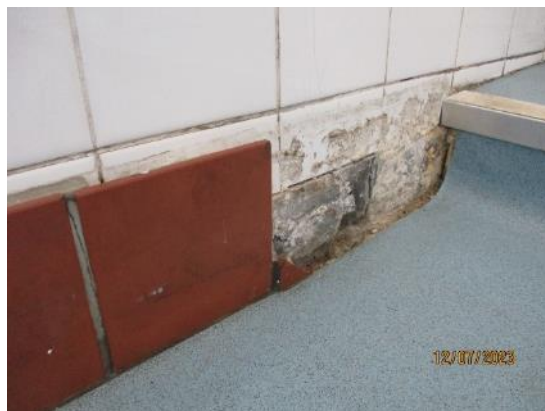
131. Broken/missing quarry tile skirting

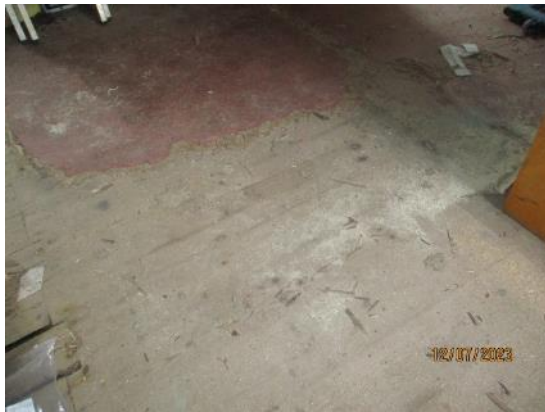
132. Damaged linoleum in the Hut

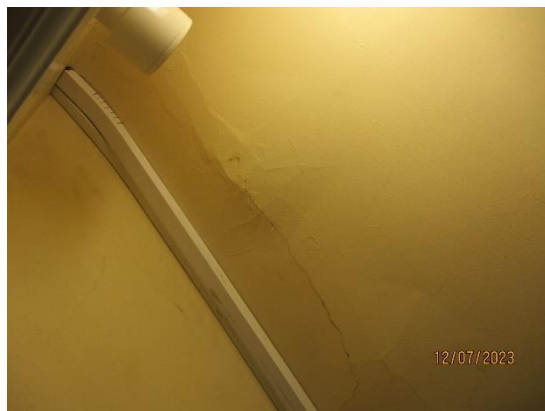
142. Cracked lath & plaster ceilings

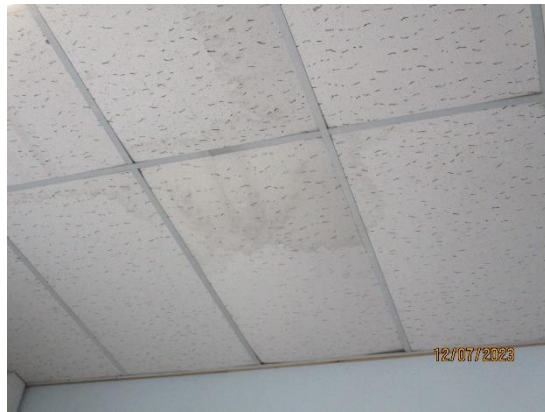
144. Damaged, sagging ceiling tiles

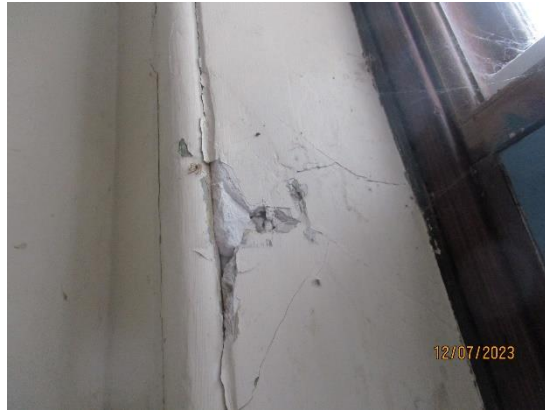
155. Damaged lath & plaster

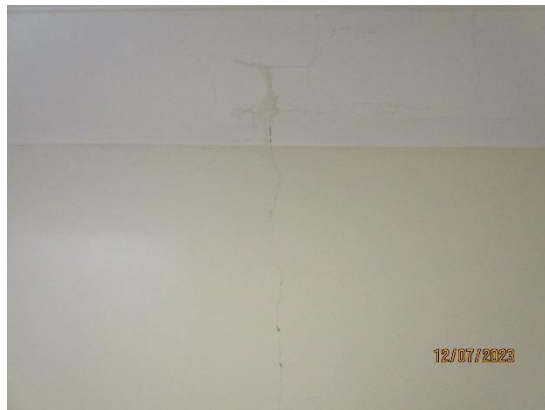
157. Cracked lath & plaster

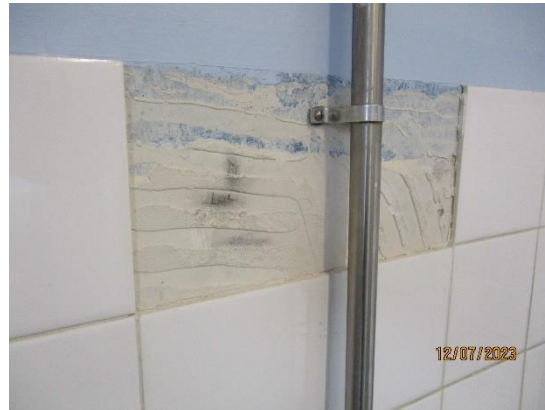
163. Missing ceramic tiles

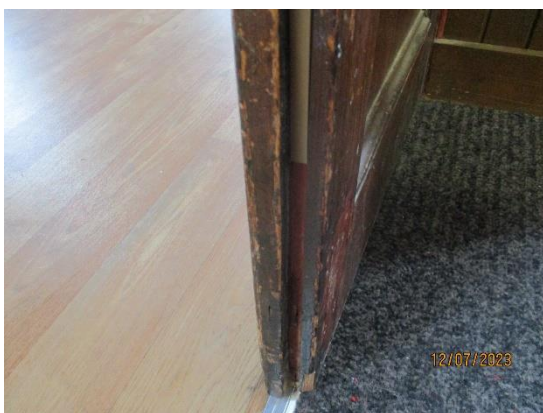
176. Missing intumescent strips

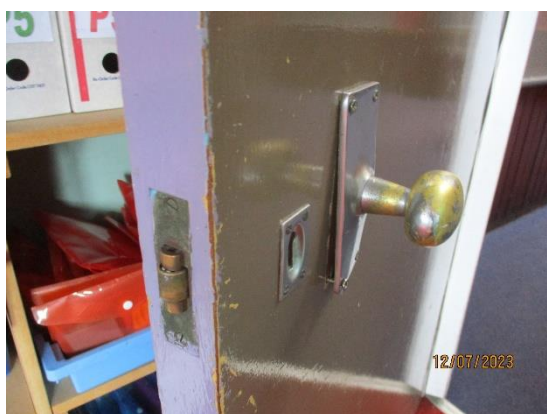
190. Worn, defective ironmongery

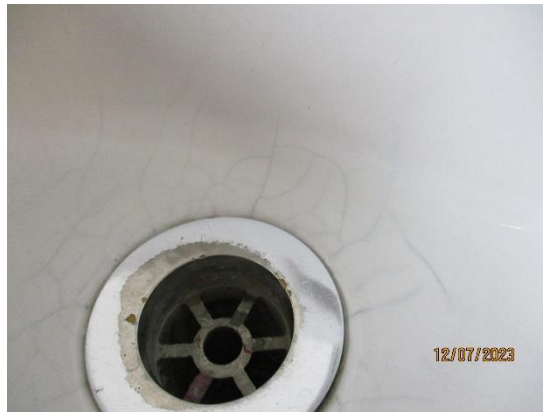
197. Cracked china basins

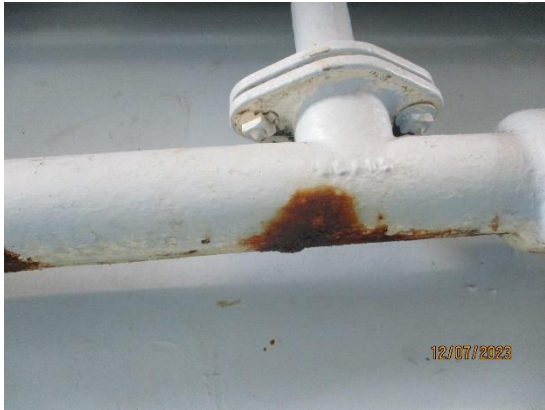
202. Leaking cast iron waste pipes

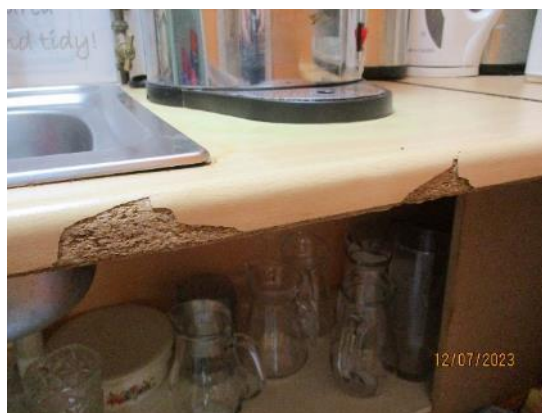
225. Chipped and water damaged worktops

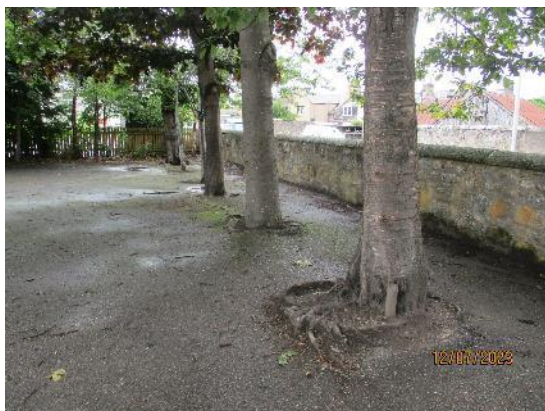
299. Tarmacadam damaged by tree roots

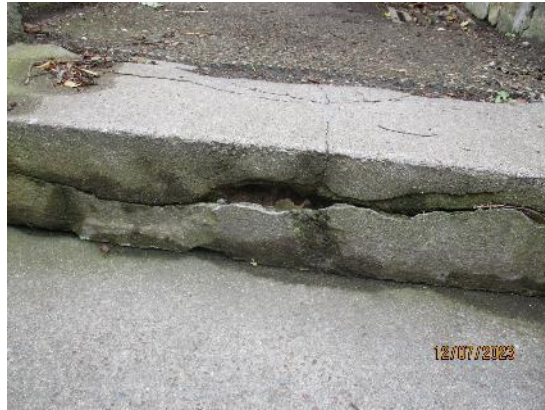
307. Damaged concrete steps

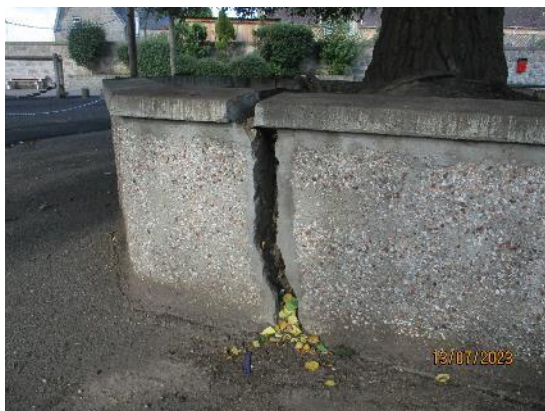
311. Damaged tree planters

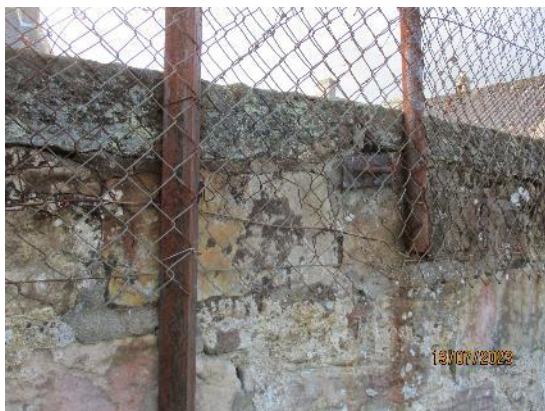
316. Corroded chain link posts

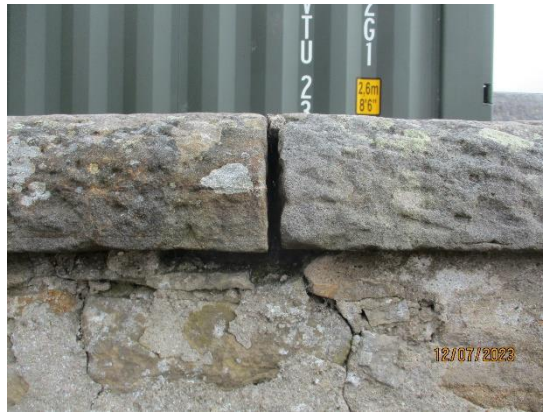
331. Missing pointing
