# **Summary Building Condition Survey Report**

**New Elgin Primary School  
Bezack Street, Elgin IV30 6DP**

**18<sup>th</sup> & 19<sup>th</sup> January 2023**

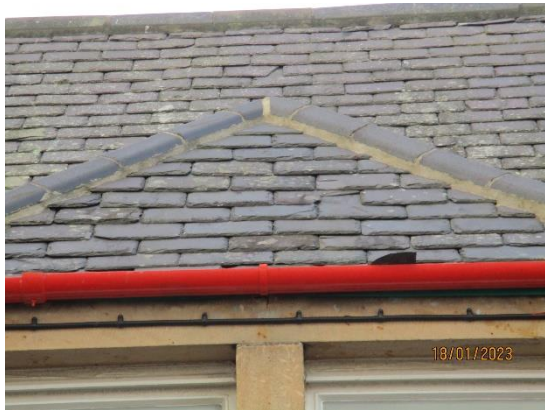
8. Slipped and broken slates

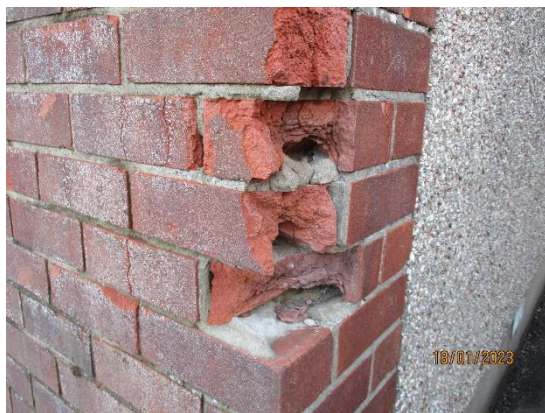
48. Damaged brickwork

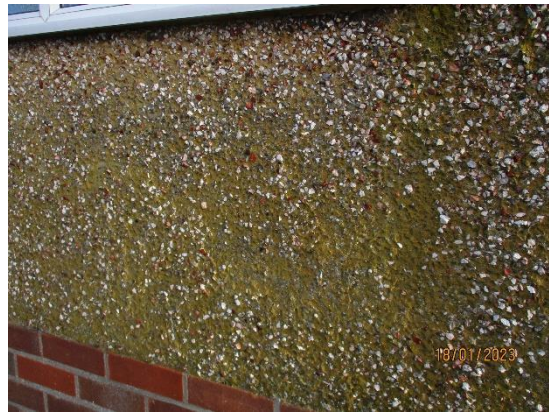
50. Spalling roughcast

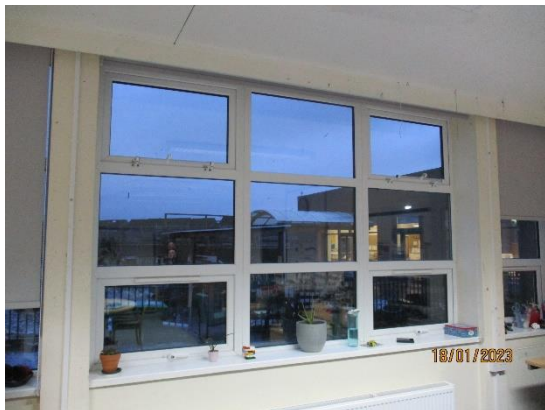
67. Glazing seals failing

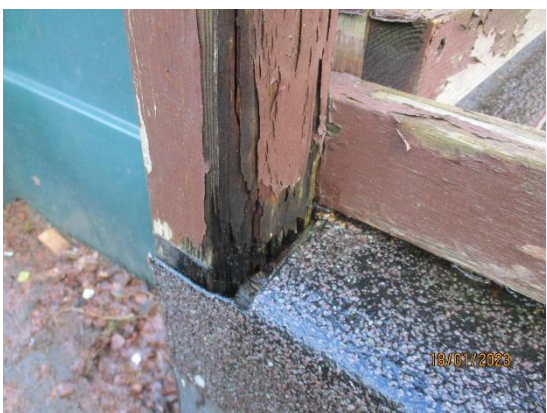
89. Wet rot in timber posts

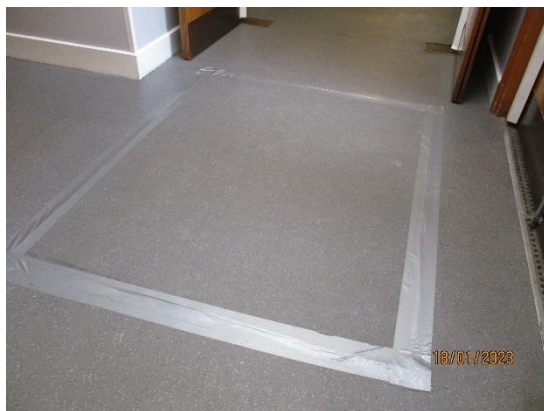
85. Tape repairs to vinyl

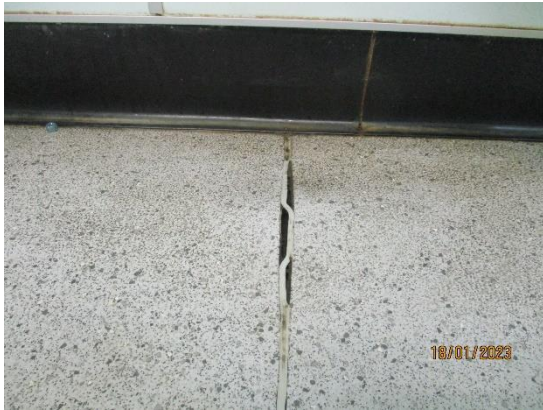
86. Open joints in vinyl flooring

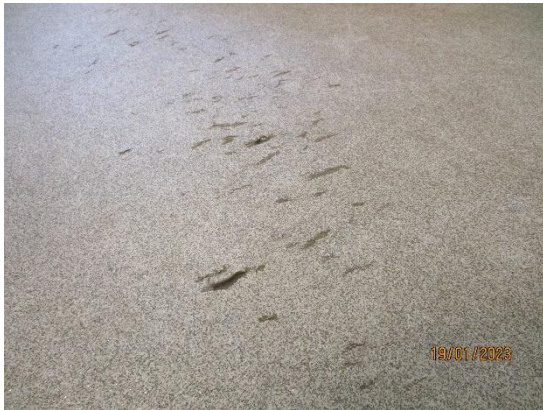
88. Surface damage to vinyl flooring

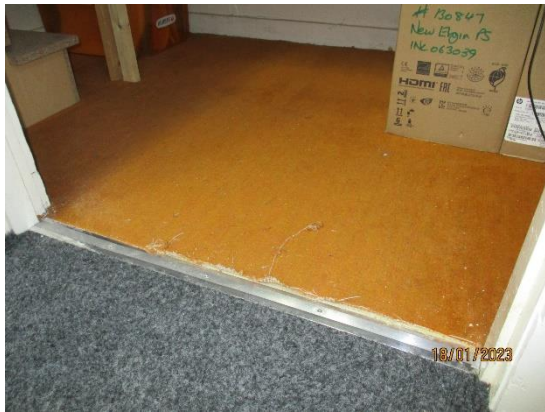
92. Damaged carpet flooring

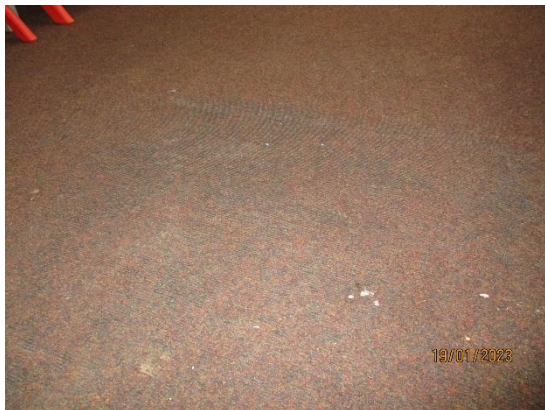
94. Soiled and worn carpets

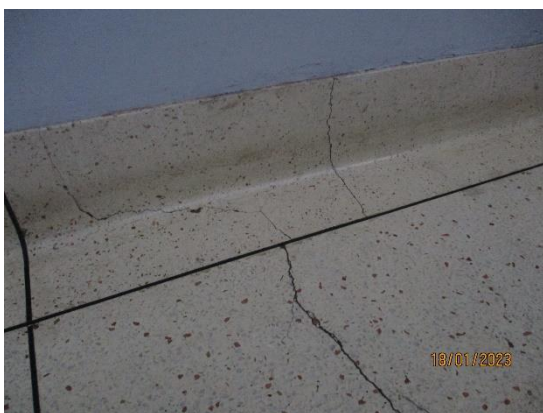
96. Cracked Terrazzo flooring

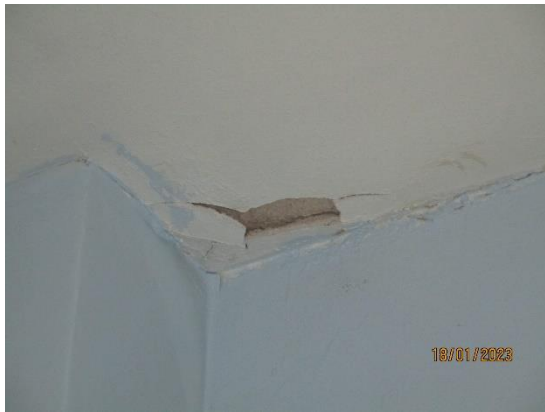
115. Cracked and spalling plaster

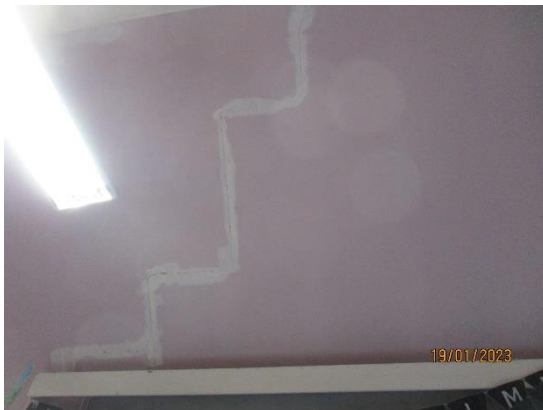
117. Previous repairs to cracks

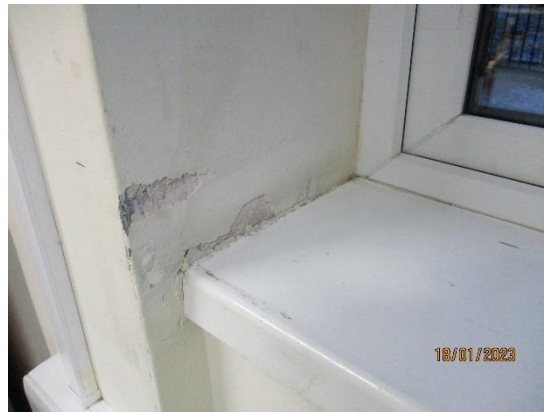
128. Damage to plastered walls

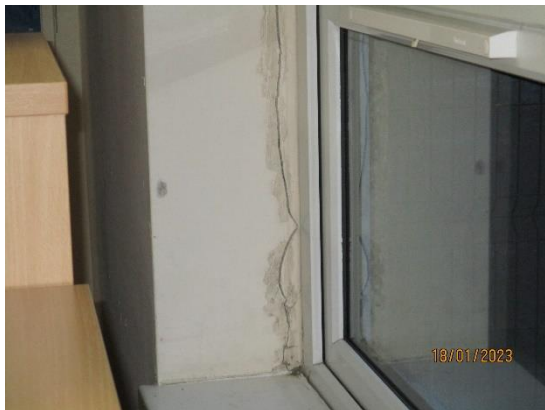
129. Cracked plaster walls

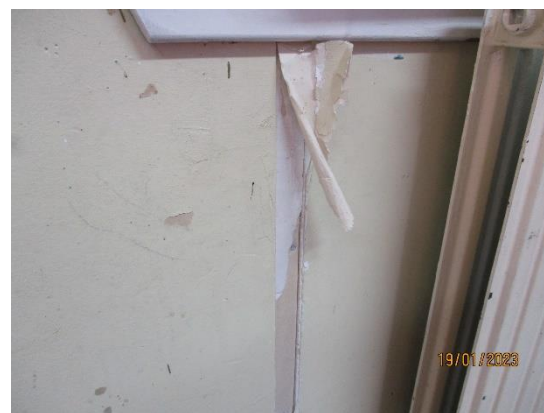
132. Failed taped joints to plasterboard

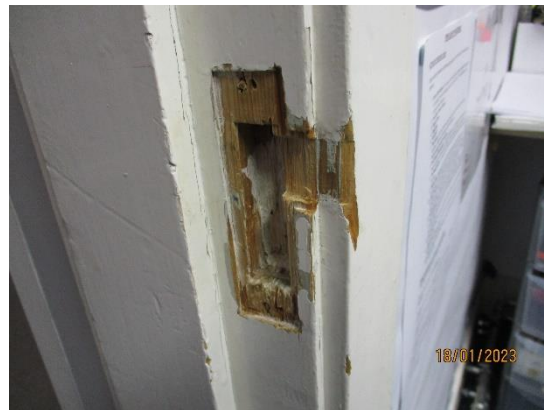
154. Missing ironmongery

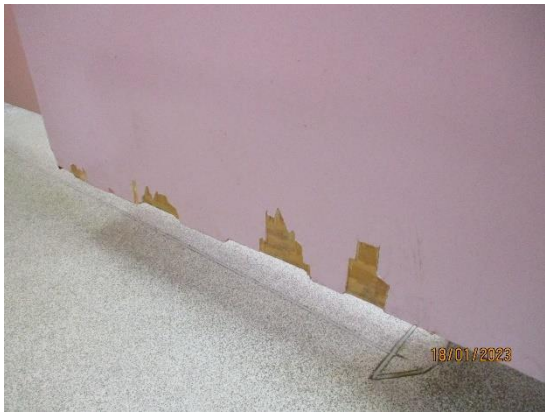
175. Damaged cubical partitions

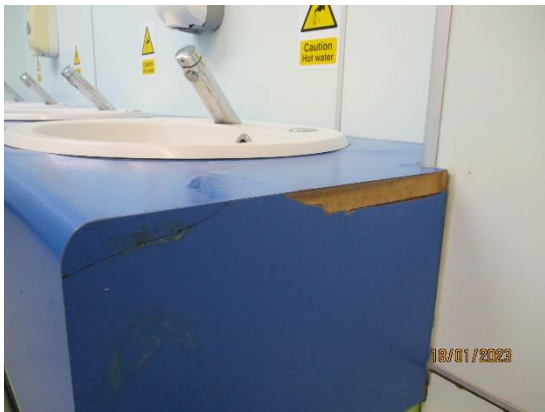
177. Damaged vanity units

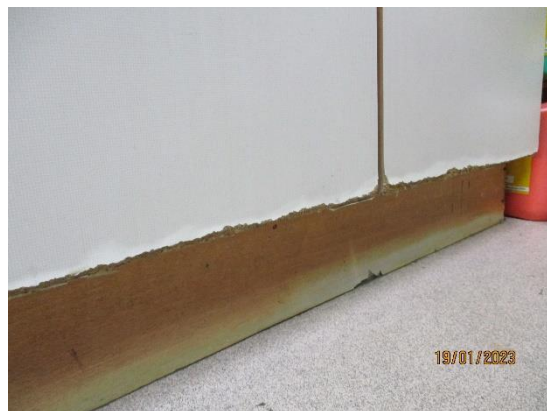
197. Damaged sink base units

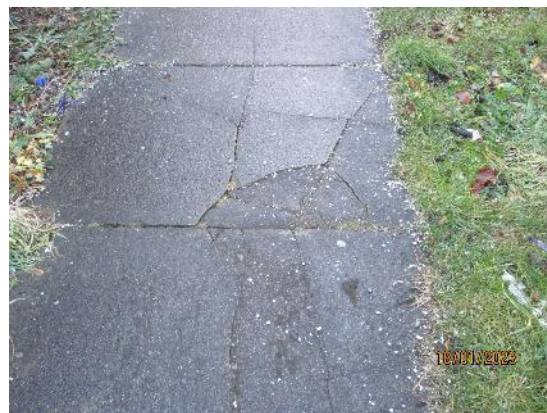
296. Damaged paving slabs

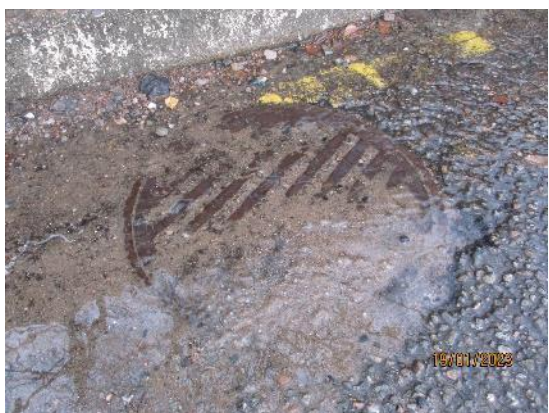
- Paving slab footpaths cracked and broken.
- Playground drainage is blocked.
- Playground shelter requires concrete and brickwork repairs.

314. Blocked drainage

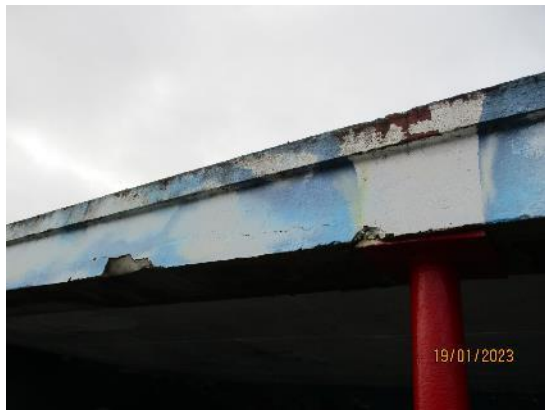
317. Spalling concrete structure
