# **Summary Building Condition Survey Report**

**Mosstowie Primary School**  
**Miltonbrae, Milntonduff, Elgin IV30 8TY**

**3<sup>rd</sup> April 2023**

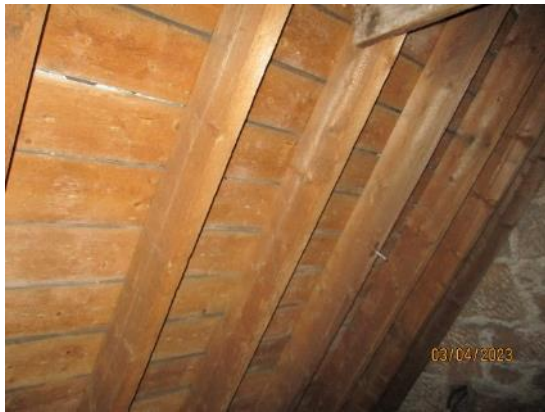
1. Timber rafters and sarking boards

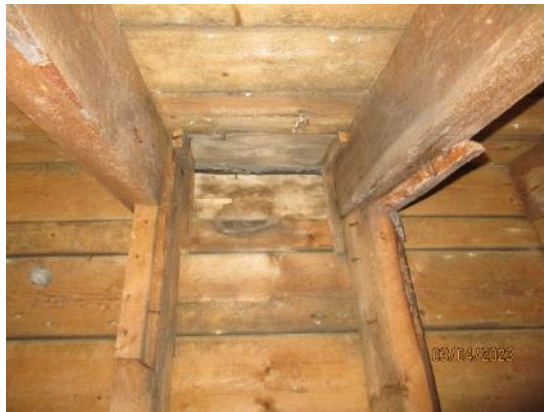
- The GRP roof covering is blistering, with deck fixings showing.
- The slate roofs and stone skew stones, require isolated repairs.
- Isolated rotten sarking boards at ridge.
- Cast iron rainwater goods have isolated leaks and joints.
- Fascia board decoration is peeling and missing resulting in isolated wet rot.
- Roughcast walls are cracking at regular intervals. Lacking expansion joints.
- Tarmacadam playground is partly obscuring underfloor ventilation.
- External decoration to joinery items is flaking and peeling exposing timber surfaces.
- External decoration to all cast iron rainwater goods is poor.
- Some timber suspended floors/floor boards, creak.

2. Isolated rot in sarking boards

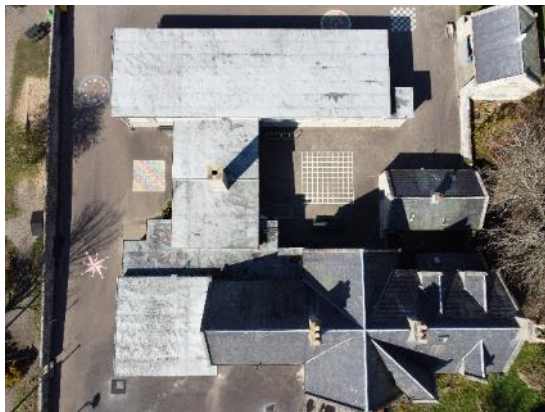
3. Overview of roofs

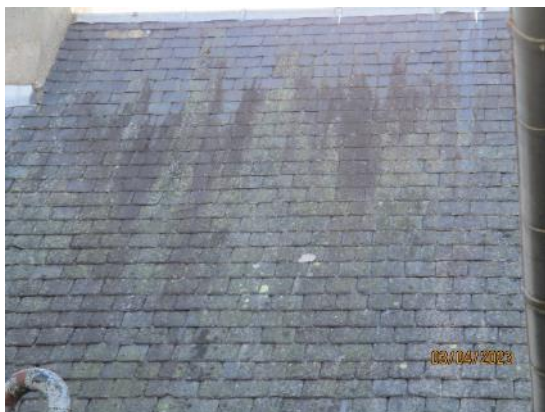
5. Minor lichen on slates

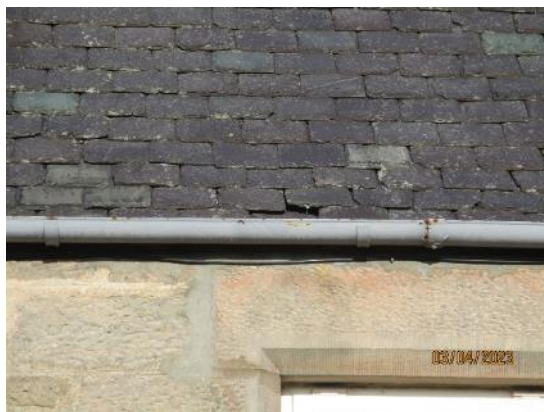
6. Isolated slate damage

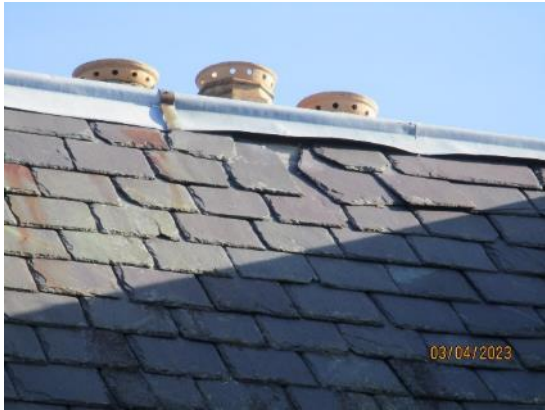
7. Isolated slate damage

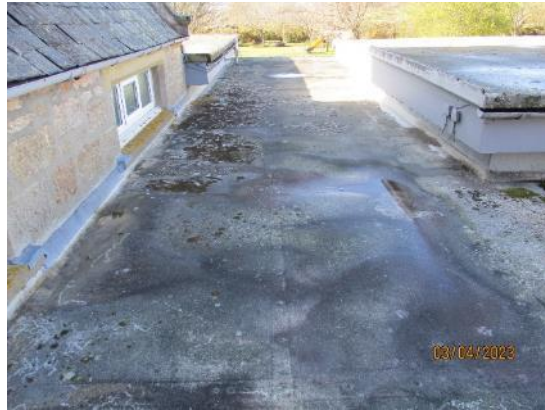
8. GRP roofs are blistered and uneven

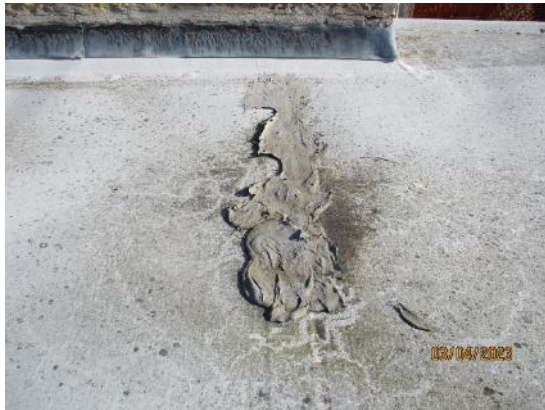
10. Evidence of previous patch repairs

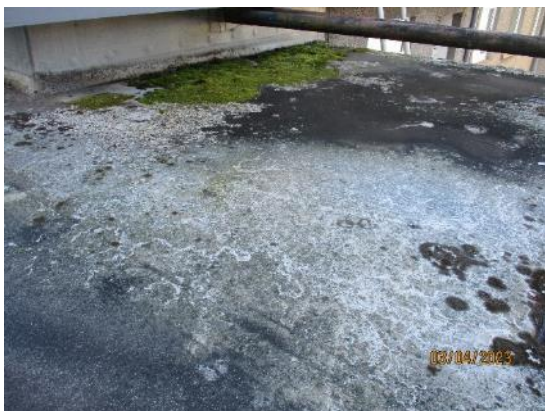
11. Vegetation and silt in sheltered areas

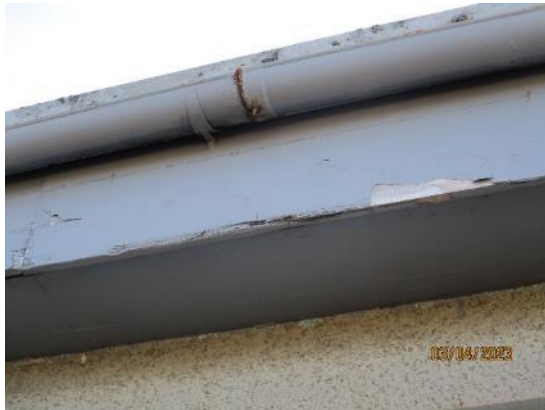
15. Early evidence of fascia timber rot

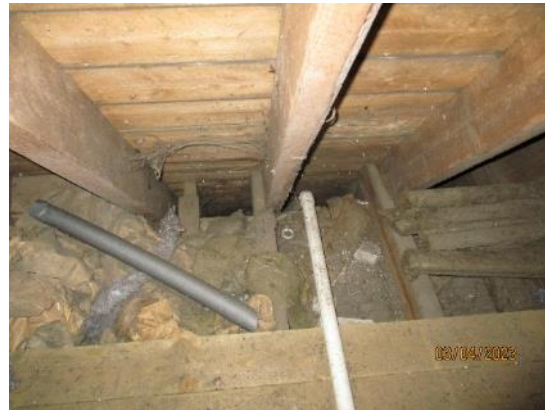
16. Partial insulation above ceilings

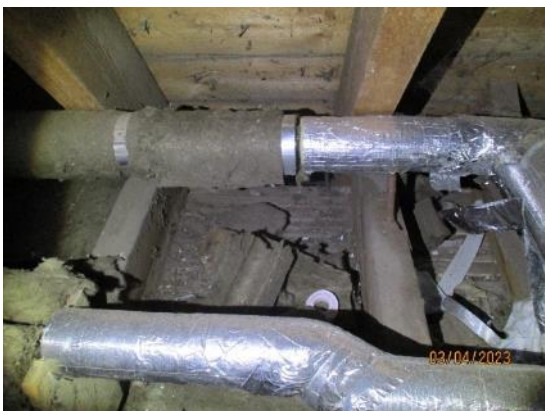
17. Insulation missing from lath & plaster ceilings

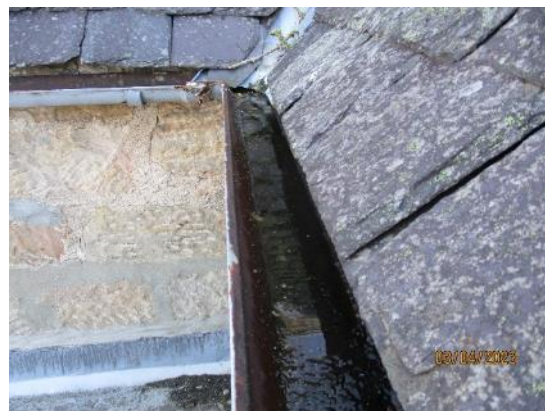
18. Cast iron gutters with some standing water

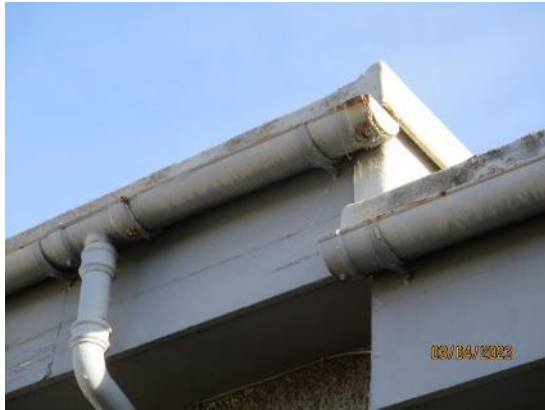
19. Leaks from gutter joints

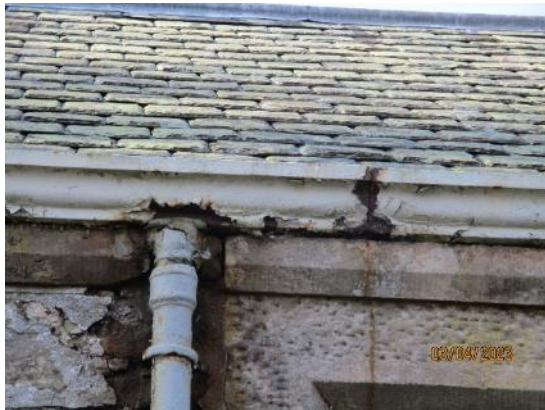
21. Cast iron ogee gutter in poor condition

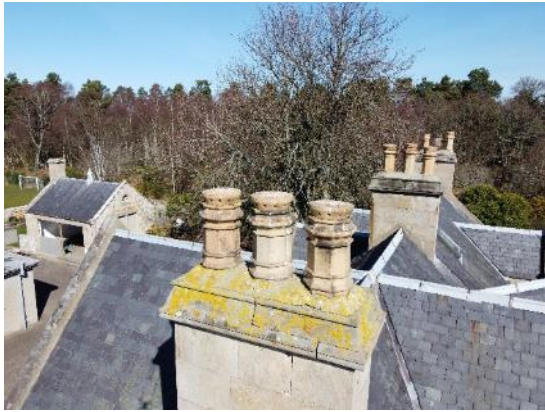
25. Chimney copes require repointing

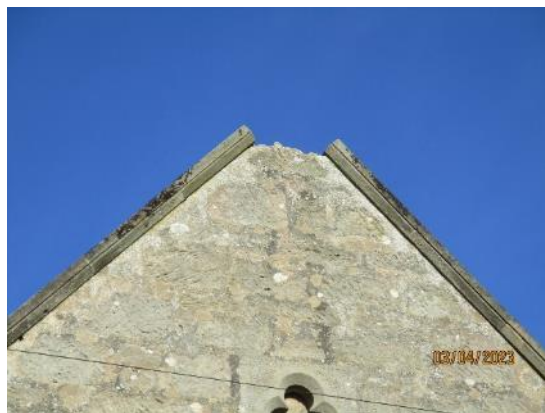
29. Missing apex stone and finial

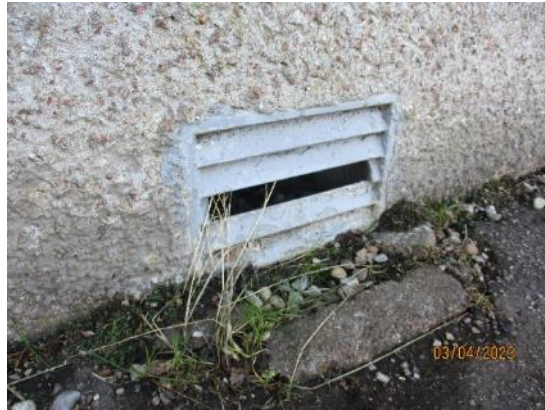
31. Broken louvre grills

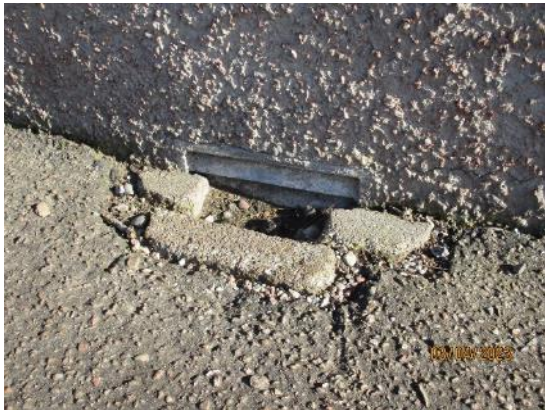
32. Ground level above vents

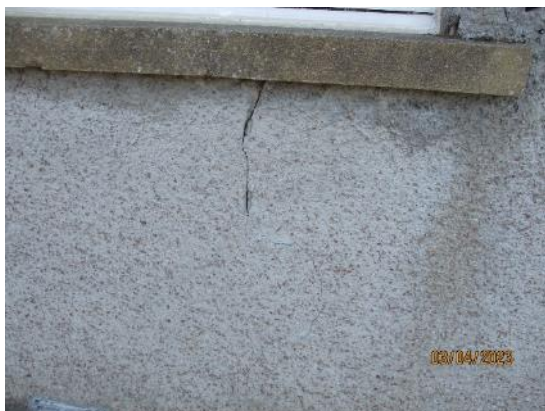
35. Vertical cracks at regular intervals

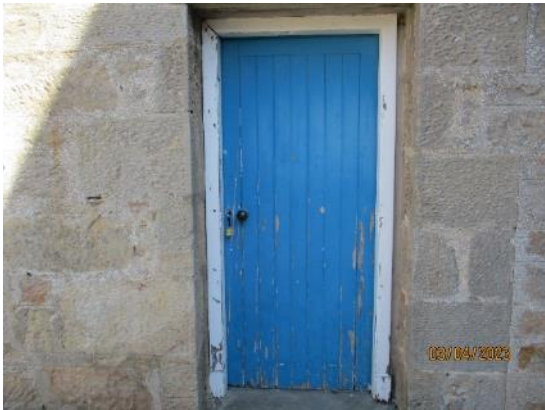
38. Rot and surface damage to timber linings of external store

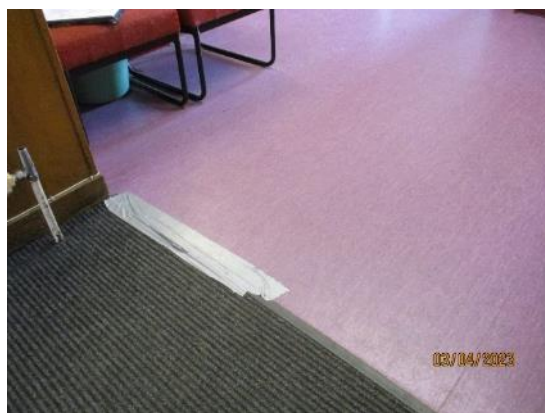
52. Isolated tape repairs

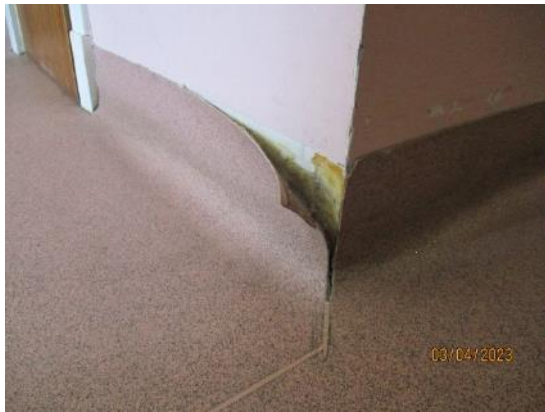
53. Coved skirting damage in Girls toilet

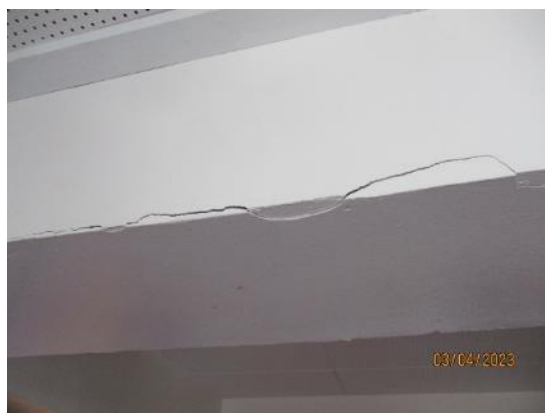
70. Cracking to concrete beams in corridors

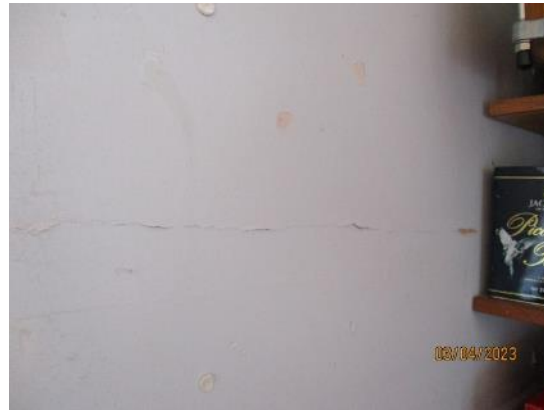
74. Hairline cracks in lath and plaster walls

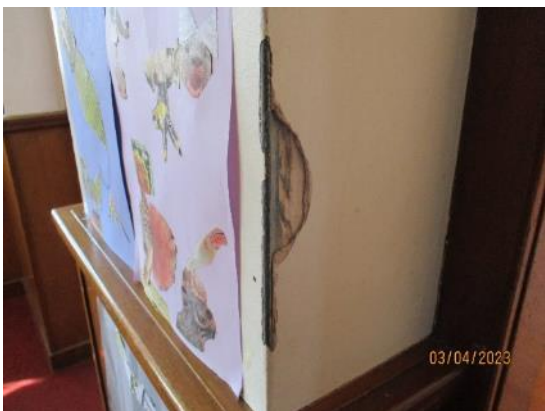
75. Isolated damage to plastered walls

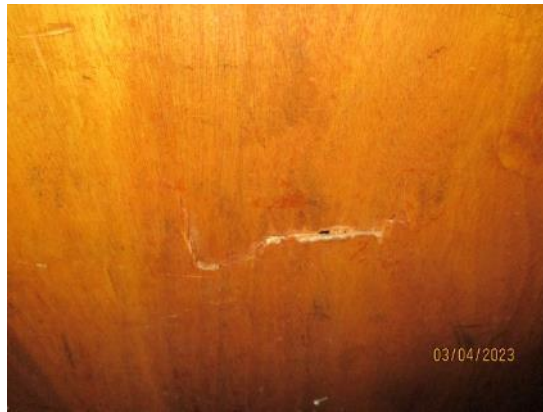
84. Surface damage to timber hollow core doors

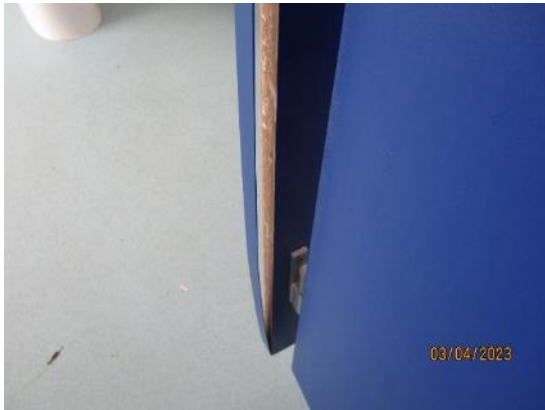
97. Loose edge trim on cubicle partition

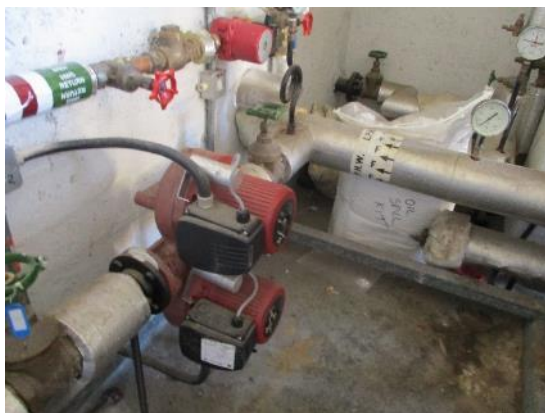
116. Pumps and Pipework – Heating system Room 0/14

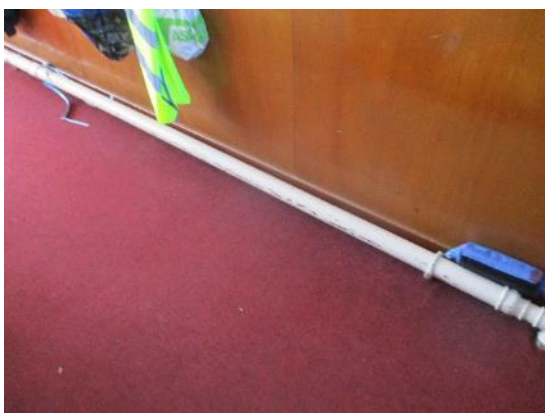
122. Pipework – heating system 1-4 class

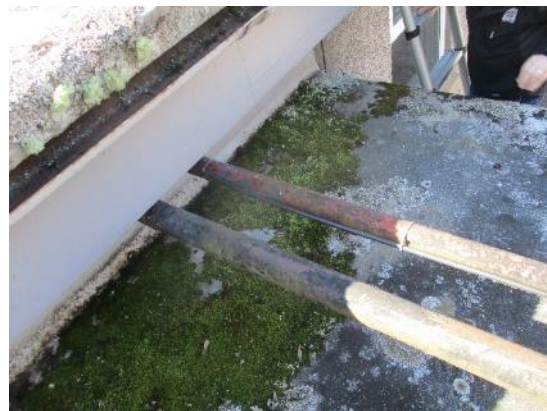
129. Oil fill and vent pipework. High level above 1/2a

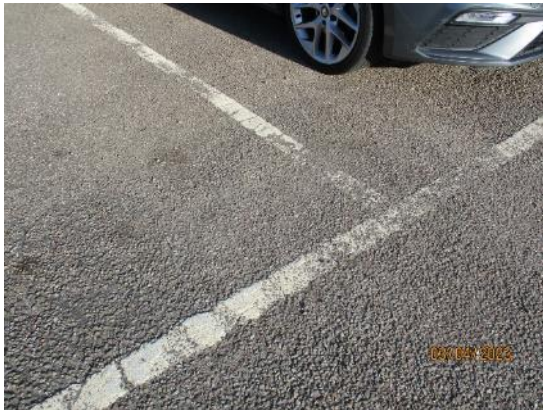
162. White lining wearing thin
