# **Summary Building Condition Survey Report**

**Greenwards Primary School**

**Edgar Road, Elgin IV30 6UQ**

**28<sup>th</sup> & 29<sup>th</sup> November 2022**

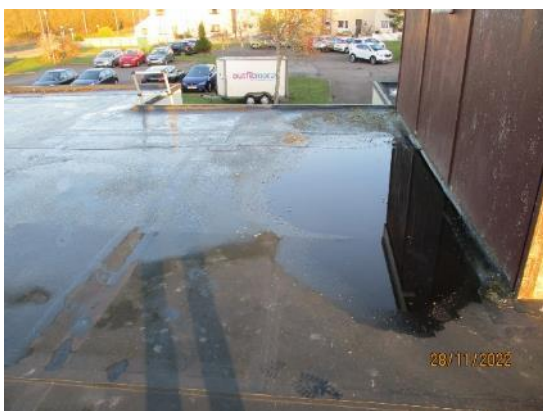
4. Previous patch repairs

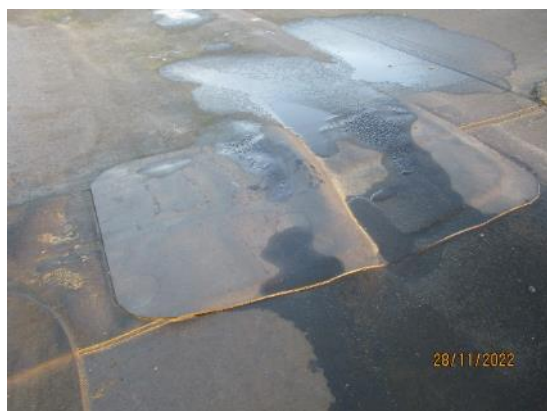
- Falls on flat roofs are poor resulting in standing water and silt.
- Isolated damage to single ply membrane roof covering.
- Rainwater downpipes blocked.
- Plywood fascia boards have extensive rot.
- Corrosion of roller shutter frame.
- External decoration overdue.
- Bats have been reported within the roof space and classrooms.
- Ceiling tiles are damaged and watermarked following previous roof leaks.

5. Inadequate falls

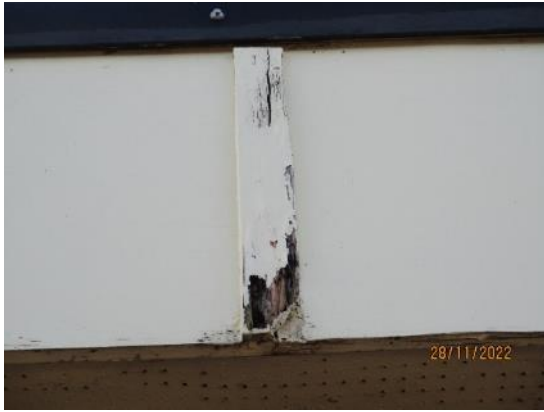
18. Rot in plywood fascia boards

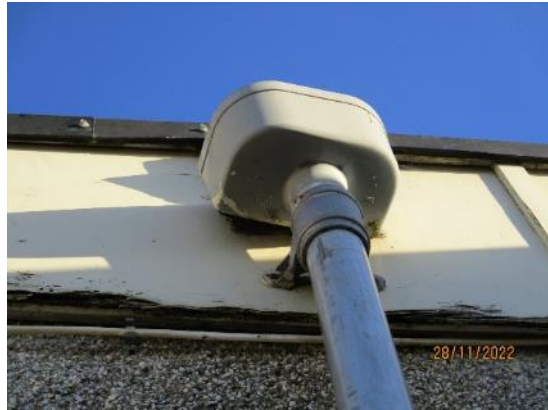
25. Minor surface damage

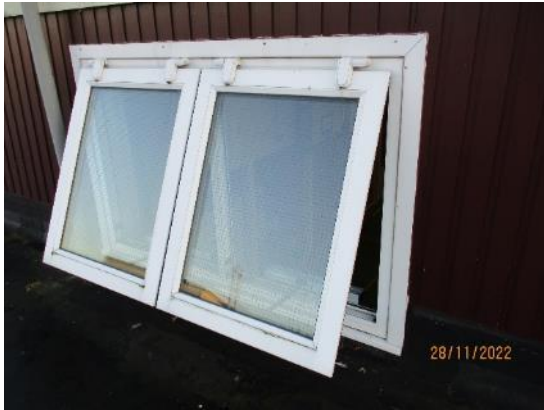
47. Rot in timber sills

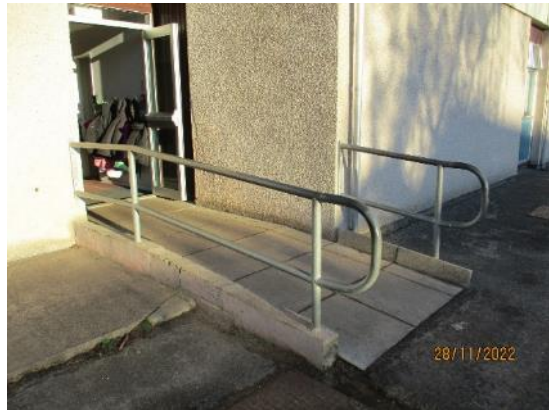
61. Broken paving slabs

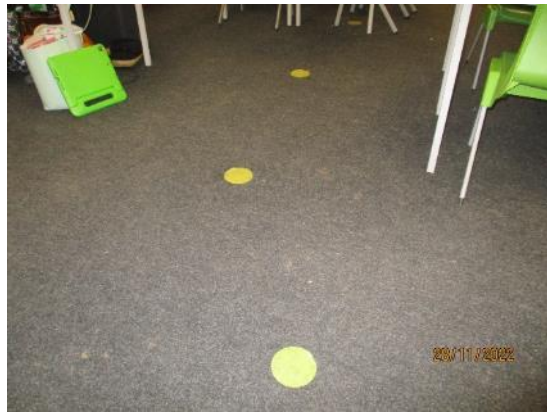
64. Carpet – soiled and stained

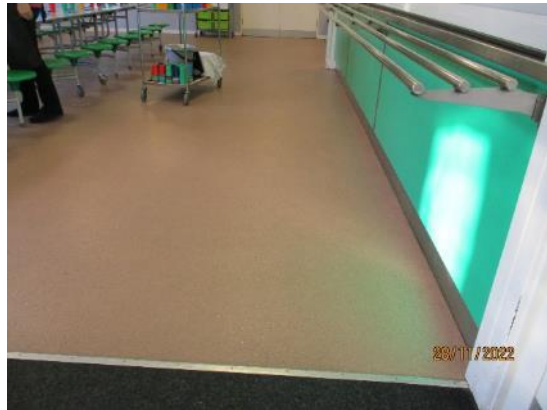
66. Damage to carpets

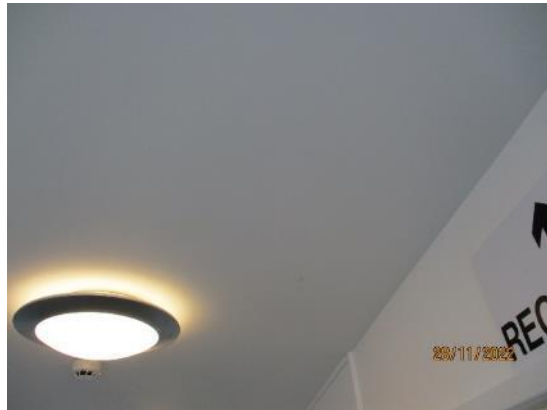
78. Damage to textured ceiling finish

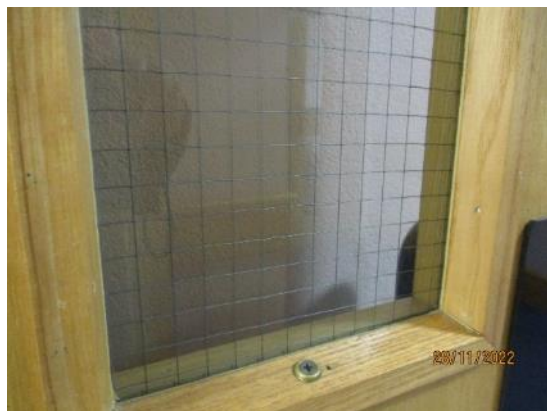
97. Damage to timber doors

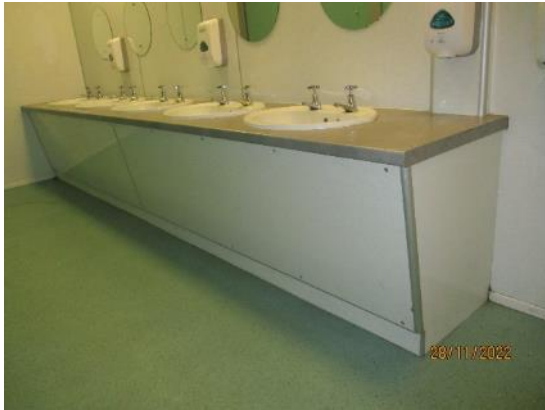
115. Damaged base units

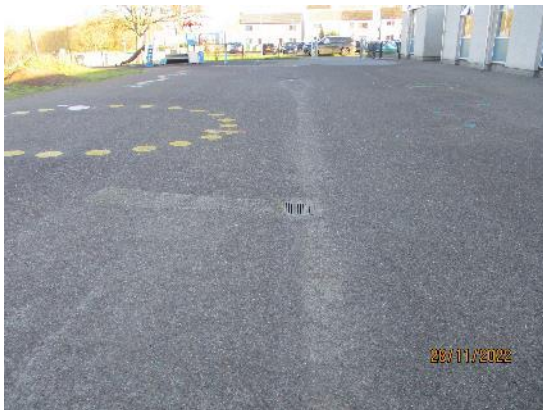
204. Damaged tarmacadam

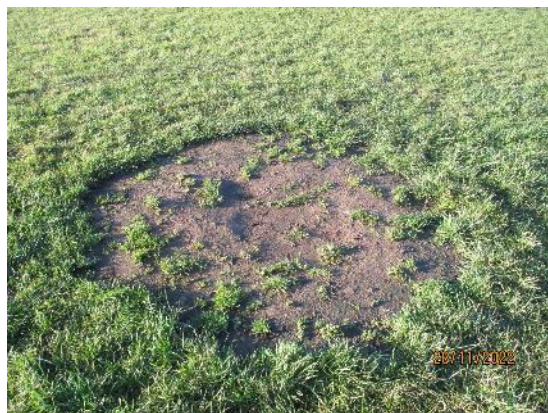
- Sports field floods – inadequate surface water drainage.
- Brick wall to south ramp eroded at ground level.

237. Repairs required
