ARTHURS BRIDGE

Principal Inspection Report

B234M205-J-ART-STR-REP-PIR-0001

A Principal Inspection of Arthur’s Bridge was undertaken by Jacobs on the 11th February 2025. Access to the half joints, suspended and cantilever spans were obtained through the use of an underbridge unit. All elements of the structure were inspected apart from the buried foundations and waterproofing system.

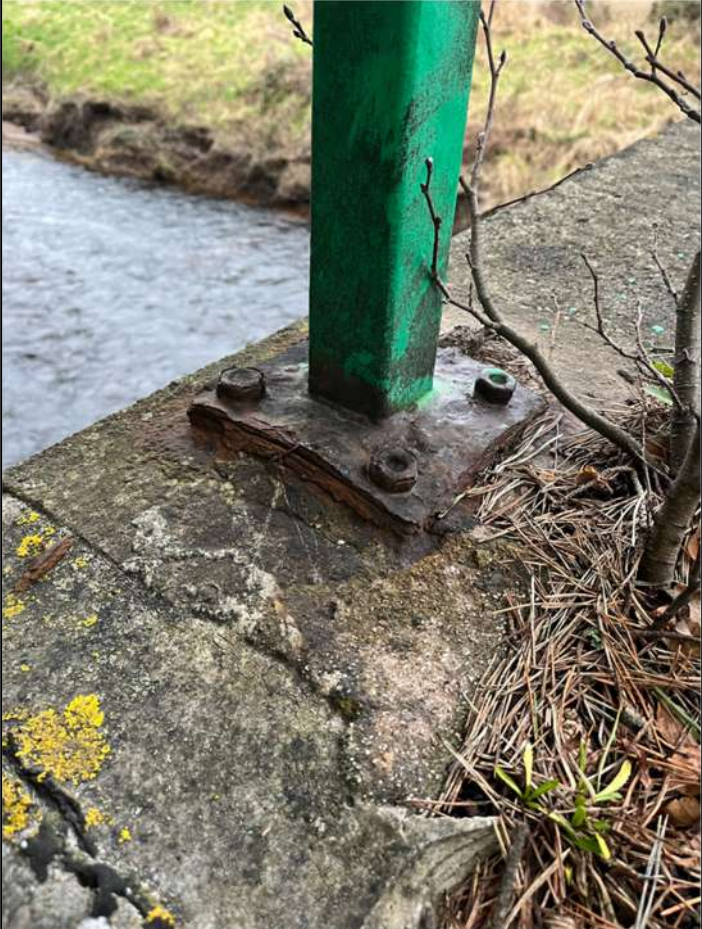
</div> <p style="text-align: center;">Fig 15. Section loss of guardrail base plates</p>		
BCI	Severity 3	Extent B	Defect 1.2
Defect Description:	Metalwork: Moderate section loss causing some reduction in functionality		
Work Required:	Grit blast and repaint the corroded guardrail and baseplates		
Works Priority:	2. Recommended before next General Inspection (GI) (2 years)

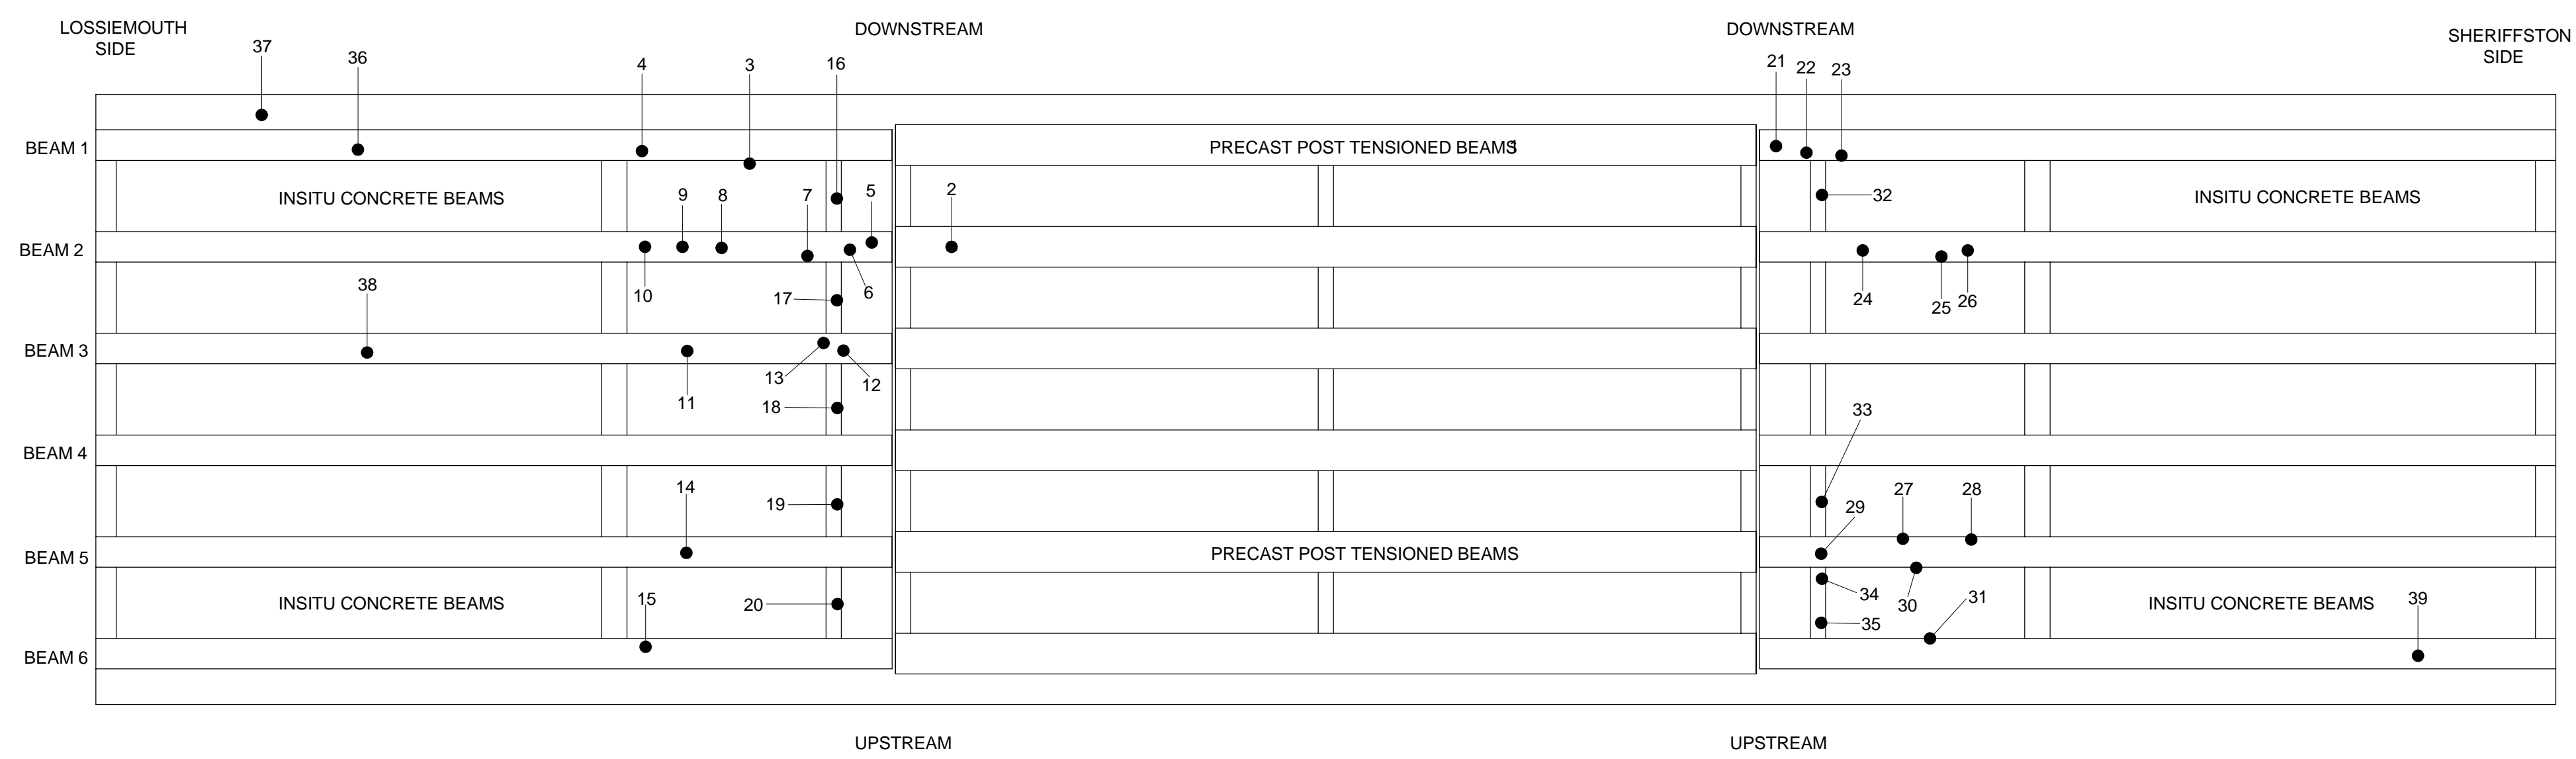
PLAN
SCALE 1:75

Defect Number	Span	Beam Number	Size	Description	Photograph Number
1	Suspended span	Beam 1 soffit	NA	Small corrosion spots	1
2	Suspended span	Beam 2 soffit	NA	Rebar staining along soffit of beam, clear lines where shear links are sitting	2
3	Cantilever span west	Beam 1	2370 x 200 x 100 mm	Large spall, inside corner of beam	3
4	Cantilever span west	Beam 1	400 x 70 x 60 mm	Delamination close to bearing, severe staining	4
5	Cantilever span west	Beam 2	450x180x30mm	Defect on bottom face of cantilever span at half-joint (A)	5
6	Cantilever span west	Beam 2	100x100mm	Defect on bottom face of cantilever span at half-joint (B)	6
7	Cantilever span west	Beam 2	470mm long, 1.1mm thick	Longitudinal crack (D)	7
8	Cantilever span west	Beam 2	800 x 400 x 100mm	Exposed and corroded reinforcement and spalled concrete (E)	8
9	Cantilever span west	Beam 2	500 x 340 x 40 mm	Exposed and corroded reinforcement and spalled concrete (F)	9

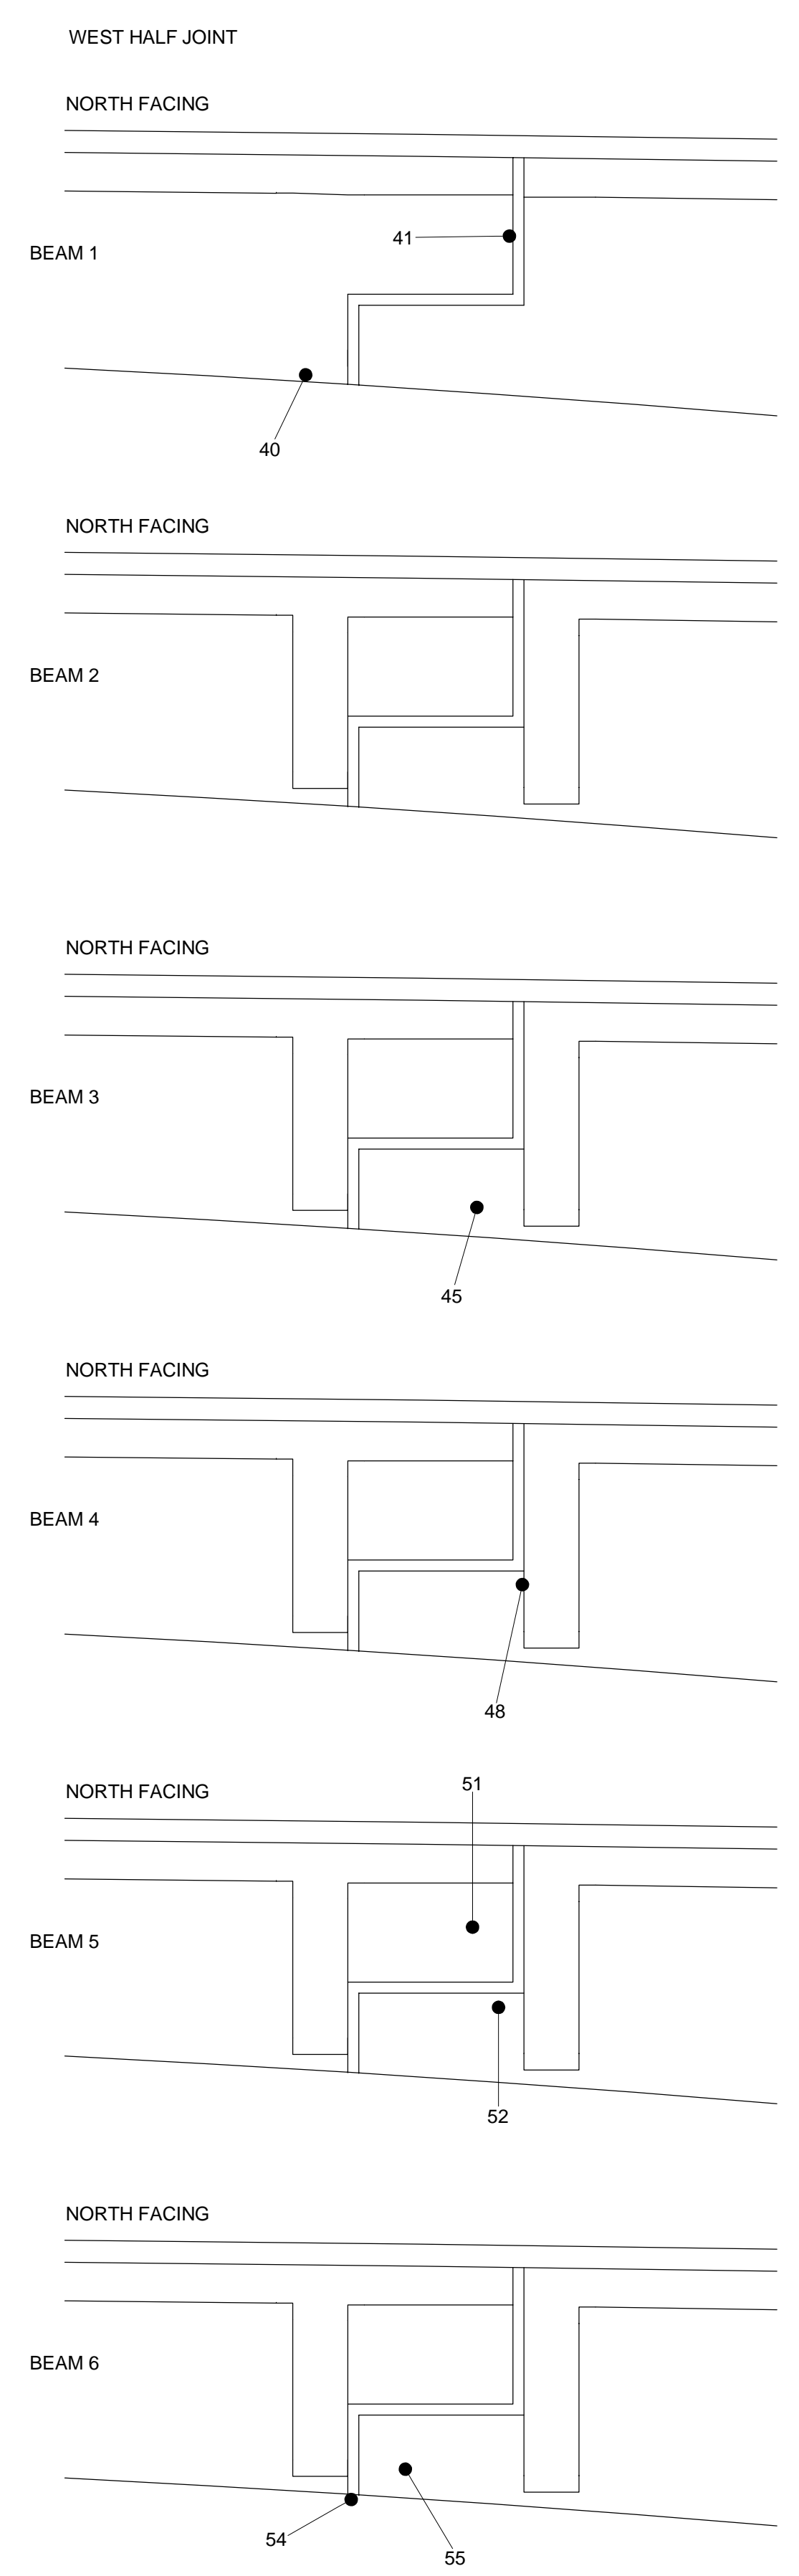
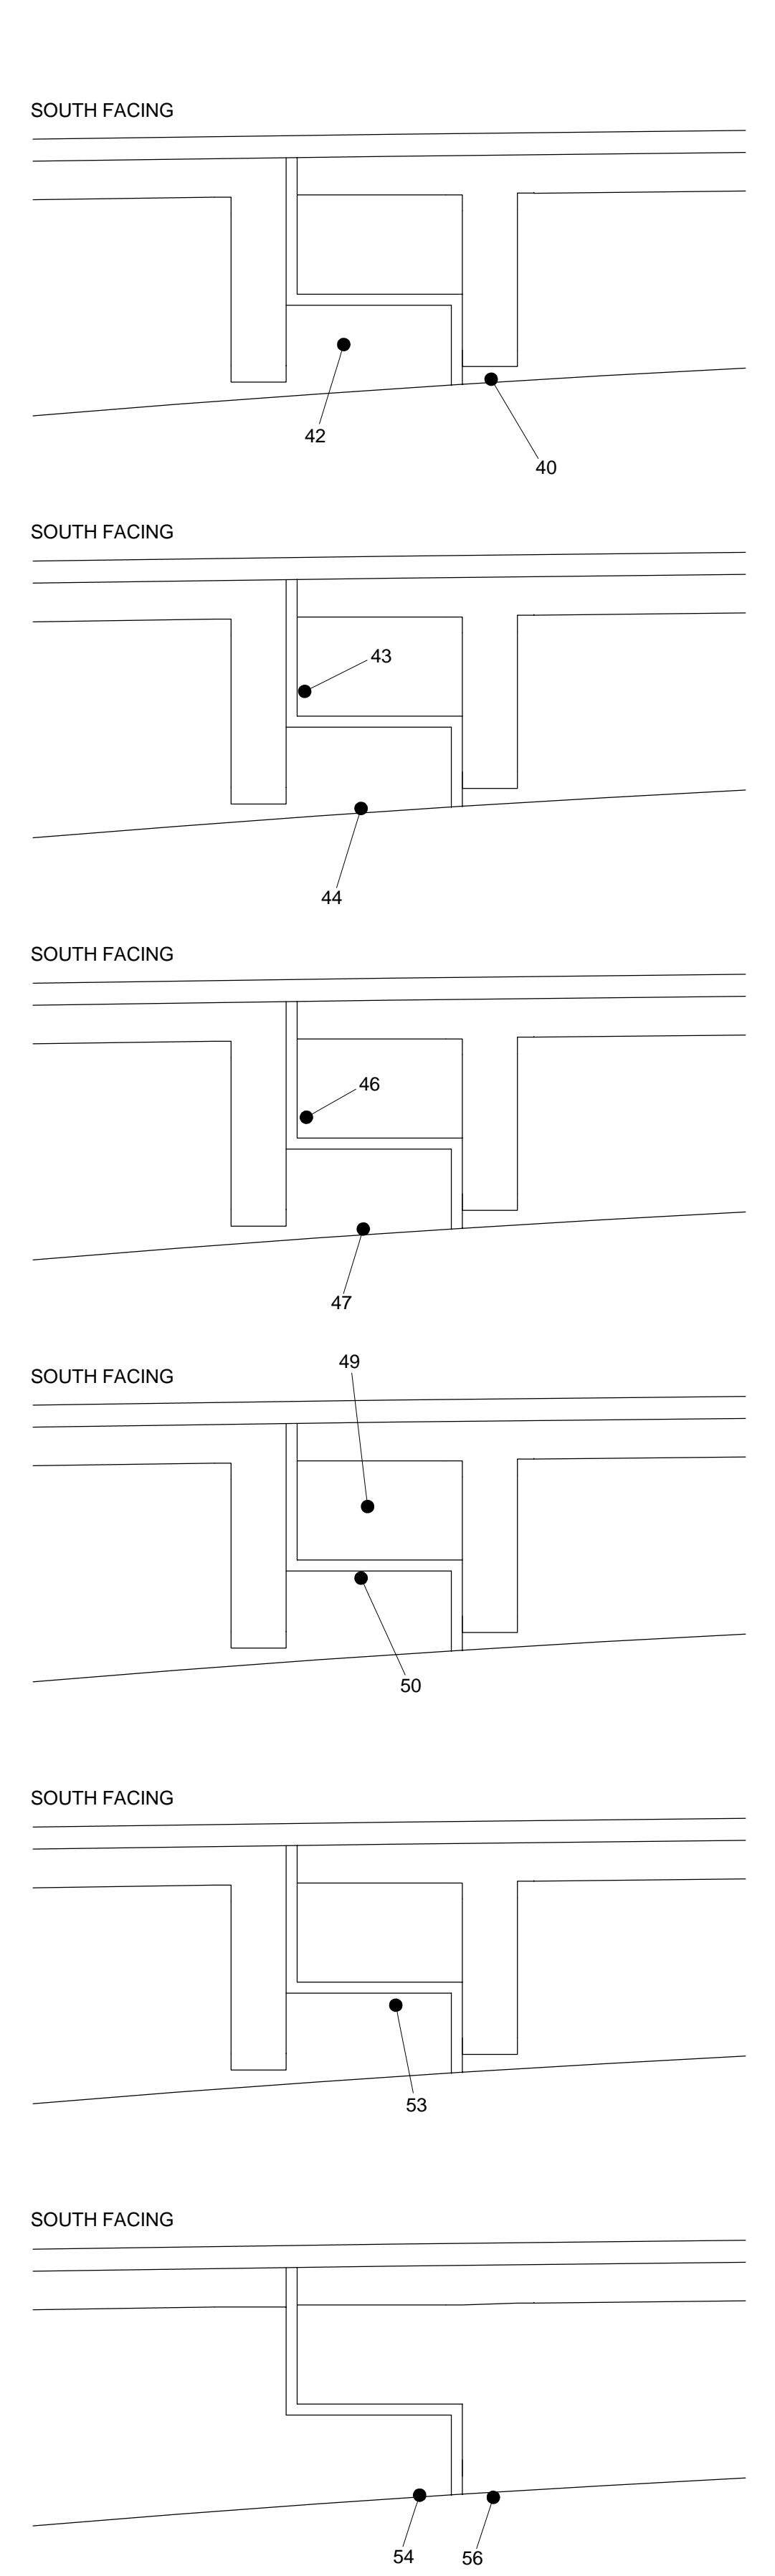
Drawing No. B234M205-J-ART-STR-DWG-PIR-0002 Revision P01

Defect Number	Span	Beam Number	Size	Description	Photograph Number
40	Half joint west	Beam 1 (north and south facing)	400 x 300 x 100 mm	Severely corroded and exposed links, spall at end of beam	40
41	Half joint west	Beam 1 (north facing)	NA	Water ingress, damp and green mould on outside face	41
42	Half joint west	Beam 1 (south facing)	650 x 400 x 80 mm	Delaminated face, beginning to spall, hollow sounding with large crack in bottom face (A)	42
43	Half joint west	Beam 2 (south facing)	50 mm depth	Crack and spalling of corner of suspended span	43
44	Half joint west	Beam 2 (south facing)	950 x 250 x 150 mm	Loss of corner of the bottom section, 60mm deep	44
45	Half joint west	Beam 3 (north facing)	300 mm long, 1 mm max width	One main crack, with further hairline cracks visible in same area	45
46	Half joint west	Beam 3 (south facing)	380 x 340 x 90 mm	Suspended span, corner missing, with exposed reinforcement	46

47	Half joint west	Beam 3 (south facing)	700x200x140mm 60mm	Spalled bottom corner, exposed reinforcement	47
48	Half joint west	Beam 4 (north facing)	NA	Hollow sounding in top corner, concrete starting to delaminate	48
49	Half joint west	Beam 4 (south facing)	100 x 100 mm	Patch repair	49
50	Half joint west	Beam 4 (south facing)	680 mm long, 1.6 mm width	Crack, indicating future spalling at top corner, depth of 150 mm from top face	50
51	Half joint west	Beam 5 (north facing)	320 x 300 x 30 mm	Spalling on face with exposed rebar	51
52	Half joint west	Beam 5 (north facing)	280 x 200 x 100 mm	Area of missing concrete in joint corner, previously repaired	52
53	Half joint west	Beam 5 (south facing)	400x280 mm repair, 50 mm long crack	Previous repair, with new hairline crack going into the repair patch	53
54	Half joint west	Beam 6 (north and south facing)	550 x 660 x 150 mm	Large spall of bottom of cantilever beam end, previously repaired, corroded reinforcement exposed	54

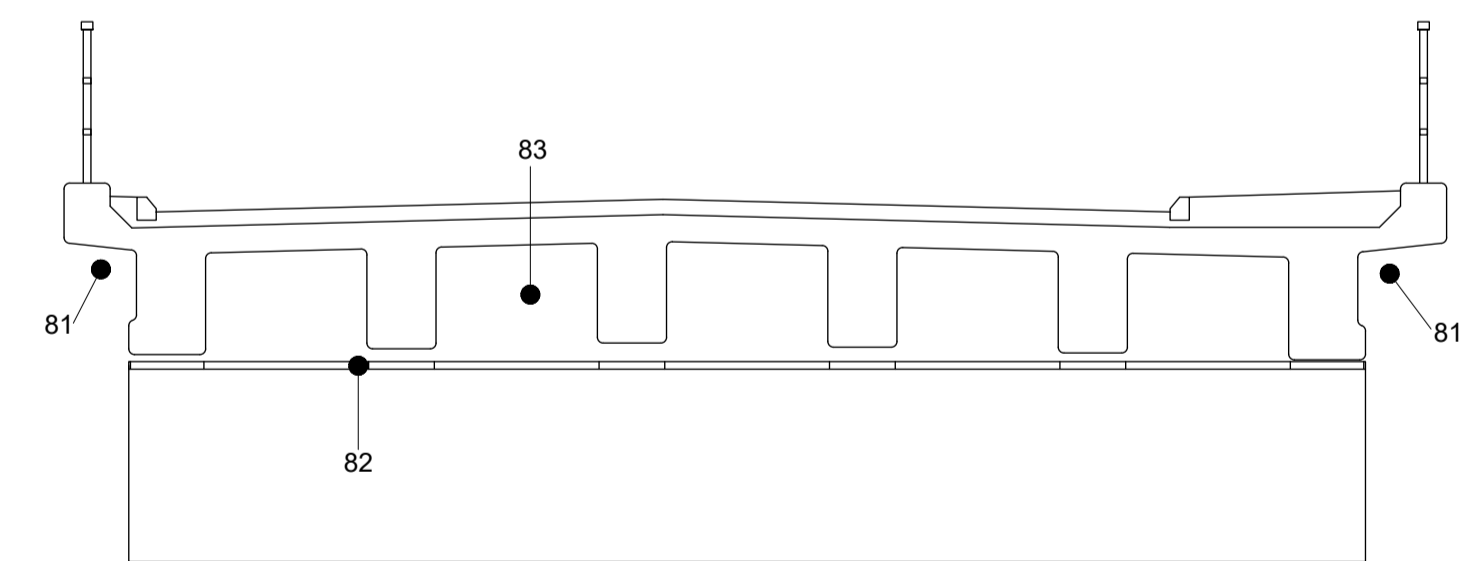
WEST ABUTMENT

Defect Number	Span	Beam Number	Size	Description	Photograph Number
76	Central cross beam	Beam 2 – Beam 3 (both faces)	400 mm long, 0.45 mm thick crack	Hairline crack, starting from soffit of deck and is on a diagonal, visible on both sides of cross beam	76
77	West pier, east face	Beam 1 – Beam 2	220 x 220 x 40 mm	Spalling in area of large aggregate, some corrosion staining	77
78	West pier, east face	Beam 3 – Beam 4	250 x 230 x 60 mm	Spalled concrete with cracks extending from spall	78
79	East pier, west face	Beam 4 – Beam 5	NA	Hairline crack with corrosion staining	79
80	East pier, west face	Beam 5 – Beam 6	440 x 180 x 40 mm	Concrete spalling, some corrosion staining	80
81	East and west abutment	Abutment corners	NA	Staining and seepage at all corners, residue build up	81
82	West abutment	Top of abutment	NA	Delamination of top of abutment	82
83	West abutment	Back face of abutment between beams	300 x 140 mm	Delamination and general corrosion stains between beams, multiple spots	83

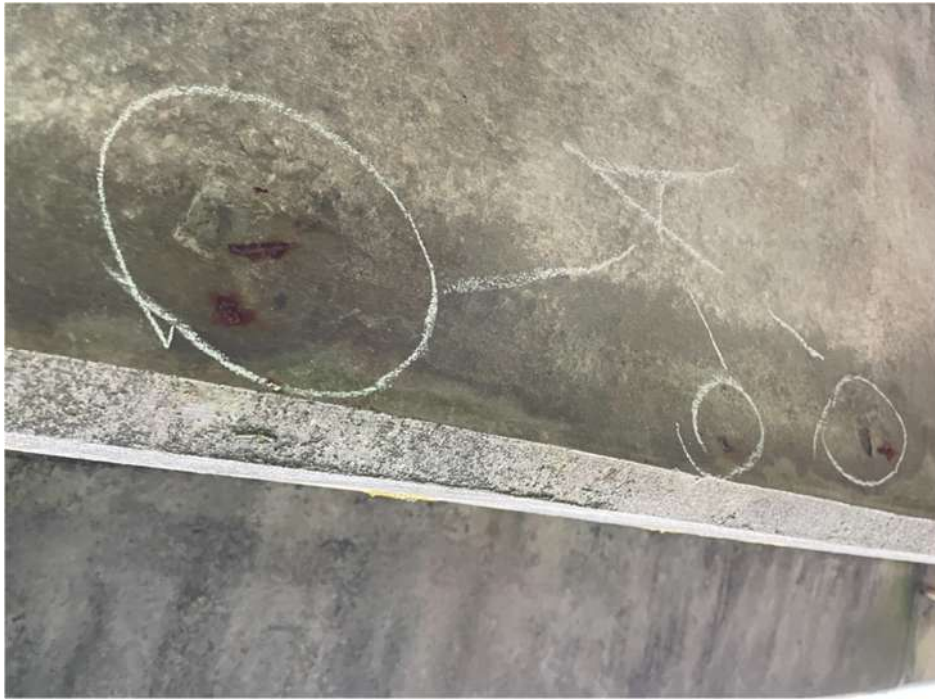
Photograph 1: Beam 1 soffit, suspended span, small corrosion spots

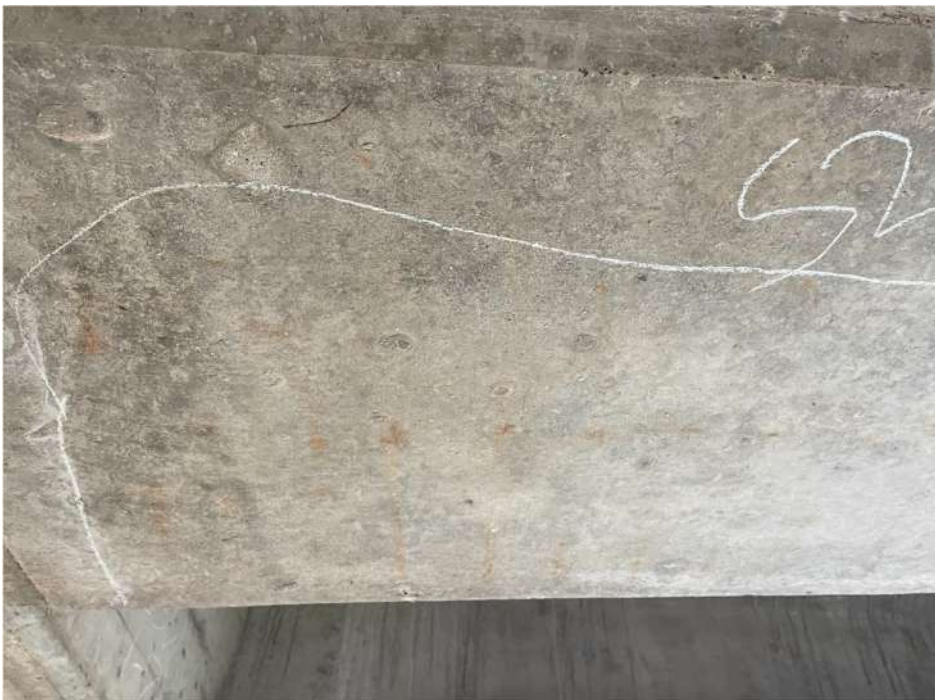
Photograph 2: Beam 2 soffit, suspended span, rebar staining

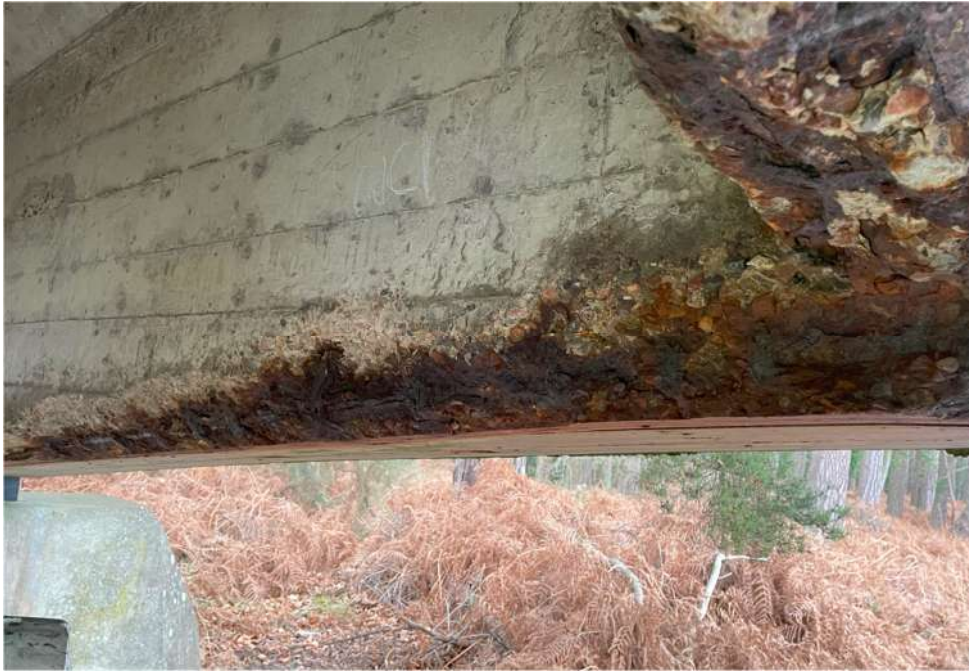
Photograph 3: Beam 1, cantilever span west, large spall

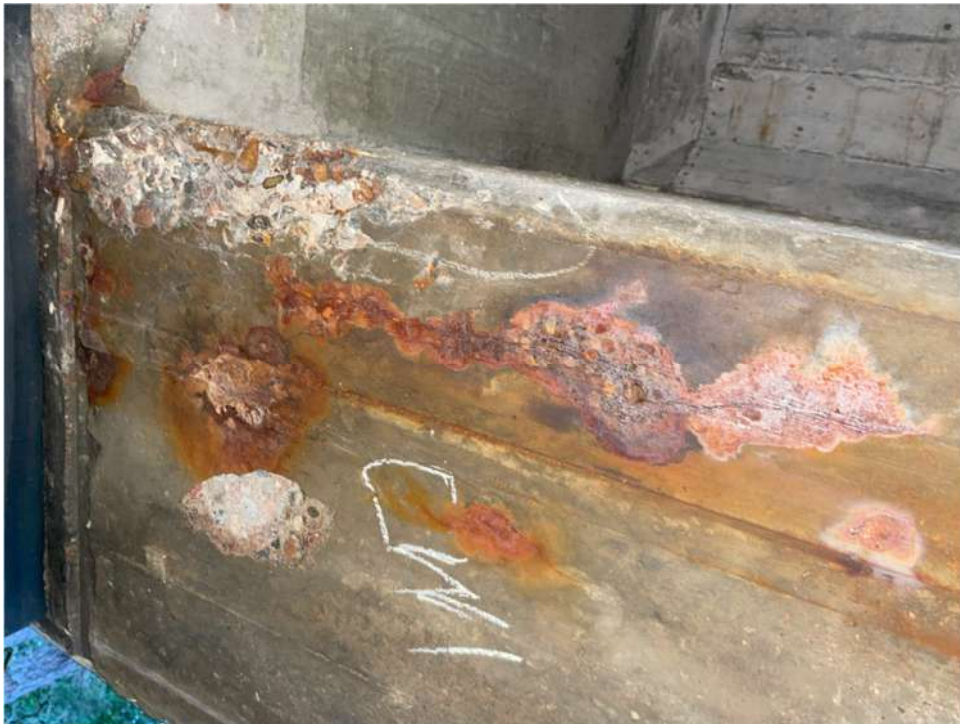
Photograph 4: Beam 1, cantilever span west, delamination and severe staining

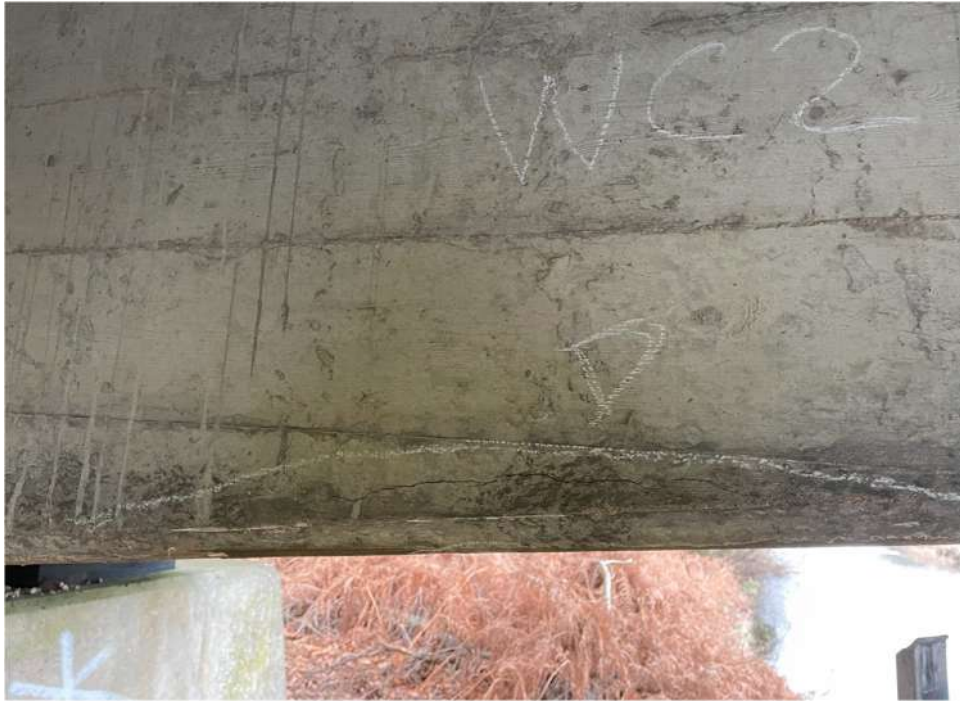
Photograph 7: Beam 2, cantilever span west, longitudinal crack

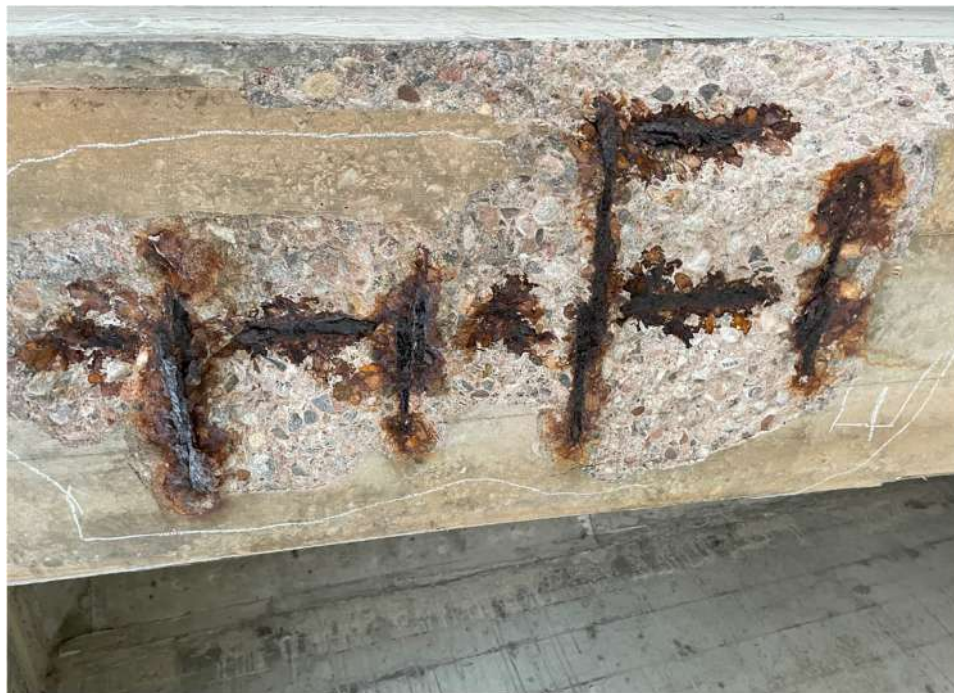
Photograph 8: Beam 2, cantilever span west, exposed and corroded reinforcement

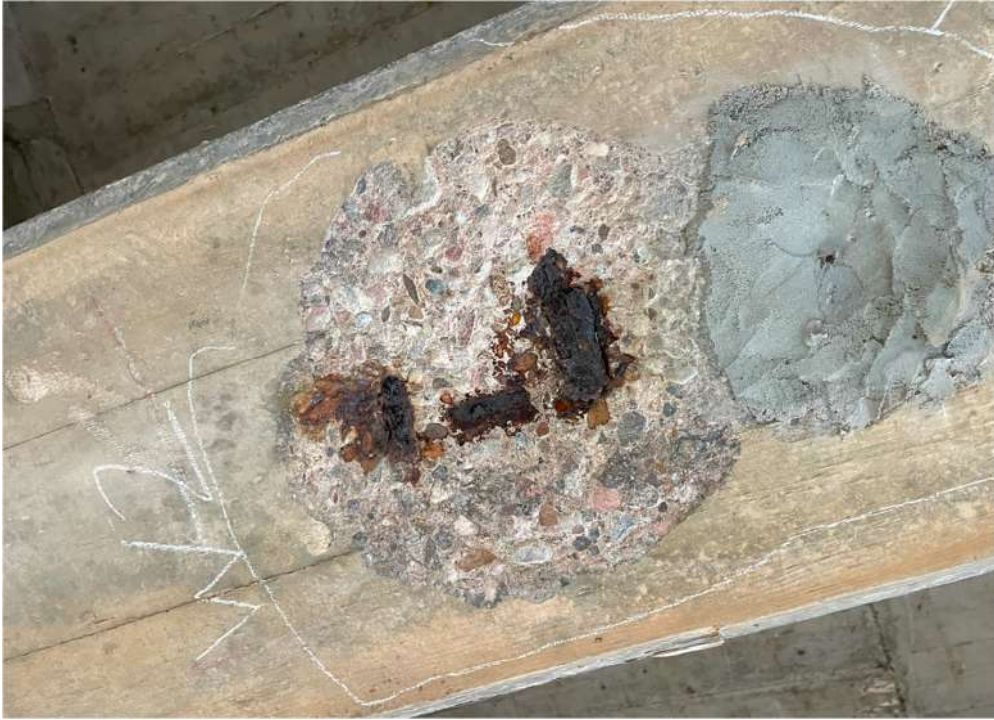
Photograph 9: Beam 2, cantilever span west, exposed and corroded reinforcement

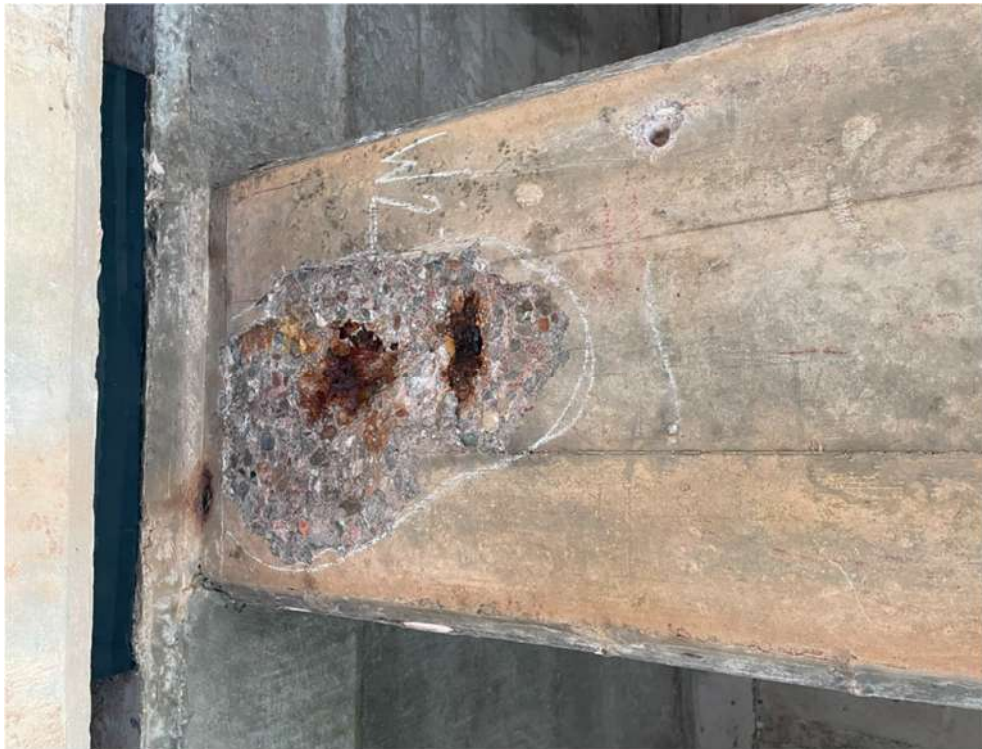
Photograph 10: Beam 2, cantilever span west, exposed and corroded reinforcement

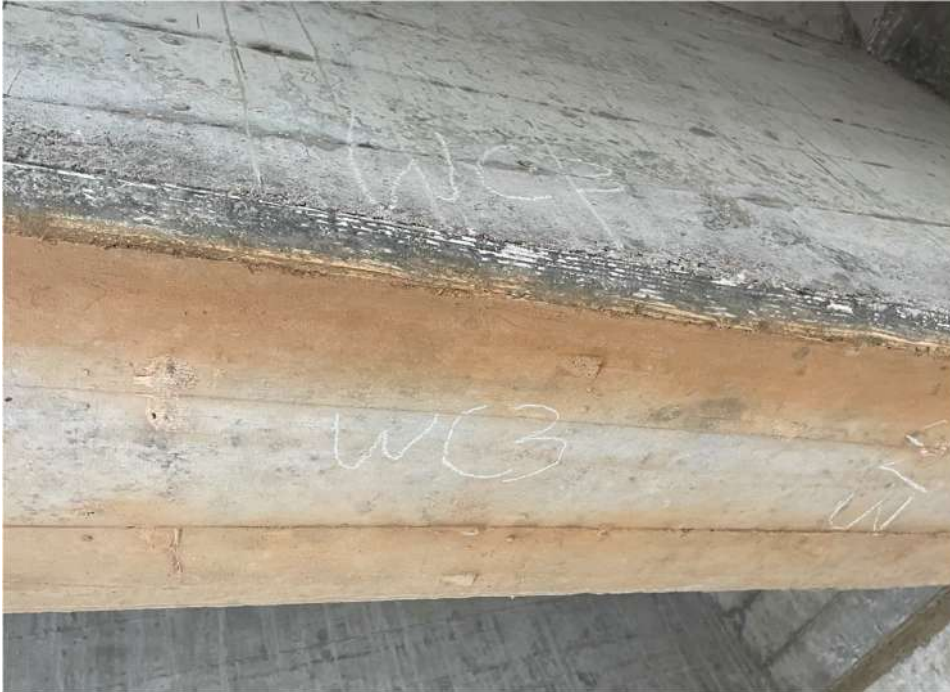
Photograph 11: Beam 3, cantilever span west, staining

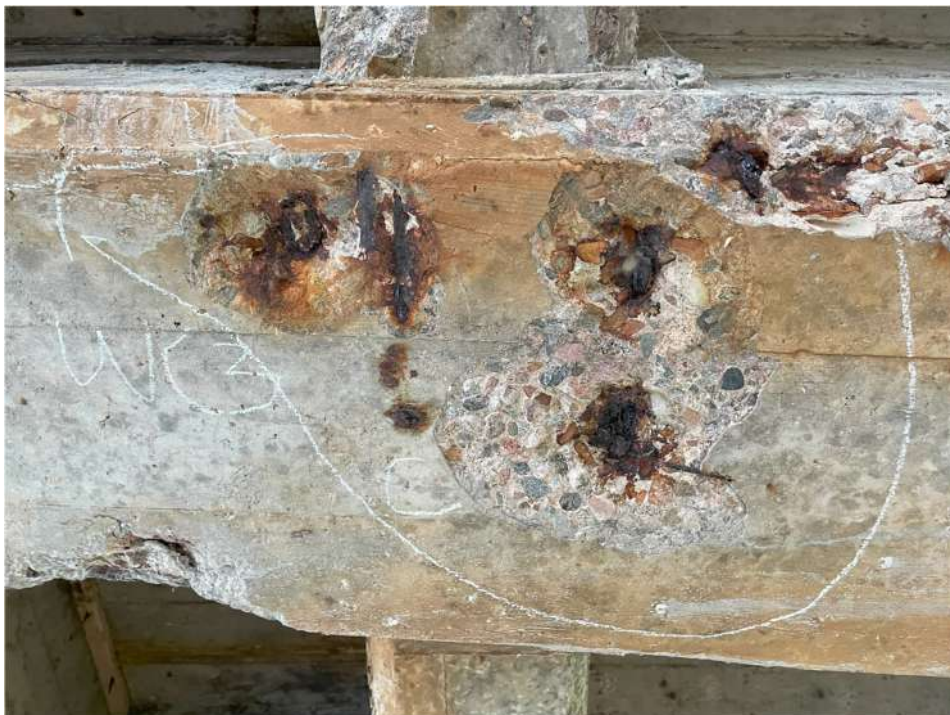
Photograph 12: Beam 3, cantilever span west, small spalls and reinforcement exposed

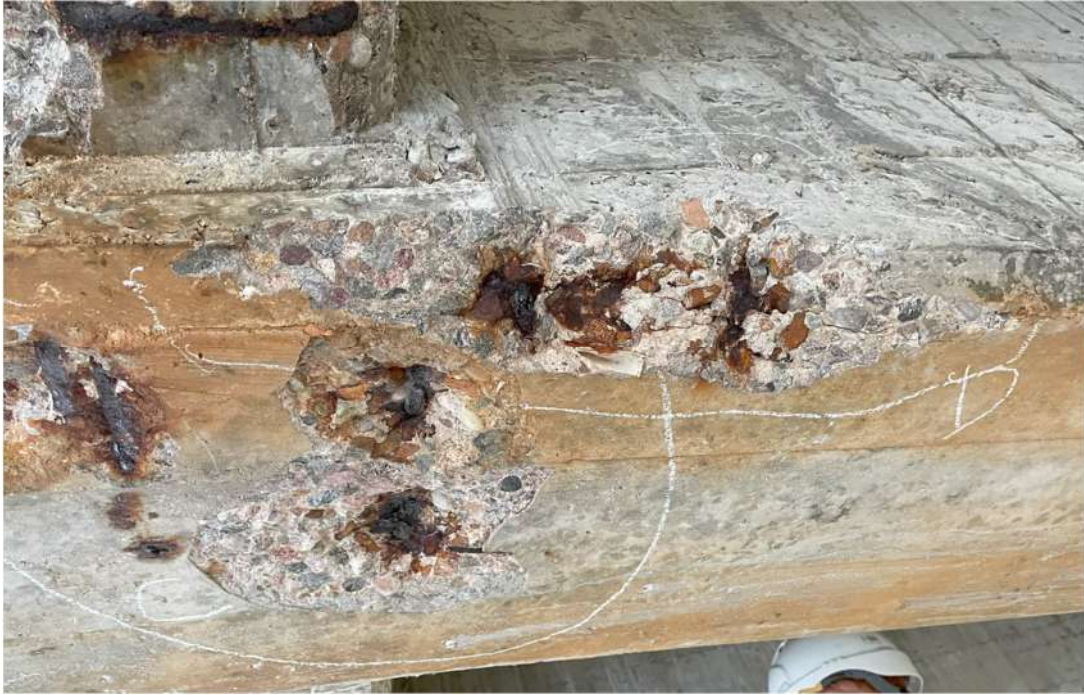
Photograph 13: Beam 3, cantilever span west, spalled concrete and reinforcement exposed

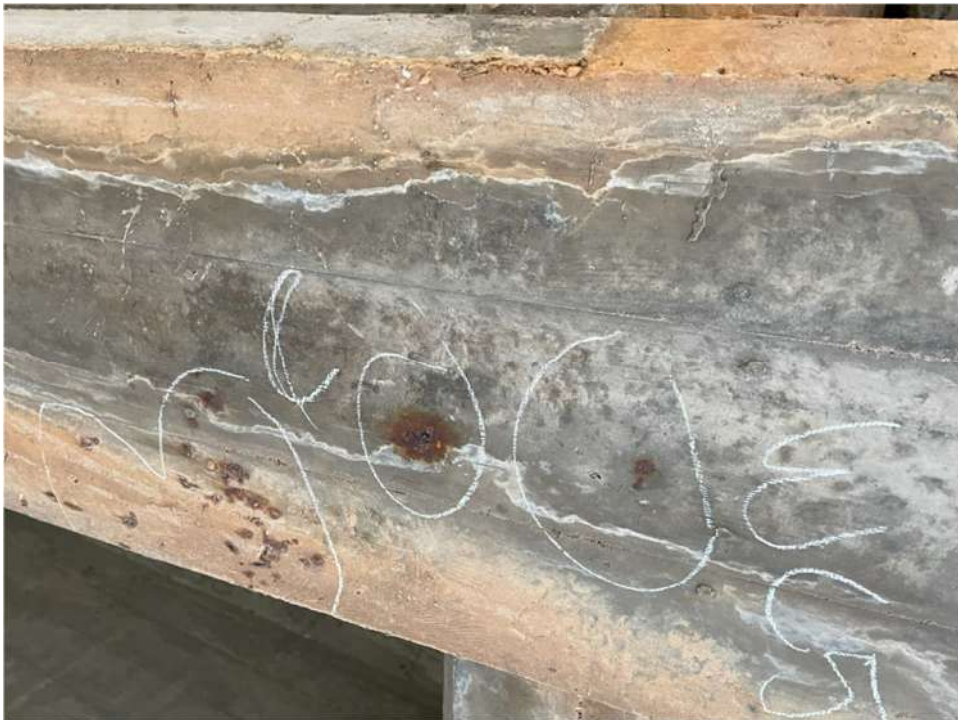
Photograph 14: Beam 5, cantilever span west, spotted corrosion marks

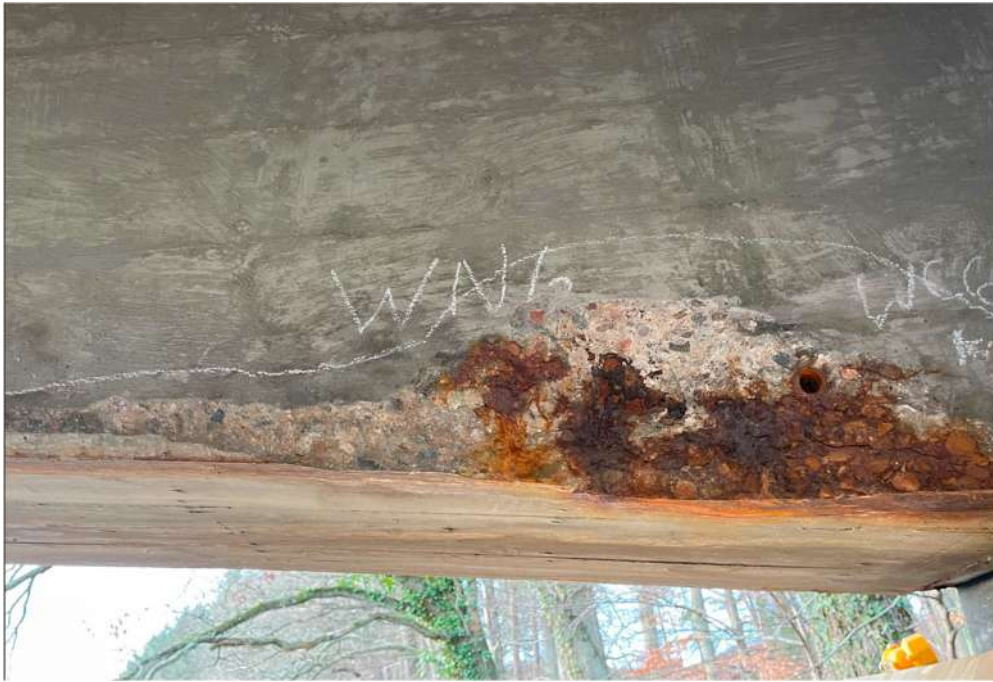
Photograph 15: Beam 6, cantilever span west, large spall

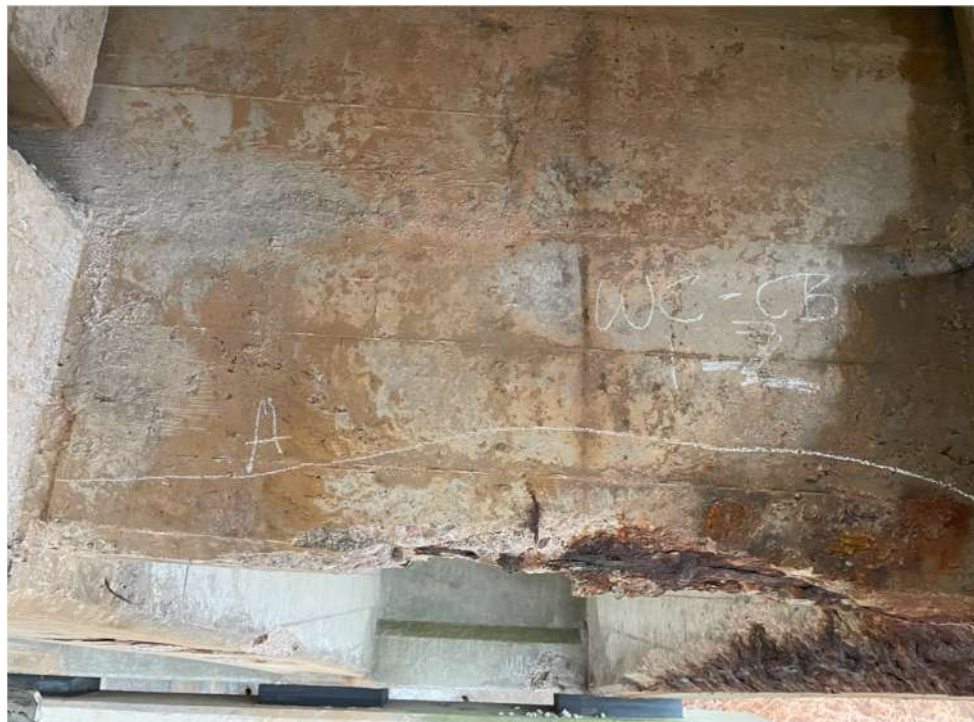
Photograph 16: Beam 1 – Beam 2, cantilever span west, cross beam, full width spall with exposed reinforcement

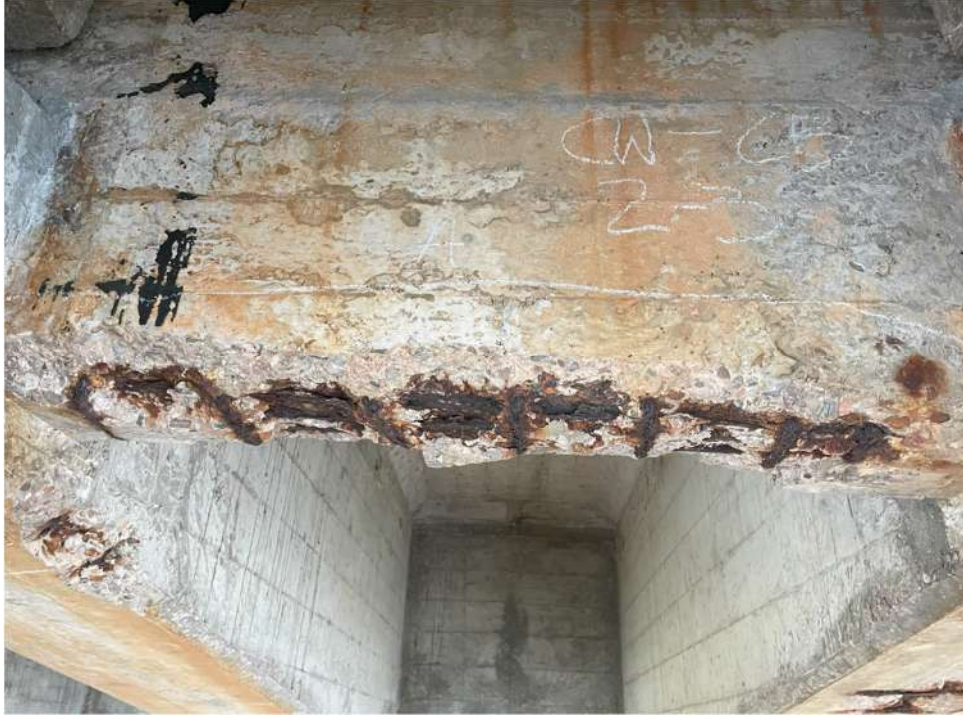
Photograph 17: Beam 2 – Beam 3, cantilever span west, cross beam, full width spall with exposed reinforcement

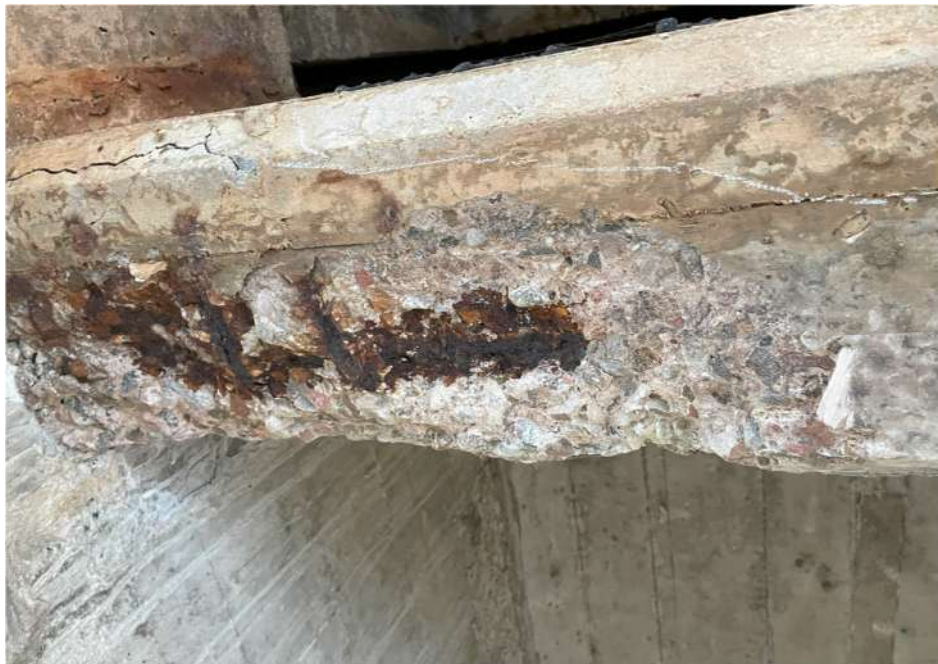
Photograph 18: Beam 3 – Beam 4, cantilever span west, cross beam, full width spall with exposed reinforcement

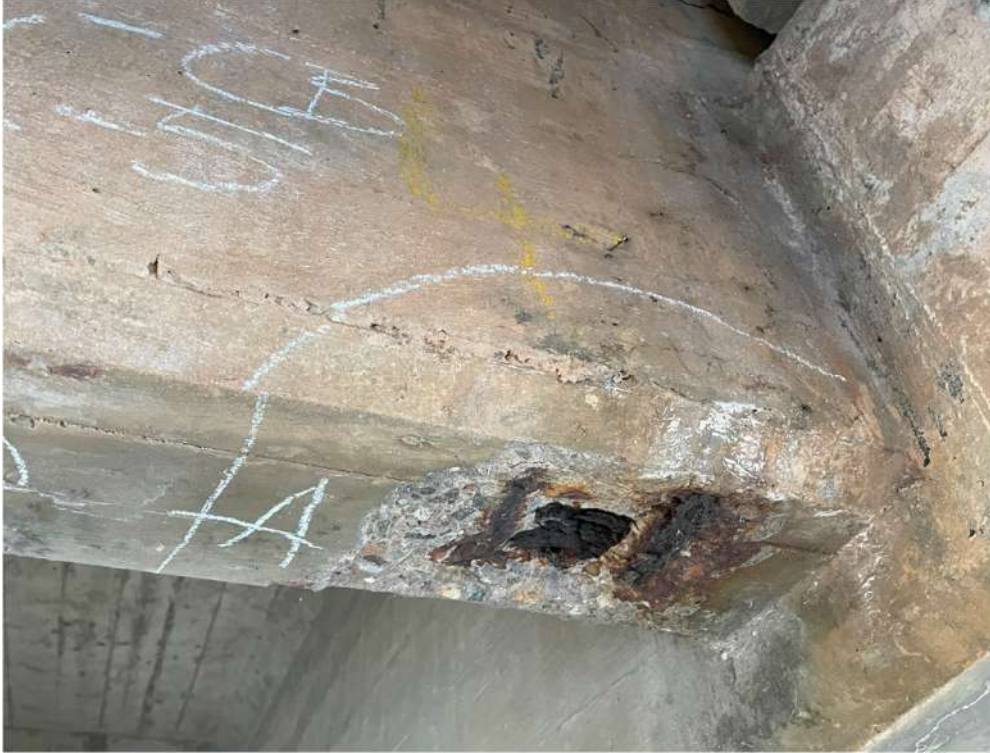
Photograph 19: Beam 4 – Beam 5, cantilever span west, cross beam, full width spall with exposed reinforcement

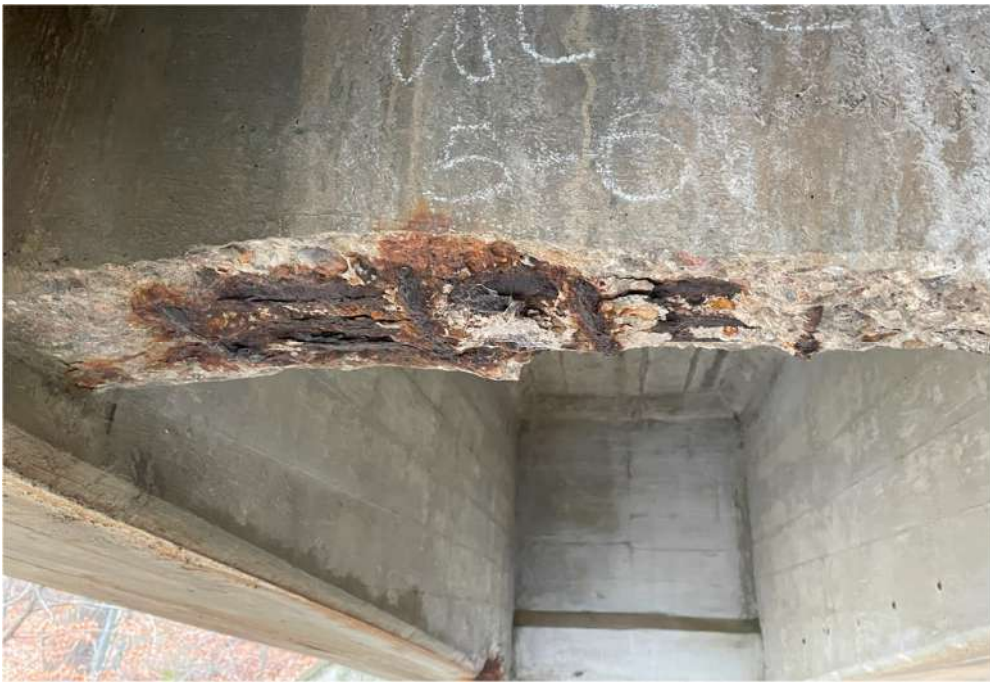
Photograph 20: Beam 5 – Beam 6, cantilever span west, cross beam, full width spall with exposed reinforcement

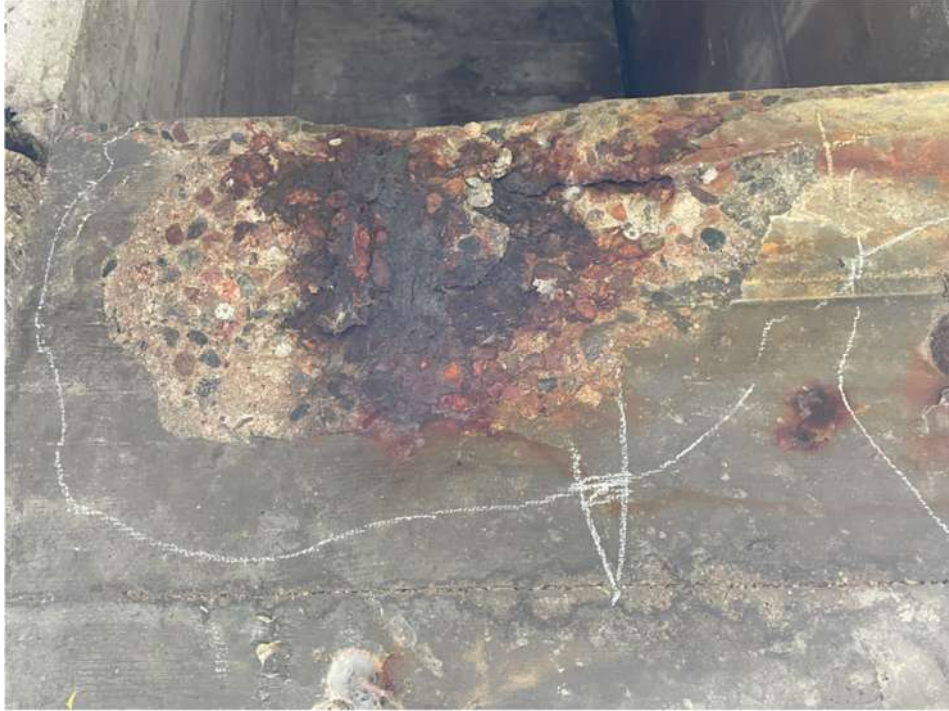
Photograph 21: Beam 1, cantilever span east, spalling on soffit of half joint

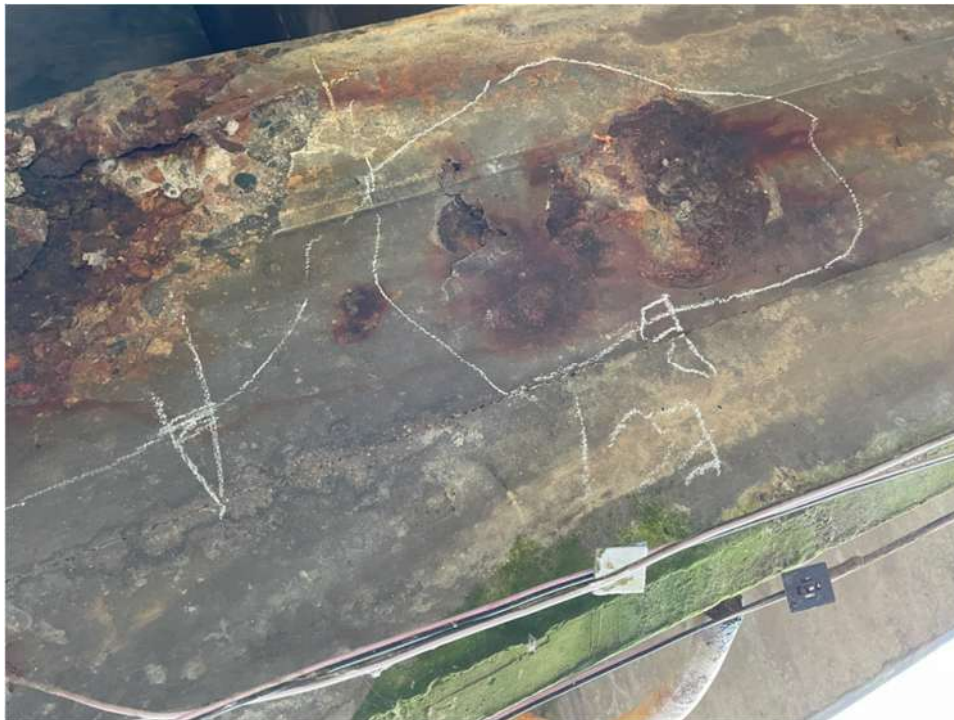
Photograph 22: Beam 1, cantilever span east, spalling and delaminating concrete
