ARTHURS BRIDGE

Principal Inspection Report

B234M205-J-ART-STR-REP-PIR-0001

A Principal Inspection of Arthur’s Bridge was undertaken by Jacobs on the 11th February 2025. Access to the half joints, suspended and cantilever spans were obtained through the use of an underbridge unit. All elements of the structure were inspected apart from the buried foundations and waterproofing system.

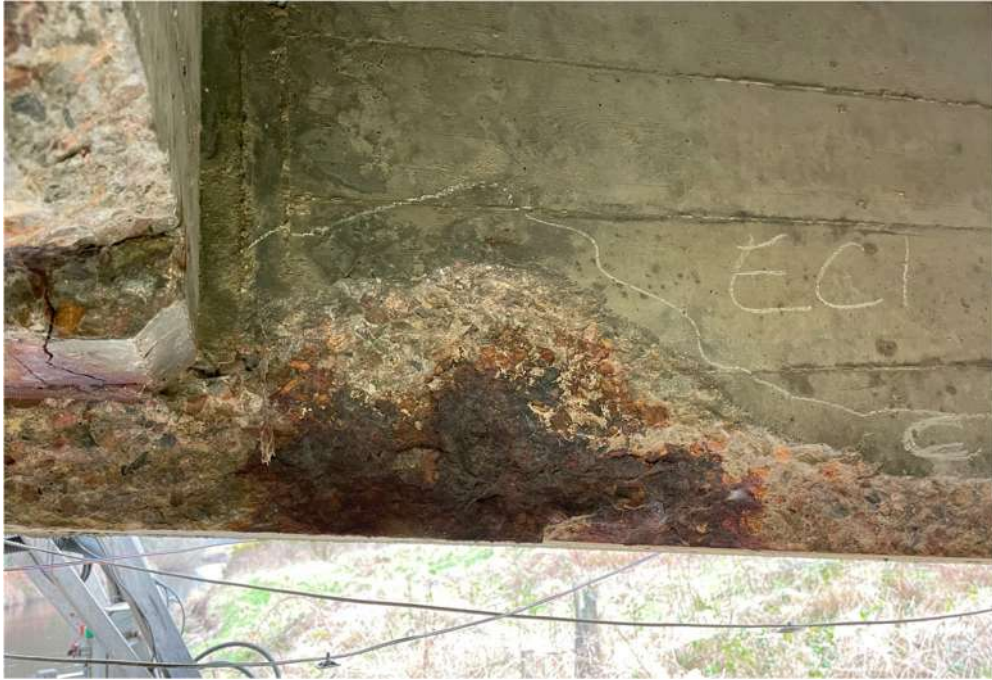
Photograph 23: Beam 1, cantilever span east. Large and deep spall, reinforcement exposed and corroded

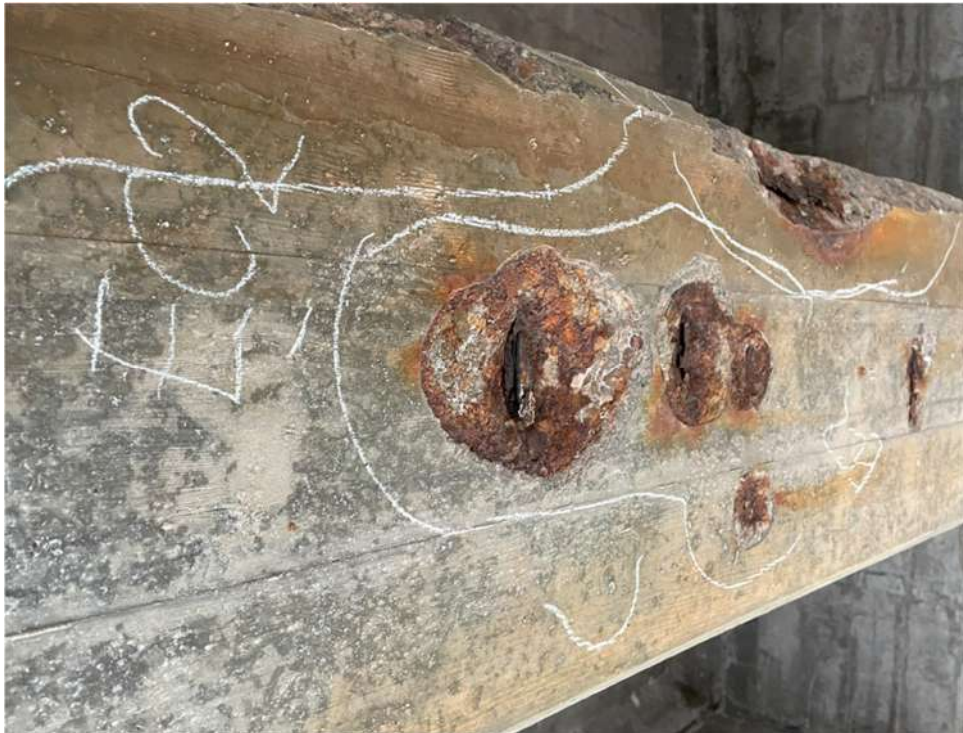
Photograph 24: Beam 2, cantilever span east, areas of small spalls and corrosion

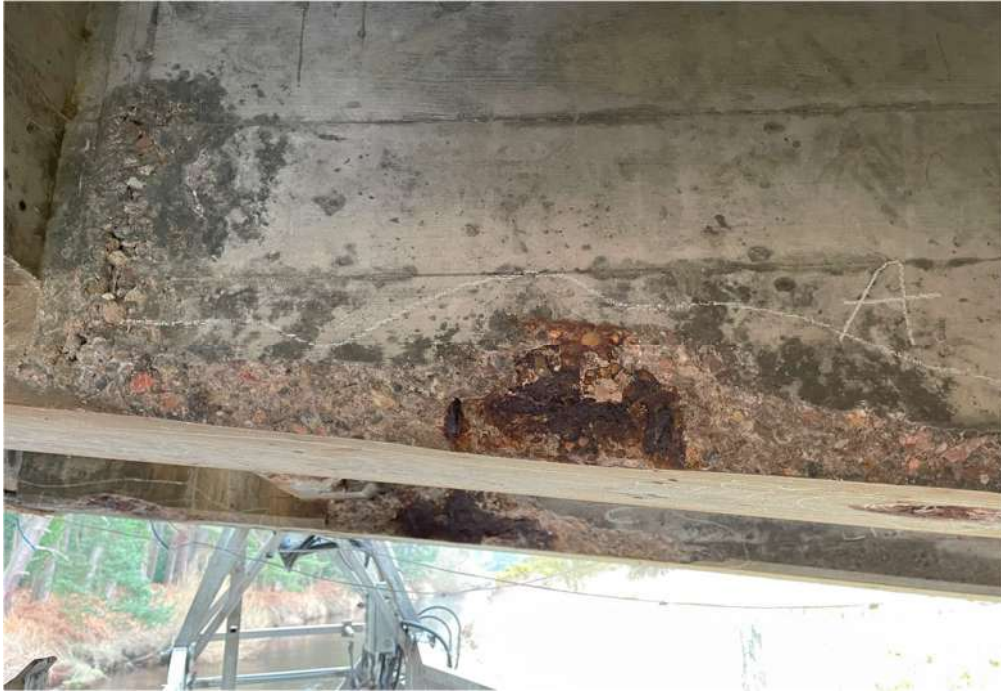
Photograph 25: Beam 2, cantilever span east, long spall, corner of beam is missing

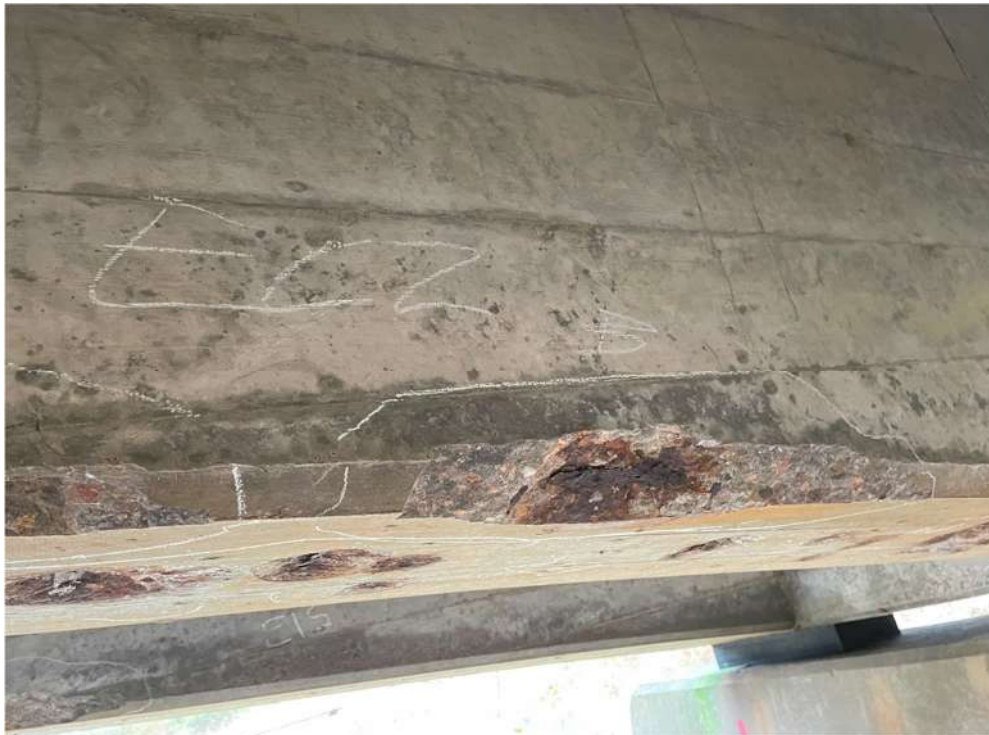
Photograph 26: Beam 2, cantilever span east, spalling concrete and staining

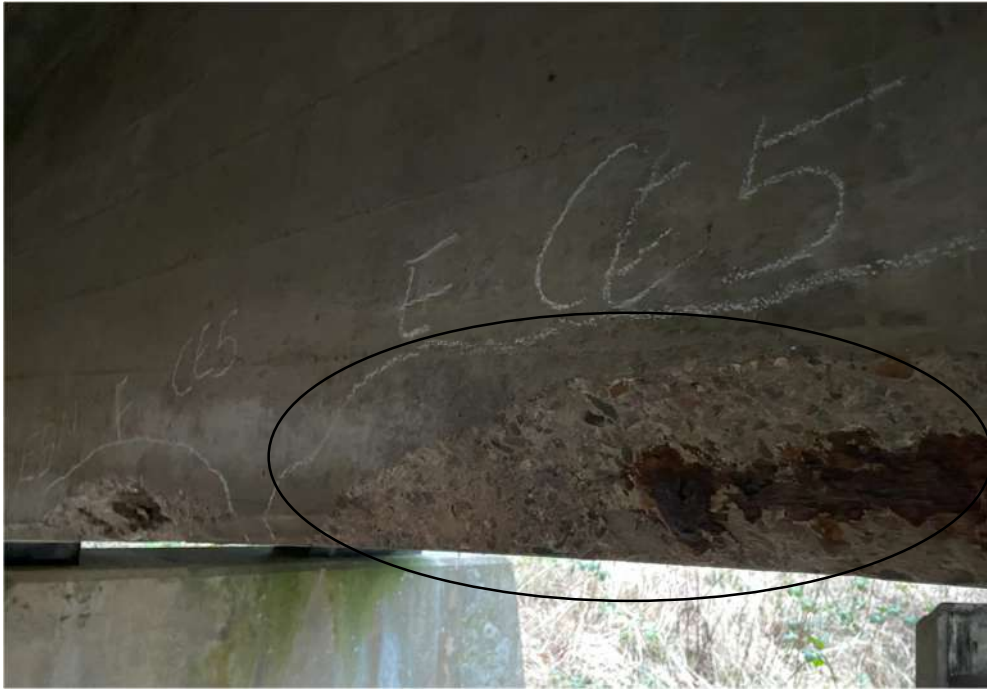
Photograph 27: Beam 5, cantilever span east, large spall reinforcement exposed and corroded

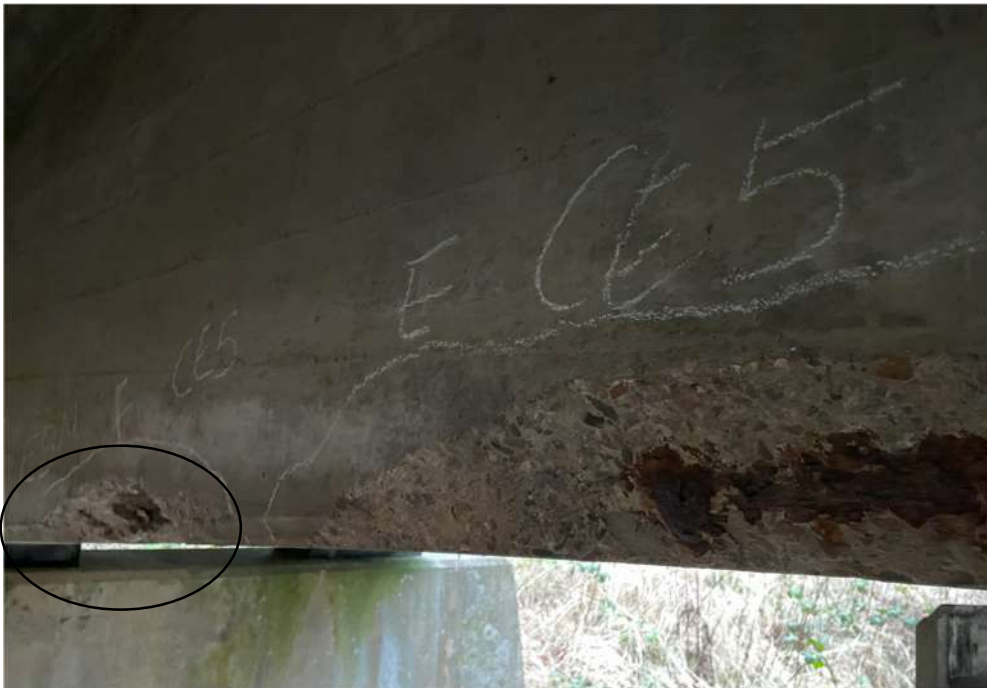
Photograph 28: Beam 5, cantilever span east, spall reinforcement exposed and corroded

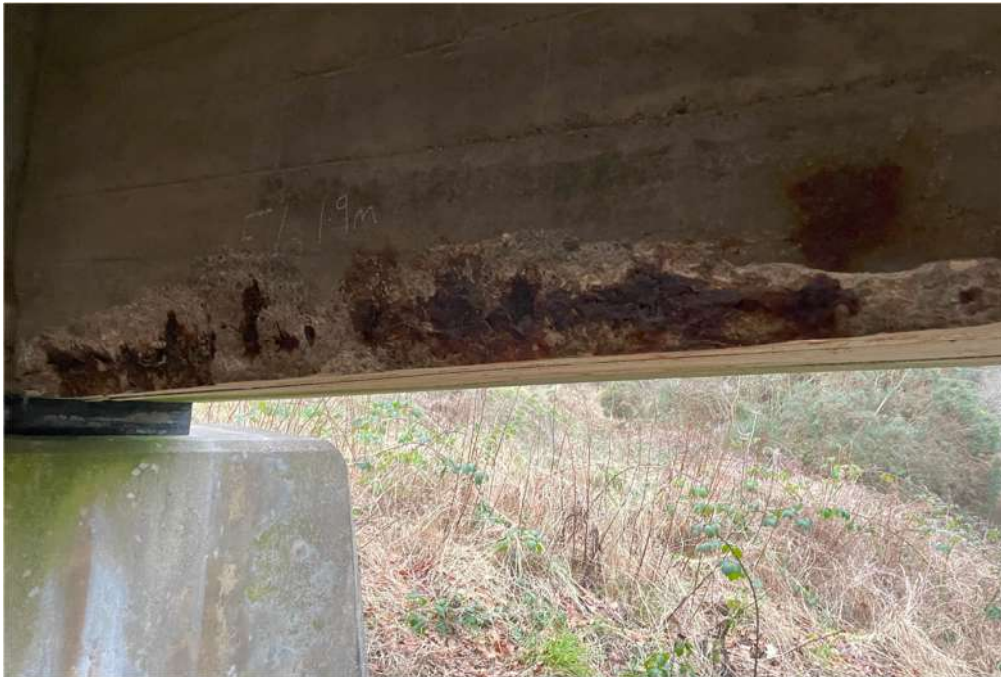
Photograph 31: Beam 6, cantilever span east, spall along bottom corner of beam, longitudinal reinforcement and links exposed

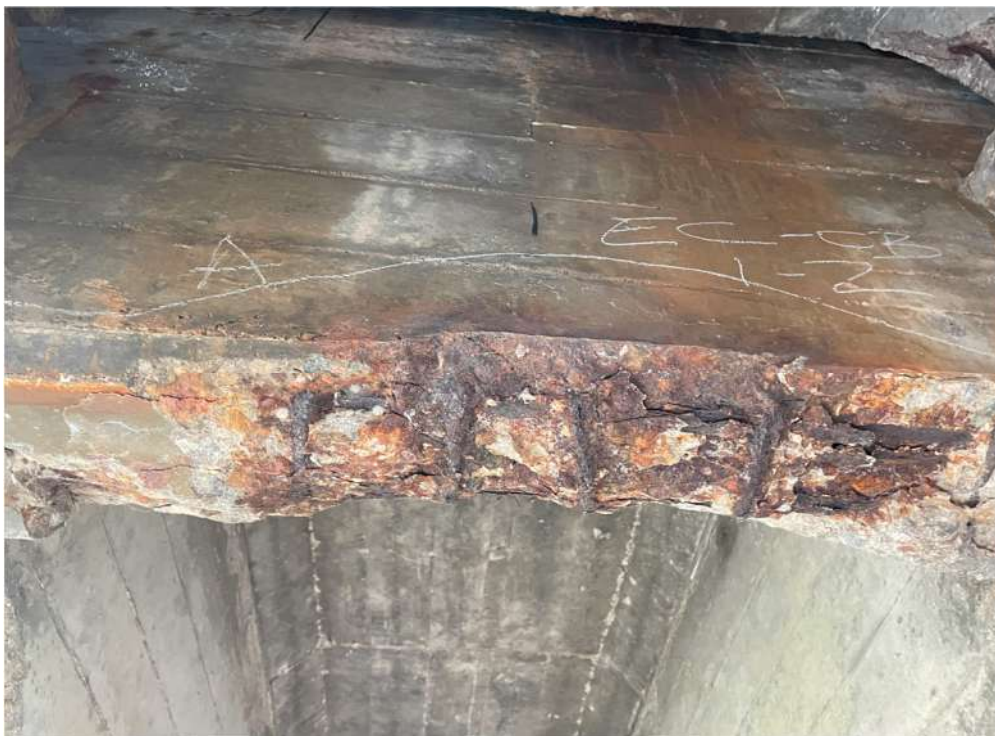
Photograph 32: Beam 1 – Beam 2, cantilever span east, crossbeam, full width spall with exposed reinforcement

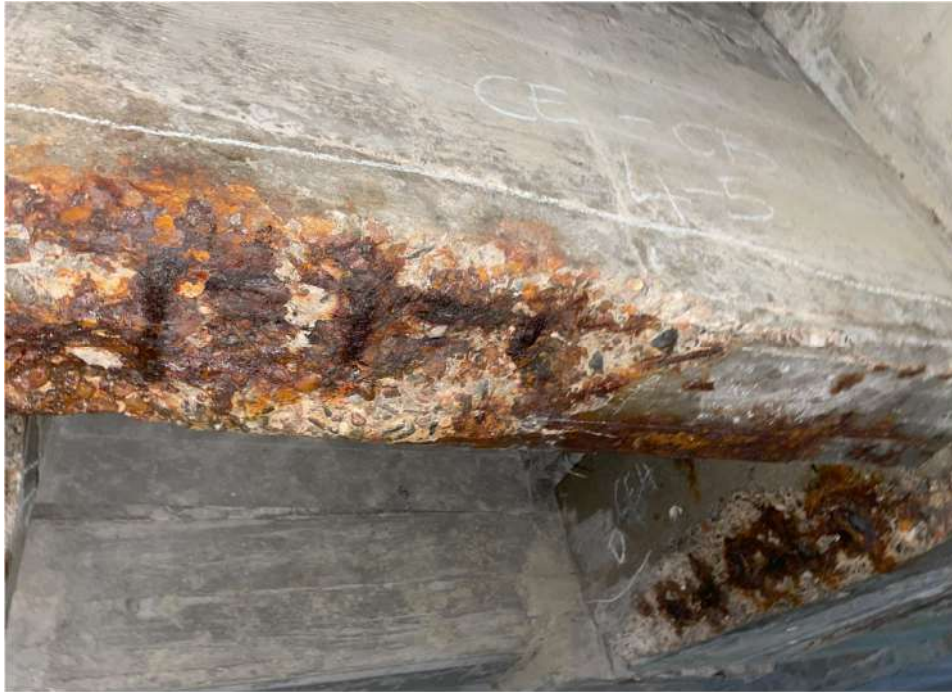
Photograph 33: Beam 4 – Beam 5, cantilever span east, crossbeam, full width spall with exposed reinforcement, full length crack through spall

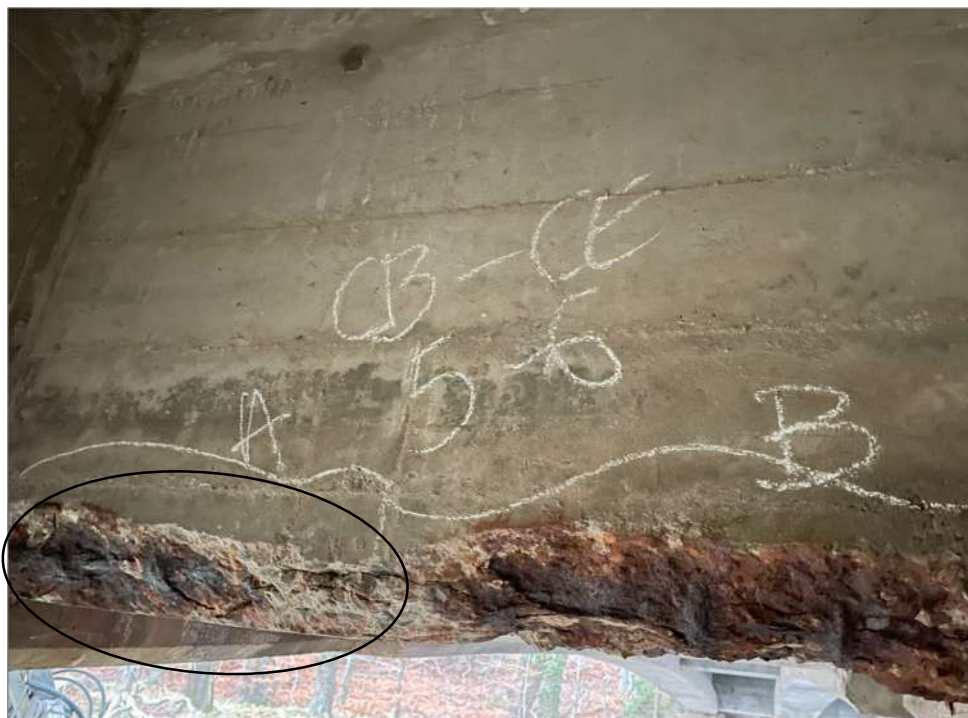
Photograph 34: Beam 5 – Beam 6, cantilever span east, crossbeam, spall with exposed reinforcement linked to defect 35

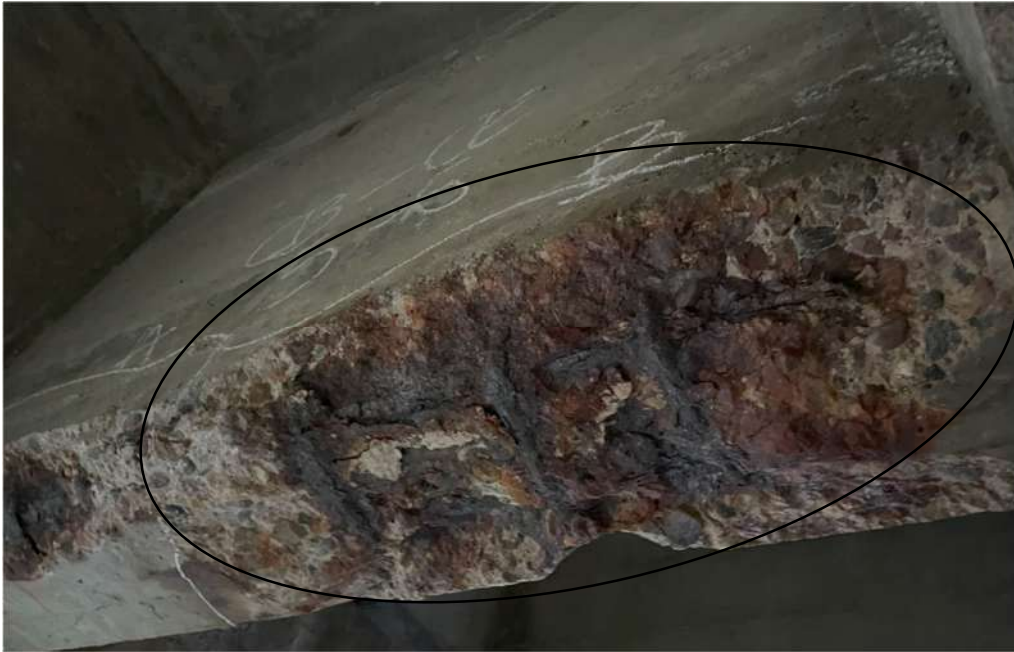
Photograph 35: Beam 5 – Beam 6, cantilever span east, crossbeam, full width spall with exposed reinforcement linked to defect 34

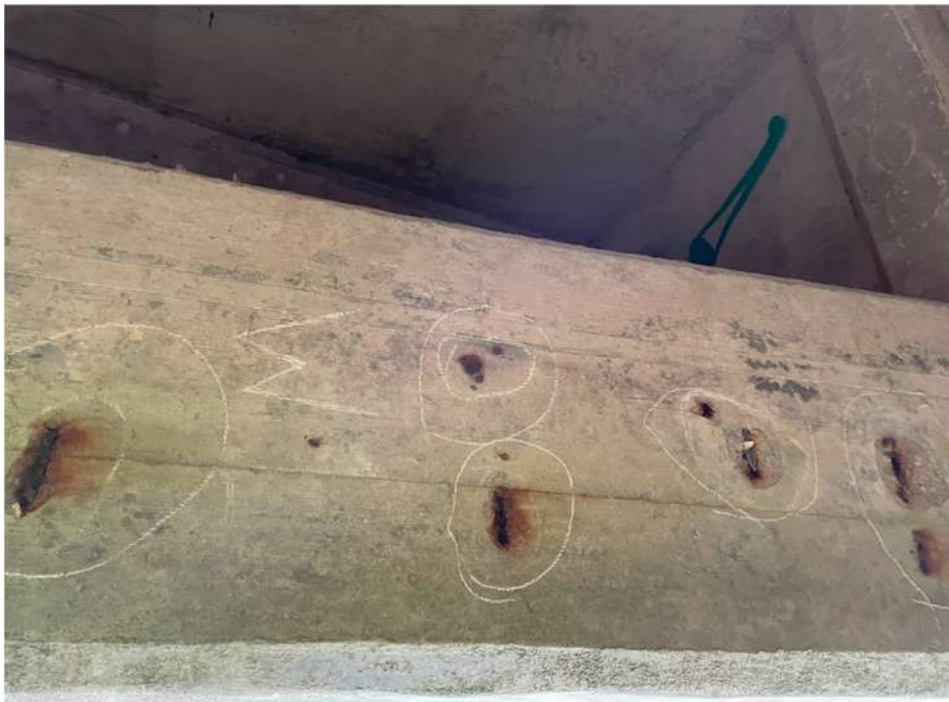
Photograph 36: Beam 1, outer span west, small areas of spalling

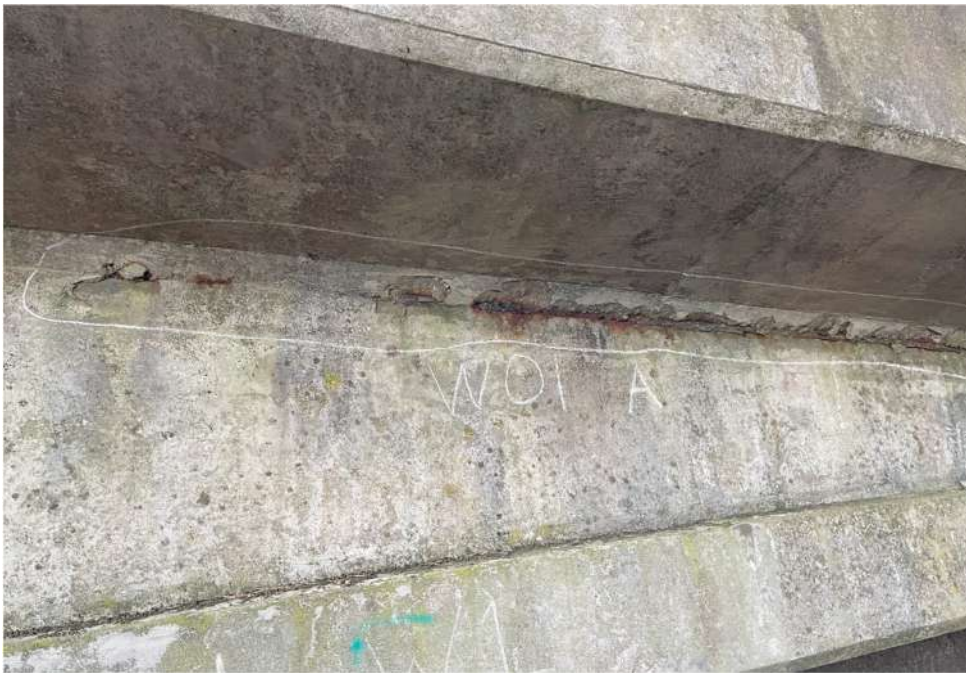
Photograph 37: Beam 1, outer span west, spalling along chamfer of the cantilever beam

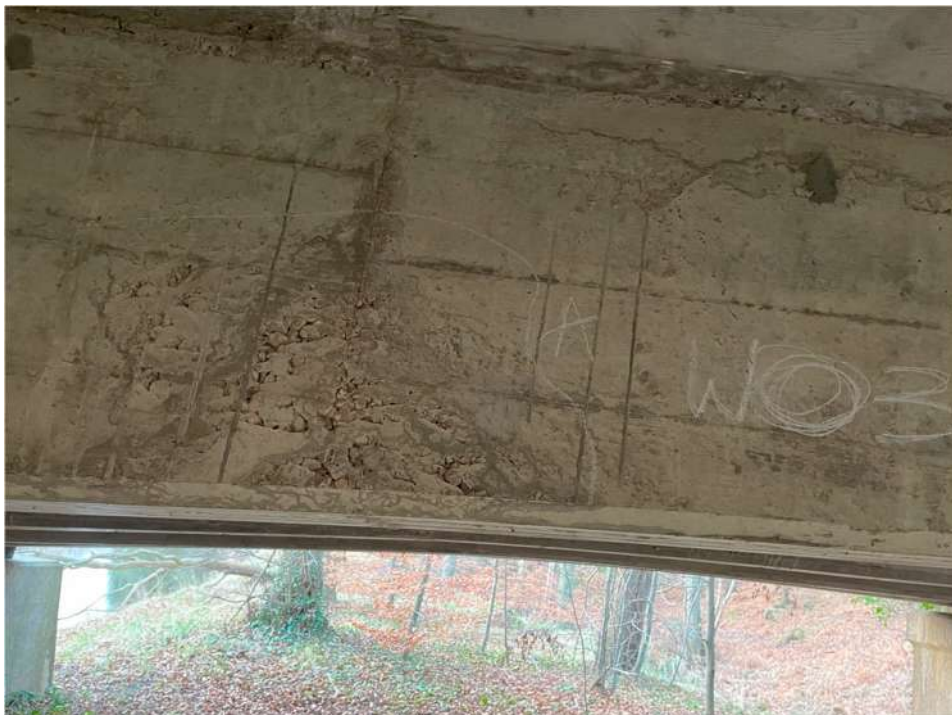
Photograph 38: Beam 3, outer span west, honeycombing on side face

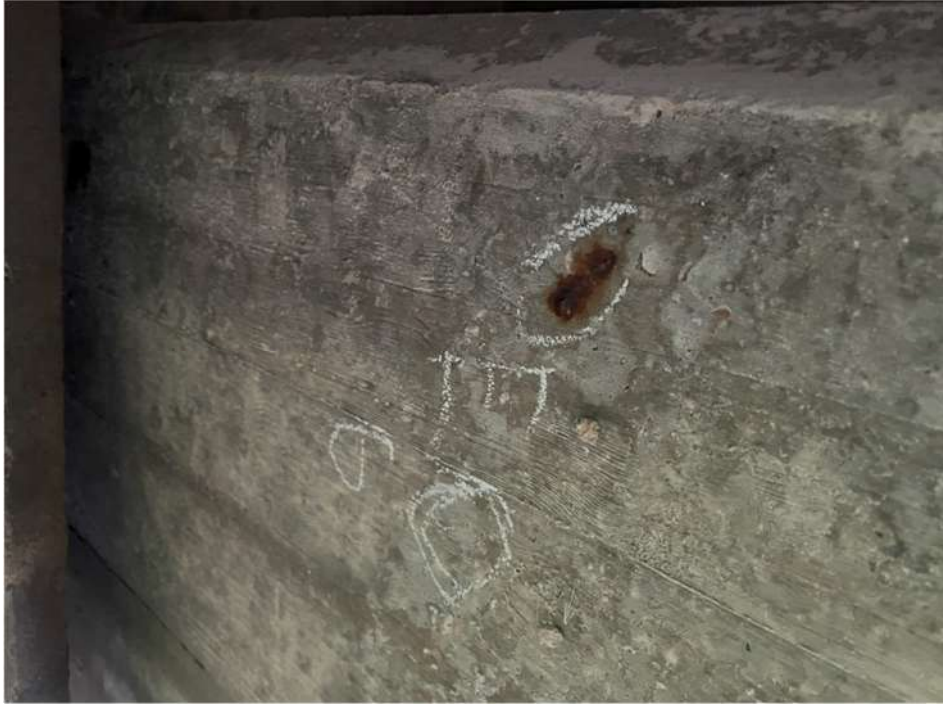
Photograph 39: Beam 6, outer span east, small spalls

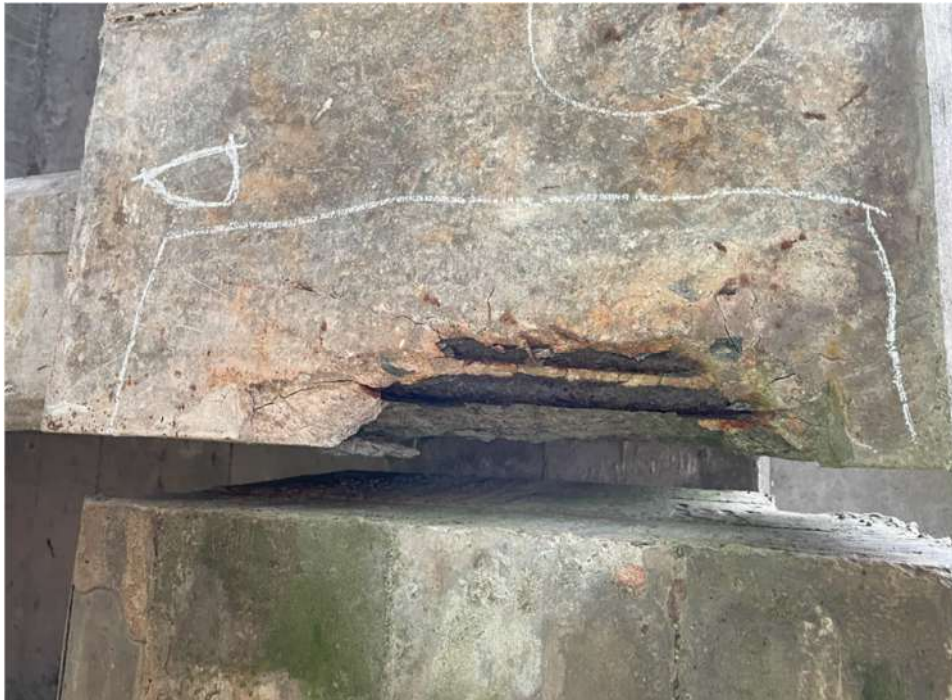
Photograph 40: Beam 1 (north and south facing), half joint west, severely corroded and exposed links, spall at end of beam

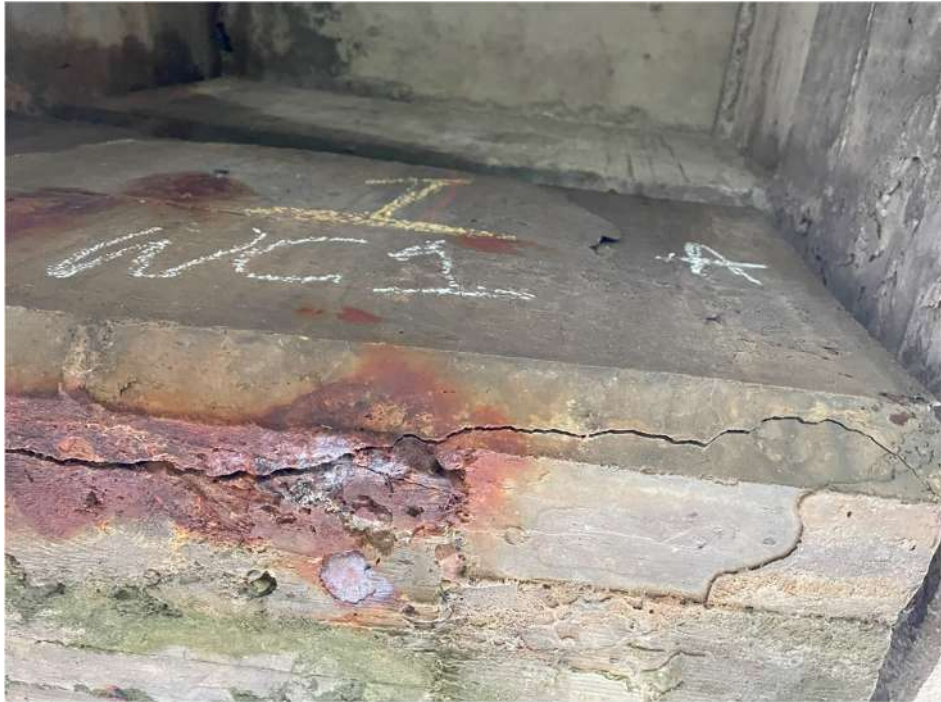
Photograph 42: Beam 1 (south facing), half joint west, delaminated face, beginning to spall, hollow sounding with large crack in bottom face

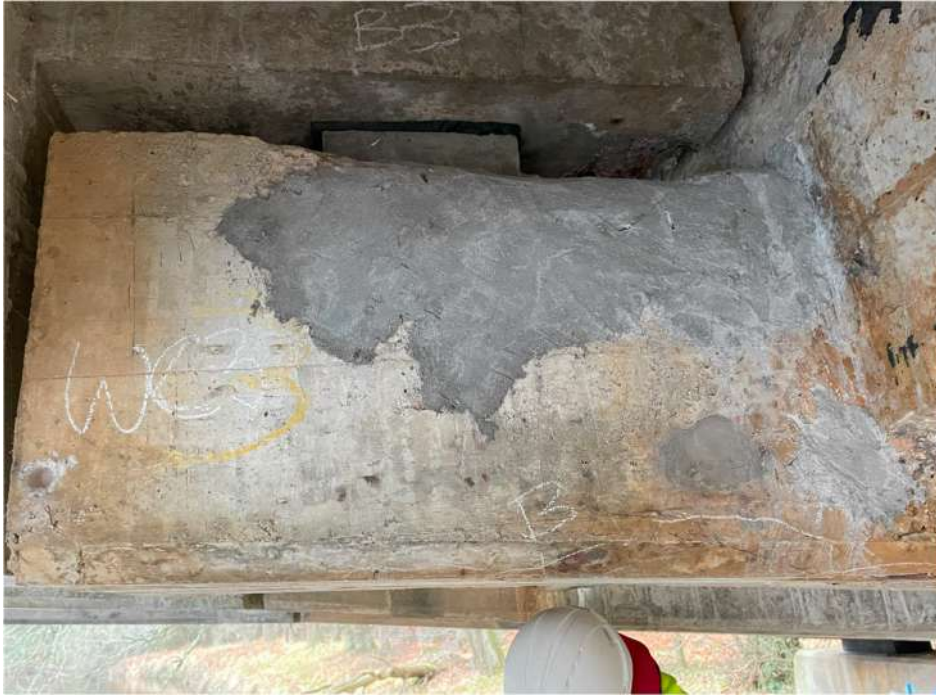
Photograph 45: Beam 3 (north facing), half joint west, crack with hairline cracks in same area

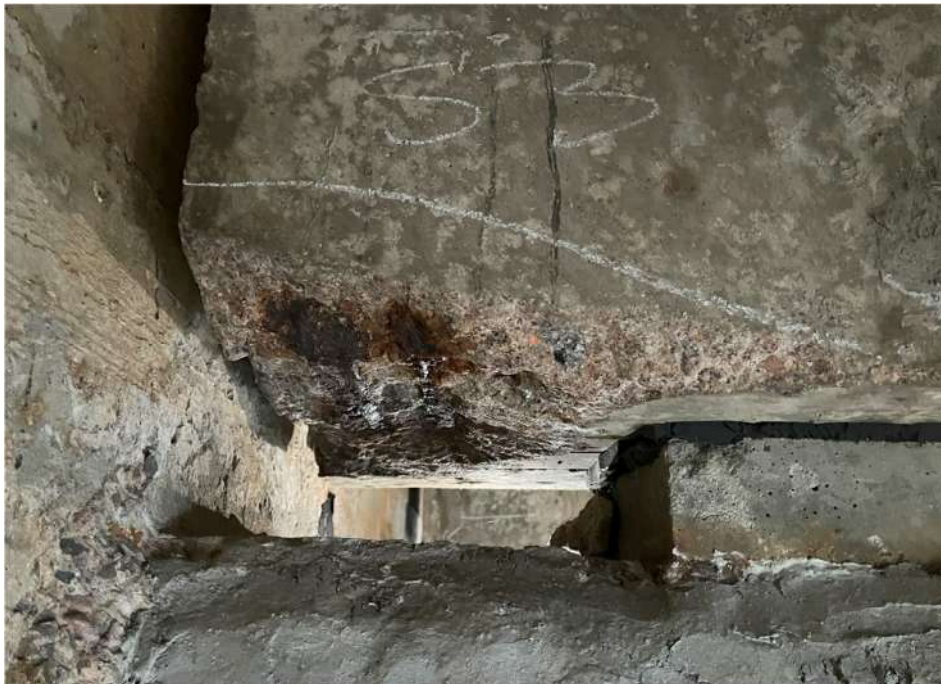
Photograph 46: Beam 3 (south facing), half joint west, spalled corner with exposed reinforcement

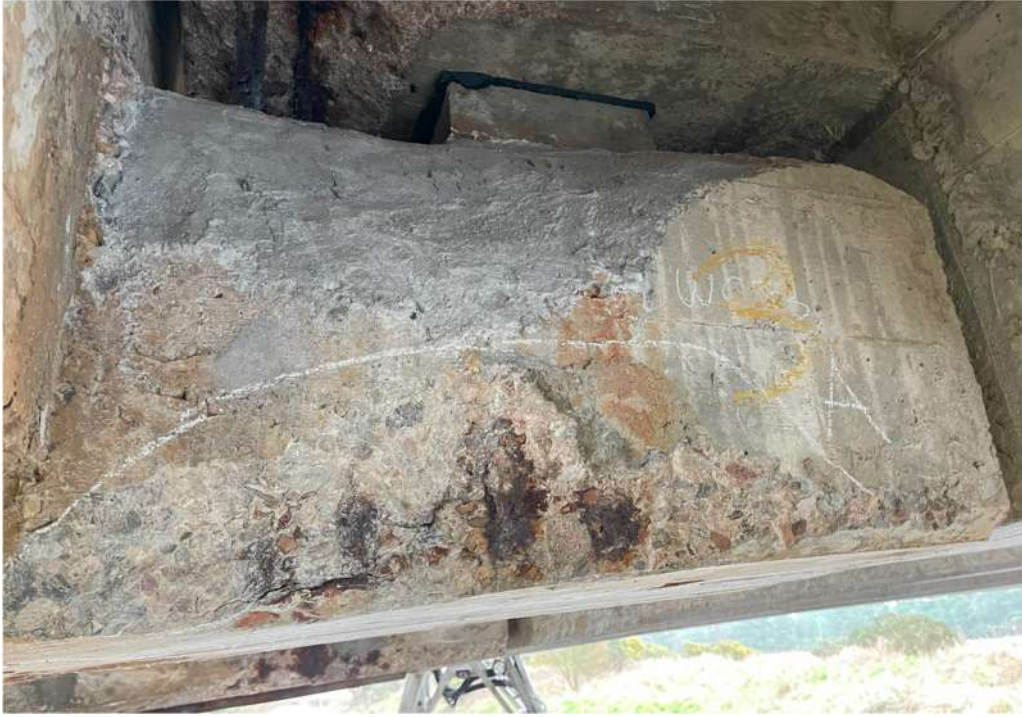
Photograph 47: Beam 3 (south facing), half joint west, spalling and exposed reinforcement, evidence of previous repair

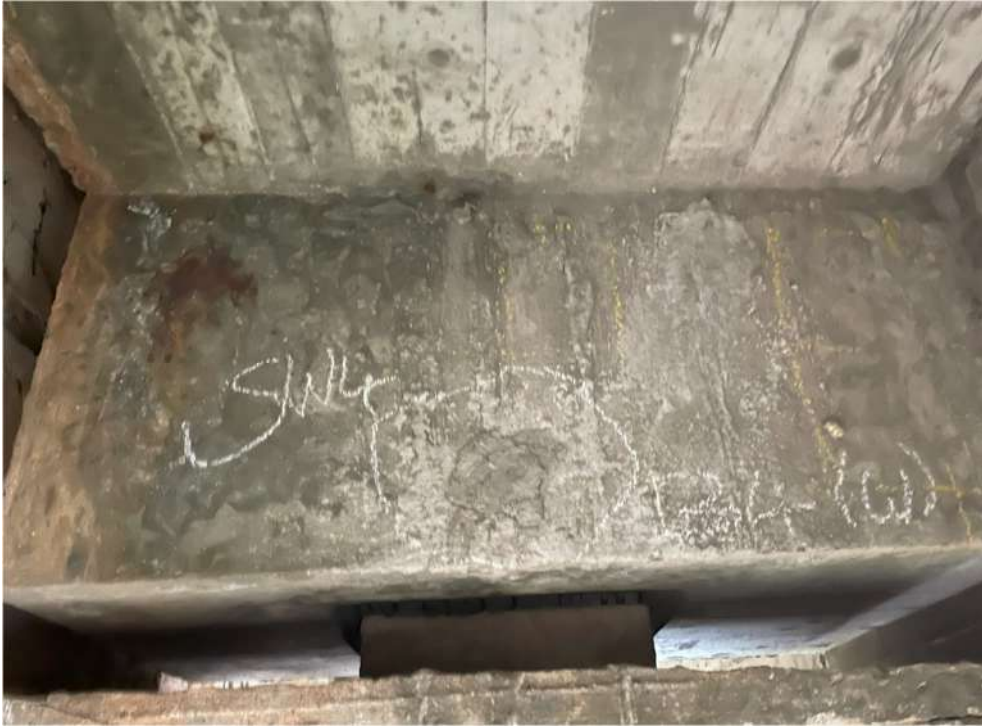
Photograph 49: Beam 4 (south facing), half joint west, patch repair

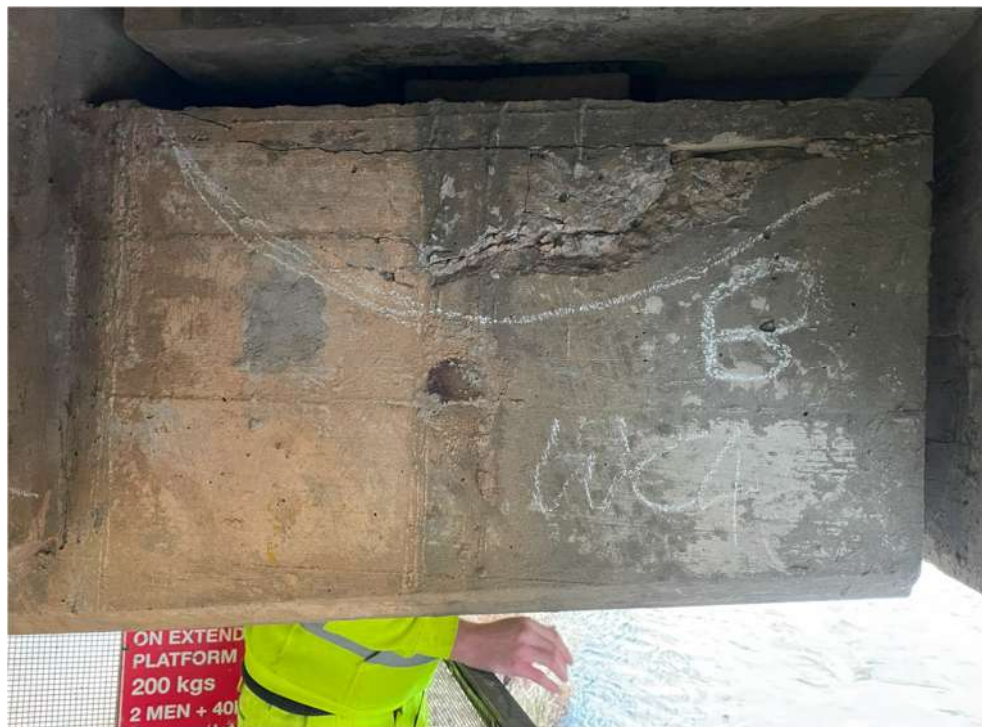
Photograph 50: Beam 4 (south facing), half joint west, crack below top face

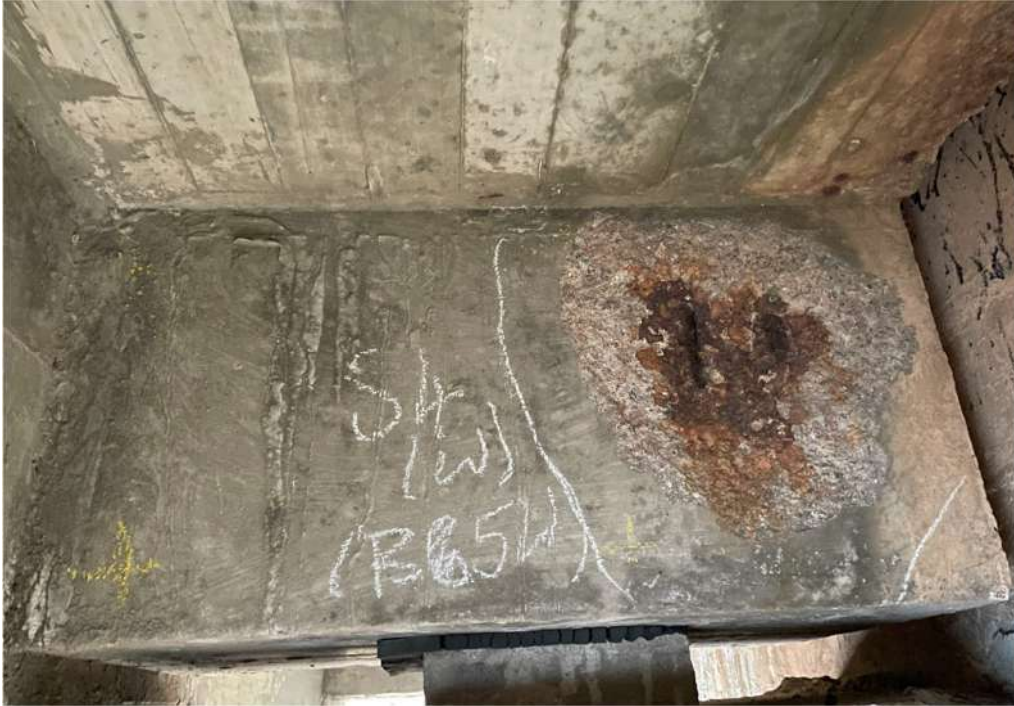
Photograph 51: Beam 5 (north facing), half joint west, spalling with exposed rebar

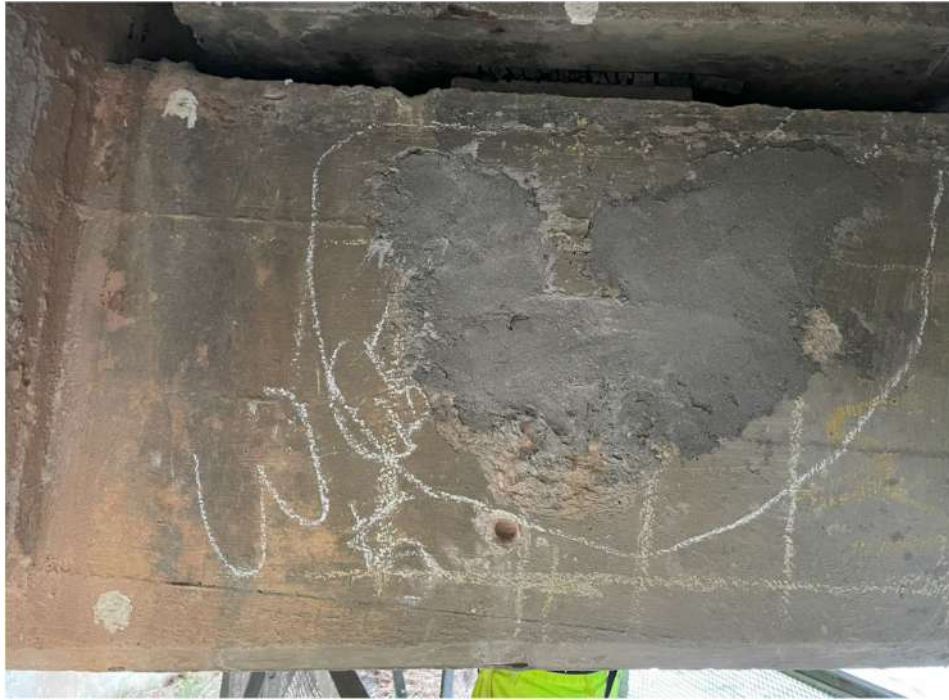
Photograph 53: Beam 5 (south facing), half joint west, previous repair with new hairline crack going into patch

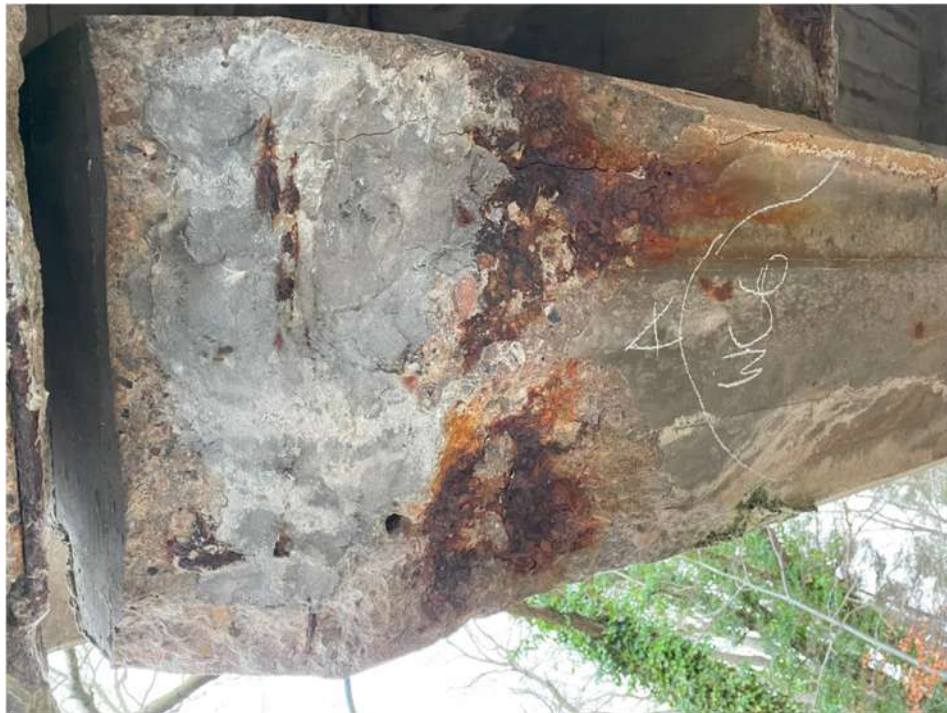
Photograph 54: Beam 6 (north and south facing), half joint west, large spall, previously repaired and corroded reinforcement exposed

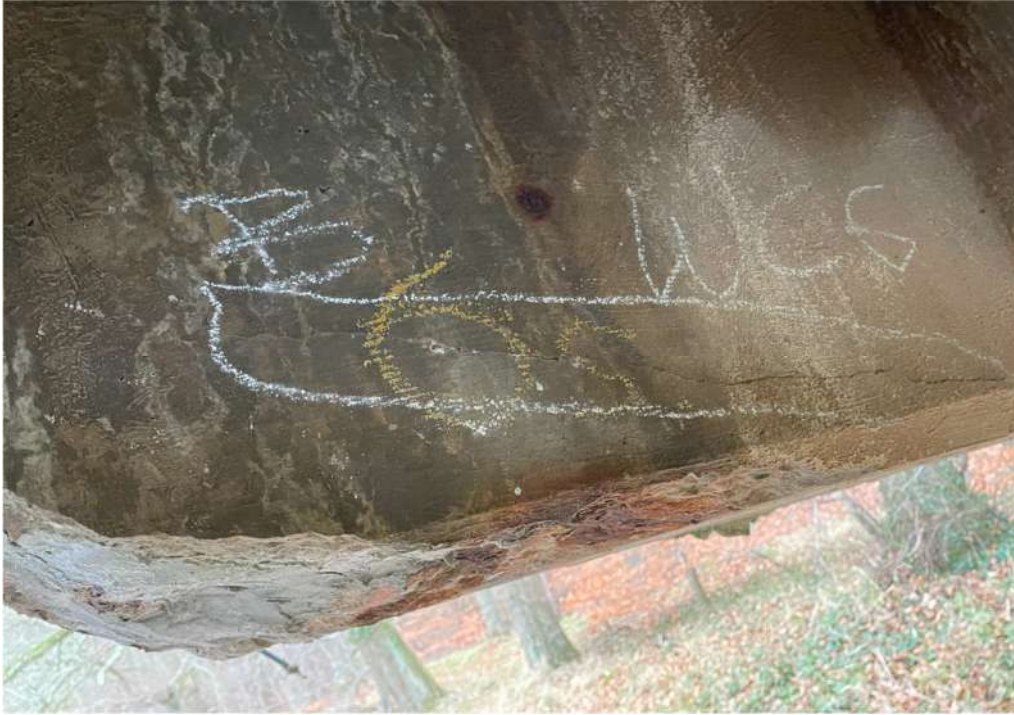
Photograph 55: Beam 6 (north facing), half joint west, crack, joins into Defect 54

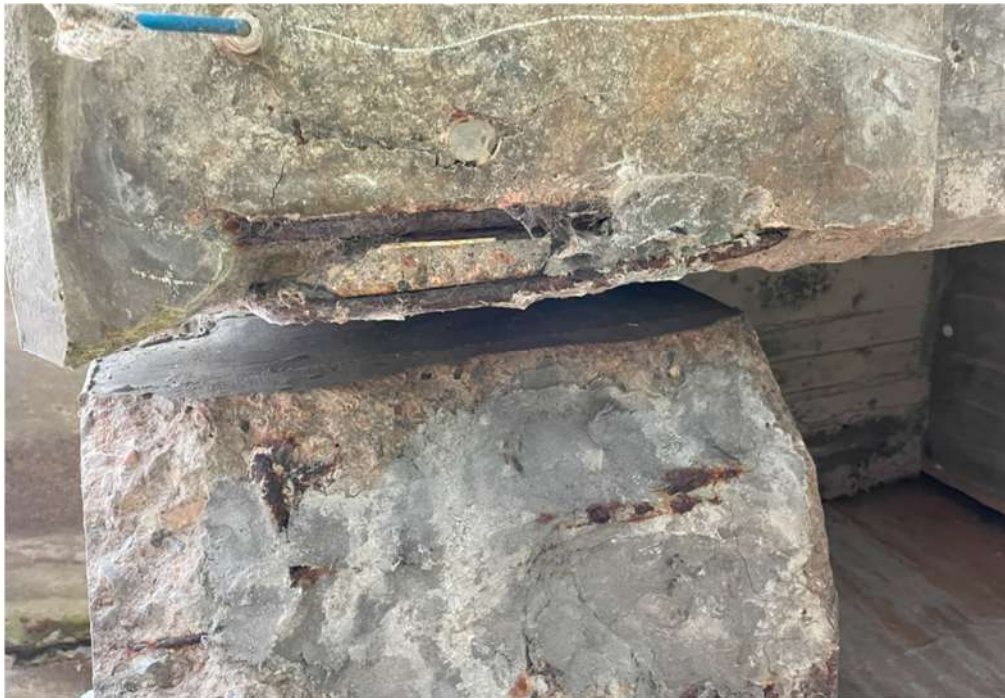
Photograph 56: Beam 6 (north facing), half joint west, spalling of soffit of end of suspended span, end links exposed

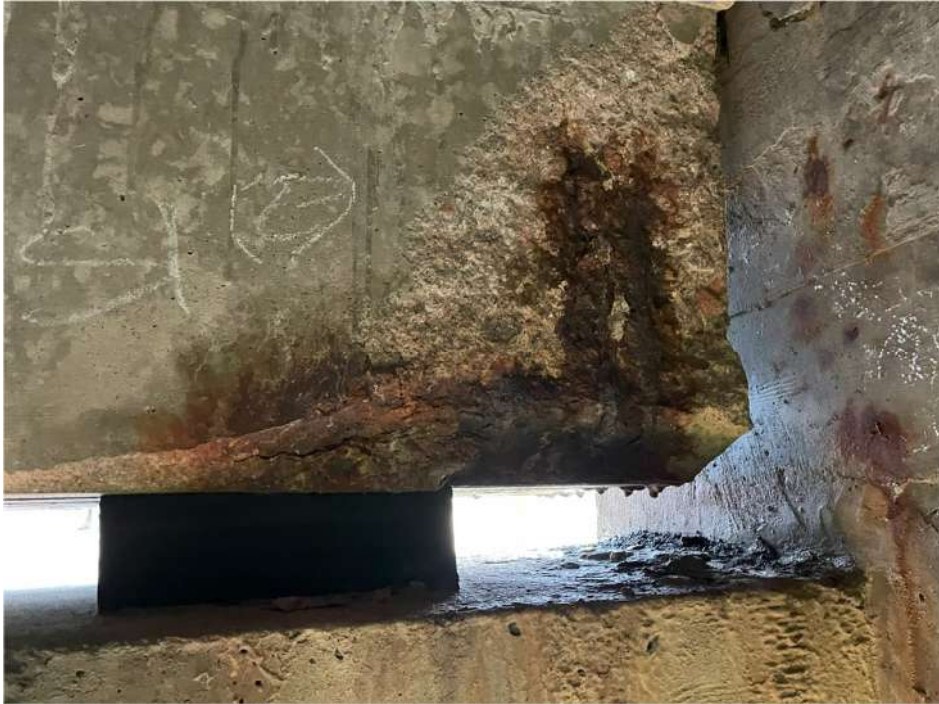
Photograph 57: Beam 1 (south facing), half joint east, spalling with exposed and corroded reinforcement

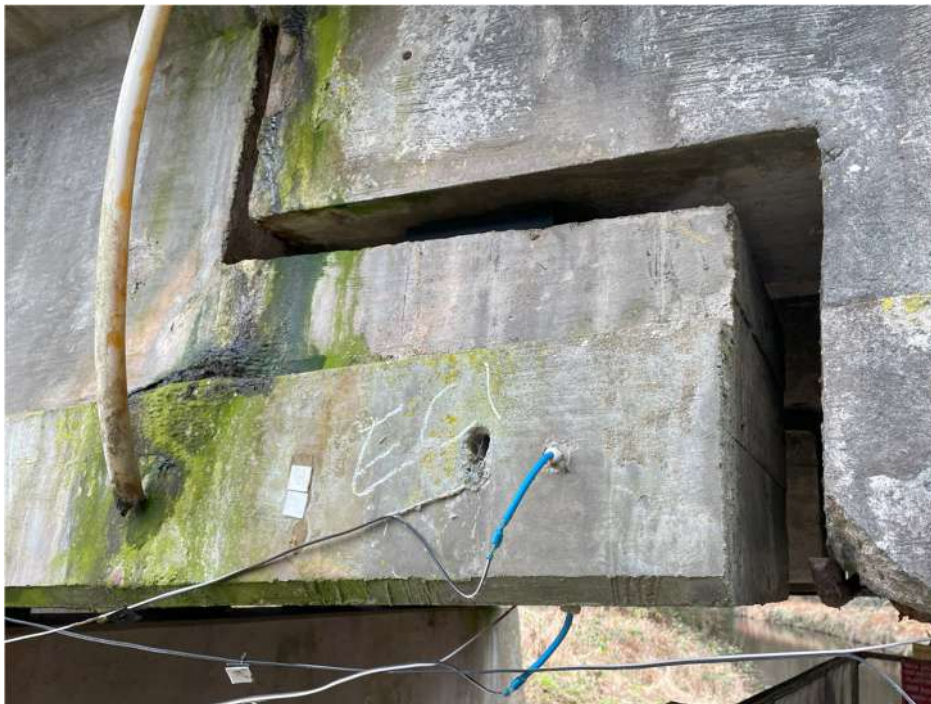
Photograph 58: Beam 1 (north facing), half joint east, water ingress with active water dripping and green mould on outside face

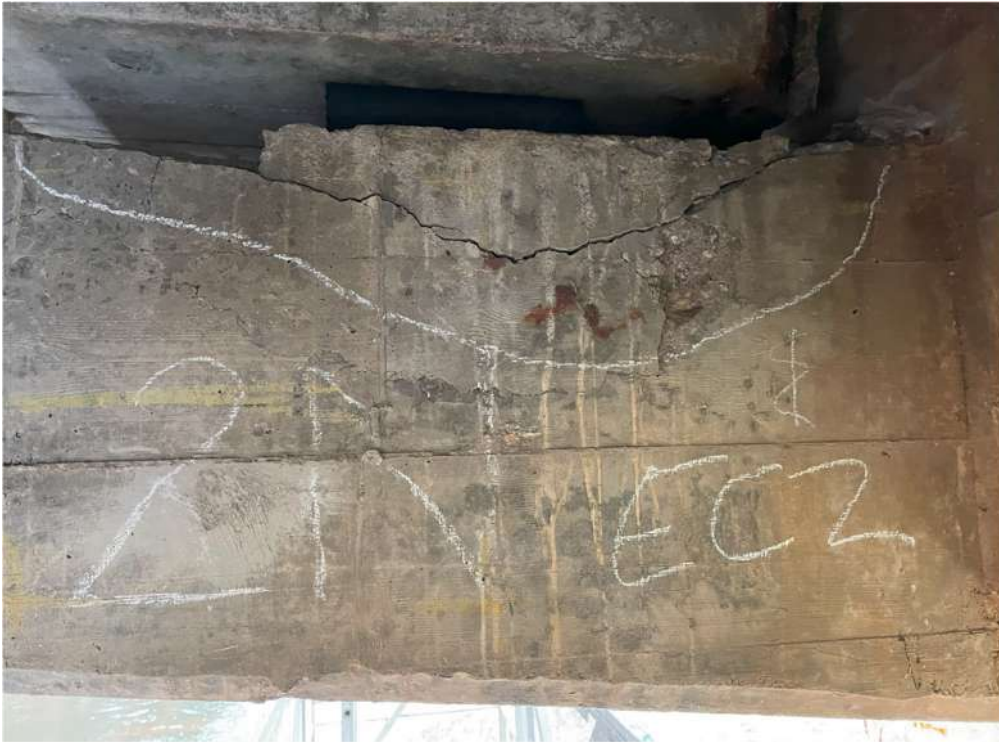
Photograph 61: Beam 2 (south facing), half joint east, spalling concrete indicated by cracking, bursting off corner

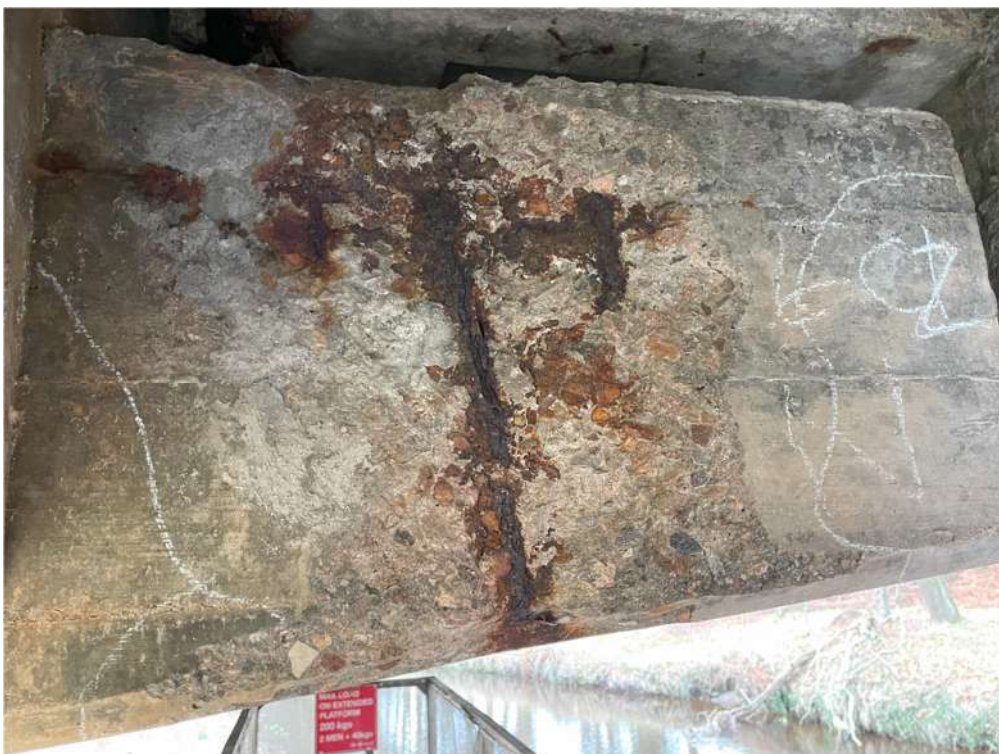
Photograph 62: Beam 2 (north facing), half joint east, exposed and severely corroded reinforcement

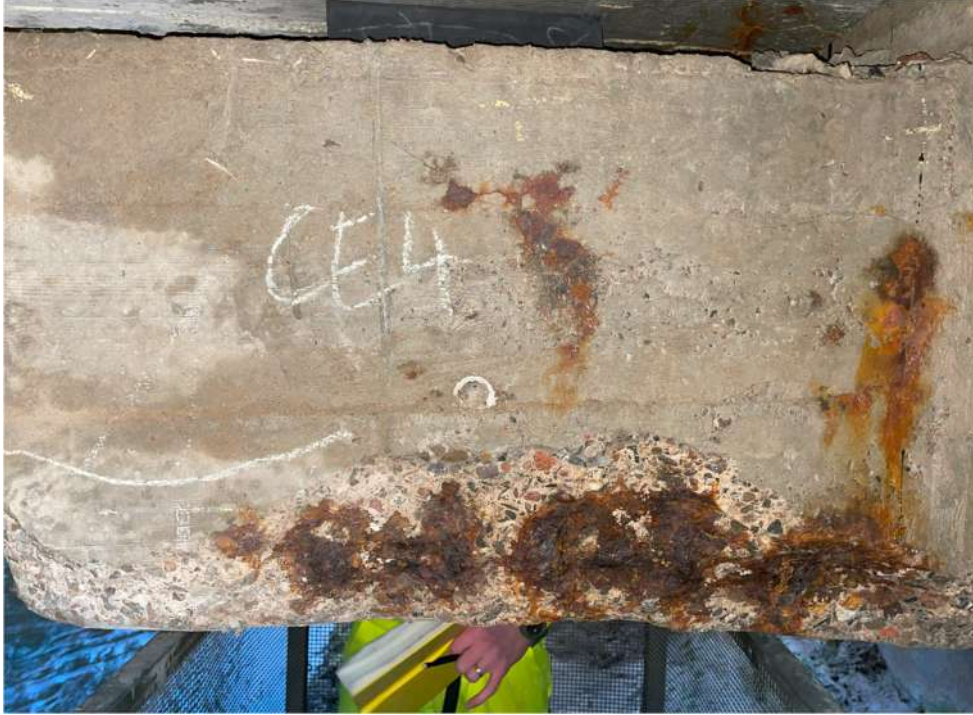
Photograph 65: Beam 4 (south facing), half joint east, spalling of bottom corner of beam, reinforcement exposed and corroded
