ARTHURS BRIDGE

Principal Inspection Report

B234M205-J-ART-STR-REP-PIR-0001

A Principal Inspection of Arthur’s Bridge was undertaken by Jacobs on the 11th February 2025. Access to the half joints, suspended and cantilever spans were obtained through the use of an underbridge unit. All elements of the structure were inspected apart from the buried foundations and waterproofing system.

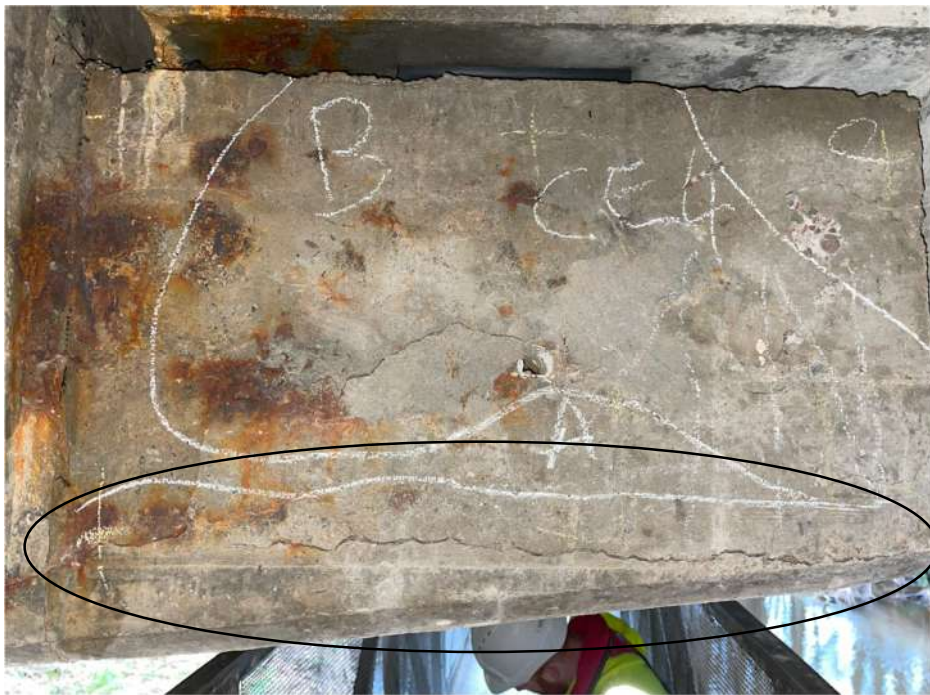
Photograph 66: Beam 4 (north facing), half joint east, spalling and cracking

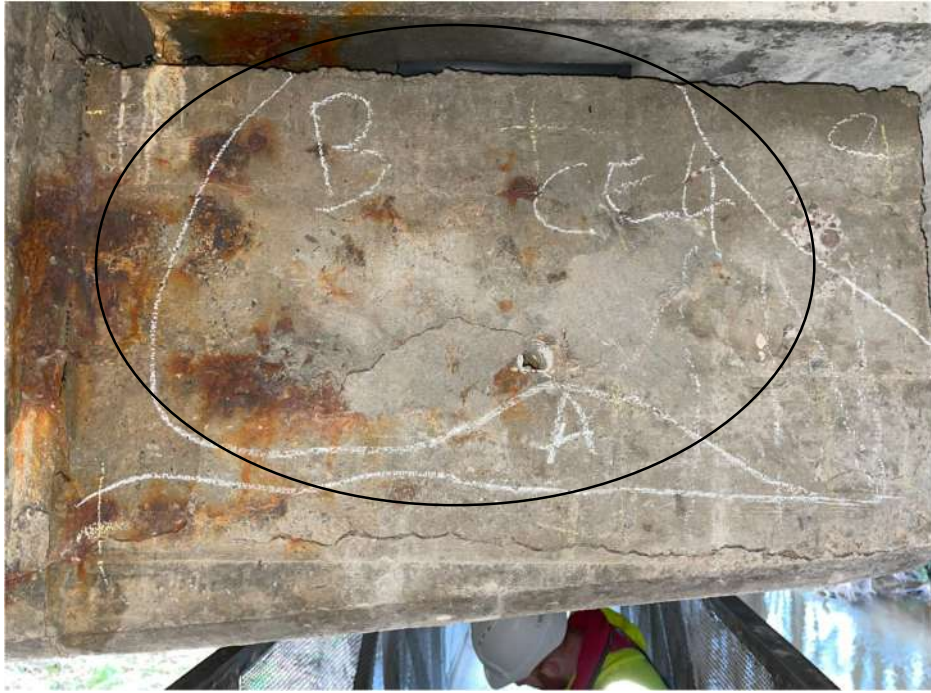
Photograph 67: Beam 4 (north facing), half joint east, delaminated face of beam

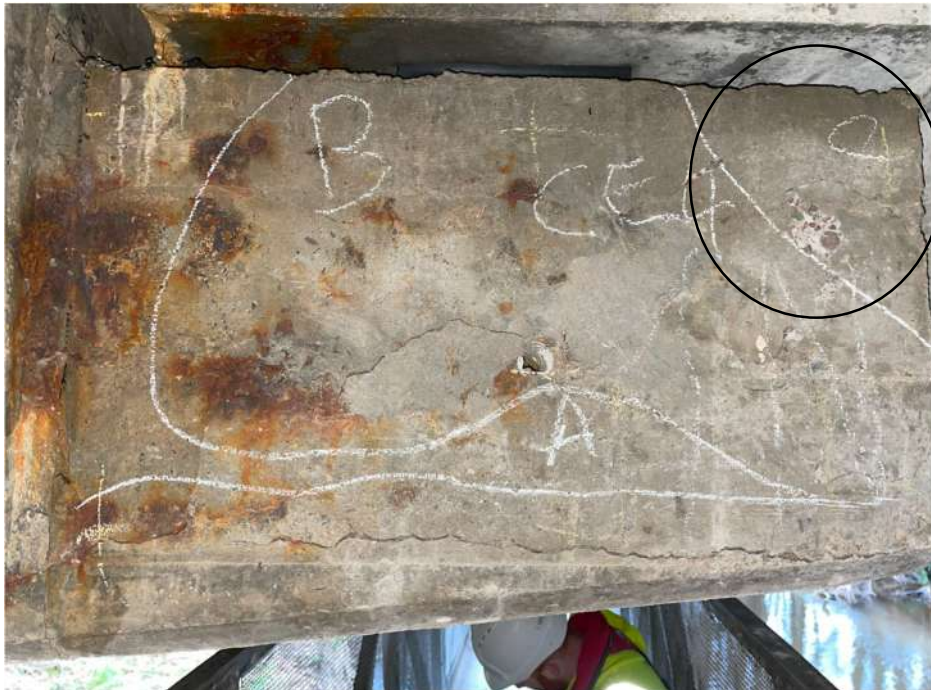
Photograph 68: Beam 4 (north facing), half joint east, cracking and spalling

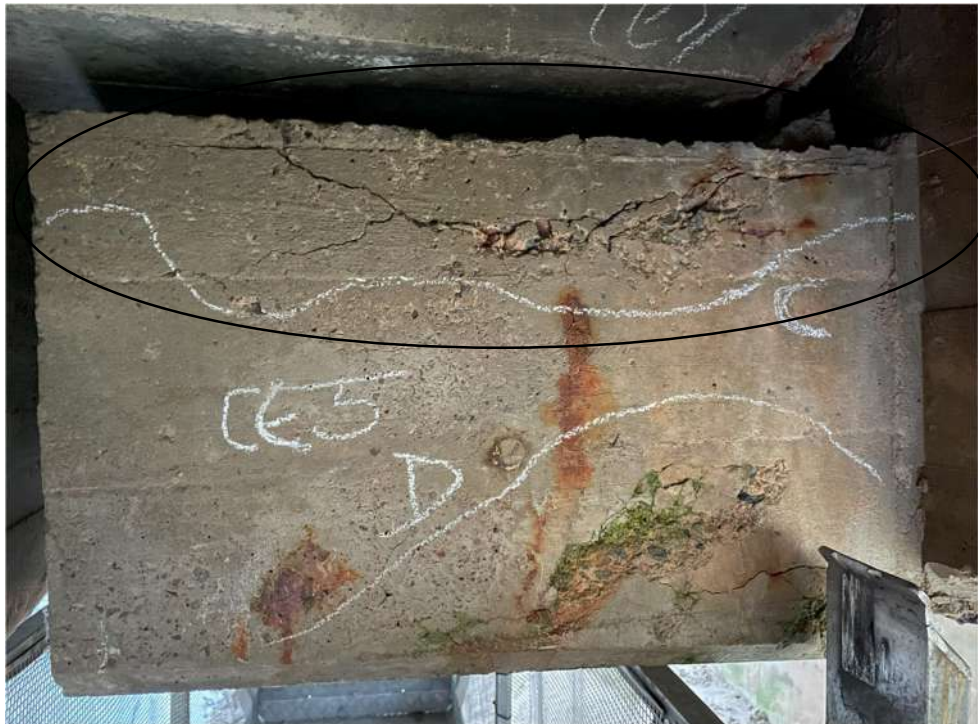
Photograph 70: Beam 5 (south facing), half joint east, crack below top edge, bursting

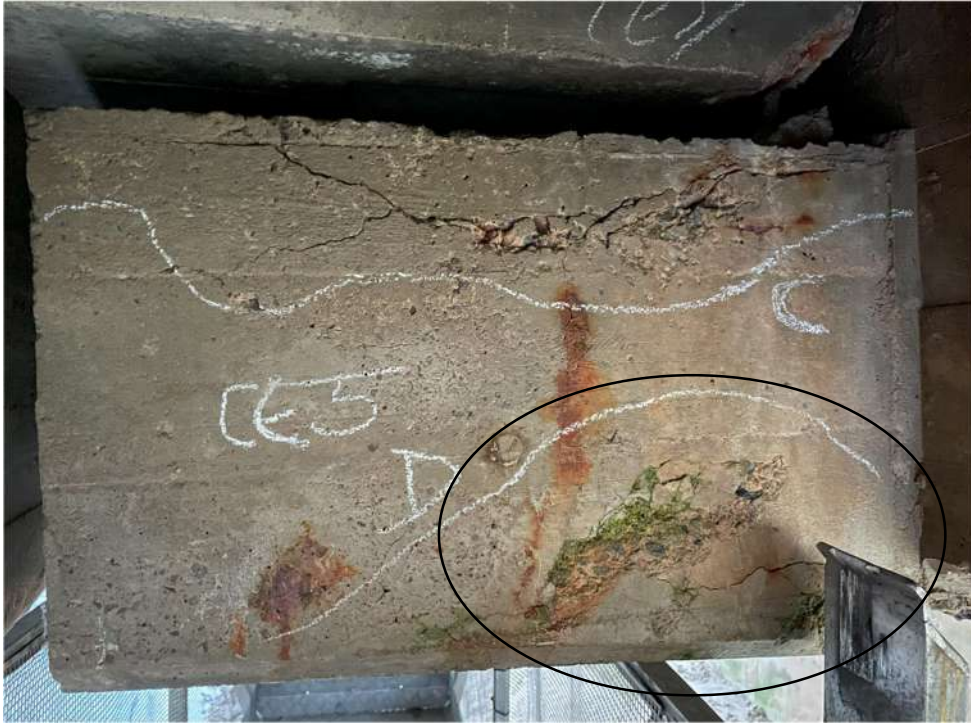
Photograph 71: Beam 5 (south facing), half joint east, spalling with cracking present

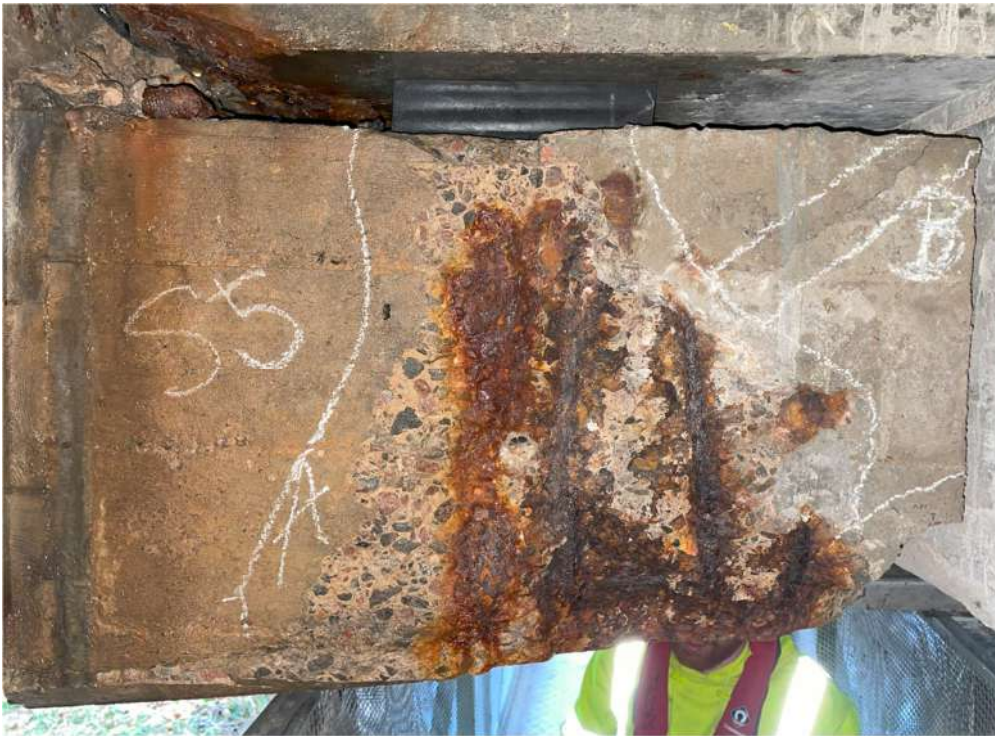
Photograph 72: Beam 5 (north facing), half joint east, significant spalling with exposed and corroded reinforcement

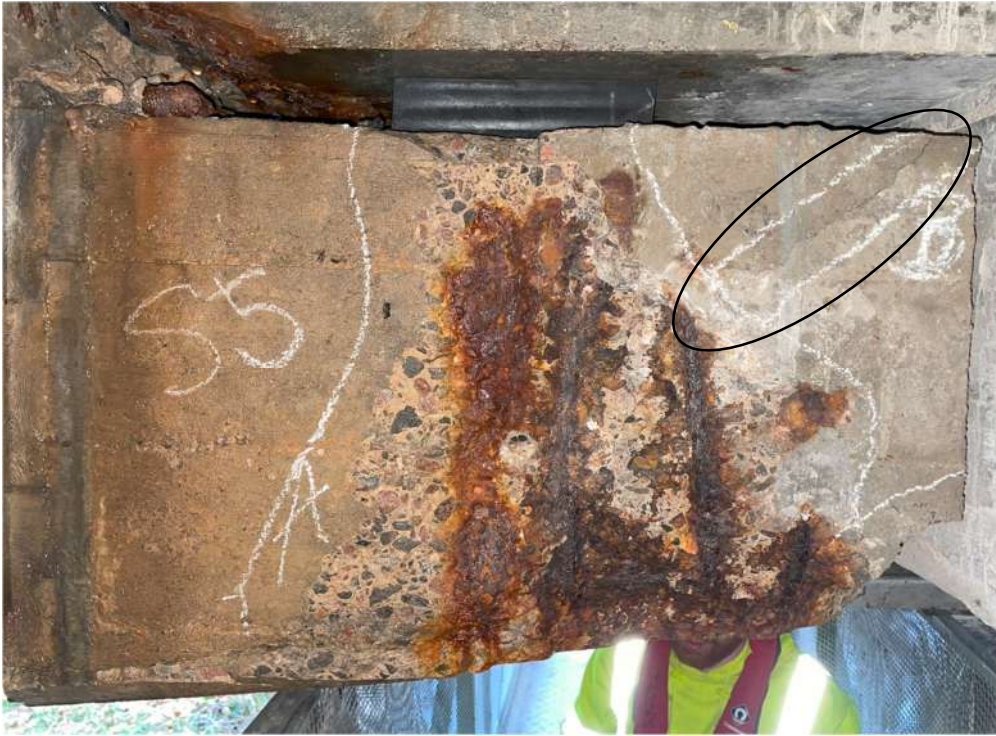
Photograph 73: Beam 5 (north facing), half joint east, crack running from spalled area to top corner

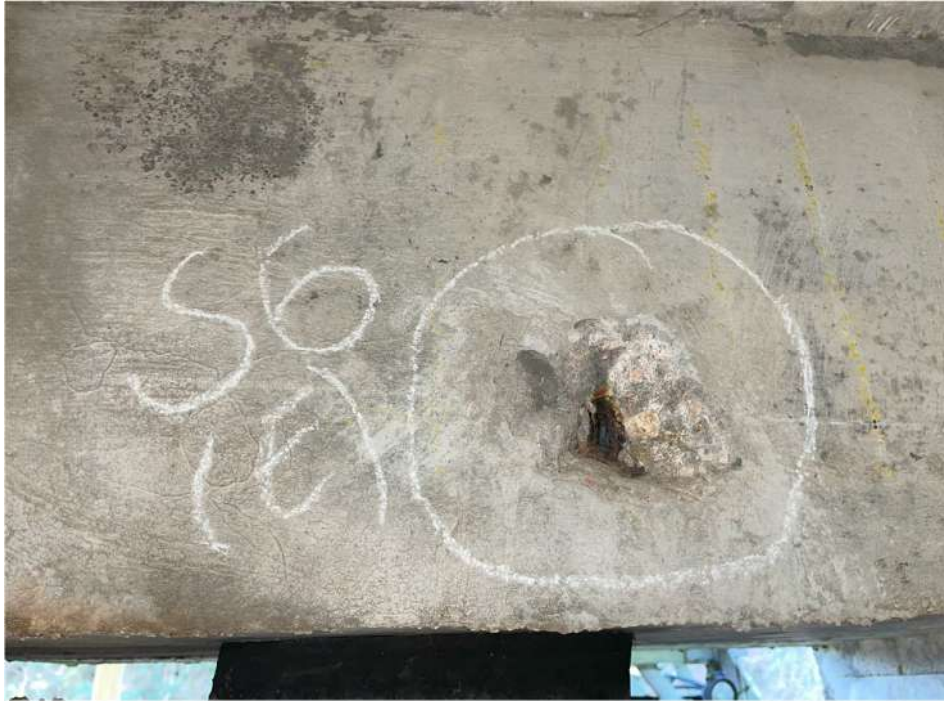
Photograph 75: Beam 6 (north facing), half joint east, isolated deep spall

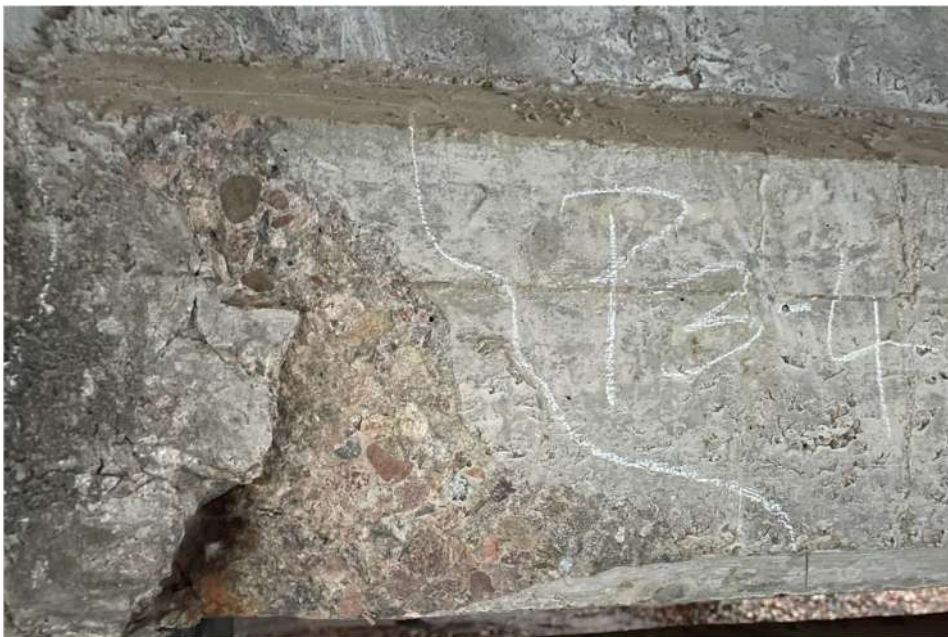
Photograph 78: Beam 3 – Beam 4, west pier, east face, spalled concrete with cracks extending from spall

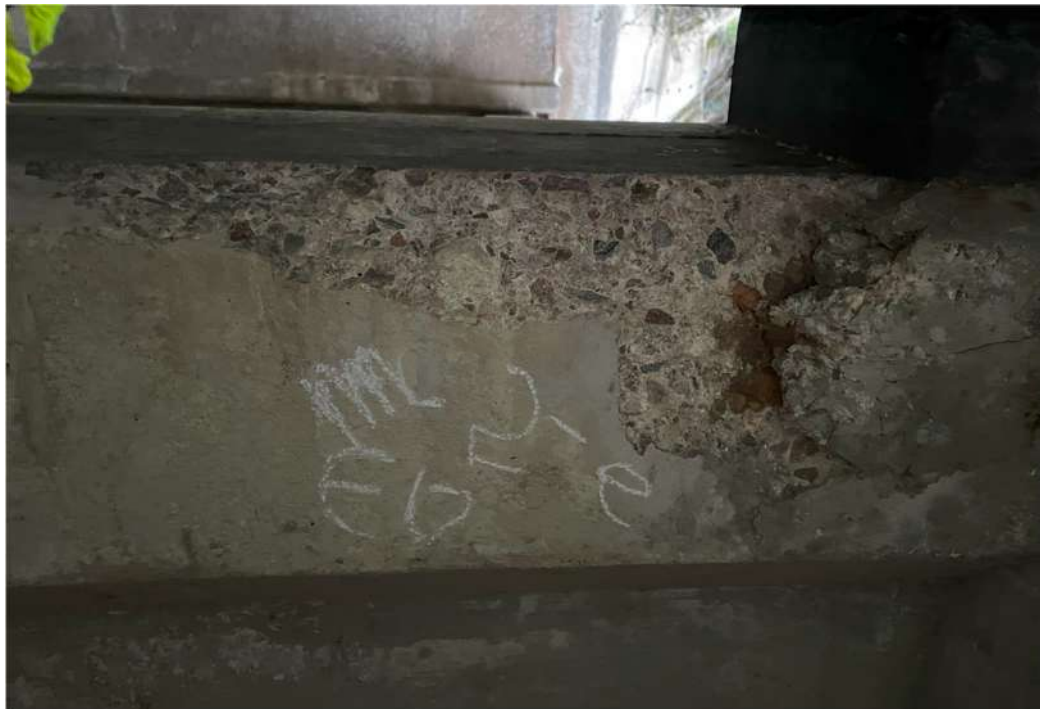
Photograph 80: Beam 5 – Beam 6, east pier, west face, concrete spalling with staining

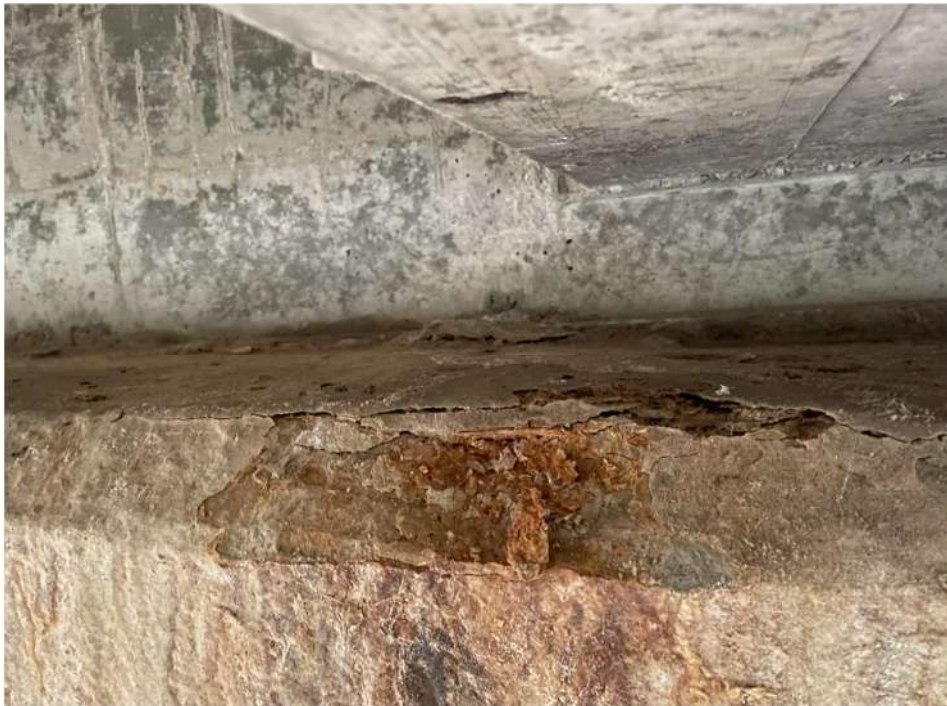
Photograph 82: Top of abutment, west abutment, delamination of top of abutment

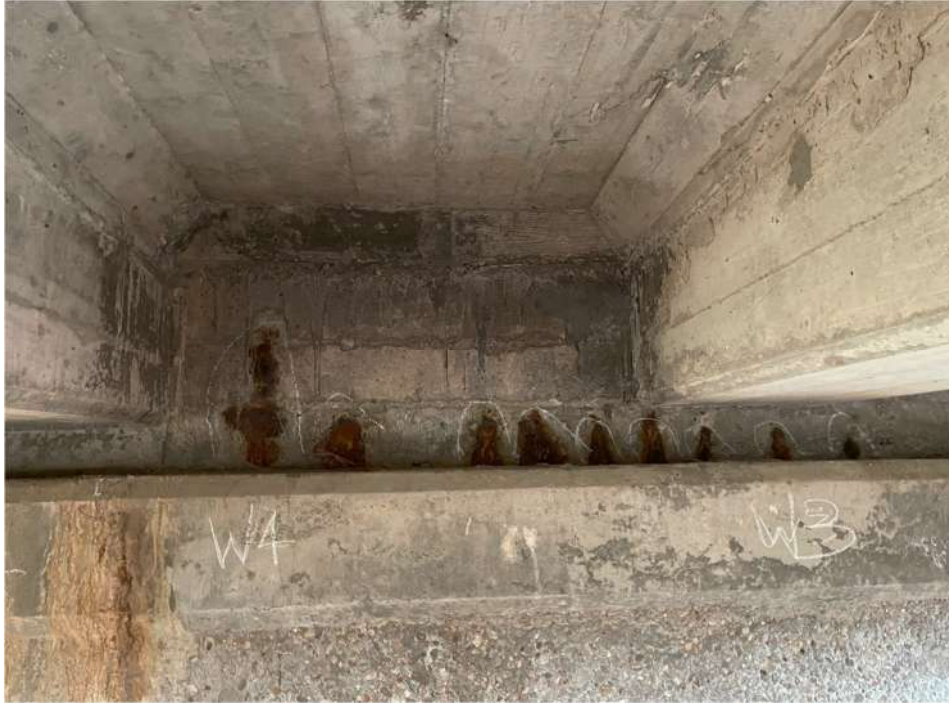
Photograph 83: Back face of abutment between beams, west abutment, delamination and general corrosion stains between beams, multiple spots
