## GRANT LODGE, ELGIN FABRIC INSPECTION REPORT

AUGUST 2012

Address of Property:	Grant Lodge, Elgin
Date of Inspection:	21 <sup>st</sup> August 2012
Weather Conditions at Time of Inspection:	Dry and bright
Inspection Carried Out By:	Pinny Neill, Architect and Ian Fraser, Associate, LDN Architects llp, 29 St Leonards Road, Forres IV36 1EN

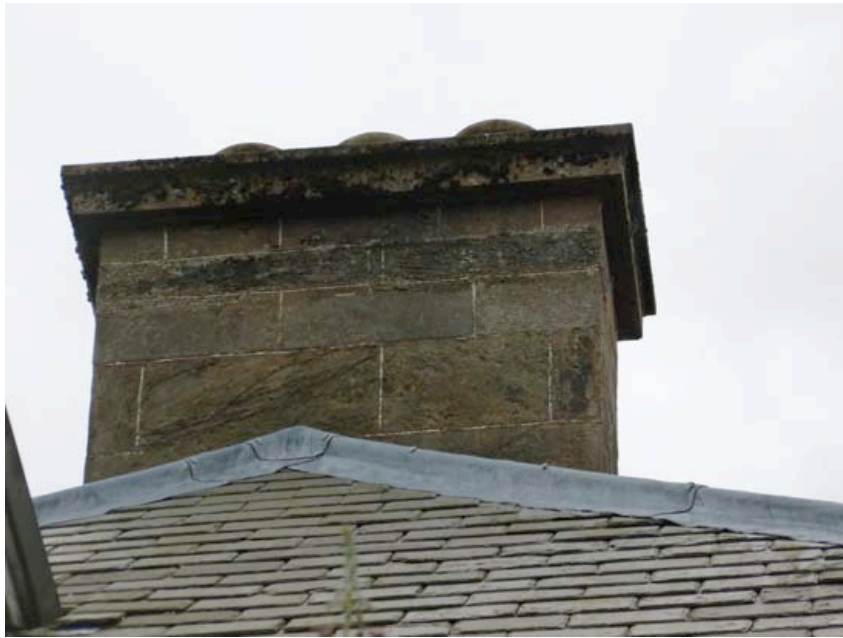
*Photograph 001: Fixings for the lead ridges penetrate the lead sheet. These have been clad with lead cover pieces, which have lifted. Fixing through the lead weakens the sheet and may also be a source of water ingress.*

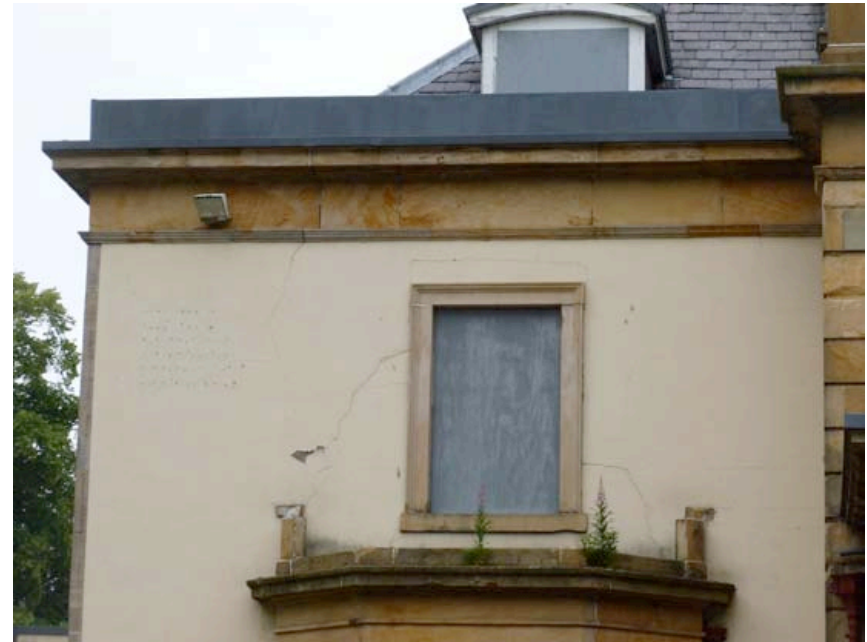
*Photograph 002: The parapet walls have been clad in sarnafil.*

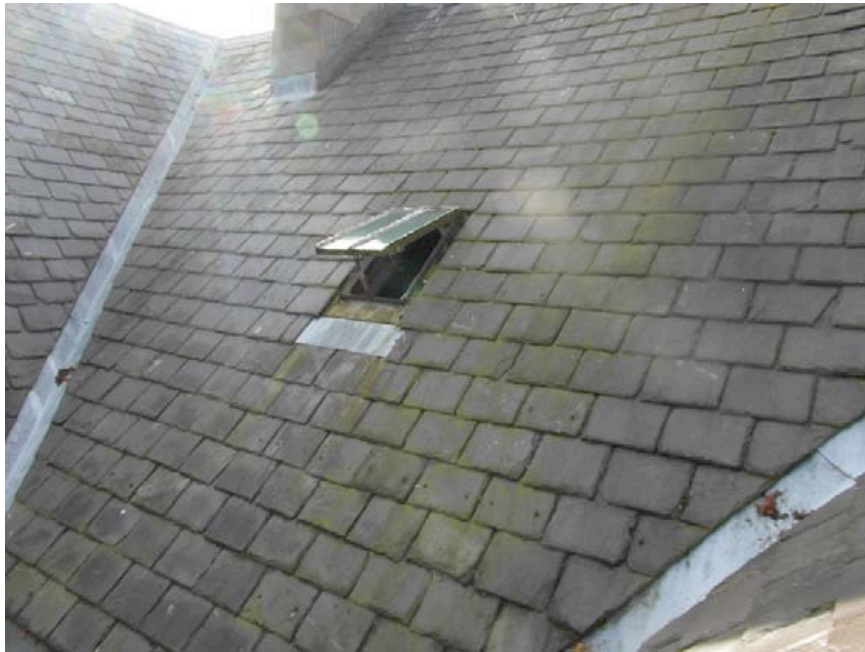
*Photograph 003: The lead valleys have begun to show signs of erosion and creeping.*

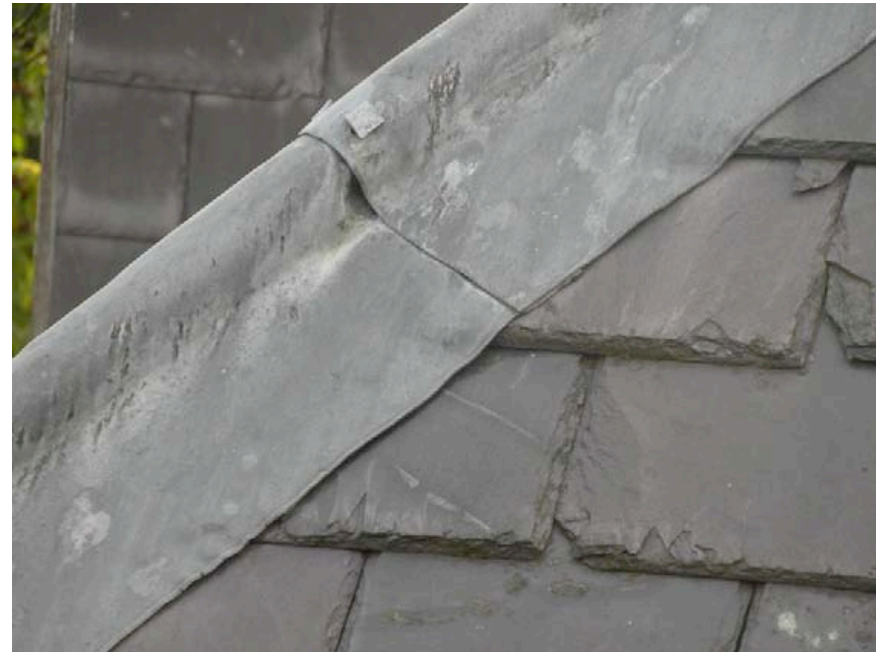
*Photograph 004: The lead hips are showing signs of fatigue, and as noted in the photograph above, the fixings penetrate the sheet.*

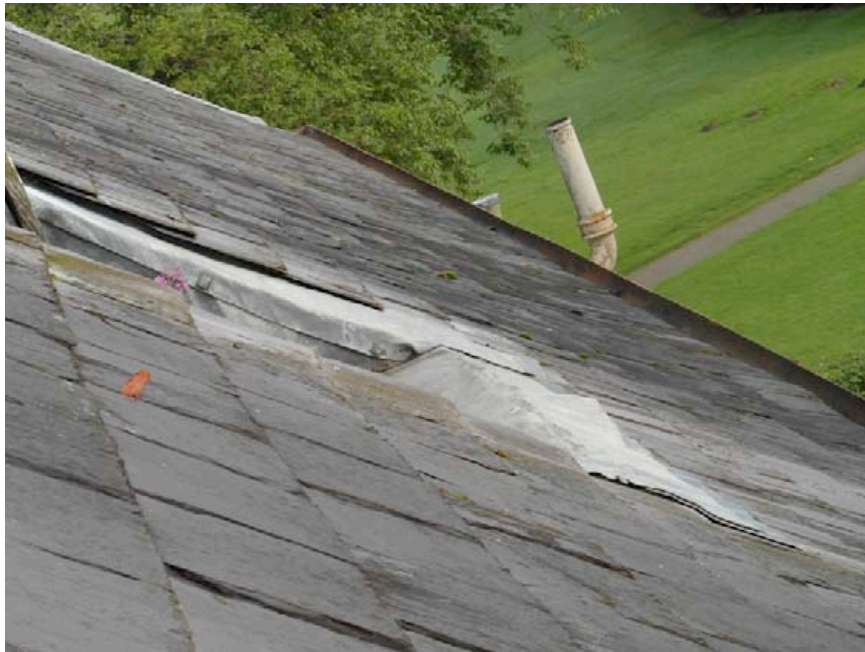
*Photograph 005: An additional piece of lead has been fitted over the existing lead aprons to the dormers. The additional piece of lead has been subjected to wind lift and is showing signs of fatigue.*

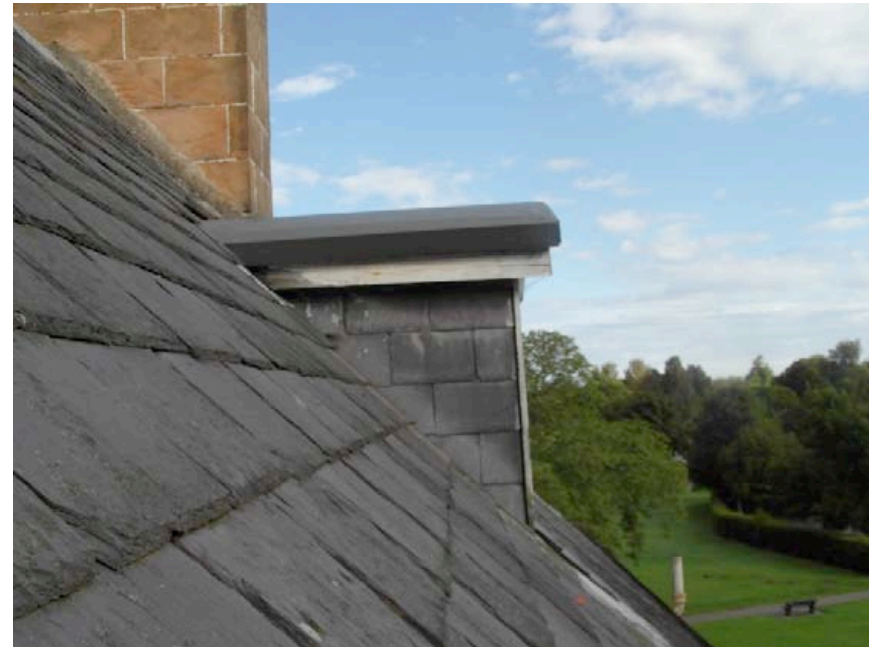
*Photograph 006: At the lead apron to the chimneys there is a considerable amount of mortar running along the raggle, in which the lead is turned into, it appears that this has begun to have a corrosive effect on the lead flashing.*

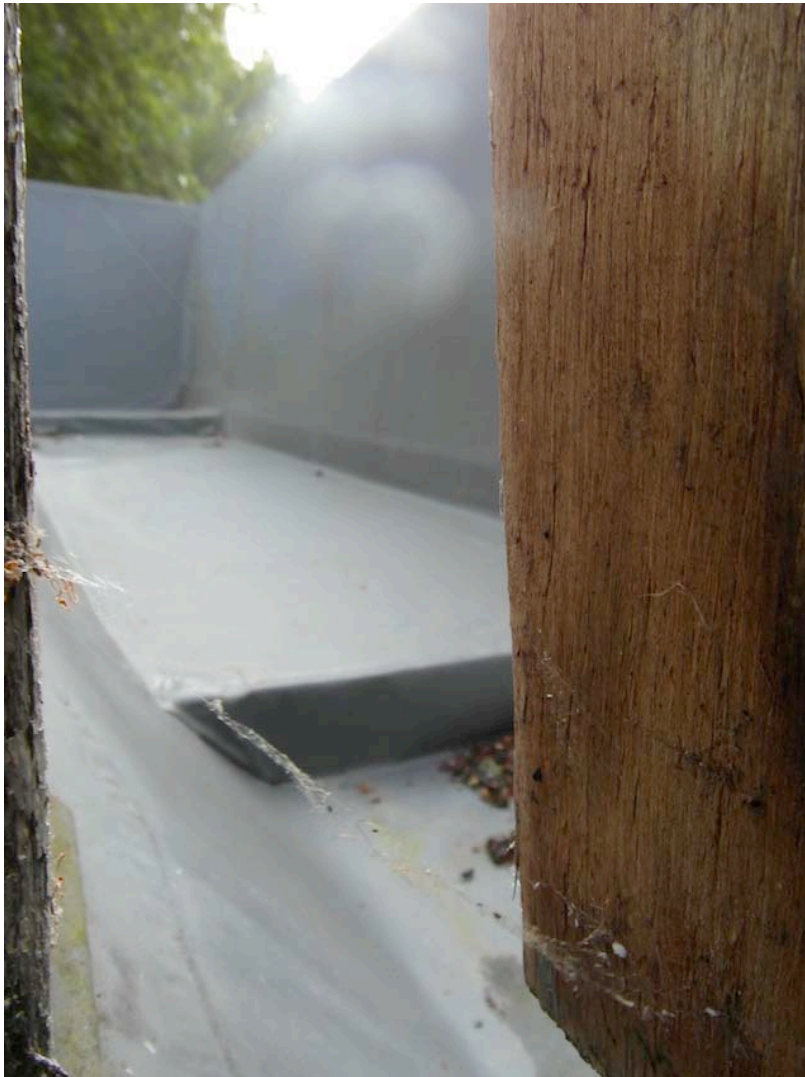
*Photograph 007: The perimeter parapet gutter has been clad in sarnafil.*

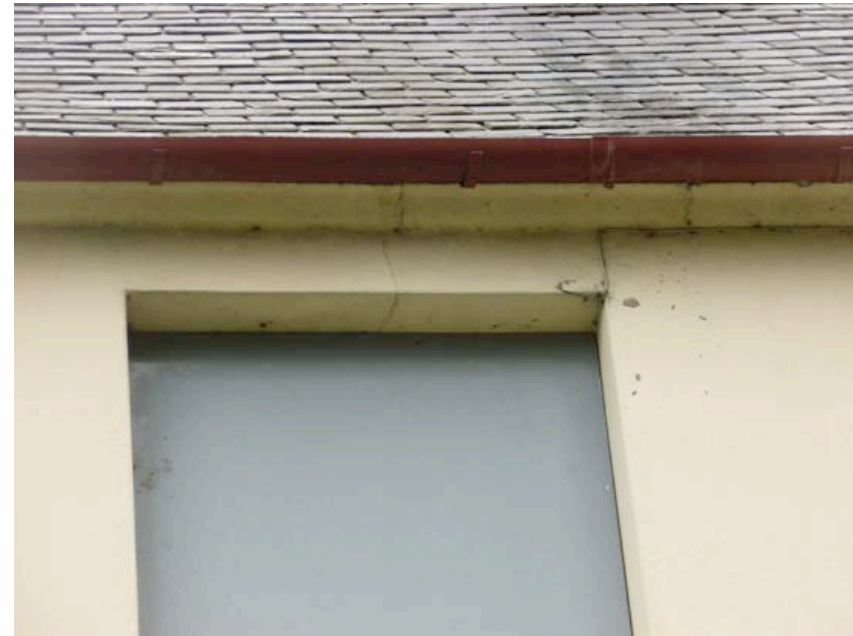
*Photograph 008: The existing half round cast iron gutter has been primed in red oxide. There is a build up of debris within the guttering.*

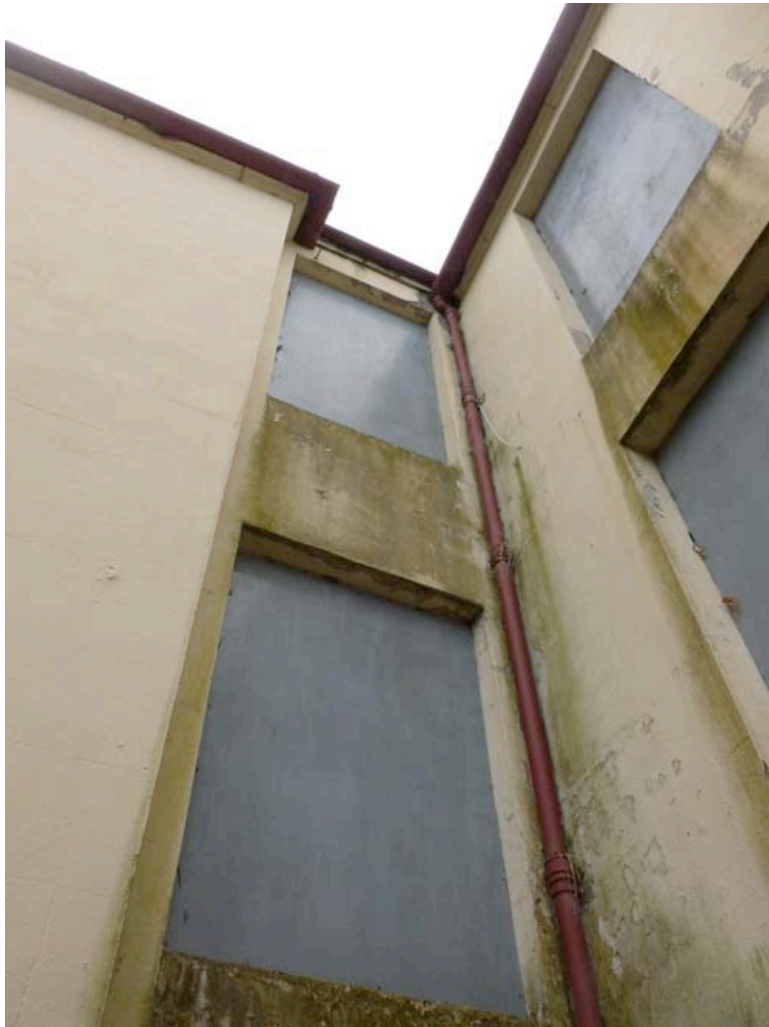
*Photograph 009: The existing downpipes have been painted in red oxide. The downpipe, shown above, has been blocked by vegetation, which has in turn caused a build up of water in this location.*

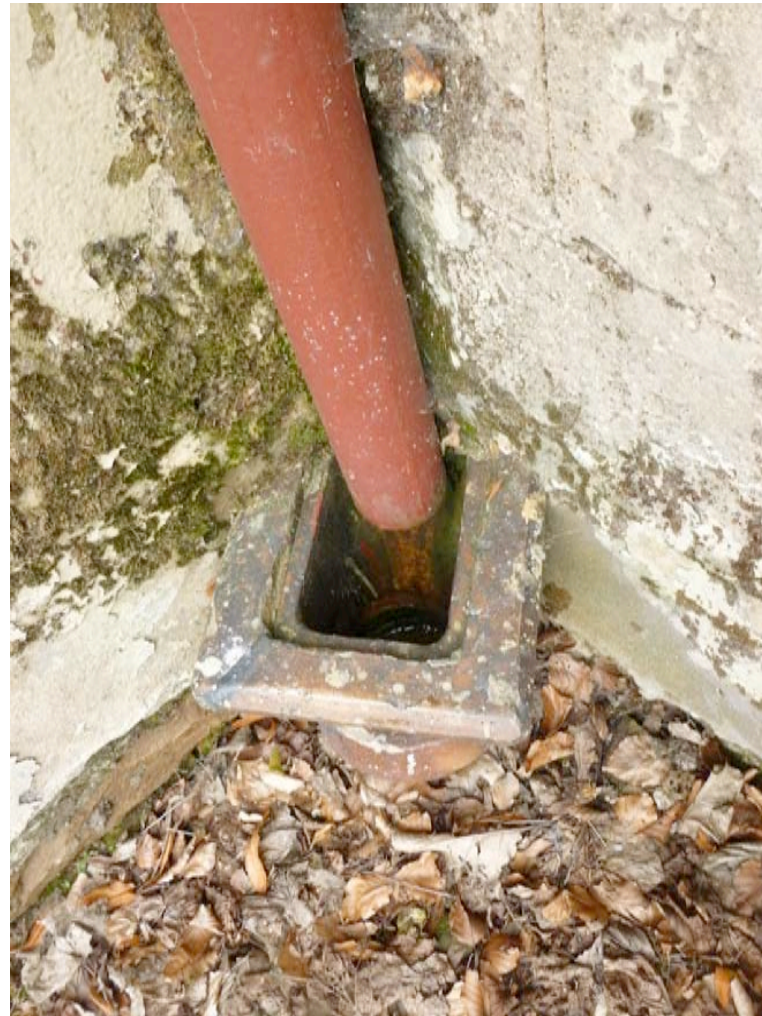
*Photograph 010: The gully arrangement to the base of some pipes is unsatisfactory. It varies between pipes disappearing into the ground, to visible open gulleys, some of which are broken.*

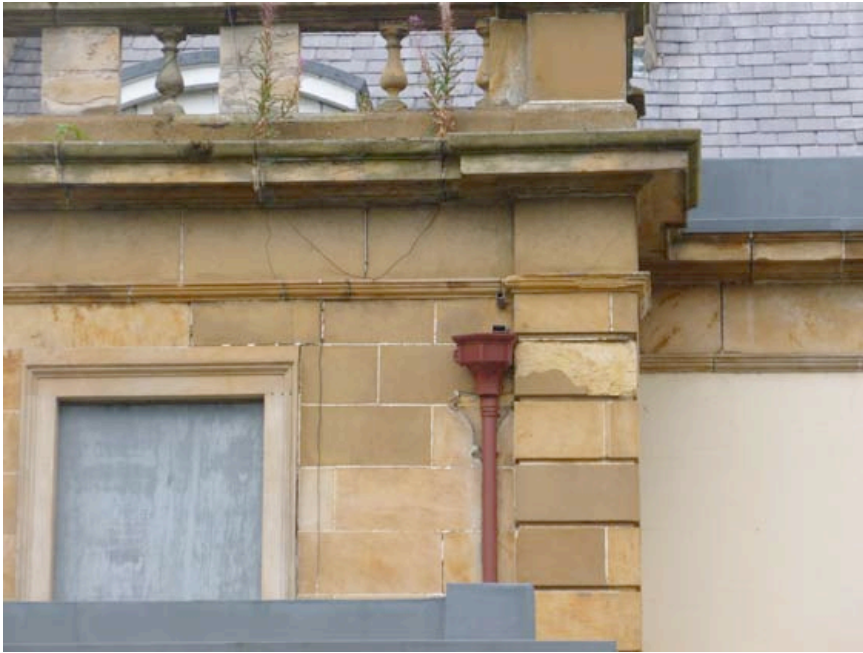
*Photograph 011: The cast iron hopper heads have also been primed in red oxide and are fitted to the downpipes on the front elevation. The photograph above shows that the hoppers have been moved up by one length.*

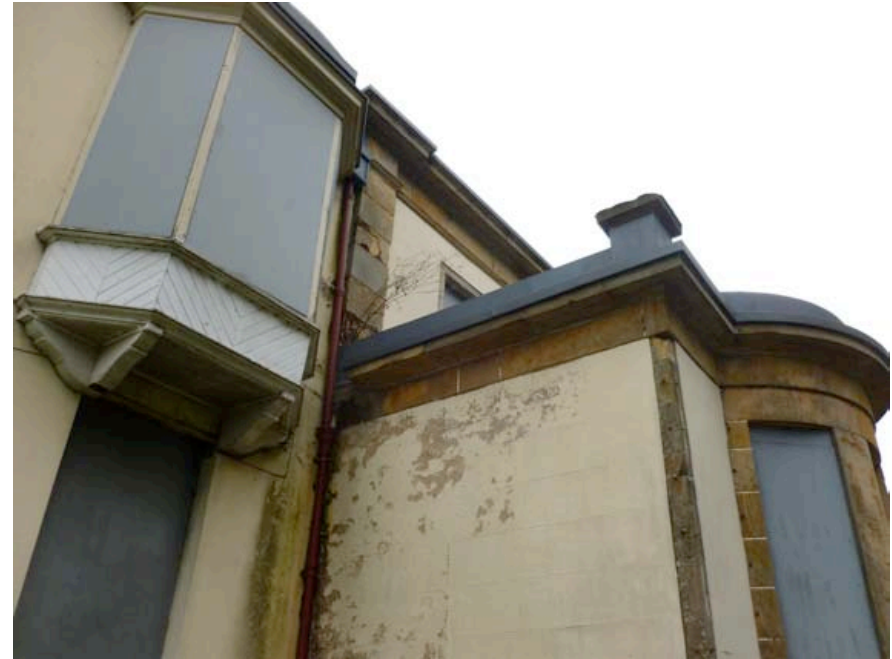
*Photograph 012: An satisfactory hopper head, clad in samafil, has been formed on the east elevation. The staining on the face of the elevation indicates that there is a blockage.*

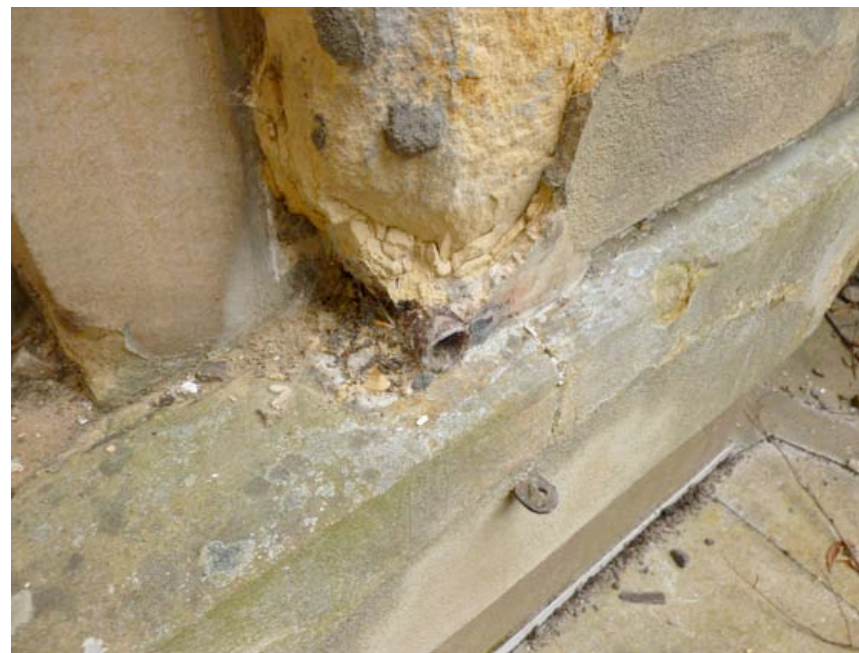
*Photograph 014: There are numerous ferrous fixings/ pipes located in the walls around the building that are causing damage to the stonework.*

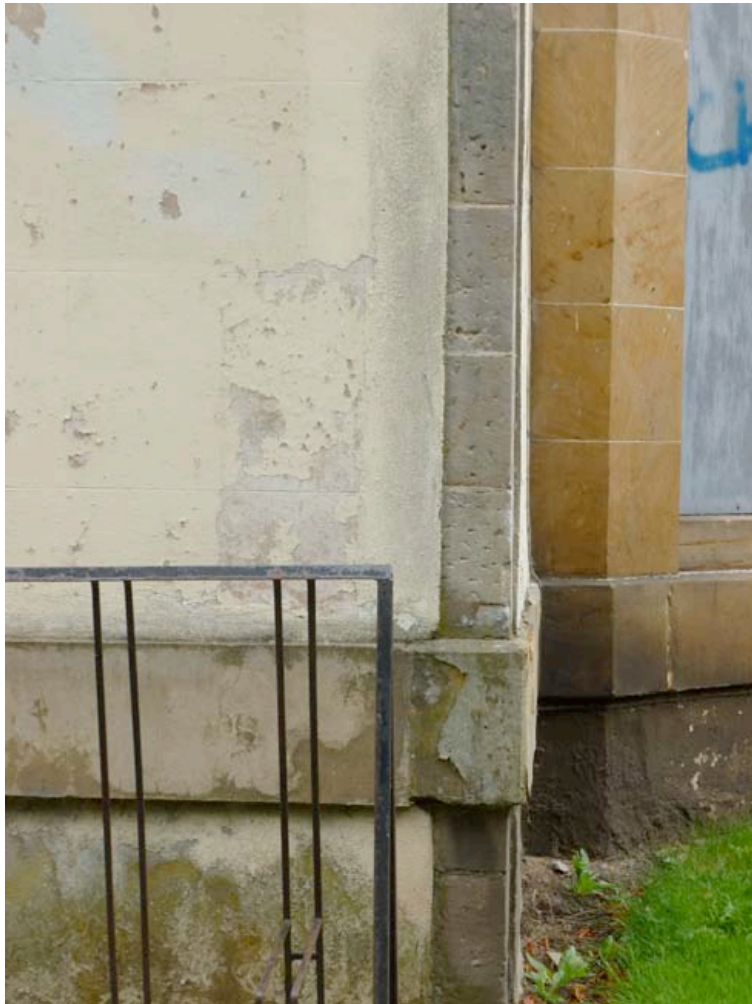
*Photograph 015: The corner quoin stones have been left exposed and they have been dressed (stugged finish). The tooling may indicate an intention at some stage to carry the render over the margin stones. Some cement repairs have been made to the quoin stones.*

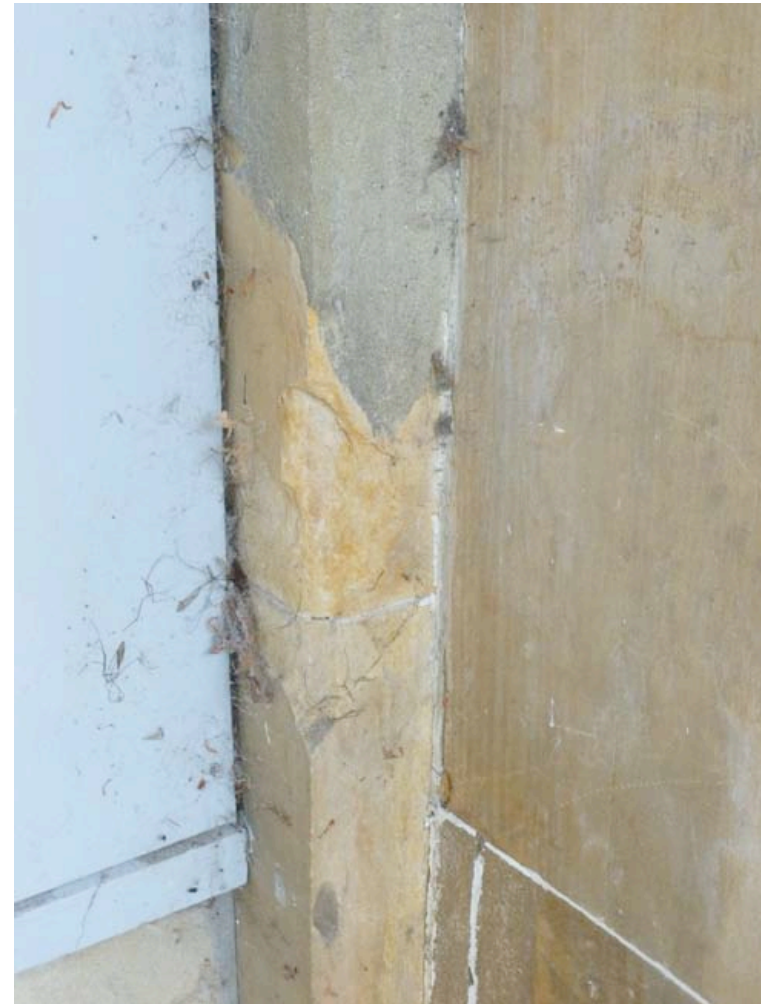
*Photograph 016: The rebats for some of the windows and doors have been left exposed. Cement repairs have been made in an attempt to repair the delamination.*

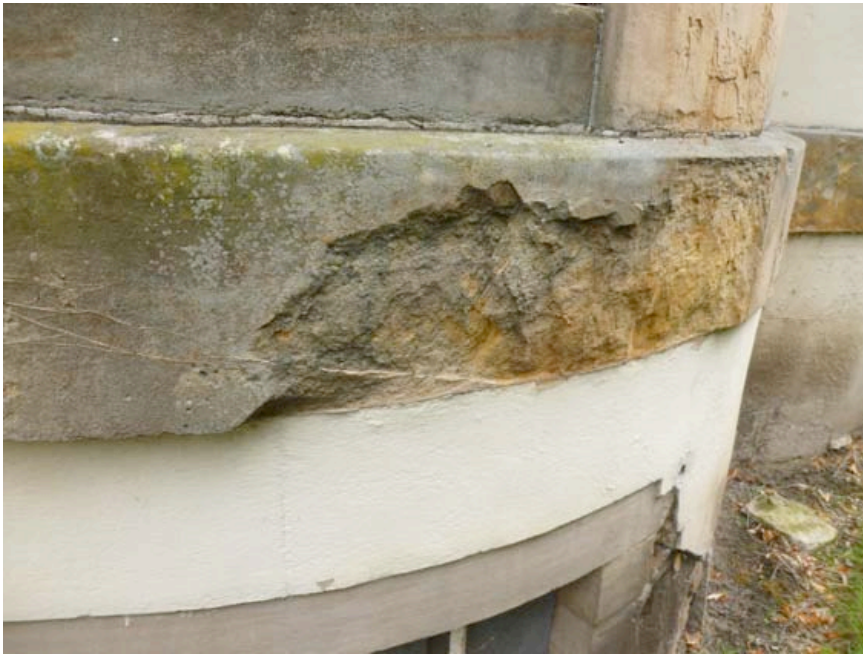
*Photograph 017: There are significant areas of delamination to the exposed ashlar base course.*

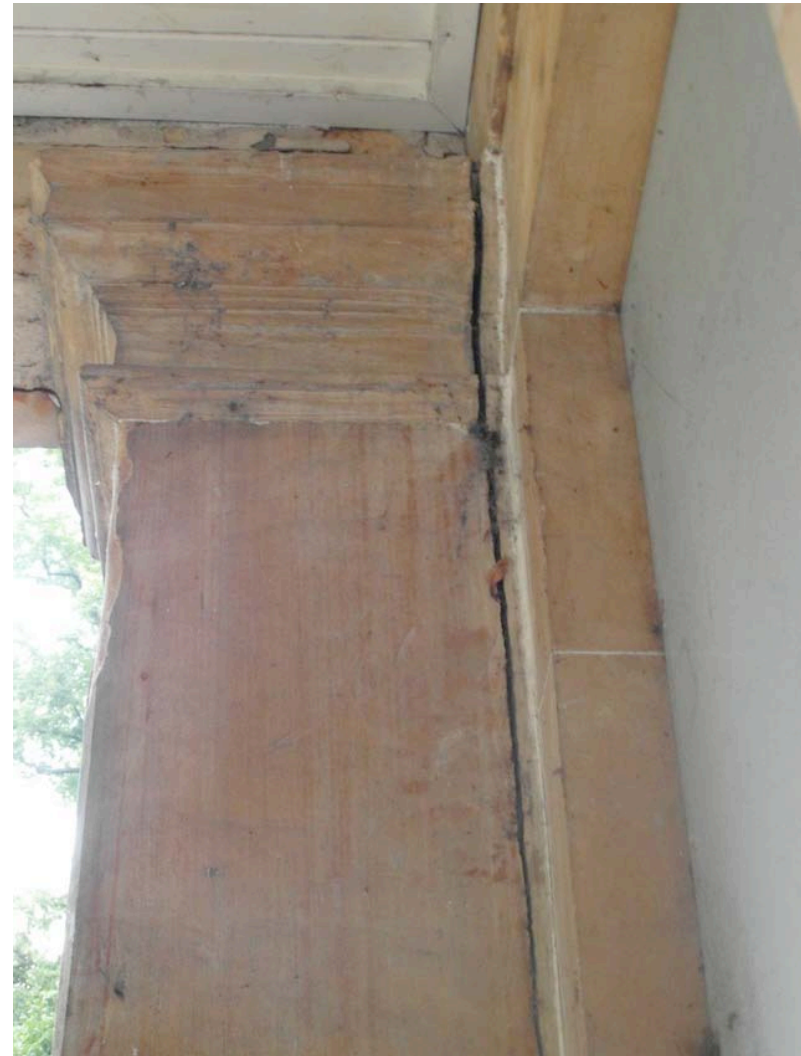
*Photograph 018: Noticeable movement has occurred between the portico and the main front wall of the building.*

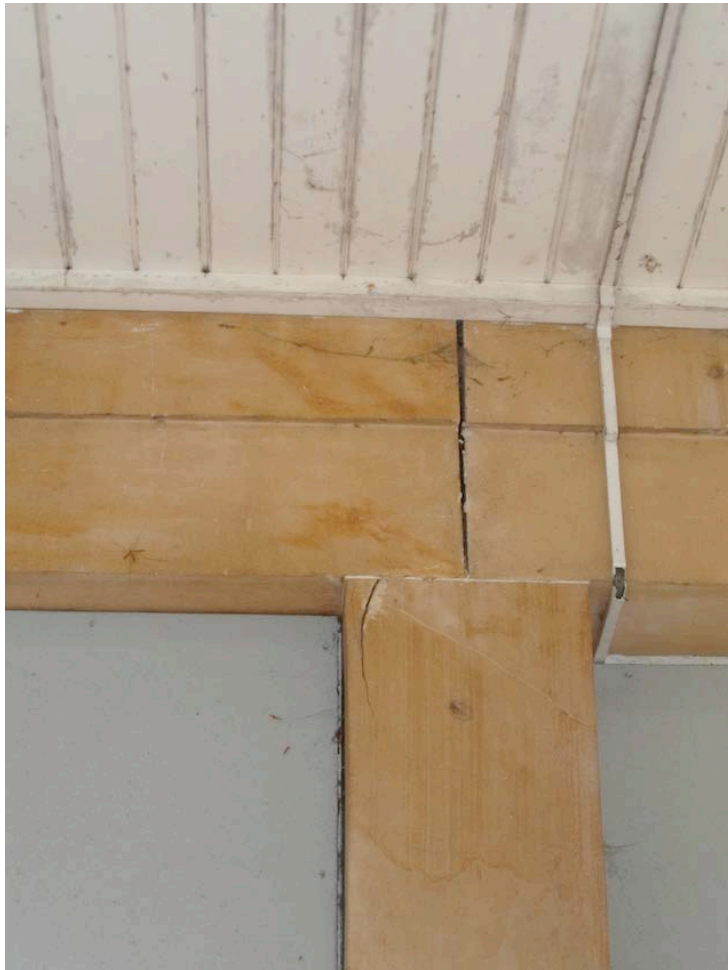
*Photograph 019: The joint between the high level lintel on the porch structure has opened up which is a result of the movement in the two corner columns.*

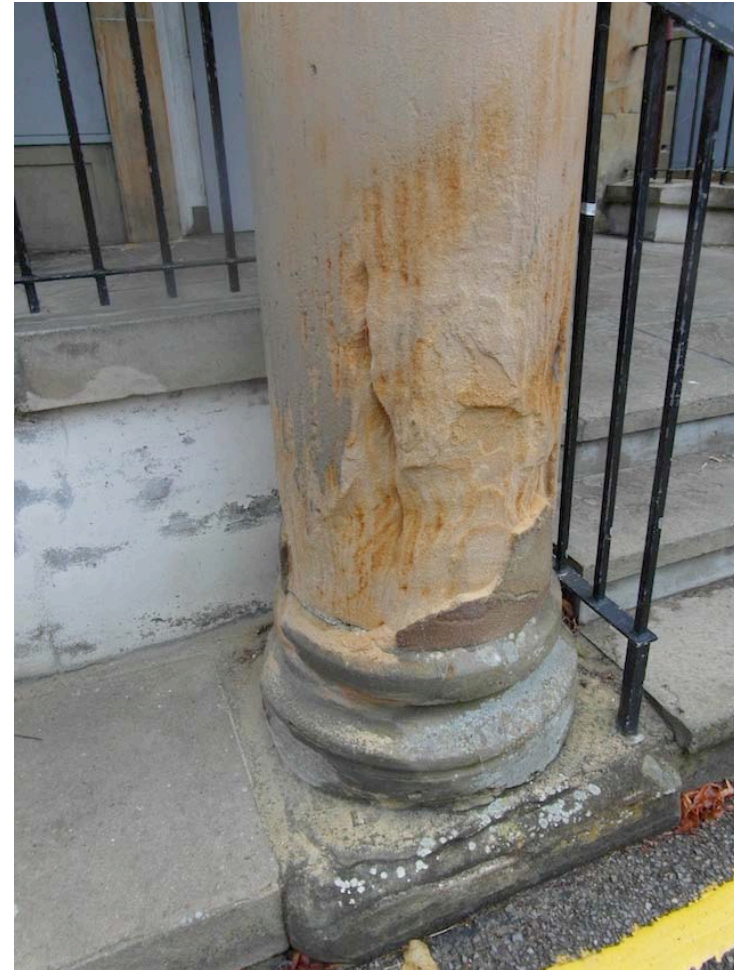
*Photograph 020: The splitting and delamination to the stonework appears to have been counteracted by the application of a slurry wash in places.*

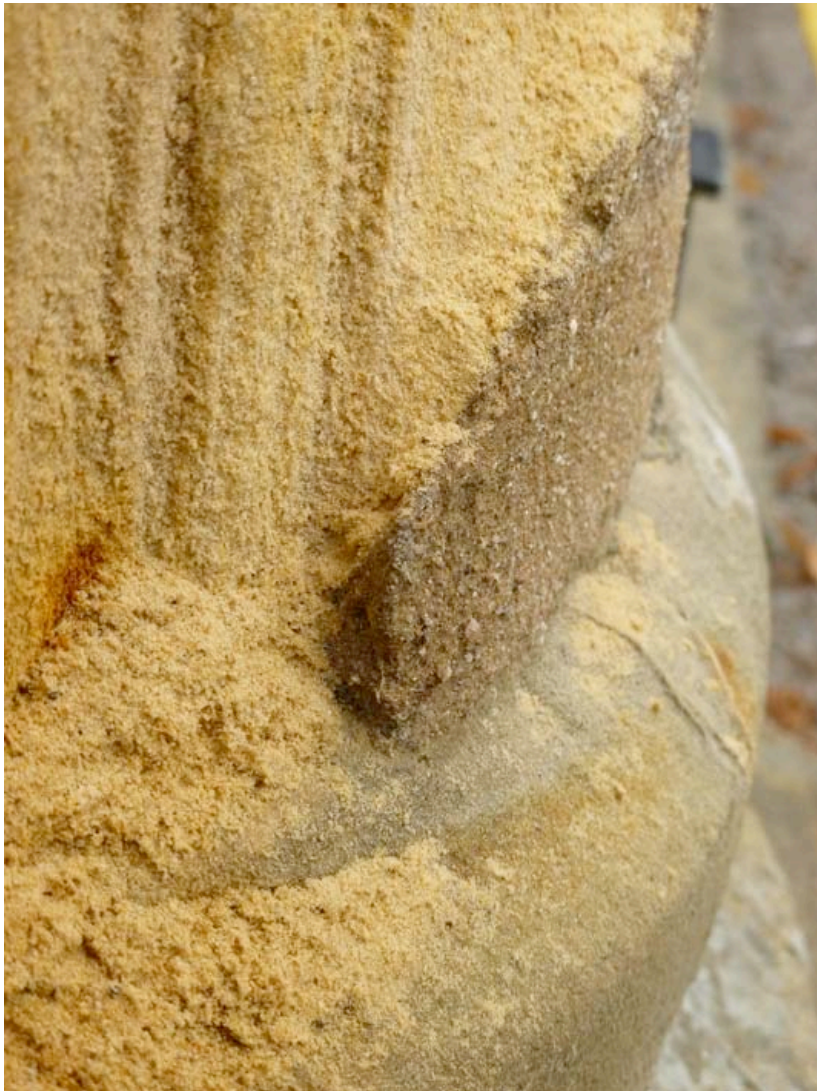
*Photograph 021: The delamination of the stonework is considerable at the base of the pilasters.*

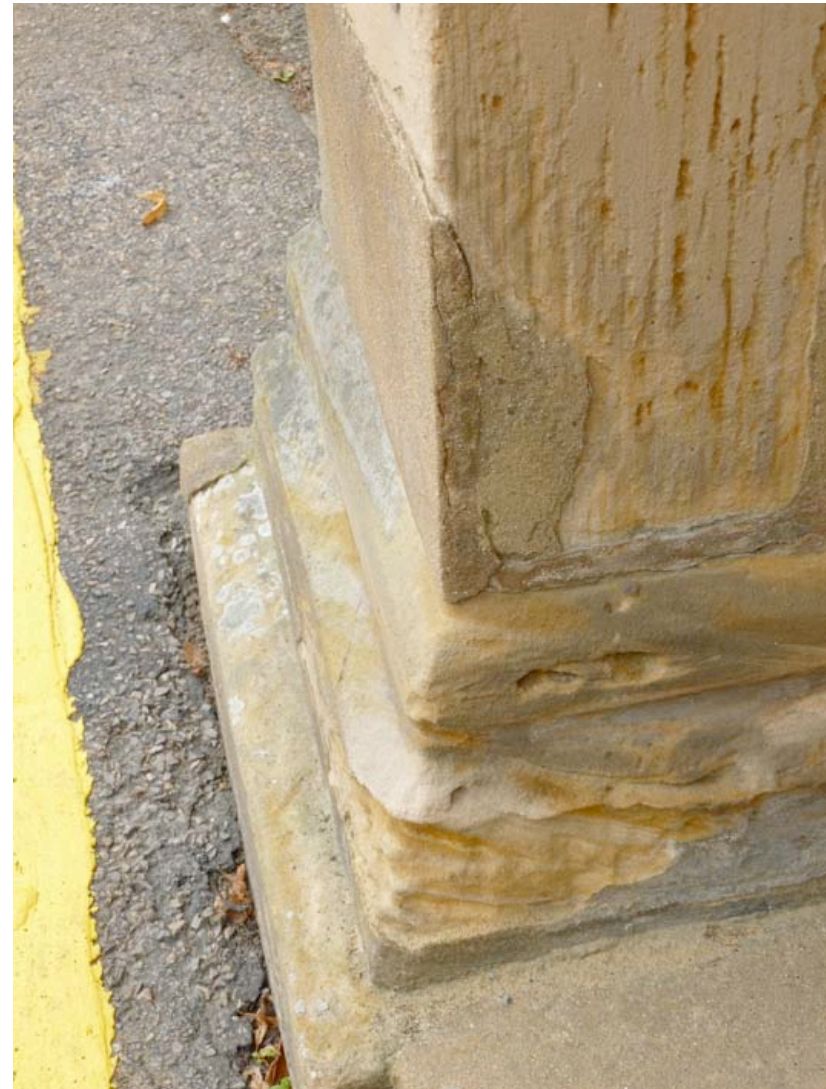
*Photograph 022: Plastic repairs have been applied to the base of the column to counteract the delamination.*

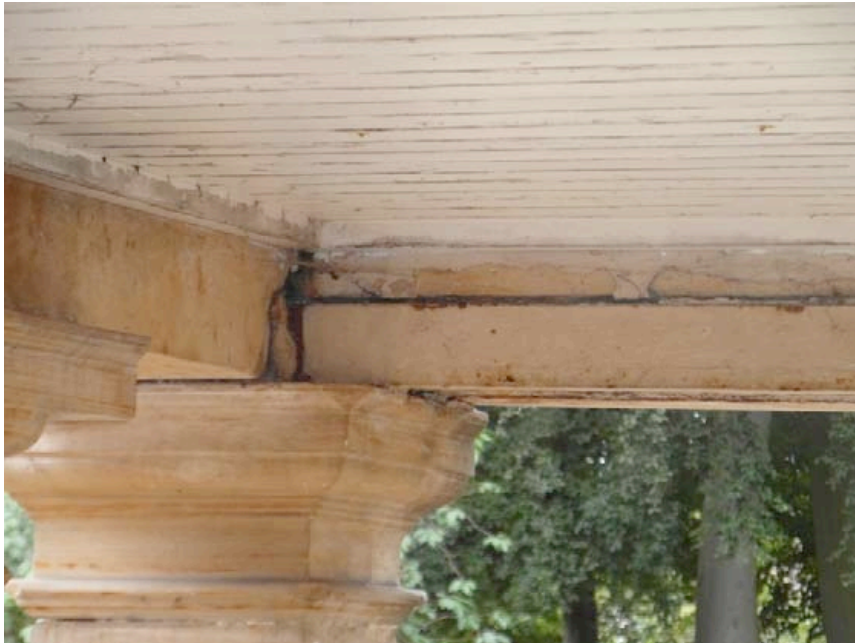
*Photograph 023: The edge beams to either side of the porte-cochere have, in the past, had cast iron channels inserted for additional support. These channels are showing signs of erosion.*

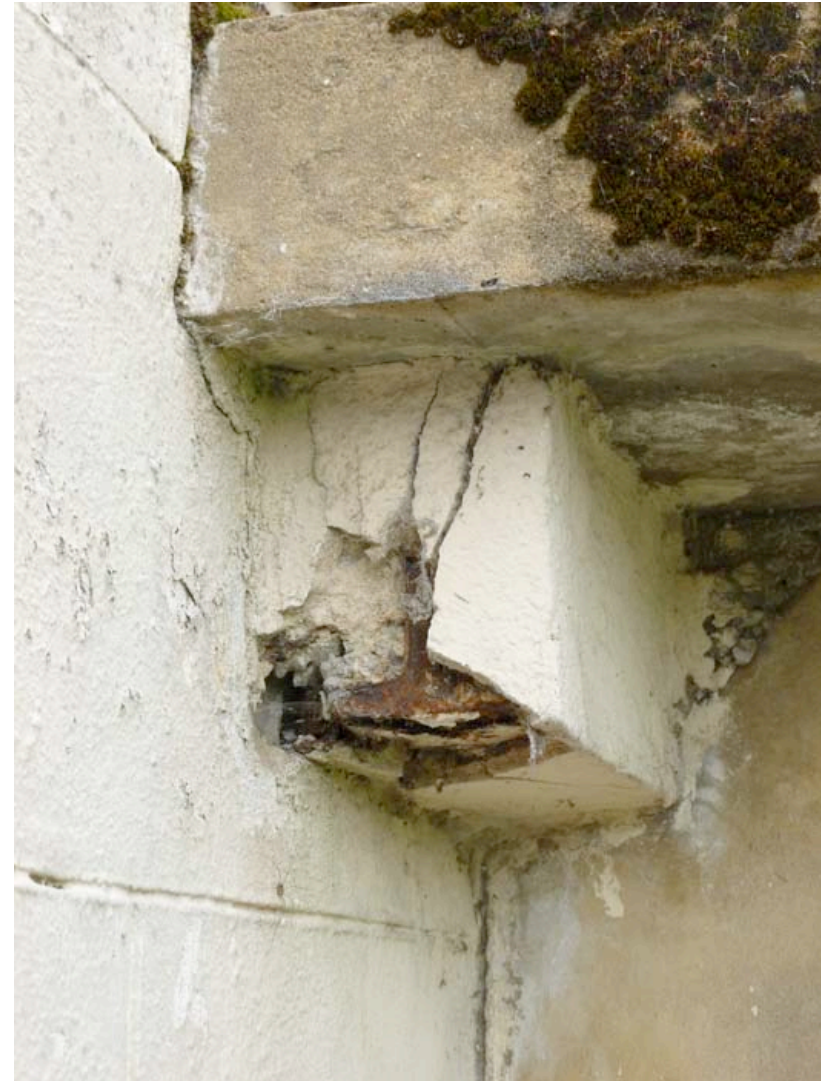
*Photograph 024: The I beam supporting the external concrete landing, on the north elevation, is badly corroded.*

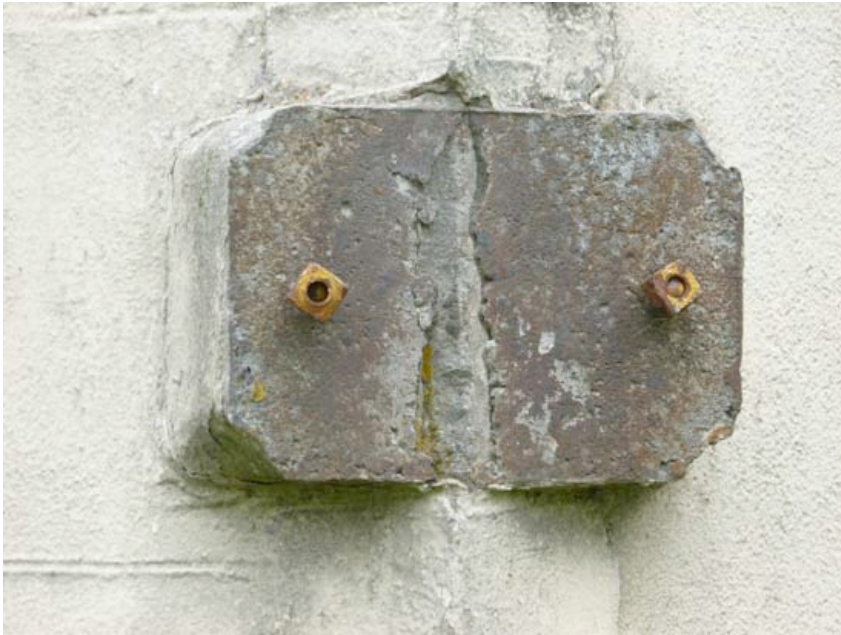
*Photograph 025: In the southwest corner of the building exists a small concrete angled pad stone with bolts cast in and the purpose of this is unclear at present.*

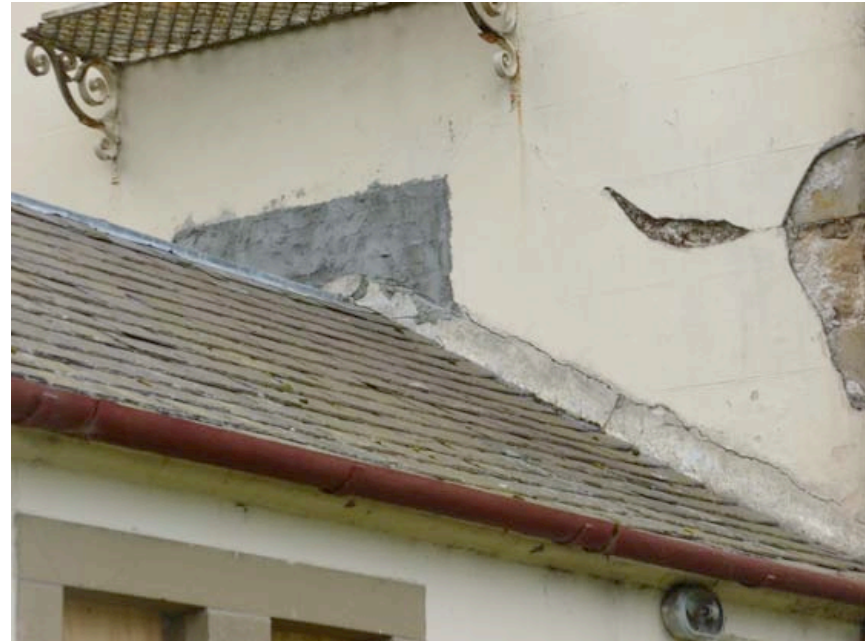
*Photograph 026: It is noted that on the east side of north extension earlier openings have been blocked up where the single storey ancillary building abuts the main building.*

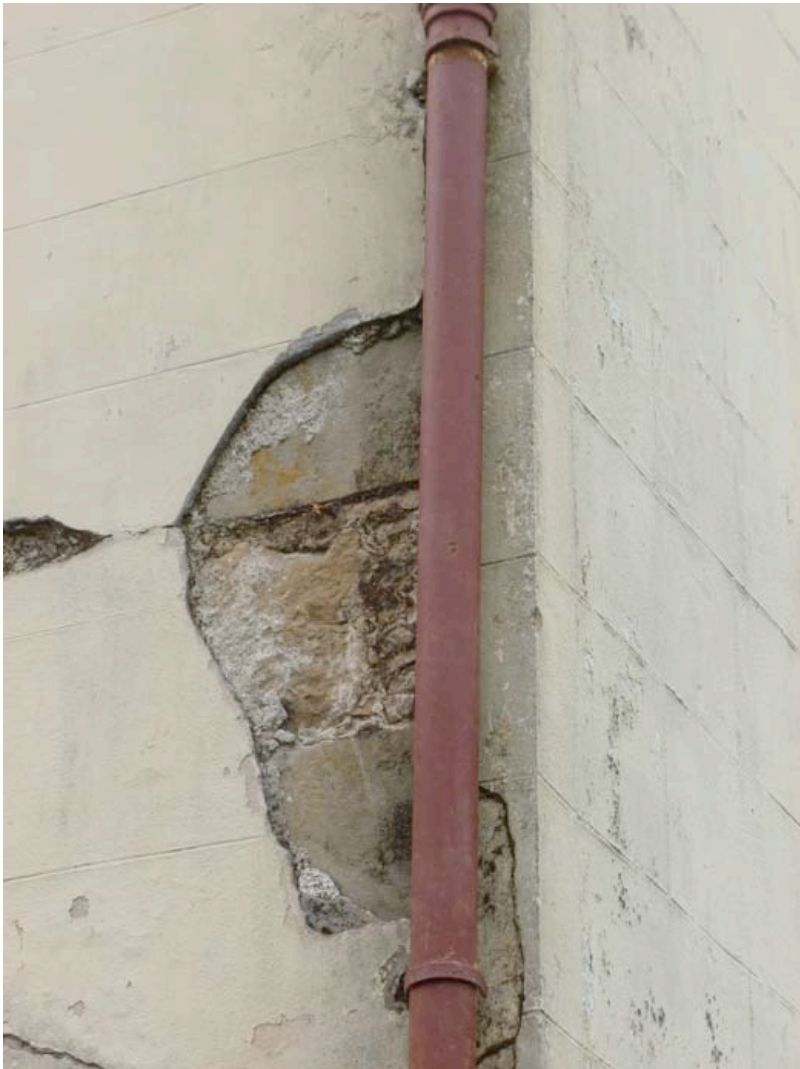
*Photograph 027: The render has failed approximately 2m from ground level on the north most corner on the east gable. Delamination has occurred to the stones that are now exposed.*

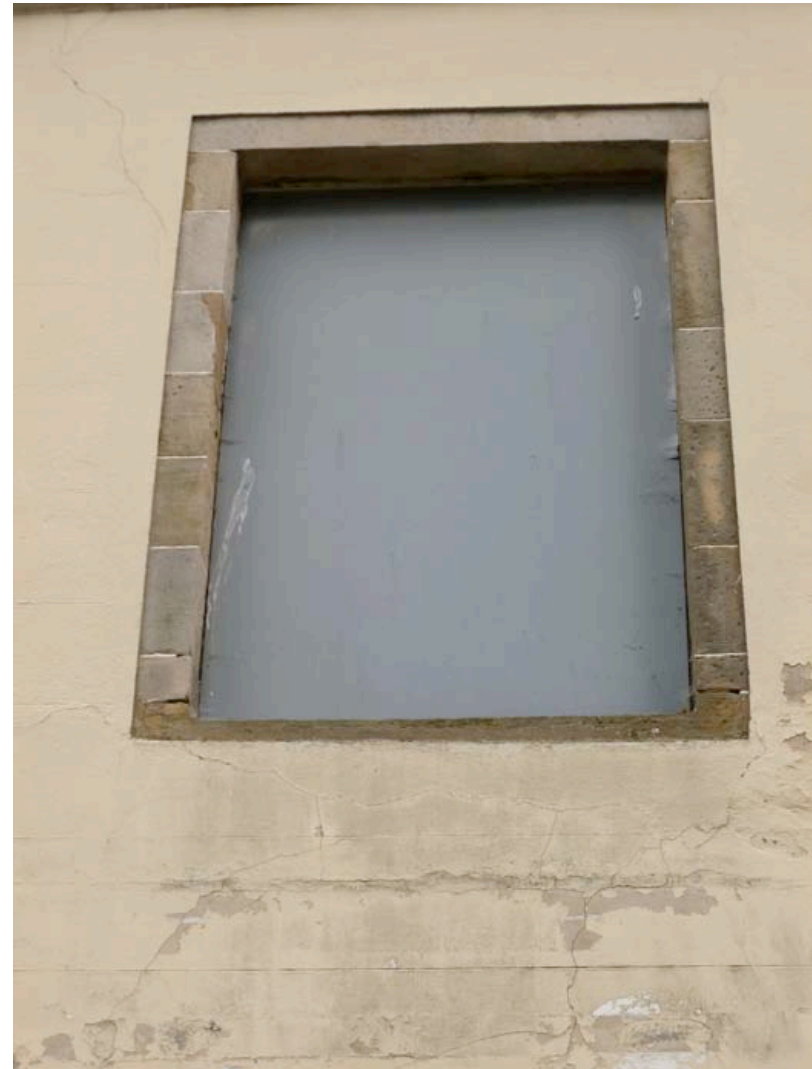
*Photograph 028: There are several cracked cills around the building. This is especially apparent on the west elevation as shown in the photograph above.*

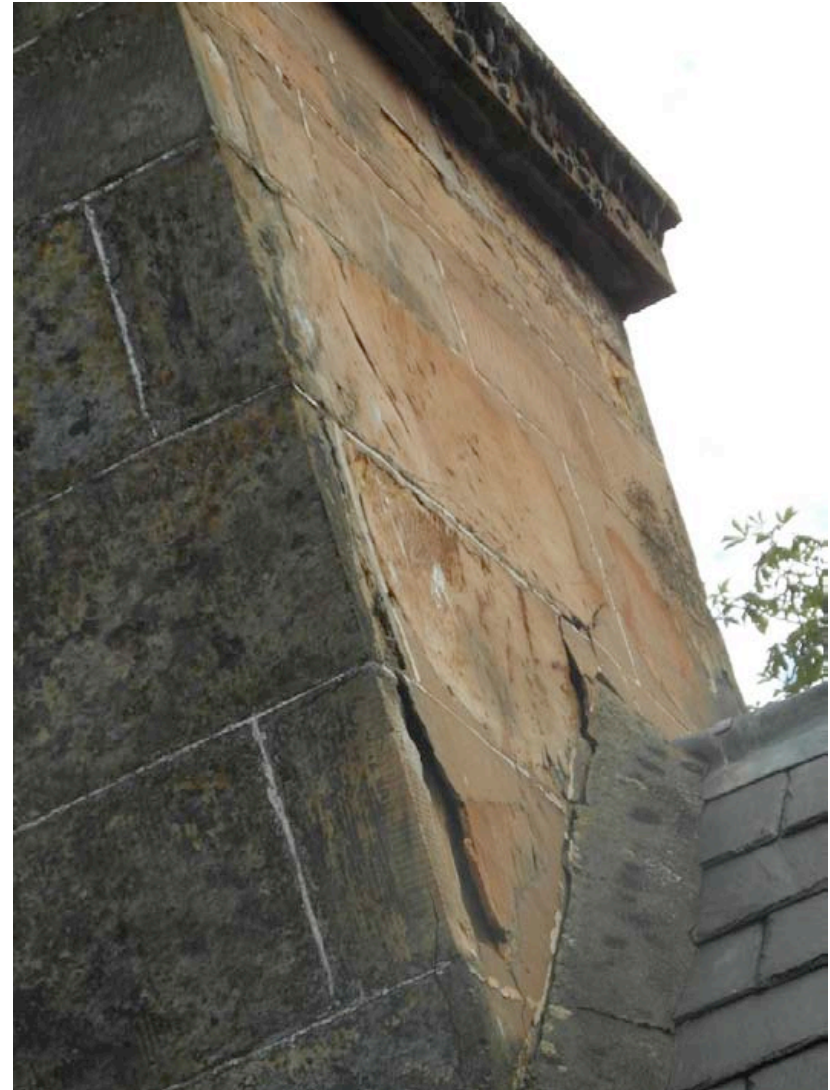
Photograph 030: The south face of the front east chimney has significant delamination.

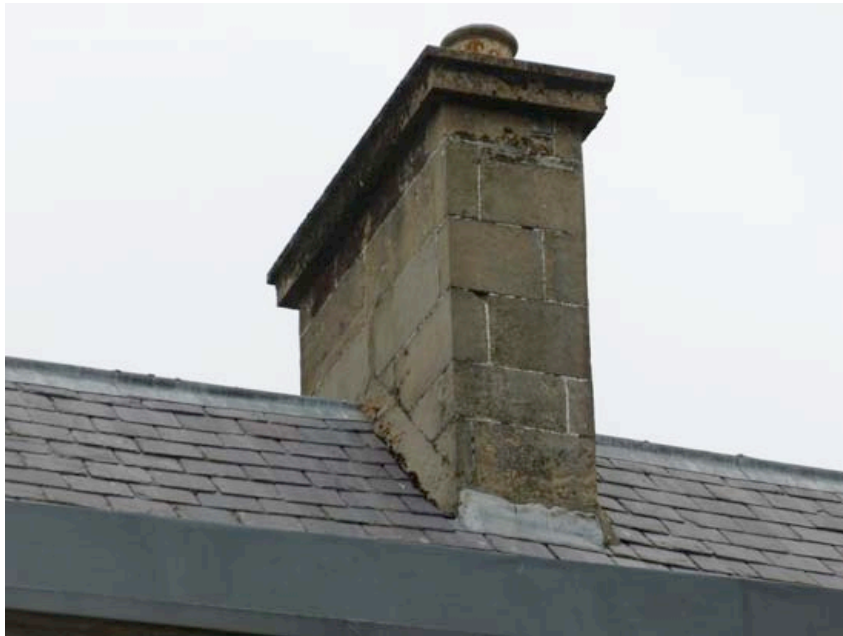
*Photograph 031: There are several open joints on each of the chimneystacks.*

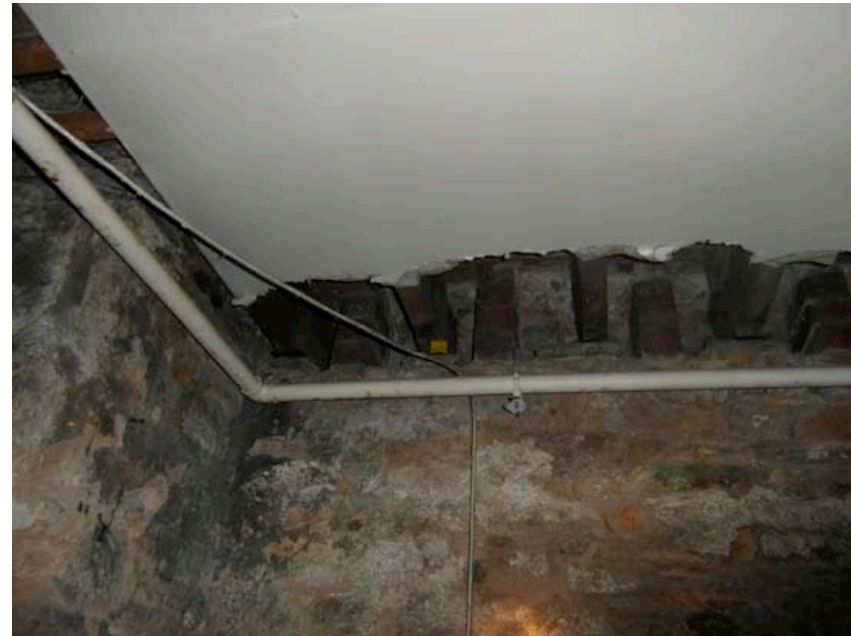
*Photograph 032: The ground floor joists have been replaced in xB.06. The ends sit on either concrete pads or a new timber wall plate. The wall pockets have been opened up and brick piers inserted to allow air circulation.*

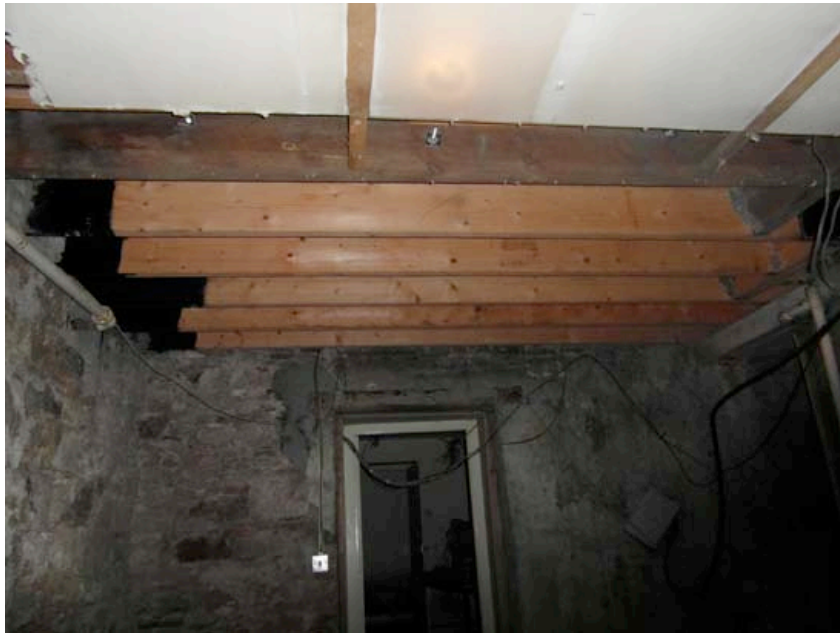
*Photograph 033: Replacement ground floor joists below the fire damage.*

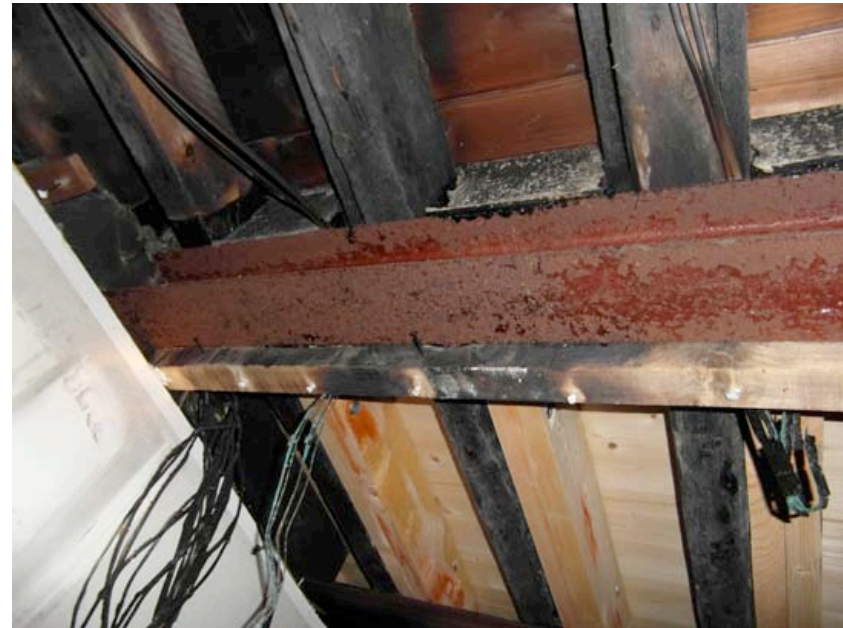
*Photograph 034: Some of the ground floor joists below the fire damage have had splice repairs carried out. This has exposed corroded cast iron I beams which were previously installed to strengthen the floors.*
