## GRANT LODGE, ELGIN FABRIC INSPECTION REPORT

AUGUST 2012

Address of Property:	Grant Lodge, Elgin
Date of Inspection:	21 <sup>st</sup> August 2012
Weather Conditions at Time of Inspection:	Dry and bright
Inspection Carried Out By:	Pinny Neill, Architect and Ian Fraser, Associate, LDN Architects llp, 29 St Leonards Road, Forres IV36 1EN

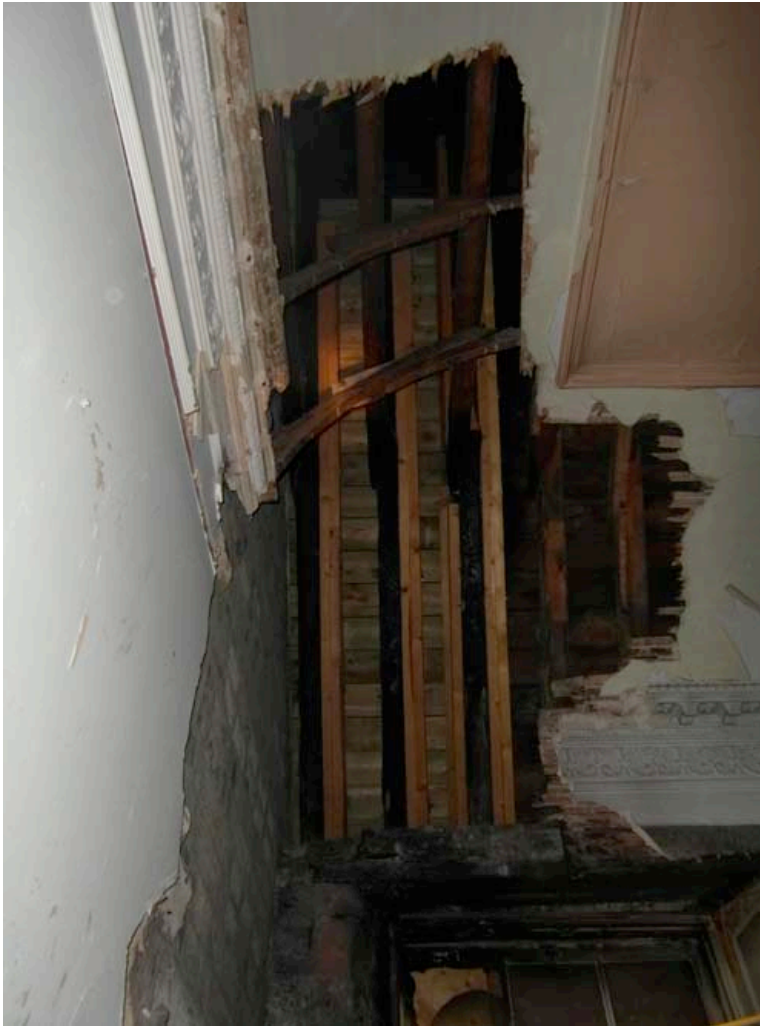
*Photograph 035: The ceiling has been damaged in xF.06 on the south wall by a previous outbreak of fire.*

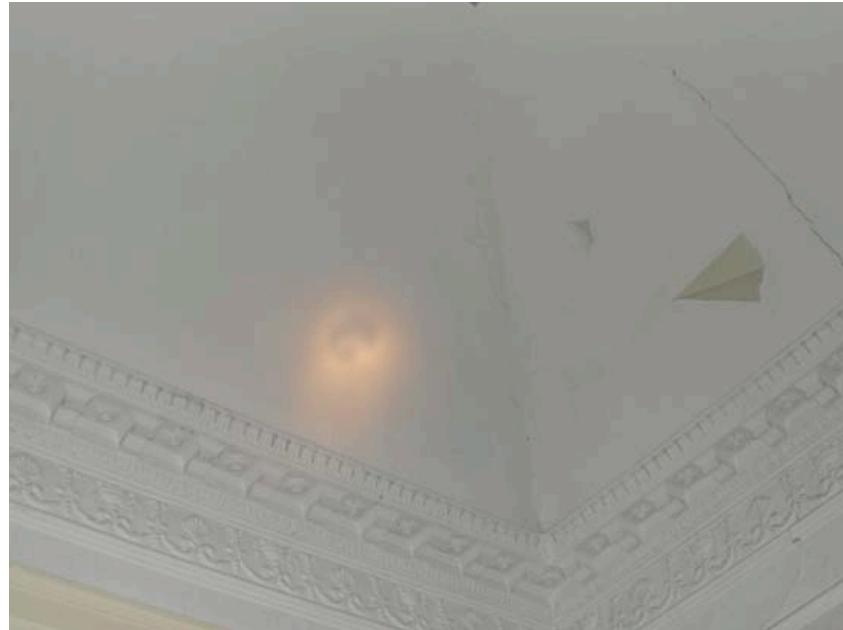
*Photograph 036: The coomb of the ceiling on the south wall exhibits a crack running up from the cornice to the central moulded section, the crack continues down the right hand end of the door lintel below.*

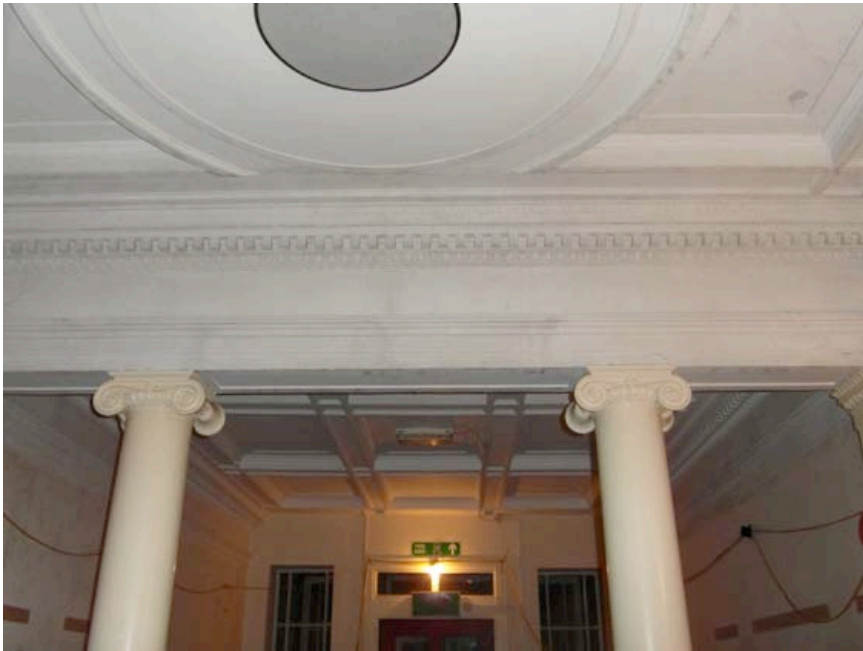
*Photograph 037: At the north end of the coffered ceiling in the entrance hall there is cracking visible at the downstand beam and it appears to have sagged in the centre.*

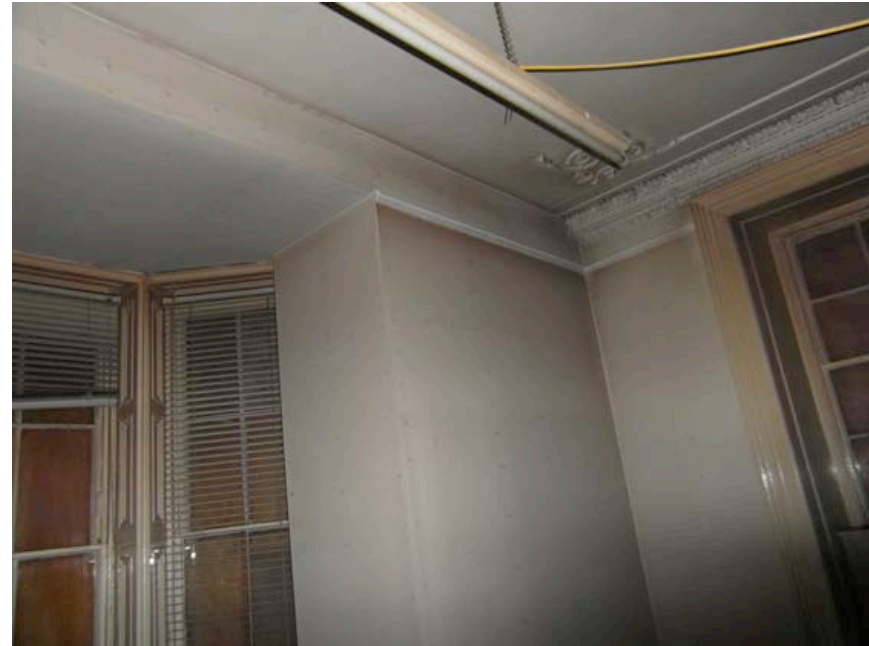
*Photograph 038: The plastered ceiling in xG.04 has a decorative border that runs around the perimeter of the ceiling. The decorative detail on the ceiling and cornice at the south side has been lost due to previous interventions.*

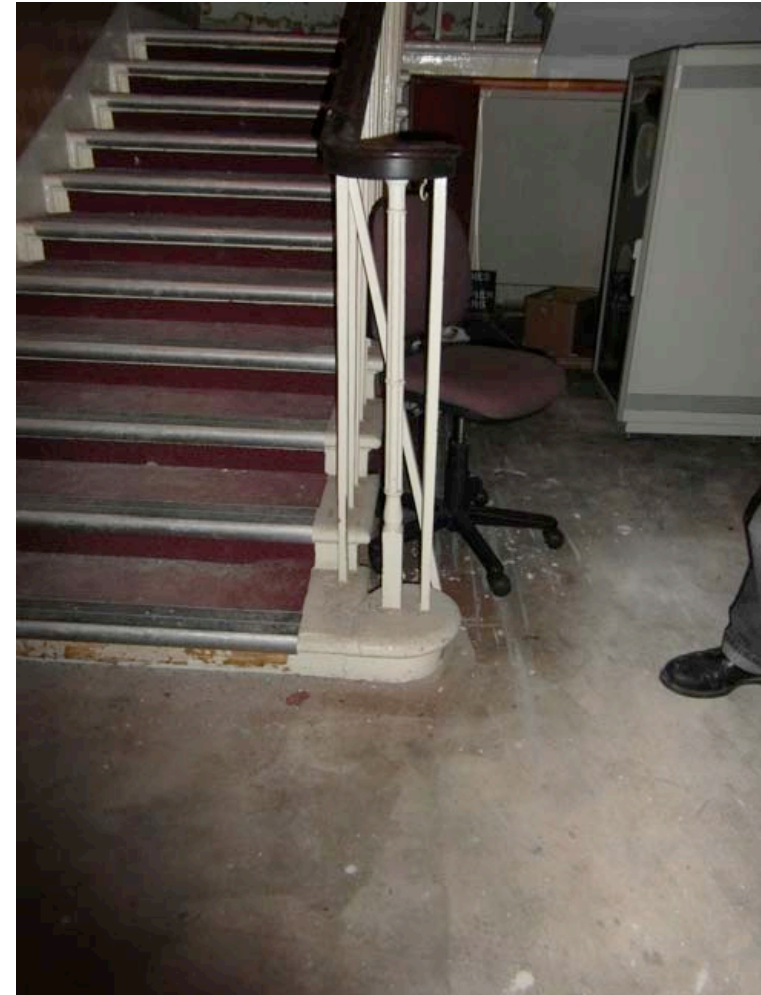
*Photograph 040: Simple cast iron balustrades and timber handrail to service stair. It is assumed that a diagonal prop was added at the bottom of the stairs due to a concern over the stability of the balustrade.*

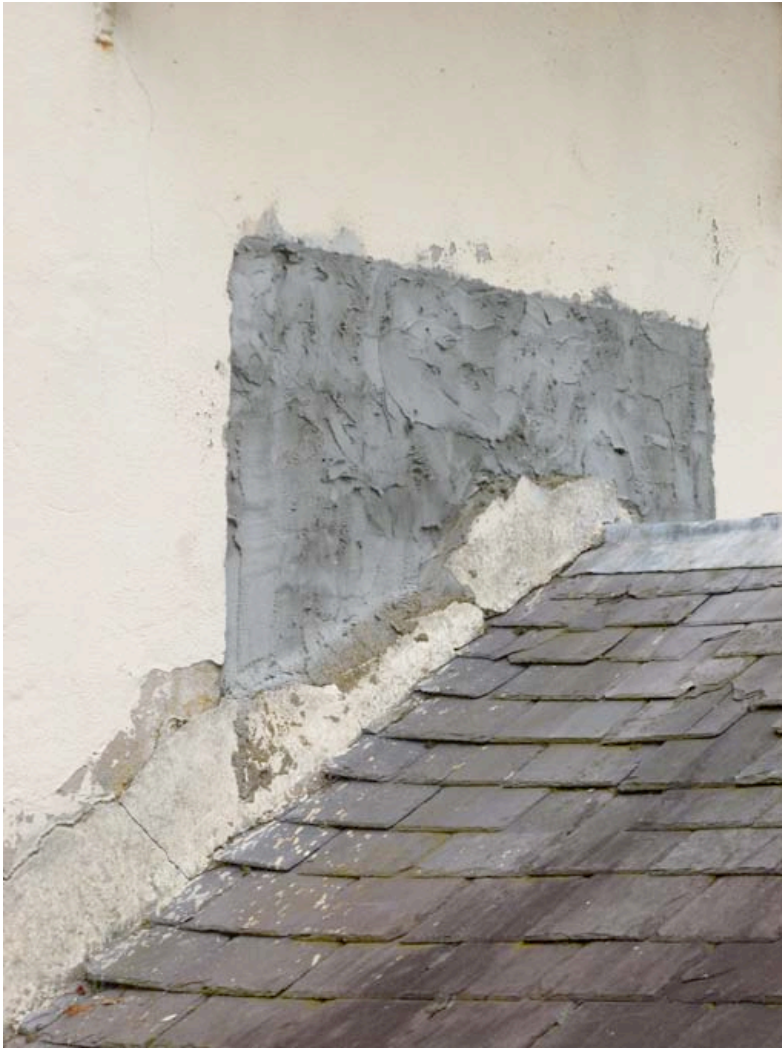
Photograph 041: Single storey ancillary building. There are a number of chipped and missing slates.

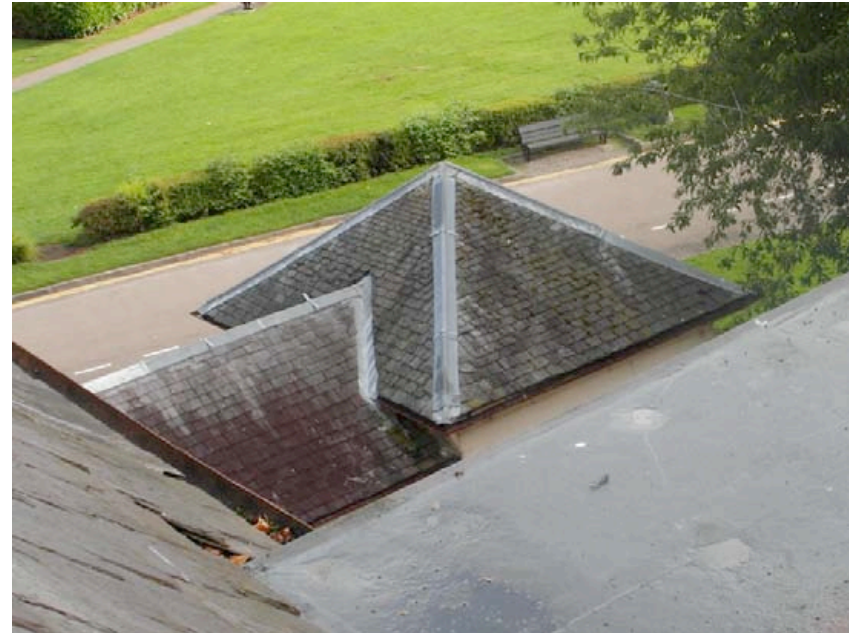
Photograph 042: The single storey ancillary building terminates into a small pyramidal roof at a slightly higher level. It appears that a section of the ridge on the lower roof has been replaced in zinc.

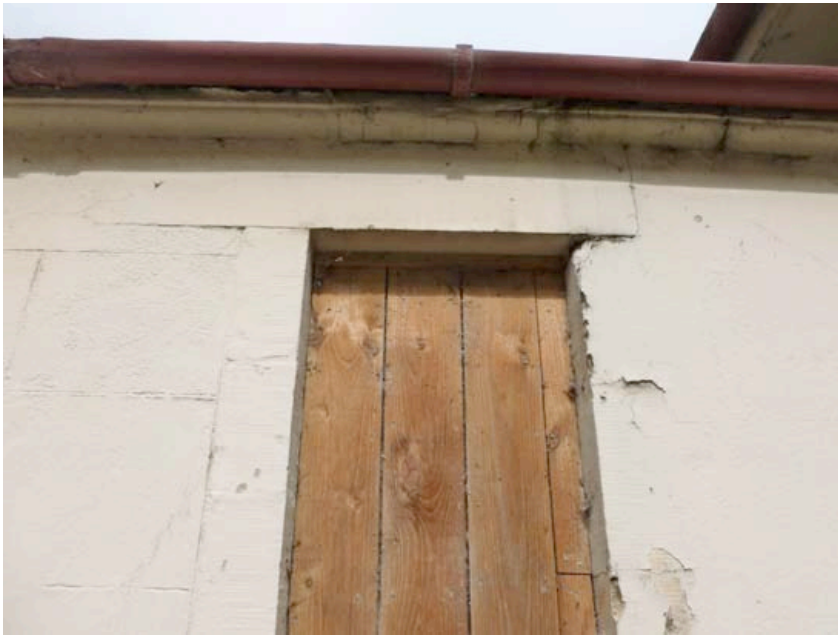
*Photograph 043: One of the openings on the ancillary building has been reduced in size.*

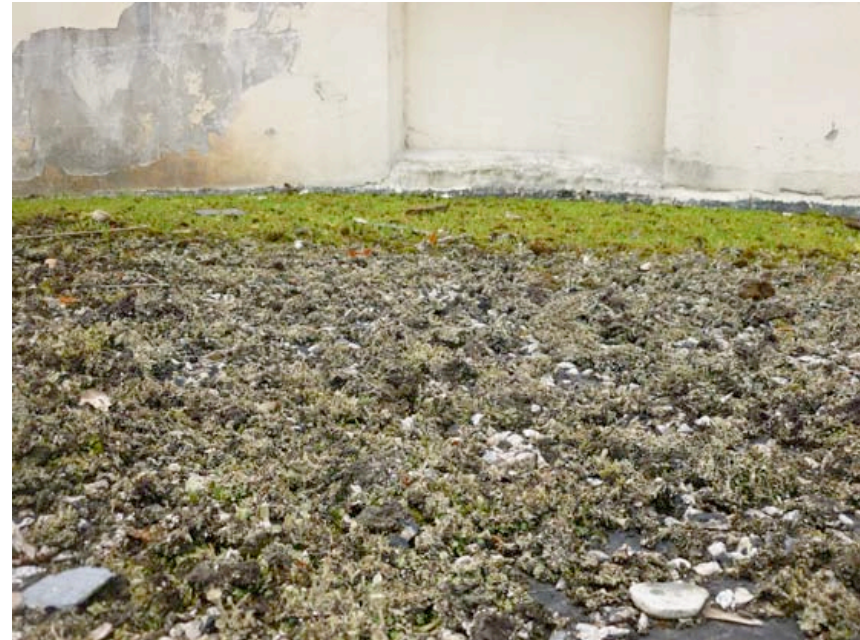
*Photograph 044: The roof of the 'boot room' is clad in felt and is covered in moss. Below the moss there is evidence of bubbling and decay, which indicates that the roof may be at the end of its life span.*
