# DUFFTOWN CLOCK TOWER, THE SQUARE, DUFFTOWN

## CONDITION SURVEY

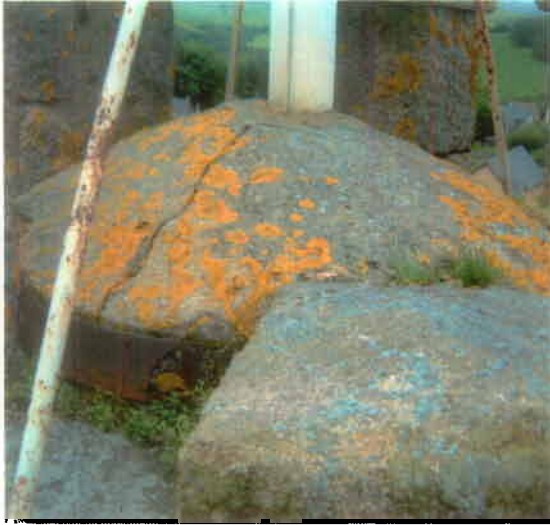
Flat, lead covered roof beneath bell with lead roof and timber canopy above bell. Lead to tower roof in poor condition, cracked and causing moisture penetration to roof timbers.  
Slated pitched sections in good condition, lead gutters below good, some debris in gutters. Flagpole base to S.E. corner cracked. Gutter outlets require to be cleared, and debris removed from the flat lead gutters. The store turrets to the four corners are generally in fair condition, with slight vegetation growth and minor repointing required.

**Photo 1 – SE Corner Flagpole Base**

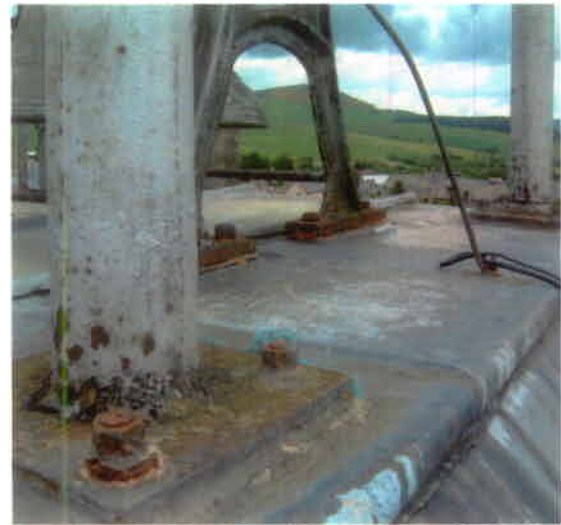
**Photo 4 – Flat Lead Roof Beneath Bell**

Renewal of lead roof to tower.	£4,000.00
Replacement of 3 no. timber windows, timber treatment works and other joinery repairs.	£4,000.00
External stonework repairs to tower and annexe.	£1,000.00
Internal stonework and pointing repairs to tower	£5,000.00
Plasterworks to remove loose plaster and patch cracks etc.	£2,000.00
New external electrical sockets for Xmas lights (present set up causing water ingress)	£500.00
External decoration (to timber doors & windows)	<u>£1,000.00</u>
Total	<u><b>£17,500.00</b></u>

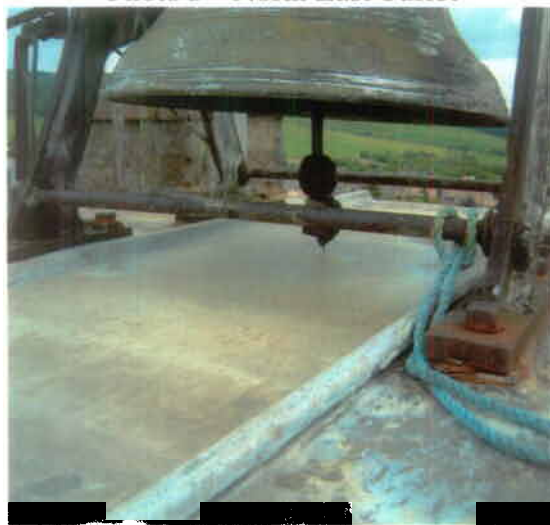
**Photo 5 – Flat Lead Roof Beneath Bell**

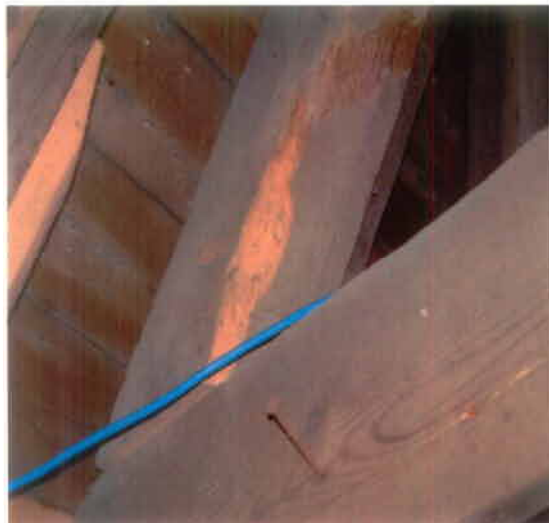
Evidence of water ingress to timber sarking in various locations below lead flat roof. Previous timber repairs evident with the lower 2 sarking boards replaced to all four sides. All rafter ends have been previously spliced with new timber. Main timber roof beams are water damaged at wall heads.

**Photo 11 – Rotten Timber Rafter in Top Floor**

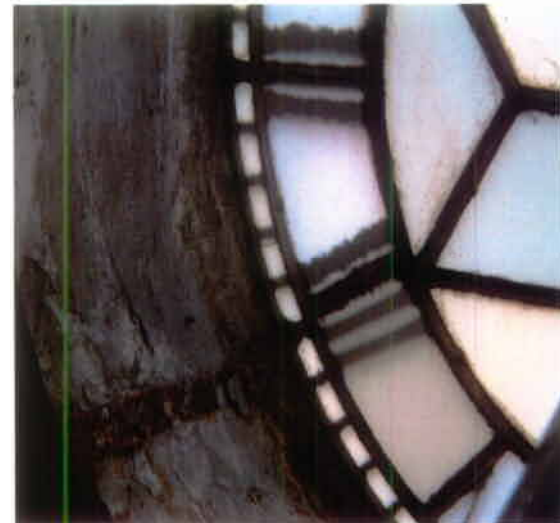
Metalwork tracery rusty and some sections loose / missing (See photo 12). Although close inspection was not possible, the external sections of tracery may also be loose.

**Photo 12 – Typical Reveal to Clock Face**

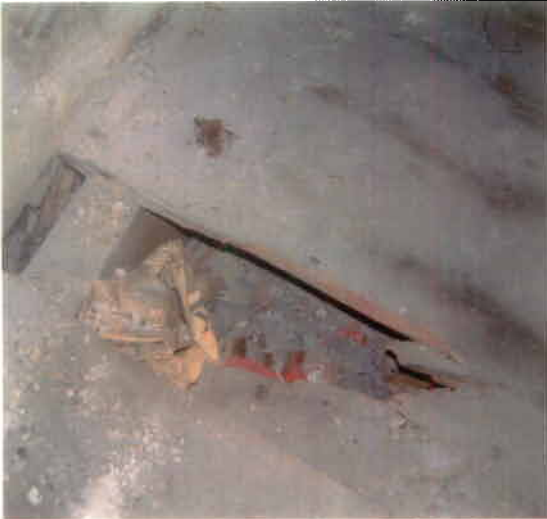
Tongued and grooved timber boards on joists. Generally fair – some rotten / loose / missing. (See photo 13). Floorboards oil stained under clock mechanism.

**Photo 13 – Rotten Floorboard – Top Floor**

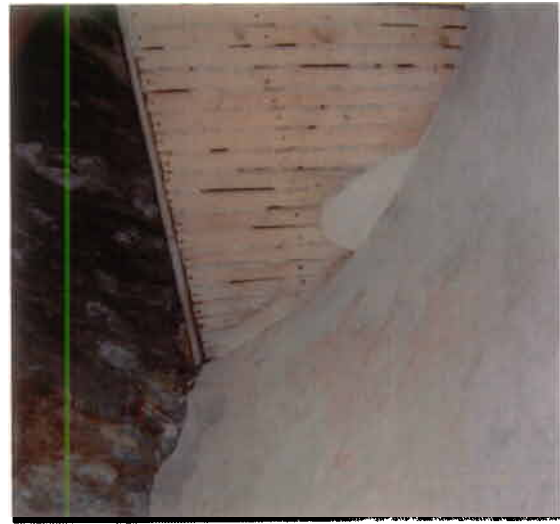
Timber stairs down to third floor – treads and risers in fair condition. Large sections of plaster missing from curved walls, especially at stair treads. There is a large crack through the lath. (See photos 14 & 15).

**Photo 14 –Missing Plaster to Top Floor Stairwell**

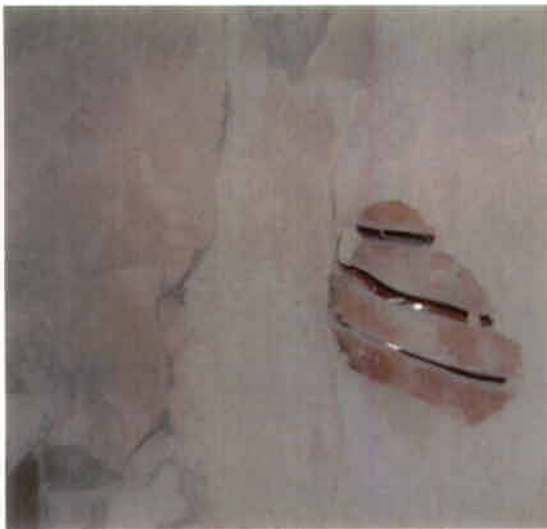
**Photo 15 – Crack and Exposed Lath to Top Floor Stairwell**

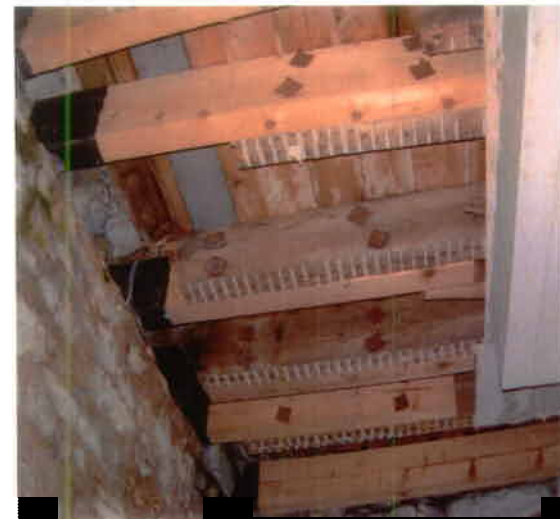
New rafter ends and sockets throughout, with new floorboards above. (See photo 18). Only 50% of lath and plaster ceiling remaining (See photo 19) with much of remaining plaster cracked and requiring removal.

**Photo 18 – Previous Joist Repairs to 3rd Floor Ceiling**

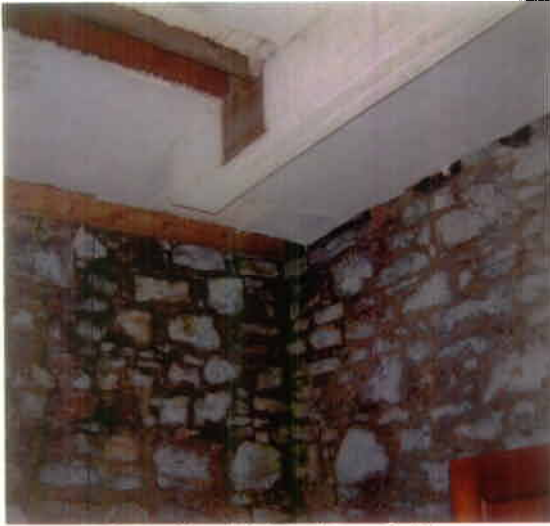
**Photo 19 – Third Floor Ceiling**

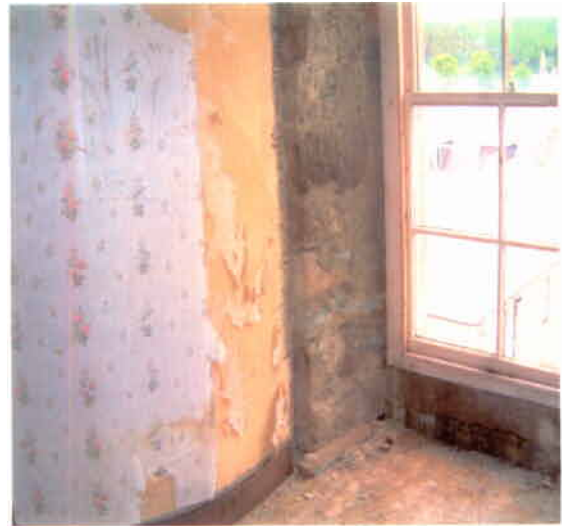
**Photo 20 – Window to Third Floor**

Stonework dry, minor holes in pointing.  
The timber sash and case single glazed window appears to have been installed within the last couple of years and is primed internally but not painted. Internal and external redecoration of window frame required. (Photo 20). The previously removed window has been left on the floor. Timber lintels above window fair, evidence of woodworm exit holes. Timber panelled door to spiral stairwell fair, requires redecoration.

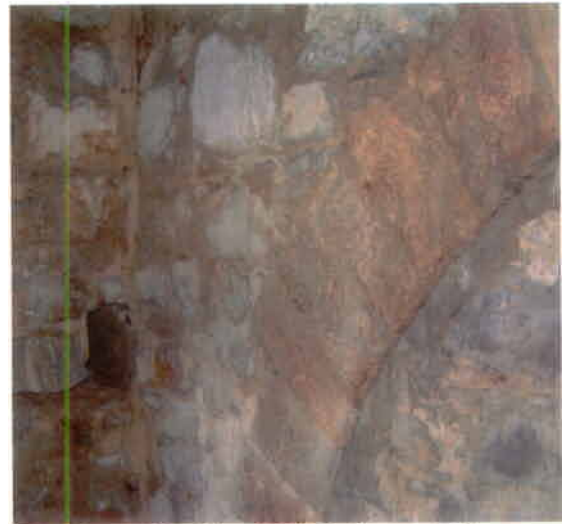
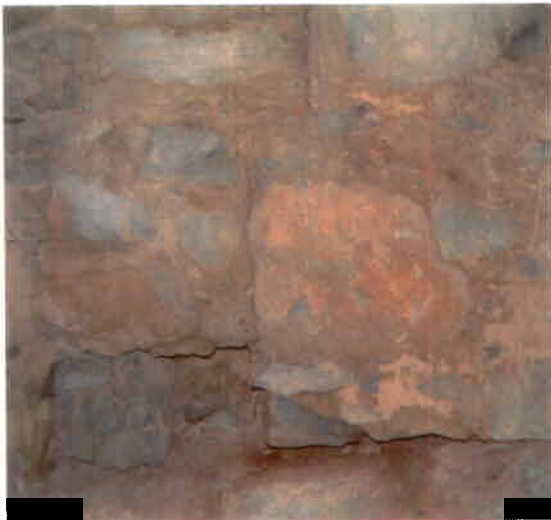
<b>Ceiling</b>	10% plaster remaining, loose. 50% lath remaining. Some full rafters have been replaced, some have been spliced. All floorboards above have been renewed. Central light rose (inoperational).
<b>North Wall (Photos 22 + 23)</b>	Small cracks and minor holes in stonework. Arched stonework section around timber window – cement to infill section cracked. Concrete brick infill at ceiling height.
<b>Window</b>	Single glazed timber sash and case window in poor condition. Window has been jammed 100mm open to allow Xmas rope lighting to pass through (thereby allowing blown rain penetration). This should be addressed urgently.
<b>West Wall</b>	5 large pockets in stone left from previous joist removal. (Photo 24) Large floor to ceiling crack near cast iron fireplace.
<b>South Wall</b>	Missing / loose pointing especially at low level. Cast iron downpipe in recess at SW corner.
<b>East Wall</b>	6 pockets where previous joists have been removed. Dryrot fruiting bodies evident to some pockets – timber treatment required. Isolated small holes in pointing. Timber panelled door to stairwell in fair condition and decoration. Light switch missing. Wiring dated. 10% of lath and plaster missing from curved wall surrounding stairs. Floor – timber floorboards to North and South replaced (17 no.) Plaster debris on floor.

**Photo 22 – North Wall, Second Floor**

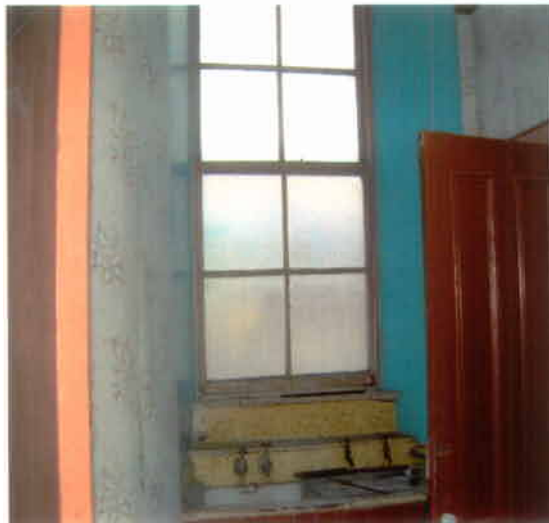
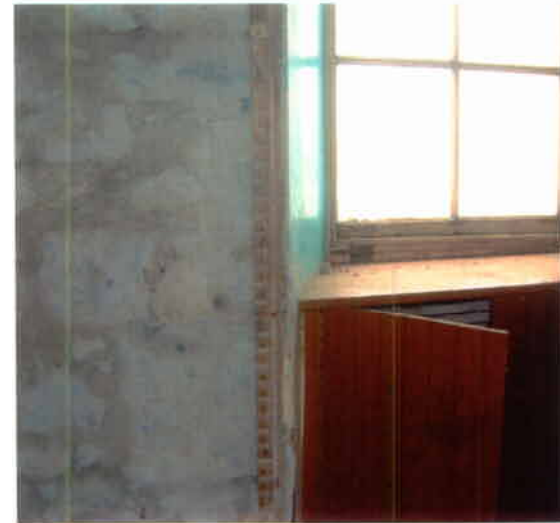
<b>1<sup>ST</sup> FLOOR</b>	
<b>Ceiling</b>	70% plaster remaining although much of this is cracked. 95% lath cracking. Some joist ends have been spliced at north wall. Central pendant light fitting.
<b>North Wall (Photos 26 &amp; 27)</b>	Pointing required to infilled arch area. Electrics mounted on board on wall to right of previous opening / archway.
<b>West Wall</b>	75% of lath & plaster remaining, wallpapered – should be removed prior to repointing. “Nu-weather” integrated stove with fire and surround. Stonework exposed in NW corner with a number of areas of missing stonework / pointing and a large hole penetrating 600mm through stone wall (Photo 31). Glistening residue to pointing in NW corner indicative of water ingress.
<b>South Wall (Photo 28)</b>	Lath and plaster all intact. Double Belfast sink with lead wastepipe in timber sink unit. (Photos 32 & 33). Single glazed timber sash & case window with perspex panes in poor condition and in need of replacement. (Photos 29 and 30)

**Photo 29 – First Floor – Window**

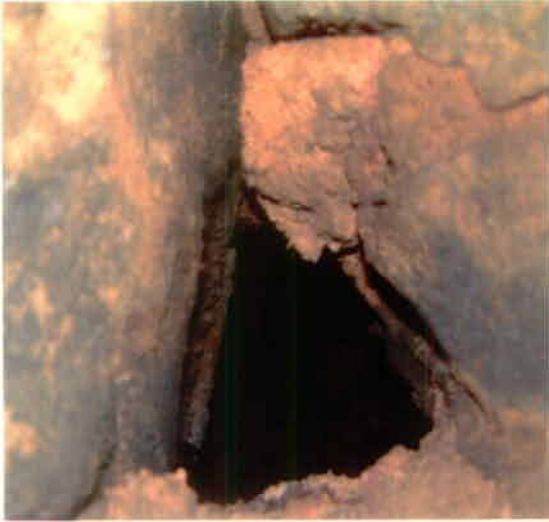
**Photo 31 – Large Hole in West Wall**

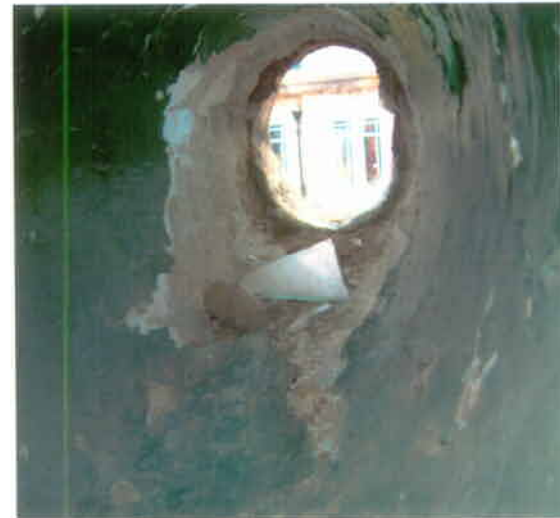
**Photo 36 – Missing Glass to First Floor Staircase Peephole**

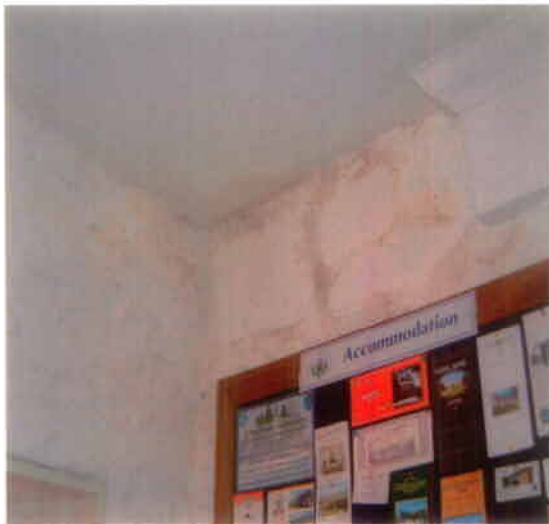
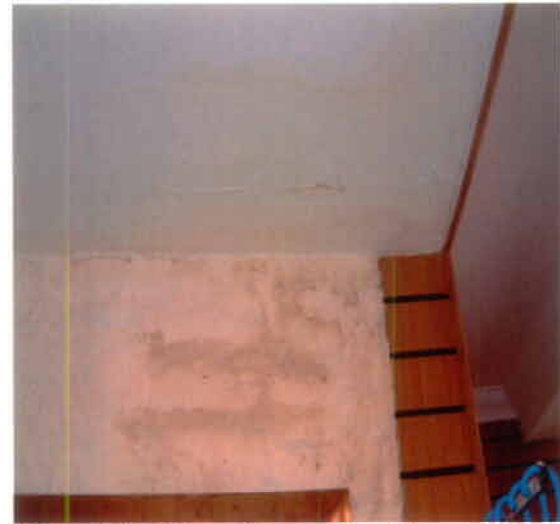
Signs of water ingress at north facing wall from west elevation. (photos 39 & 40) (believed to be emanating from the open window on the north elevation of the tower).

Photo 39 – Water Ingress NW Corner  
Ground Floor

Photo 40 – Water Penetration Ground Floor  
Slapping

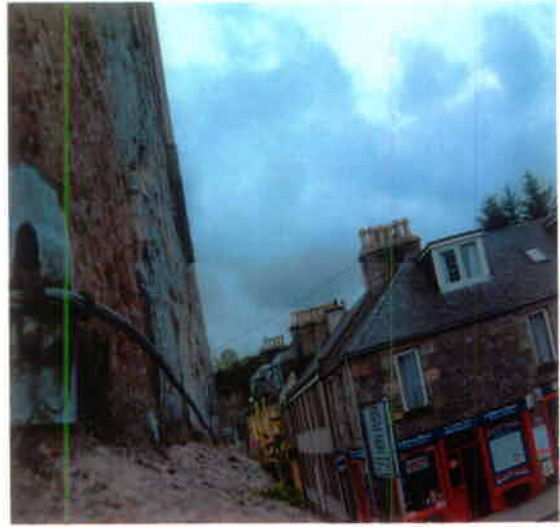
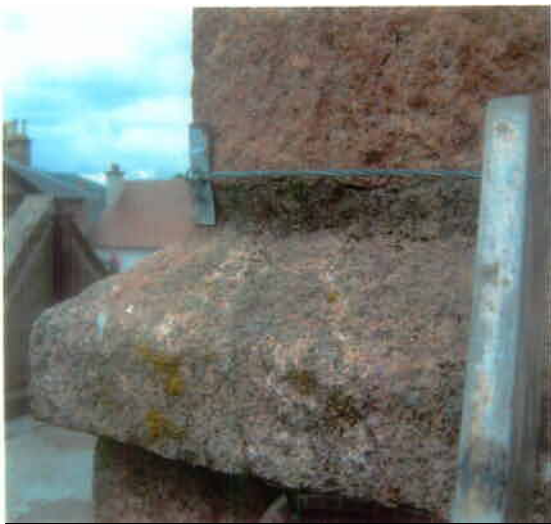
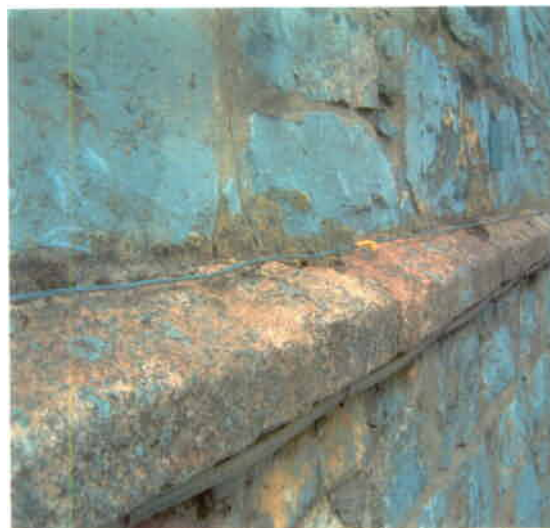
Stone walls and pointing generally good, although there is a large vertical crack which may be causing some moisture to penetrate internally. (The internal walls on the west elevation are saturated).  
Vegetation growth to string course beneath clock face.  
Timber door with glazed panelling to Tourist Information in good condition.

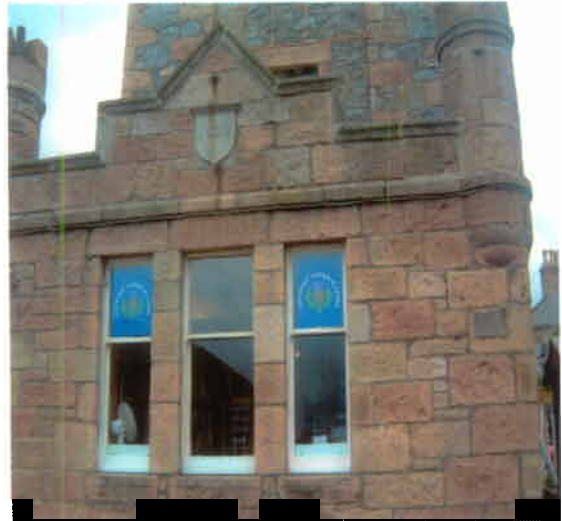
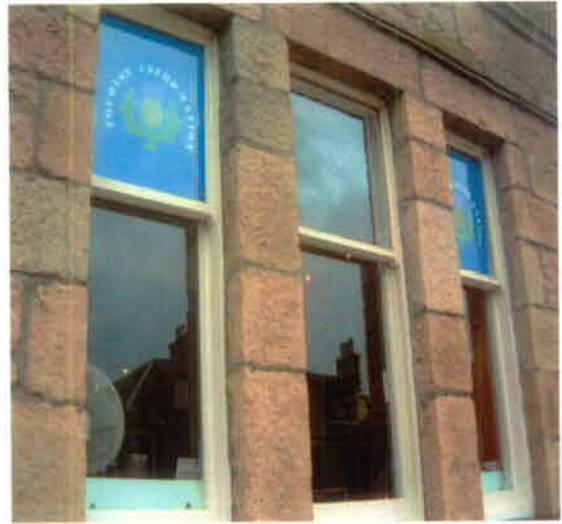
Previous pointing repairs noted.  
Cement to Turret at high level cracked - repointing required.  
3 timber sash and case windows with stone mullions in fair condition and decoration. (Photo 50)

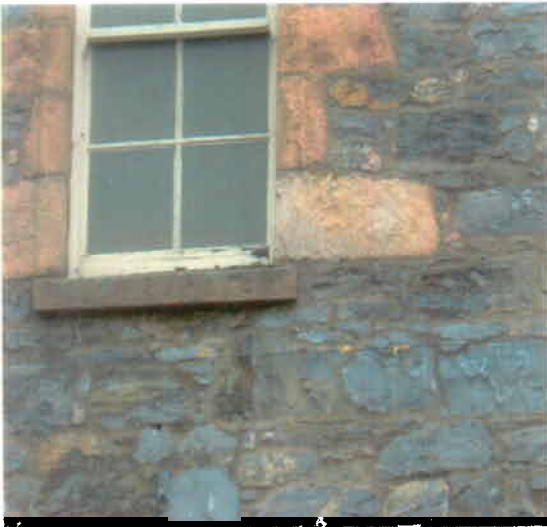
**Photo 51 – Window to East Wall**

Stonework and pointing good – vegetation growth to string course below clock face.  
Large sash and case timber window at First Floor level in fair condition and decoration. (Photo 51).  
Small timber casement window at Ground Floor level in fair condition – top pane cracked.

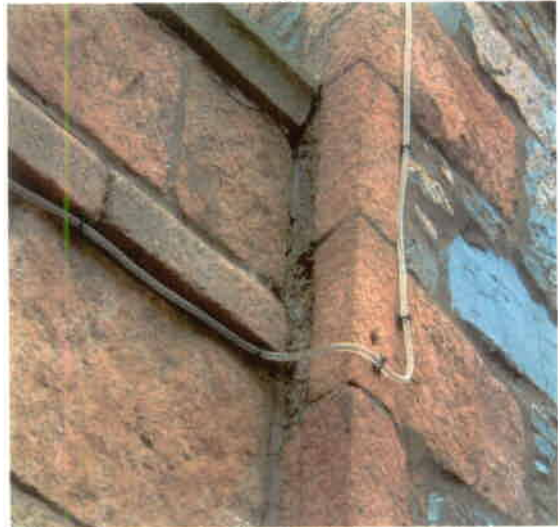
**Photo 52 – Defective Pointing – NE Corner of Tower at Junction with Flat Roofed Section**

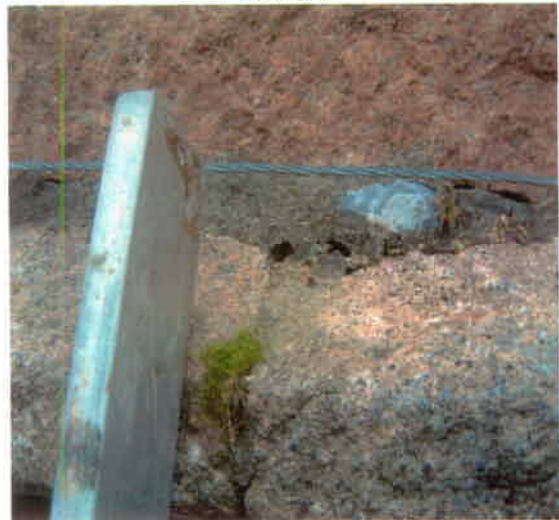
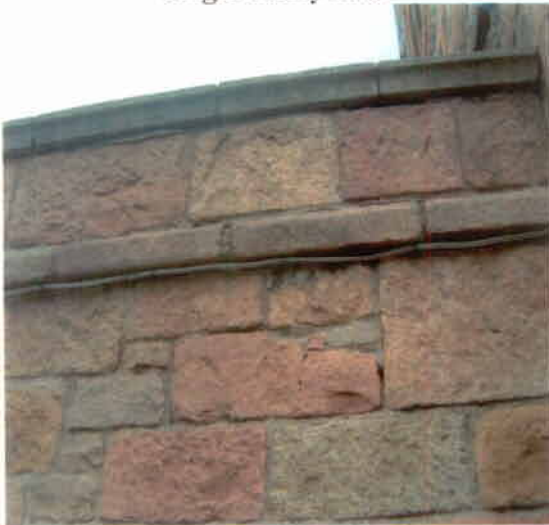
Minor repointing required to loose / missing sections and pointing beneath stone tabling. (Photos 47, 52, 54)

**Photo 54 – Pointing at Single Storey West Wall**

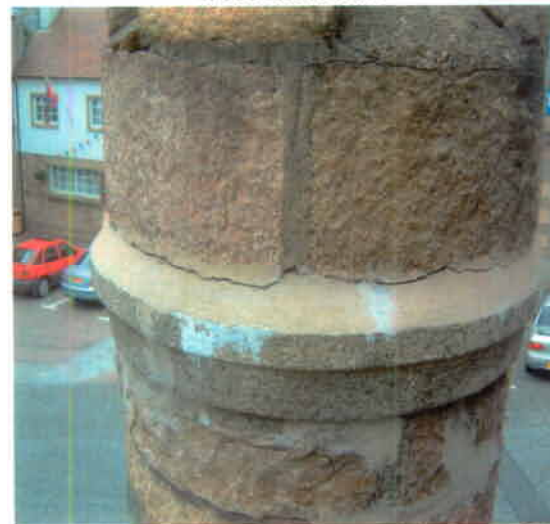
Renewed in 2002 with “Dryseal” GRP finish in good condition (Photos 43 – 45, 57 & 58)  
Cement to turret at NE corner cracked.

**Photo 58 – Cracked Cement to Turret at NE Corner of Single Storey Roof**
