**REPORT TO: ECONOMIC DEVELOPMENT AND INFRASTRUCTURE
SERVICES COMMITTEE ON 30 SEPTEMBER 2014**

**SUBJECT: GARMOUTH VIADUCT IMPROVEMENTS AND BROOM OF MOY
BRIDGE CONDITION**

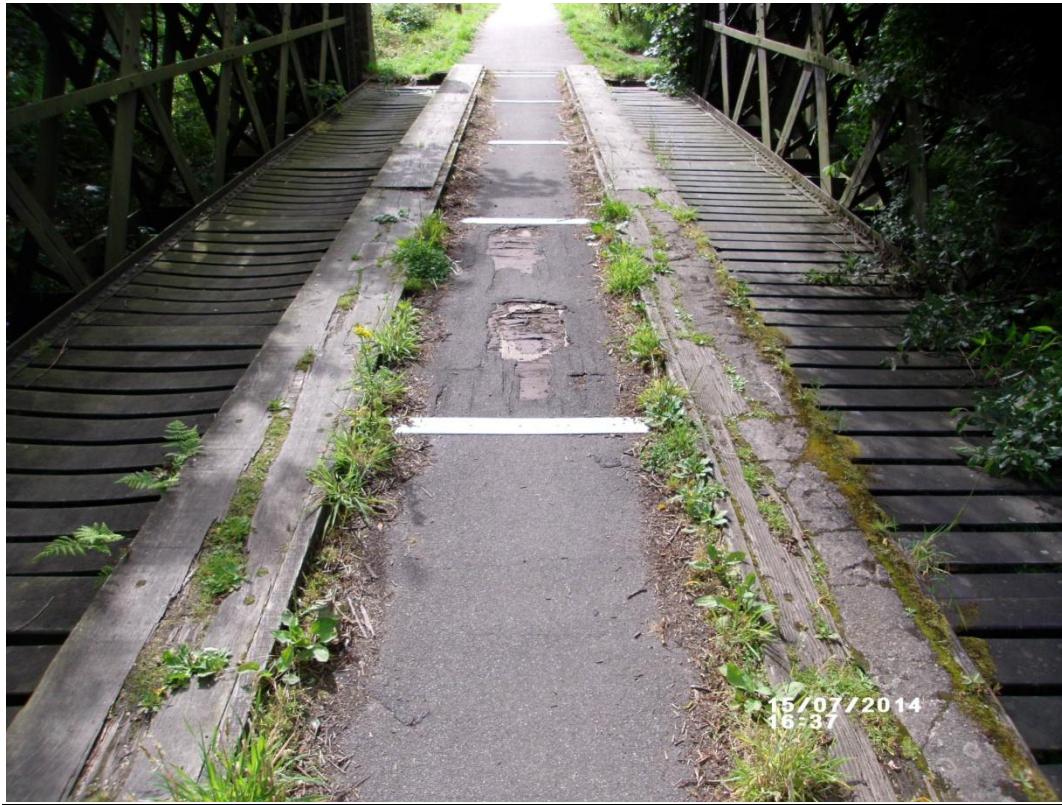
- 3.4 Work was carried out in July and August this year to replace six defective plywood panels with glassfibre reinforced plastic (GRP). This material does not rot and provides a non-slip walking surface. It costs 50% more than a timber ply replacement but has a lower whole life cost. An assessment considered that 30% of the panels are defective now, with the remainder having less than five years life remaining.

Typical section of existing walkway

- 5.1 The plywood walkway panels should be replaced with GRP sections in entirety on whole life cost and level of service grounds. Most timber baulks remain serviceable but those assessed otherwise should be replaced.**
- 5.2 The preliminary project as detailed in APPENDIX I be submitted to Asset Management Working Group as part of the Council's capital plan process**
- 5.3 A full structural inspection of the bridge would be required to assess the condition of the steelwork, the paint system and to check for any scour damage at the substructures prior to the capital submission being considered.**
- 5.4 Replacing the deck at Broom of Moy Bridge can only be justified on aesthetic and deferred maintenance grounds. The costs would substantially outweigh benefits so no action should be taken at this time.**

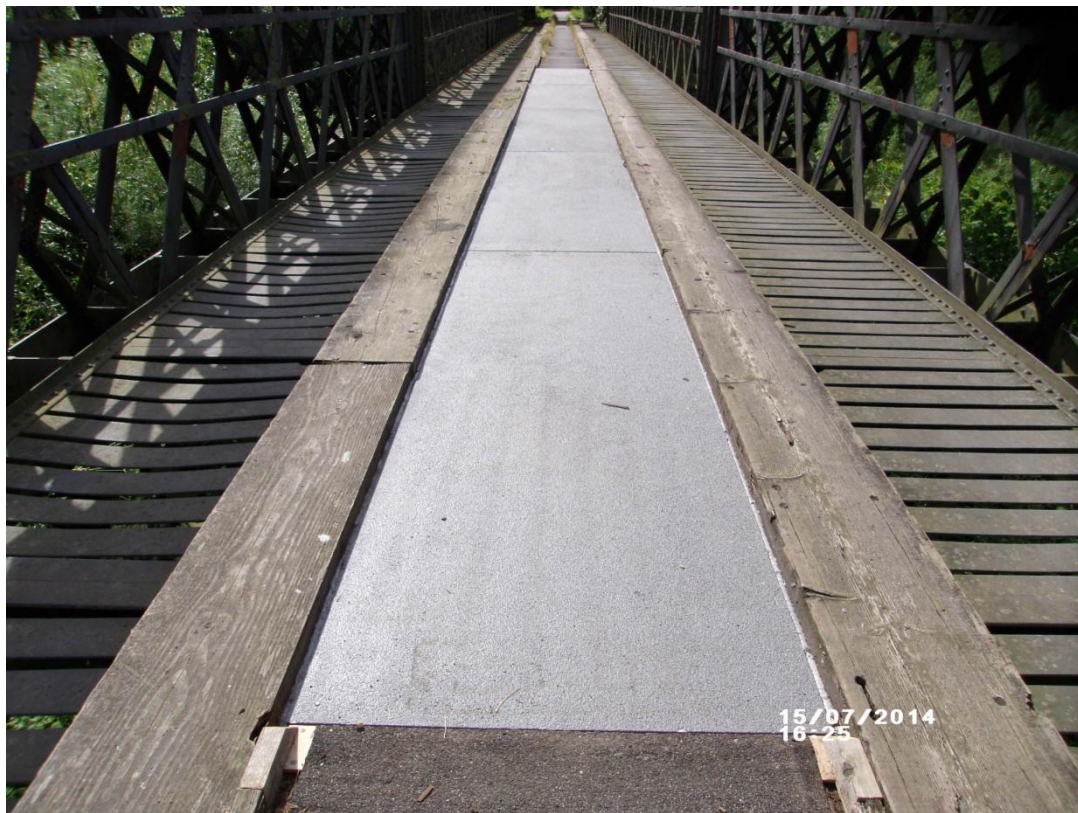
New section of GRP panels

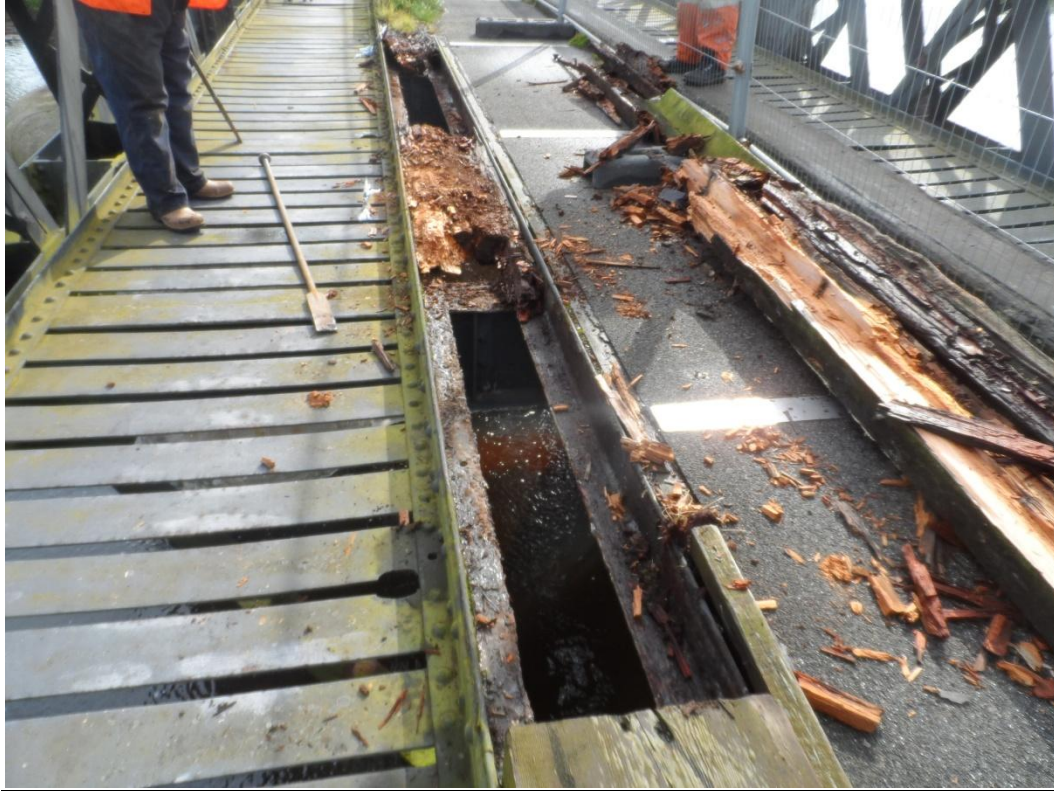
- 3.5 The timber baulks either side of the walkway no longer form any structural function but they are part of the history of the bridge and therefore need replacing with similar section timbers. The condition of these timbers has been assessed and 16% are in a very poor condition. Two sections of timber (20 metres in total) were replaced as emergency work during the operation to install the GRP panels.

Remains of a rotten timber baulk

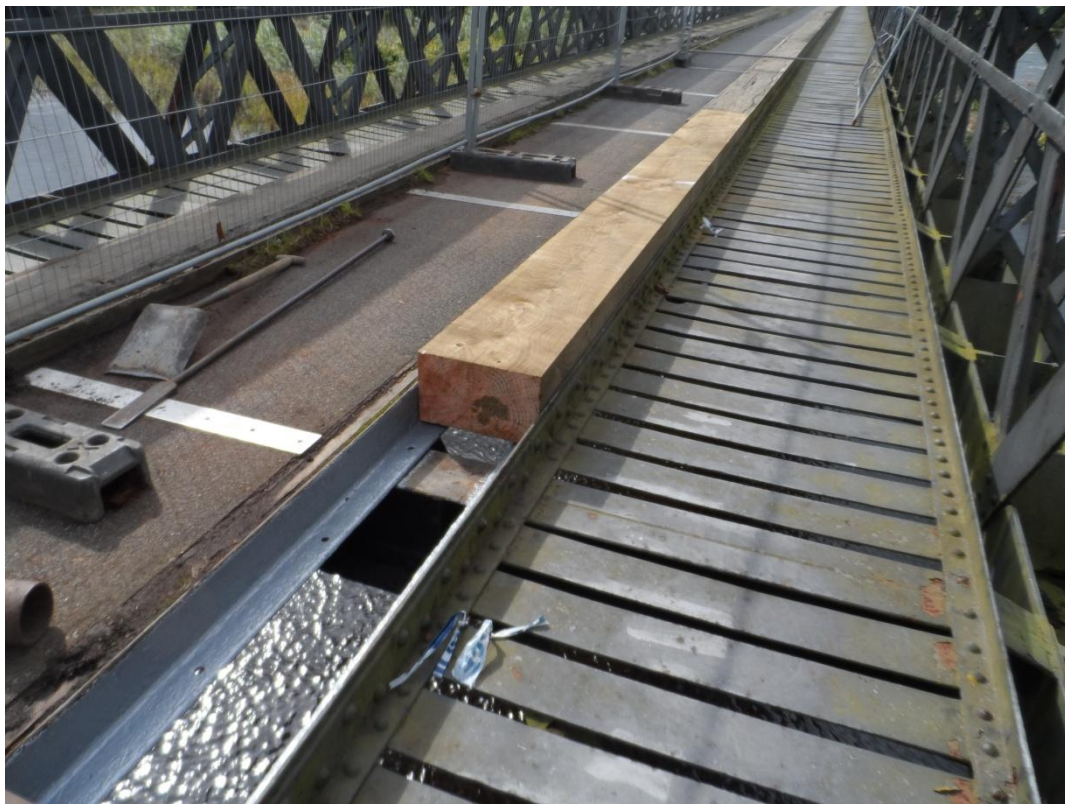
Replacement timber in place
