# **Summary Building Condition Survey Report**

**St Thomas Primary School  
Chapel Street Keith AB55 5AL**

**10<sup>th</sup> January 2024**

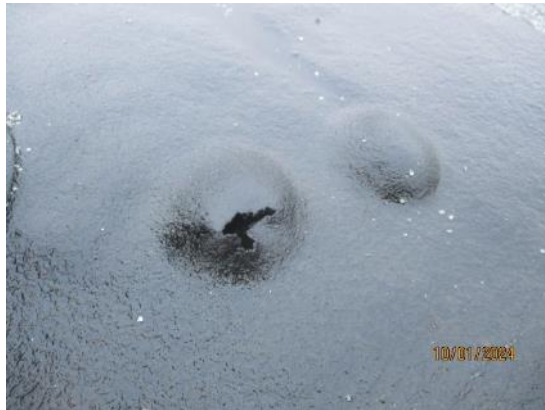
8. Surface erosion of felt flashings

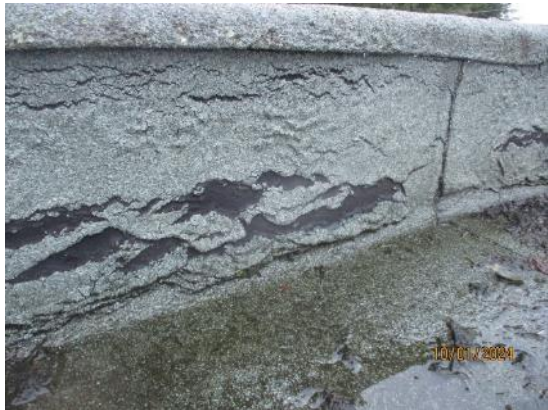
9. Punctured blisters in bitumen repairs

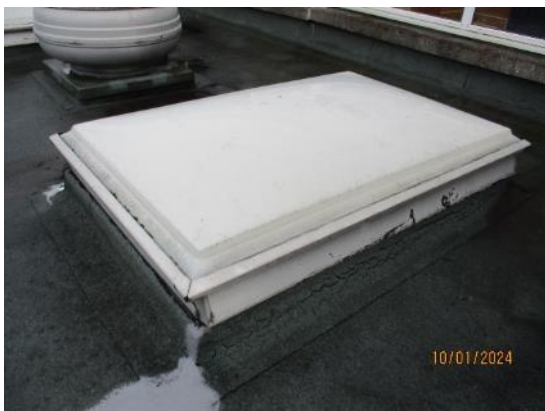
10. Cracking and surface erosion of upstands

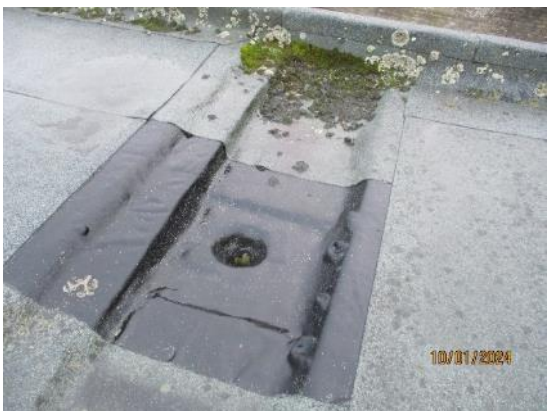
16. Blistered previous repairs

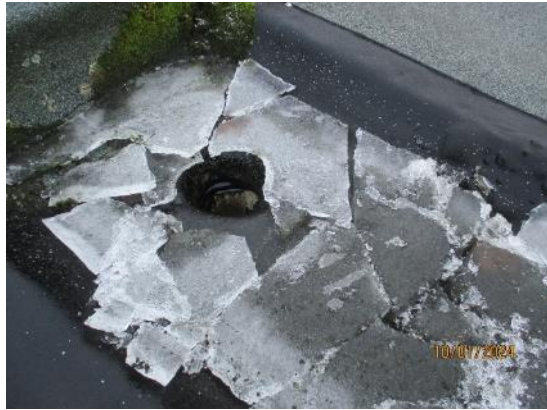
19. Blocked box gutters

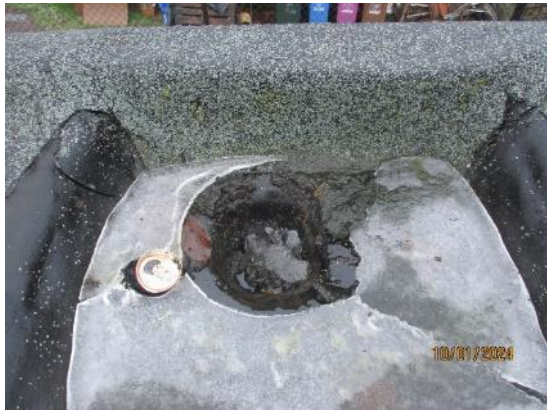
20. Missing balloon gratings

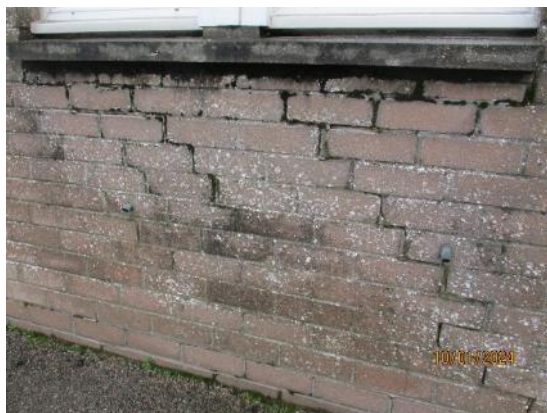
24. Cracking to brickwork walls

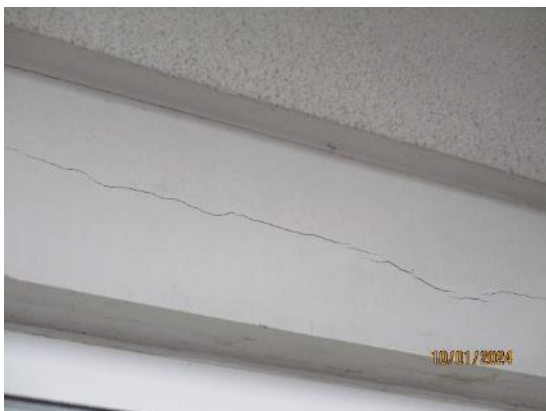
29. Cracked surface of concrete lintels

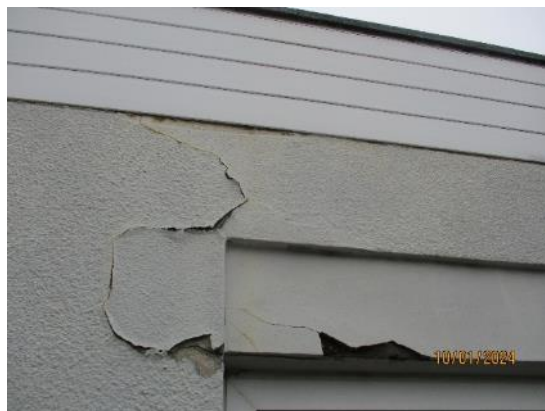
30. Cracking around lintels

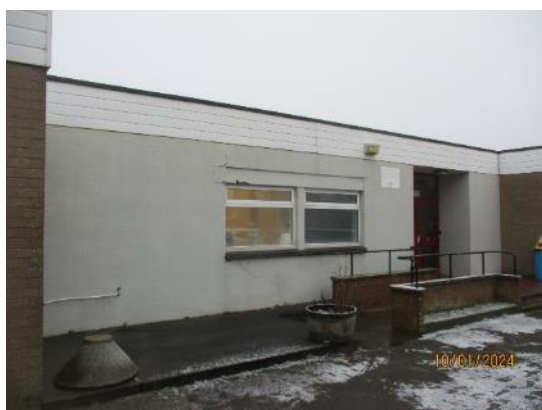
34. Cracked render finish

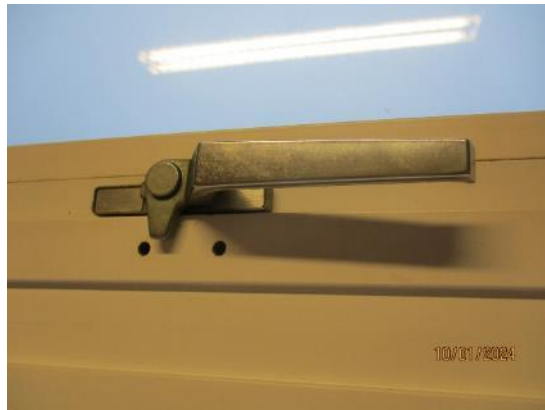
50. Missing keepers

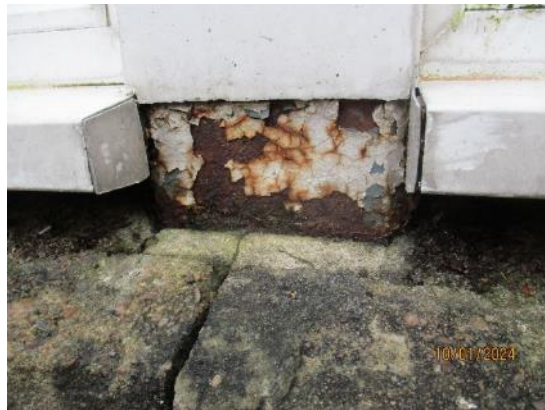
56. Surface corrosion to Courtyard steel frame

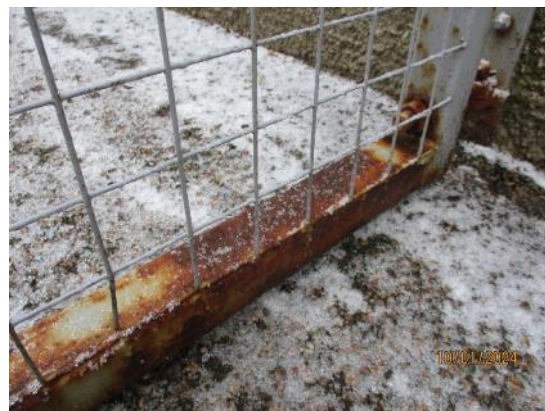
60. Surface corrosion to steel gates

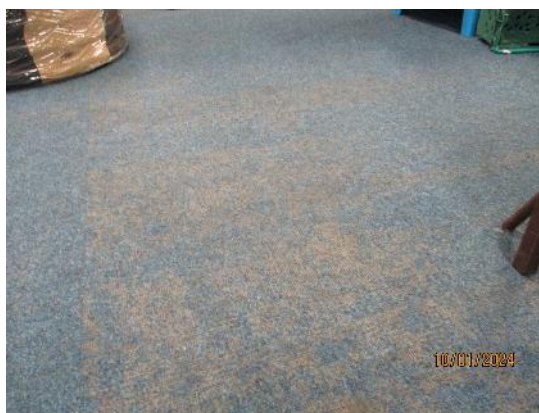
72. Worn carpet

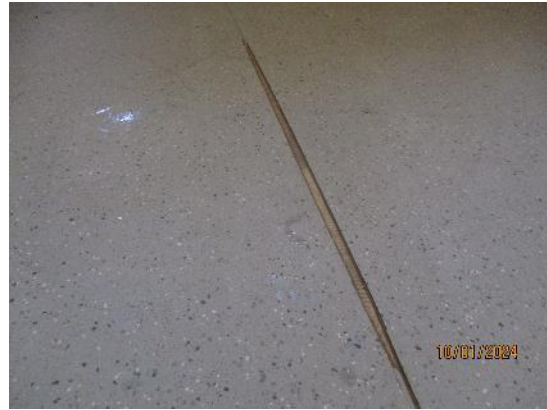
74. Sheet vinyl with open joints

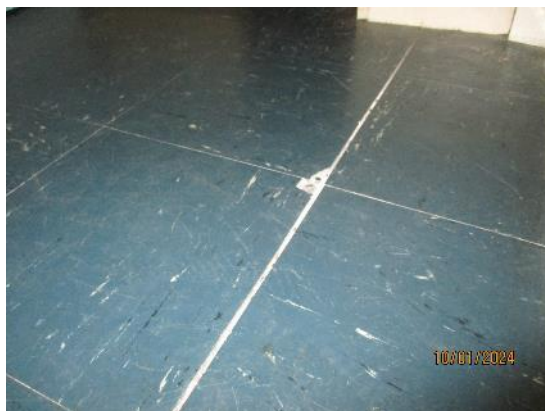
77. Chipped and broken vinyl tiles

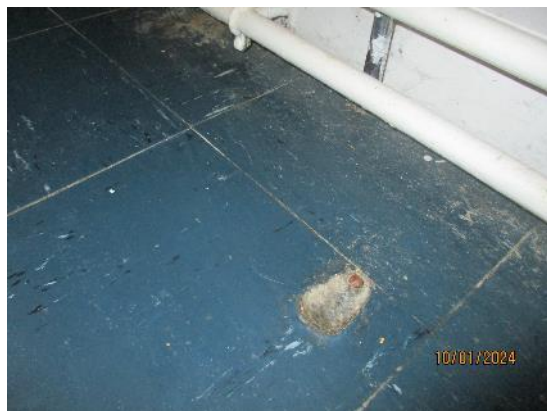
78. Damage to vinyl tiles

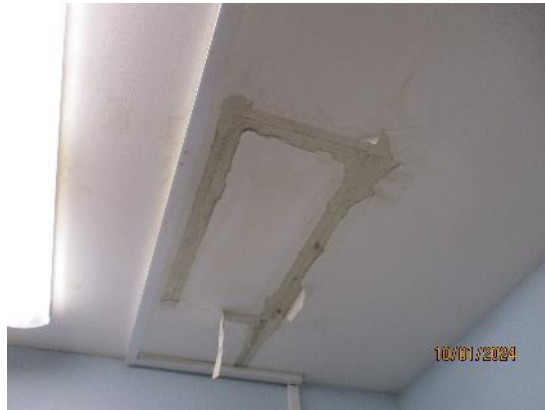
87. Water damaged plasterboard ceiling

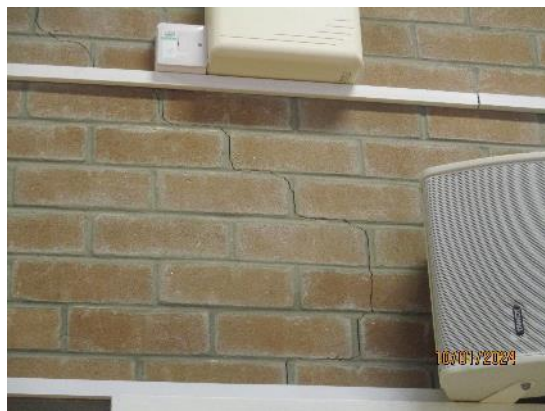
89. Cracking to Games Hall

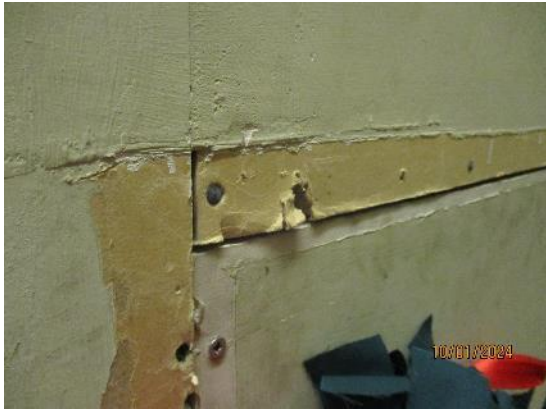
96. Isolated damage in Store Rooms

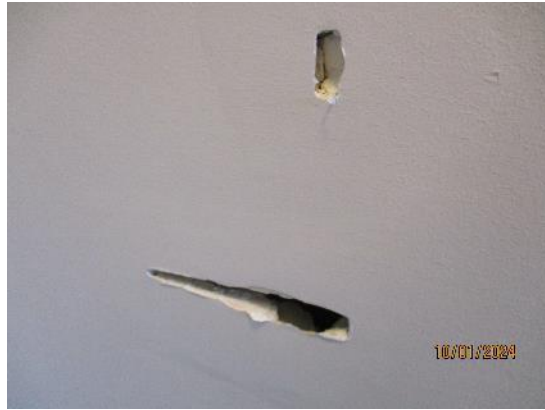
97. Door handle damage to plasterboard

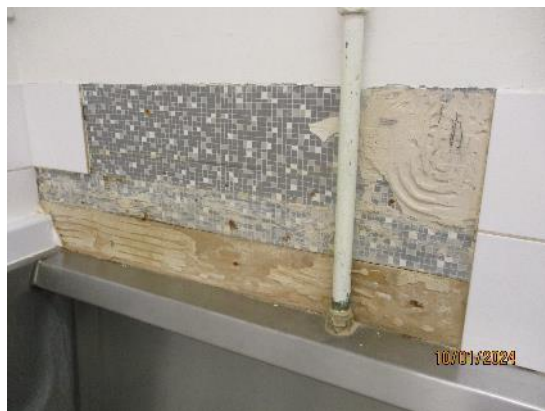
101. Missing ceramic tiles – Boys toilet

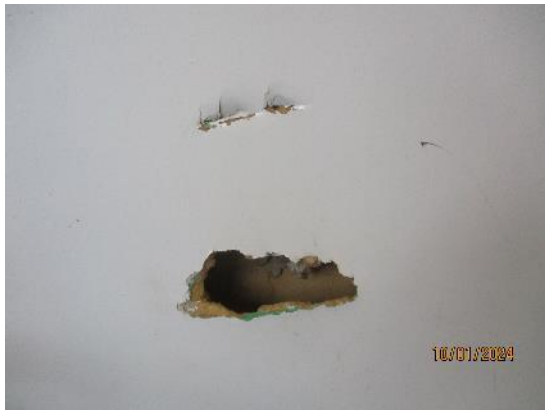
108. Isolated damage to hollow core doors

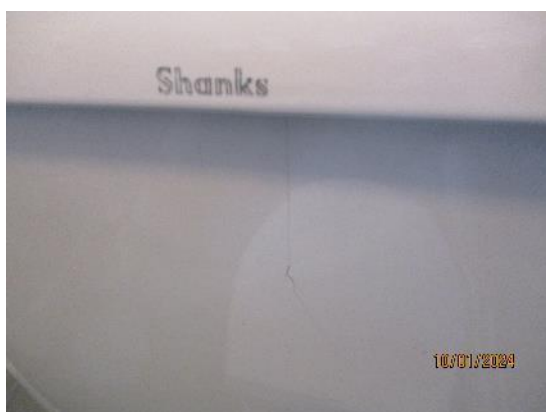
120. Cracked cistern

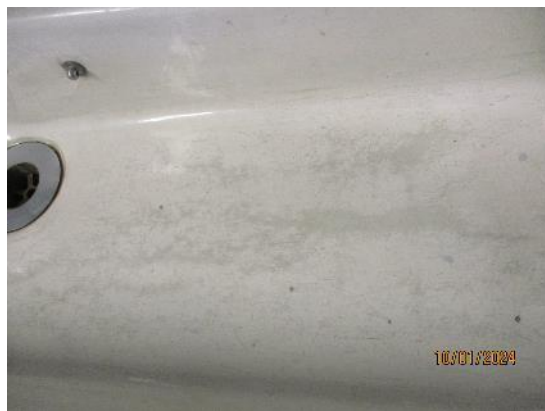
136. Surface wear and erosion

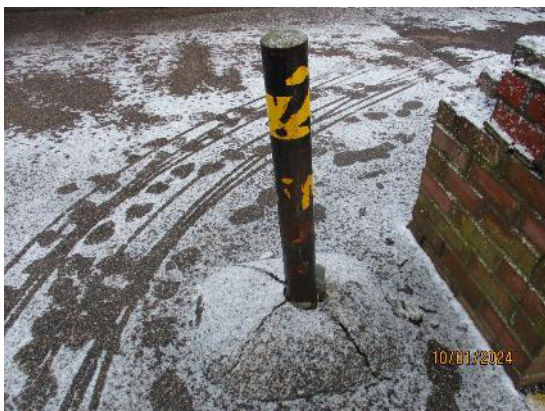
201. Loose steel bollard

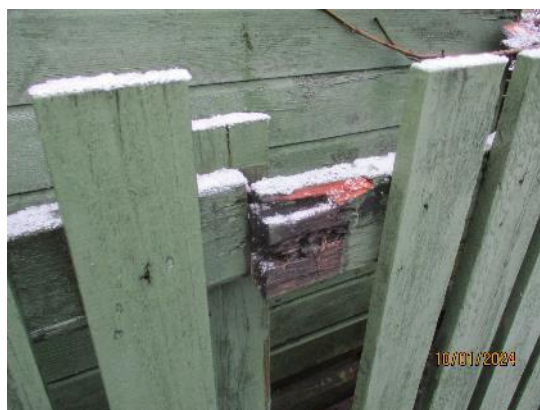
210. Damaged timber fencing

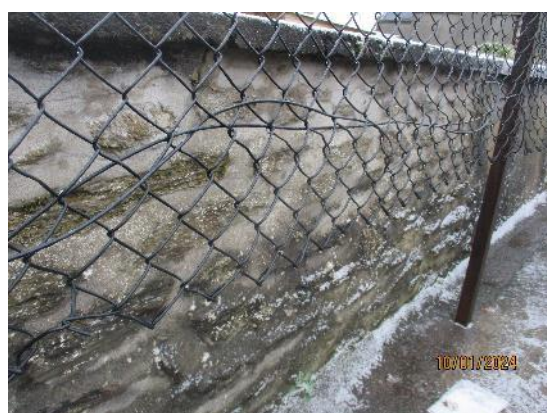
213. Damage to chain link fencing

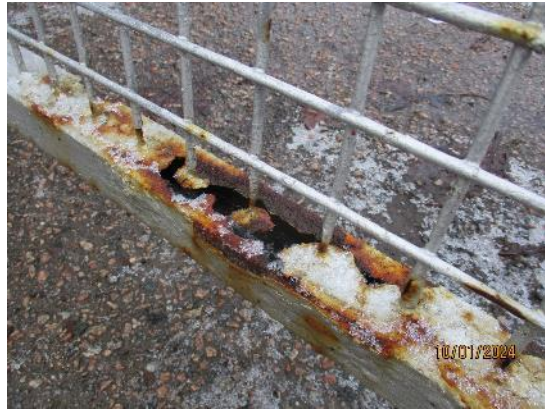
216. Metal frame corrosion

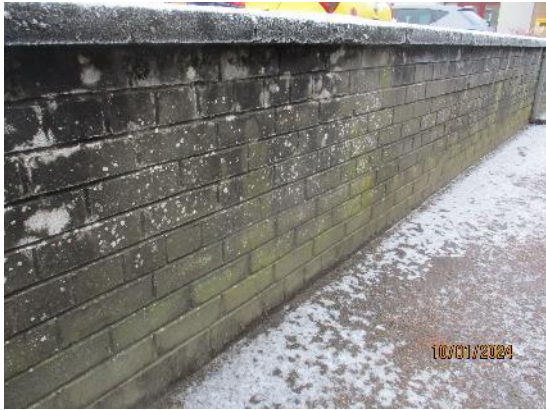
221. Impact damage to brick walls

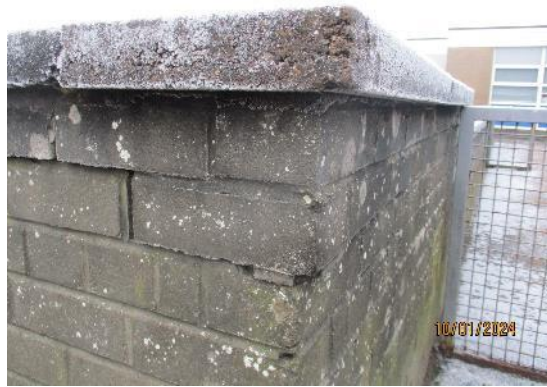
222. Impact damage to brick walls

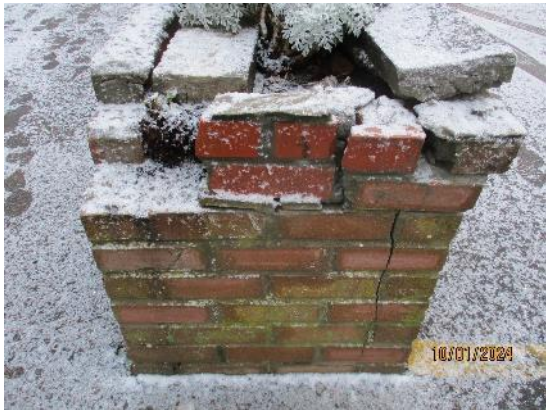
223. Impact damage to brick walls

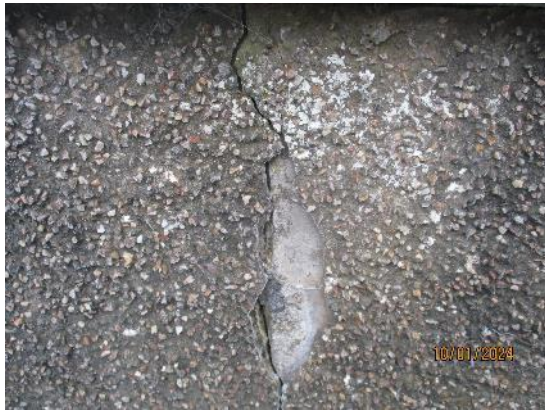
230. Roughcast cracking and spalling
