# **BRIDGE INSPECTION REPORT**

**Client:**  
**Moray Council**

**Site:**  
**Broom of Moy**

Date of Inspection: 15<sup>th</sup> January 2004  
Report Date: 11<sup>th</sup> February 2004

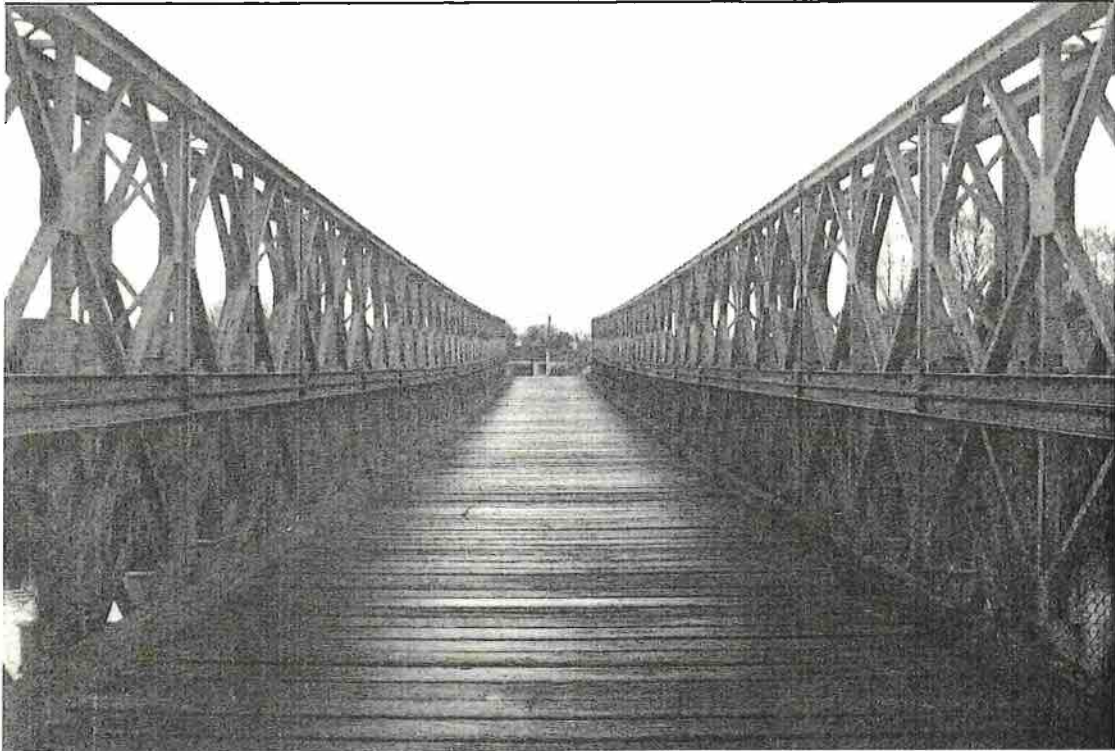
Bridge looks to be in a reasonable condition, there are no major signs of corrosion on the steelwork and all major components are still present.  
Some of the timber decking has rotted away leaving holes in the timber chesses.  
A sag of 300mm approx is present in the bridge.

Showing deflection of the bridge

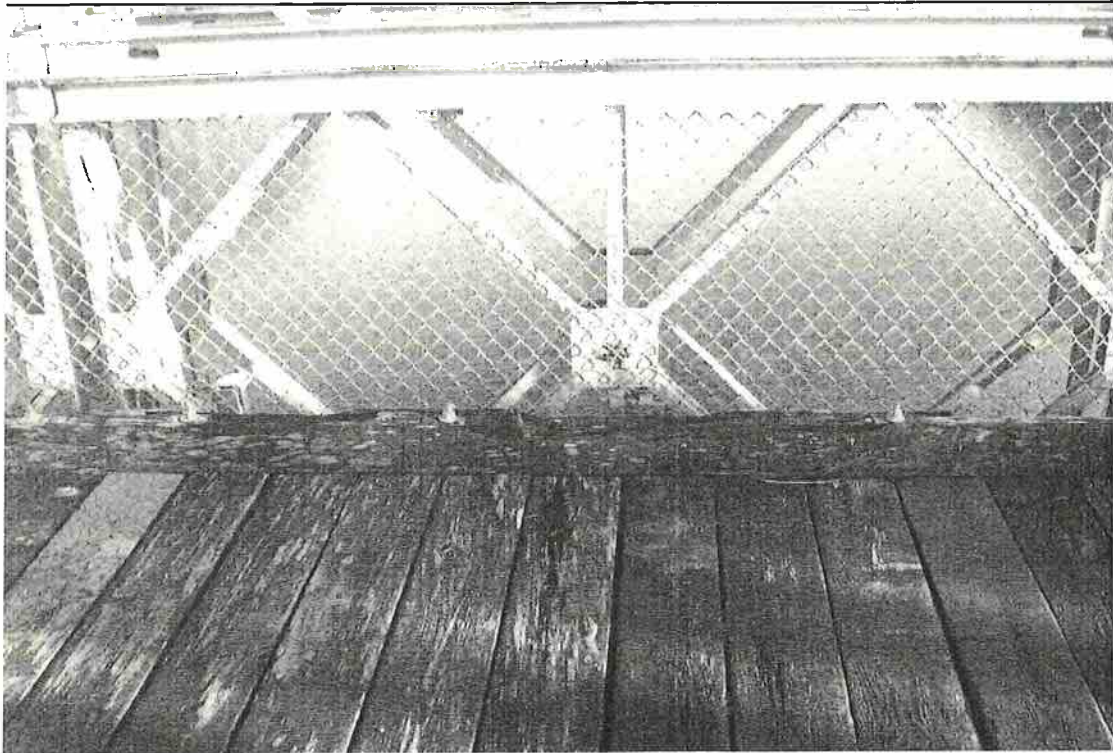
The chesses are deteriorating and need to be individually assessed for condition, and replaced as necessary. All chesses are splitting horizontally at the ends and some have quite sizable holes through the decks.

These also are deteriorating and need to be individually assessed for condition, and replaced as necessary.

Showing condition of the ribands and the timber chesses

- i) Replacement of timber chesses and ribands as necessary.
- ii) A visual inspection of the stringers when replacing timber chesses.
- iii) Fully clear all bearings of debris, clean and check for excessive rusting. Apply a surface protection.
- iv) Clean all surfaces of the bridge and apply a protective coating to minimise further deterioration of the structure.

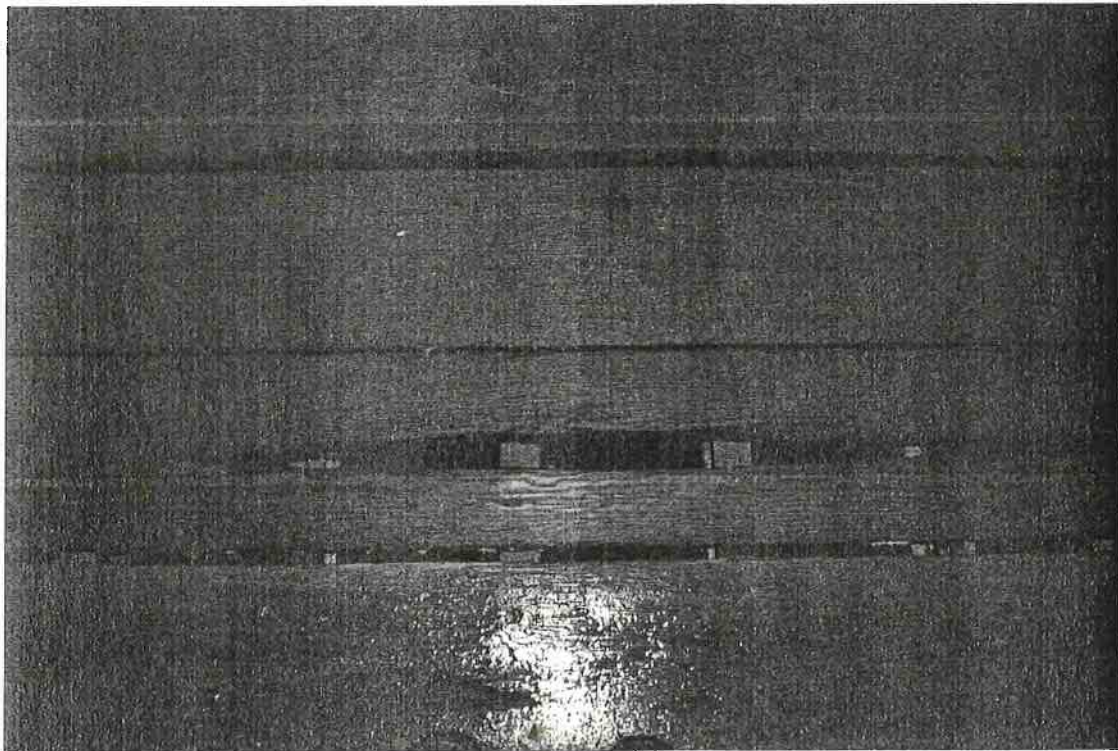
Showing holes in the timber chesses

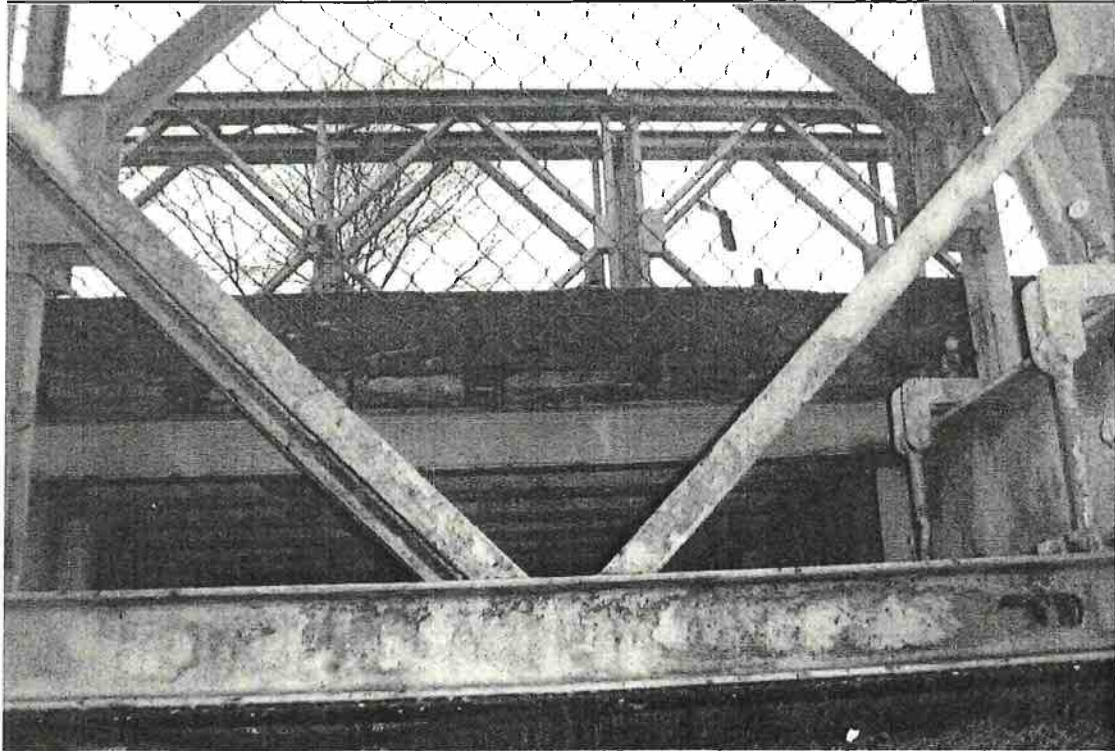
Showing horizontal splits in the end of the timber chesses

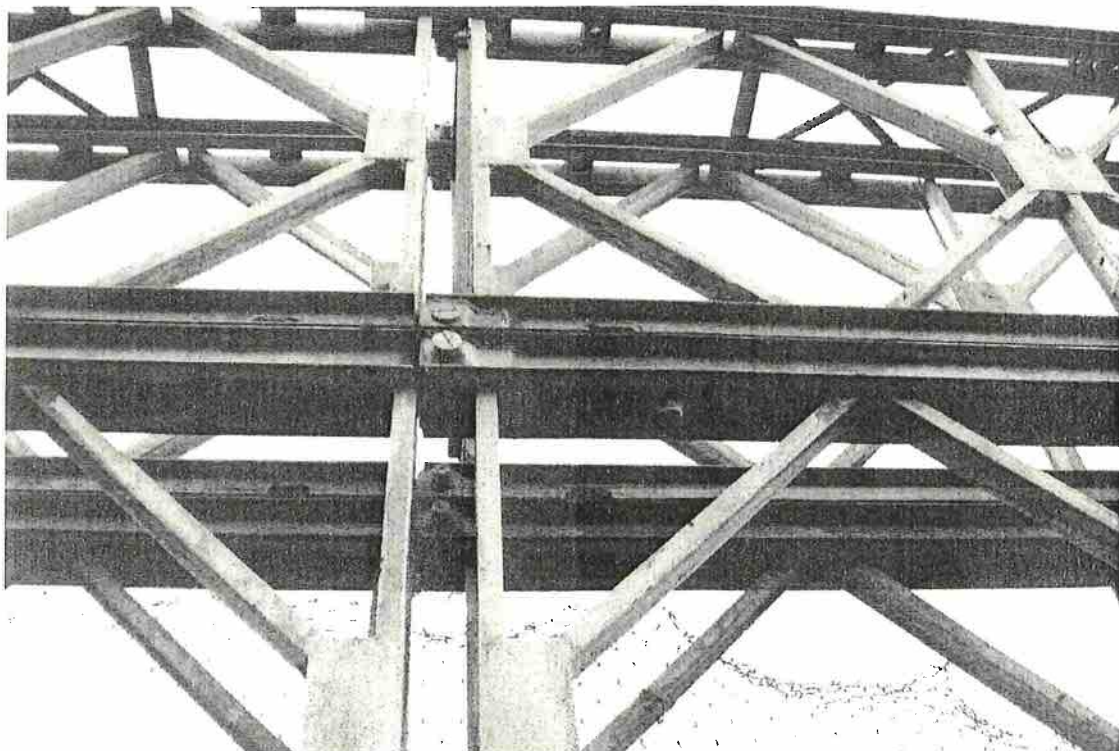
All but one panel pin is in position, although no safety clips are present throughout the bridge. One pin on the outside North truss has not been fully inserted. All pins are coated in paint and are in a good condition.

Showing pin not fully inserted on North truss

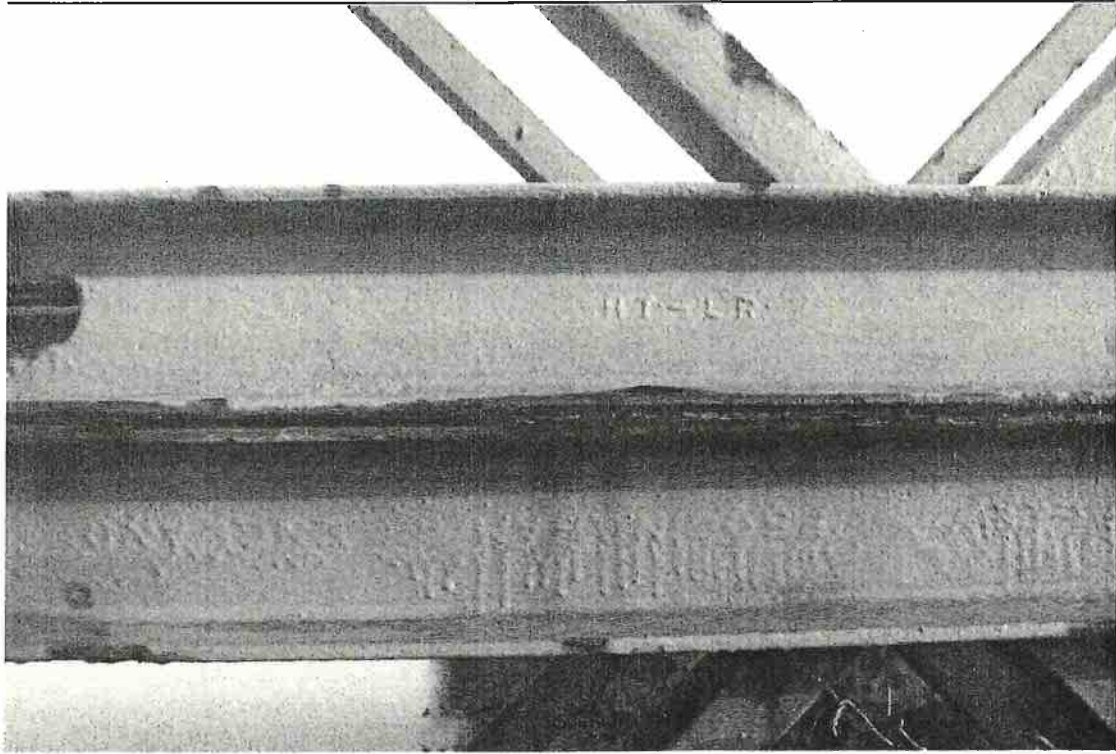
All panels look to be generally in a good condition. The surface coating has been applied fairly thickly and is protecting most of the steelwork. Where the surfacing coating has been chipped off ie at the junction where the chords of the double story panels meet, there has been some corrosion.

Showing extent of corrosion where the bottom panel meets the top panel.

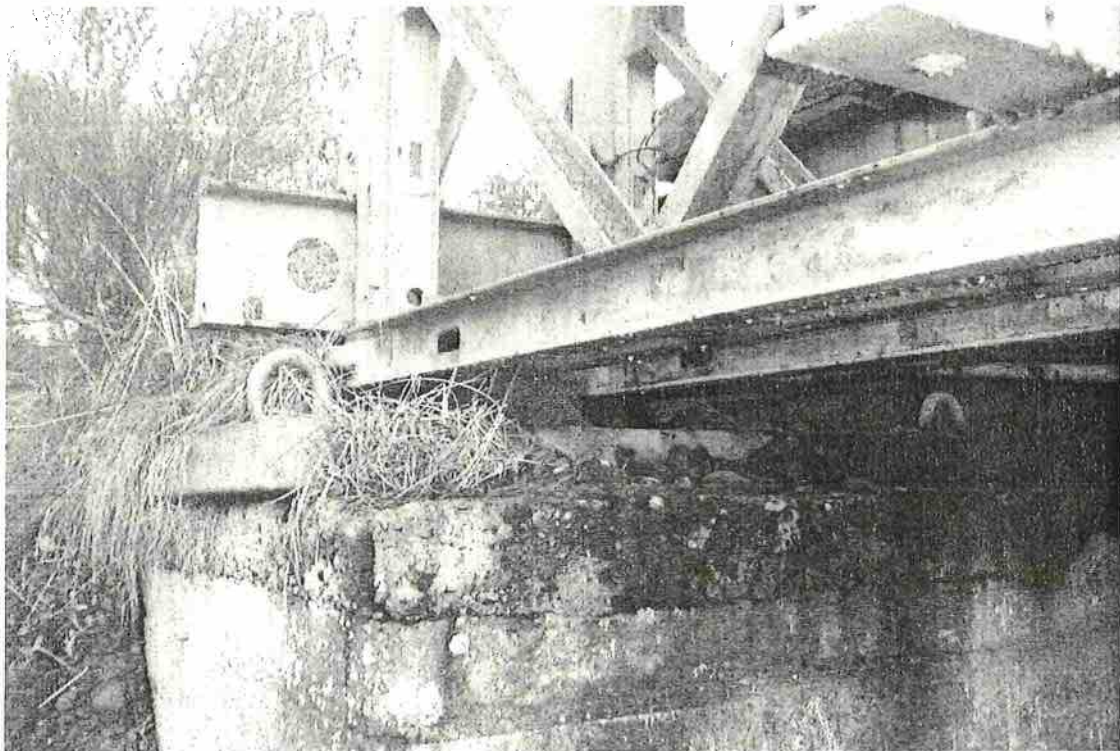
There is not too much debris present around the two ends of the bridge. This has allowed the air to flow around the bearings/lower part of the panels and along with the surface coating has resulted in little corrosion.

Debris prevented an assessment of the likely movement of bearings due to temperature effects.

Showing bearingsa

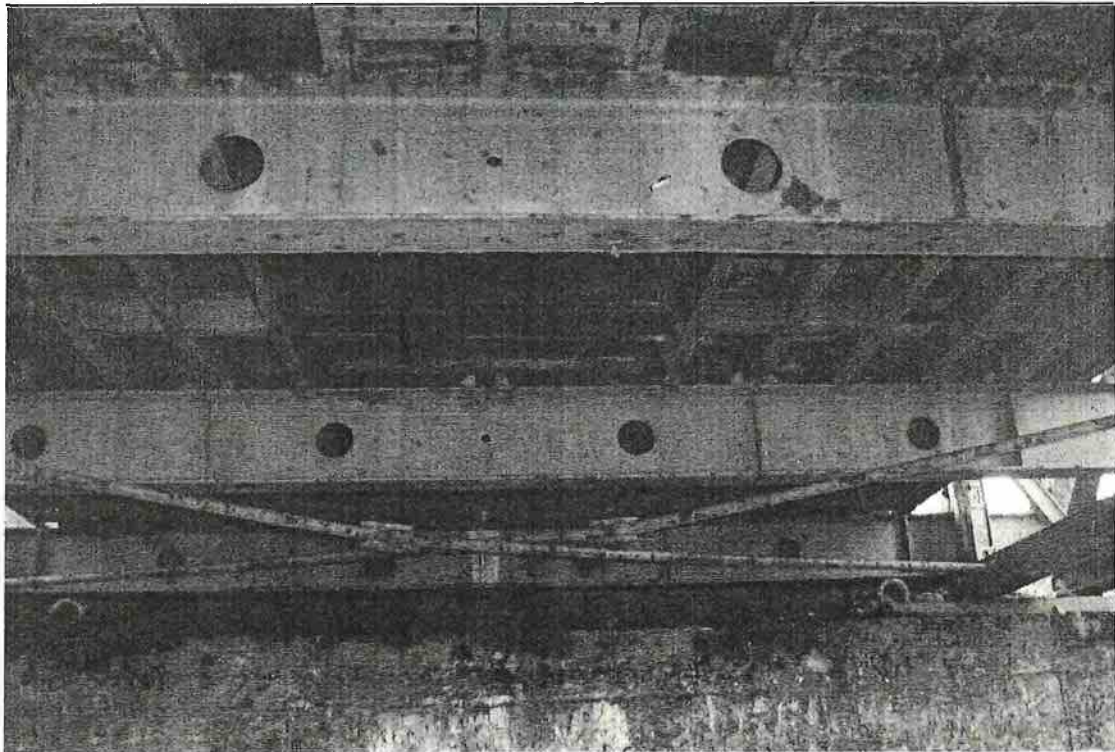
The swaybraces are all present and most are tight. The turnbuckles which allow adjustment of the braces are likely to be completely seized.

One middle stringer has been removed at the East (female) end to allow a steel post to be welded onto the transom.

Showing missing stringer and transom/swaybrace condition

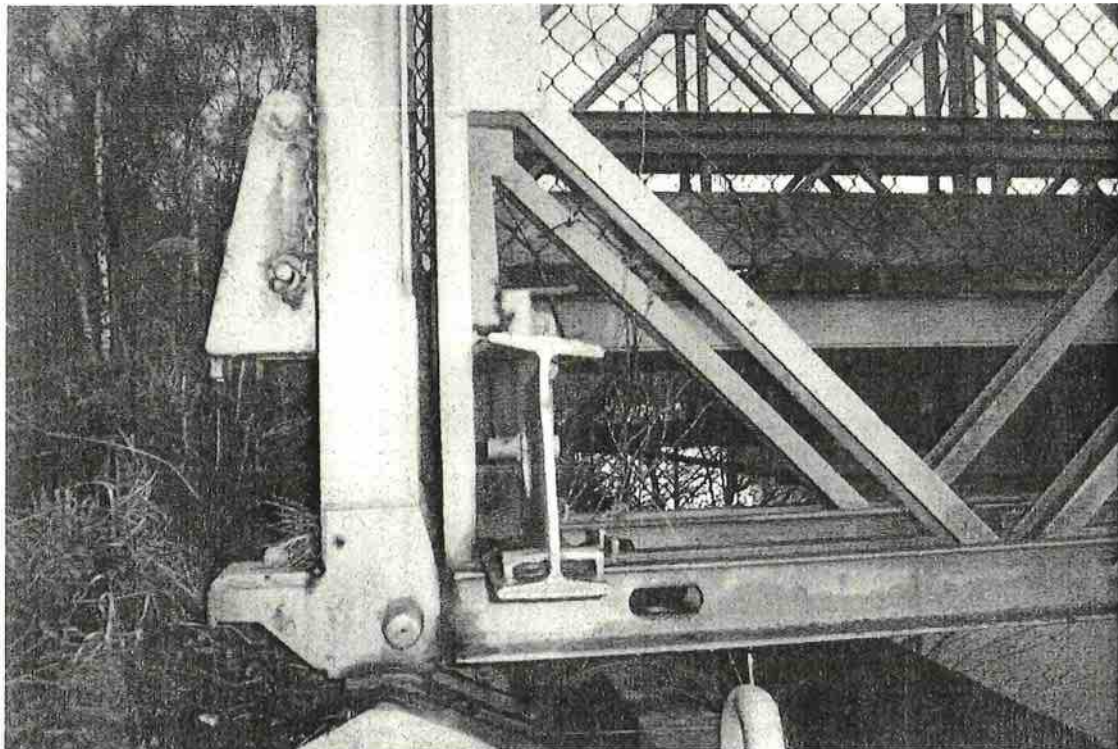
The 1<sup>st</sup> transom on the West side has a bent top flange that has resulted in the web bending slightly at the top. This was probably done while the transom was in service on another bridge or during erection.

Showing bent top flange of the male end transom
