# **Summary Building Condition Survey Report**

**Botriphnie Primary School  
Drummuir, Keith AB55 5JF**

**28<sup>th</sup> August 2023**

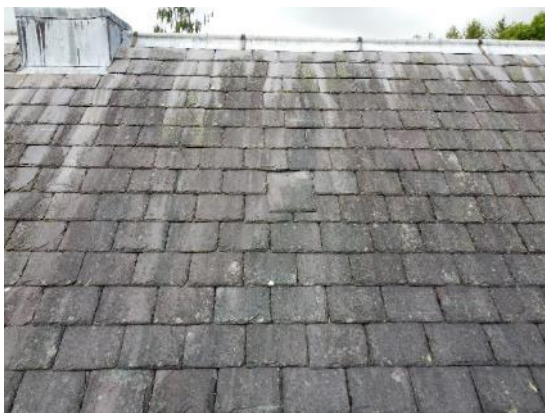
10. Isolated slipped slates

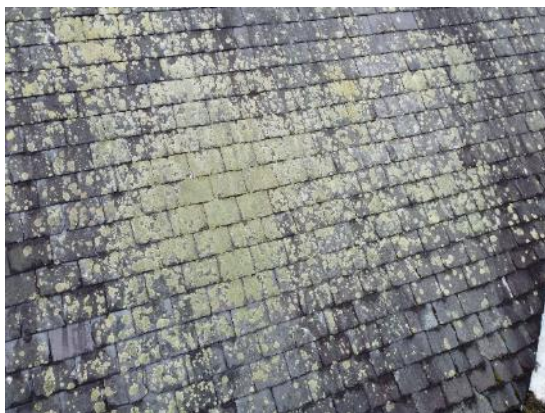
11. Isolated slipped slates

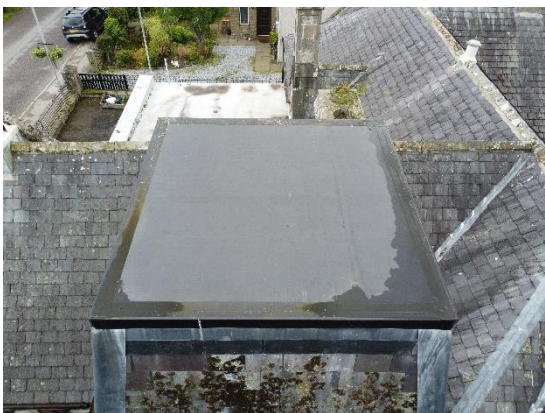
16. Blistered GRP roof with ponding

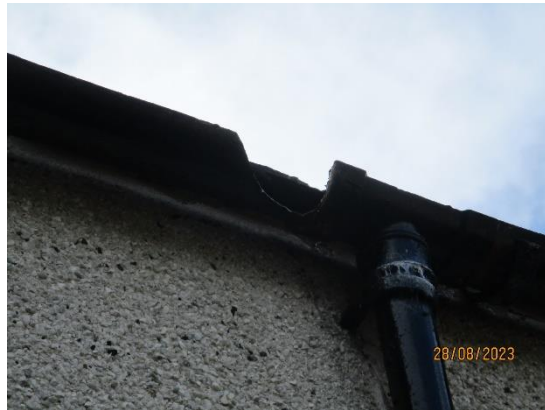
21. Gutters with isolated blockages

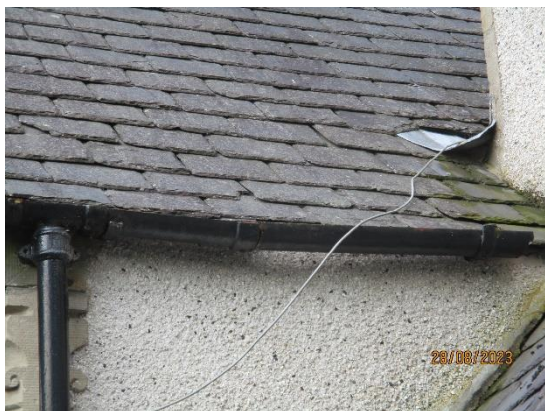
22. Broken section of cast iron gutter

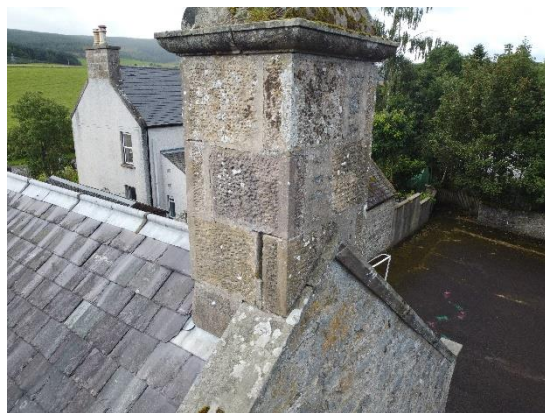
29. Chimney heads requiring repointing

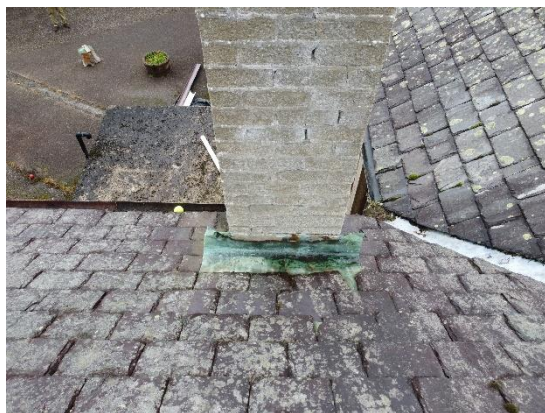
35. Defective flashing to boiler flue

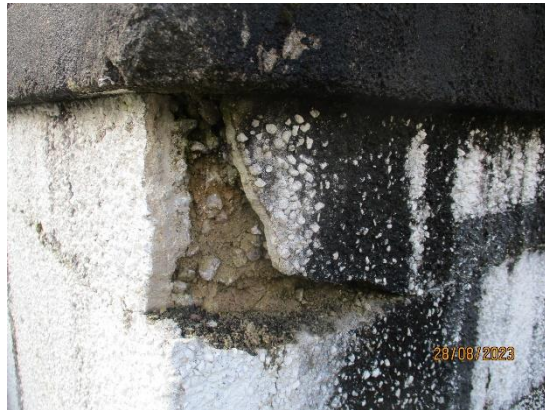
46. Damaged roughcast to Boiler Room

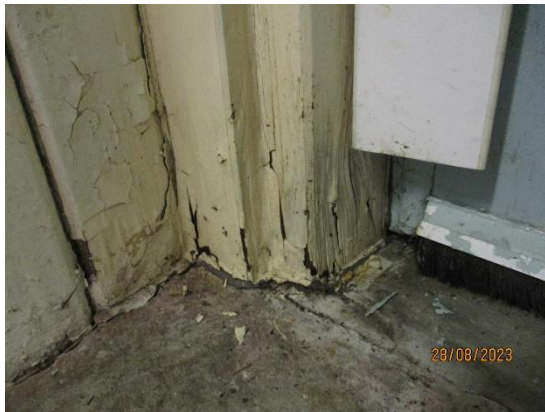
49. Rot in timber doors and frames

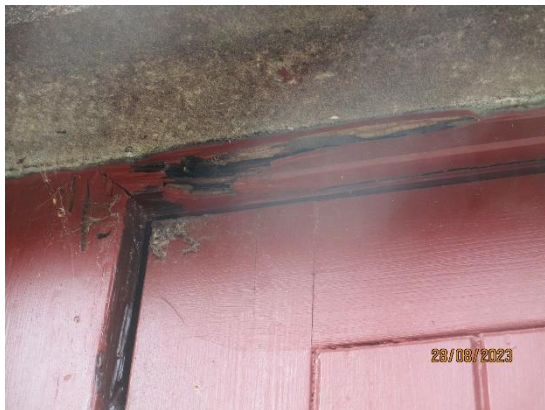
52. Extensive wet rot in timber frames

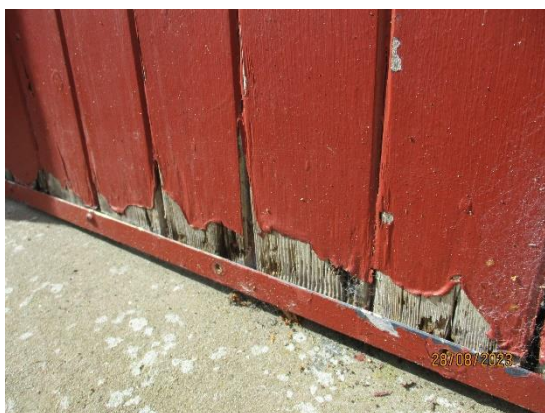
53. Rot in timber TG&V doors

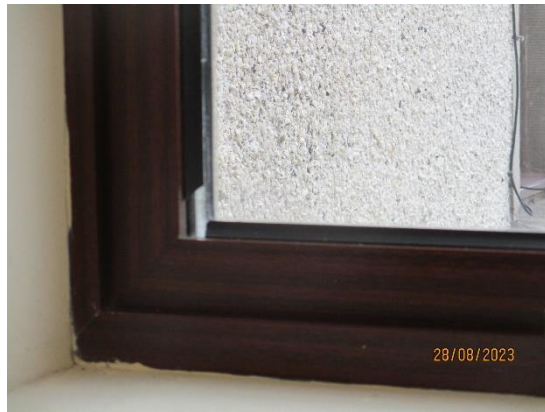
56. Seals failing to double glazed units

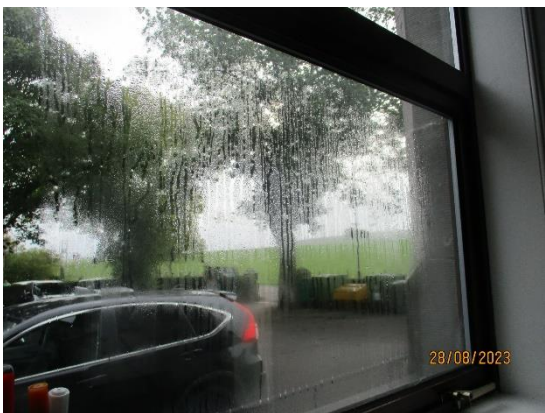
59. Double glazing units fogged with condensation

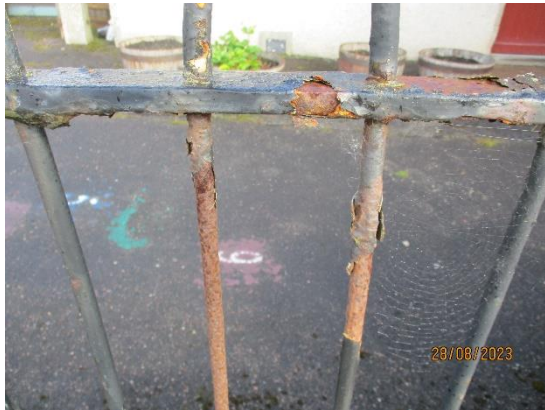
63. Surface corrosion to metal railings

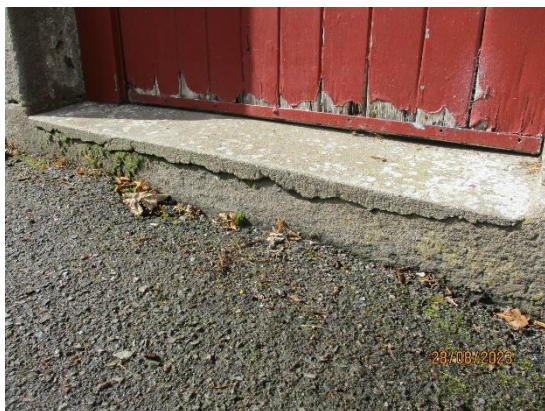
65. Spalling render to concrete steps

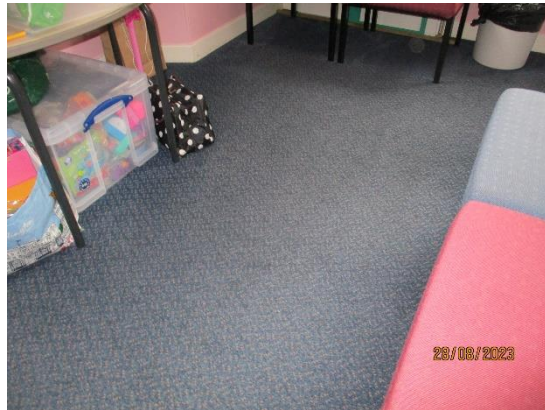
75. Isolated surface wear

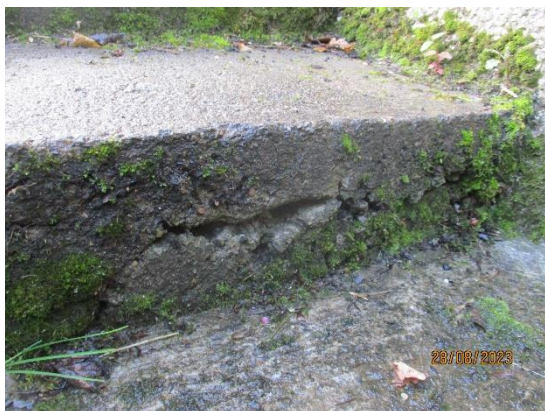
77. Cracked steps to Boiler Room

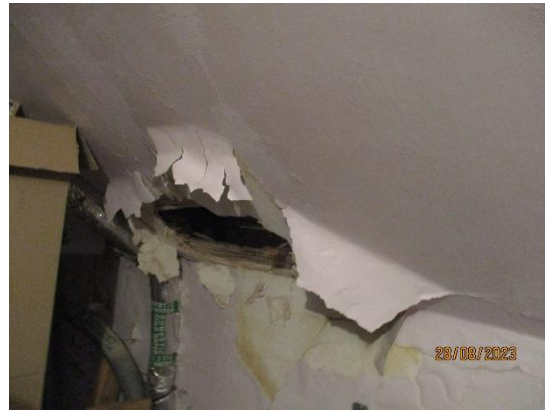
81. Damaged plaster in isolated areas

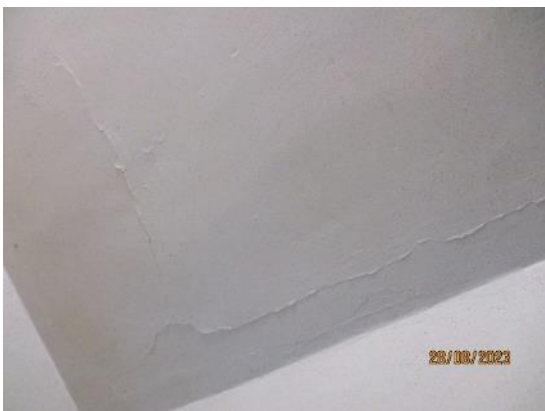
82. Cracking to lath & plaster ceilings

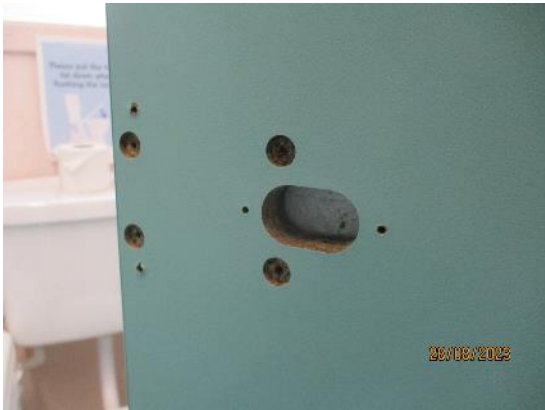
109. Defective and replacement latch mechanism

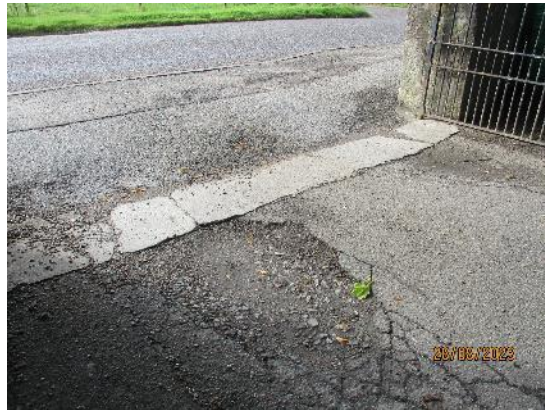
172. Potholes and cracking

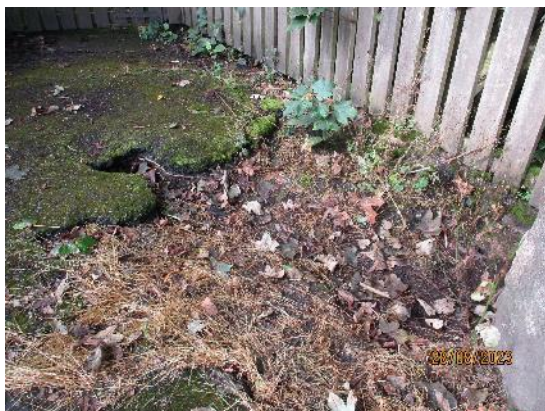
174. Holes and cracks in tarmac surface

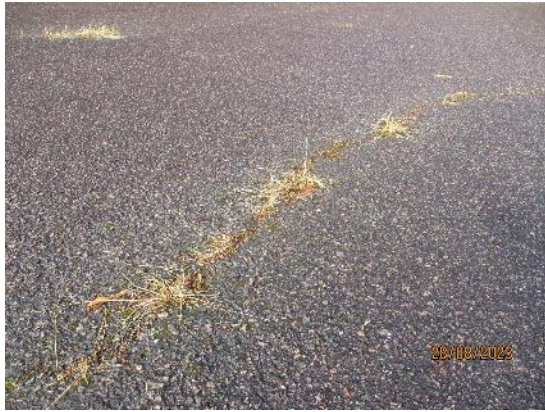
175. Cracked tarmacadam surface

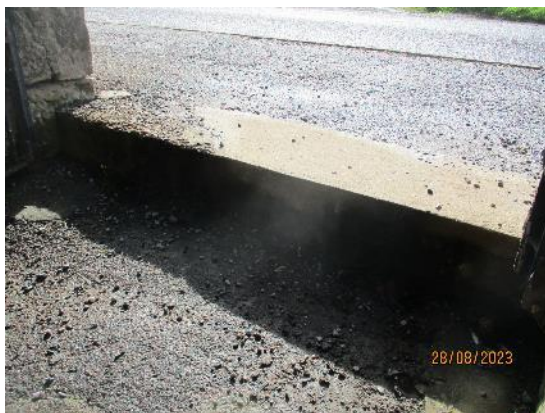
179. Cracked concrete step at entrance

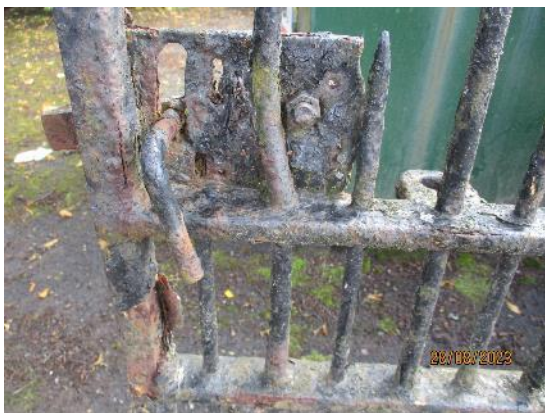
185. Corroded, damaged gates

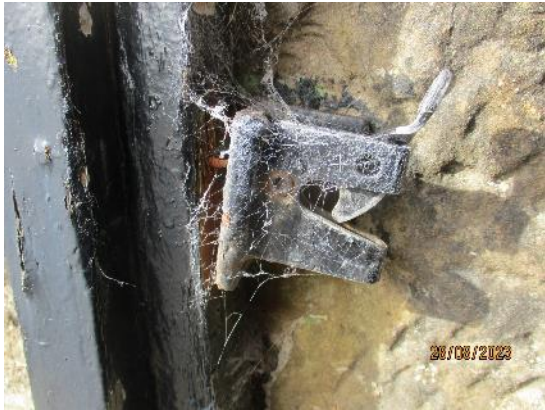
187. Defective damaged gate ironmongery

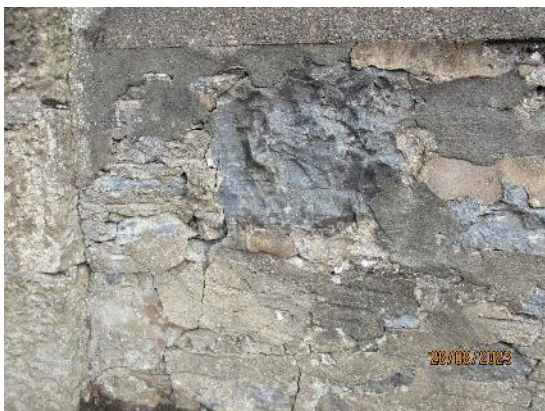
191. Isolated cracking, pointing required

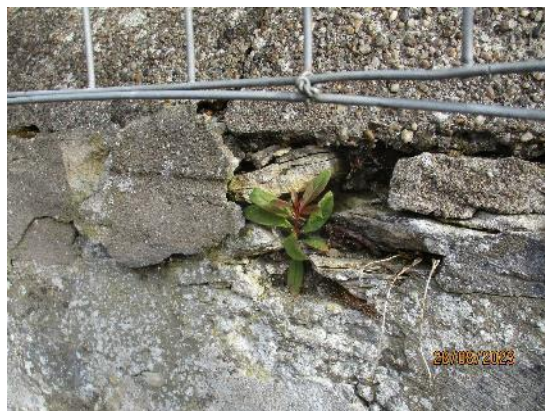
192. Isolated surface erosion

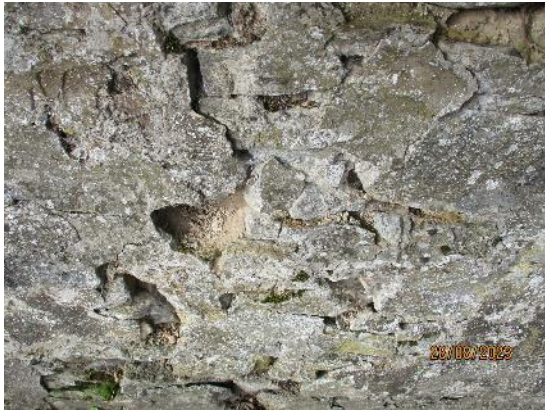
193. Stone wall repairs required

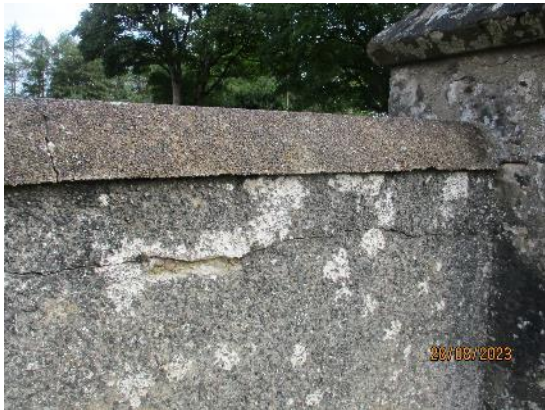
195. Cracks and spalling roughcast
