# **Summary Building Condition Survey Report**

**Keith Grammar School and Leisure Centre  
School Road, Keith AB55 5GS**

**9<sup>th</sup> to 12<sup>th</sup> October 2023 and 22<sup>nd</sup> to 25<sup>th</sup> January 2024**

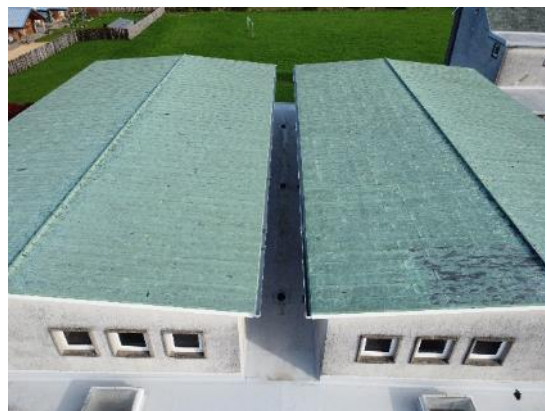
11. Slipped and broken slates

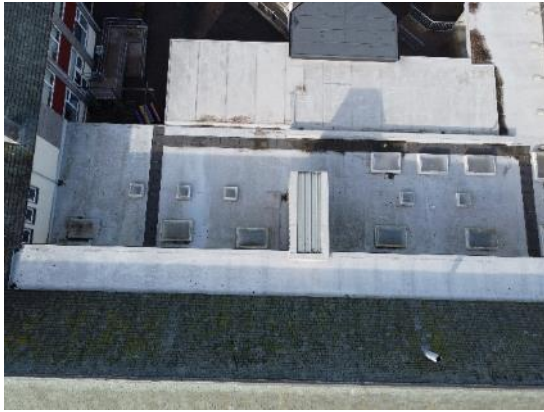
18. Damaged asbestos roofs

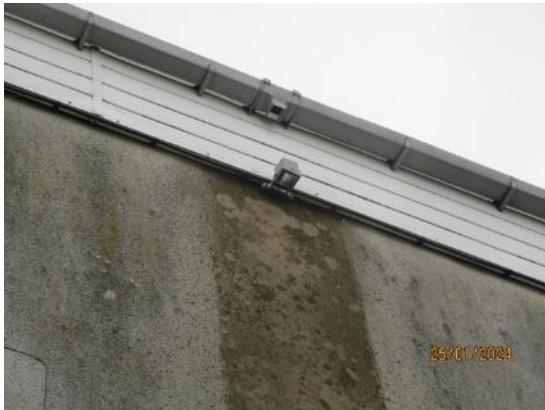
68. UPVC downpipes insecure – Leisure Centre

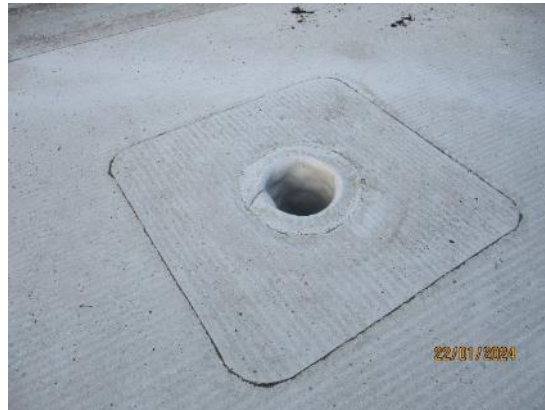
69. Leisure Centre downpipes missing

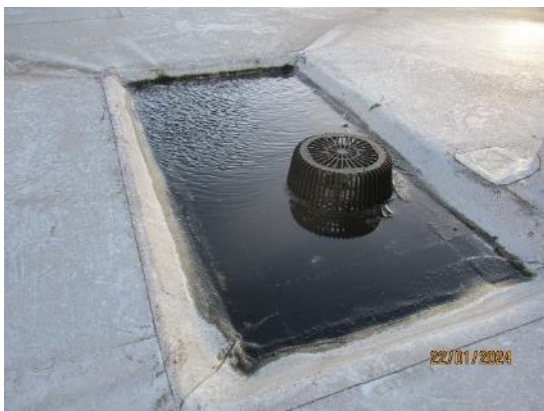
70. Internal downpipes missing balloon gratings

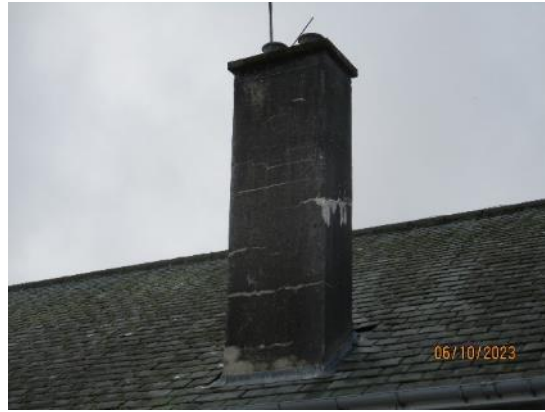
73. Clay pots are open

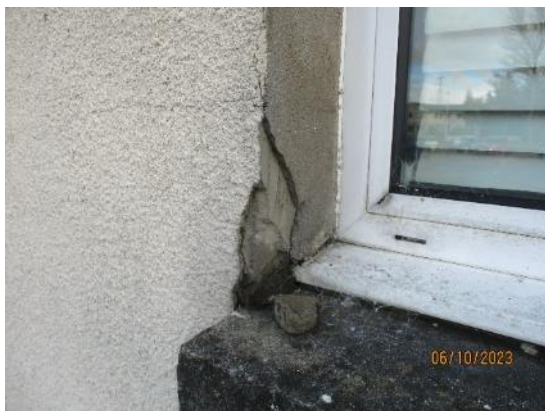
76. Roughcast walls

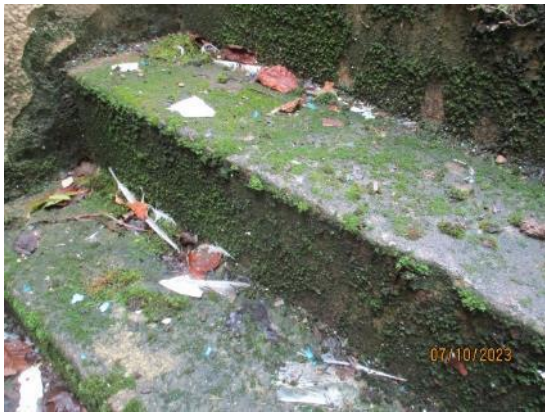
136. Concrete steps to boiler room

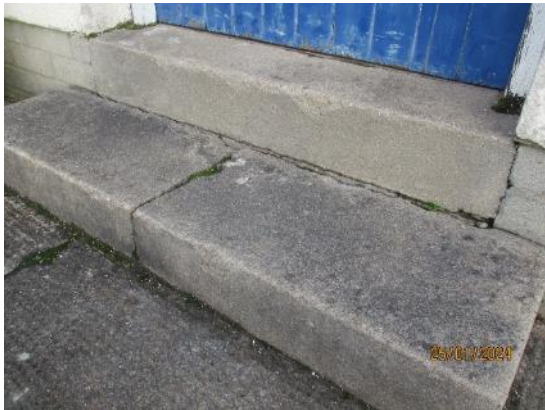
138. Concrete steps to Leisure Centre staff room

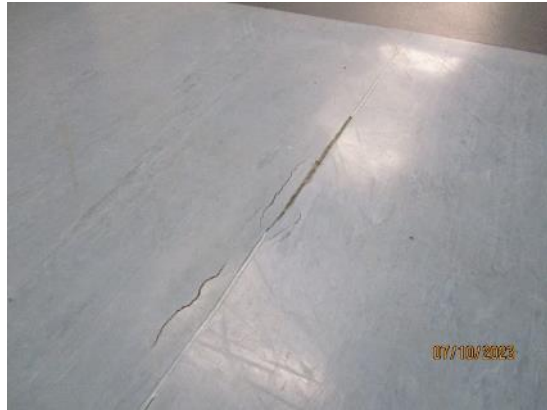
149. Sheet vinyl/lino - School

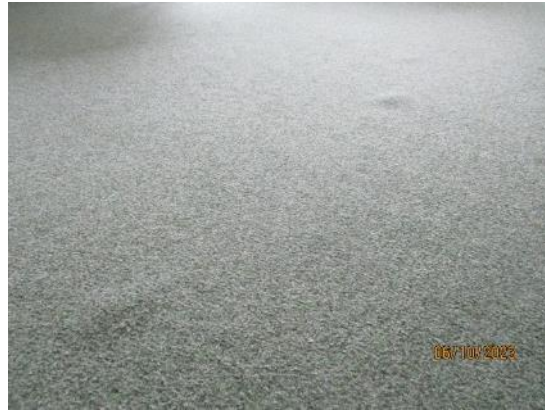
155. Isolated damage

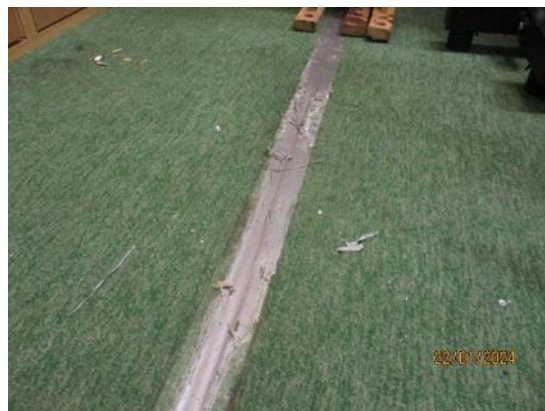
164. Carpet floor finish – Leisure Centre

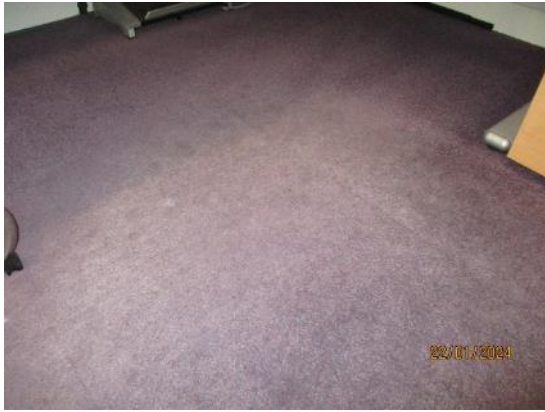
165. Damaged carpet

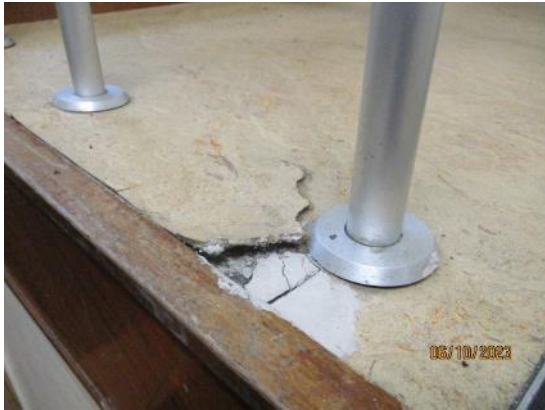
183. Vinyl treads and risers - School

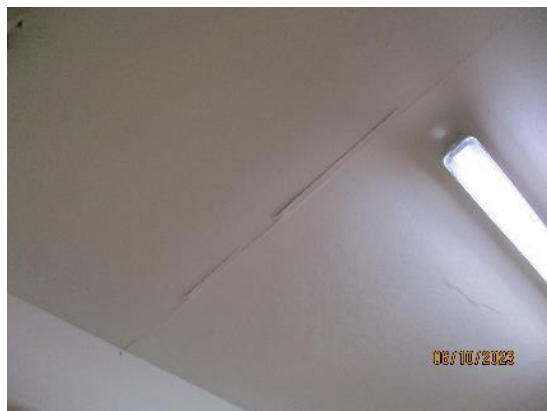
204. Plaster/plasterboard ceilings - School

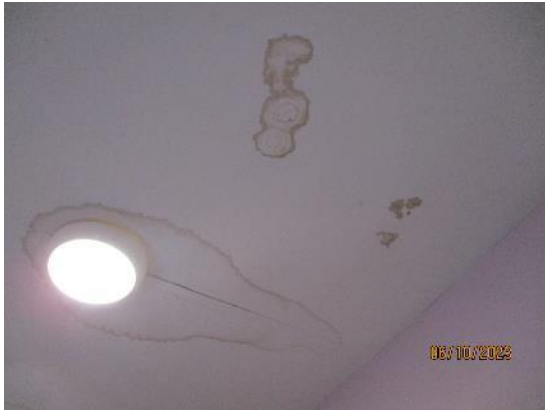
205. Failed taped joints

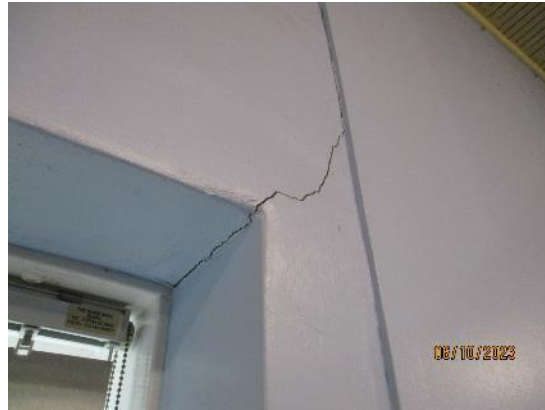
224. Plaster internal linings - School

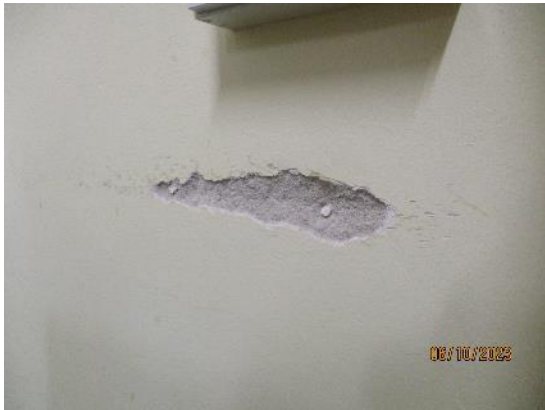
225. Cracked plaster

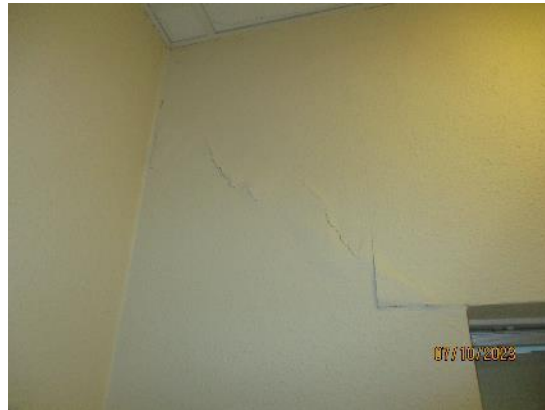
226. Impact damage

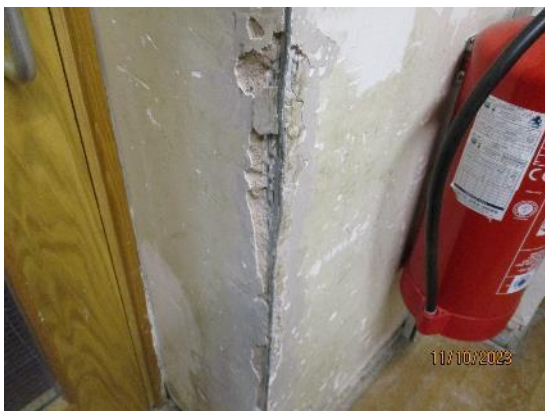
227. Cracked plasterboard walls

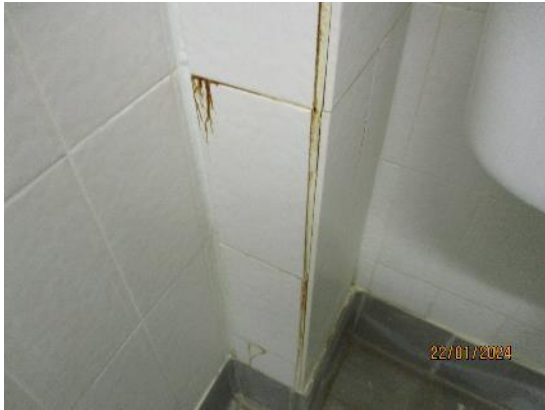
247. Ceramic tiles around the pool

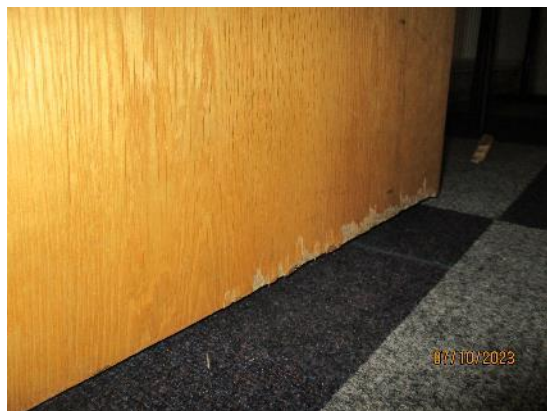
258. Varnished timber doors

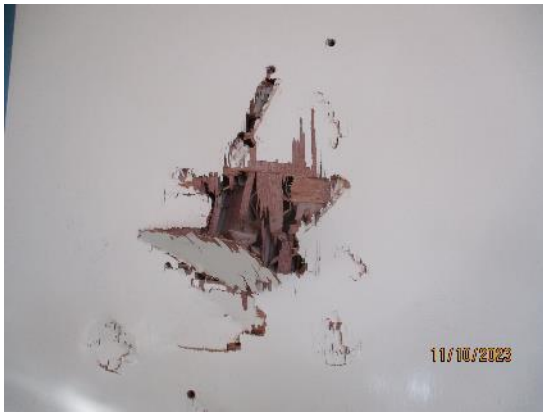
259. Damaged face

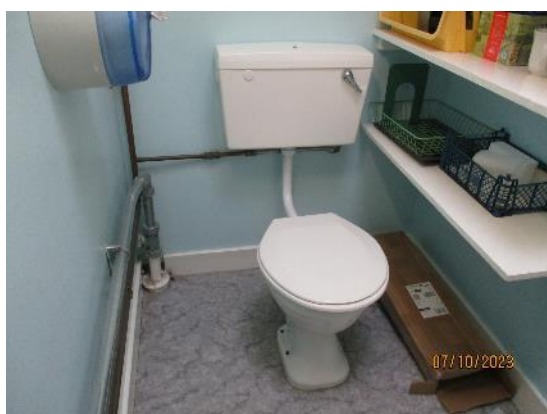
282. School W.C.'s

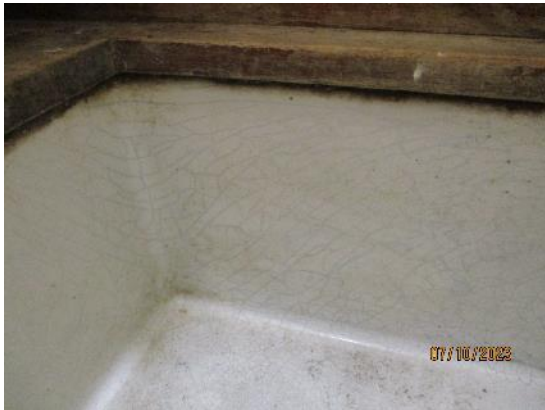
314. Cleaners Butler sinks

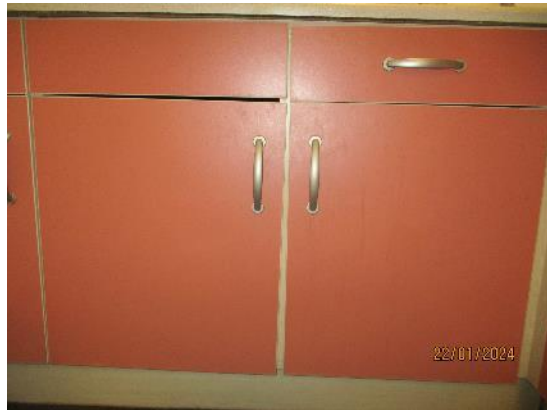
344. Missing base units

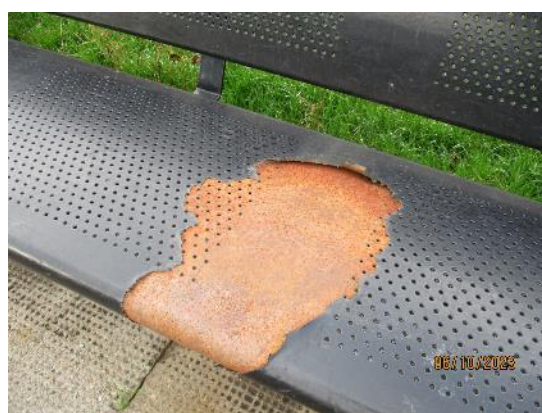
516. Metal benches

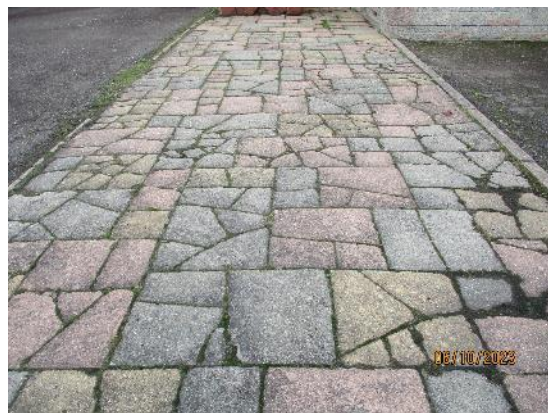
522. Moss growth on footpaths

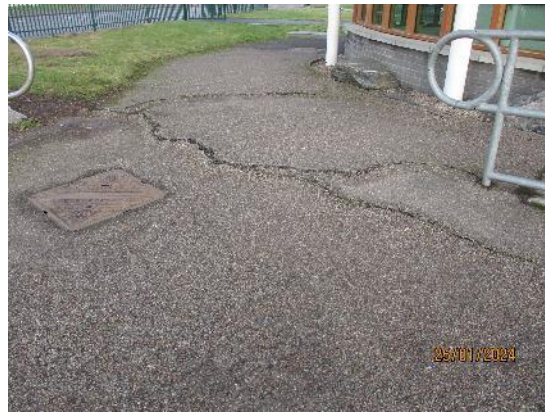
524. Tarmacadam footpath – Leisure Centre

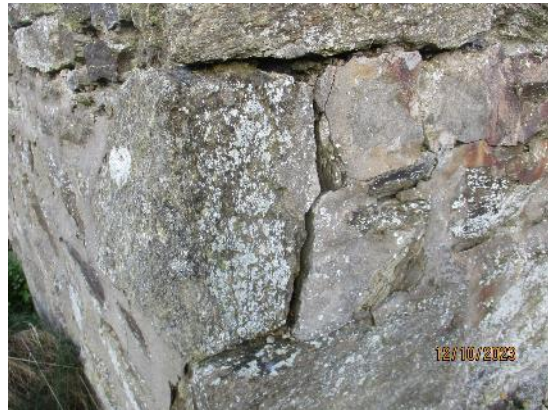
538. High stone wall to rear
