# **Summary Building Condition Survey Report**

**Rothiemay Primary School  
Main Street, Rothiemay AB54 7LT**

**25<sup>th</sup> September 2023**

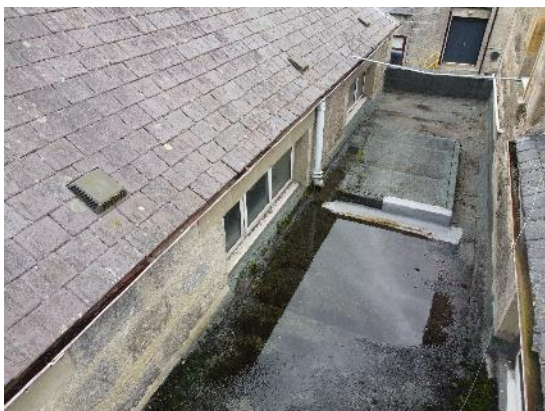
11. Inadequate falls causing ponding

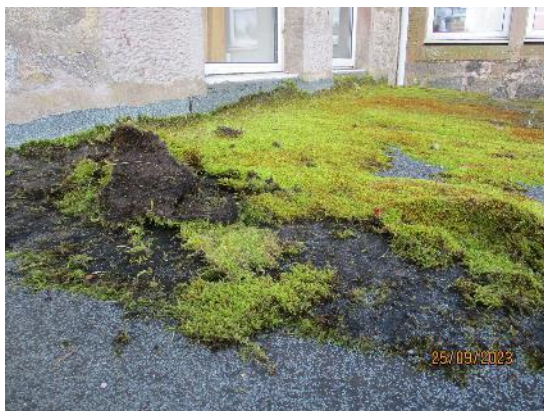
12. Felt roof to Boiler Room has extensive moss growth

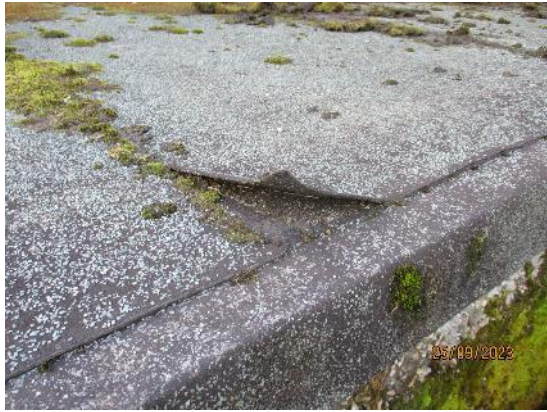
13. Felt lifting at edges

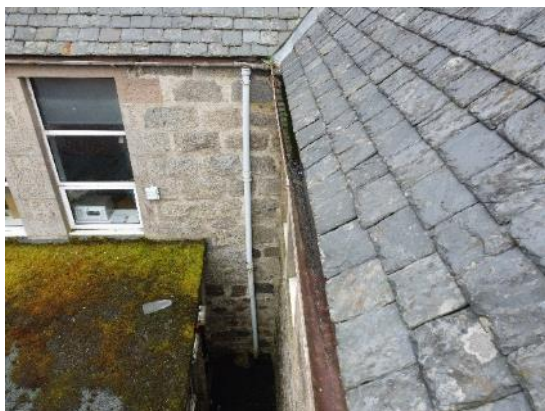
23. Corroded cast iron gutters

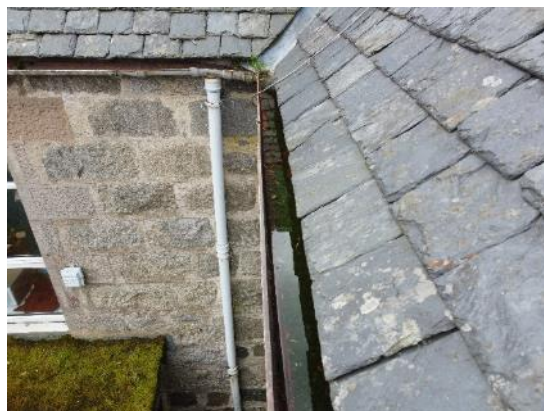
24. Ponding

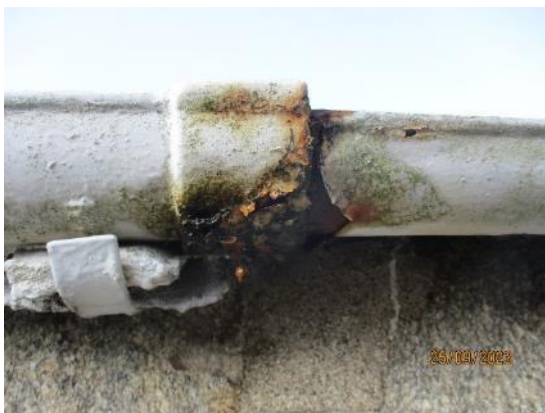
29. Corroded, leaking cast iron gutters

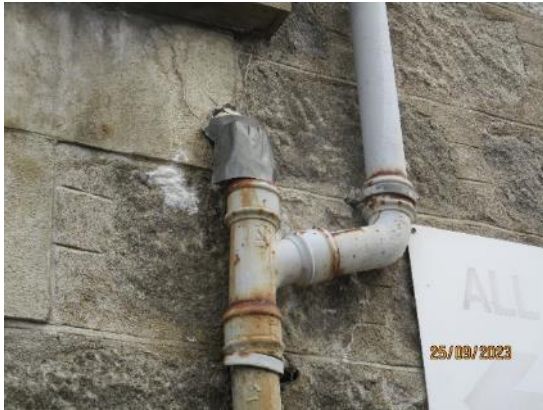
31. Patch repair to cast iron downpipe

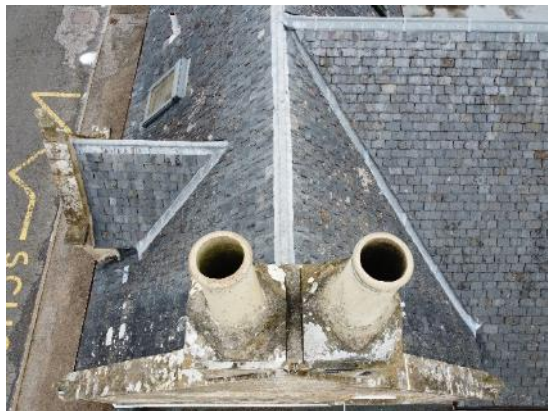
36. Open, uncapped chimney pots

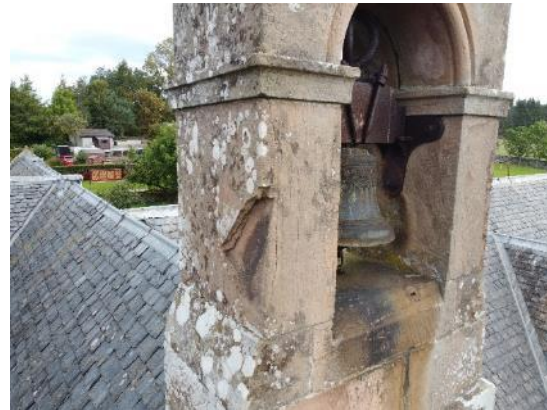
40. Cracked/spalling stonework

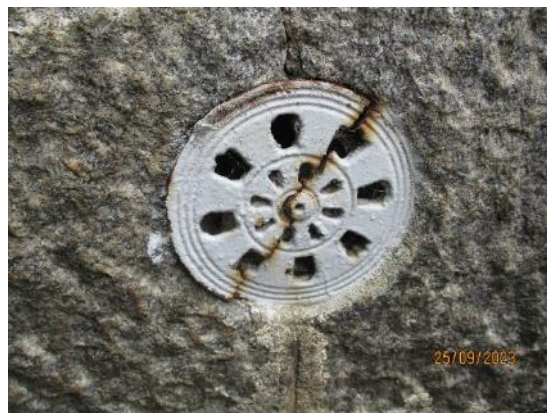
42. Broken vent covers

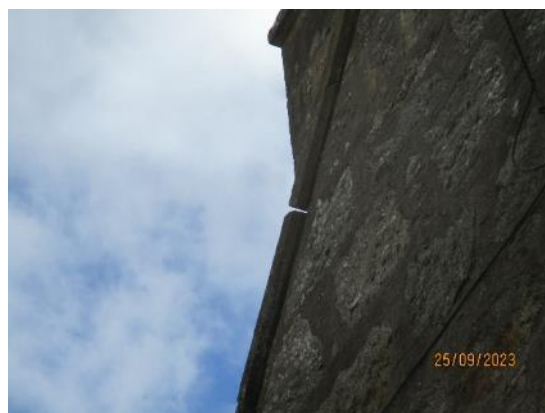
48. Repointing of skew stones

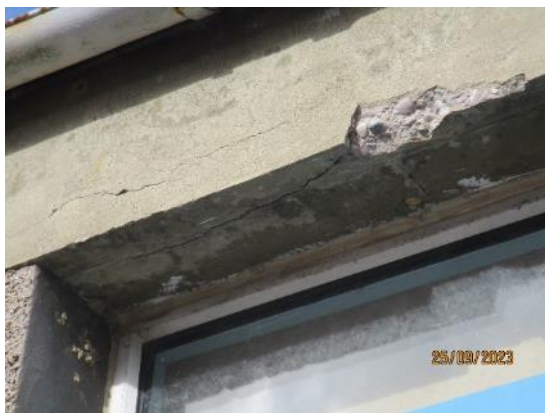
53. Cracked and spalling concrete lintels

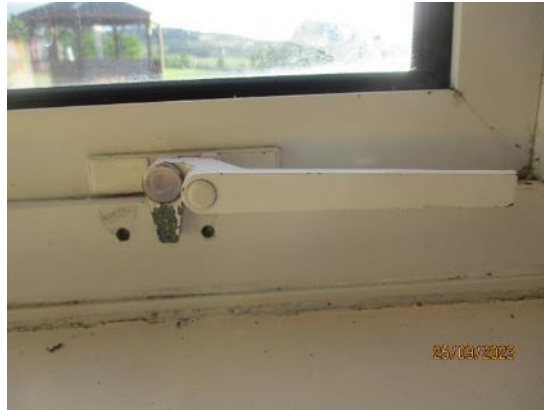
62. Missing keepers

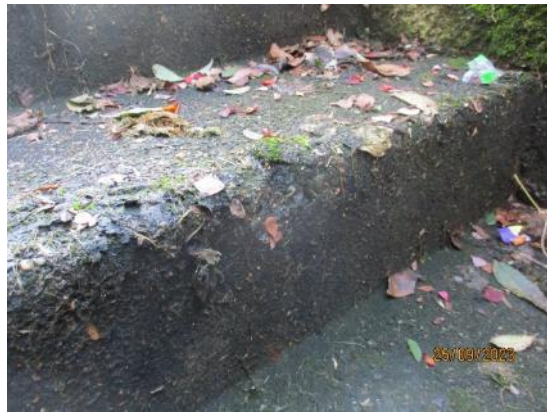
74. Chipped nosings

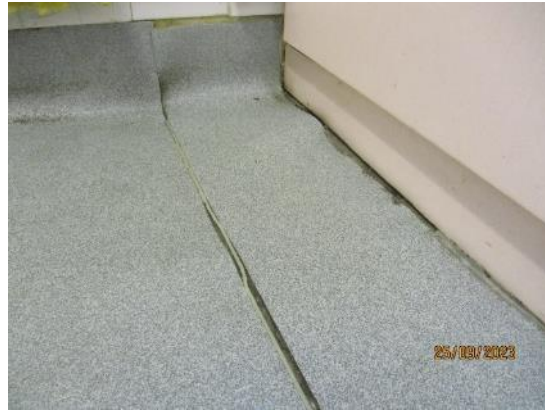
86. Damaged sheet vinyl in Girls toilet

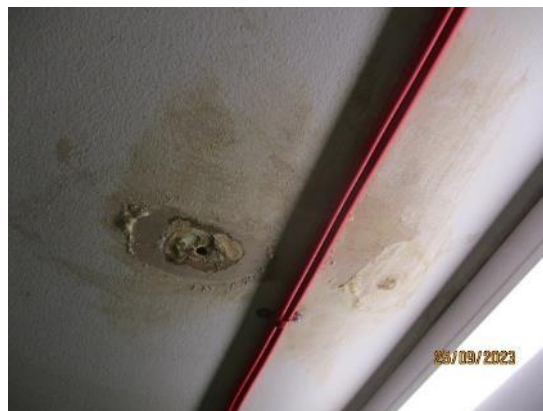
101. Water damaged plasterboard ceilings

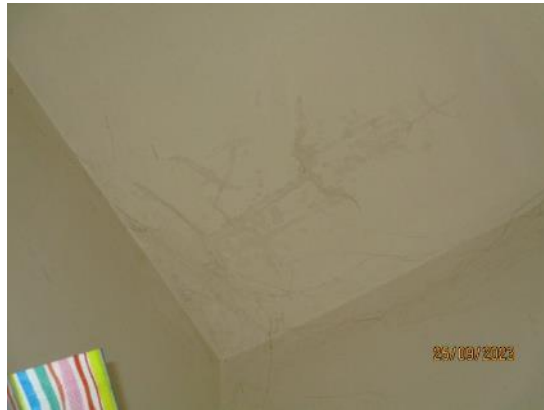
105. Hairline cracking to lath & plaster ceilings

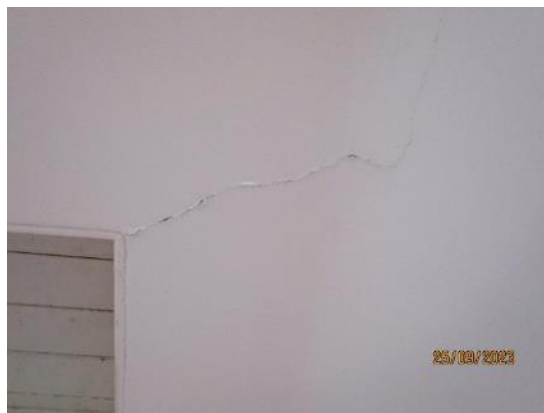
107. Hairline cracking at loft hatch

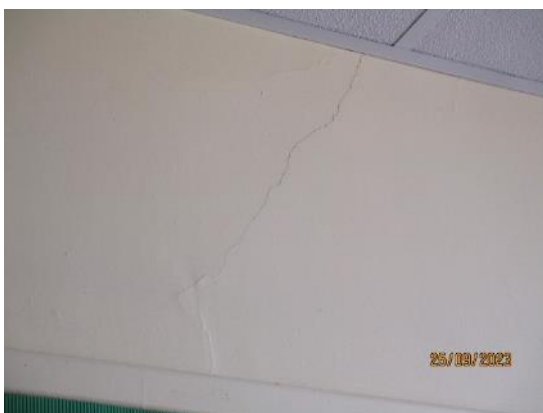
112. Hairline cracking to lath & plaster walls

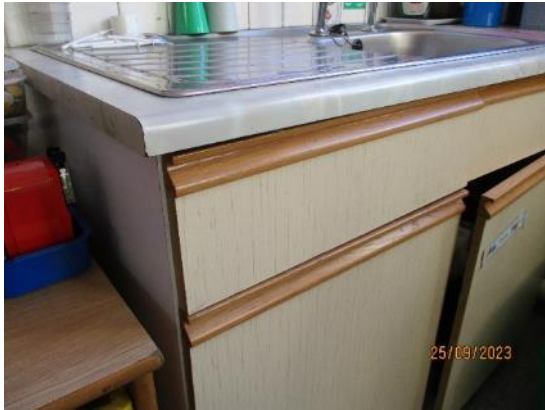
156. Damage to doors and drawers

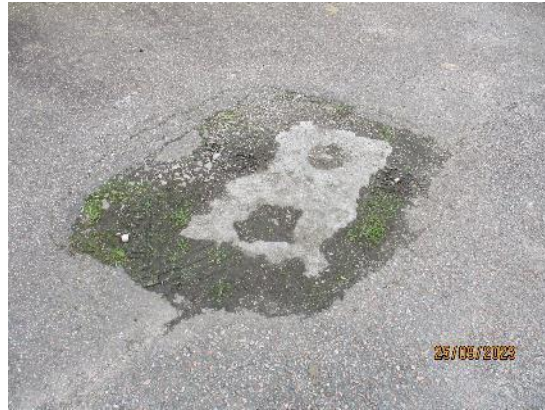
203. Isolated surface damage

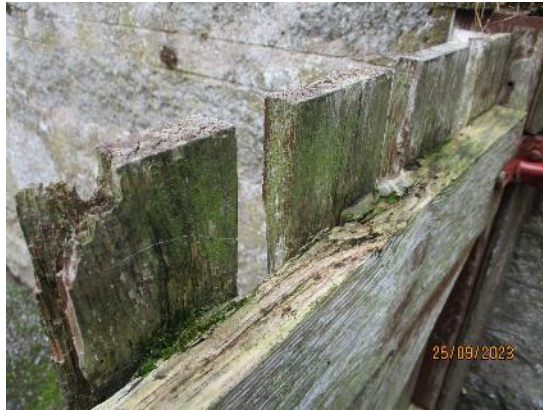
221. Timber rot in frame and slats

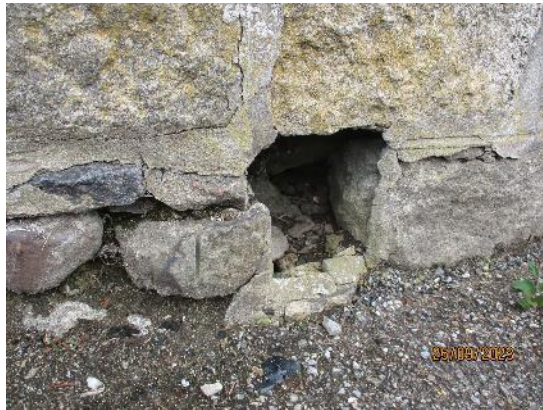
223. Isolated repairs and repointing
