# **Summary Building Condition Survey Report**

**Newmill Primary School  
Middle Brae, Keith AB55 6US**

**11<sup>th</sup> September 2023**

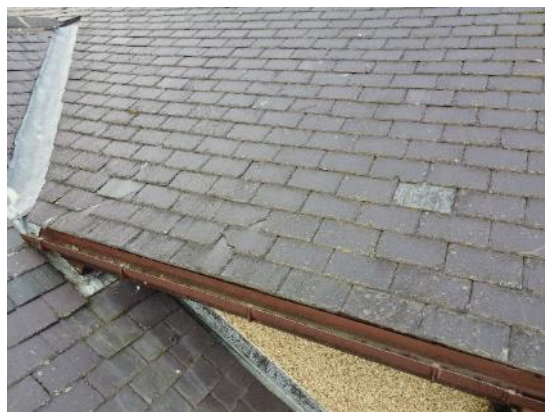
5. Slipped and broken slates

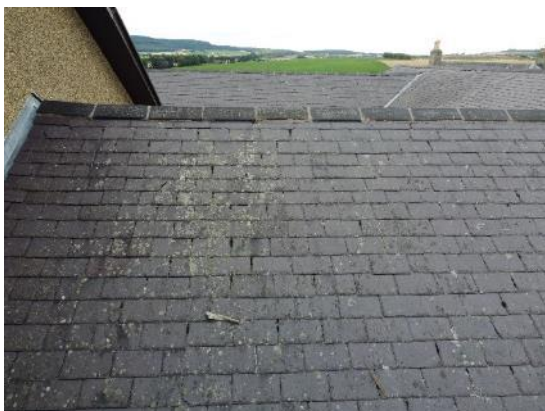
10. Ridge vents and slipped slates

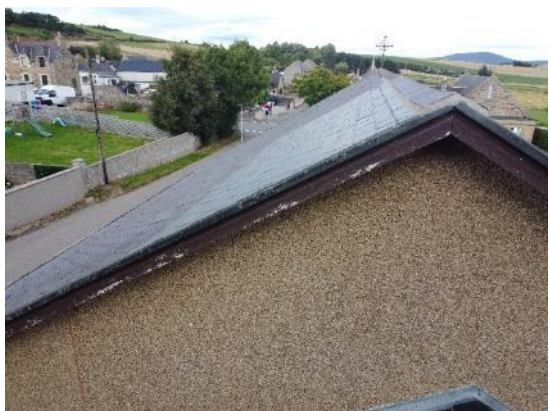
11. Ridge tiles missing pointing

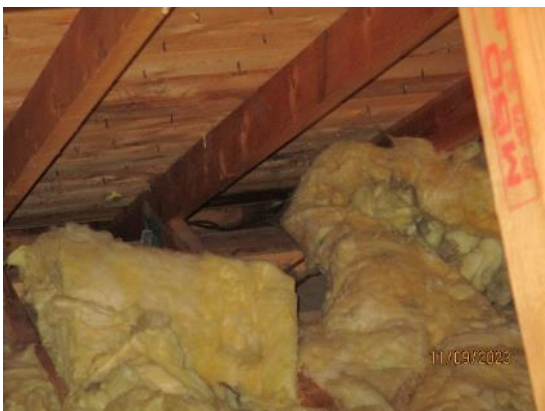
16. Missing insulation

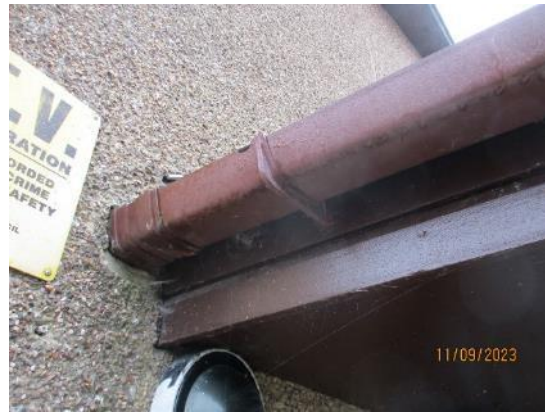
19. Blocked/leaking gutters

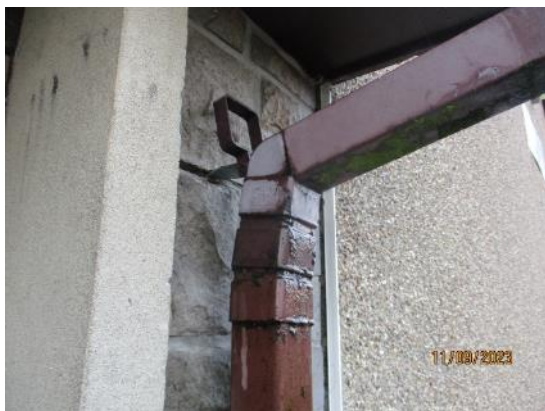
22. Downpipes blocked and leaking

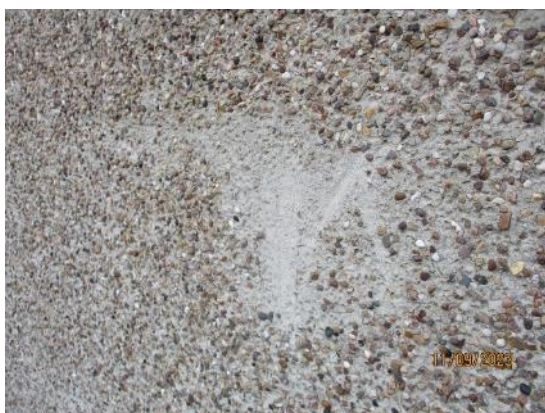
35. Damaged roughcast finish

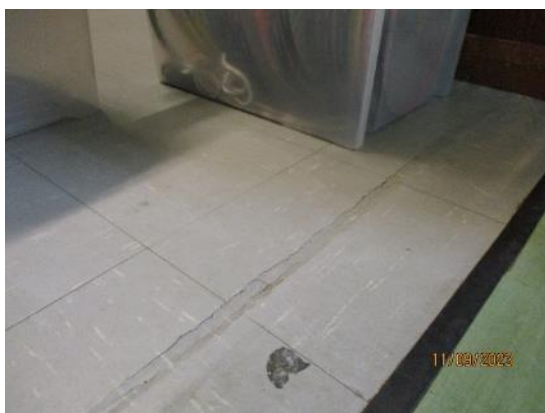
62. Vinyl tiles cracked and breaking up

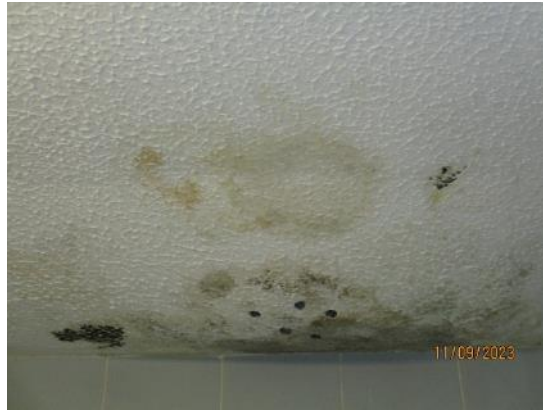
70. Water penetration and damage

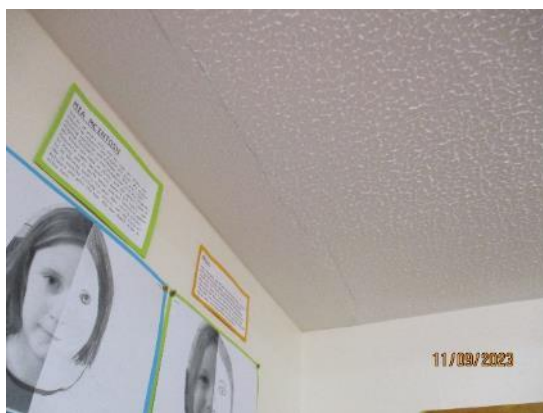
72. Watermarked plasterboard

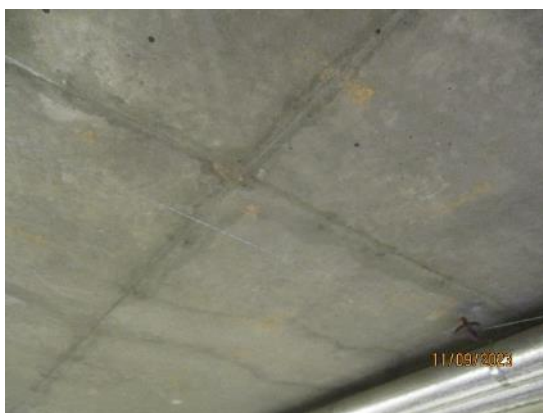
73. Hairline cracks at board edges

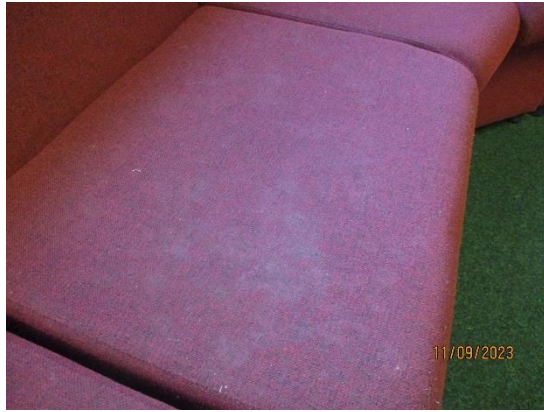
111. Fabric worn and soiled

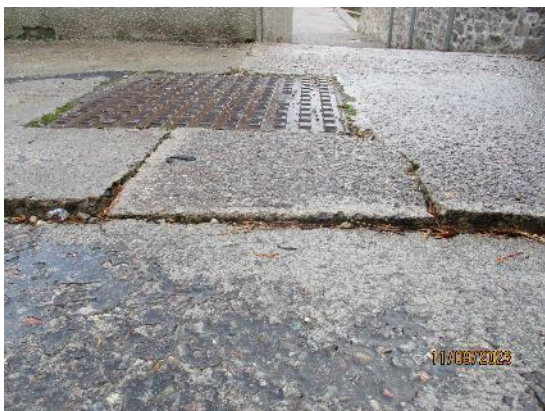
163. Raised edges and trip hazards

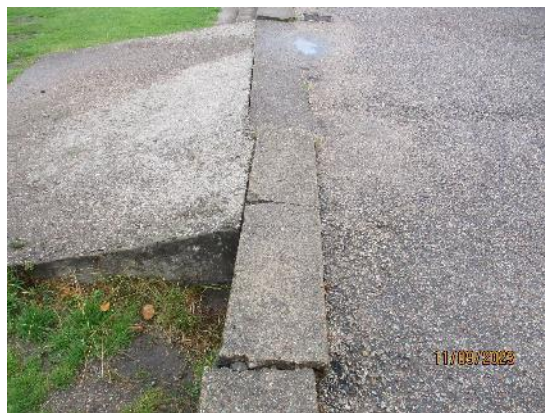
171. Slipped and poorly aligned

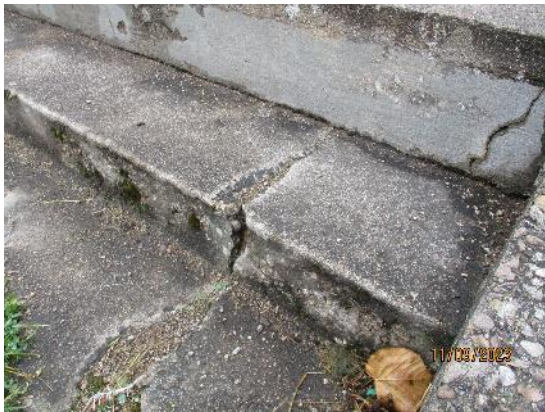
172. Cracked concrete steps

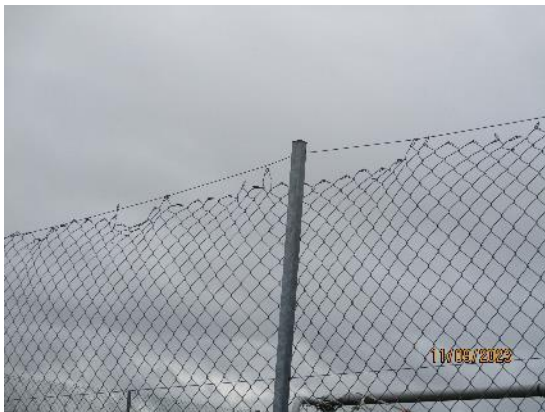
174. Isolated areas of damage

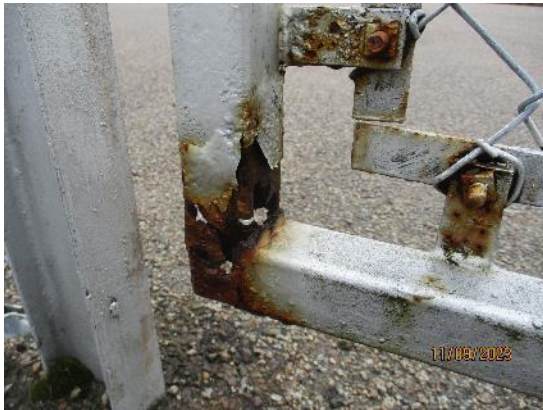
180. Corrosion to metal frame

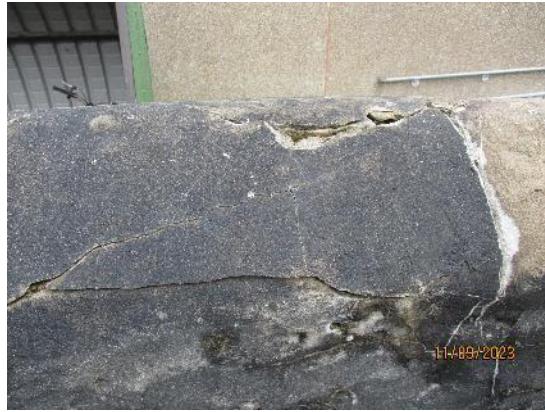
185. Cracked render coping

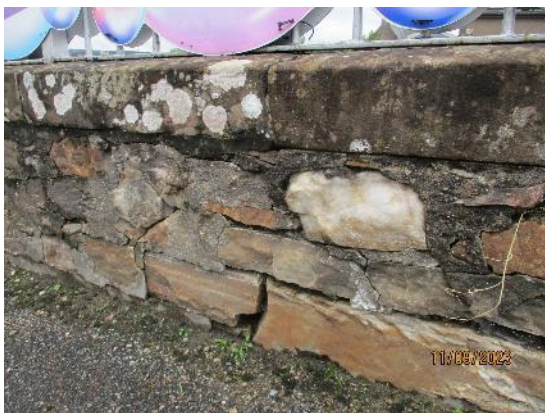
188. Repointing required

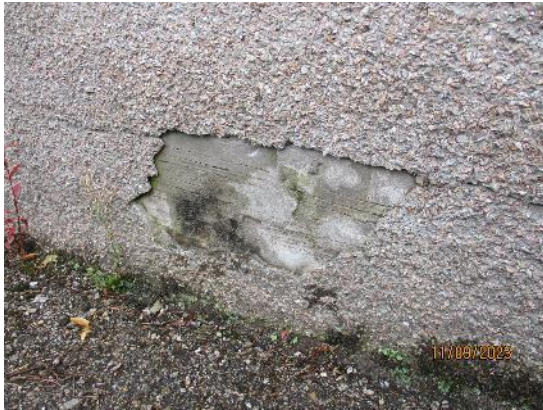
190. Spalling roughcast surface

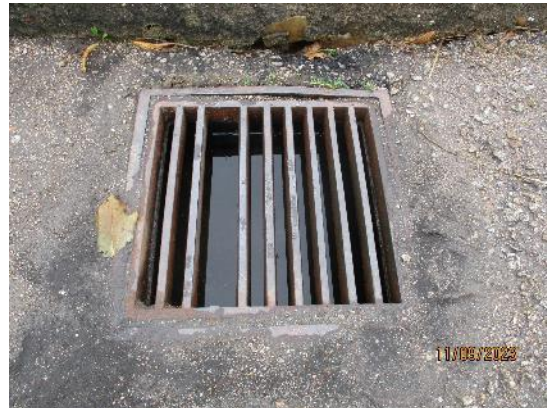
193. Isolated damage to gully gratings
