| PROJECT :<br>MORAY COUNCIL<br>HARBOUR INSPECTIONS | | | | |
| TITLE :<br>HOPEMAN HARBOUR - 2020<br>SURVEY AREA | | | | |

The Moray Council engaged Arch Henderson to undertake an inspection of Hopeman Harbour which was to include principle structural assets above and below the water line. Assets were to include sea walls, piers, jetties, quays, slipways and steps. At Hopeman these assets are constructed from masonry in the original parts of the harbour or from insitu concrete in areas where the harbour has historically been extended. No historic drawings of the structures are available and the assessment of defects is based on comparison with adjacent areas and archive photographs. Arch Henderson has no knowledge and has made no assessment into the load bearing capacities of the structures which would require further analysis.

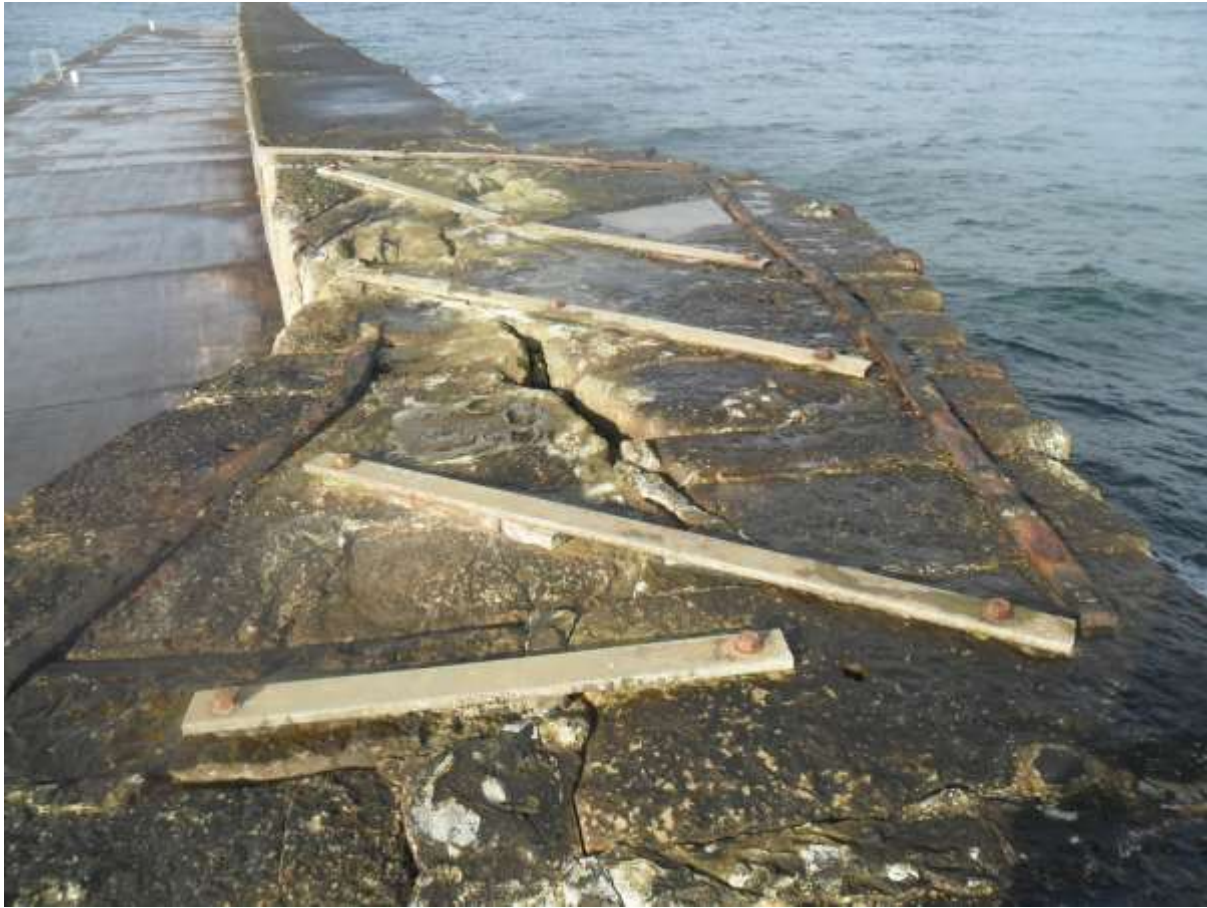
**Reinforcement Bars on Masonry Parapet**

At the root of the North Pier, where masonry construction still exists, a large number of concrete repairs are evident to the outer face however no new voids were identified. There is a masonry knuckle in the parapet where it meets the concrete section and this has been locally strengthened with steel bars to the top surface and down the face. The vertical bars on the outer face are heavily corroded with complete loss of section in the lower areas. The corroded bars are not considered to be effective however newer galvanised bars have been installed to the top surface. It is evident this section has historically displaced and should be monitored for further movement. It is recommended to analyse the dislodged section to identify if the loss of the corroded bars is critical and if additional reinforcement is required.

Analysis of the masonry reinforcement on the North Pier parapet knuckle is recommended to ensure it is stable and identify if additional reinforcement is required to replace the corroded sections. Analysis of the existing rock armour and the displaced wall section at defect 38-20 is also recommended to be carried out to confirm the current level of stability and provide repair options. The analysis will require a wave study to be carried out.

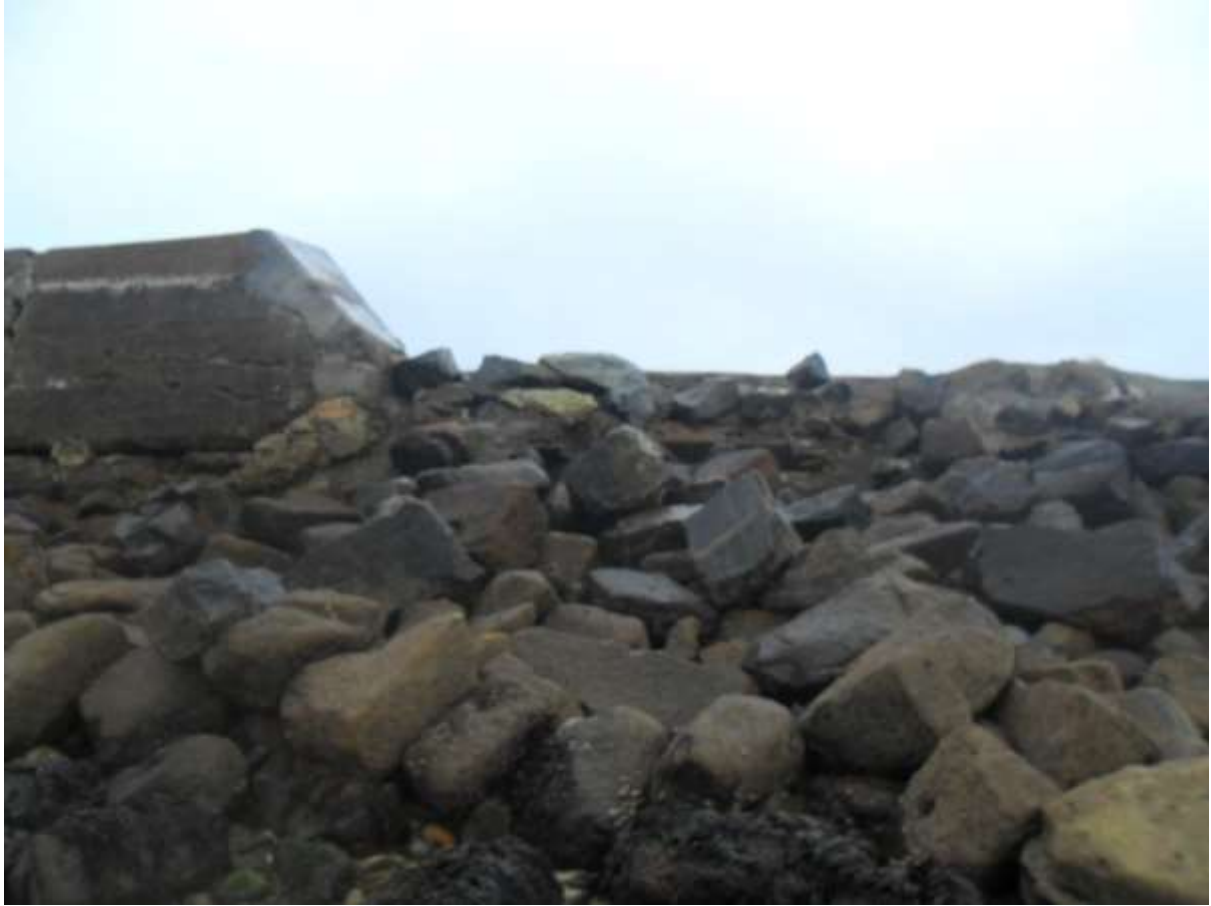
**Displaced rock armour and wall section at root of West Pier**

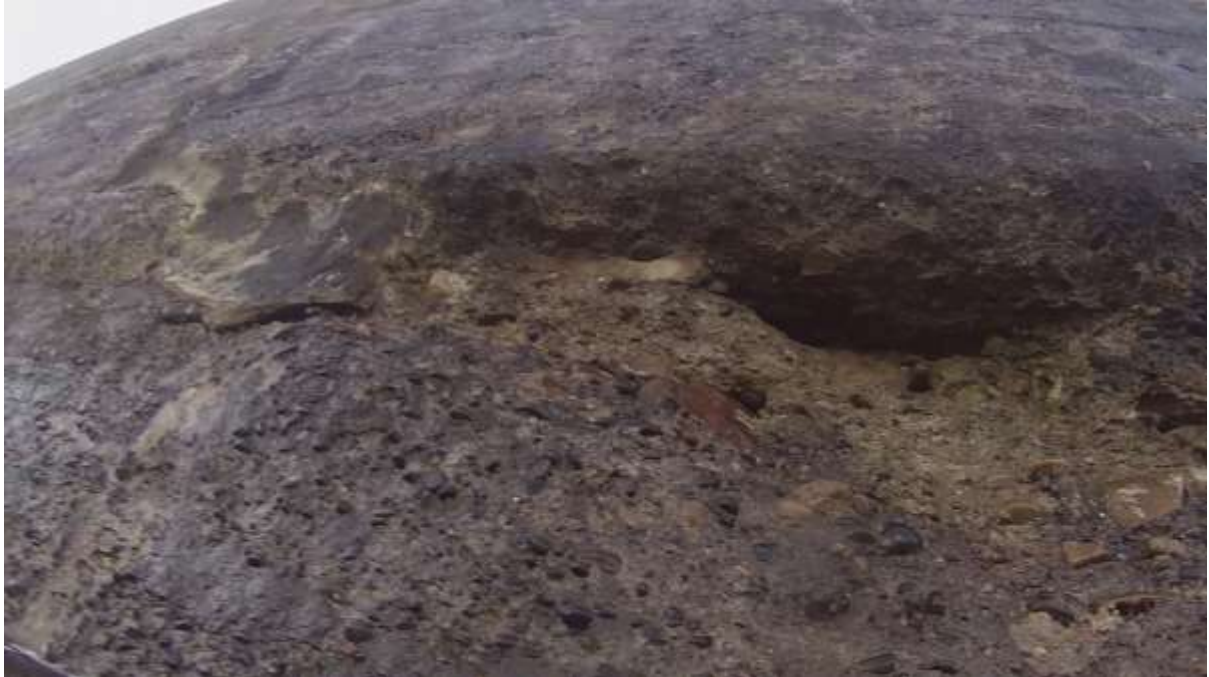
Defect 1

| Reference | Description | Easting | Northing |
|---|---|---|---|
| 1 | Abrasion to horizontal joint at mid height of wall on outer face - approximately 2m long x 1m high x 0.3m deep - further areas of shallower abrasion adjacent | 314401 | 870030 |

At defect 01-20 there is an area of abrasion to the outer concrete wall, just below deck level, which extends over the length of the outside face of the wall. The intermittent remains of a previous patch repair are evident which should be monitored for deterioration. Locally at the seaward end, a cavity is forming which is recommended to be repaired. The depth of the cavity should allow for a competent concrete repair using shuttering and reinforcement with minimal breakout of the surrounding concrete.

- Defect 01-20 North Pier abrasion cavity
- Defect 02 to 07-20 Small cavities in outside face of North Pier
- Defect 10-20 and 19-20 cavities forming in North Pier inner cope
- Defect 20 & 21-20 Area of abrasion to North Pier
- Defect 13-20 High level cavities in East Pier masonry parapet
- Defect 30, 31 & 33-20 Abrasion cavities in South Pier
- Defect 37-20 Exposed cabling and damaged cope
- Defect 38-20 Wall abrasion, movement and displaced armour
- Defect 39-20 Wall abrasion
- Defect 43-20 Damaged gabion

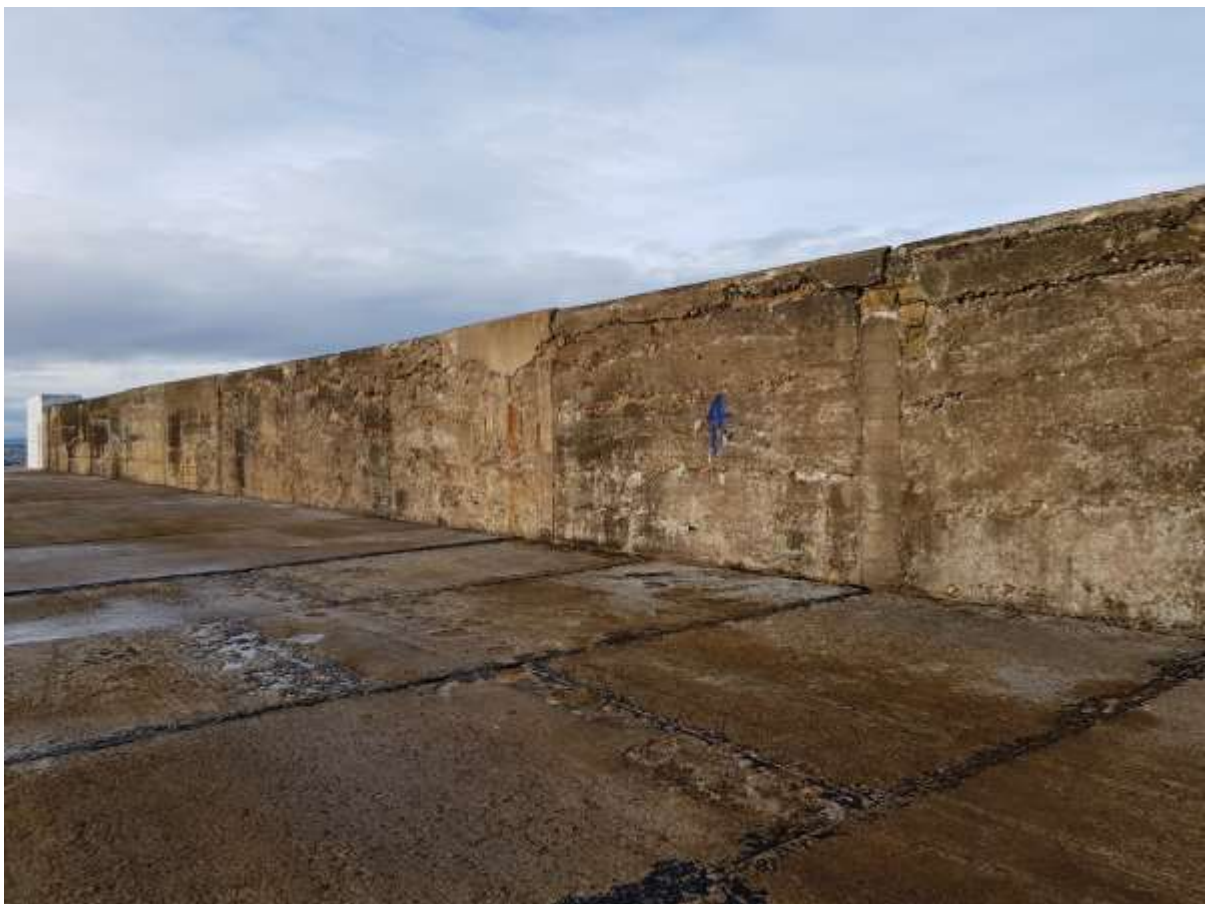
Defect 8

| Reference | Description | Easting | Northing |
|---|---|---|---|
| 8 | Spalling concrete along inside of parapet | 314430 | 870031 |

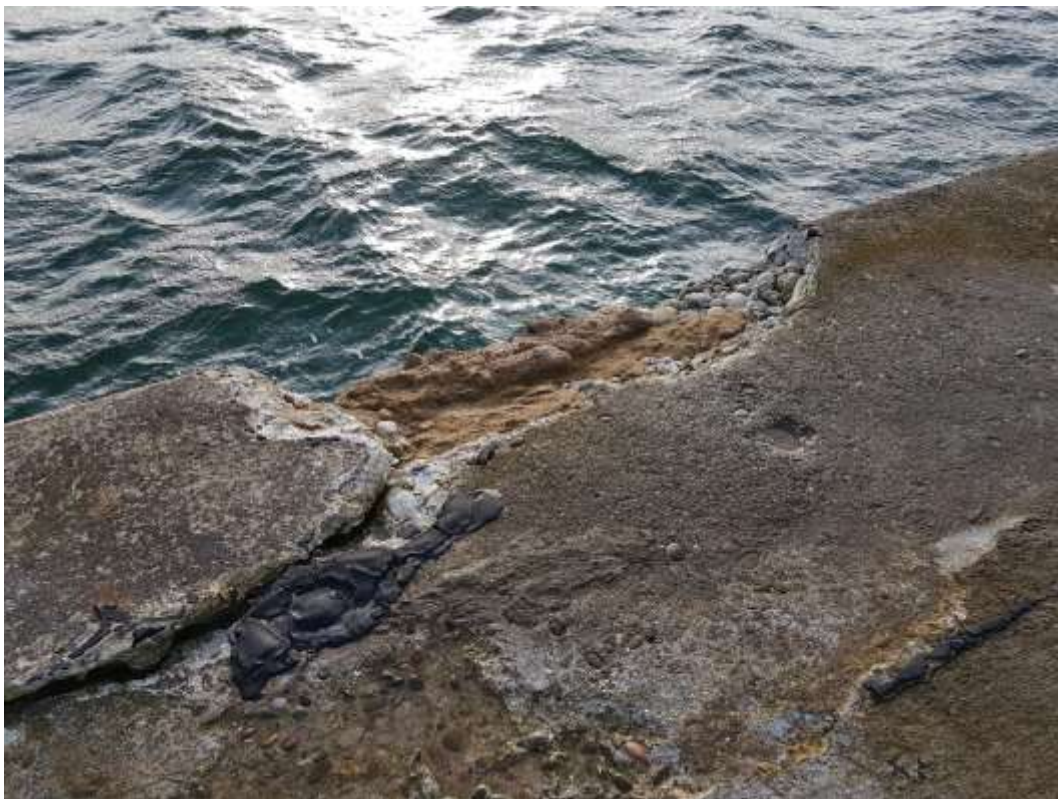
Defect 10

On the inside face, at the defects marked 10-20, cavities are forming on top of the concrete cope which are recommend to be infilled. At defect 19-20, adjoining the largest cavity in the top of the cope, there are cavities forming under the cope and further deterioration is expected to lead to the loss of this 4m section of cope.

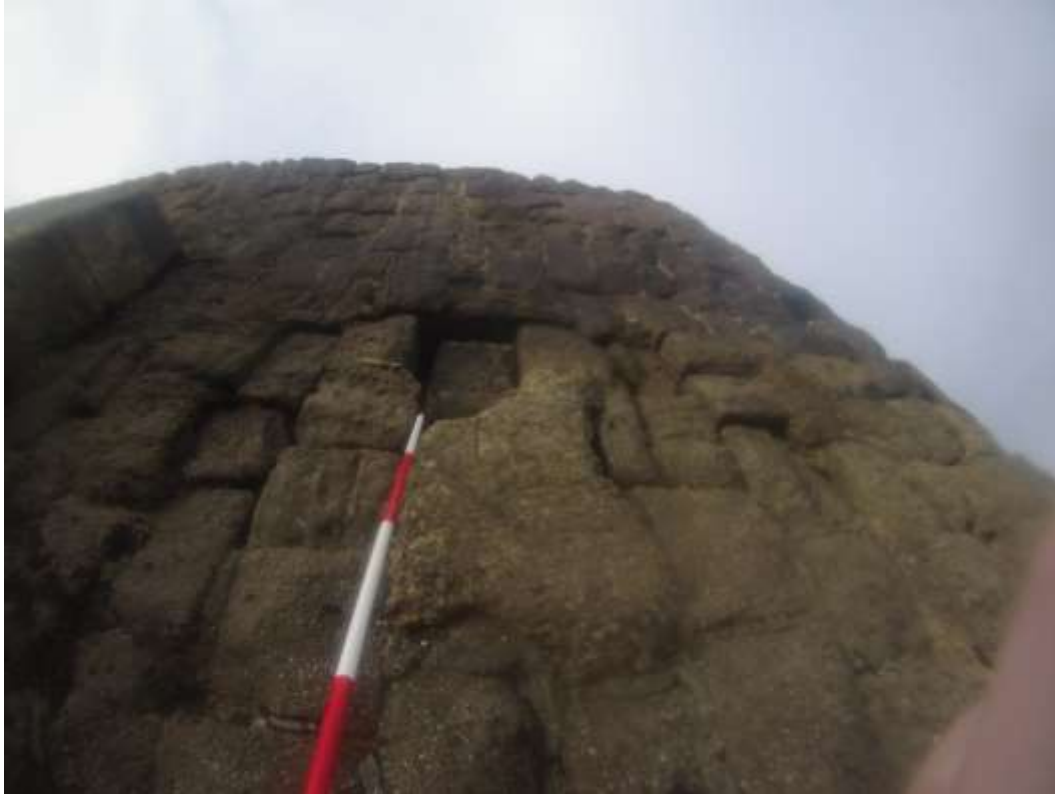
Defect 11

| Reference | Description | Easting | Northing |
|---|---|---|---|
| 11 | Sunken block above concrete repair with open joint to perimeter | 314517 | 870043 |

On the outside face there are several historic holes in the wall, all of which appeared stable, but they should be monitored to ensure there is no loss of material occurring (defects 11-20, 12-20 and 14-20). At the top of the parapet, at defect 13-20, there is an open joint in the face of masonry which coincides with a number of small cavities and open joints on the top surface of the parapet. These could combine leading to the loss of a large section of masonry and are recommended to be repaired.

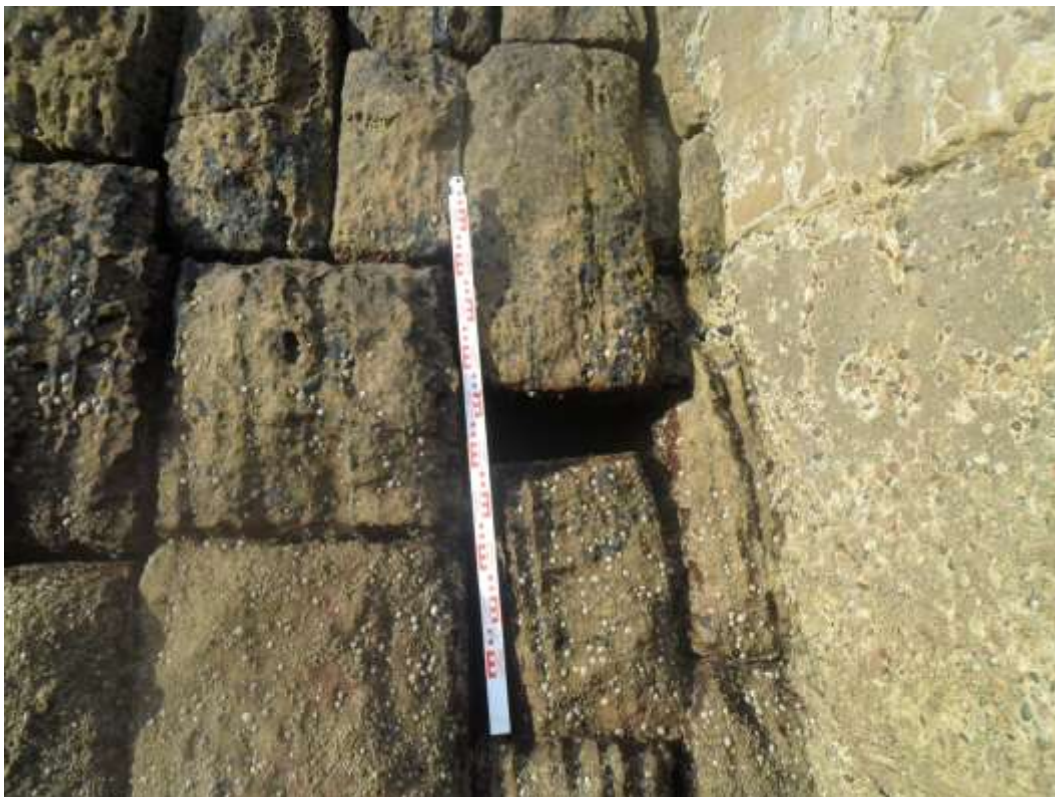
Defect 12

| Reference | Description | Easting | Northing |
|---|---|---|---|
| 12 | Missing block 0.6m deep adjacent berm | 314532 | 870027 |

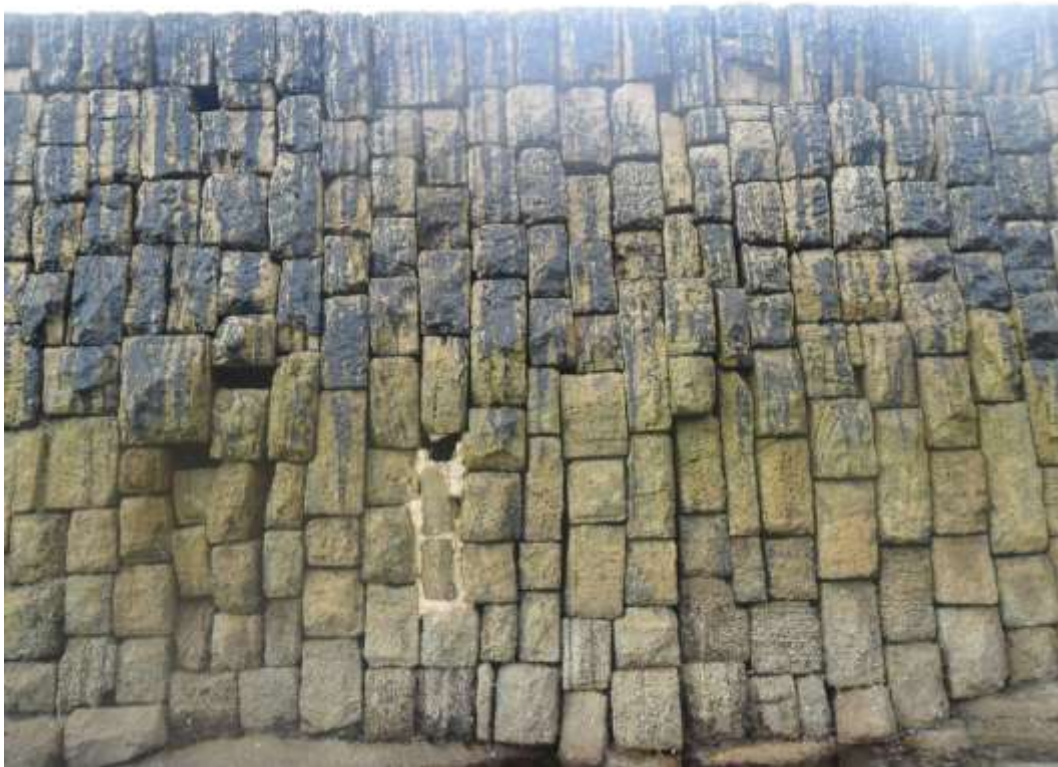
Defect 14

| Reference | Description | Easting | Northing |
|---|---|---|---|
| 14 | Missing blocks approx. 1m deep with 0.25m x 0.25m opening | 314561 | 869994 |

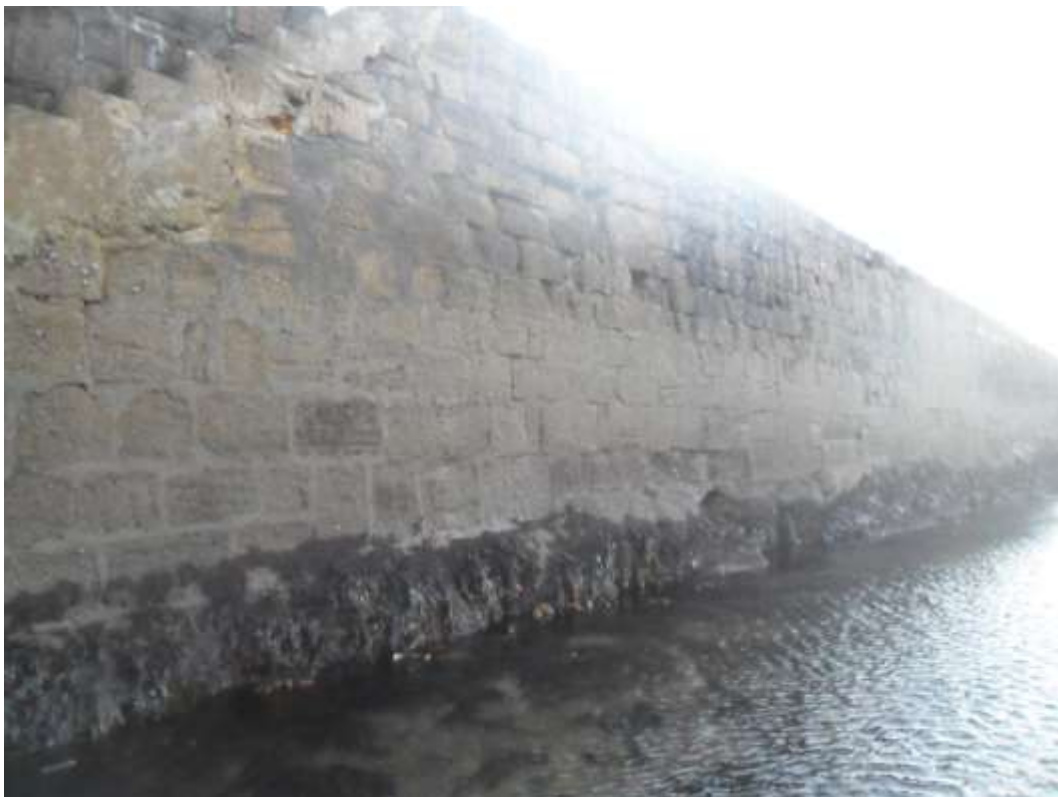
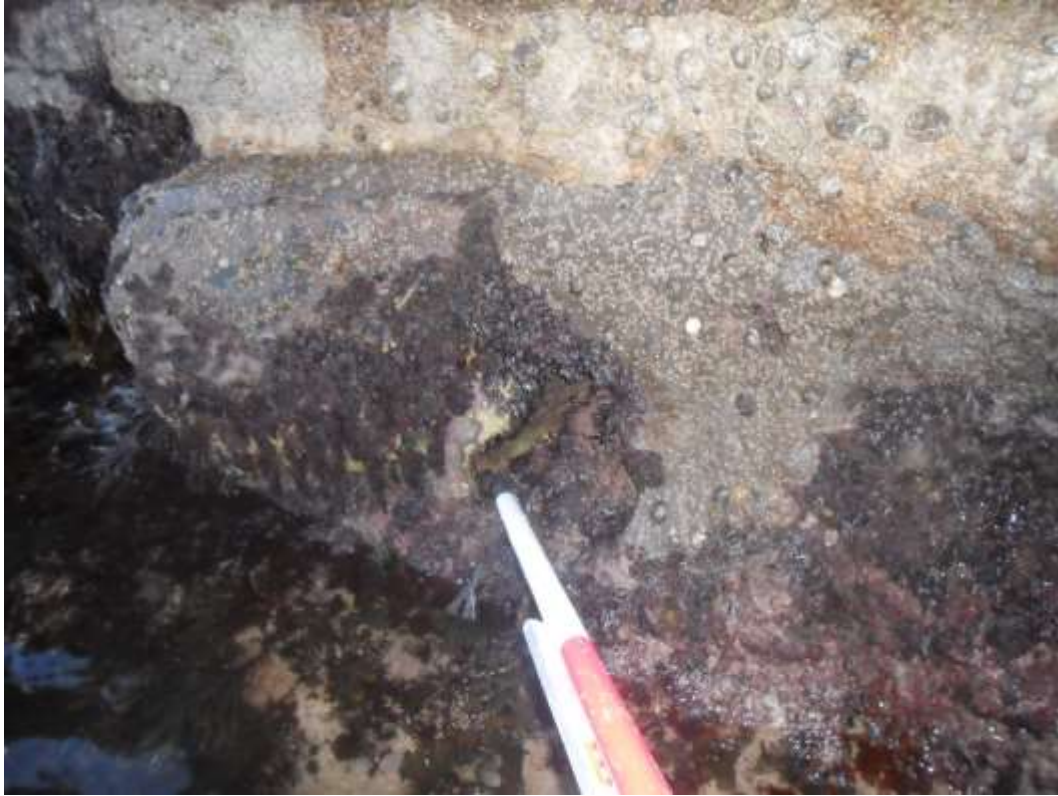
Defect 17

| Reference | Description | Easting | Northing |
|---|---|---|---|
| 17 | Small cavity at base of steps and spalling below steps | 314520 | 870023 |

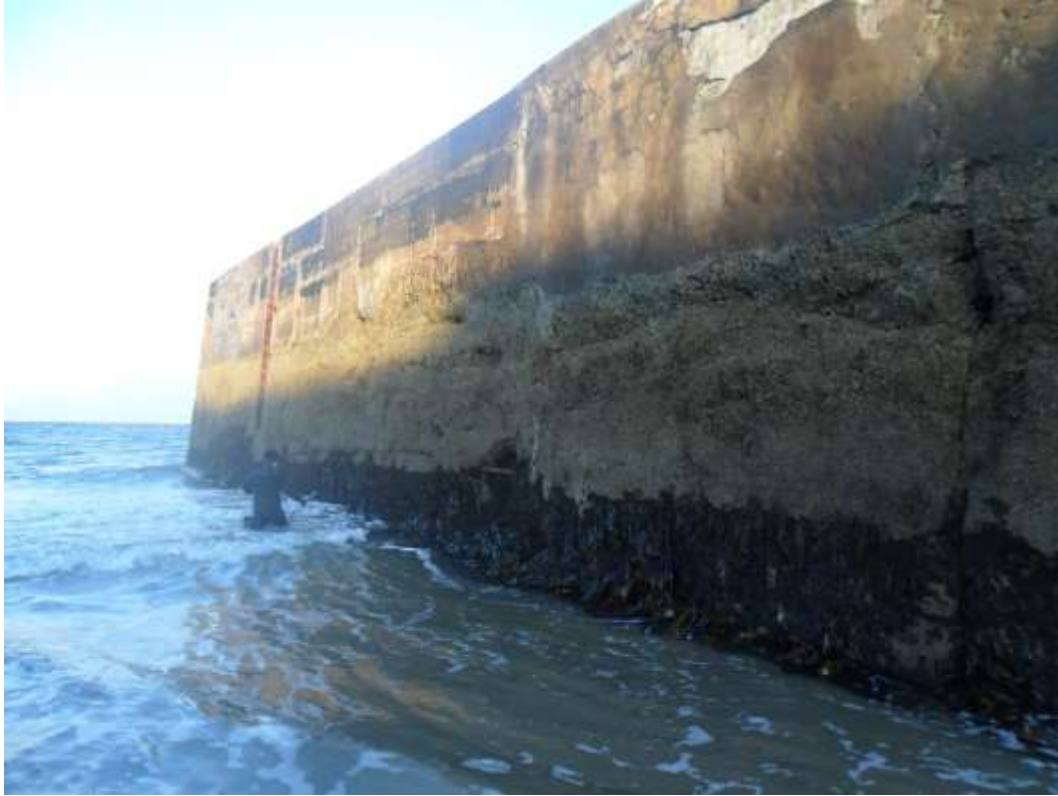
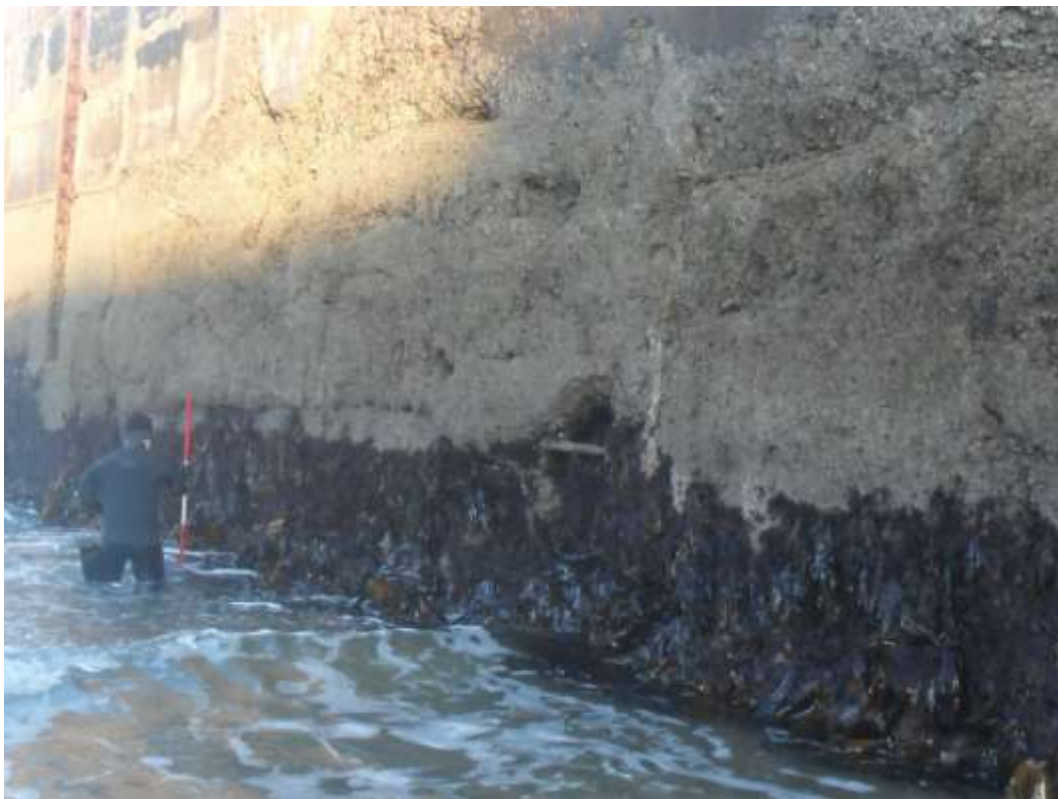
Defect 20 and 21

A large area of abrasion is evident at defects 20-20 and 21-20 which is not considered to be critical at this stage but should be considered for repair to prevent further deterioration.

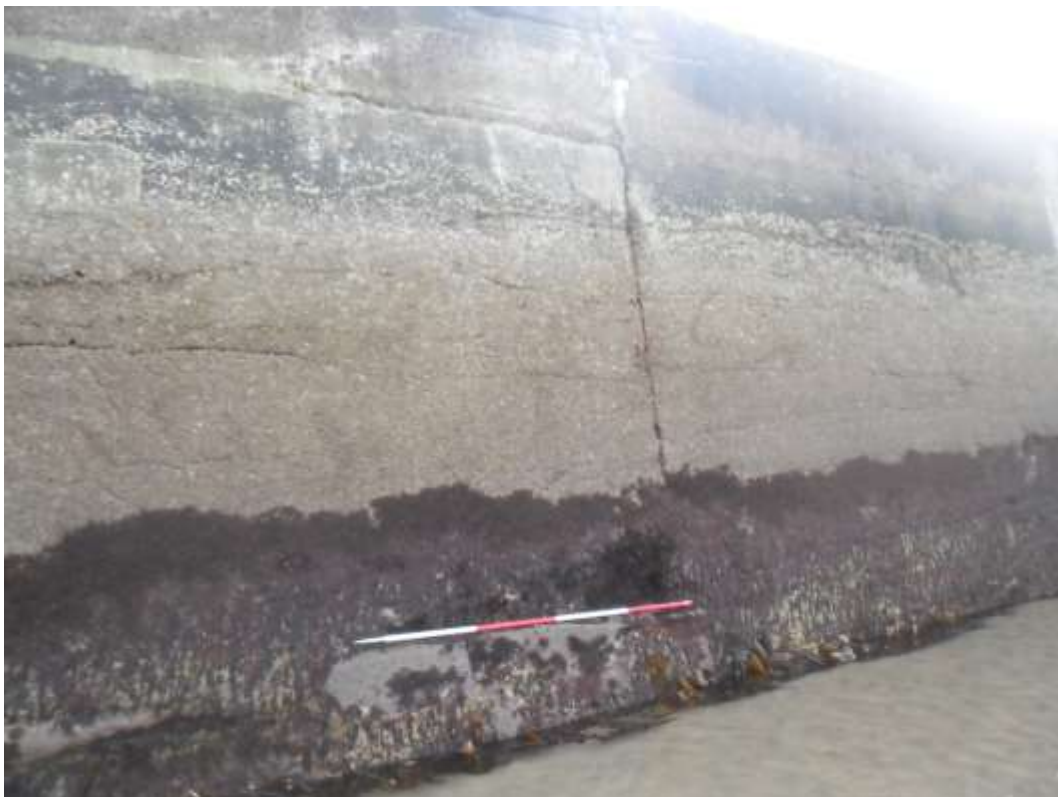
Defect 24

| Reference | Description | Easting | Northing |
|---|---|---|---|
| 24 | Cavity above concrete repair 2.5m long x 0.5m high x 0.2m deep | 314458 | 870002 |

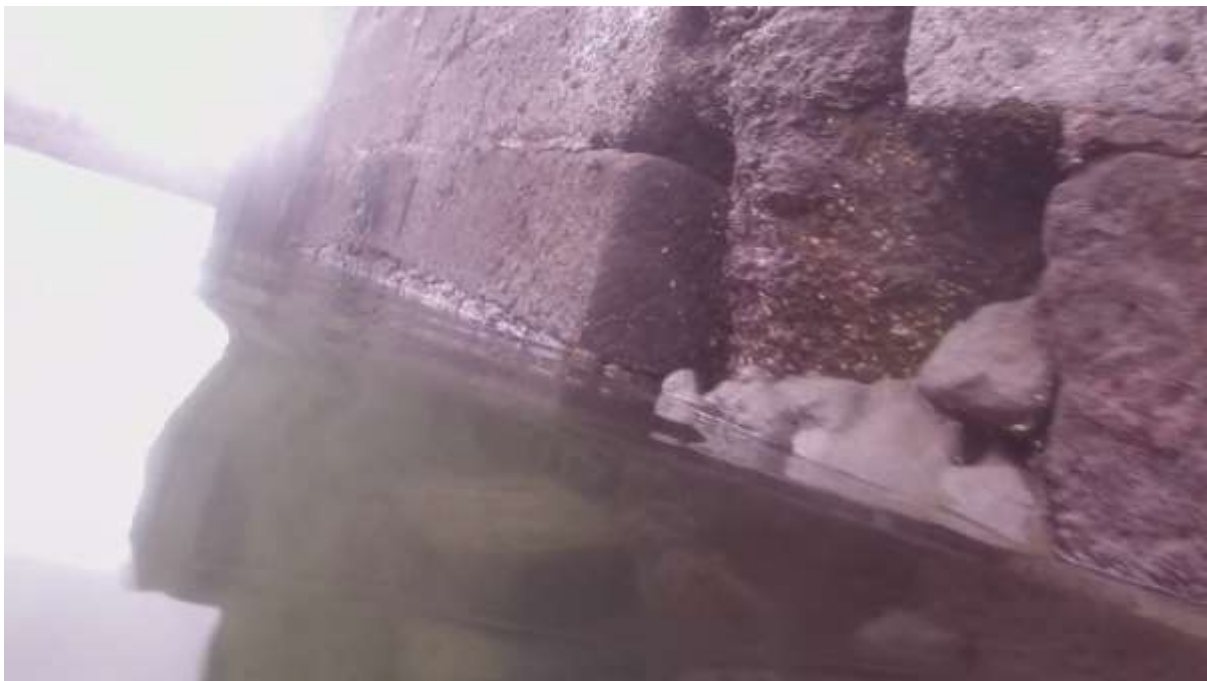
Defect 27

The outside corner has been refaced. There are cavities in the wall at the end of the pier and areas of undermining at defect 27-20. Recommendations have previously been given to continue the refacing around the end face and inner corner. High levels of sand covered the majority of the undermining during this inspection but there are open joints / dislodged masonry on the inside corner which should be monitored. Scour holes have formed at the pier corners preventing them from drying out at low tides.

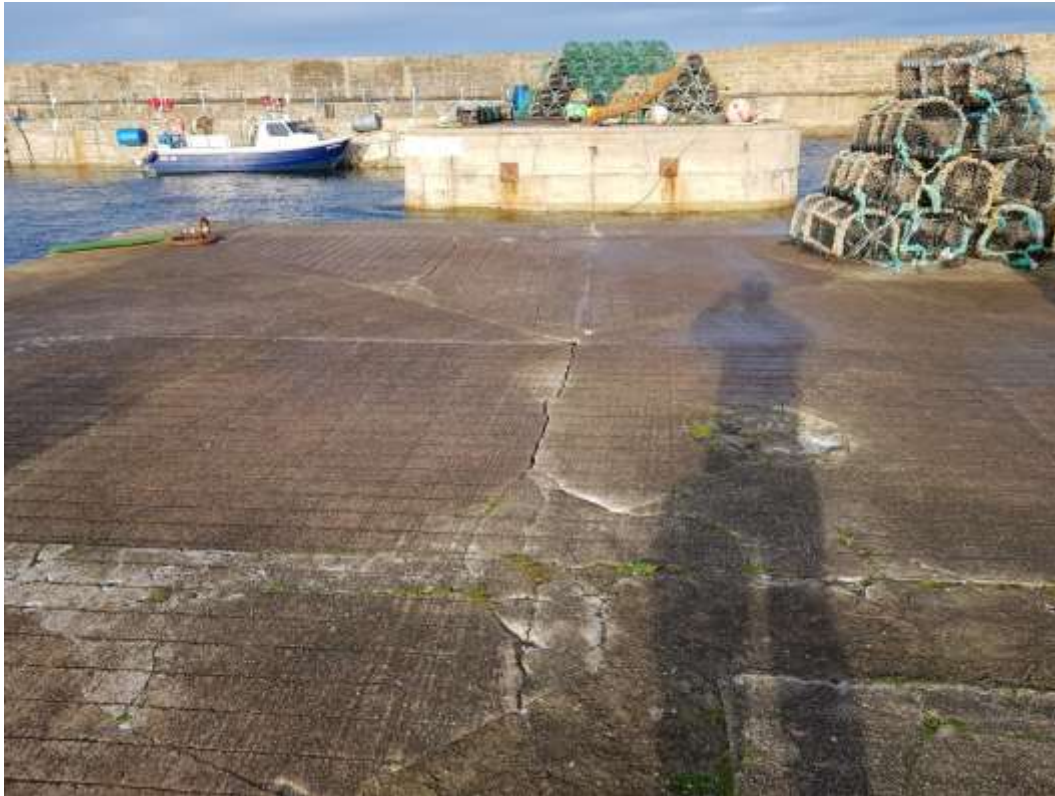
Defect 28

| Reference | Description | Easting | Northing |
|---|---|---|---|
| 28 | Cracking to deck and cope at end of pier | 314487 | 869981 |

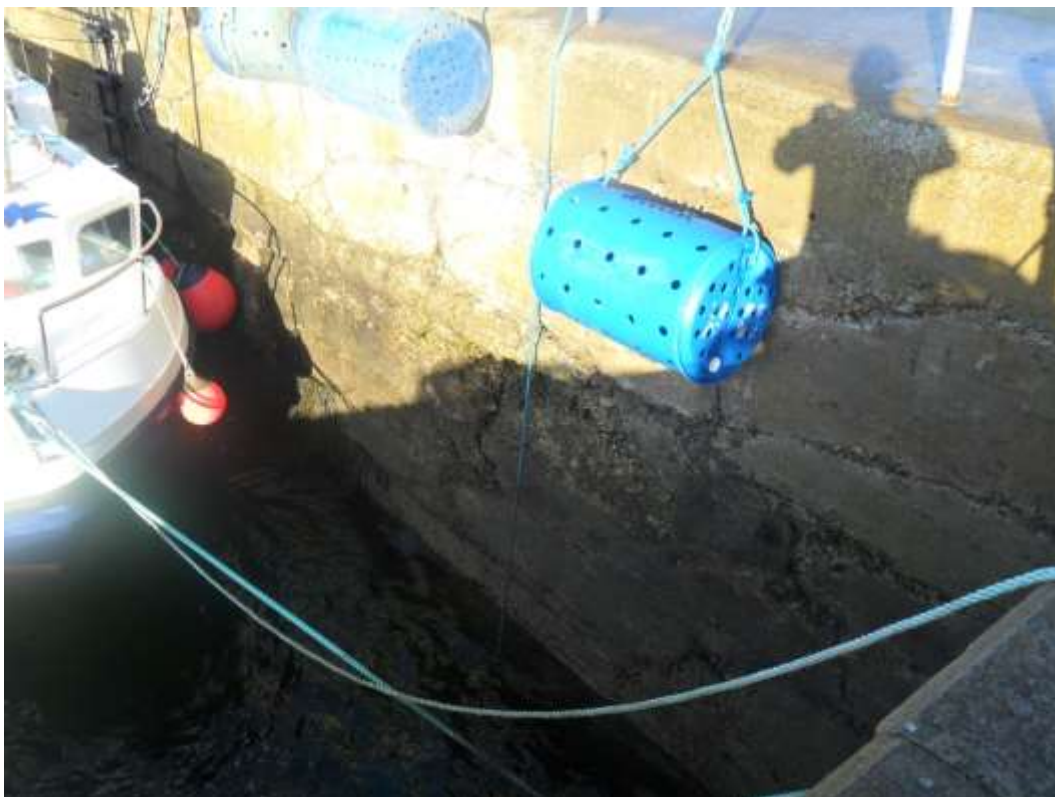
Defect 30

The South Pier is constructed from insitu concrete. It is in generally sound condition however there are several large areas of abrasion on the basin side at defects 30-20, 32-20 and 33-20. Cavities are forming within the abrasion at defect 33-20 which is recommended to be repaired. A number of minor cavities and abrasion are evident to the outer channel side which should be monitored.

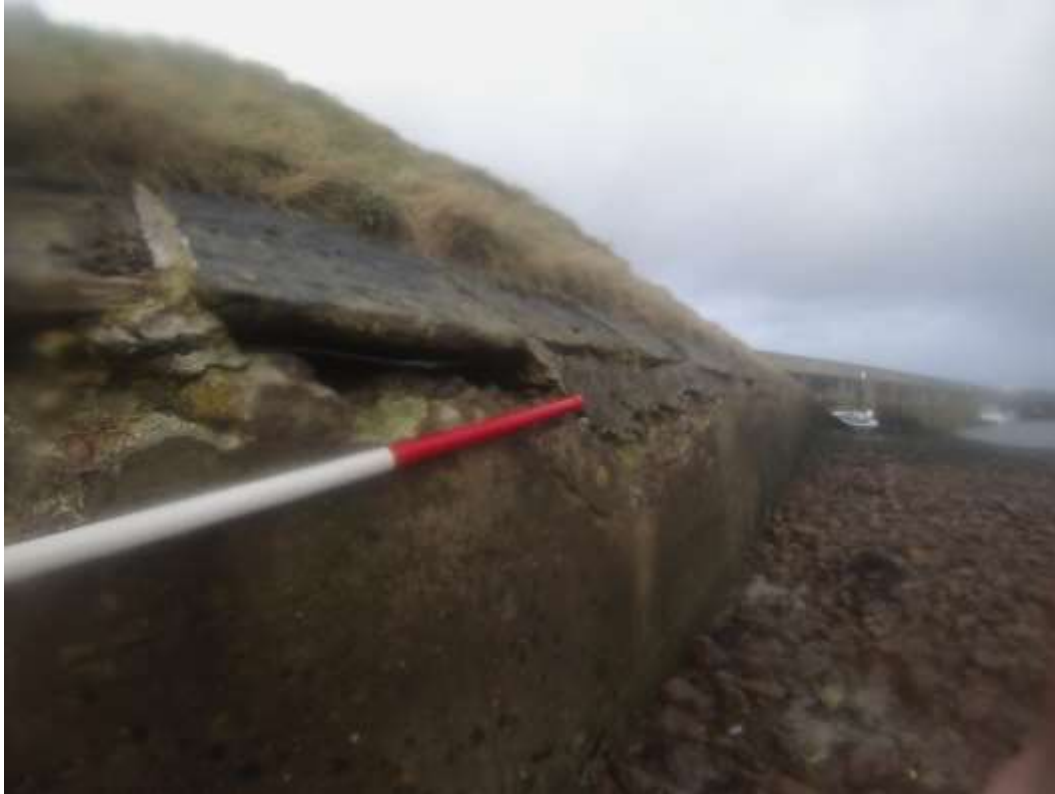
Defect 37

On the opposite side at defect 37-20 there is general abrasion to the wall which may be related to waves breaking over the parapet. The coping to the top wall is also breaking up exposing a cable which has been embedded in the concrete.

Minor repairs are recommended at defect 37-20 to protect the cable and to repair the damaged gabion at defect 43-20.

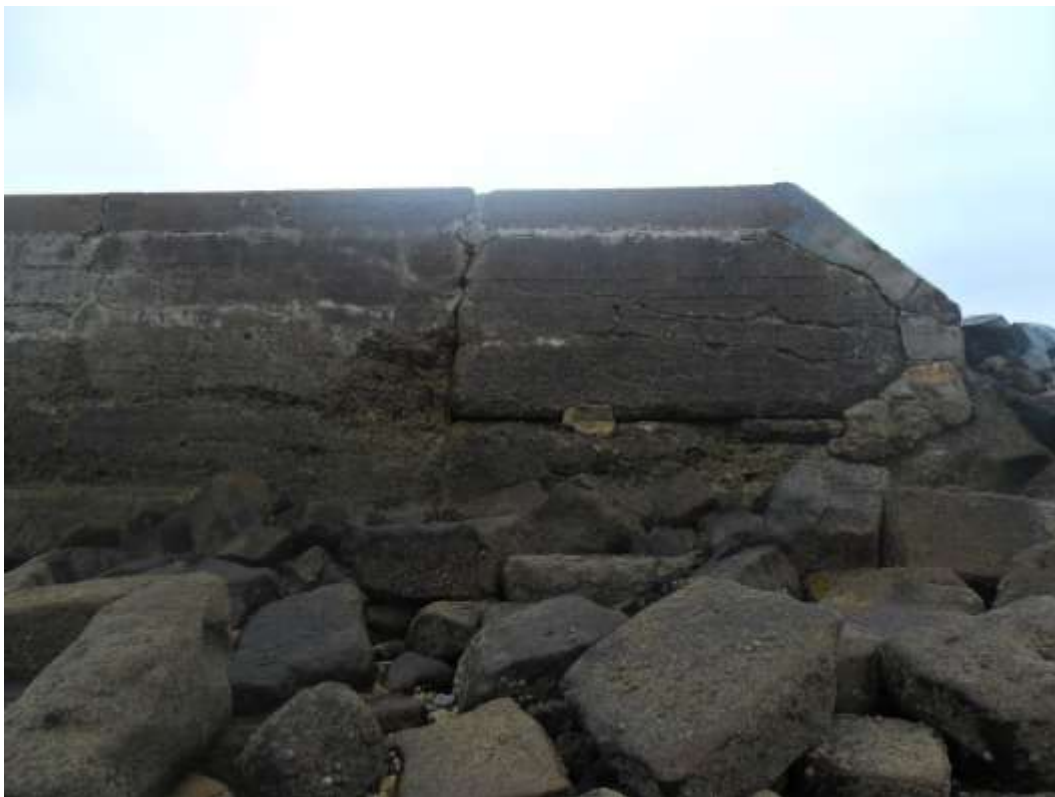
Defect 38

| Reference | Description | Easting | Northing |
|---|---|---|---|
| 38 | At end of concrete wall the end section has been displaced - evidence of historic repairs. Block is abraded on outer face over 5m long x 2m high area. Cavity forming under abrasion 1m x 1m 0.5m Deep. Adjacent rock armour is displaced exposing pitched stone slope | 314438 | 869857 |

At defect 38-20 historic damage has occurred at the root of the pier to the end panel of the parapet which has been previously repaired. Misalignment of the repair concrete indicates there has been further movement and the repair concrete to the outer face has largely been lost. Rock armour in this location also appears to have been displaced and is likely undersized for an extreme tidal and wave event. The displaced rock armour has exposed a pitched masonry slope which may be vulnerable to future defects as previous concrete repairs are evident. Adjacent to this area, at defect 39-20, there is large area of abrasion to the outer face of the parapet wall.

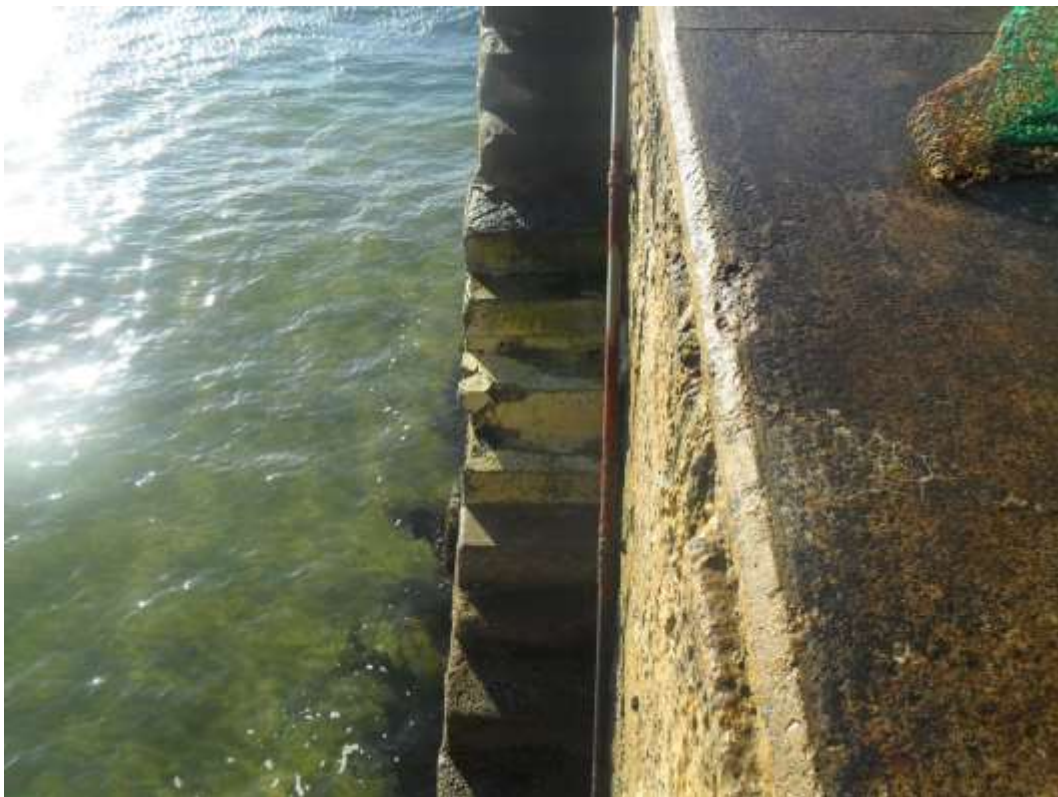
Defect 44

| Reference | Description | Easting | Northing |
|---|---|---|---|
| 44 | Spalling of concrete at edge of concrete steps | 314489 | 870006 |

At defect 44-20 there is minor loss of concrete to the edges of the concrete steps which should be monitored.
