# **Summary Building Condition Survey Report**

**Crossroads Primary School**

**Grange, Keith AB55 6LX**

**26<sup>th</sup> October 2022**

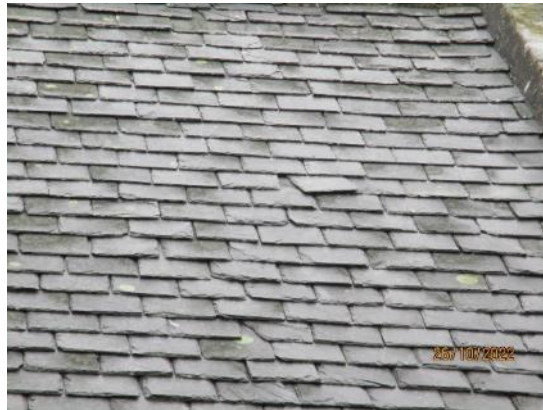
4. Isolated slipped and missing slates

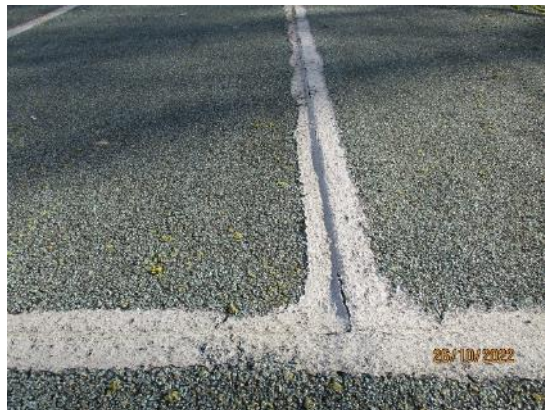
10. Previous joint repairs are failing

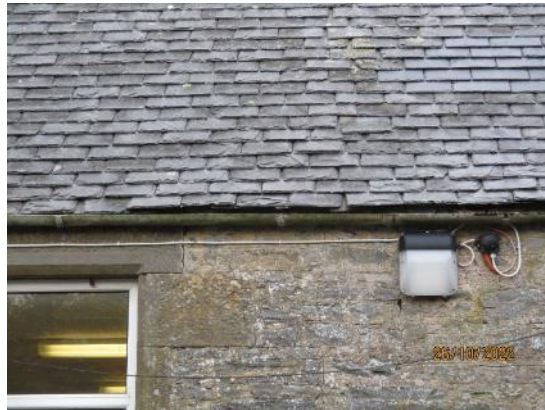
22. Miss-aligned gutters

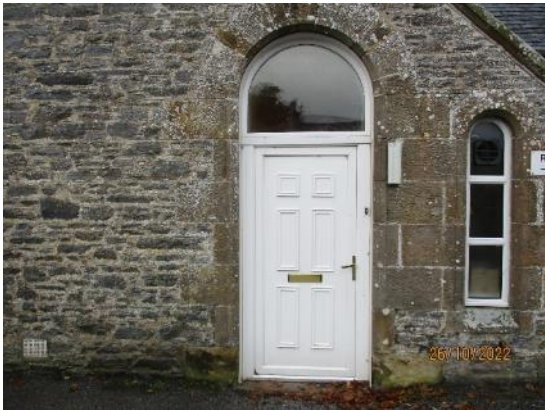
39. UPVC door to old building

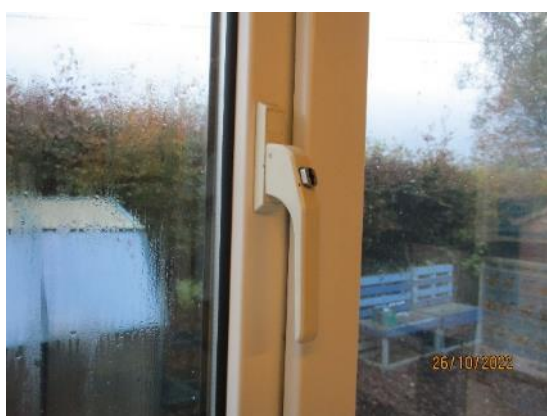
47. Lever handles – White windows

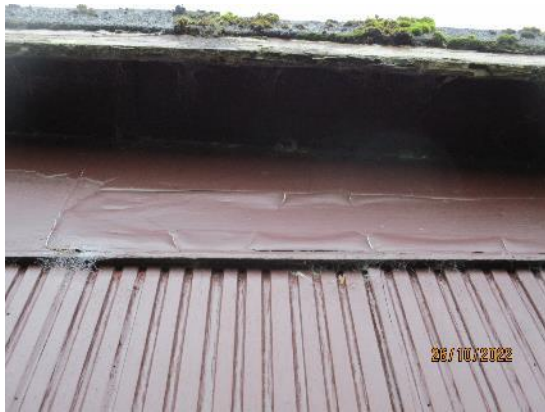
49. Timber cladding flaking and peeling

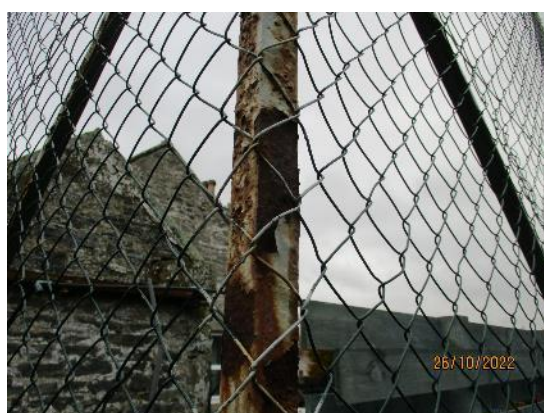
54. Corroded fence posts

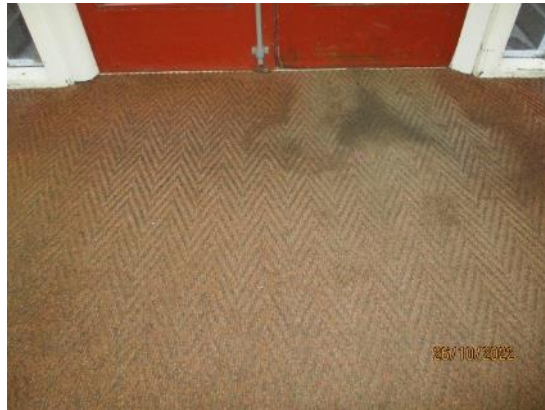
63. Stained and watermarked

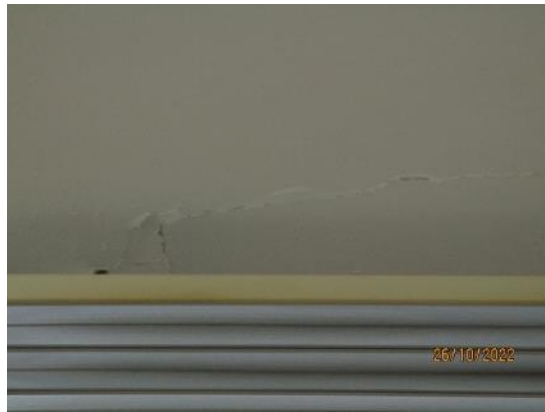
72. Lath and plaster - cracked

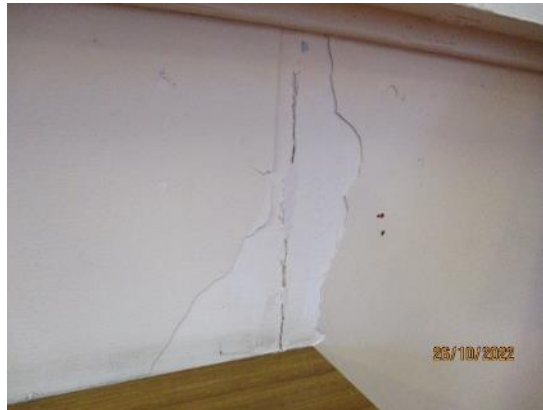
79. Surface damage to plasterboard

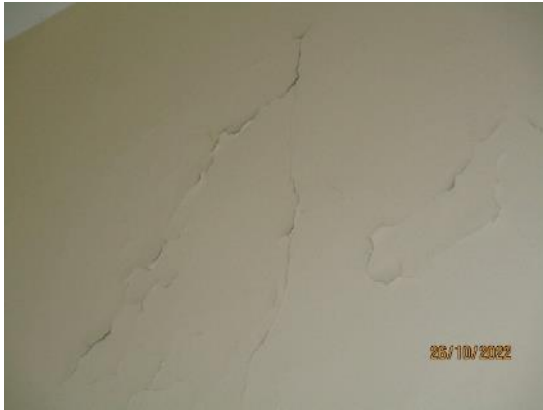
82. Cracked lath & plaster walls

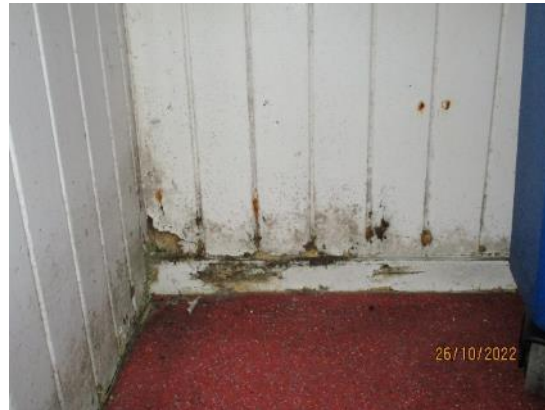
84. Timber decay in linings

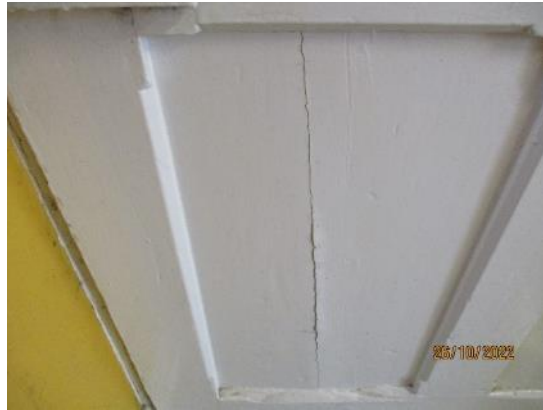
89. Damage to timber doors

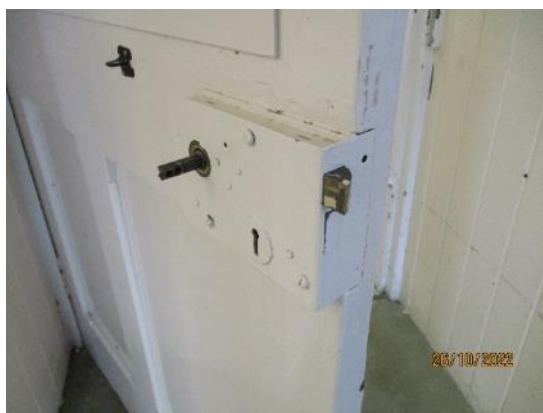
82. Missing ironmongery

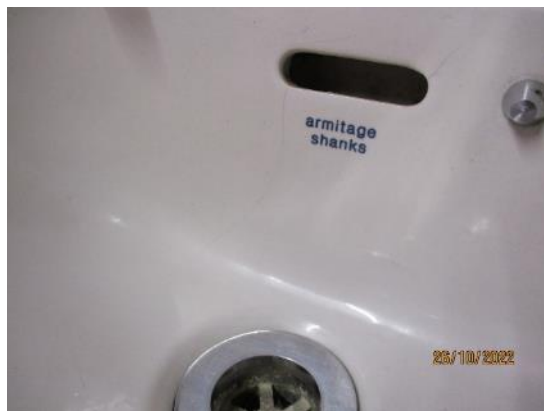
88. Hairline cracks

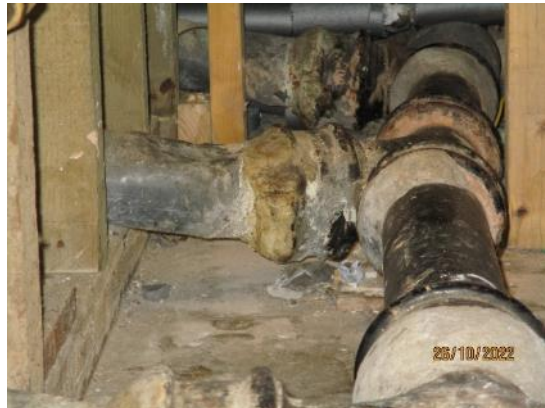
90. Damaged lead waste pipes

- Replace lead connections to cast iron waste pipes.
- Increase field of CCTV cameras to cover more of site and both buildings.
- Install intruder alarm systems in both buildings.

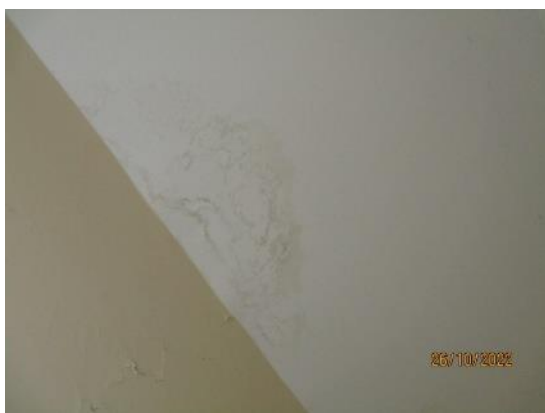
86. Watermarked ceilings

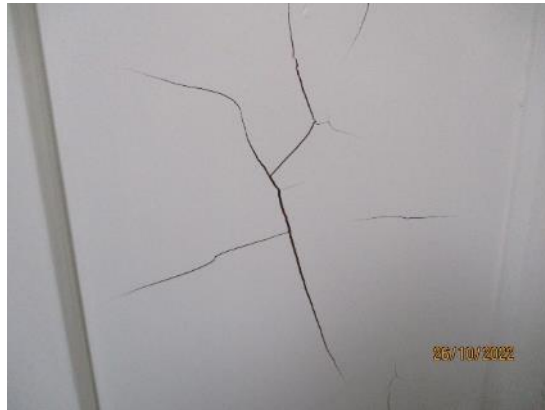
91. Cracked paint to doors

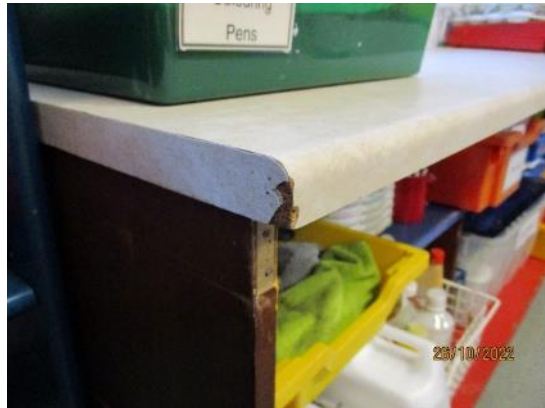
96. Damage to worktops

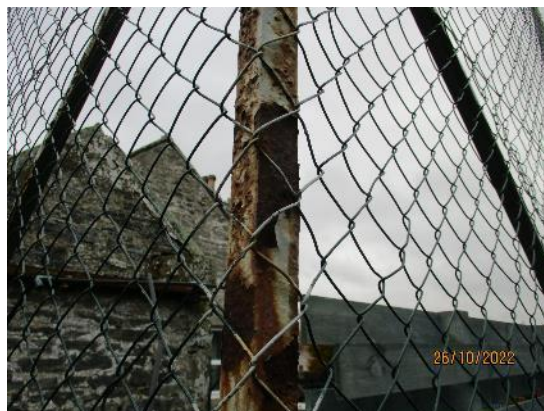
146. Corrosion of steel posts

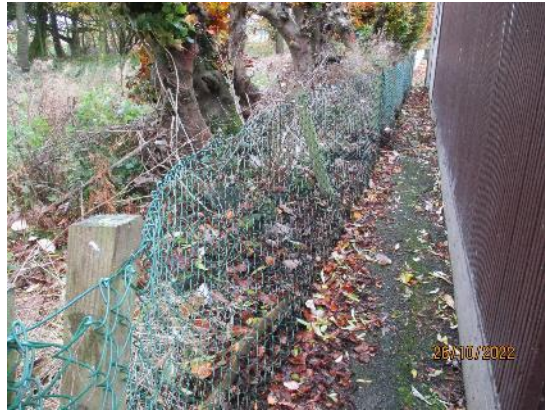
148. Rotten timber posts, damaged chainlink

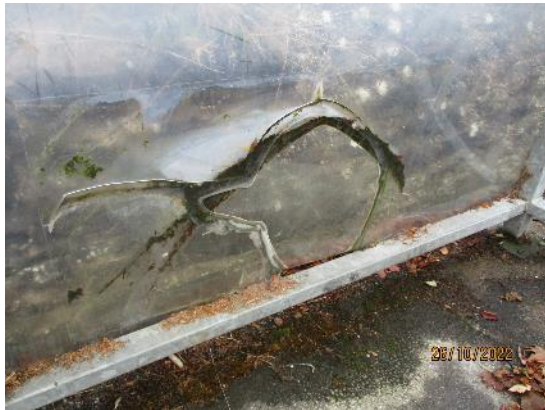
155. Damaged PVC cladding
