Forres Conservation Area

Part 3: Conservation Area Action Plan

November 2013

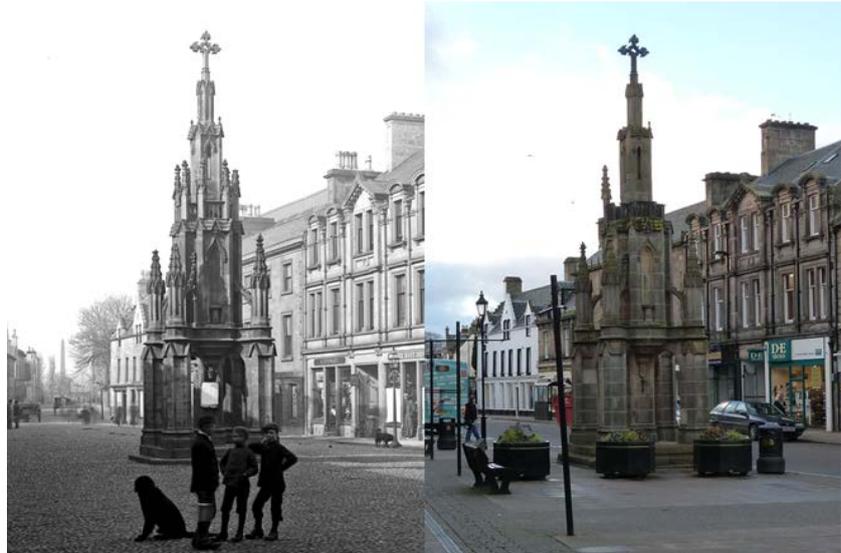
The historic photograph of the Market Cross c1875 reveals how much of the architectural detail of the monument has been removed during the constant repair programmes of the late twentieth century

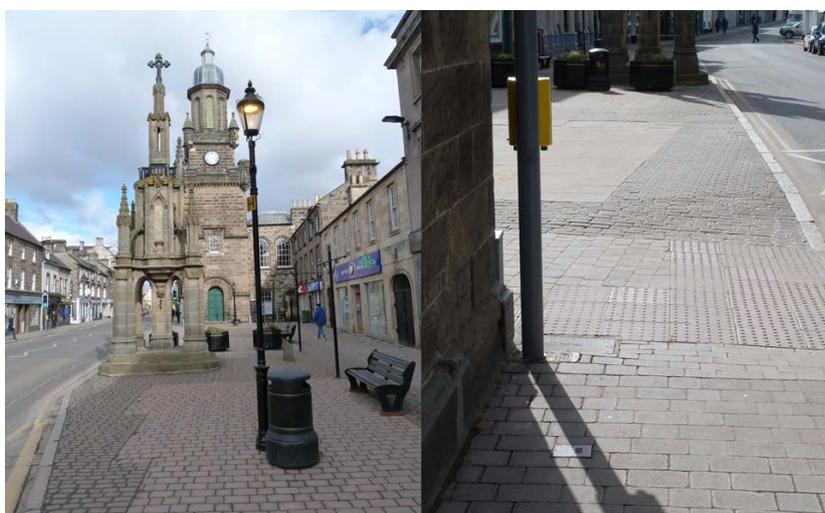
Disjointed finishes from serial improvements at the Plainstones, poor materials and street furniture suggest a more creative solutions can be devised to improve the public realm at the heart of the old burgh

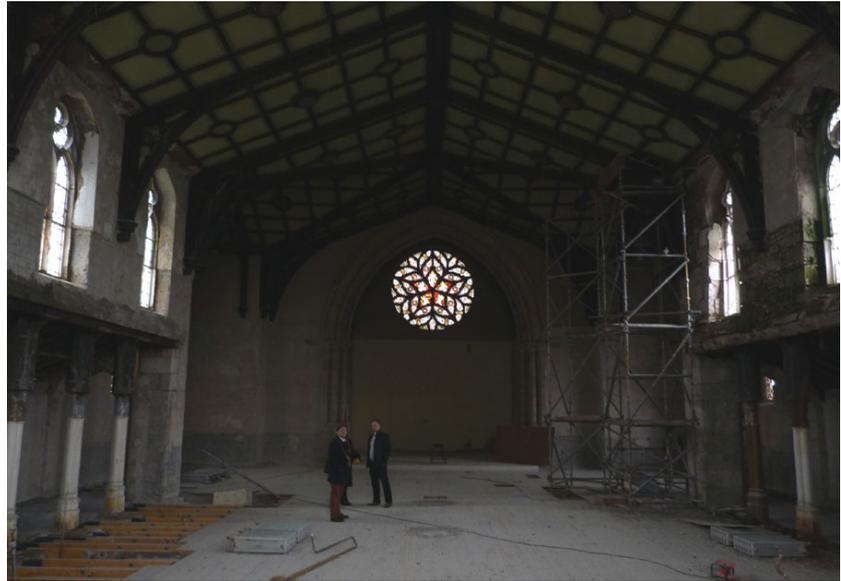
Interior of the former Castlehill Church (February 2013)

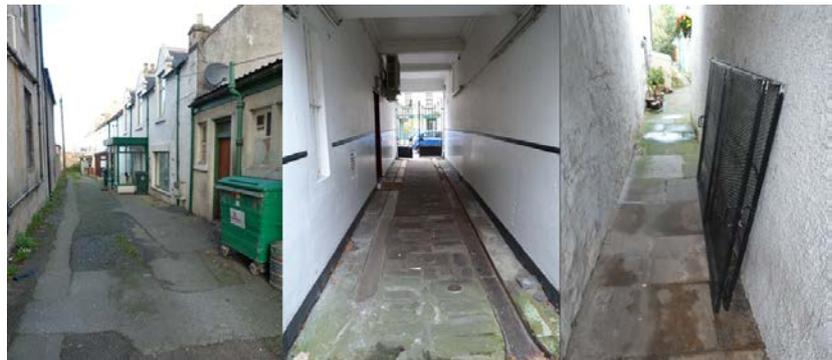
A mixture of historic and tired modern finishes to the surfaces of the wynds

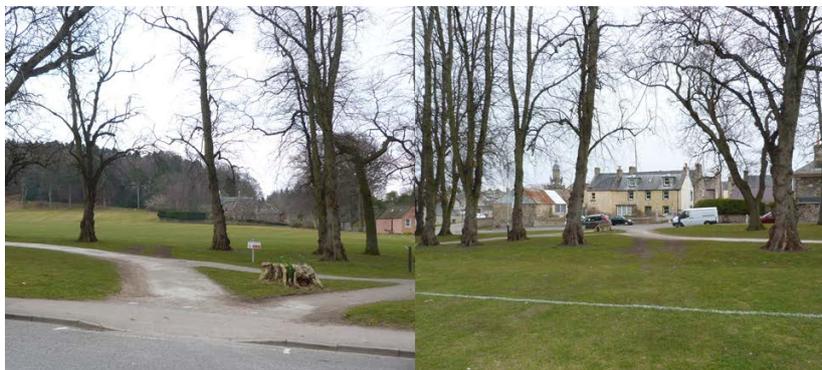
Makeshift vehicular access to the Grant Park for public events

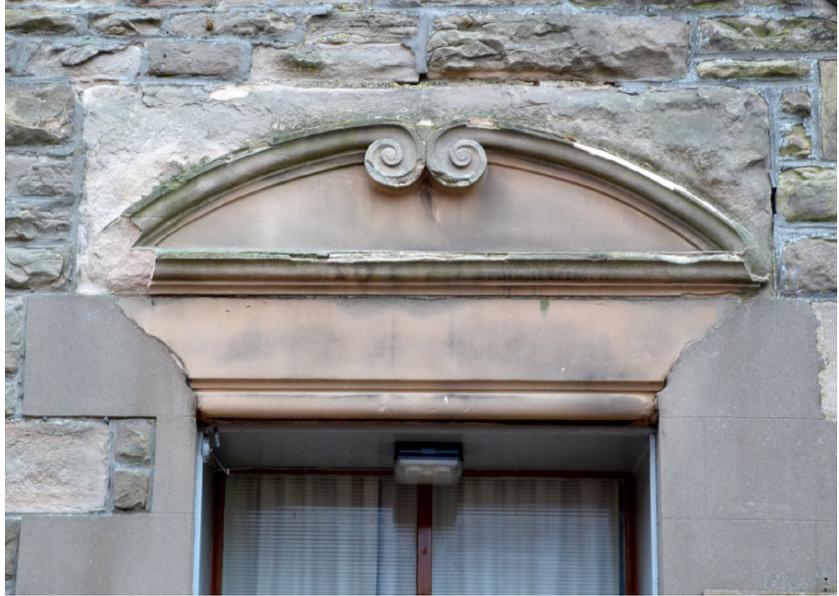
The heritage of Forres at risk: a soft blonde sandstone quarried in the early twentieth century for which dense cement pointing to the square snecked rubble is increasing the rate of decay, while the carved mouldings of the pediment are beginning to disappear. The rybats have also been given a dense coating of cement render with the consequential loss of the roll moulding preventing the underlying masonry to breathe

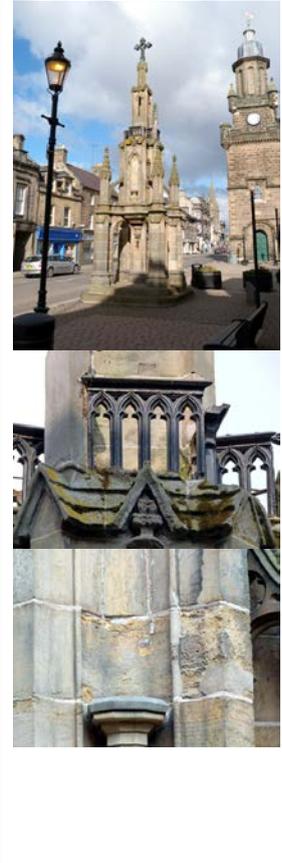
<p><b>Market Cross (1844)</b> Thomas Mackenzie, Architect (B listed)</p> <p>Several attempts have been made to repair the structure which lies at the heart of the historic burgh. While the more recent repairs have proved satisfactory, some of the earlier repairs have been damaging to the fabric of the monument and its long term stability. The structure has been denuded by the removal of carved pinnacles of which only one now remains <i>in situ</i>. The upper stages of stonework may require to be taken down and rebuilt with stainless steel dowels and cramps, with the cast iron balustrading set in lead where in contact with the masonry and firmly constrained with stays. Missing pinnacles are assumed to have been lost and will require to be replaced with matching carved detail. A conservator's report should be sought for the carved detail and consolidation of friable stonework undertaken, for which it is assumed that the most decayed stonework will require some replacement. For the remaining ashlar masonry all plastic repairs carried out in dense cement should be carefully removed and indents inserted in matching stonework. The horizontal surface at the plinth at the base of the monument should have the cement infill removed and polished sandstone slabs laid down. The whole of the structure should be repointed in lime mortar, for which a specialist report should be sought. Appropriate lighting of the monument should be considered as part of the public realm works.</p>

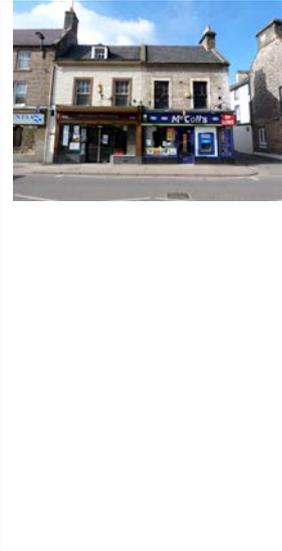
<p><b>McColls and Rowlands Chemist, 81-83 High Street</b></p> <p>Early 19thc with modern shopfronts inserted. Reset cope of north gable chimneyhead where bulging. Overhaul slates and replace lead and clay ridges respectively with new lead ridge. Insert new dormer at No 81 to maintain symmetry of the façade. Overhaul window joinery and replace missing astragals to lower sashes of first floor windows. Overhaul cast iron rainwater goods and install new downpipe at east end of roof. Remove paint finish from walls, repoint masonry in lime mortar and apply unifying limewash finish to the wall. Gild the mortar and pestle sign and redecorate supporting bracket and remove all unused brackets to the façade. Replace the shopfront and fascia at No 81 in accordance with the evidence of historic photographs. Reset alarm sounders at fascia level. Redecorate the harled wall to the gable at North Street and overhaul cast iron rainwater goods.</p>

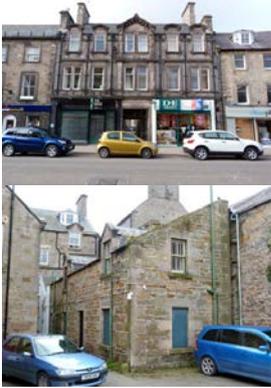
<p><b>DE Shoes and redundant shop unit (formerly Victoria Wines) and structure to rear, 101-105 High Street (C listed, 1883)</b>  Frontage with 3 storeys of extended height, with much of the original cast iron frontage at No 105 intact; this frontage, together with the monopitch-roofed building to the rear, is redundant and on the BARR. Check over slating and overhaul, and check soundness of the pointing to the tall chimney stalks; assume some resetting of the copes will be required to the rear of the east chimneyhead. Repoint open joints to rubble masonry at the east gable. Overhaul decorative cast iron rainwater goods and redecorate, and in particular check the efficiency of the arrangements at fascia level for disposal. Redecorate external joinery. Overhaul cast iron gate at entry to the wynd and redecorate. Encourage the installation of a new shopfront at No 101 to match the adjoining shop at No 105, or an earlier known design. Remove the security shutters at No 105. Remove dense cement pointing from the rear wall and repoint in lime mortar. Overhaul the slated roof and lead ridges to the dormers to the building at the rear, and repoint where defective in matching lime mortar. Repair and redecorate sash and case windows and reinstate the missing windows at ground floor.</p>

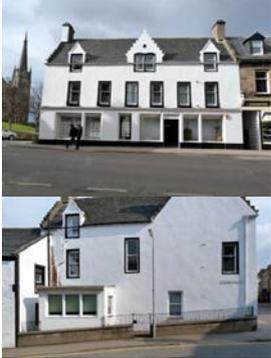
<p><b>R&amp;R Urquhart, 117-121 High Street (C listed)</b>  Prominent corner building in the townscape at the corner of Gordon Street, mid-18thc and later; despite many alterations, including Victorian cast iron shopfronts, high levels of authenticity meriting higher than the C listing. Well maintained. Front wall leaning inwards from first floor and while some structural movement observed it may not be progressive. Remove dense cement pointing at 3 chimneyheads: assume that on close inspection 2 may require taking down and rebuilding (leaning and bulging), replacing decayed stones and pointing up in hydraulic mortar. Repoint open joints at the crowsteps and replace only the worst affected decayed stones. Lift and rebed stone ridging on hydraulic lime mortar, replacing clay tiles with stone to matching profile. Overhaul slating and replace cement hips with lead rolls at the 2 storey wing. Renew lead ridges to dormers and assume that all lead valleys should be replaced with disturbance to the slating. Reinststate missing ball finial to the central High Street dormer. Consider removing the modern tyrolean cement render at the Gordon Street elevation and replacing it with an ashlar render to match the High Street elevation. Replace two modern windows on the Gordon Street elevation with traditional sash and case windows in accordance with historical precedent. Consider taking down the modern mild steel railings and gate at the corner with Gordon Street and replacing with more substantial railings or, alternatively consider improvements to the public realm on the street corner.</p>
