Our Ref. 080142/mjh
Your Ref. TM/KT/CL/08-02487-FUL

**CONTAMINATED LAND REQUEST FOR PLANNING APPLICATION: 08/02487/FUL -
RENOVATE AND REUSE REMAINS OF EXISTING LIME KILN TO CREATE
DWELLINGHOUSE AT BRAEHEAD QUARRY, KEITH**

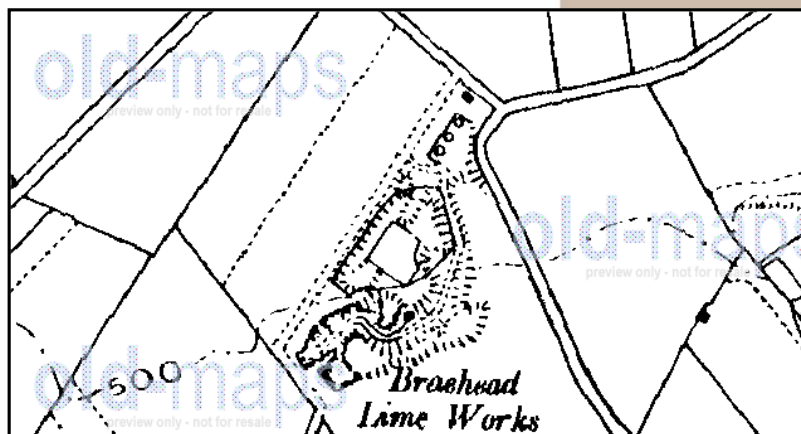
In April 1902, the Banffshire Herald makes the first reference to the quarry operation and notes that the site is to be let as a quarry. By the 1905 second edition Ordnance Survey map (See adjacent extract) the site is identified as being the 'Braehead Lime Works', and shows an extensive area to the south east of the public road being utilised for this purpose.

Fronting the public road the OS map illustrates a rectangular shaped object with three round pillars, which based on the remains on site we assume to be the lime kiln.

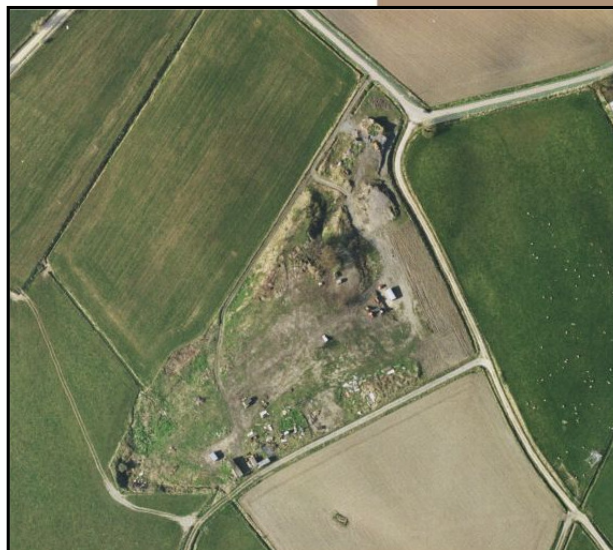
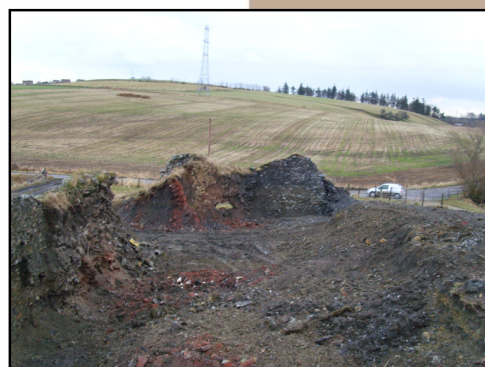
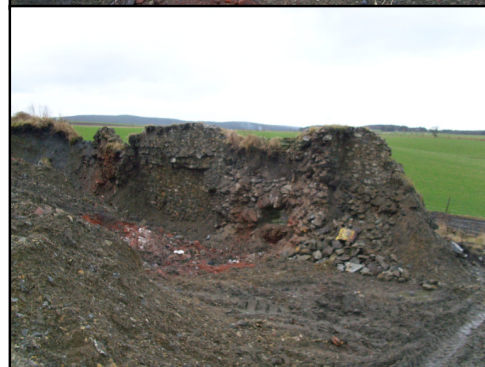
In the past few years the site has been landscaped over and replanted; consequently little evidence of the previous quarry use exists. However, the stone frontage and north-east wall of the lime kiln is still largely intact.

More recently, the applicant has dug out the lime kiln to ascertain the extent and construction of the existing building (See adjacent photographs). During the excavation operations, our client reviewed the composite of the material utilised to infill the kiln and found it to be just black earth, with no foreign material. Corollary, we consider that the material utilised to infill the Lime Kiln poses no risk to human health.
