Elgin High Street Conservation Area

Part 2: Conservation Area Management Plan

February 2012

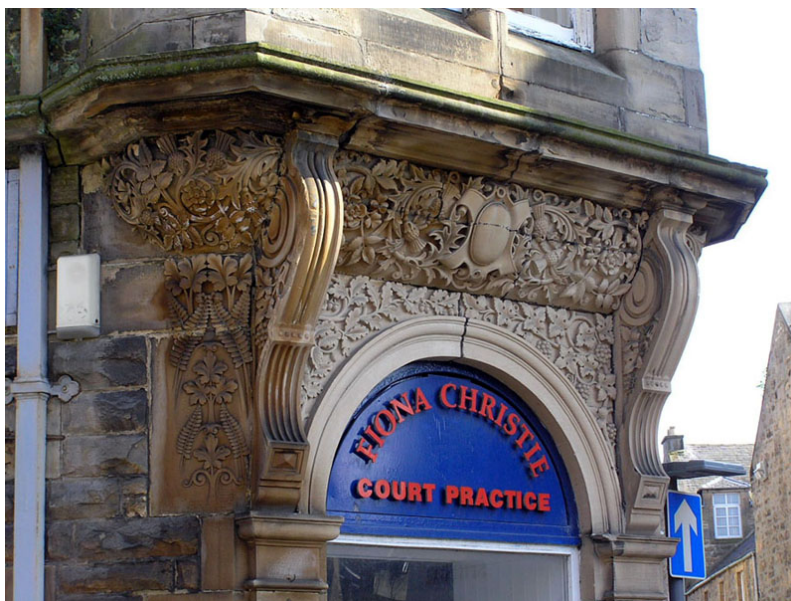
Elaborate carved stonework above the former entrance to the Grand Hotel, South Street (1898)

- 1.3.7 The character appraisal draws attention to the unusually rich legacy of finely carved architectural detail throughout the city centre. While this reflects a long tradition of the skills of the masons of the Laigh of Moray, for which the area was particularly noted throughout history, it is also a reflection of the availability from local quarries of some of the best sandstone to be found in mainland Scotland. Unfortunately, some of the quarries opened up in the late nineteenth century produced inferior material which, although easy to carve, has been highly prone to decay.

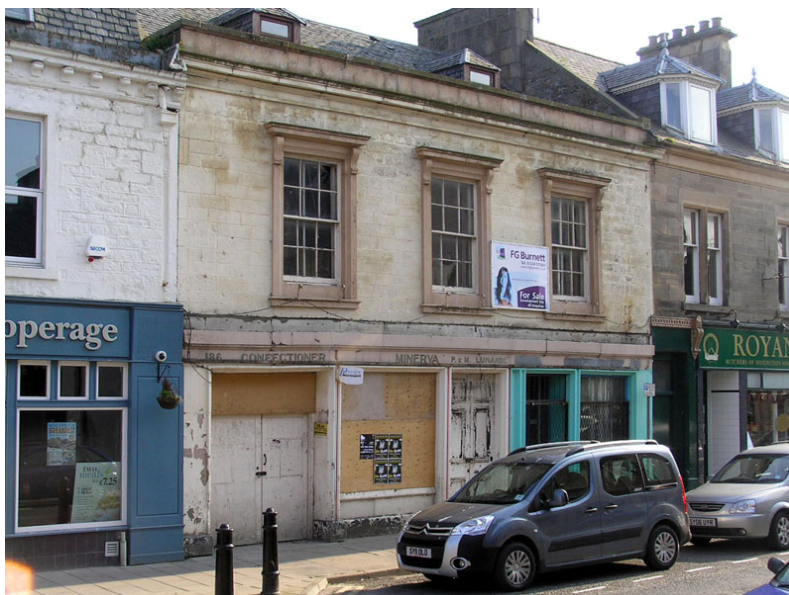
Building at Risk: 186-188 High Street

- 1.4.3 Elgin is not alone in suffering from a number of Buildings at Risk. They are listed in 5.7 of the conservation area appraisal document. Some have been vacant for a while and are awaiting investment for continuing uses, or compatible new uses. Some are in poor condition and are not being maintained, to the extent that they appear as eyesores within the street scene having a marked negative impact on the conservation area. Few are in such a dilapidated state that they could not be saved and put to beneficial use.

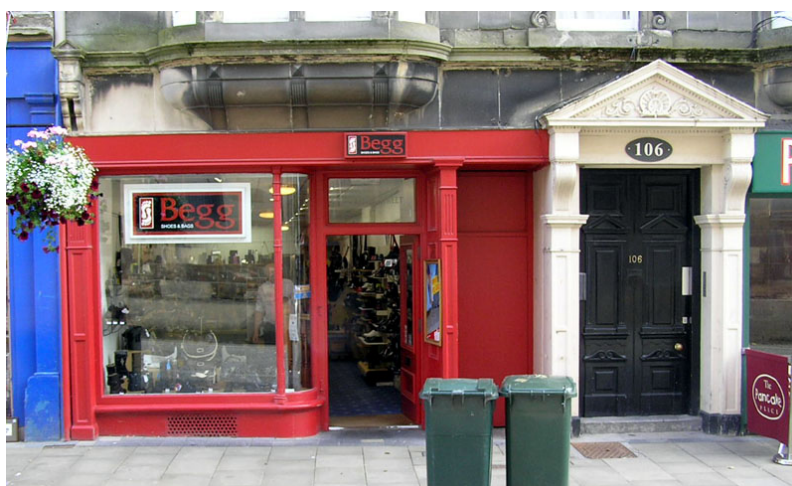
Late nineteenth century cast iron shopfront on the High Street, with retention of original features and with exemplary signage

- 3.3.6 The greatest physical changes to the High Street came with the evolution of retailing - forever at the heart of Elgin's prosperity in the past, as now - throughout the course of the nineteenth century. In the second half of the nineteenth century more sophisticated shop windows were appearing, taking advantage of the new techniques for manufacturing and transporting large panes of plate glass. It was not uncommon to see large shop windows being introduced into existing masonry walls at ground floor and, increasingly, new shopfronts were inserted in cast iron. More often than not properties would be taken down and rebuilt with an increased number of storeys at the commercial heart of the town, changing the appearance of the principal streets which had been, hitherto, characterised by a number of gable-ended domestic properties at the termination of the old burgage plots, of which only a few have survived to this day in the street pattern.

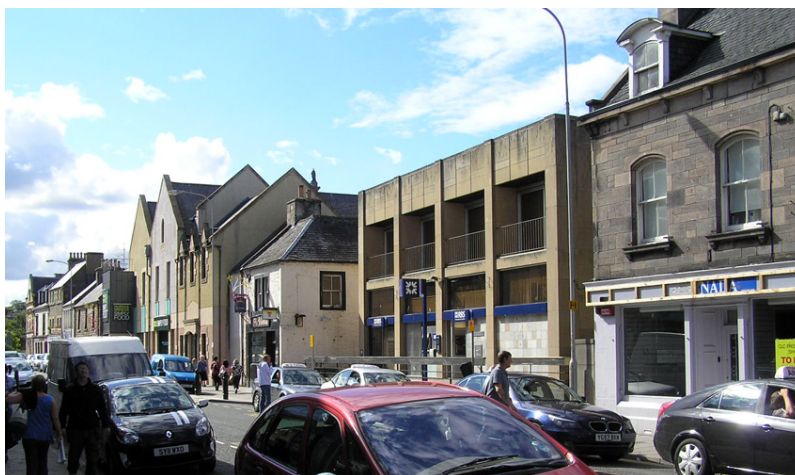
This modern bank building at the west end of the High Street replaced a distinguished Victorian frontage – while the design is not unreasonable for its age, it disturbs the townscape of the city's principal street and of the close behind it from not following the established urban grain, set back behind the line of the street and with the entrance raised on a deck.

- 3.3.7 The second half of the twentieth century was especially brutal to Elgin, and the redevelopment of several prominent sites threatened its character. A number of key buildings were demolished and sites redeveloped with new buildings that were less than distinguished. Where sites were redeveloped, building frontages, together with large extensions to the rear were always flat-roofed, setting a discordant note in a roofscape of predominantly pitched roofs and blue slate.

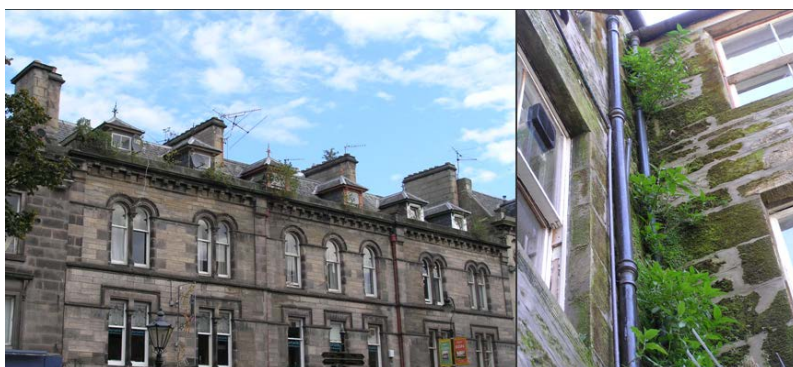
Problems with vegetation growth in the conservation area

- 3.4.1 The conservation area appraisal identified recurring problems with keeping the fabric of structures in good repair from planned, regular maintenance. Good conservation practice cannot be seen in isolation of undertaking targeted maintenance, whether replacing slipped or missing slates, repairing damaged leadwork in hidden gutters, or in removing debris and vegetation growth from high level gutters and repairing cracked downpipes.
- 3.4.2 Failure to carry out regular maintenance can place a property at considerable risk and place a financial burden upon property owners if unattended problems lead to damage of the internal fabric from wet rot, or more devastatingly, from dry rot.

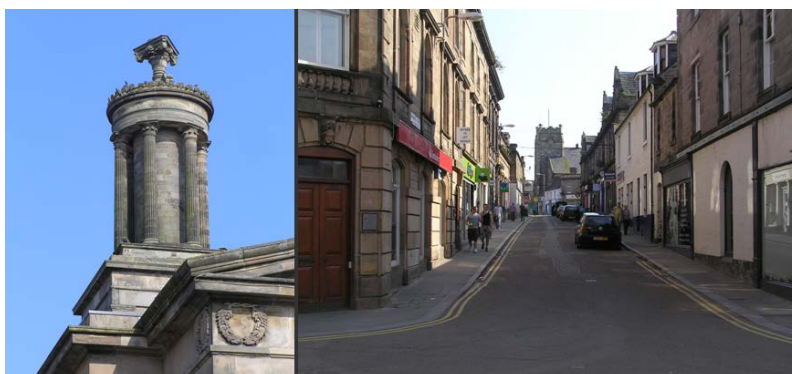
The supremely elegant tower of St Giles which dominates the townscape and the truncated tower of the former UP church on Moss Street, closing off the vista on Commerce Street

- 4.2.1 Towers and spires are among the most important elements in the historic townscape making a contribution to the character and appearance of the conservation area. Dominating the conservation area is the supremely elegant staged tower of St Giles Church, crowned by its Choragic Monument, seen on the skyline from a distance from outside the conservation area. It frames all of the key

- 4.2.2 As it occurs on one of the highest points within the conservation area, the tower of the former church on Moss Street also dominates the skyline and is more prominent than the steeple of St Giles when viewed to the south of the conservation area. It frames the view south from Commerce Street. The tower is in a very poor state, and as a consequence of advanced masonry decay the parapet has already been reduced in height and rebuilt. The lower parts are continuing to decay - see also 4.20.
- 4.2.3 Less visible within the townscape because of the surrounding trees and from being set back from the High Street, the elegant tower of the Elgin Museum is important for framing the view behind the Little Cross at the east end of the High Street.

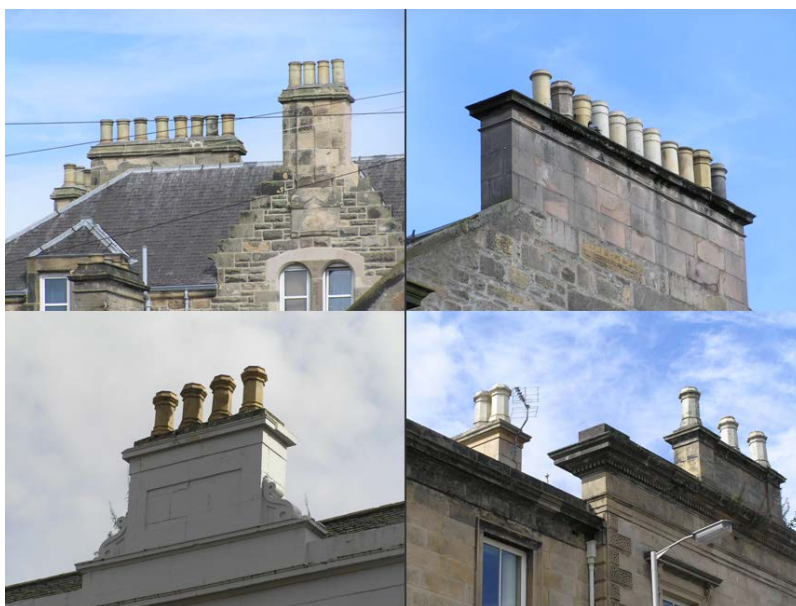
Good ranges of chimney cans of varying patterns

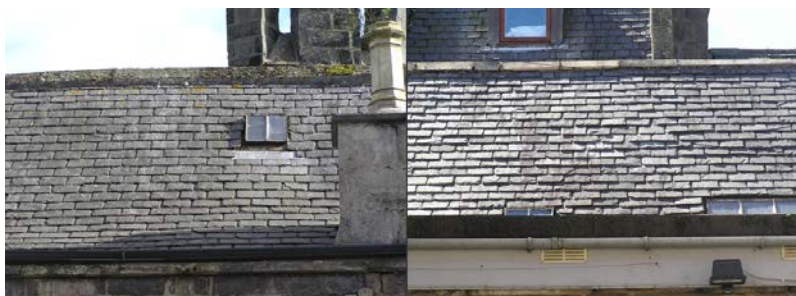
Blue slate roofs with stone and yellow clay ridge tiles

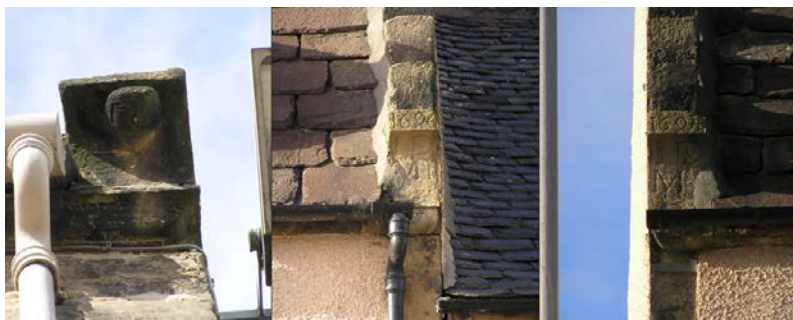
Carved skewputts to crowstepped gables: the carved head is from the 1720s and the other examples are dated 1694

- 4.5.1 Crowstepped gables are important features within the townscape, most closely associated with the earliest buildings in the conservation area. The detail is sometimes found in revivalist buildings of the mid- to late-nineteenth century. They should always be preserved and kept well pointed up to prevent water penetration.

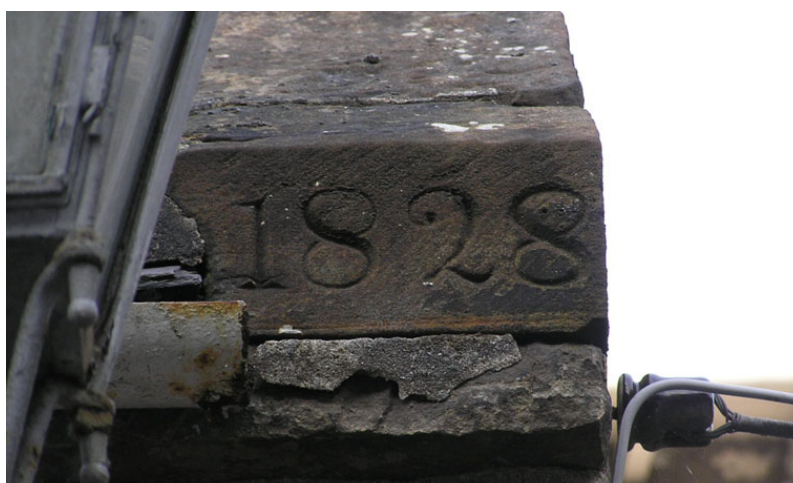
Gable with plain skews and a skewputt carrying the date 1828 (Braco's Close)

- 4.5.2 More commonly found for buildings of all ages are plain stone skews with plain blocked skewputts, very occasionally with dates carved into the face. As the nineteenth century progressed skews would become increasingly three-dimensional, reflected in steeply angled or triangular shaped skewputts in the more elaborate examples of the high status buildings. A further development emerged with a growing preference for 'tympan' gables with complex profiles built off the wallheads of the street elevations around the end of the nineteenth century.

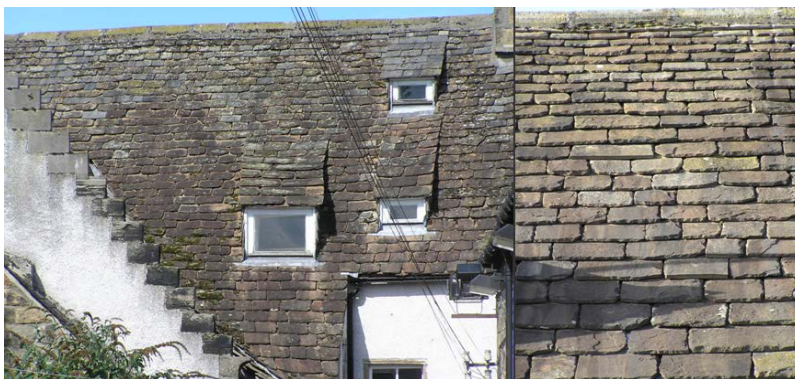
Elgin's distinctive stone slate roofs, appearing on buildings of the late seventeenth century

Heavy stone roofing slates must always be preserved and repaired using salvaged slate or with matching new stone slate that matches the texture and appearance of the roof. Where roofs have been replaced with blue roofing slate encouragement will be given to restoring the original stone slate finish.

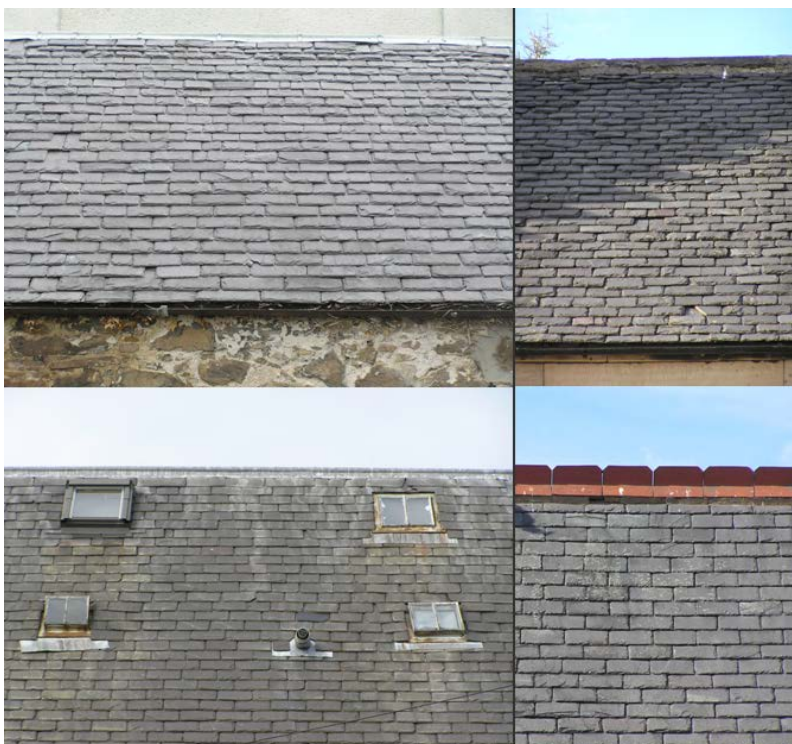
Blue slate roofs: the upper images show random face widths laid in diminishing courses; the lower images show regular machine dressed slates; ridges vary from lead, to stone and a decorative red clay ridge (bottom right)

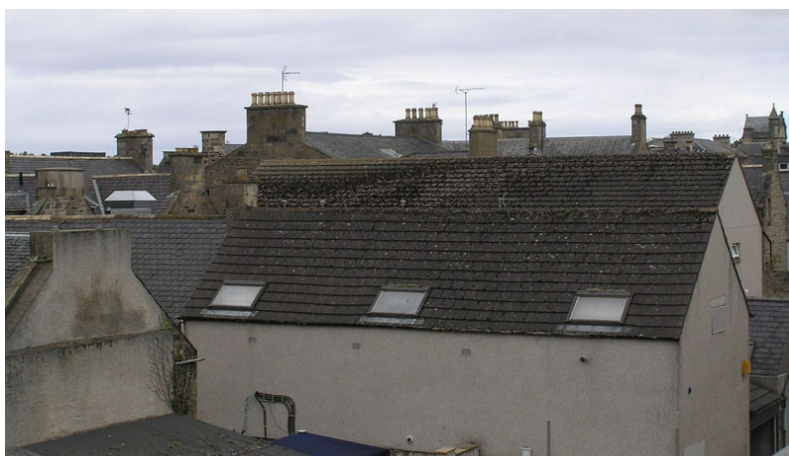
Concrete interlocking tile roofs appearing as alien finishes within a roofscape of predominantly blue slates

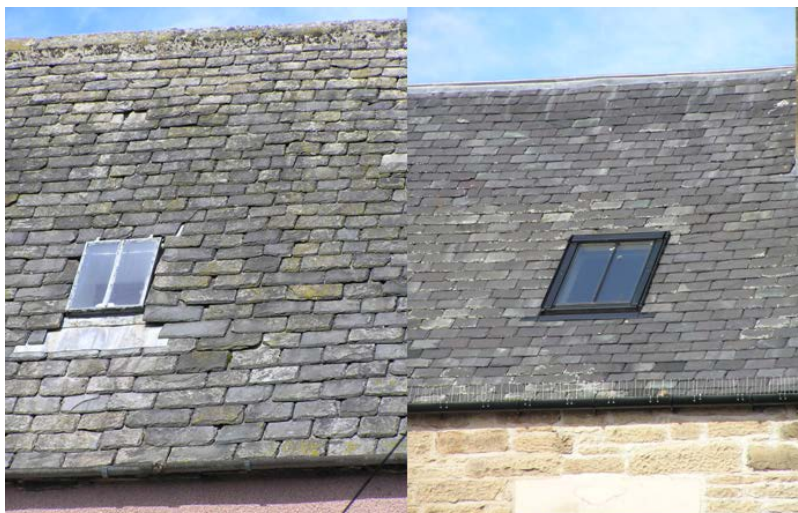
Traditional cast iron skylight (left) and modern conservation rooflight (right): although the top frame member is heavy the unit does not sit too high above the slates, and the middle astragal is slender, but there are less intrusive conservation rooflights than this on the market

Wherever possible rooflights should be confined to the reverse slopes of roofs, and should be kept as low as possible in relation to the roof ridge.

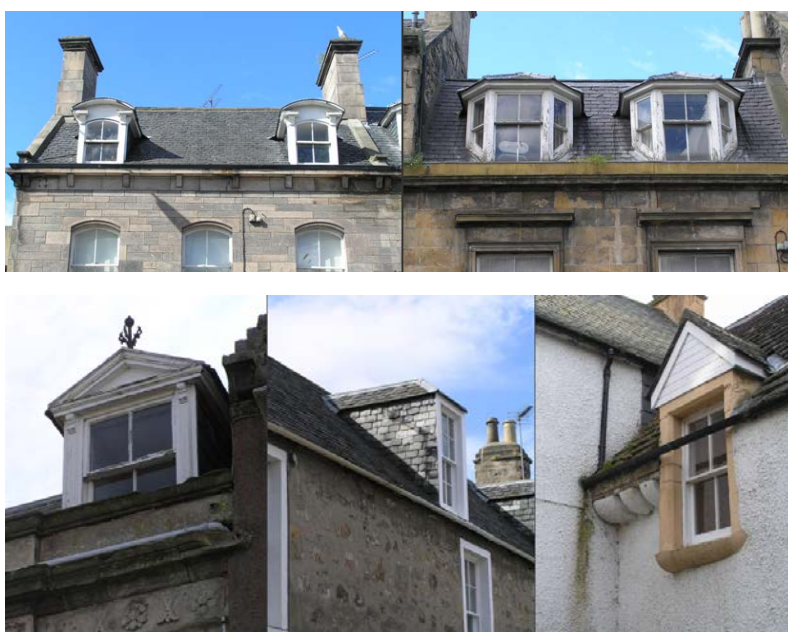
Examples of traditional dormers

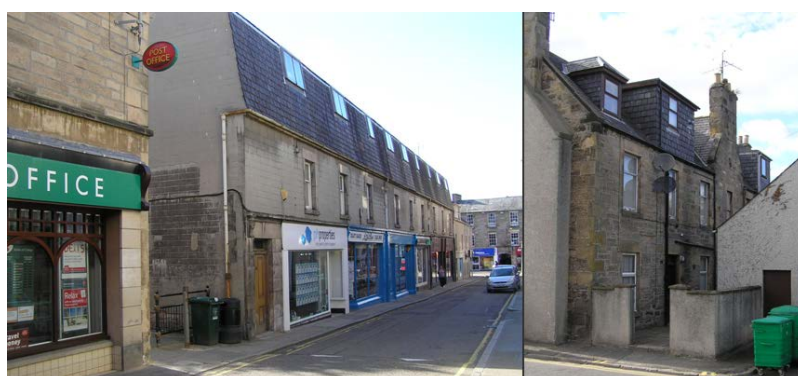
The modern Mansard roof has diminished what had been a fine range of late nineteenth century buildings on Batchen Street (left); modern box dormers are interspersed with traditional dormers in one of the closes (right)

- 4.10.2 Towards the end of the nineteenth century the design of dormers became more diverse – while some are plain pedimented, others have semicircular heads or are gables blocked out to complement a gothic façade. There are also some fine, vertically proportioned dormers built off the wallheads with distinctive carved detail. It is not uncommon to find that carved stone detail, for instance in finials, has been damaged through decay, with many features lost, and not replaced.

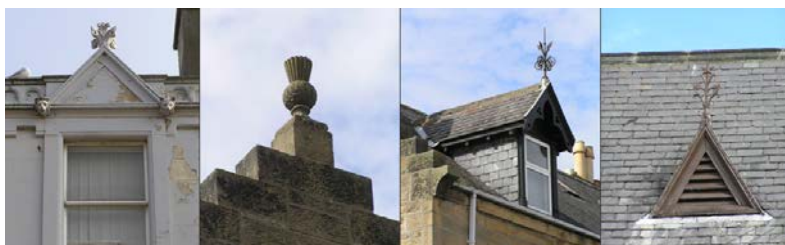
Carved stone and iron finials

Encouragement will be given to ensuring that decorative finials which have been lost, and for which there is historic photographic evidence, are restored to the original patterns.

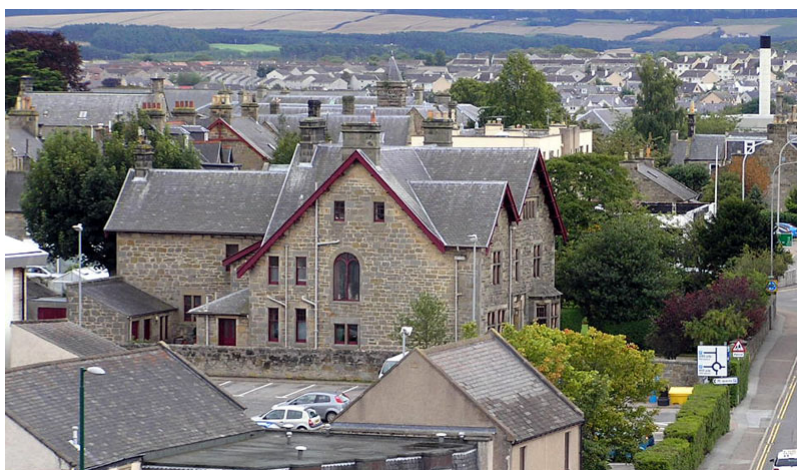
St Michael's, a large detached villa at the western extremity of the conservation area, with overhanging eaves and bargeboards

Painted bargeboards and eaves boards where they are original should be preserved always and maintained. There will be a presumption against renewal in modern maintenance free materials such as uPVC.

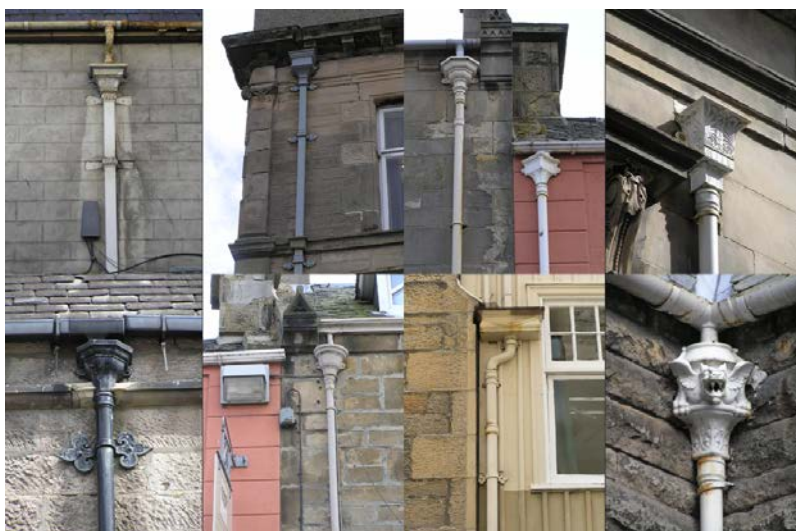
Decorative cast iron rainwater goods

- 4.14.2 Buildings from the early nineteenth century onwards were normally fitted up with ordinary half-round cast iron rhones and round downpipes. Towards the end of the nineteenth century more elaborate patterns appeared on the principal buildings, of which some have survived. Decorative cast iron rainwater goods were used extensively up to the 1930s. Not all of them are in good condition and some damaged sections have been lost and replaced. Square downpipes with decorative holderbatts, hoppers and ogee rhones supported on wall brackets, supplied by a number of different foundries, are to be seen on the buildings of the principal streets.

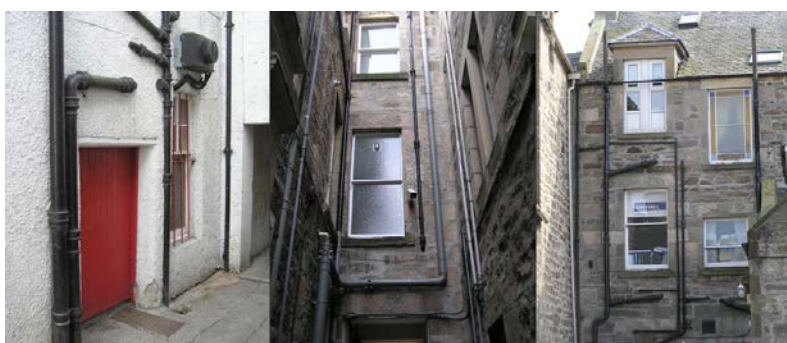
Unsightly soil and vent pipe systems to the rear of buildings on the forelands of the closes

- 4.15.1 Cast iron soil and vent pipework appearing on the face of buildings will be likely to date to the late nineteenth century onwards and reflect the introduction of sanitary regulations. More often than not, in older properties they reflect changes that have been made. Later systems may be of modern materials, such as uPVC. They are, without exception, disfiguring in appearance, especially where they occur on a principal elevation, or where seen along the length of a close.

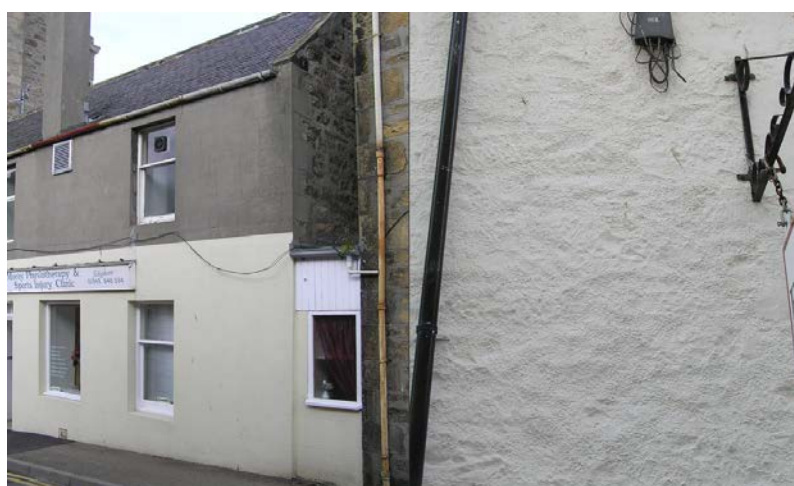
An early Portland cement smooth render, left, and possibly an early lime harl, right

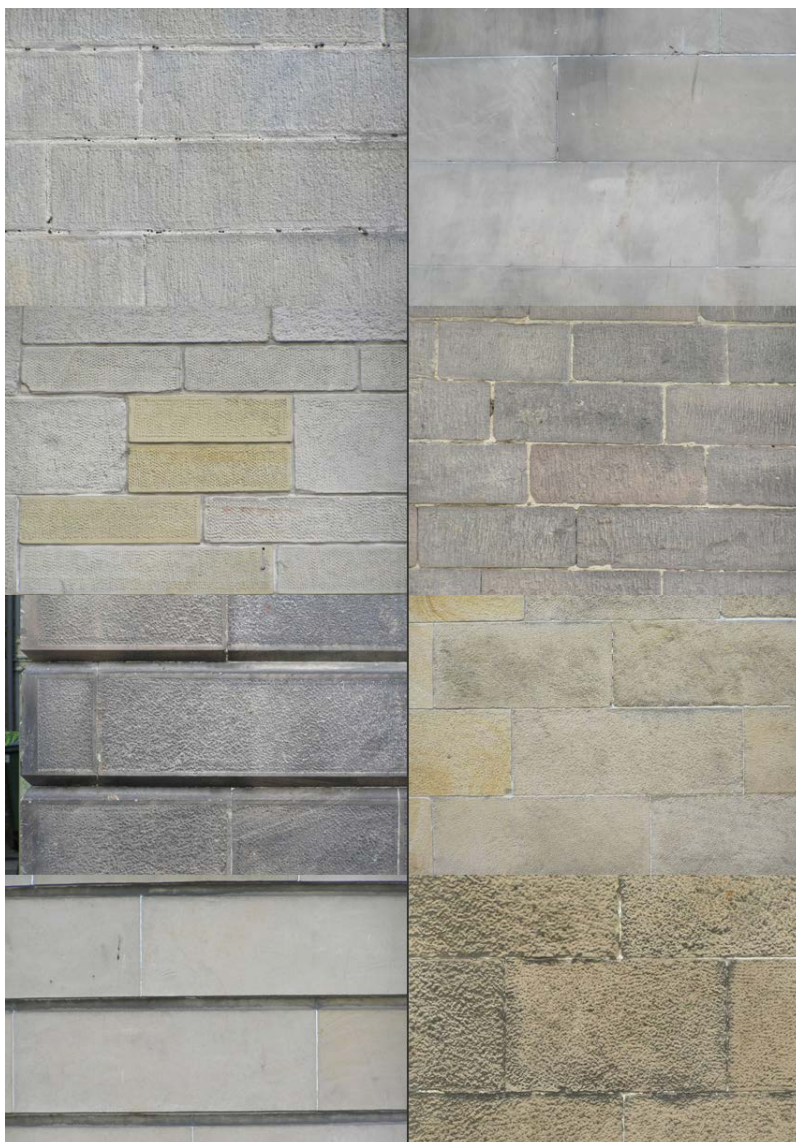
Sandstone ashlar masonry

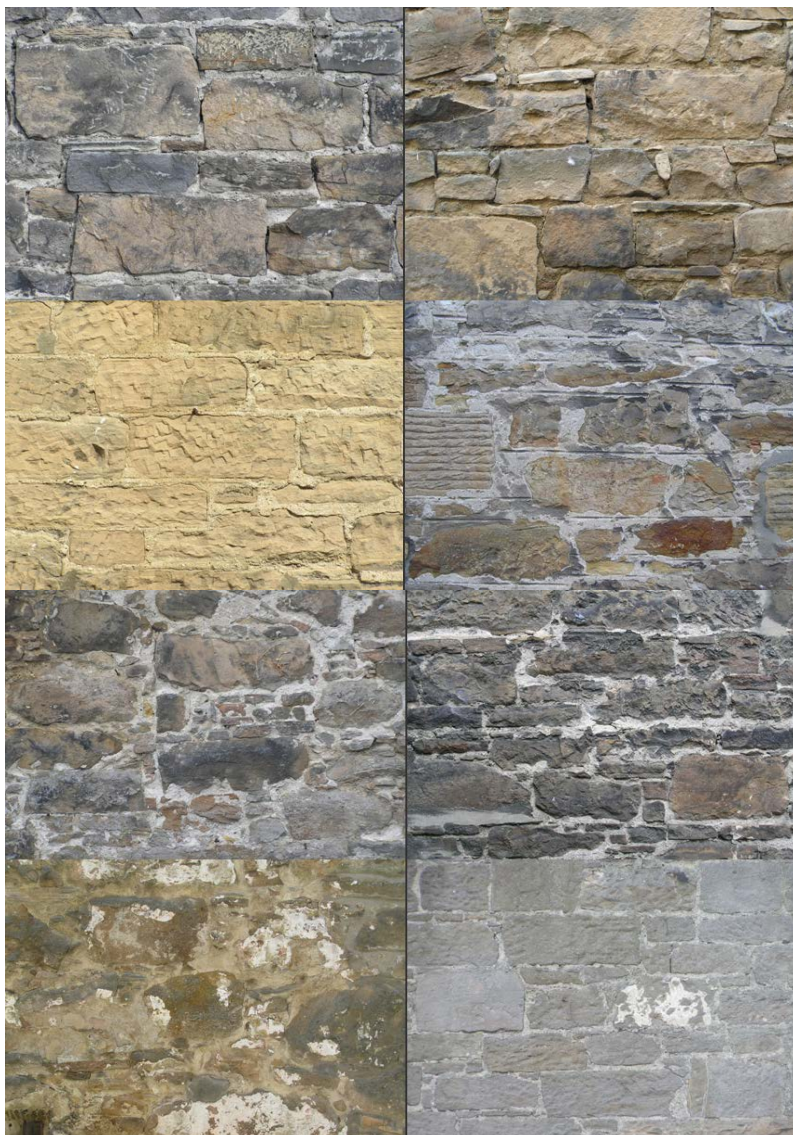
Varieties of Rubble stone walling

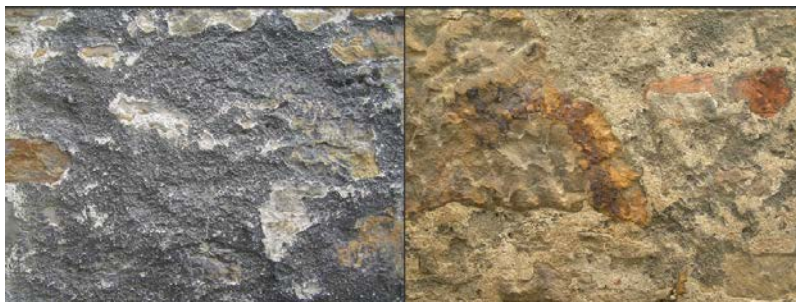
Rubble stonework with evidence of lime harling, or sneck harling

- 4.18.3 There is strong evidence to suggest that, prior to the mid-nineteenth century, in the growing absence of applied harled finishes to walls built of rubble were given coats of limewash to improve their appearance.
- 4.18.4 It is not unusual to encounter frontages on the principal streets where the less important buildings were to be found constructed of regular coursed rubble, or of square coursed snecked rubble.
- 4.18.5 Very few examples were seen where the original lime pointing has survived, and in the majority of cases rubble walls have been repointed in dull grey dense cement mortar, changing the appearance of the wall.

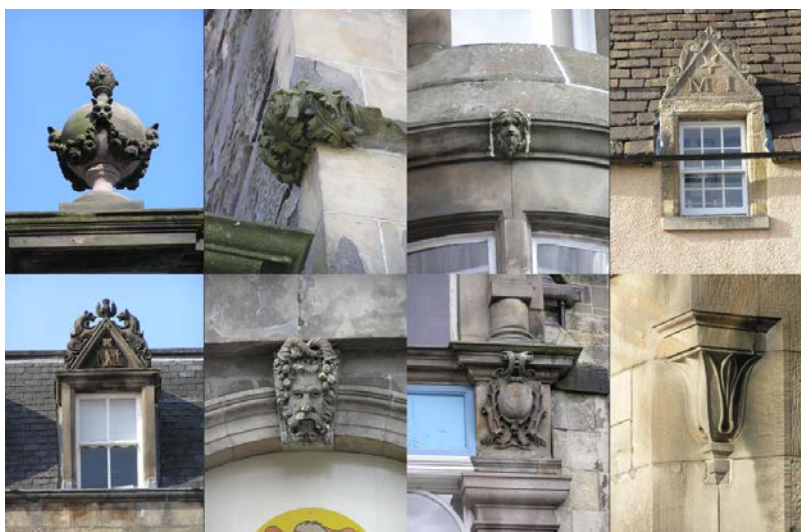
Sculpture and carved architectural detail (1)

The quality of the carved architectural detail of all ages to be discovered on the buildings of Elgin is exceptional, and makes a strong contribution to the character and appearance of the conservation area. While in the past durable sandstone, readily available throughout the district had been used and has lasted well, towards the end of the nineteenth century softer sandstones were often used which masons found easier to carve, but these stones have been prone to extensive decay with the consequential loss of carved detail. As much of this resource occurs at high level, it is highly vulnerable to decay, and constant monitoring is encouraged to ensure that it remains in good condition. In some cases it may be possible, and indeed appropriate, to restore lost detail for reasons of maintaining the architectural integrity of a composition – for instance, in the replacement of missing finials. However, if the loss of carved detail is extreme it may have to be accepted that it cannot be restored. Fine carved detail should be repaired and consolidated only by skilled craftsmen and conservators. In general there will be a presumption against repairing damaged carved architectural detail and sculpture with plastic repairs, or by the use of proprietary mortars.

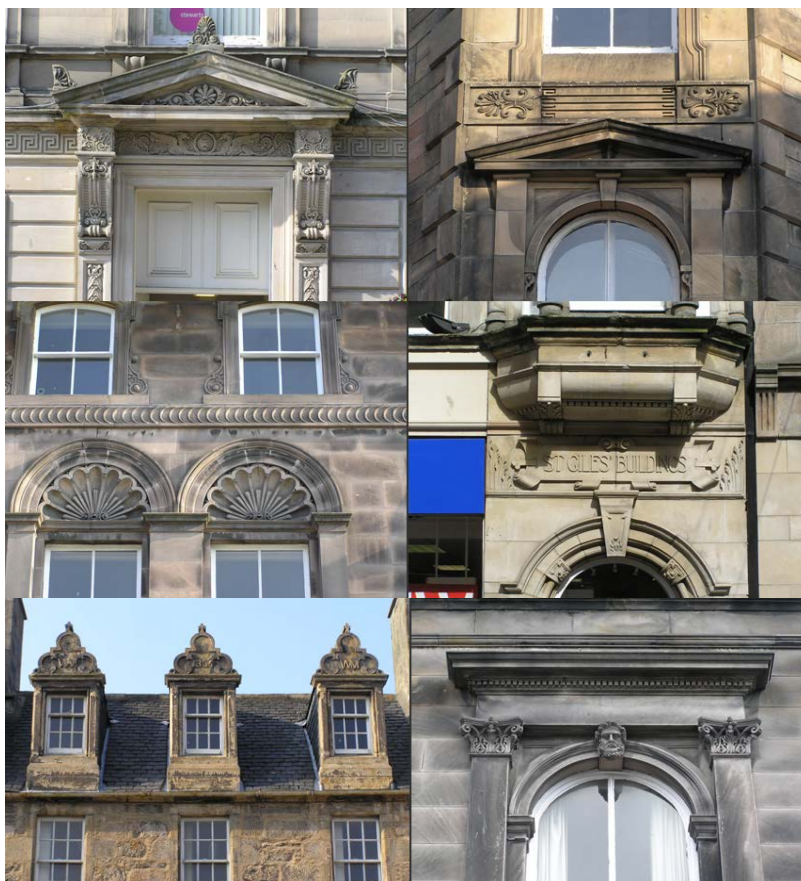
Sculpture and carved architectural detail (2)

Sculpture may be found on freestanding monuments, such as the Muckle Cross and the Little Cross, or on buildings in the form of carved heads or on pedimented dormers of buildings of the seventeenth and nineteenth centuries respectively. Repairs should be undertaken only by accredited conservators in accordance with a written report. Repairs to preserved armorial panels, carved lintols and other features of archaeological interest should, likewise, be undertaken only by an accredited conservator.

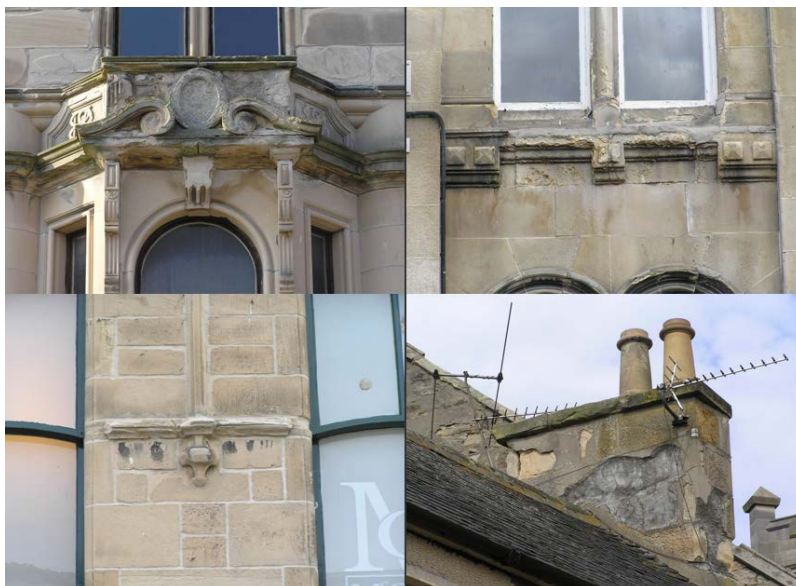
Stone decay (1)

It is recommended that the Council should work with Historic Scotland's Cathedral Workshop in establishing appropriate repair strategies for this widespread problem.

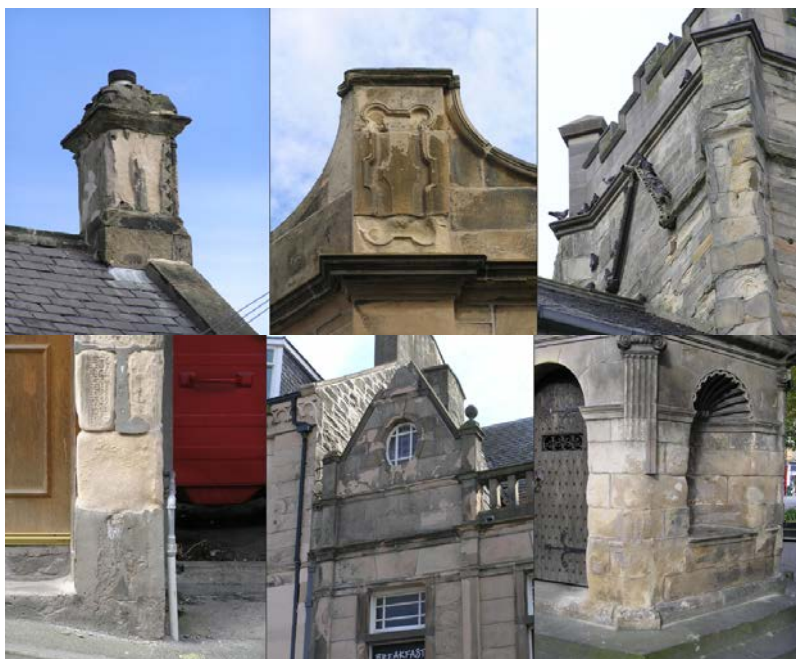
Stone decay (2)

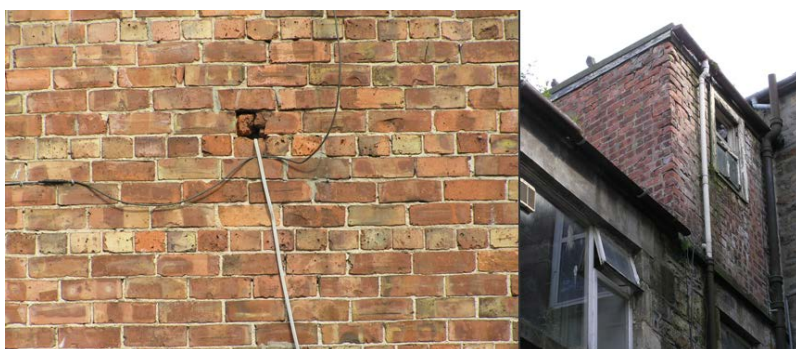
Walls of common brick in the conservation area

The contribution made by brickwork to the townscape may be relatively small, but should not be overlooked. Surviving panels should be preserved and repaired with traditional non-cement based mortars to match the original work. Where individual bricks require to be replaced, or areas of damaged brickwork taken down and rebuilt, second hand bricks to match colour, texture, and face size, should be used. Where they are unavailable, matching new handmade bricks should be substituted. Modern machine wire-cut bricks should never be used as they are different in appearance, with face dimensions that are much smaller than handmade Victorian bricks.

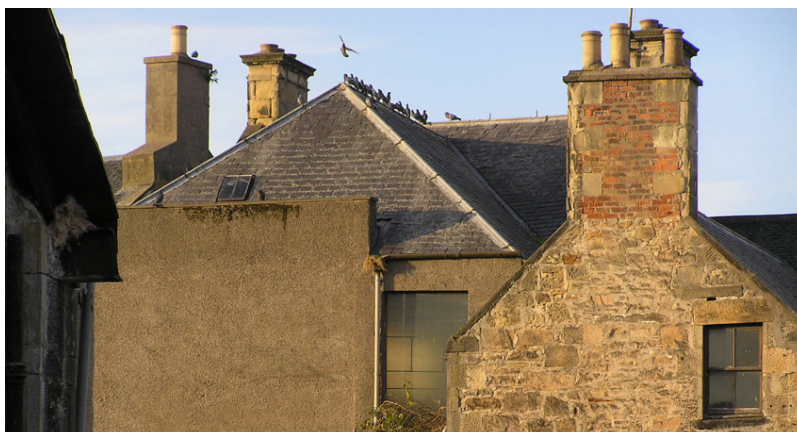
A hybrid brick and stone chimneyhead in which the soft stone has weathered worse than the brick – the stone chimneyhead in the background is in an advanced state of decay while the chimneyhead beside it has been taken down and rebuilt unattractively with a dense cement render finish

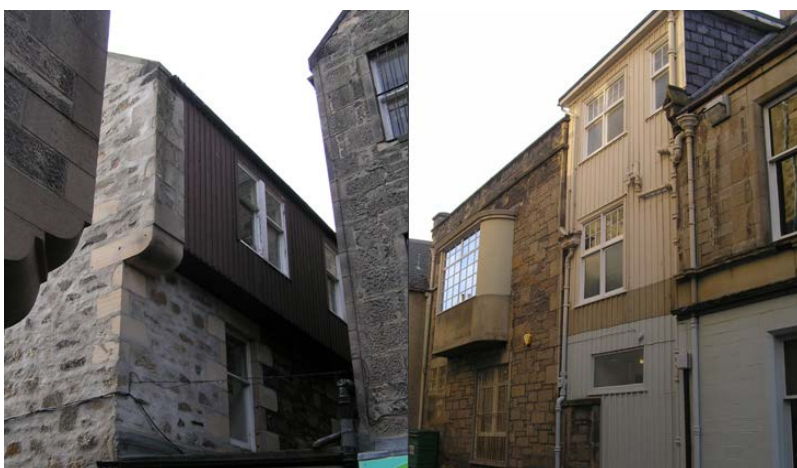
Examples of traditional timber cladding in the conservation area

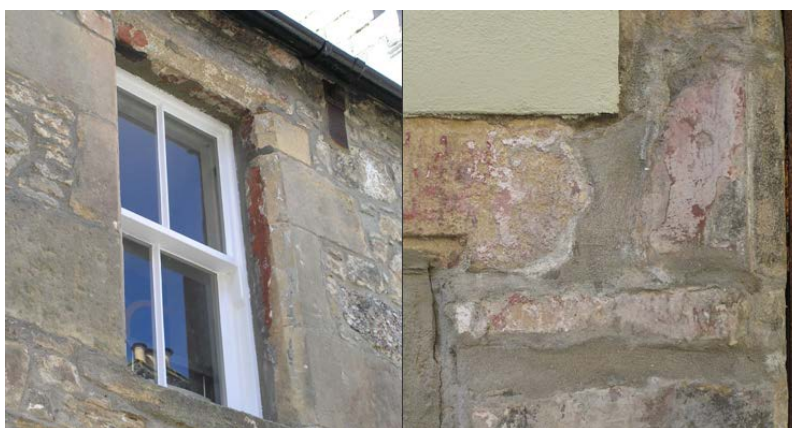
Evidence of historic limewash finishes in the closes

- 4.24.4 Entries to the closes off the High Street can occasionally give an insight to older colour schemes which are now mostly obscured by later decoration. Painted dado panels would not have been uncommon at one time, and it is possible to see that there had been more colour applied to buildings in the past where paint layers have peeled off. Within the closes to the rear of the late seventeenth century merchants' houses on the High Street can be seen remnants of colours applied to masonry which suggests that the historically the buildings of the city may have been more colourful than they are at present. These fragments of decorative schemes suggest traditional limewash, pigmented with ox blood.

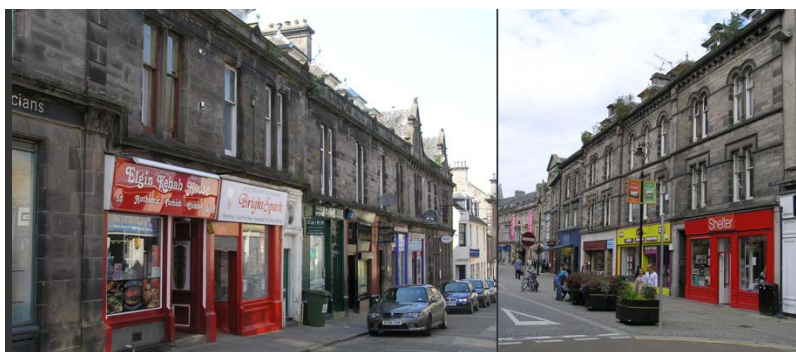
The use of bright, or strident, colours in shopfronts can have a jarring effect within the overall streetscape

- 4.24.2 Shopfronts can appear more brightly coloured, but even here it is not uncommon to find the structural elements of the shopfront painted white, black or cream. Vivid colours can have a disturbing effect on the townscape, and the impact can be even greater if the associated signage is over-sized, or too brightly coloured.
- 4.24.3 Occasionally a unified design as part of a street frontage can be disturbed by the walls above a shop frontage having been painted out.

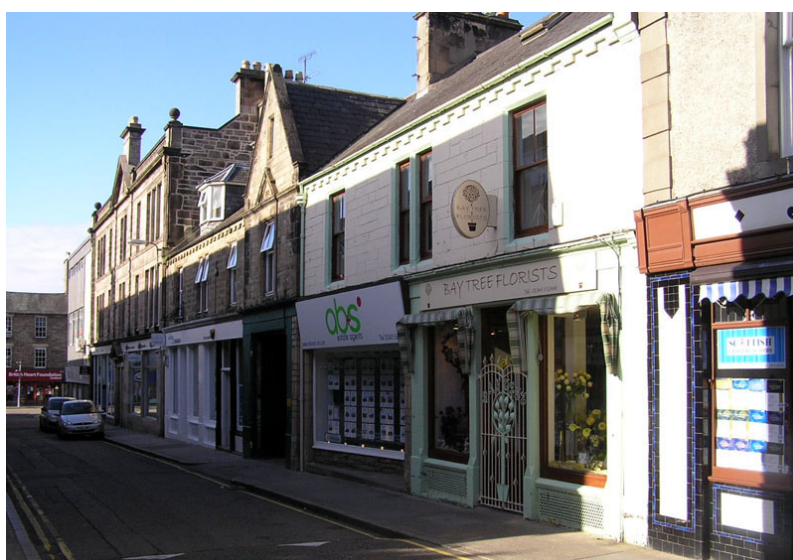
A unifying architectural scheme disrupted by painting the wall above one of the shopfronts

Where painting schemes that have been introduced are disruptive to the overall appearance of a unified architectural design within the streetscape, consideration should be given always to removing the paint and restoring the original wall surface.

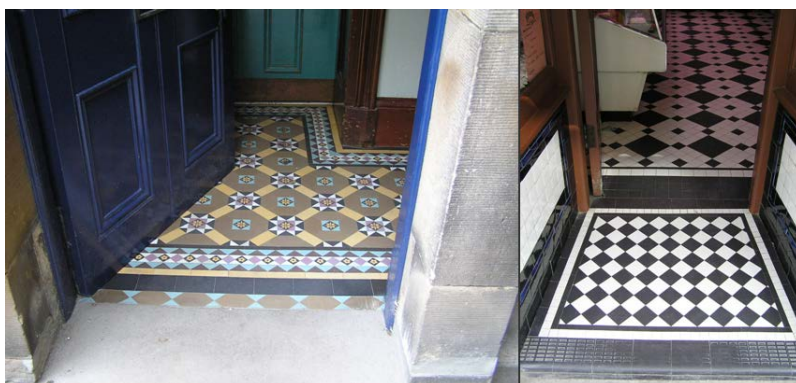
Encaustic tiled floors to door lobbies, late nineteenth century, left, and 1930s, right

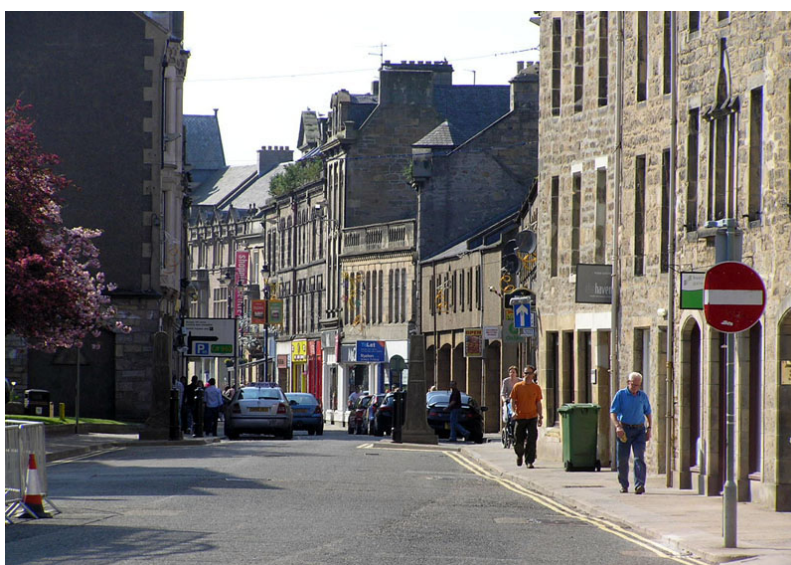
East end of the High Street, looking west

- 4.26.1 In common with many historic burghs, while alterations were taking place throughout many stages in the evolution of the city centre to respond to the pressures of retailing at street level, the pattern of window openings remained substantially unaltered at the upper storeys, giving a strong sense of authenticity to the historic townscape. They create an unbroken rhythm at the upper storeys and punctuate the wall planes, characteristics which can be appreciated in the long vistas from the ends of the High Street, and along its length.

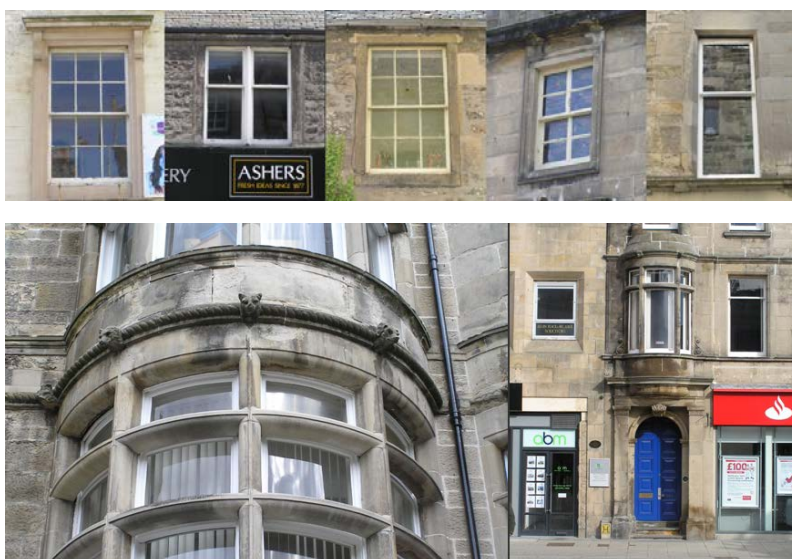
Traditional windows in the conservation area

- 4.27.1 Together with the treatment of the surrounds, windows have much to inform us about the history of the building and architectural styles. The earliest surviving windows in the conservation area are likely to date from the early nineteenth century by which time the production of sash and case windows with elegant narrow astragals was well within the capabilities of local house carpenters and joiners. There were limitations on pane sizes producing the universal multi-paned sashes of which there are now, perhaps surprisingly, relatively few examples in the conservation area, but more perhaps than in other comparable conservation areas.

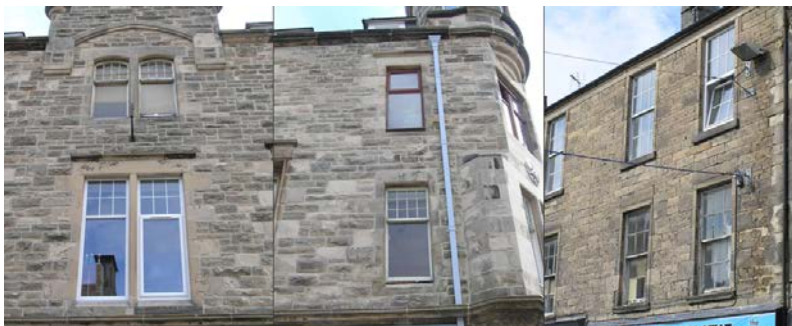
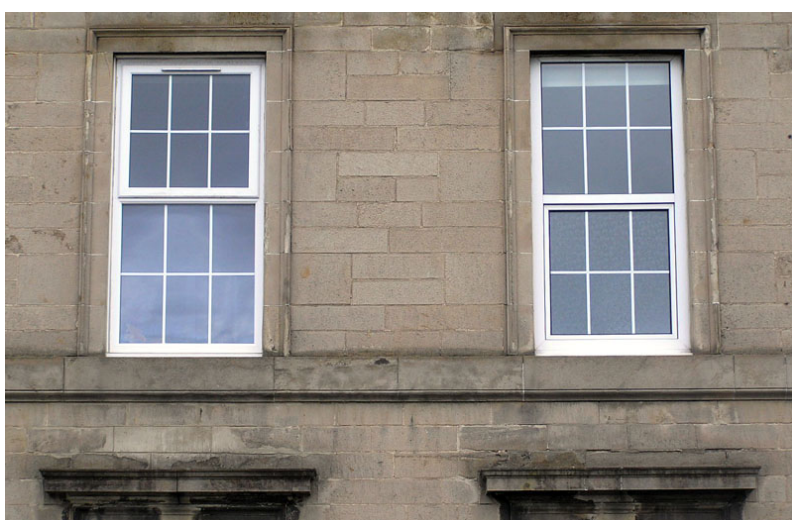
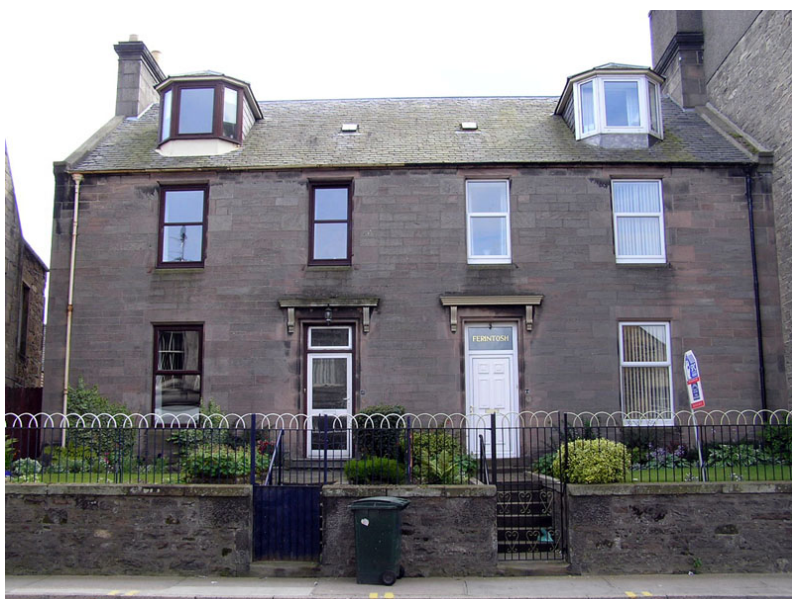
The impact of non-matching window patterns within tenements or semi-detached dwellings

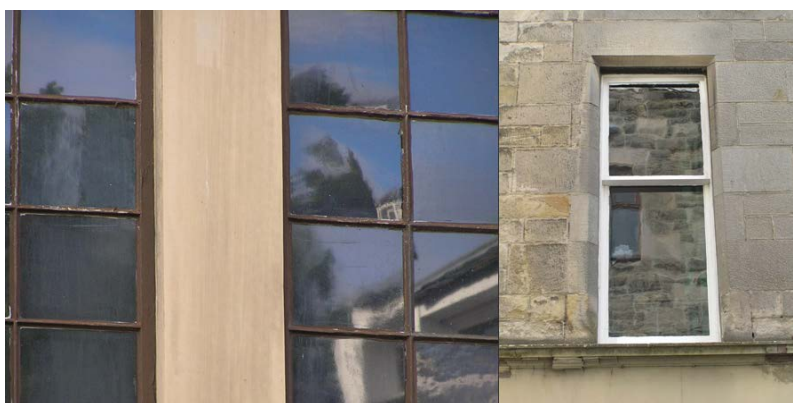
Distorted reflections from historic glass

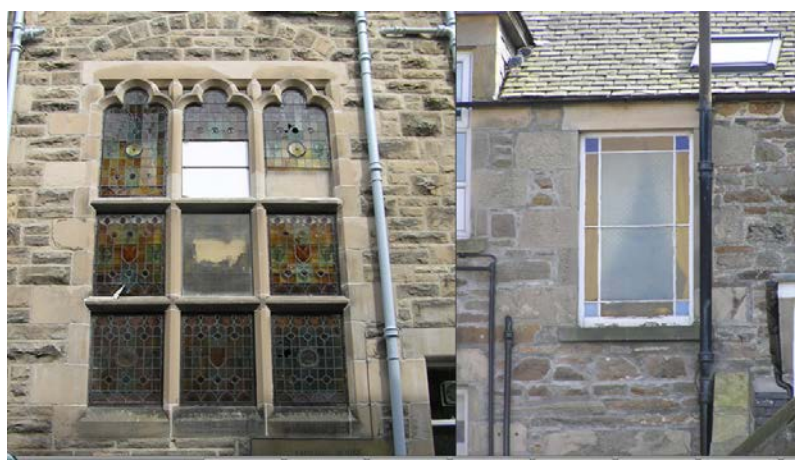
Stained glass windows in the conservation area

- 4.29.1 St Giles Church has fine architectural glass appropriate to the high status of the building, of which some of the glass panels have been damaged in the past. Other church buildings, whether in use as places of worship or not, have retained window panels of diamond-shaped glass set in frames of either lead or zinc. Some of these windows have been renewed with modern window assemblies, and where this has happened, without exception the appearance of the building has been damaged.

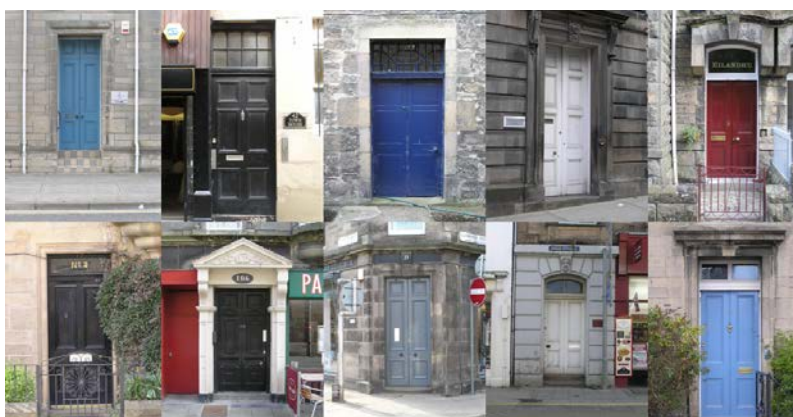
Panelled doors in the conservation area – a rich and varied resource

- 4.30.1 Elgin has a remarkably good collection of traditional doors serving various kinds of properties of differing ages, many of which have survived despite the rash of modern substitute doors which have affected, in the main, only domestic properties.

- 4.30.2 Doors are of many styles. Examples seen in the conservation area consist of flush panelled, panelled with raised bolelection mouldings, double margin, beaded panelled and fielded panelled doors. Simpler doors are usually vertically lined. Many doors were observed with traditional fanlights. A few doors of the late nineteenth century serving commercial premises were observed with highly decorative design motifs.
