Elgin High Street Conservation Area

Part 2: Conservation Area Management Plan

February 2012

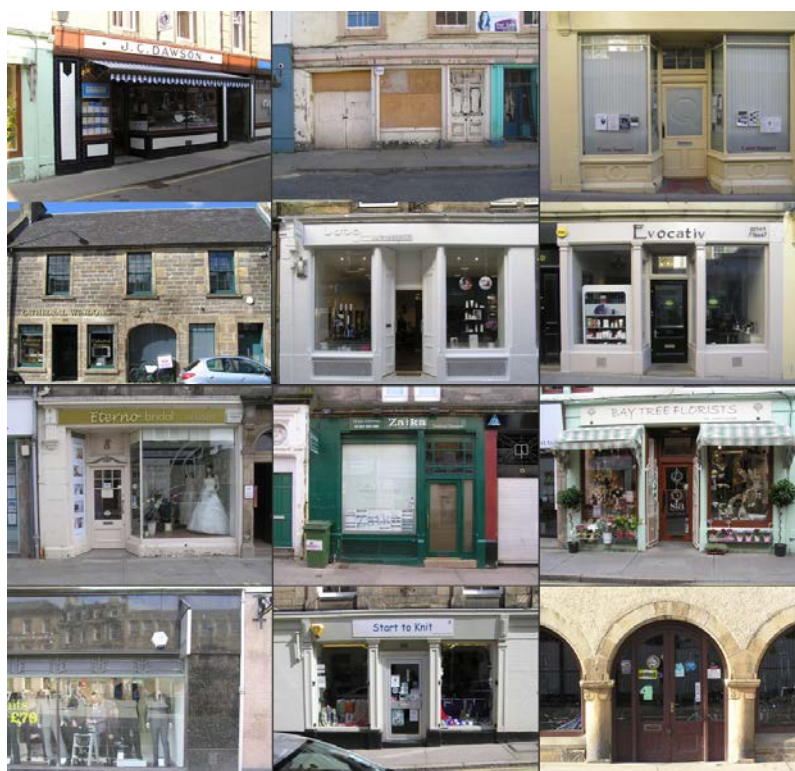
A small selection of Elgin's many traditional shopfronts from different eras

- 4.32.1 Cast iron shopfronts were introduced to Elgin in the latter half of the nineteenth century. Until then most shopfronts had plain masonry piers as can be seen in some of the shop units at the west end of the High Street, although some early stone shopfronts were more elaborate. In the shopfronts of the early nineteenth century arches were incorporated within the façade to give access for horse-drawn vehicles to the close, and they would be located to one side or at the centre of a frontage extending over two or more of the original burgh plot widths. As stone shopfronts became more sophisticated the stone pillars were reduced in order to maximise the amount of glass, made possible with advances in plate glass manufacturing and transportation. Cast iron shopfronts were probably supplied from the Newmill iron foundry, and are often difficult to distinguish from stone in having chamfered pillars and lintols. They are often combined with plain iron lintols which can be distinguished by the fact that they are always painted.

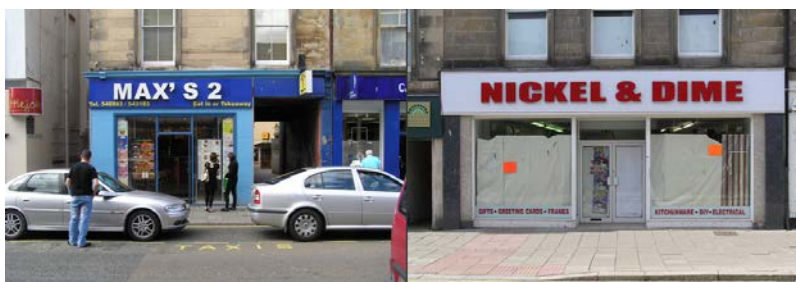
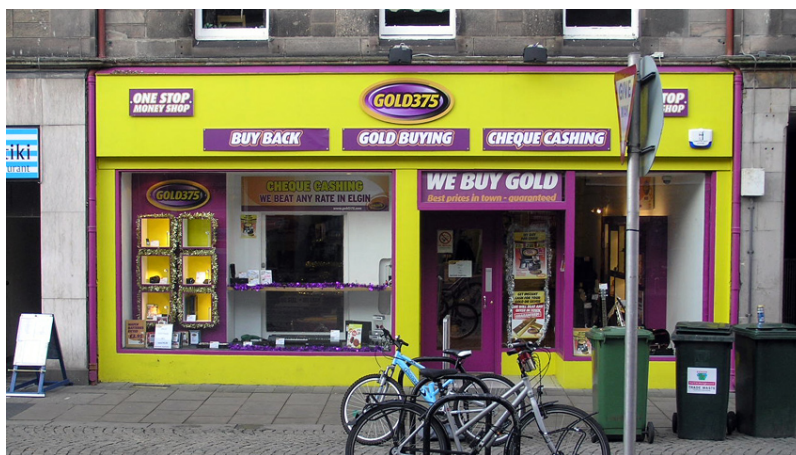
Shop frontages with overbearing fascias which appear disruptive within the street scene

- 4.33.2 Nowadays none of the original shop signs have survived on the High Street, and signwriting has become much less practised as an art. Some of the signs on the High Street are of highly reflective plastic and, with few exceptions, are intrusive, often with poorly designed computer-generated letters and images. Many of the signs are overlarge for the shopfront, overwhelming any interesting architectural detail that may have survived. In townscape terms, the effect of continuous arcading of columns and shaped lintols can disappear, or be interrupted. Against this, there are exemplary shopfronts to be found which conform with good practice.

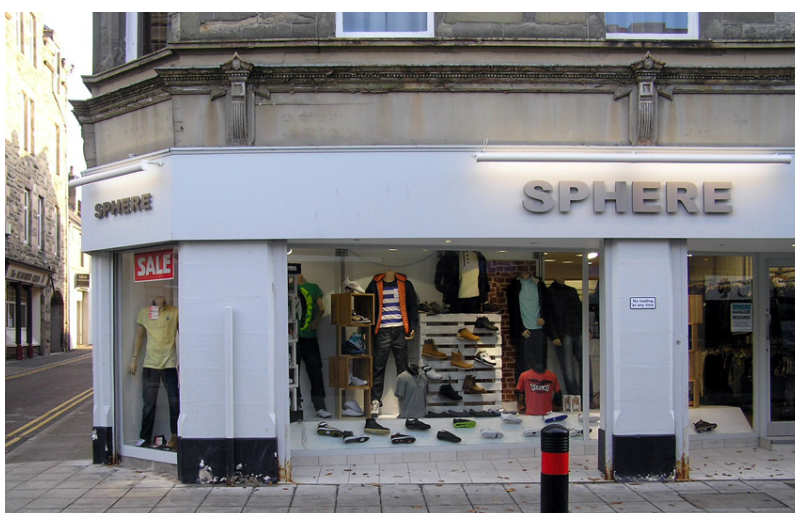
A shopfront marred only by the rusting guides for the security shutters and the modern shop fascia have been introduced below the original ornate one of timber, which is now at risk from not having been maintained

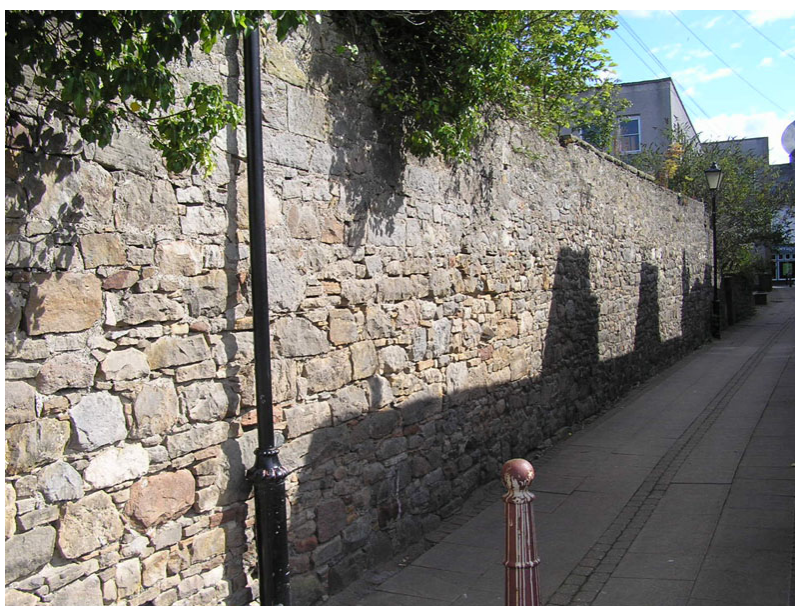
Tall stone boundary wall defining burgage plots, or 'rig' boundaries

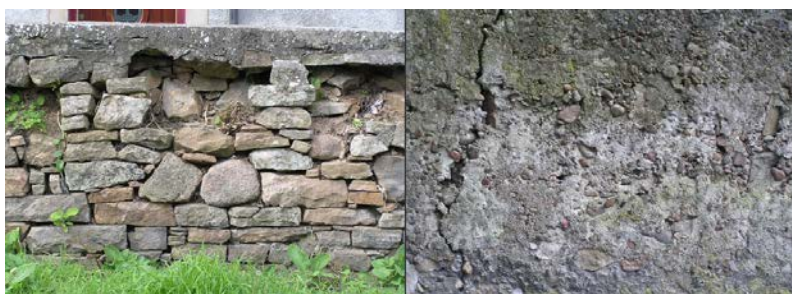
Unusual materials: boundary wall bonded with earth mortar and mass unreinforced concrete wall

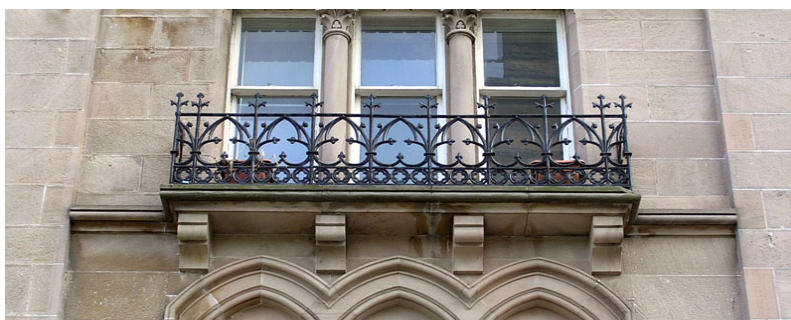
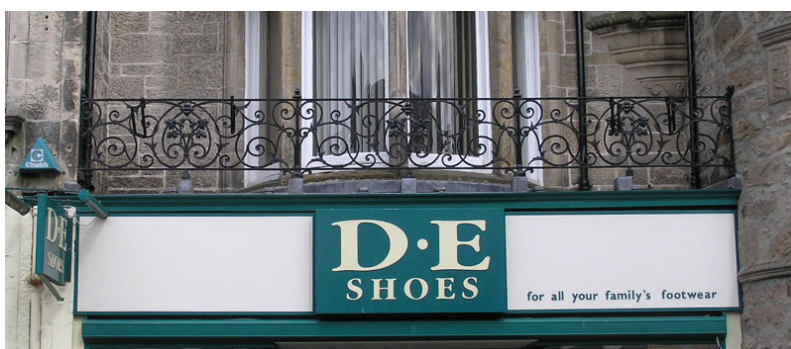
Decorative architectural ironwork to buildings on the High Street

- 4.36.2 A few buildings on the High Street of the late nineteenth century have cast iron railings fitted to projecting balconies. They appear to be to standard patterns, and make a positive contribution to the character and appearance of the streetscape. Other decorative metalwork can be found in unexpected places, for instance above close entries. Original gates at the entries to closes have all been removed.
- 4.36.3 There is a fine bracket in the shape of a bull's head supporting a lantern at 82 High Street.
- 4.36.4 Less attractive are the metal escape stairs which have been added to the rear of commercial buildings in the city centre.

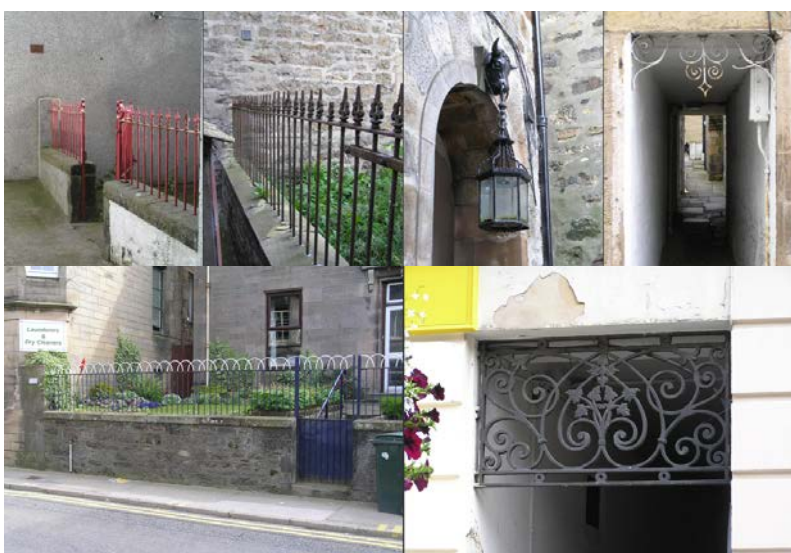
Cast iron railings within the closes, wrought and cast iron panels at close entries, light bracket and hooped railings to front gardens on South Street

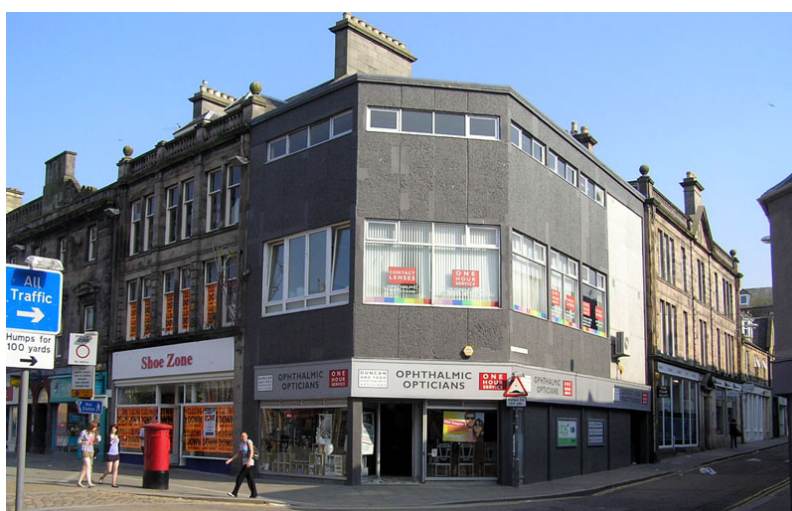
A soulless modern building having a marked negative effect on the character and appearance of the conservation area at a key node point at the corner between Batchen Street and the High Street

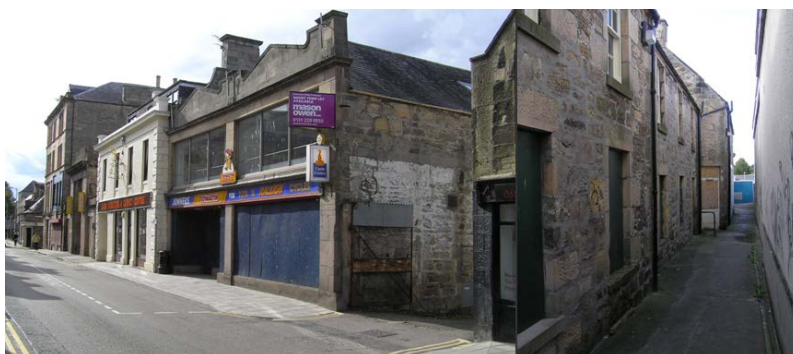
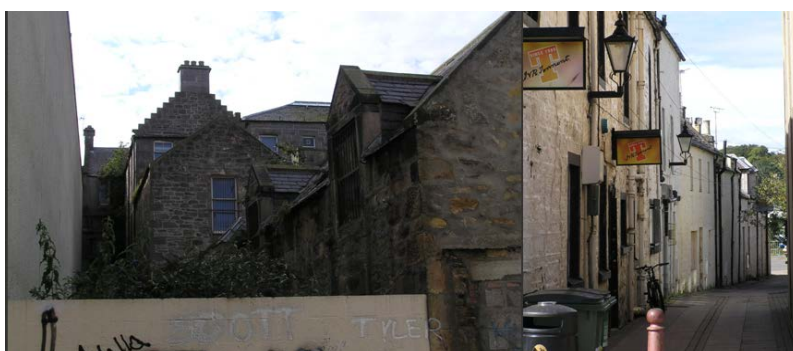
Redundant buildings on South Street, and lines of redundant and boarded up buildings within the closes

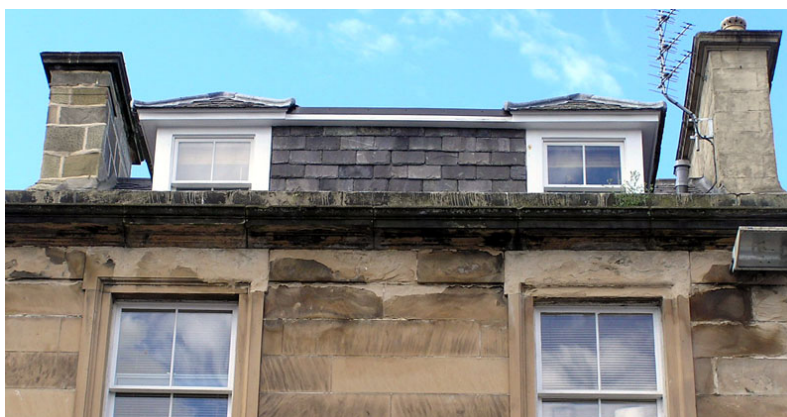
Box dormer formed between two traditional attic dormers

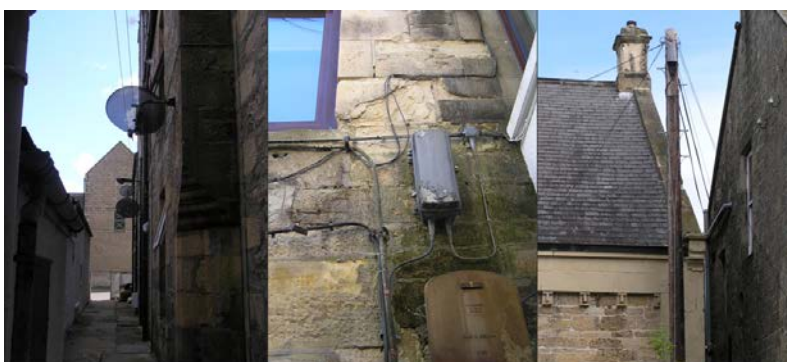
Satellite dishes, surface wiring and overhead lines

- 5.6.3 Much of the surface wiring seen on property frontages within the conservation area relates to telecommunications equipment, some of which is redundant. Redundant wiring should always be removed, and wiring to new installations should be routed indoors rather than appearing on the frontages of properties.
- 5.6.4 Further guidance is given in Managing Change in the Historic Environment: External fixtures (2010) leaflet. Policy BE3: Conservation Areas of the Moray Local Plan 2008 also sets out requirements to be complied with.

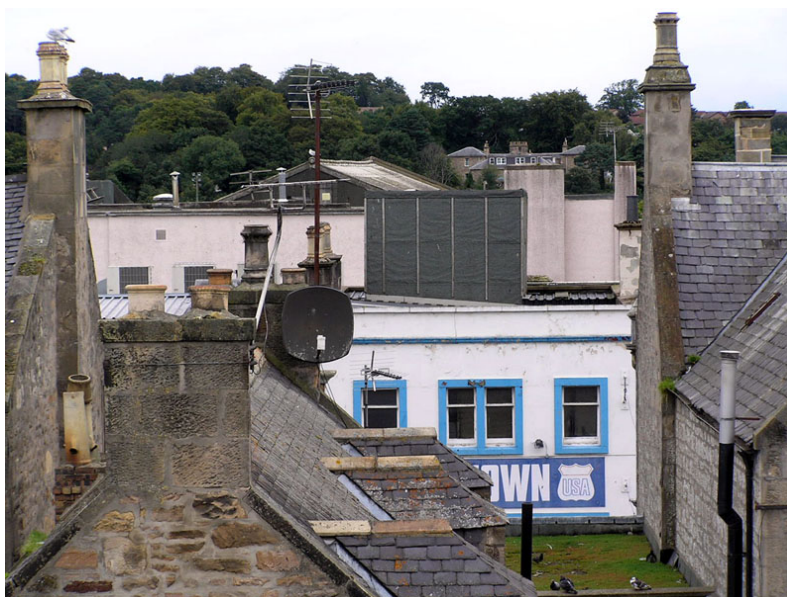
A roofscape of aerials, satellite dishes and makeshift structures for water header tanks

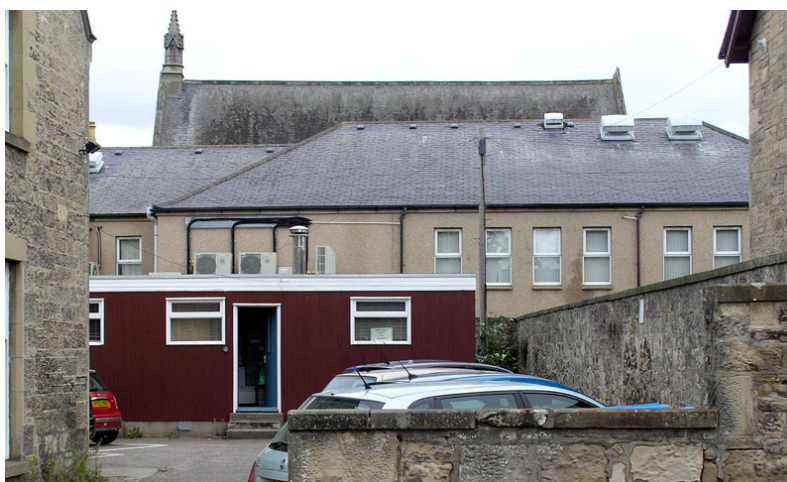
Heat exchangers and roof ventilation cowl and roof vents fitted to slating on a new building are intrusive elements within the conservation area

- 5.7.3 Efforts should be made to route flues for mechanical extractor fans through redundant masonry flues to terminate at chimneyheads,

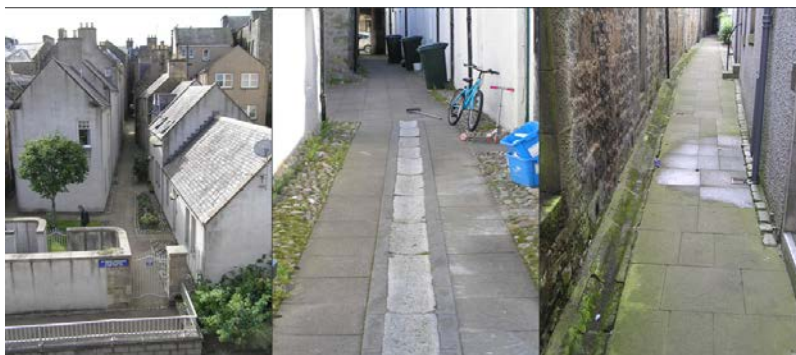
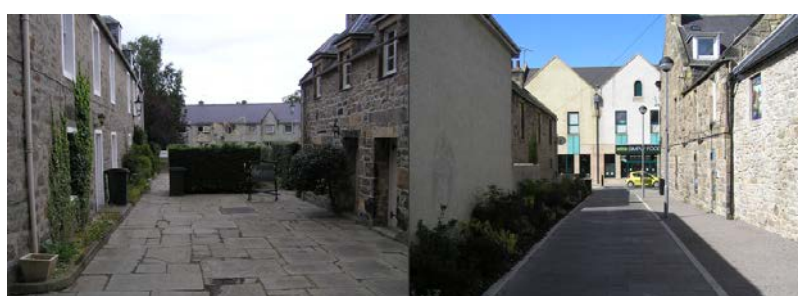
Good standards in the public realm – well maintained planting schemes and surviving details of historic stone drains and cobbles in the closes

- 5.11.3 Many of the closes are in private ownership and the surface finishes vary considerably. Some have become degraded or have been altered inappropriately. There are good examples of surviving historic surfaces in these areas and examples of improvement schemes which have enhanced the character of these areas. There is an opportunity for significant enhancement here. The closes provide characterful pedestrian links between the High Street, South Street and northwards to Alexandra Road, but in many cases the potential of these routes is not being realised. On both South Street and to the north, towards Alexandra Road, few of the entries into the closes are finished attractively, or look appealing. The Council will work with the private owners of the closes in seeking to make improvements, encouraging a high quality and consistent approach, and highlighting historic features, such as drains and cobbles, which should be retained.

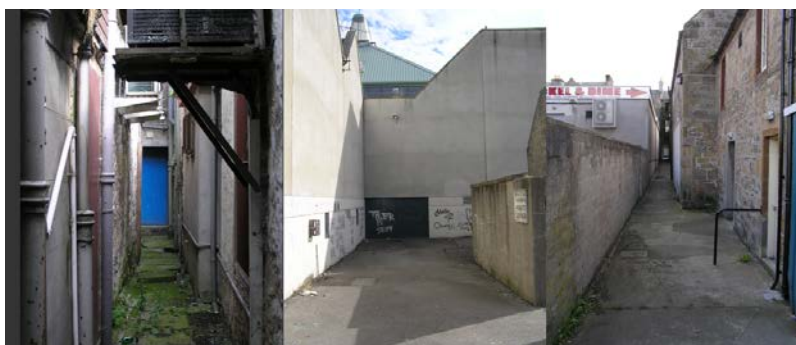
Poor standards in the public realm: unsupervised, or bland and uninvited spaces

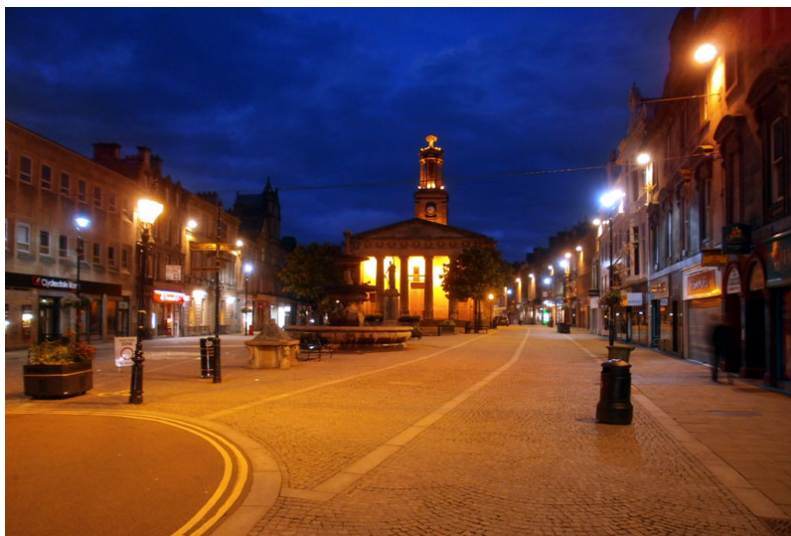
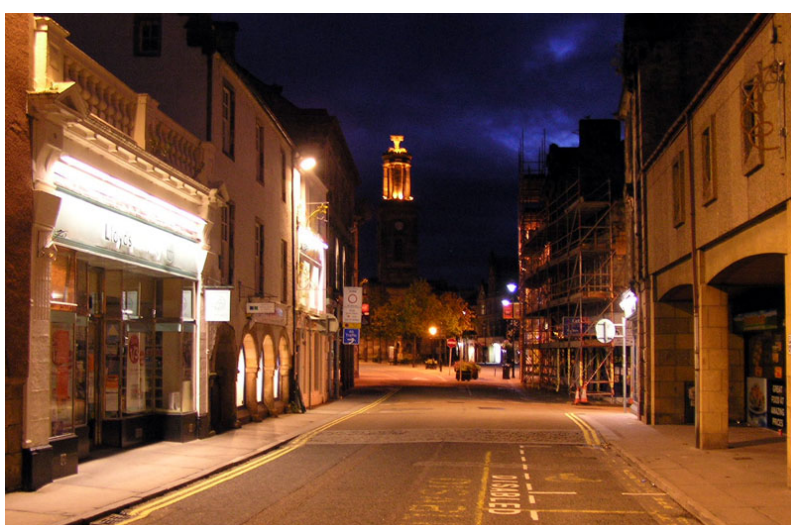
The High Street at night: lighting has become tired, and from the east the tower of St Giles Church appears to have become detached from the townscape

- 5.12.2 The mounting of street lights on the facades of buildings has been successful in removing the unnecessary clutter of street light columns. While they have been retained in the pedestrianised area of the High Street they are of an appropriate heritage design for the setting and of a diminished scale. Street lighting columns have been left at both extremities of the High Street and are much less successful. St Giles Church, the focus of the street, was installed some years ago with a 'state-of-the-art' floodlighting scheme. While the tower of the church has been illuminated, it appears detached from the rest of the building when viewed from the east end of the High Street.

5.12.3 Although the lighting of the heart of the conservation area has been successful, the over-reliance on sodium lighting detracts from the effectiveness of the lighting schemes, as technology has moved on in the intervening period. Lighting of public spaces appears tired, and the conservation area would benefit from a creative lighting scheme to enhance the appearance of the principal buildings and spaces of the principal thoroughfares. Uplighting might be introduced to illuminate the foliage of the trees around the Plainstones. The lighting scheme introduced at the Duke of Gordon's column at Ladyhill shows how effective modern floodlighting systems can be.

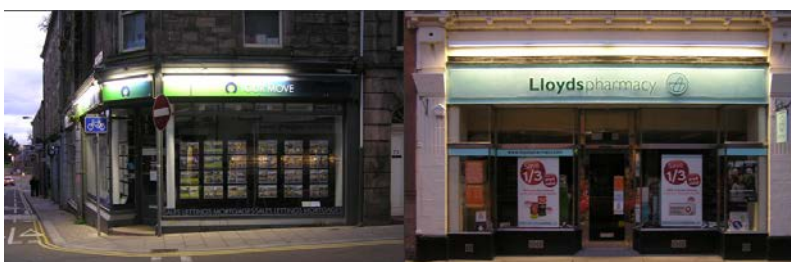
Attractive illumination of shop signs on the High Street

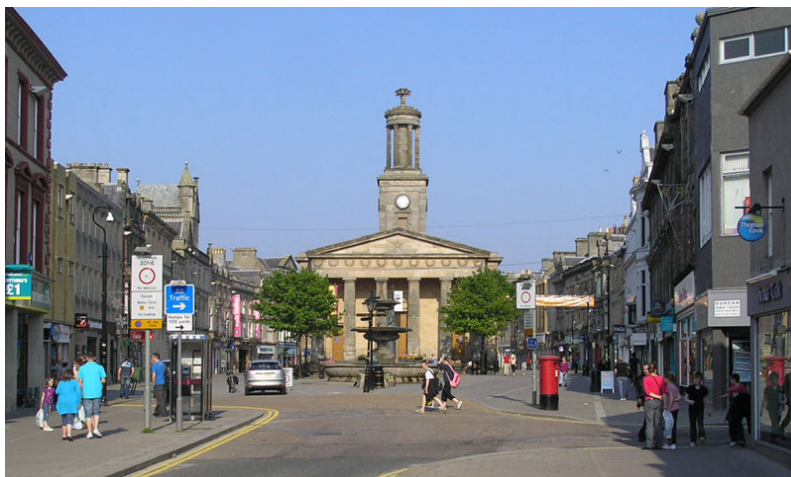
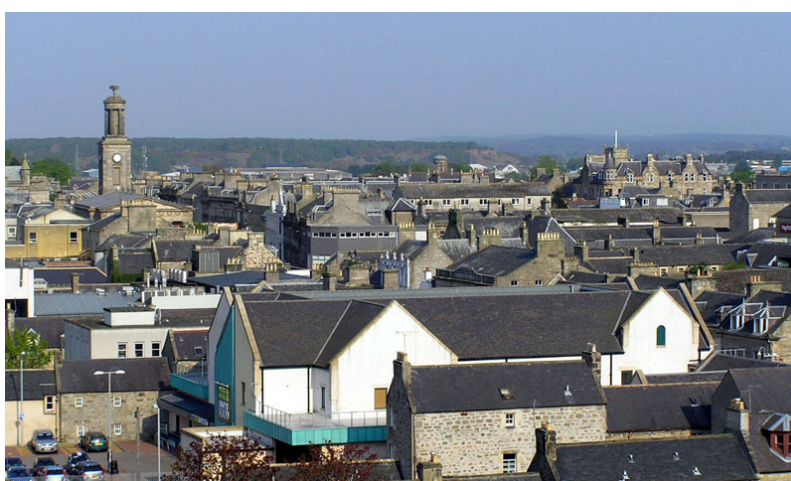
St Giles Church dominates the conservation area, a perception which is reinforced in the views over the roovescape from Ladyhill: tall buildings on South Street, to the right of the photograph, have the potential to dominate the townscape from being located on higher ground

- 6.2.6 The characteristic general height and scale of the rows of buildings at the west end of the High Street tend to be more regular, and less varied than elsewhere in the conservation area. Impressions of scale and height of buildings on Batchen Street and Commerce Street are informed by the relative narrow width of the streets. On Commerce Street there is welcome variation in the middle of the street where the Elgin Club, a tall building within the streetscape, abuts the former single storey bank frontage. The scale and height of buildings on South Street is also much more varied, with some tall buildings to be found here of an equivalent four storeys of domestic height. Tall buildings proposed on South Street must take into account the impact on the wider conservation area, being located on higher ground.

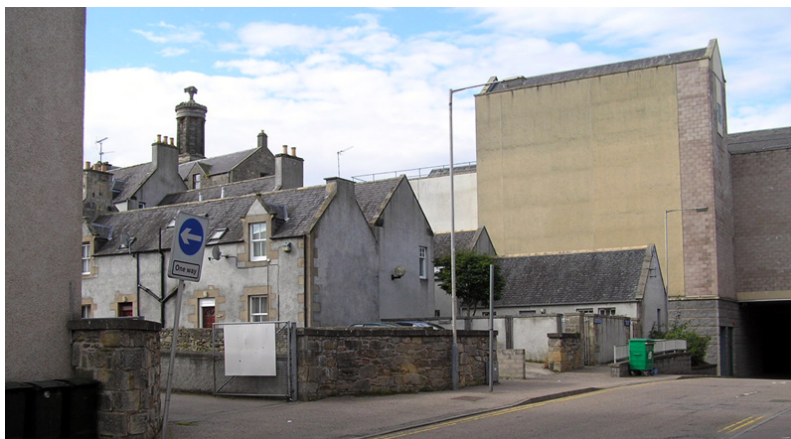
Problems of relative scale: while the tall block of the St Giles Centre does not challenge the height of the tower of St Giles Church within the wider conservation area, it dwarfs the adjoining terraces of traditional houses within the closes

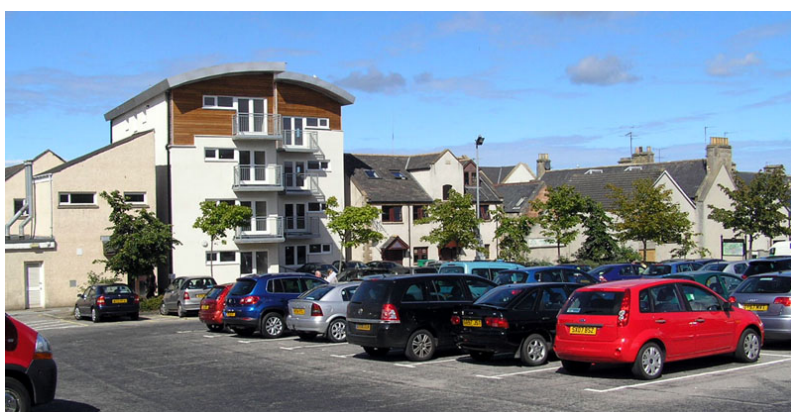
The height, roof form and choice of materials are such as to render this new building disruptive within the established urban grain of the western end of the conservation area

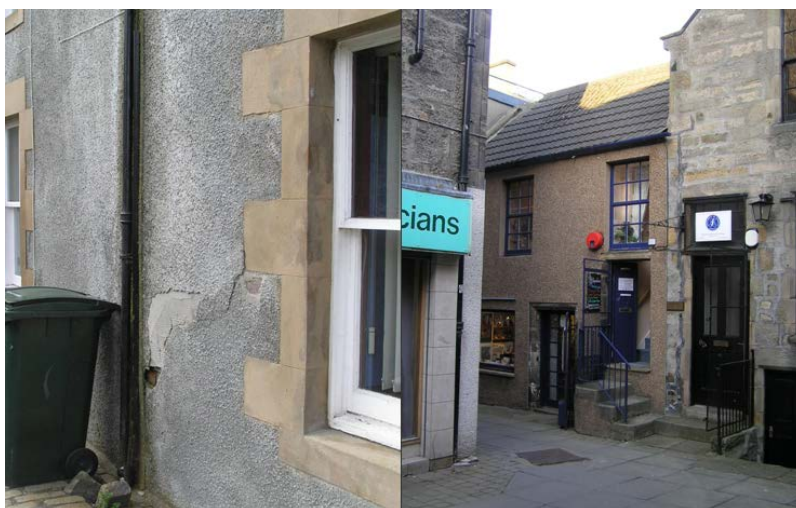
Wall finishes in the closes: an unattractive dense cement wet-dash harled finish with coloured cement quoins (which is failing) and a property rendered with a dry-dash finish and re-roofed with interlocking concrete roof tiles
