Elgin Castle to Cathedral to Cashmere

Historic Landscape Statement

Project Title: Elgin Castle to Cathedral to Cashmere, Historic Landscape Statement

Client: Moray Council

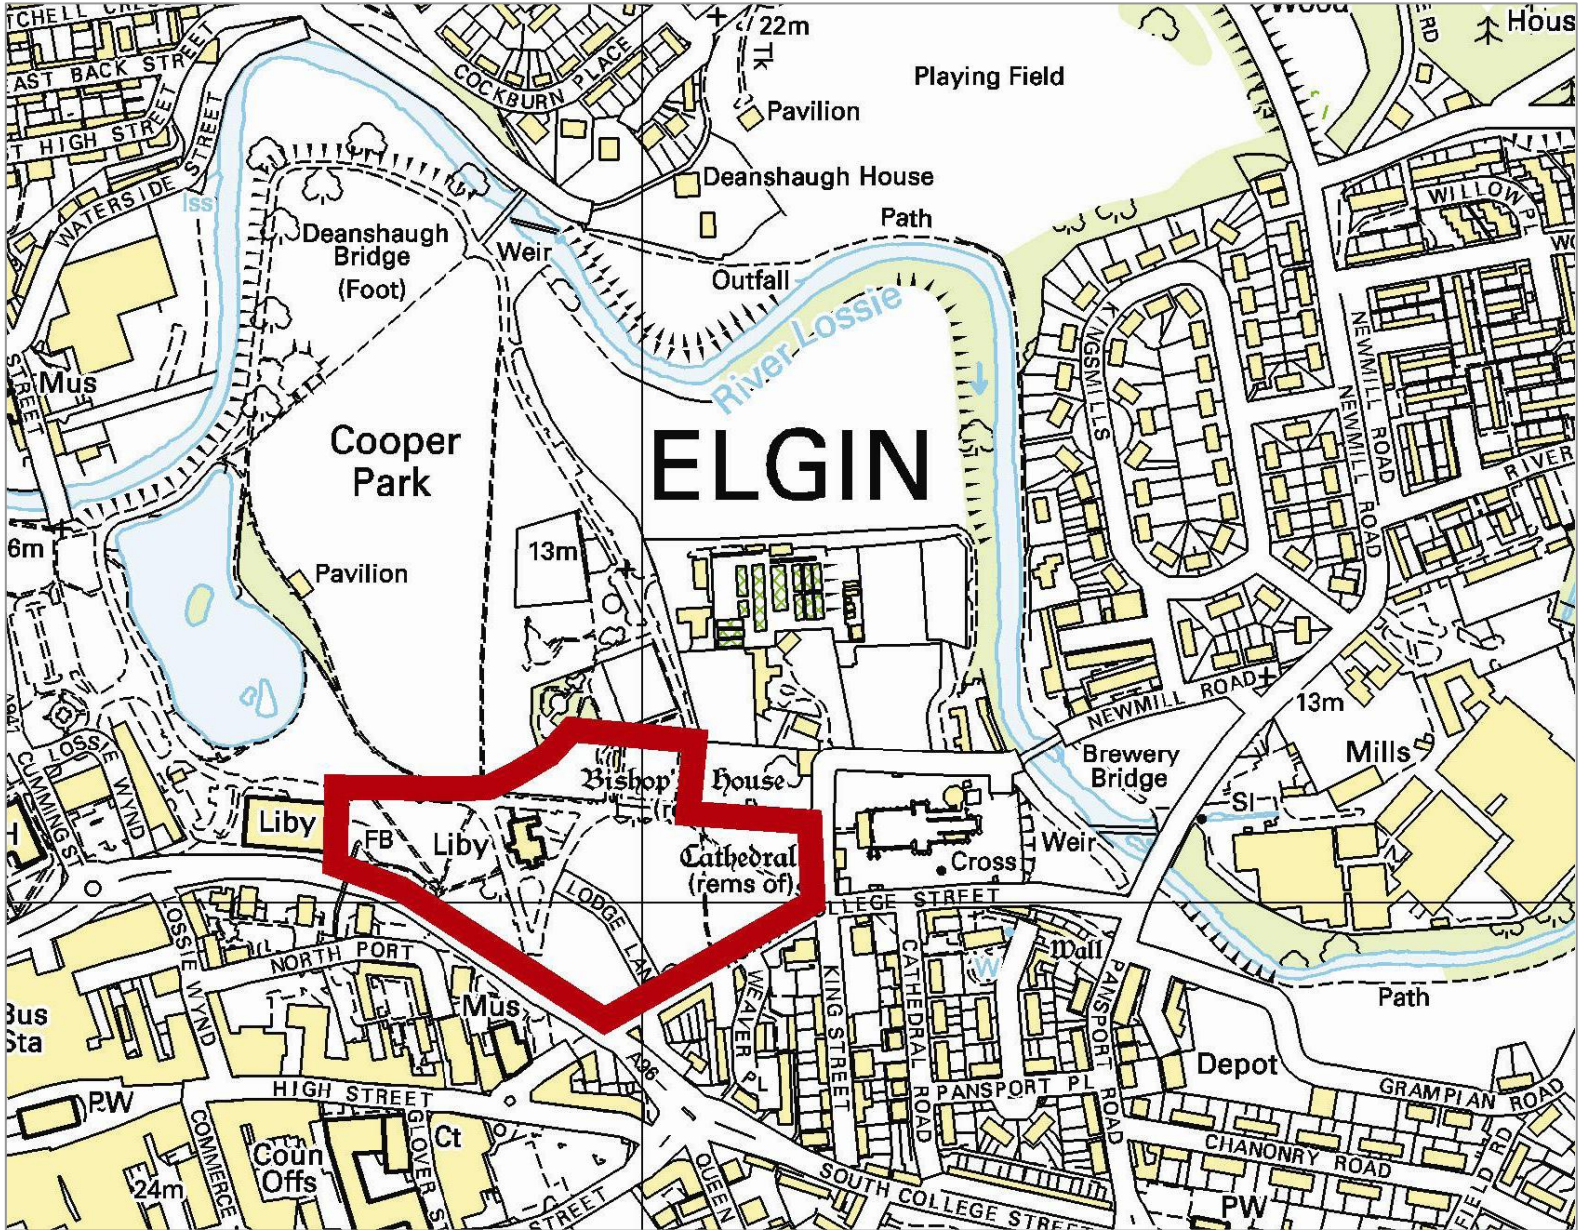
Figure 1: The study area

- 1.2 The study area includes the immediate surroundings of Grant Lodge, extending to the A96 relief road in the south (the A96), the Elgin Library building to the west, the Cathedral path to the north, and North College Street and King's Street to the East. A small area to the north of the Cathedral path, and a small area to the south of the A96 at the truncated North College Street next to Elgin Museum is also included. The study area is shown in Figure 1. It is of note also that the study also considers the context of this area, i.e. elements within the wider Cooper Park, and in the surrounding urban area. This has enabled the historic setting of the Lodge and its immediate (current) landscape to be considered.

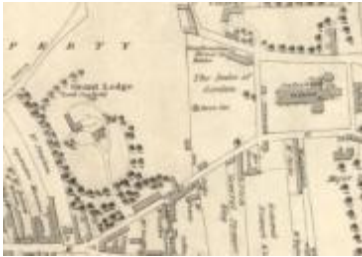
1776	Large scale map, Grant Lodge not shown. North College Street leading to the Cathedral is shown with buildings all along the north side.		Taylor and Skinner's Survey, The Road from Banff to Inverness, published 1776
1791	North-west wing of Lodge built, accommodating change in levels from north to south. (refer to Conservation Statement)		
1822	<p>Significant developments to the grounds since 1769, including:</p> <ul style="list-style-type: none"> • access from the south, with a curved route to east side of Grant Lodge • ring of tree planting around Grant Lodge, with open aspect to north-east, and open space around the building interrupted with possible specimen trees • north-west wing added previously to Grant Lodge • policy boundary limited at field boundary between Grant Lodge and the Cathedral. Land marked as belonging to the Duke of Gordon • buildings marked along south boundary (later labelled as stables), dovecot marked to west of field boundary, on Duke of Gordon's land • additional land acquired to the north east allowing expansion of policies to take in areas of former Dunkinty lands 	Figure 3	<p>John Wood, Plan of the Town of Elgin from actual survey, 1822</p>

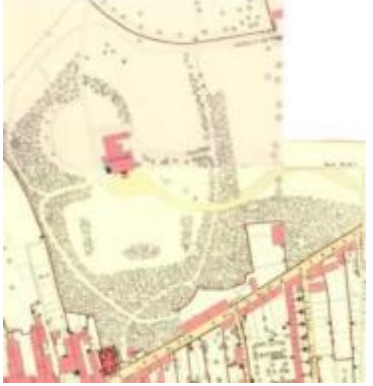
Date	Key events/landscape elements	Analysis Figure reference	Historic Map thumbnail ⁴
	<ul style="list-style-type: none"> • introduction of a sinuous (main) drive from the east with lodgehouse / cottage (dated 1851) • new paths marked through the ring of woodland, additional paths to the north-east and north west of the Lodge creating several circular walking/ riding routes around the grounds • Separate service access developed to north east side of the Lodge • Views towards Cathedral curtailed by extension of woodland belts • stable buildings along north side of North College Street are separated from the woodland by a wall • field boundary trees are marked along the former boundary with the Duke of Gordon's field • additional woodland is marked extending eastwards from the ring, around the stables and south of the sinuous drive • the dovecot is not marked, but an ice house is marked to the west of Grant Lodge • a gate cottage 'lodge' is marked at the southern corner of the policies, on North College Street, adjacent to the Museum • map does not extend to eastern boundary of policies.

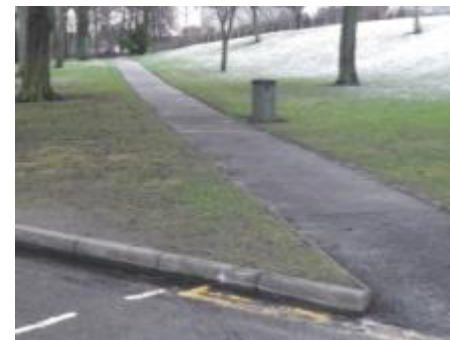
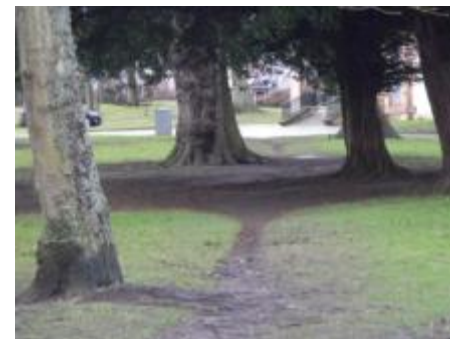
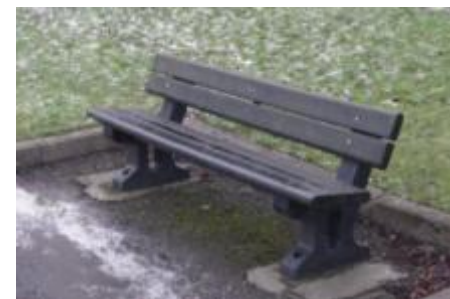
- 4.5 A major desire line runs from the path junction by the bowling green to the front of the Lodge. This path partially follows a historic route (from c.1850) but is now constrained by the presence and size of trees. The desire line path is well used and is consequently a muddy furrow through the grass.
- 4.6 Other minor desire lines exist in various locations across the site, showing as grass damage or footprints in the snow. A number of path corners are cut across by foot traffic and soil has become worn.

- Potential traffic management and restrictions to improve pedestrian amenity and the setting of Grant Lodge
- Potential restoration of historic routes as part of the new access network for Grant Lodge
- Removal of redundant truncated roads to allow landscape reinstatement and reduce scale of hard standings
- Enhancement opportunities for removal of municipal treatments to hard surfaces, kerbs, signs and road markings

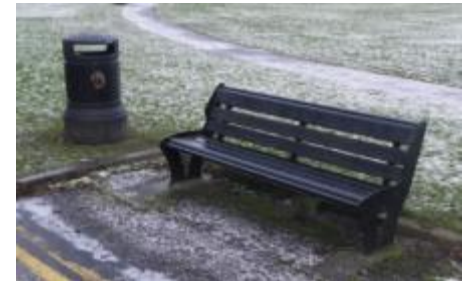
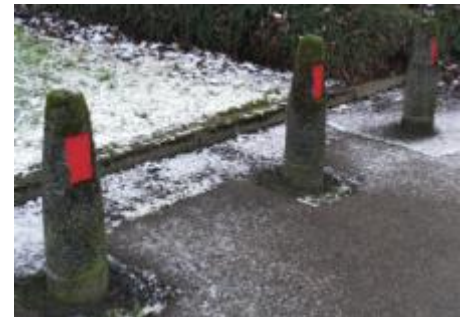
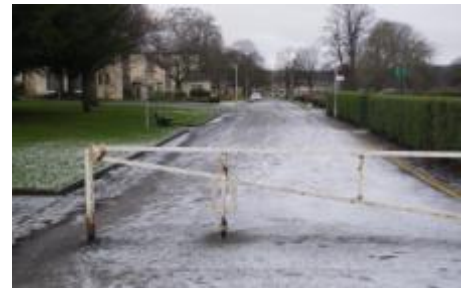
- 4.10 Bollards are used to prevent vehicular access, as in front of Elgin Library, or to denote the truncation of a former road route, as to the south of Grant Lodge.
- 4.11 Concrete conical bollards are used at the south end of the south (truncated) axis, these are old, with eroded concrete, and deep set red reflectors. Red painted post bollards are used across the Cathedral path near library. These have a narrow circular cross-section with a faceted top.
- 4.12 A metal vehicular gate crosses the Cathedral path near the path junction at the bowling green, to stop the public driving along cathedral path.

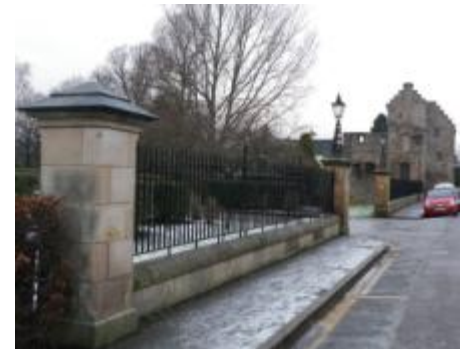
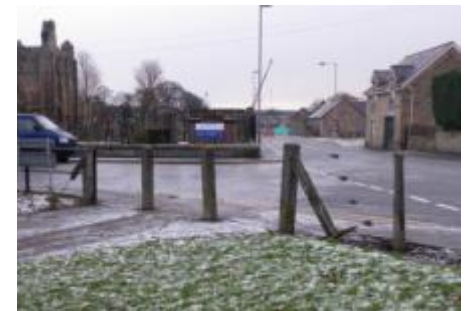
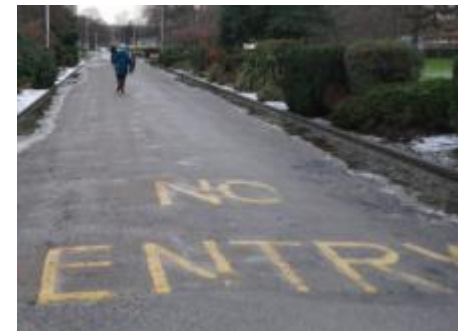
- 4.20 Signage across the site relates to modern use, and is predominantly aimed at controlling vehicular movements. Signage includes pole mounted signage and painted road markings.

- Opportunities to improve the park boundaries and gateways where there is currently only fencing
- Requirements to replace missing furniture components
- Opportunities to improve the standard of furniture and lighting and its consistency across the park
- Opportunities to remove urban clutter and traffic control devices , subject to changes in traffic management
- Requirements for drainage improvements along paths

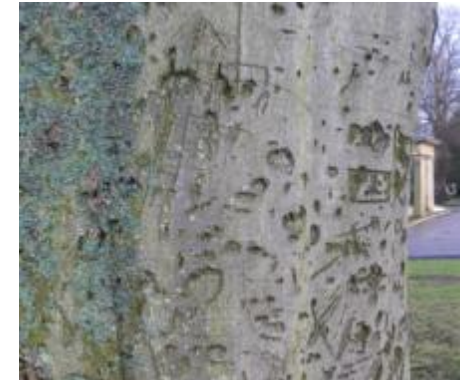
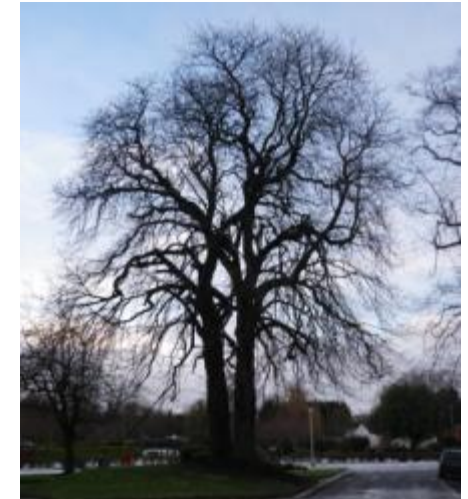
- 4.24 Many of the older trees are over-mature, with dead branches in their crowns. Many show signs of internal rot, dark weeping patches on the bark or scars and exposed wood. The stumps of trees that had similar ground level dimensions to the standing trees, which show significant internal rot prior to felling.

- 4.25 Younger trees are of varying condition, with some trees in poor condition due to damage, or over-mature due to the shorter lifespan of the species. The tree survey recommends the removal of a number of trees in poor condition, as indicated on the tree schedule in Appendix 2.

- A tree replacement strategy is required which takes into account the spatial structure of the landscape
- Veteran trees near public access routes require monitoring and tree surgery to ensure safety
- Recently planted trees in inappropriate locations could be transplanted to better locations
- There are opportunities to improve the horticultural content of the park generally for display, spatial definition and to complement key activity areas
- There are opportunities to improve the biodiversity of the park through management changes and species selection

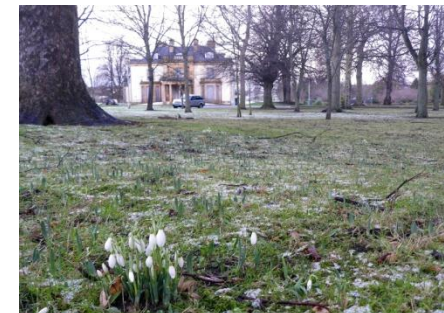
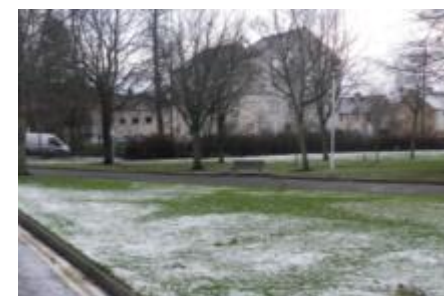
- Screening borders include plants such as berberis, roses, hypericum.
- 4.3 The former star and crescent beds in the 'teardrop' shaped lawn to the south of Grant Lodge, have now been grassed over, although they are still visible in the grass, and are picked out in light snowfall. These formerly had bedding displays. A raised and inclined bed retained for seasonal bedding is located to the northwest of the Lodge on the north side of the Cathedral axis.

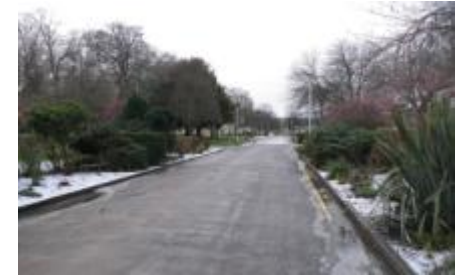
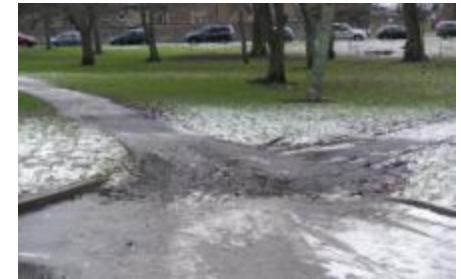
- 4.12 There are a few locations on the site that show evidence of drainage problems. These include the lowest points on paths where drainage has not been provided or has become blocked.
- 4.13 The path junction to the south of the bowling green has standing water at the exit points of the paths leaving the cathedral path. This is the wettest path location in the Grant Lodge policy area.
- 4.14 Another poorly drained section, with standing water and mud on the tarmac path, is formed in a dip in the path that corresponds to the crossing point of the route of the former sinuous drive (introduced c.1850) with the existing path.
