Spey Mouth - Management Review

Kingston-upon-Spey

Final Report

The Moray Council

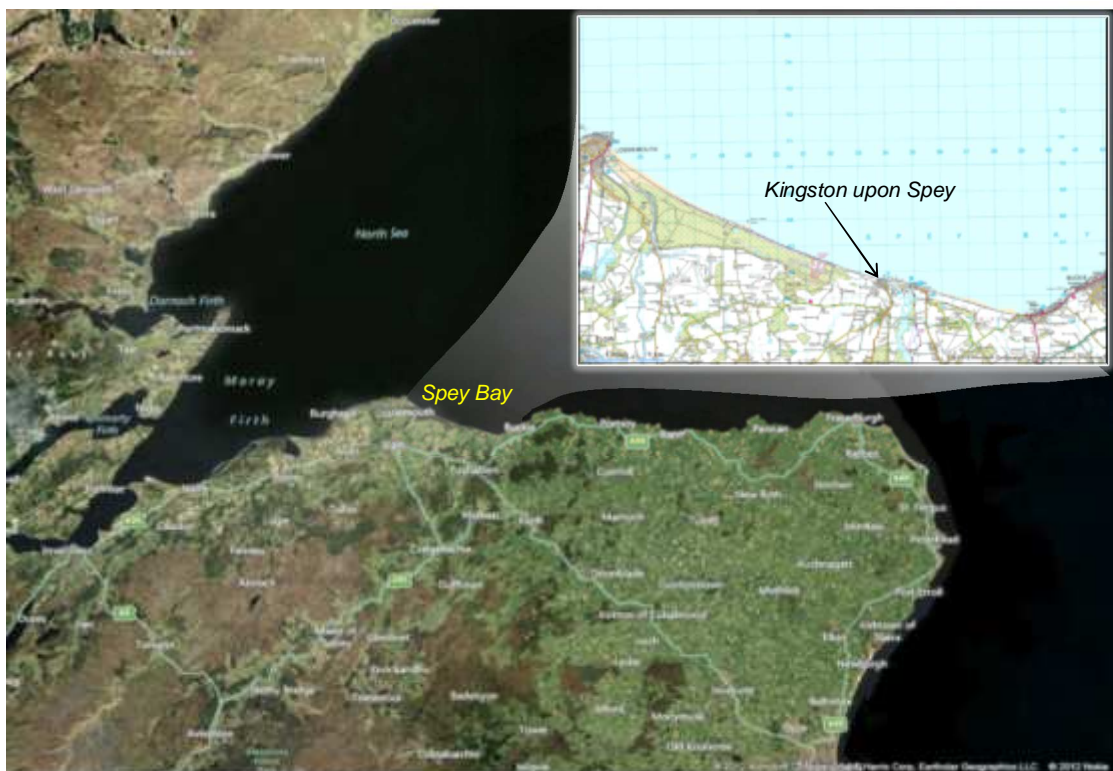
Figure 1.1 General Location Plan.

Kingston upon Spey is located on the shoreline of Spey Bay, to the western side of where the Spey River runs through to the coast. Spey Bay is situated on the northerly facing coastline within the approaches to the Moray Firth (Figure 1.1). Spey Bay extends some 18km from the headland at Lossiemouth in the west, through to harder rock coastline continuing east from Buckie. To the eastern end of Spey Bay is Portgordon. The shoreline between Portgordon and the mouth of the Spey is formed as a relatively straight section of coast, comprising a sandy, shingly beach rising to slightly higher ground behind. The village of Tugnet is situated at the eastern mouth of the Spey.

As highlighted earlier (Figure 1.1) the whole shoreline system undergoes substantial and rapid change, over months, years and decades. There are clear long term trends underlying more local cyclical patterns of change.

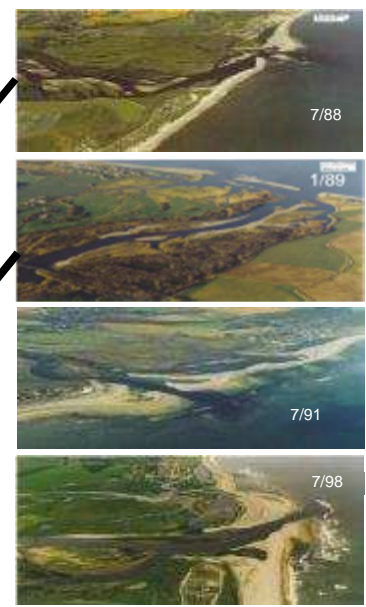
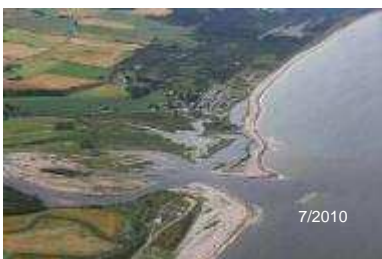
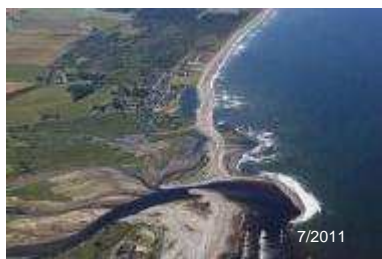
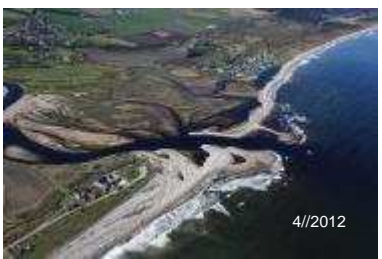
Figure 2.5 Historical Change at the Mouth of the Spey

Analysis of changes from historical maps (Grove 1955, K. Riddell, T Fuller 1994)

Subsequent air photographs

Although Figure 2.5 does demonstrate the general westward movement of the entrance channel and subsequent breach or forced breach (excavation of a new channel to the east), it has to be recognised that major change can occur on a far more rapid timescales. This is highlighted between 1991 and 1998 and again in the recent photographs covering 2010 and 2012.

Prior to the Cut shown in 1962, the main channel is reported to have lain closer to the village of Kingston and, during this period properties to the western end of Kingston were lost due to erosion. It is suggested (*K. Riddell, T Fuller 1994*) that the movement of the entrance channel is both due to the weak net drift to the west at the coast but is also determined to a degree by changes in the channel positions within the inner delta area.

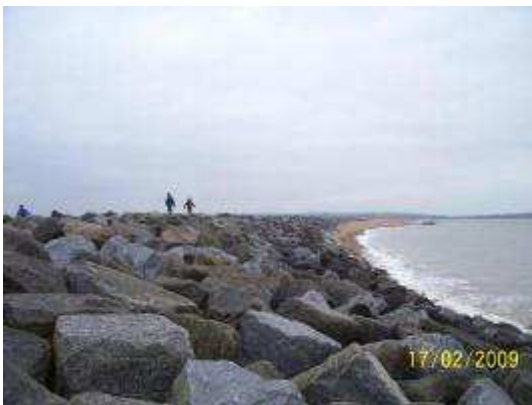
If works were undertaken in any local location that appears weak, following a storm, this would require import of large rock armour to form a substantial rock revetment. A typical

example of the scale of works is shown in the adjacent photograph, taken at Hurst Spit on the south coast. It should be noted that Hurst Spit does not show the same degree of change as that experienced at Kingston. It is also noted that these works tie into a fixed shoreline further to the west and that an offshore breakwater has been constructed at the western end to prevent outflanking. Even within a less mobile location, there has been no build-up of sediment in front of this revetment.

This highlights the difficulty of fixing a mobile feature such as the shingle ridge. By constructing a short section of revetment along one section of the Kingston ridge, the adjacent sections of the ridge would still change and roll back. In fact, because the section of rock revetment would prevent natural distribution of sediment along the ridge as a whole, adjacent sections would become more vulnerable. Under such an approach, there would be a commitment to extending the revetment further along the ridge in response. In effect, by starting to fix the ridge in this way would end up with a commitment to reinforce the ridge over its full length, typically, as a minimum a distance of some 600m.

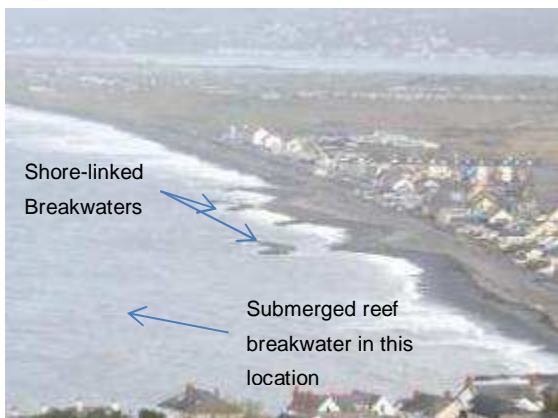
Any form of breakwater, shore connected, nearshore or submerged, including the use of sunken barges as used in Essex over the last decade, aim to modify the way in which waves approach the coast. This not only reduces the wave height behind the structure but also changes the direction of the waves over length either side of the structure. This tends to draw sediment in to the lee of the structure but with the potential to move sediment from

adjacent beaches. This affect can be seen in the adjacent photograph taken at Borth on the West of Wales coastline.

In the current situation faced at Kingston, there is significant risk that a single breakwater would draw sediment away from the adjacent beach areas, potentially increasing vulnerability across such a section and reducing the ability of the ridge as a whole to respond to different wave conditions. This could be mitigated through detailed design but it is likely to result in the need for a series of structures over the area.

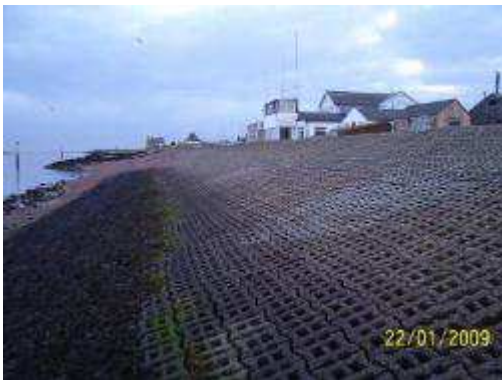
practical option would be to encase the rear bank with relatively light, flexible concrete block matting. An example of this is shown from the Suffolk coast at Felixstowe Ferry.

It would be suggested that such works would only be extended possibly over a length of some 200m, providing additional security to properties along Beach Road. The matting could be extended up over a slightly raised earth ridge at the back of the slope, making use of the width of open space generally along the frontage.
