# Forres Conservation Area Management and Maintenance Plan

May 2024

LDN Architects

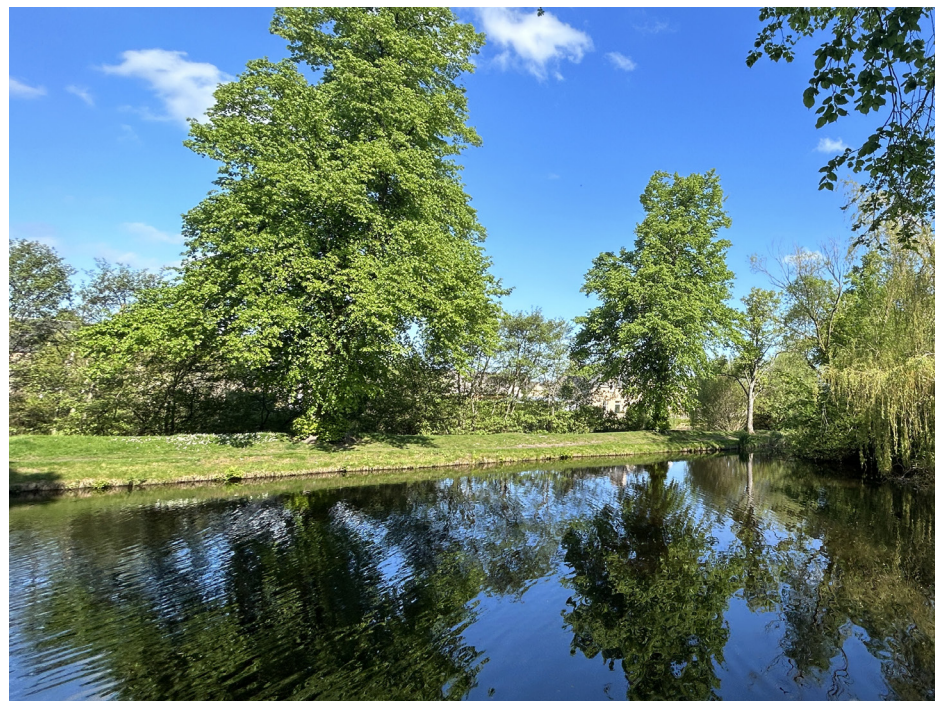
3.4 Street pattern - Photograph 001

The Mosset Burn (photograph 001) to the West of the High Street forms a natural interruption or barrier to the natural development of this pattern.

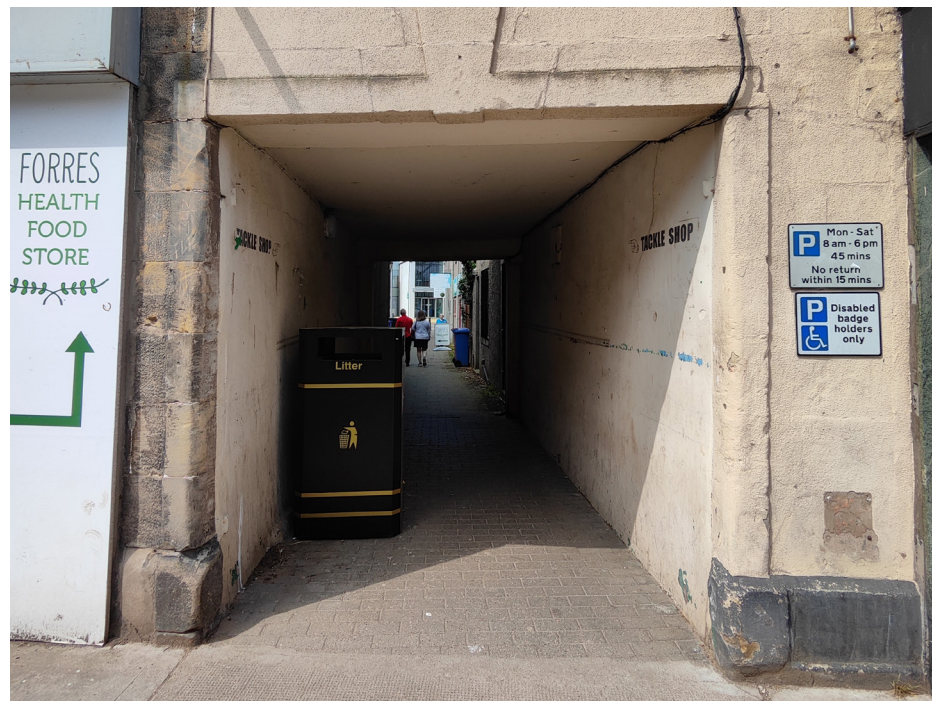
3.4 Street pattern - Photograph 002

Photographs 002 and 003 demonstrate below, how the lanes, that form connection (which are utilised) have had their importance diminished by the locating of bins with the passage.

The general condition of the Lanes is tired with the applied finishes deteriorated. Each lane has their own unique character not only through the destination but also the variance in finishes.

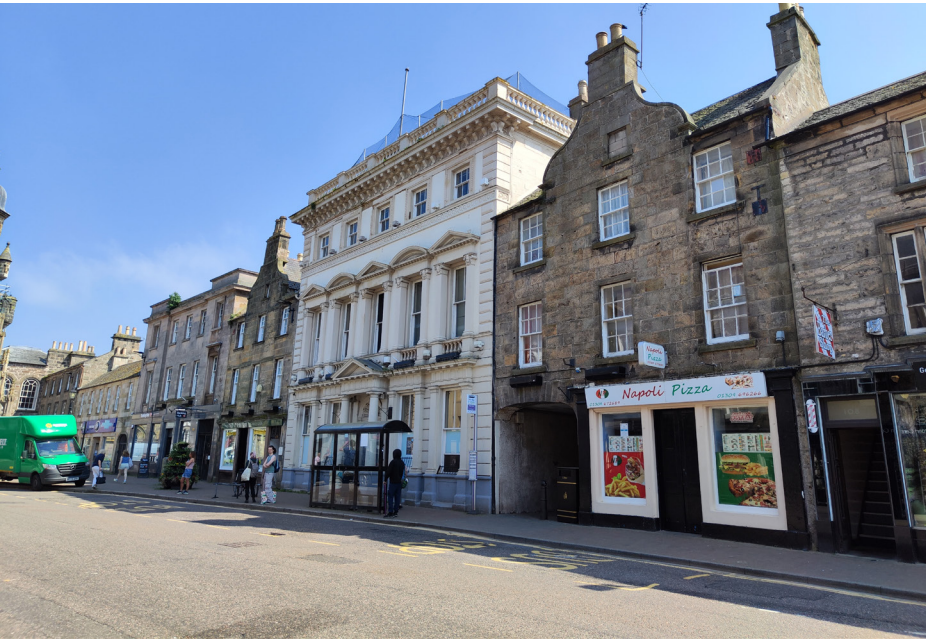
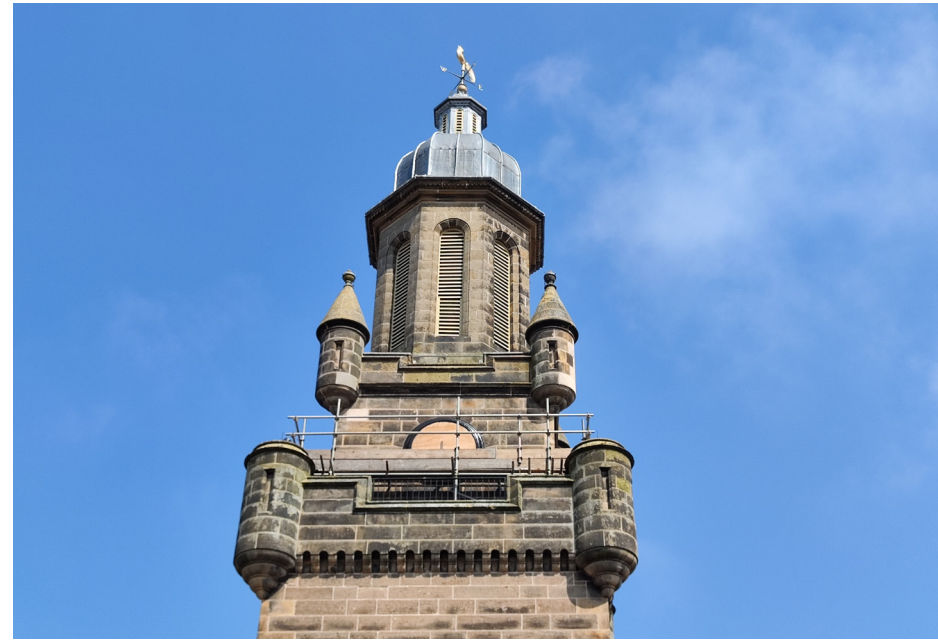
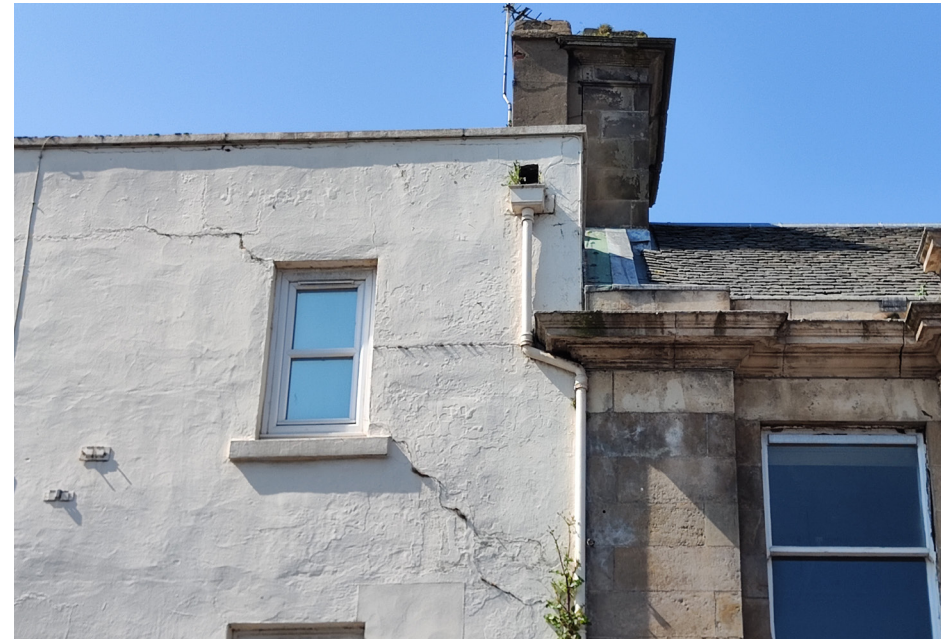
Generally, throughout the conservation area the form of the rainwater goods are half round gutters with round downpipes.

In regard to material whilst cast iron fittings remain and have a prominence there is a significant amount of replacement in uPVC in varying condition.

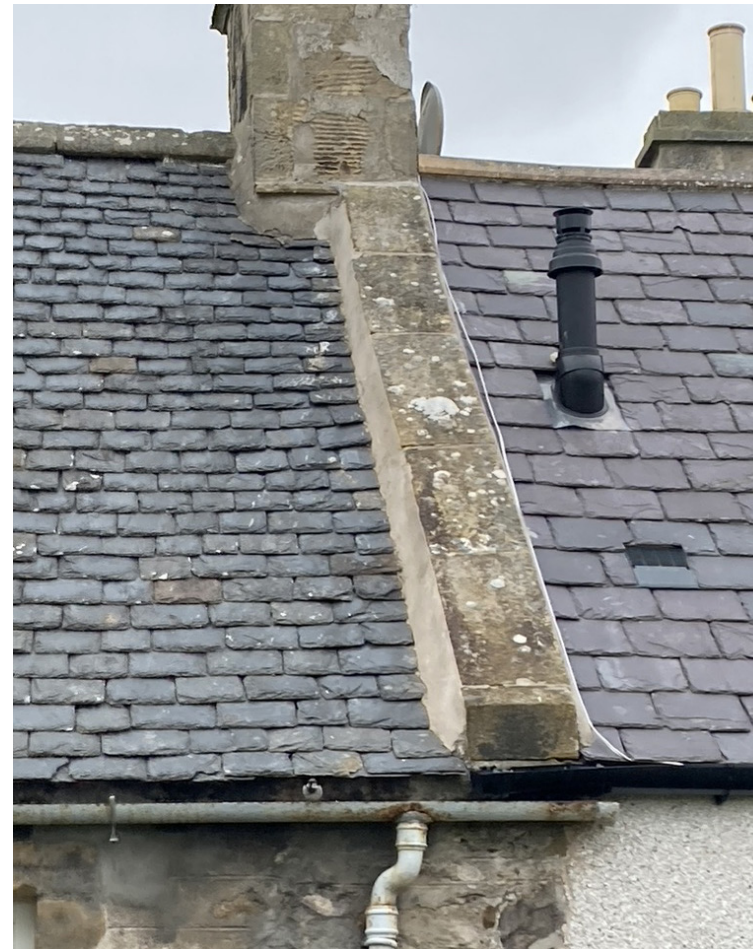
This photograph shows Scots slate on the left with a stone ridge and Welsh slate on the right hand side. with a clay ridge. Both work well. The Welsh slates may have arrived in Forres being used as ballast on boats arriving back in the Moray Firth after travelling South.

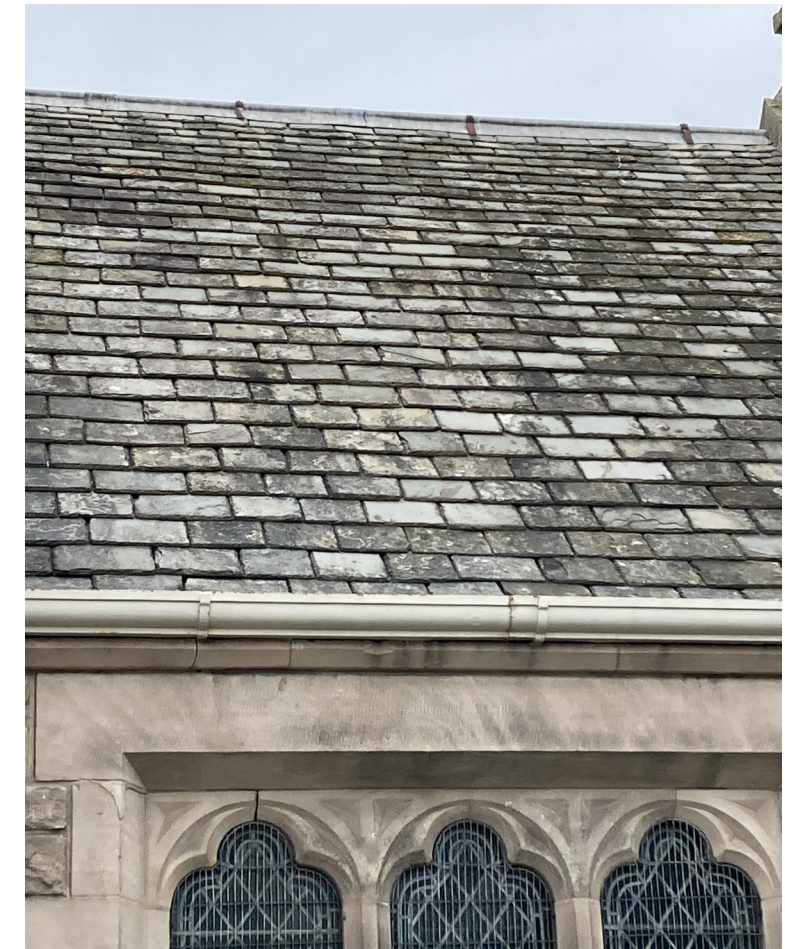
This roof has a lead ridge and greyer slate.

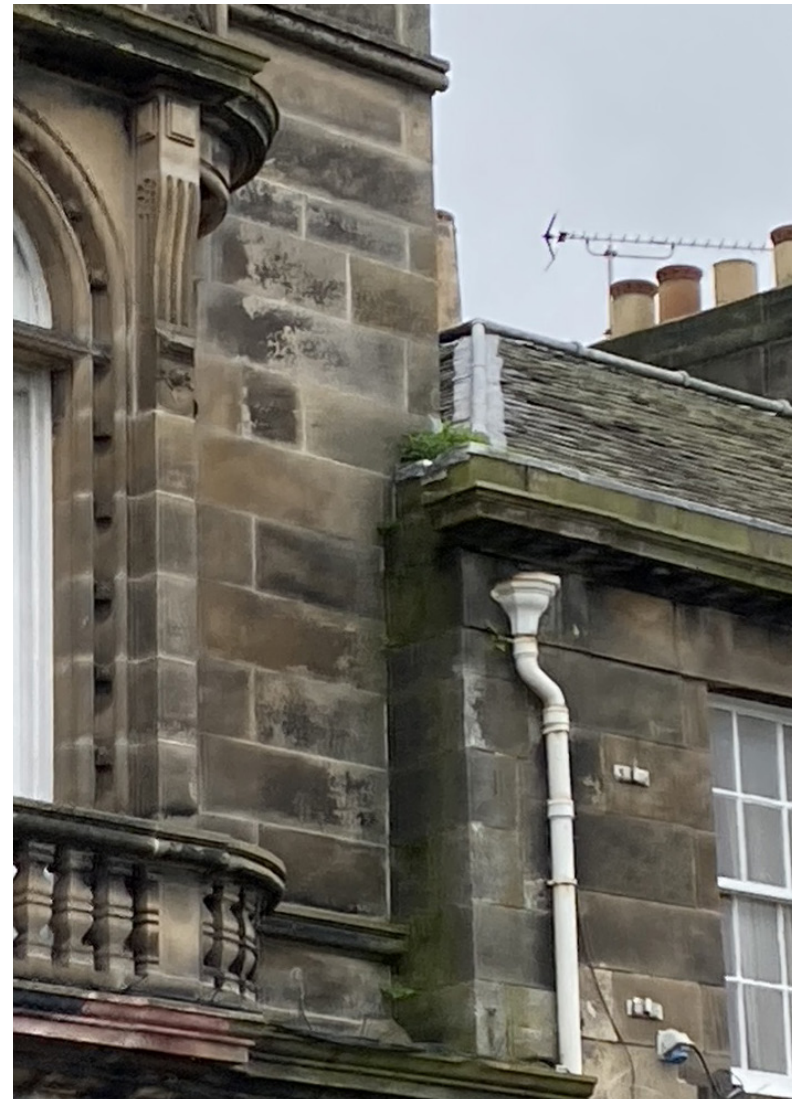
This detail shows a well maintained cast iron downpipe and hopper but with vegetation growing in the gutter above which will block the outlet to the down pipe and cause green algae staining to the stone work below.

When designing a similar detail, make sure the gutters run or fall to the outlet, protect the outlet from leaves etc. and clear the gutters at regular intervals annually. .

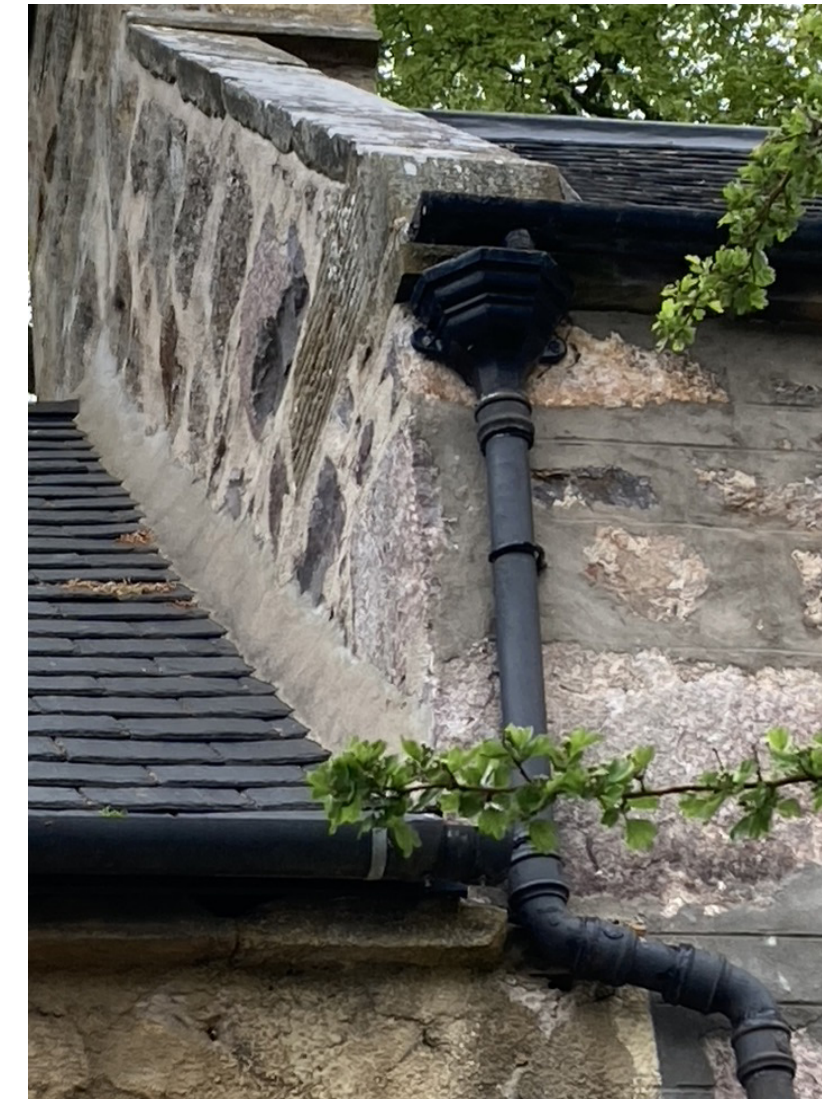
This cast iron hopper and down pipe pick up the water falling from the skew and the slating. Run off from skews can sometimes cause staining.

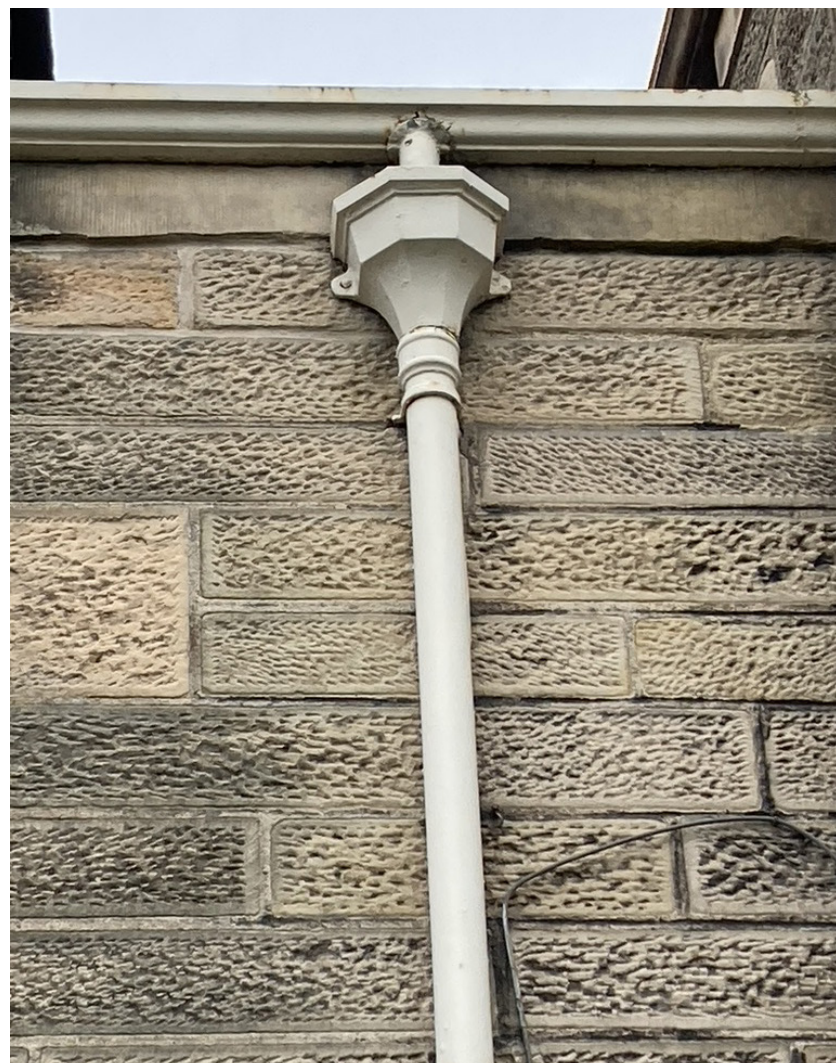
A simple well maintained detail. When fitting new fixtures, it is good to fix into stone joints rather than the face of the stone.

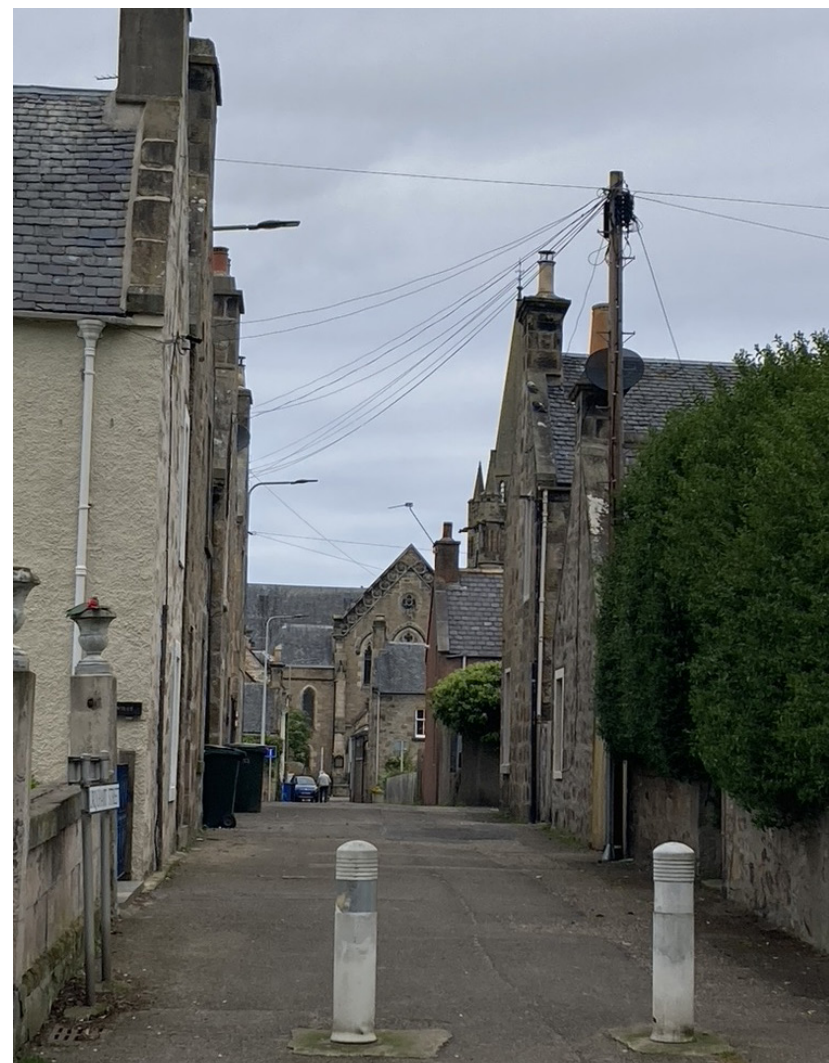
Similar detail shown in context against harling.

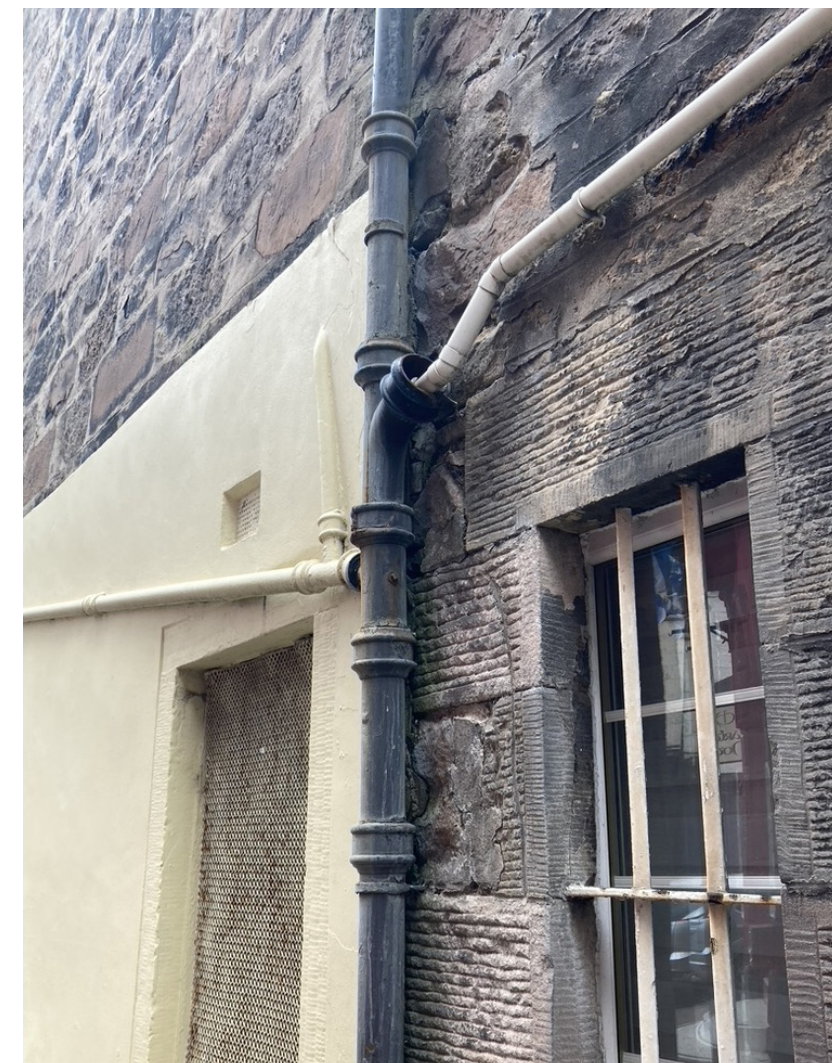
This detail shows a mixture of cast iron and uPVC with miss-matched sizing - drainage rather than rainwater, but not ideal.

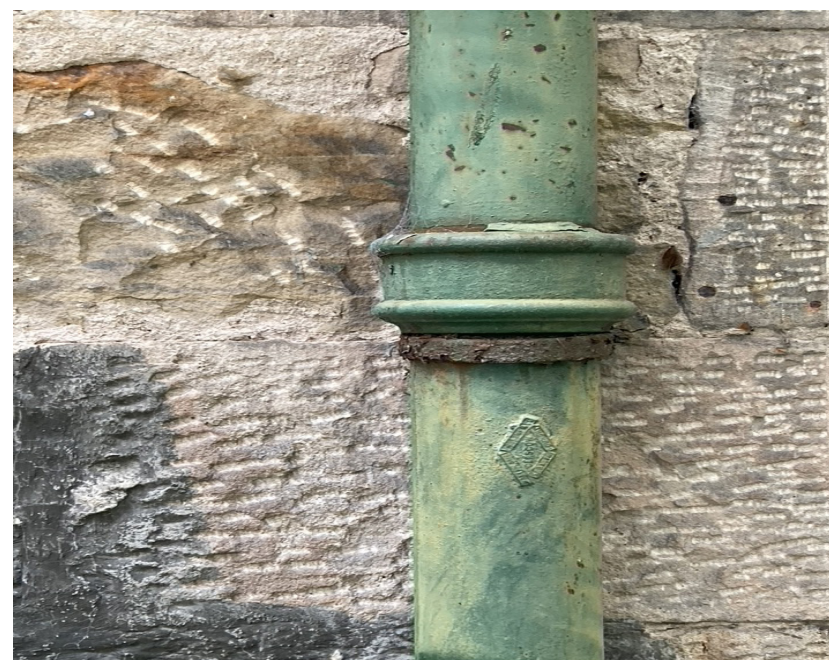
This cast iron rainwater down pipe has not been painted or maintained for a long time. The holder-bat is rusted and will fail, but again cast iron can be purchased as a kit of parts and you can take it apart, brush it down, reseal and redecorate.

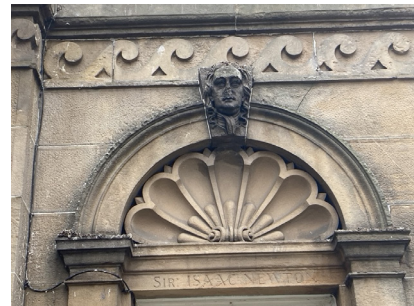
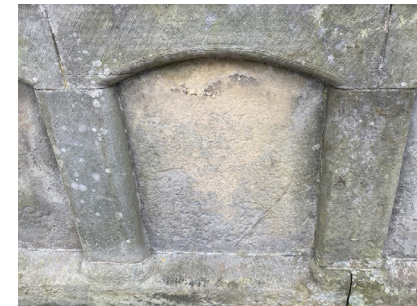
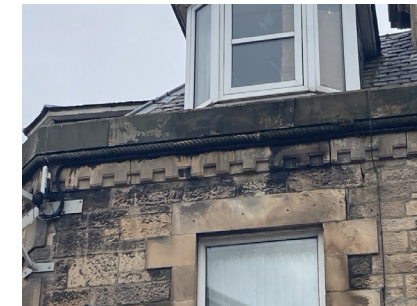
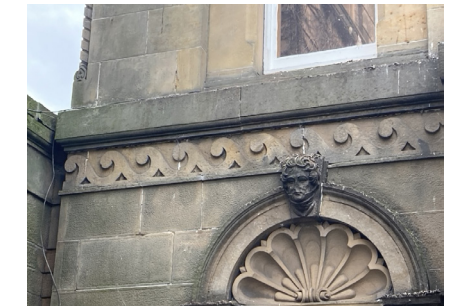
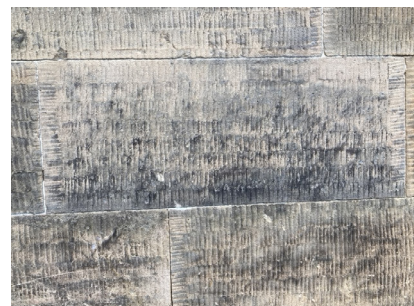
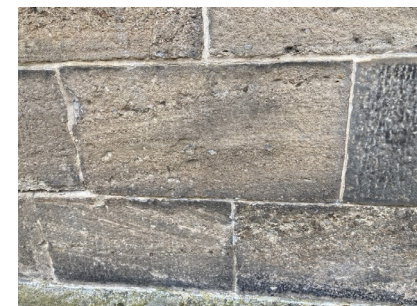
We are fortunate in this region to have many skilled stonemasons and also a training school in Elgin. This is an area which is good for the buildings and local economy. The photos show how stone can be used in many different ways; from field rubble to fine dressed ashlar and carved elements. Weak points should also be acknowledged to identify decay mechanisms.

Mortar specification, tooling, stone selection and bedding are all key factors to consider. Also protection from staining due to inadequate protection or failing rainwater goods should also be monitored. There are often concerns about falling masonry from high level. This should be monitored regularly.

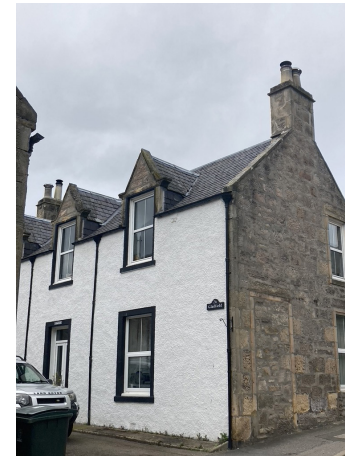
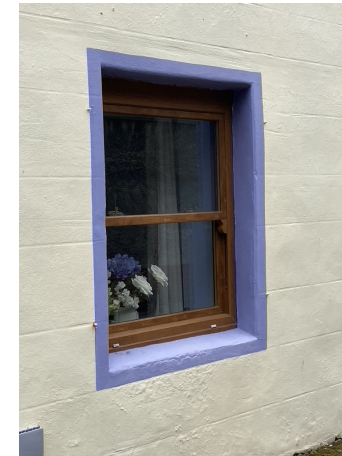
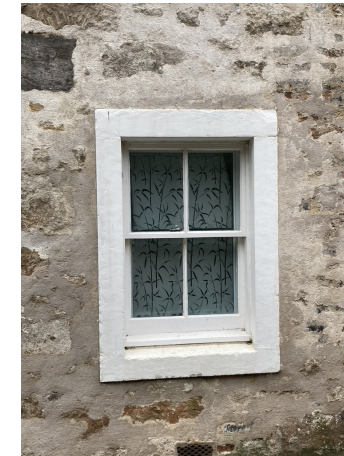
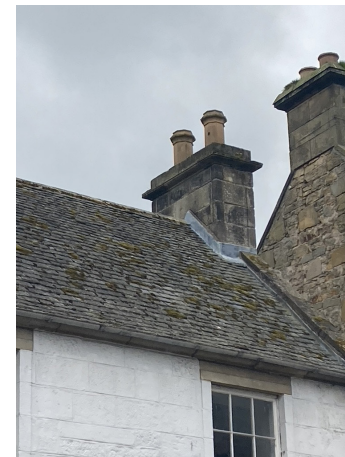
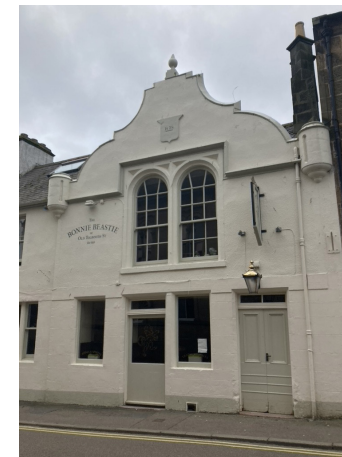
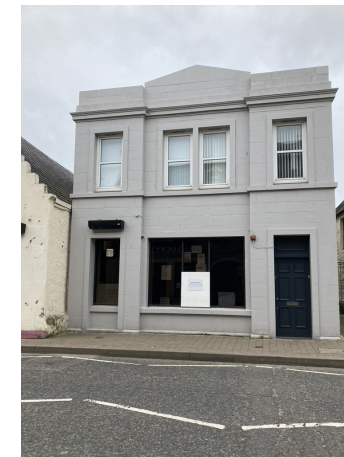
A traditional lime point or harling manages the moisture in your wall thereby improving the condition of the fabric and the internal environment.

The use of lime as an ingredient in traditional construction is important because it delivers a finer porosity and greater surface area than materials with a coarse and close to impermeable makeup - the former, in effect, becoming a poultice which draws moisture out of the wall using capillary action. This can either be the joints (lime pointing) or more effectively a lime harl as this has a much larger surface area.

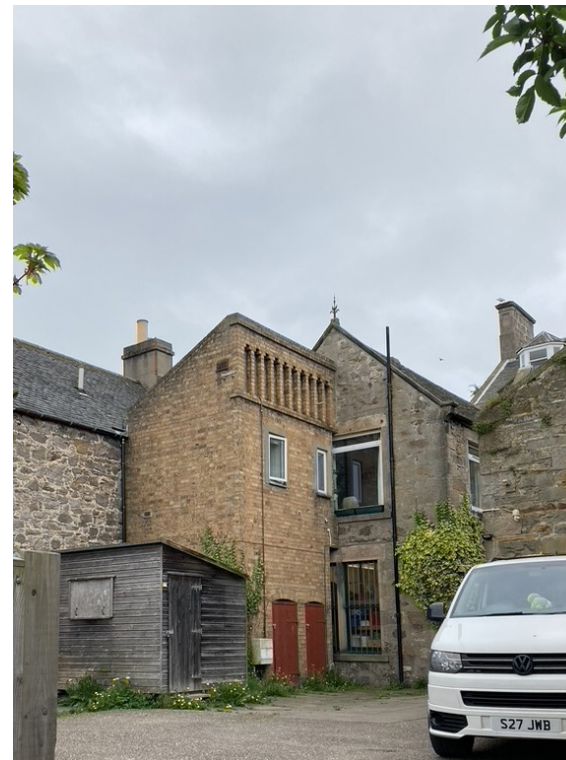
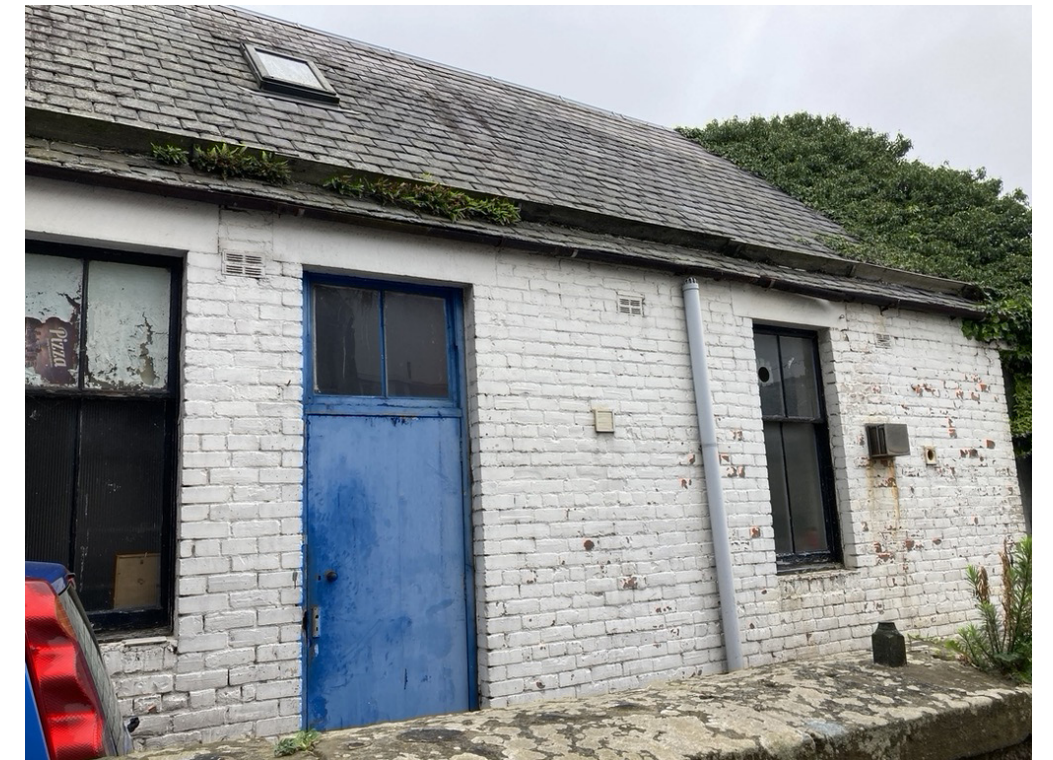
Brickwork is not used commonly in the Conservation Area but can be used sympathetically if the correct brick and locations are identified. To the rear of properties and used on a smaller scale projects.

The examples show exposed brick and painted brickwork being used.

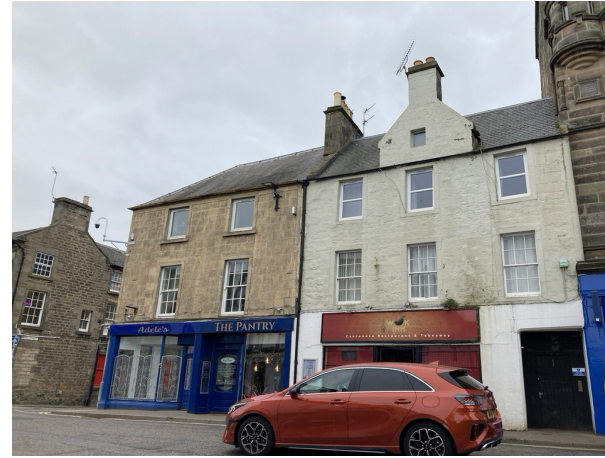
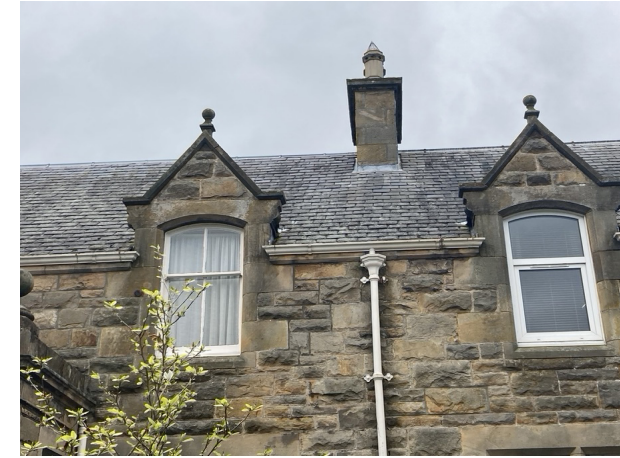
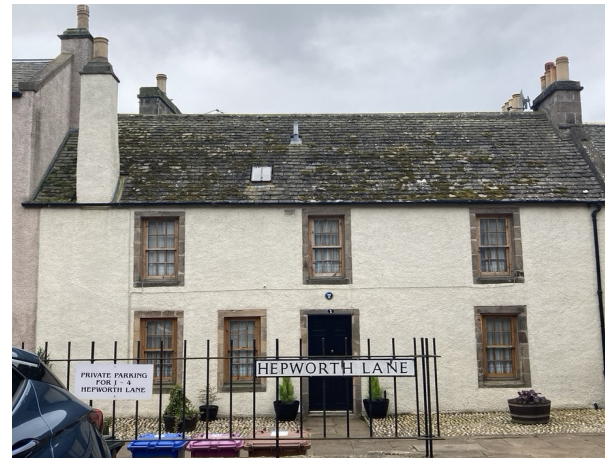
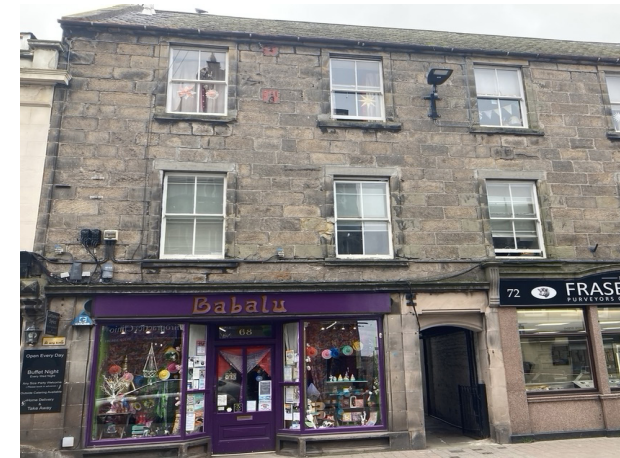
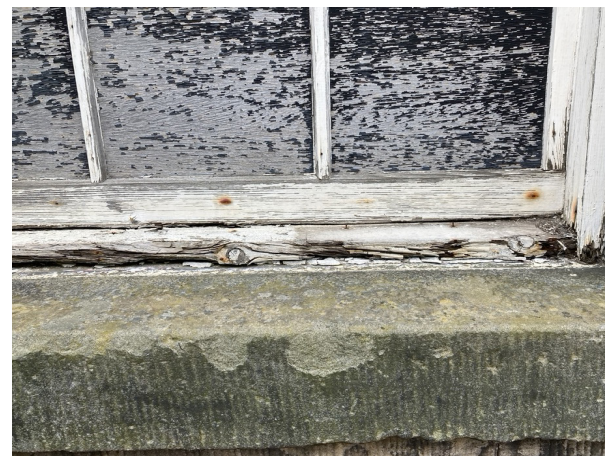
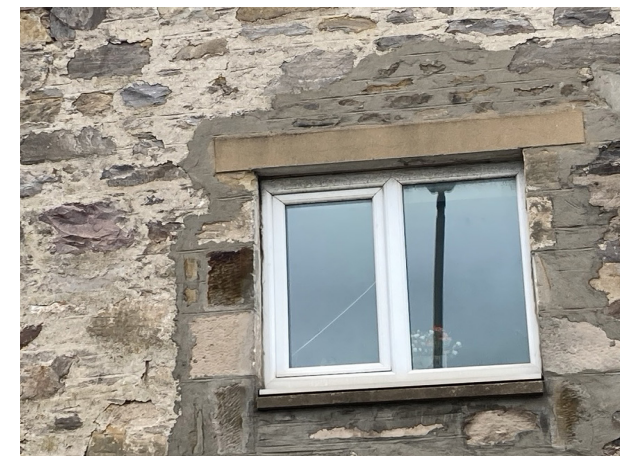
The original fenestration of Sash and Case windows form part of the character of a traditional building. If left to deteriorate these can become difficult to manage. Sash and Case windows can however be repaired and upgraded – draught stripping and double glazing (consideration should be given to depth of the frames and astragals).

If the units are beyond repair, replica sash and case windows can be made and fitted. If these are then appropriately maintained, they can have a significant lifespan. There is a common misconception that either of these options can be cost prohibitive and appropriate support and guidance should be made available to dispel this notion.

Examples of window shutters being used internally is important to the energy performance and should be encouraged. This is an efficient way to retain heat during the winter and assist with overheating during the summer.

There are a considerable number of uPVC windows in the Conservation Area. Supplementary Planning Guidance can provide a clearer direction when repairs or replacement are being considered. It is imperative that this is monitored and action taken.

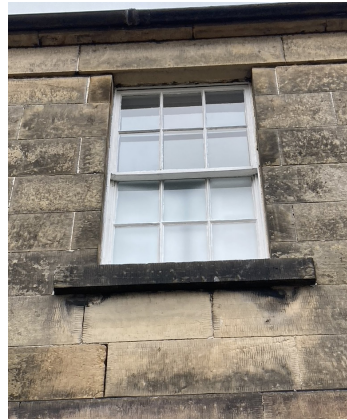
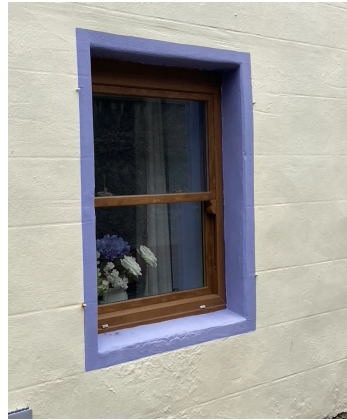
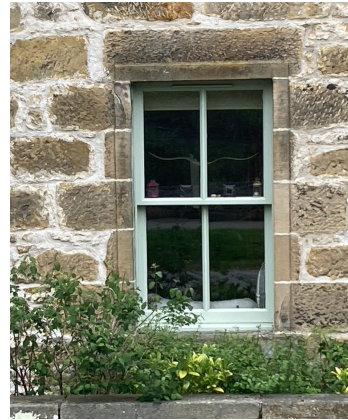
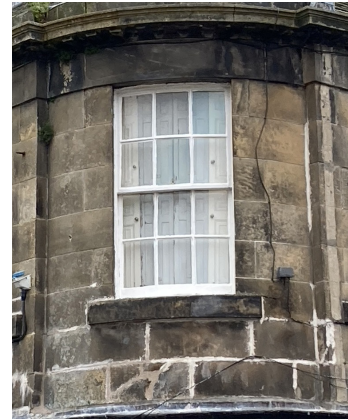
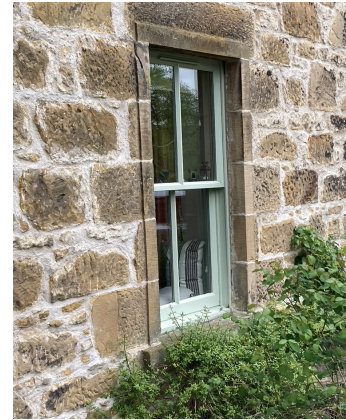
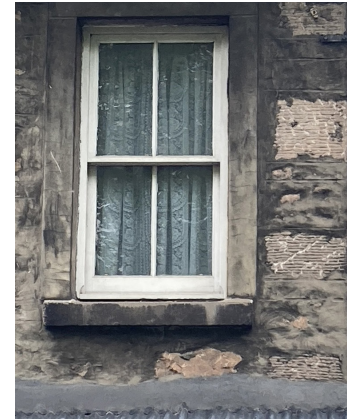
It is important to note that it is not 'one' element of a building that defines the character, it is a combination of all the elements. Traditional timber doors define the entrances to the buildings. The doors relate to the periods of architectural development of the Conservation Areas - they are significant to their time. Again, it is this mix of development that enriches the overall character.

Apply a good paint specification – an appropriate primer, undercoat and top/ finish coats – if this is maintained, it protects the main components from decay and this is what brings the longevity

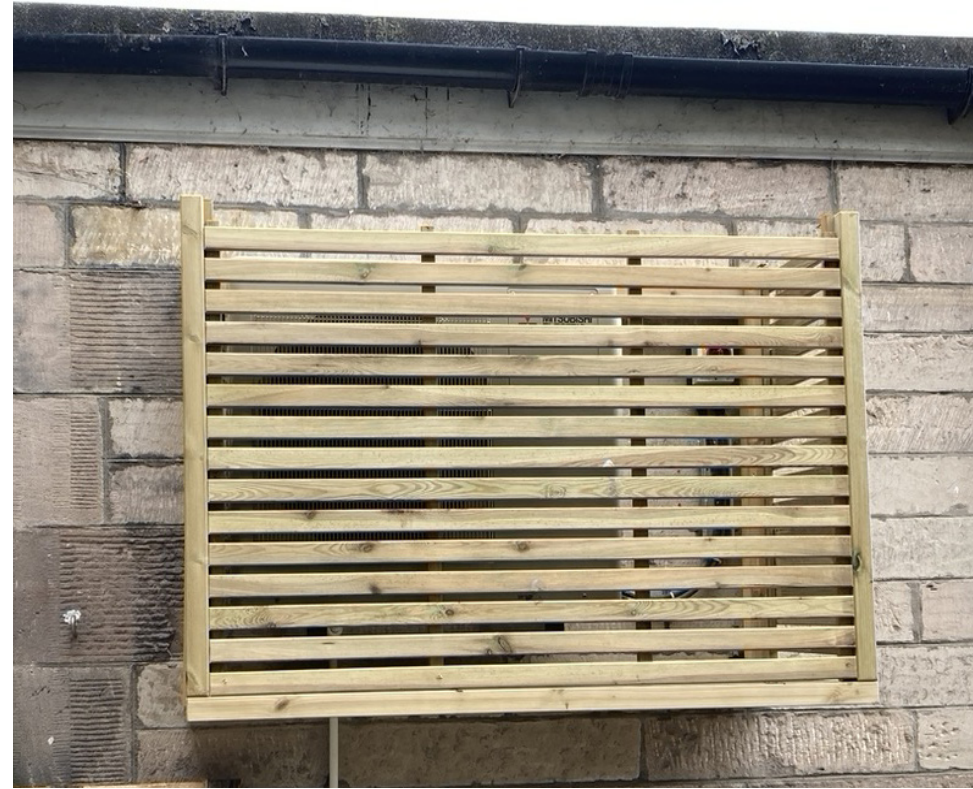
Timber detailing is not heavily used in the Conservation area, but it is a traditional material that can be very effective . It has been used here to screen M&E equipment.

Detailing is important to protect end grain etc and also when assessing if timber is to be treated, painted or left to weather to a natural finish.

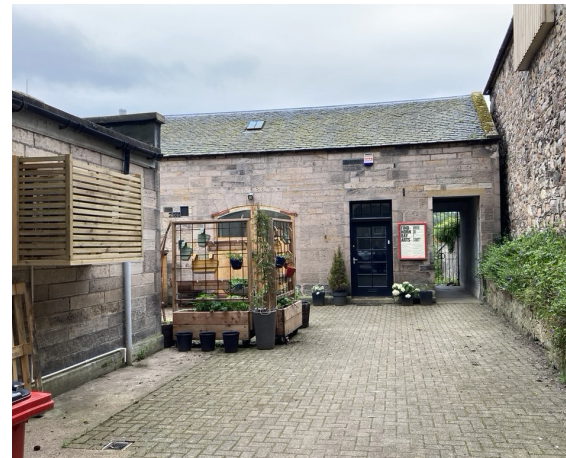
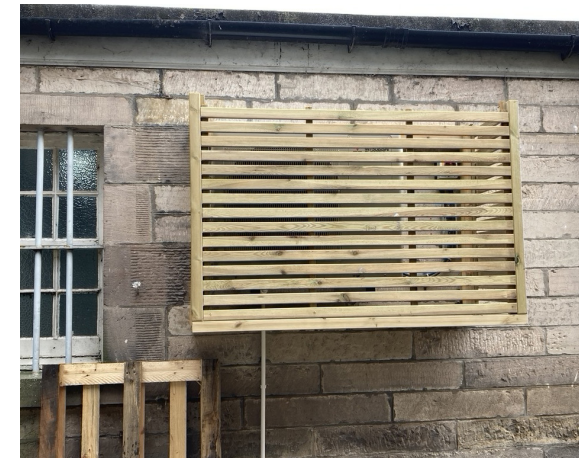
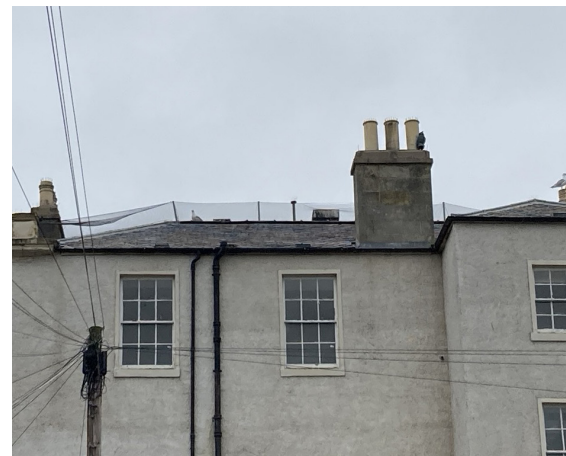
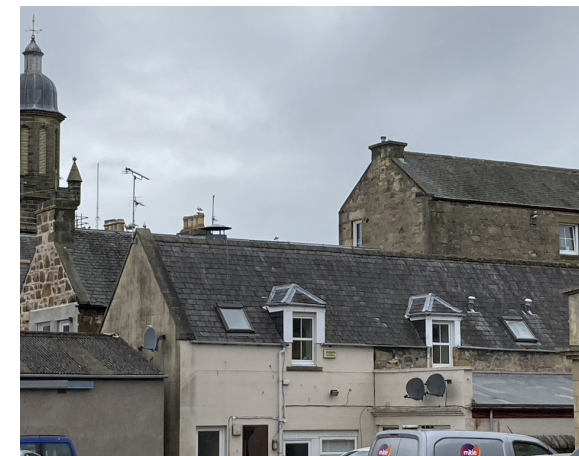
## Utilities / Services

Utilities and services can have a major impact on both visually and in terms of maintenance and management.

Noise and smell can cause environmental problems, so careful consideration and design is critical.

Air source heat pumps are an important part of the response to climate change. The siting of these types of units can provide challenges, particularly where there are multiple occupancies in a building. This also applies to air conditioning units.

Overhead telecoms or power lines are also a challenge and if they can be co-ordinated and buried, these will bring reliance against future storm damage and also have a positive visual impact.

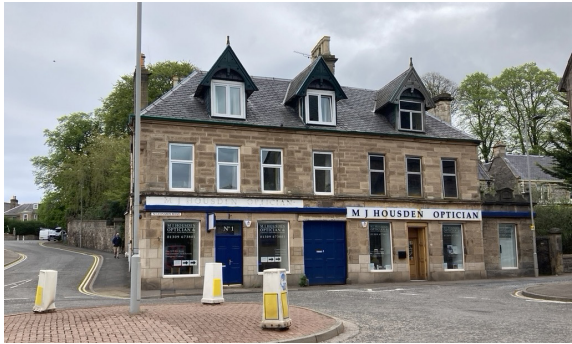
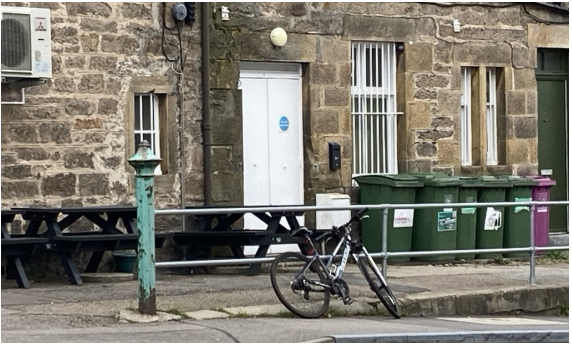
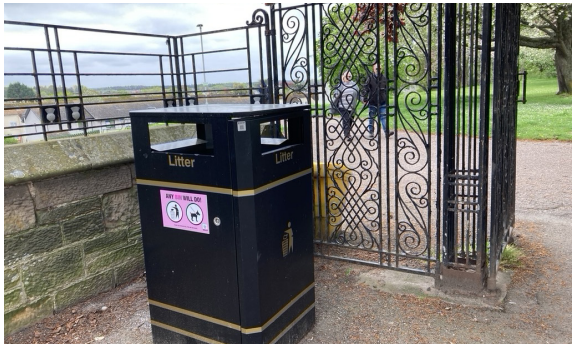
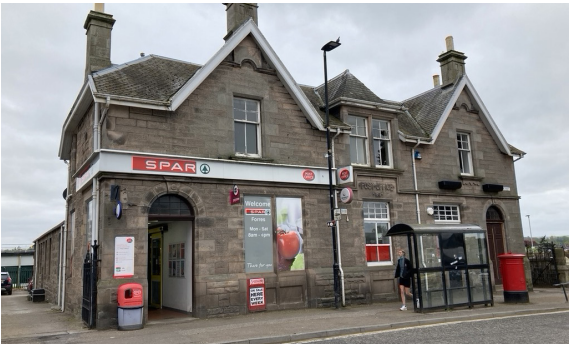
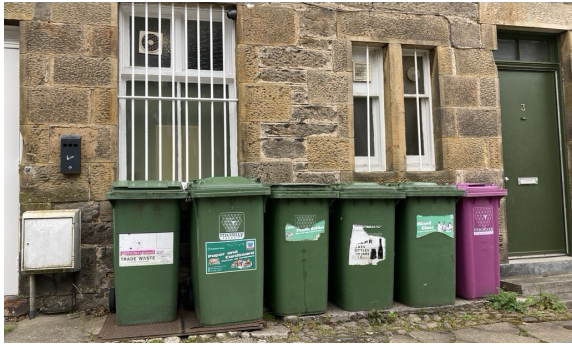
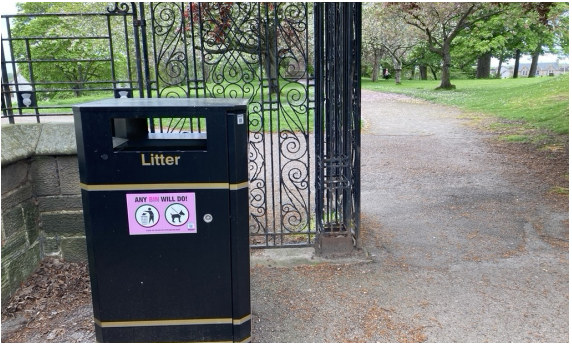
The design and placing of street furniture is very important, particularly in the immediate surroundings of the key buildings in the Conservation Area.

Maintenance is also key to the public street furniture, with painting being key and keeping notice boards up to date and cared for or having static displays in them. In addition the placement of seating should be given careful consideration especially in green spaces.

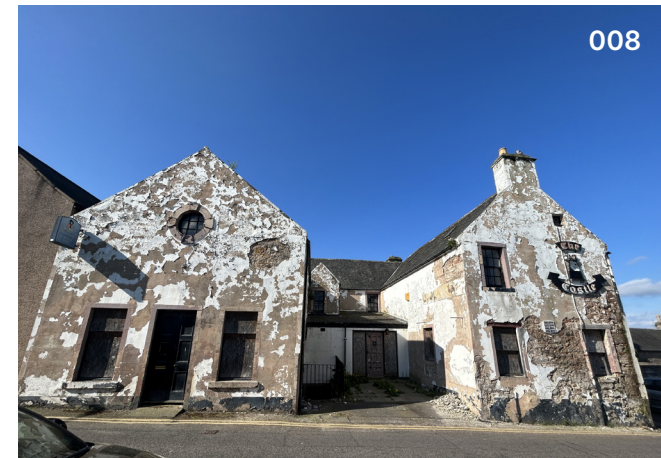
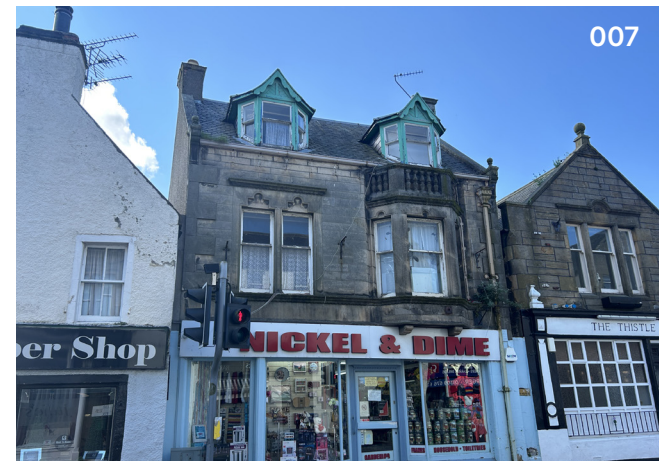
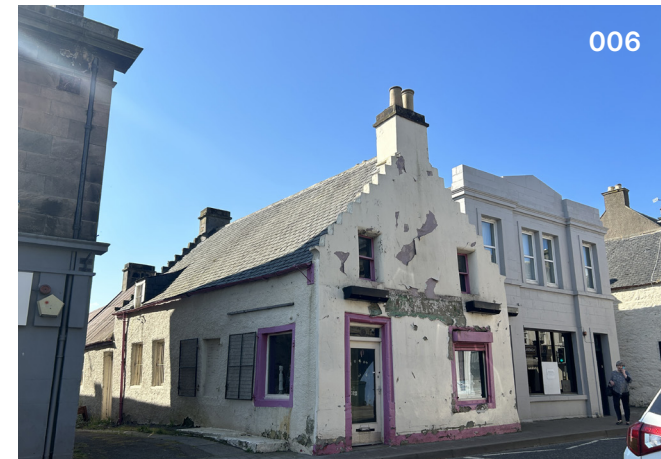
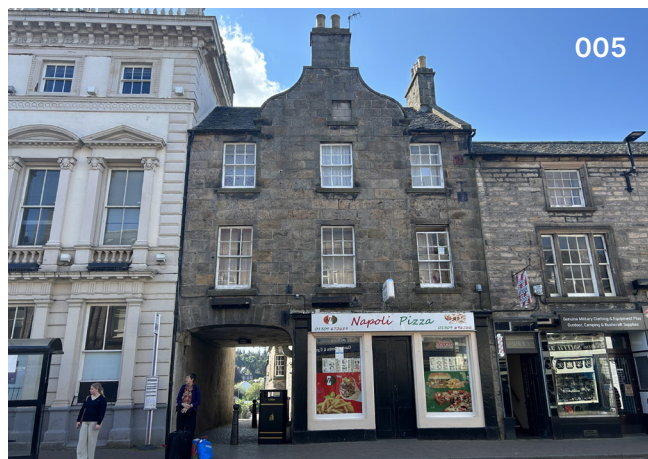
- 001 - 37 High Street
- 002 - 57 High Street
- 003 - 100 High Street
- 004 - 102 High Street
- 005 - 106 High Street
- 006 - 154 High Street
- 007 - 166 High Street
- 008 - Castle Inn, 29 Caroline Street

| Item: | Address: | | Priority Rating: | Fabric Rating: | Description: | High Level Budget Cost: | | | | |
|---|---|---|---|---|---|---|---|---|---|---|
| 001. | 37 High Street | Facetted stone corner building, 2.5 storey, stone parapet and mansard slated roof. Dormer windows. Decorative chimney. | PRIORITY 1<br>PRIORITY 5 | Urgent | Significant stone deterioration, biological growth, limited vegetation. Cast iron rainwater goods. uPVC windows to upper floors. Timber to shopfront. | £ 60,583.68 | £ 12,116.74 | £ 14,540.08 | £ 13,958.48 | £ 101,198.98 |
| 002. | 57 High Street B listed | Two storey ashlar building with parapet and slated pitch. Three number of chimney stacks. Sash and case windows to first level. Modern interventions at ground level. | PRIORITY 1<br>PRIORITY 2<br>PRIORITY 5<br>PRIORITY 6 | Necessary | Render coating applied to masonry at high-level (inappropriate repair). Scotch slated pitch with zinc ridge (clips with fixings through). Vegetation growth at failed downpipes. Vegetation and biological growths at chimneys. Movement in chimney copes - pots removed). | £288,000.00 | £57,600.00 | £69,120.00 | £66,355.20 | £481,075.20 |
| 003. | 100 High Street B listed | Three storey Scots baronial gablet with three bays. Sash and case windows (horns). Banded masonry at dressings. | PRIORITY 1<br>PRIORITY 2<br>PRIORITY 3<br>PRIORITY 5 | Necessary | Biological growths to masonry - some deterioration to stonework and pointing. Vegetation at high-level. Slipped slates. Traditional shopfront. Deteriorated console brackets and cornice (with dentals). | £79,848.00 | £15,969.60 | £19,163.52 | £18,396.98 | £133,378.10 |

| Item: | Address: | | Priority Rating: | Fabric Rating: | Description: | High Level Budget Cost: | | | | |
|---|---|---|---|---|---|---|---|---|---|---|
| 004. | 102 High Street A listed | Three storey five bay italianate building. Engaged columns at ground floor level. Blind balustrade running along first floor, engaged corinthian columns to windows with window pediments. Second floor window bands. Sash and case windows. Parapet blustrade and modillion course. Highly decorative. | PRIORITY 1<br>PRIORITY 2<br>PRIORITY 5 | Necessary | Painted stonework is blistering / flaking. The stone below is deteriorating in places. The roof level and stone projections are dominated by bird prevention measures. | £302,054.40 | £60,410.88 | £72,493.06 | £69,593.33 | £504,551.67 |
