# **Summary Building Condition Survey Report**

**Alves Primary School  
1 Main Road, Alves IV30 8UR**

**9<sup>th</sup> and 10<sup>th</sup> of May 2022**

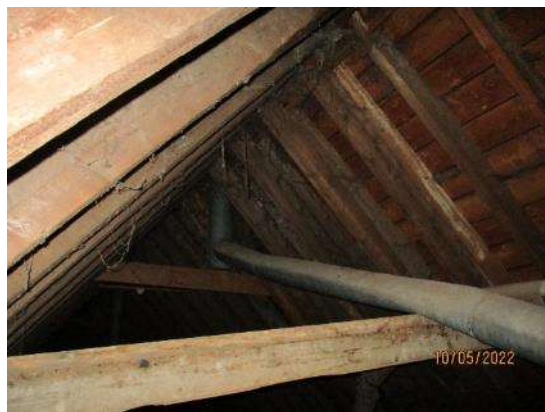
6. Dining block – vent pipes resting on structure

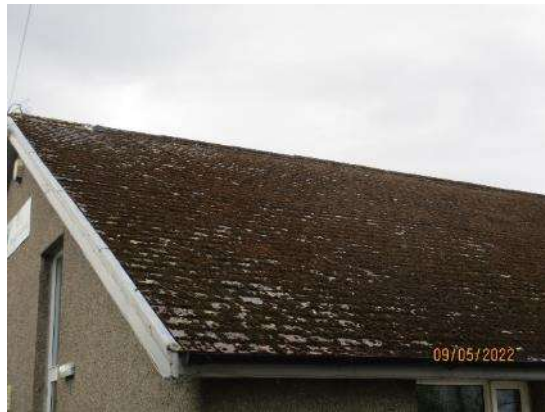
14. Asbestos tile to Teaching south

- Replacement of asbestos cement tiles.
- Underpinning of classrooms 1 & 2 to prevent further movement.
- Expansion of the field of CCTV cameras to increase security.
- Installation of an intruder alarm system in the dining block to increase security.
- Review of requirement for mechanical ventilation in toilet rooms.
- Upgrade of controls for mechanical fans and lighting for energy saving purposes.
- Upgrade of lighting in both buildings due to age and condition.
- Upgrade of heating and associated plumbing systems in both buildings due to age and condition and for energy saving and reduction of carbon emission purposes.
- Installation of a sump pump system within the dining room block basement boiler house, as it is below ground level and has potential to flood.

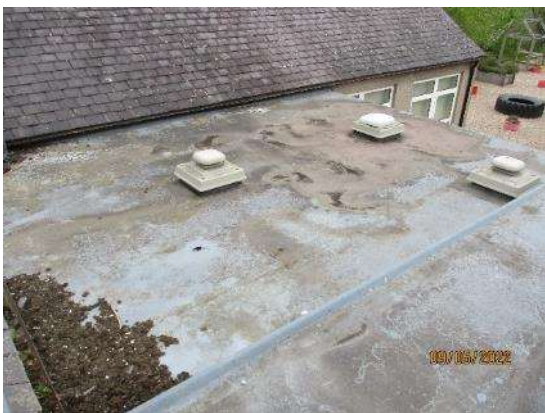
17. GRP roof above staff toilet

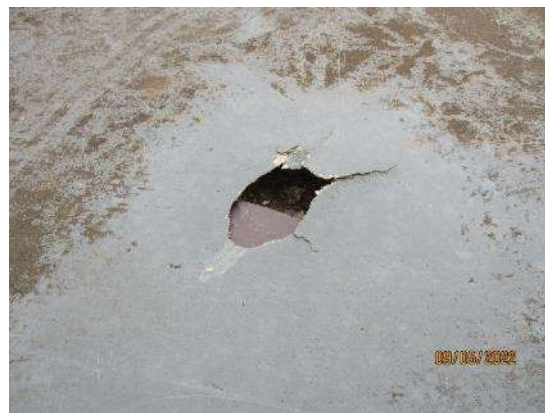
- Asbestos tiles have extensive moss growth to the East aspect.
- The GRP roof above the staff toilet has a significant hole and extensive blistering.
- External walls to classrooms 1 and 2 have extensive, significant cracking.
- Plaster and plasterboard ceilings have significant cracking.
- Internal walls also have significant cracking.
- Concrete floors to classrooms 1 and 2 have dropped by approx. 25mm.
- Internal doors are dated, glazing is single glazed and ironmongery is defective.

18. Hole in GRP roof

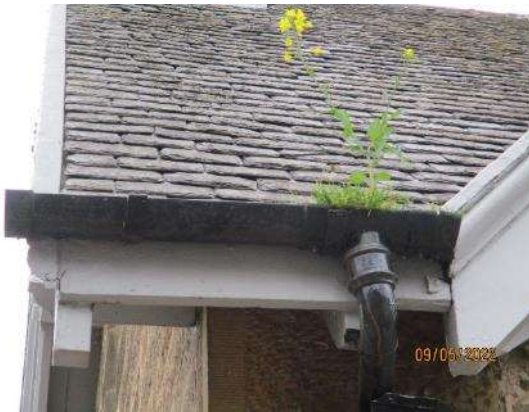
- The GRP roof is punctured in several places and has extensive blistering.
- Cast iron gutters, hopper heads and downpipes are partially blocked with vegetation.
- Timber sliding sash windows are in poor condition and largely painted shut.
- External timber doors have wet rot at the bottom edge.

31. Vegetation in rainwater goods

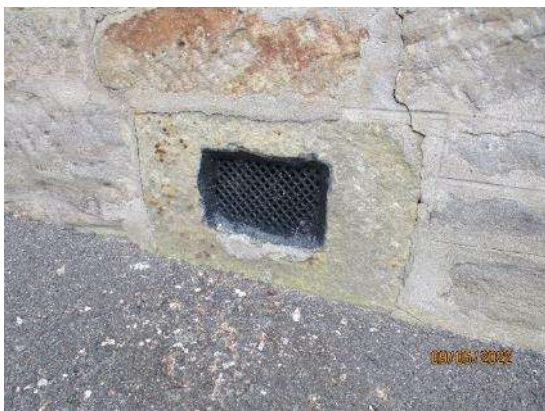
47. Below floor ventilation – Dining block

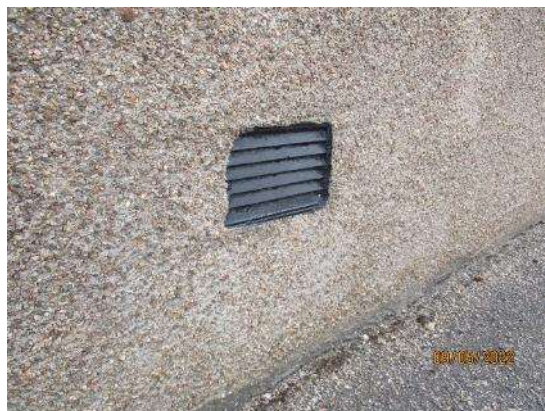
48. Below floor ventilation – Teaching south

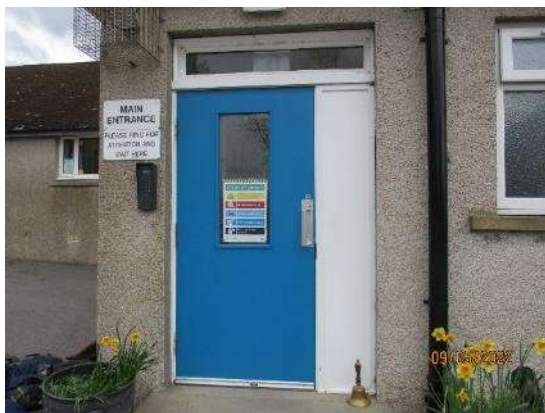
54. Main entrance door – Teaching block

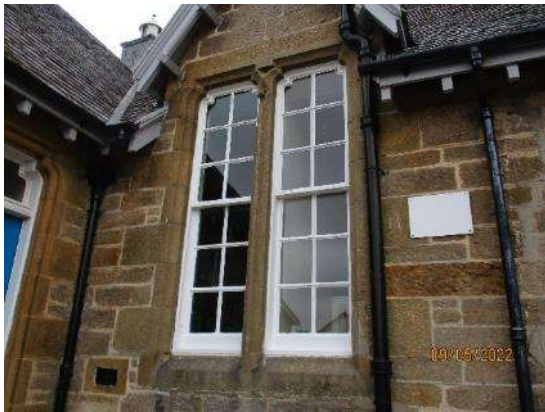
61. Timber sliding sash windows

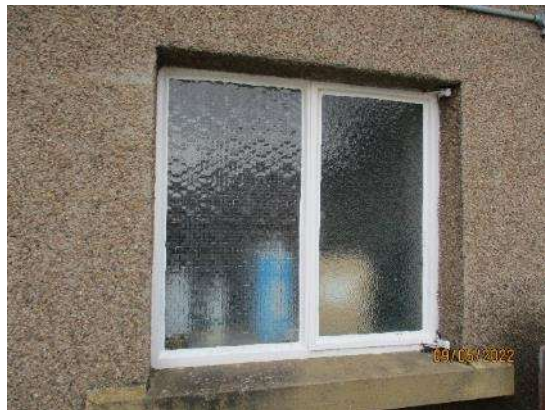
64. Crittall window to Plant Room

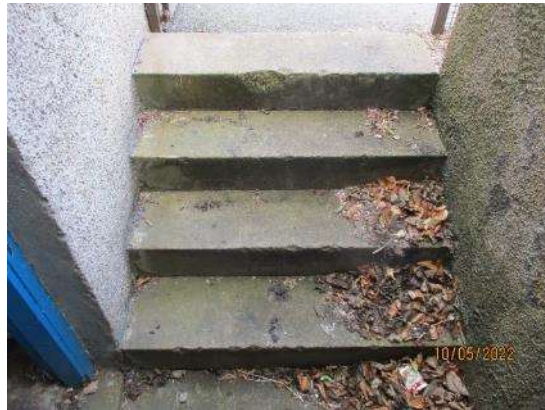
75. Concrete steps to Boiler House

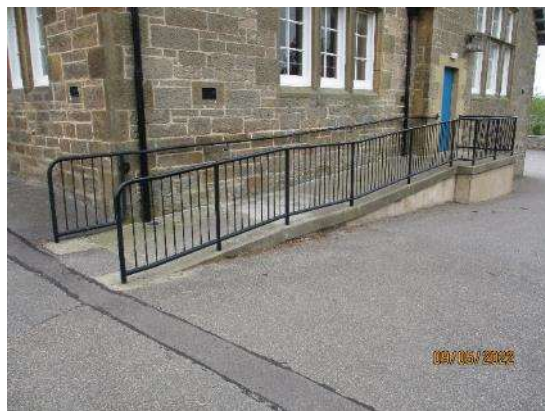
77. Ramps and guard rails

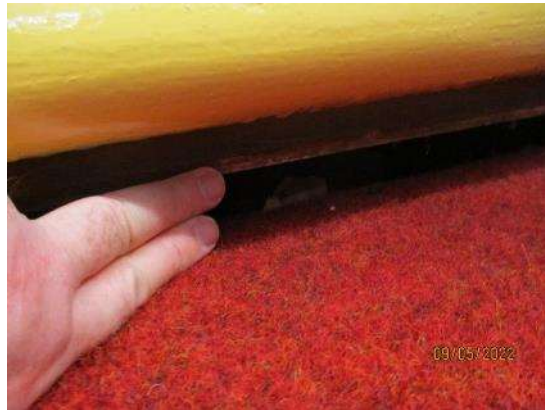
81. Concrete floor subsided

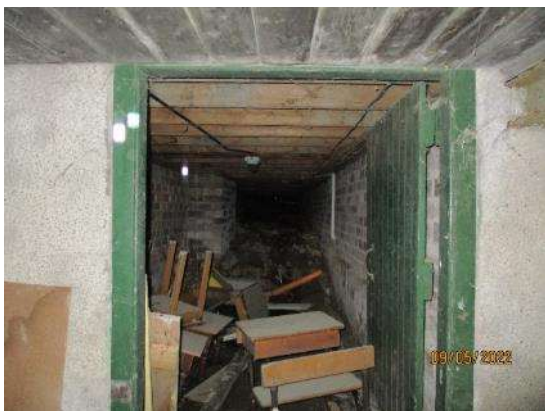
82. Below timber suspended floor – Teaching south

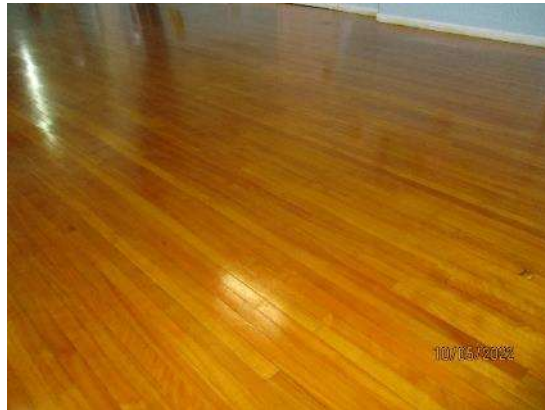
87. Varnished floor boards

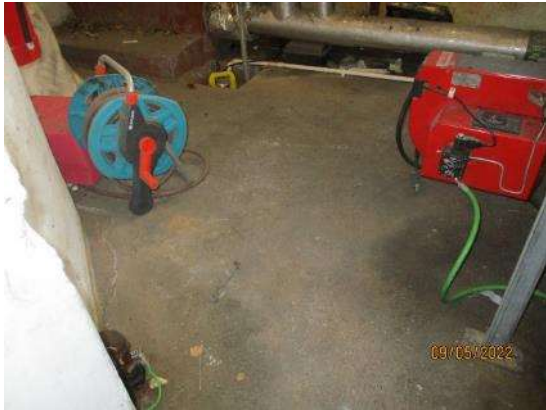
90. Concrete floors to Boiler & Plant rooms

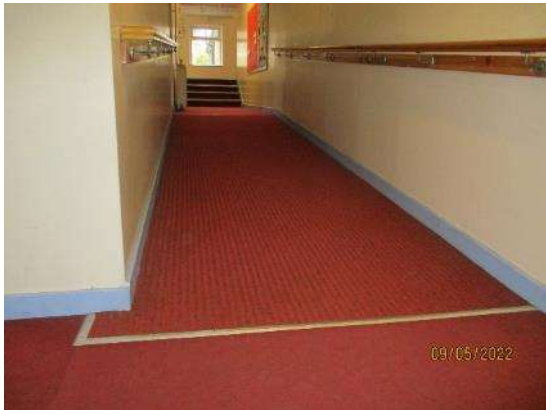
92. Ramps to Teaching corridor

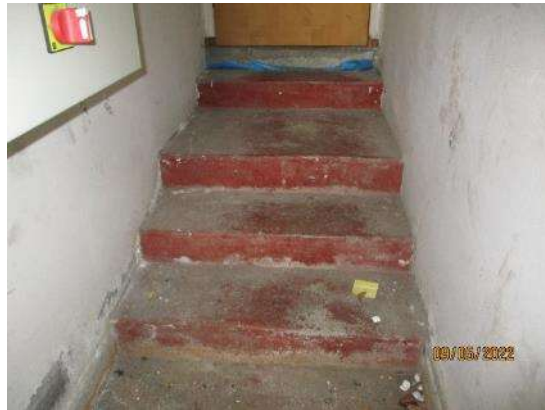
93. Concrete steps to Plant Room

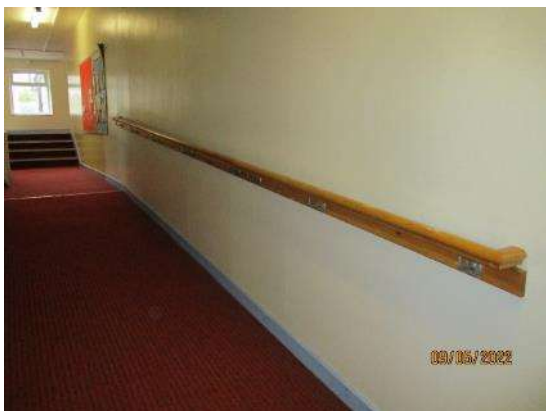
94. Timber handrails to ramps

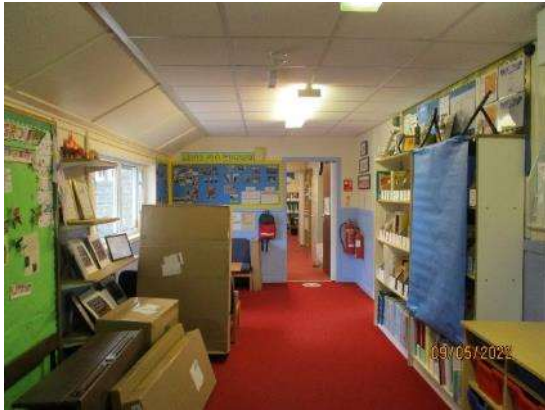
95. Suspended ceiling tiles

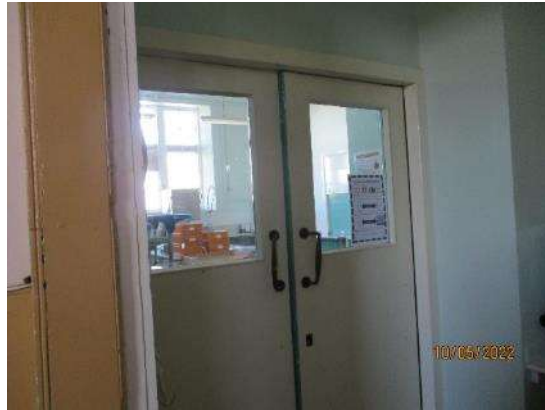
114. Internal double doors

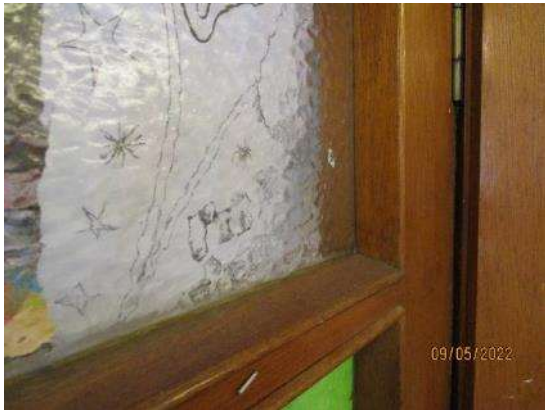
115. Single glazing to doors

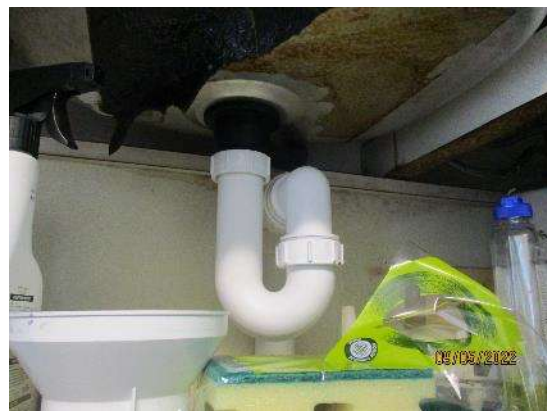
129. PVC waste pipes

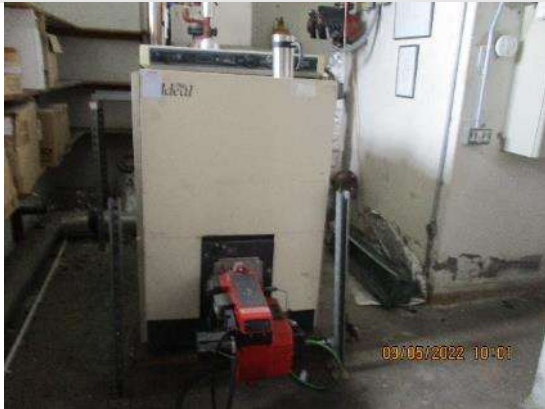
- Heating systems are reaching the end of their useful life and should be considered for upgrade to avoid potential for serious failure, causing service disruption and to be more energy efficient and to emit less carbon related products of combustion. Neither building has back up heating system to one oil boiler.

134. Oil fired heating only boiler.

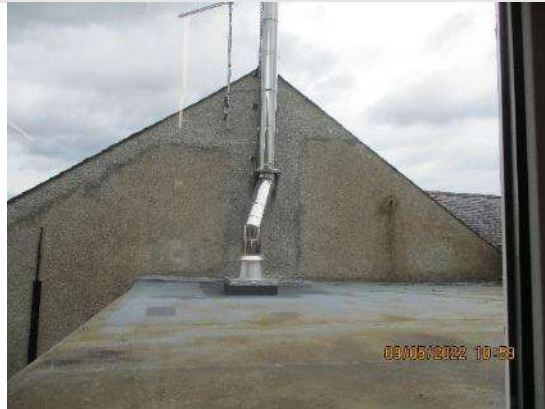
135. Boiler stainless steel chimney system.

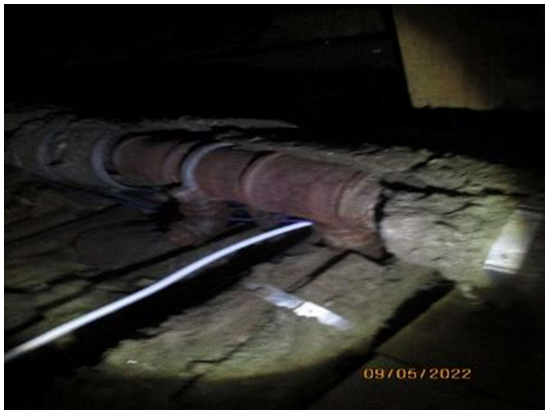
136. Pipework – Heating system distribution in teaching block attic.

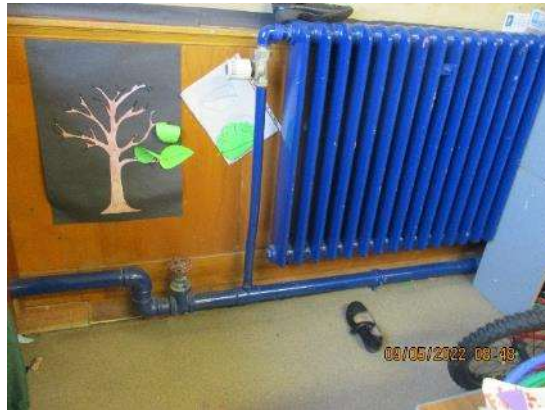
137. Radiator – heating system teaching block example.

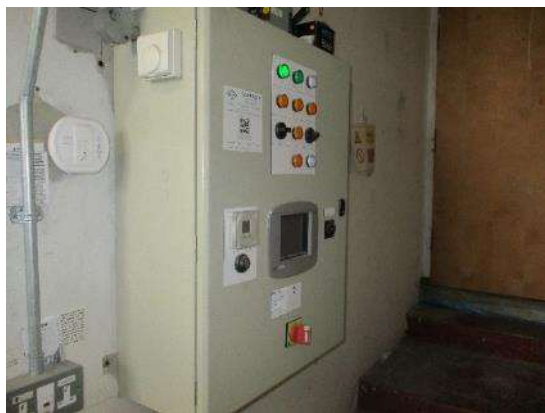
138. Heating system BEMS control panel. Teaching block.

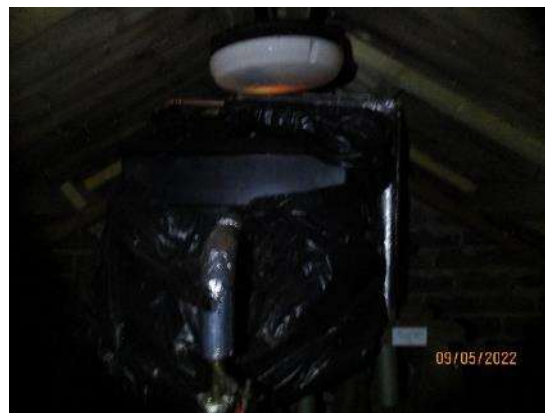
139. Heating feed and expansion tank. Teaching block attic.

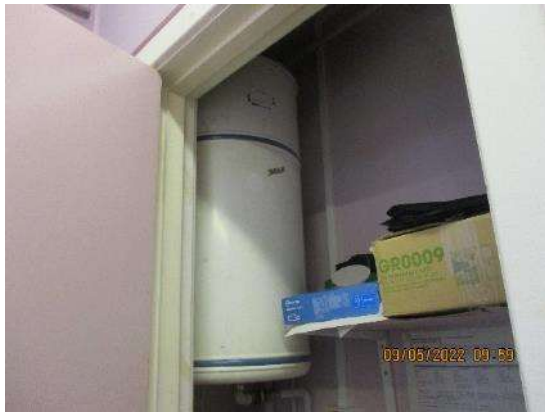
140. Hot water storage tank teaching block – electric. Girls toilets cupboard.

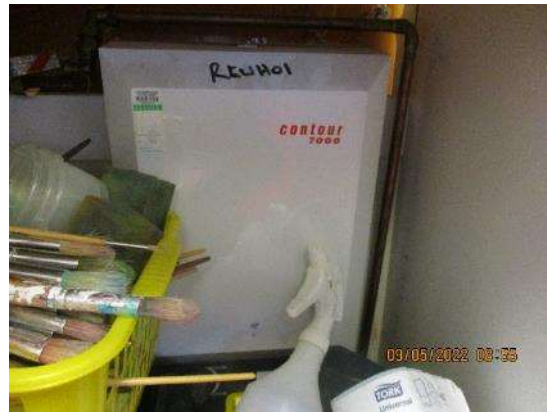
141. Point of use electric water heater. Teaching block classroom typical.

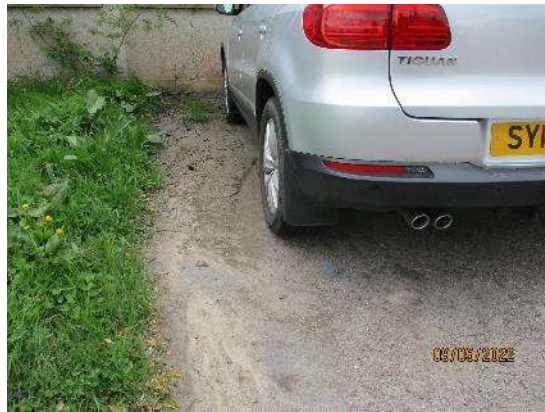
201. Surface water ponding

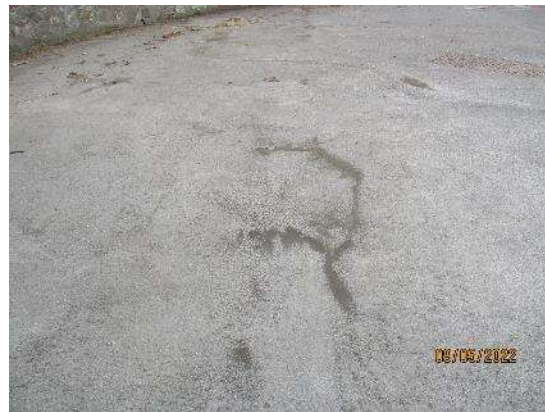
203. Evidence of water ponding

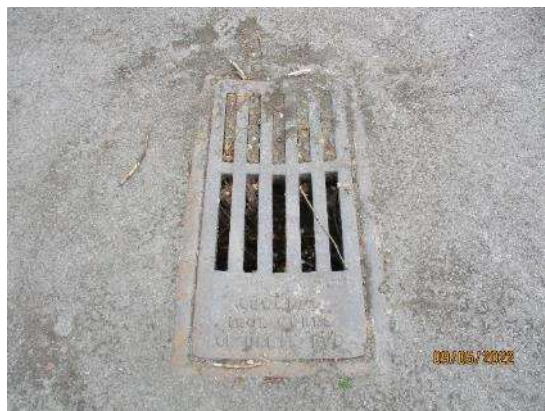
217. Road gullies, part blocked

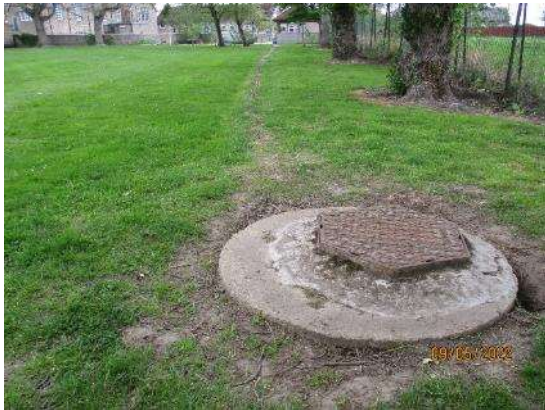
- Rodding eyes and manhole covers are loose and raised above ground level.

220. Raised manhole covers

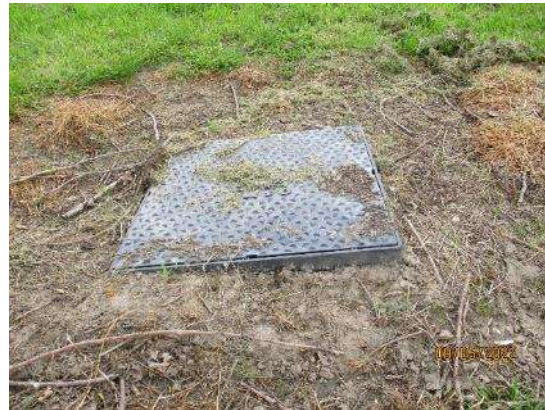
221. Insecure manhole covers
