# **Summary Building Condition Survey Report**

**Andersons Primary School  
High Street, Forres IV36 1DB**

**31<sup>st</sup> January & 1<sup>st</sup> February 2022**

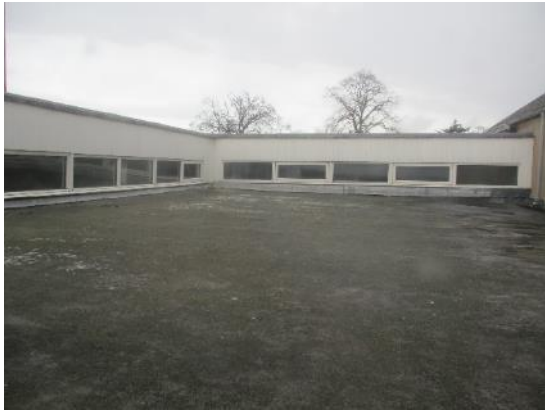
3. Mineral felt roof above Gym Hall

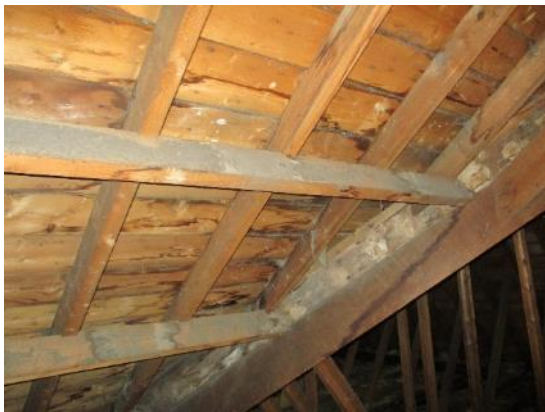
6. Water marked timbers

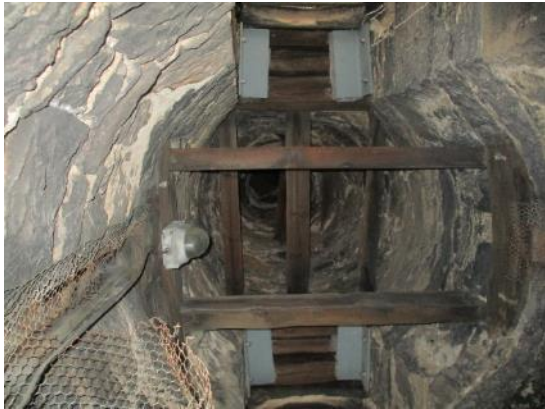
7. Timber structure within the steeple

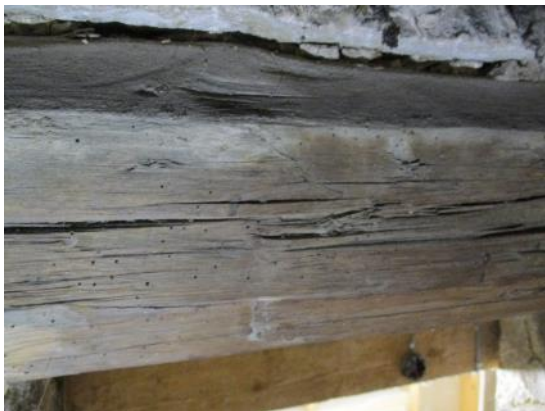
9. Woodworm in lintels

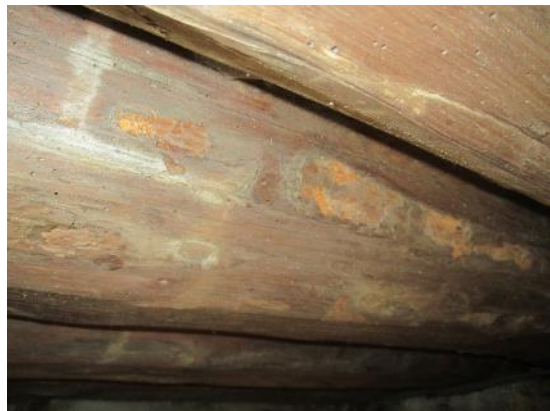
10. Woodworm in lintels

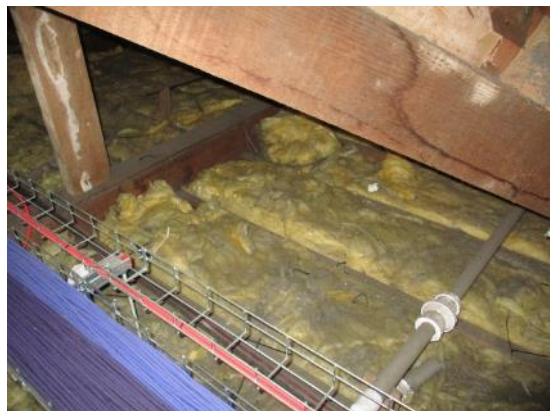
12. Mineral insulation over lath & plaster

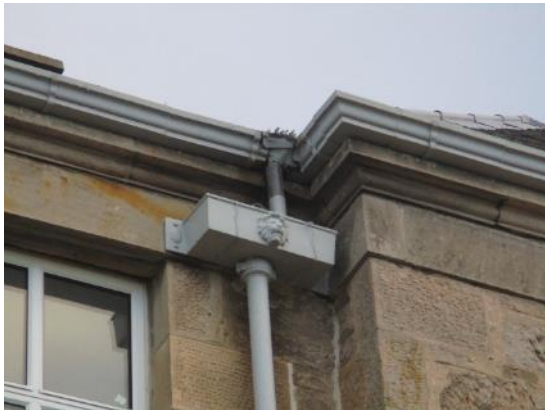
15. Previous repairs to gutter outlets

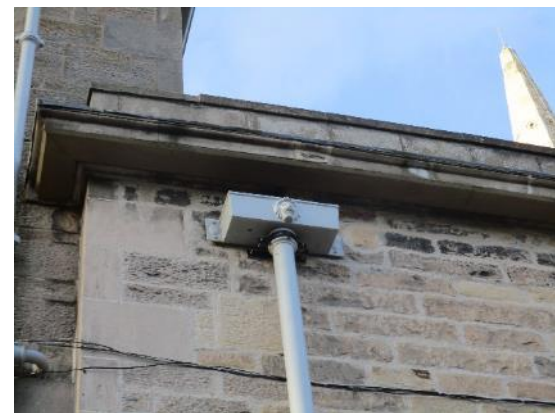
18. Cast iron hopper heads

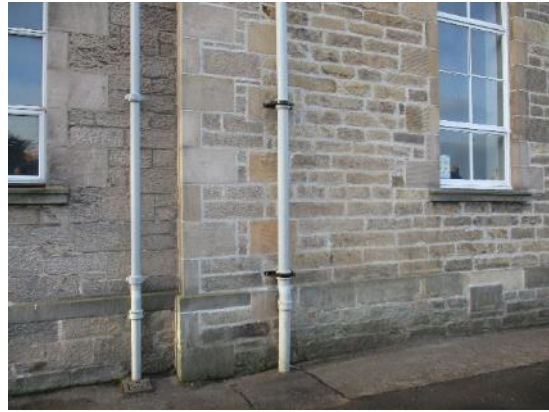
20. Cast iron down pipes

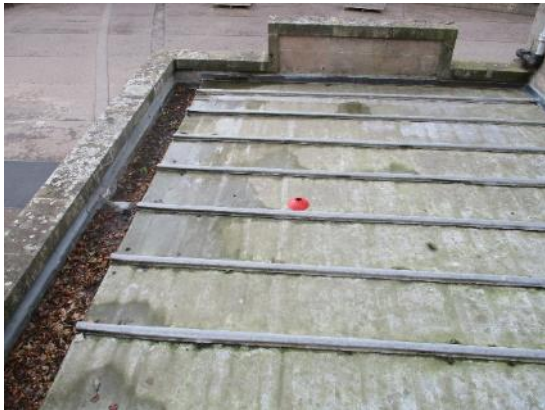
21. Lead roof box gutters

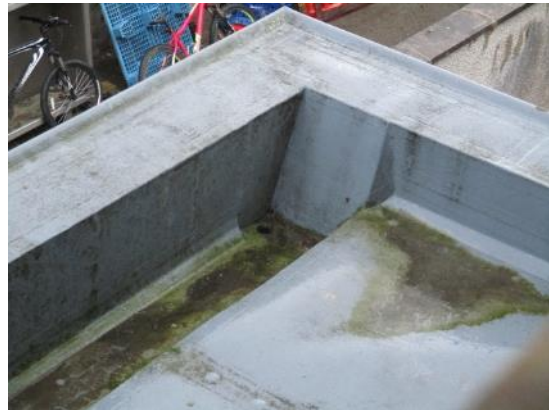
22. GRP roof box gutters

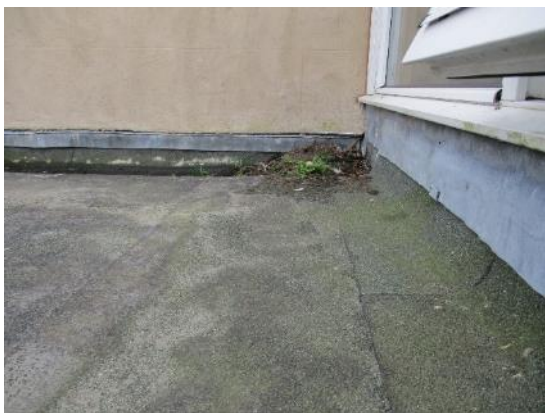
23. Felt roof box gutters

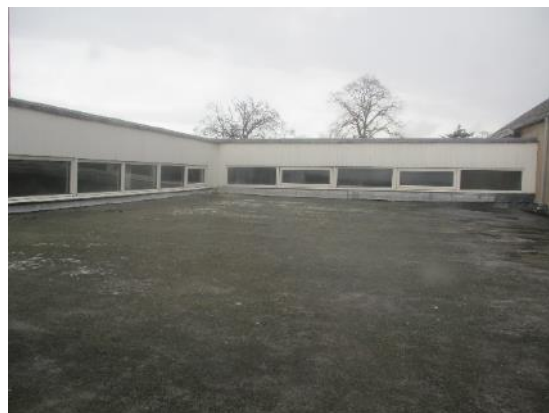
24. Parapet wall to felt roof

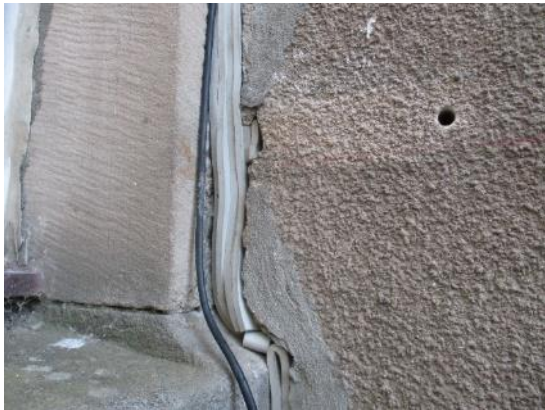
34. Expansion tape filling the gap

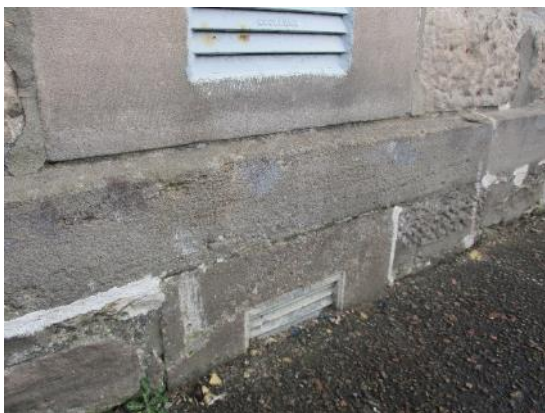
- Vegetation was visible in gutters.
- All chimney pots to be investigated, redundant flues should be capped and ventilated.
- Suspended floor ventilation is obstructed by playground levels and cycle racks.
- Following recent underpinning, the Kitchen extension should be monitored to ensure no further movement is taking place.
- Significant repairs are required to the external walls of the Kitchen extension.
- Loose, unclipped external cabling.
- Window mechanisms and ironmongery are in poor condition.
- MDF window sills and surrounds laminated and swollen.
- Isolated areas of woodworm in the clock tower timber lintols.
- Floor finishes cut, holed and worn.
- Kitchen units and worktops laminating.
- Sanitary ware dated, cracked and damaged.
- WC cubicles dated worn and damaged.

36. Under floor ventilation obstructed

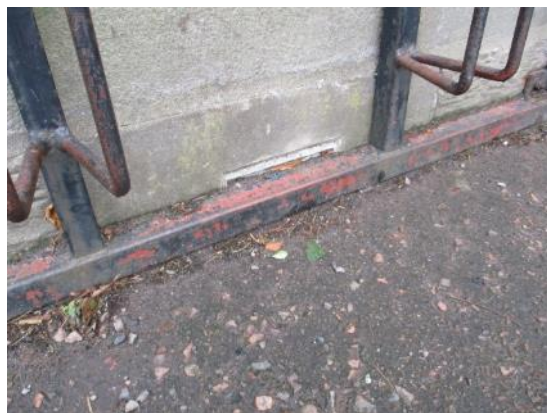
37. Under floor ventilation obstructed

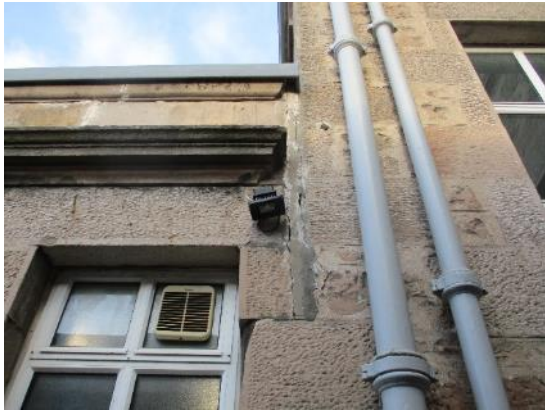
38. Isolated repointing required

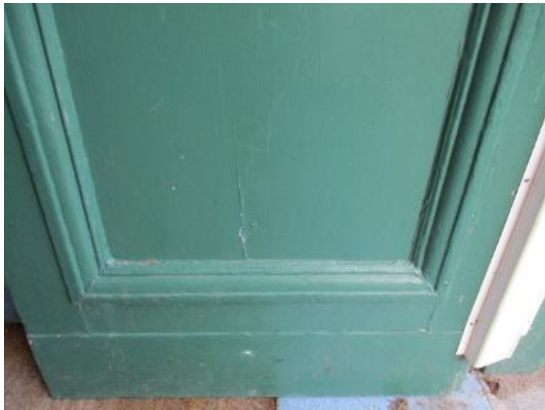
40. Isolated repairs required

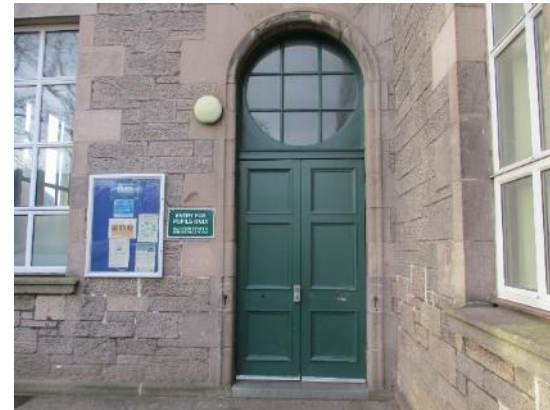
41. Timber fire escape doors

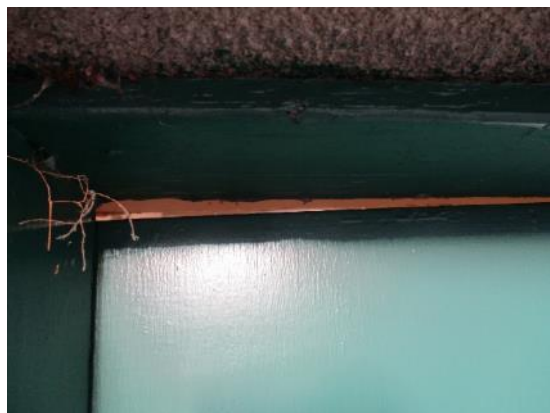
43. Door does not fit frame

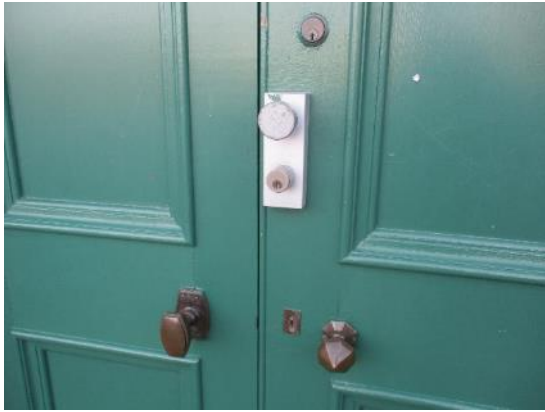
44. Door ironmongery in fair condition

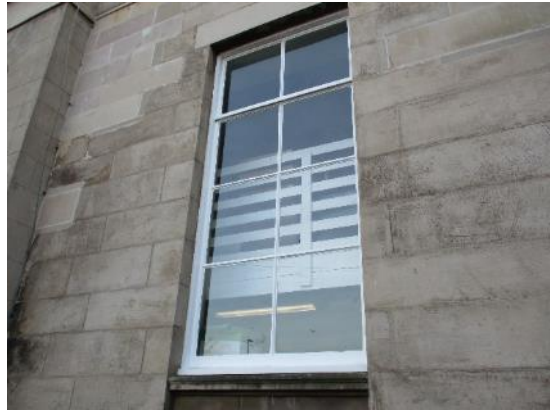
45. Timber framed windows

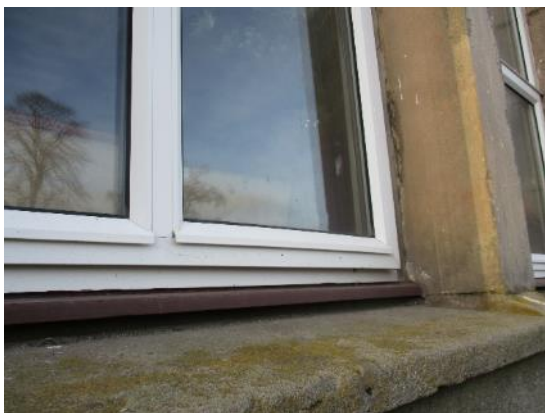
47. Powder coated metal windows

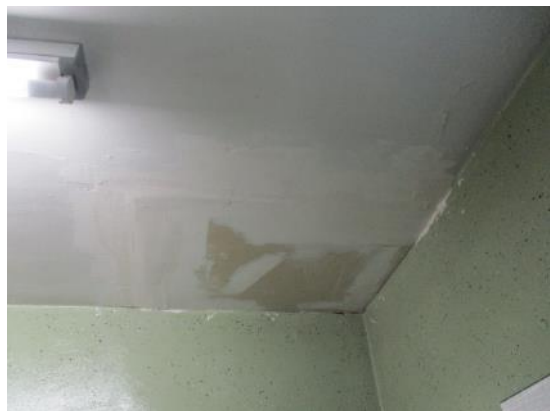
62. Cracked lath & plaster ceilings

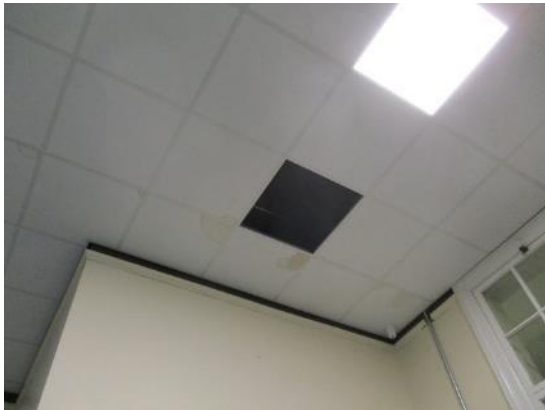
65. Isolated water marking

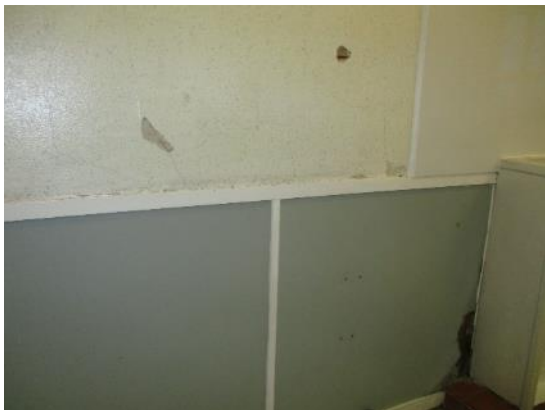
72. Isolated surface damage

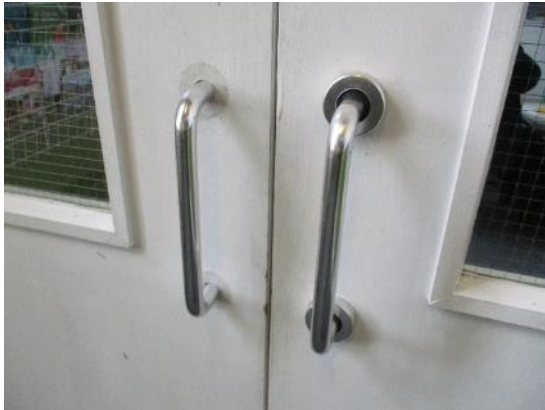
88. Isolated missing ironmongery

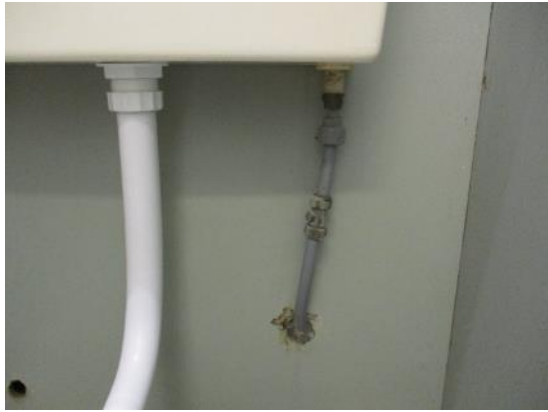
100. PVC waste pipes

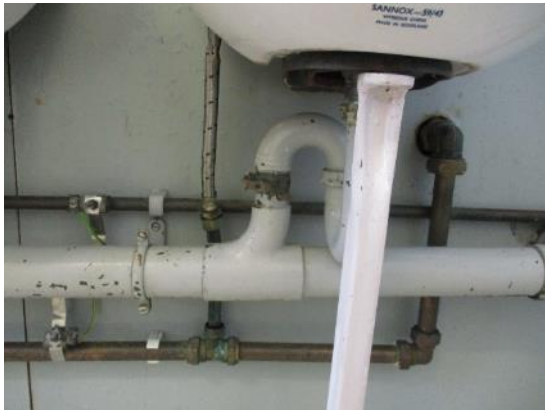
101. Copper waste pipes

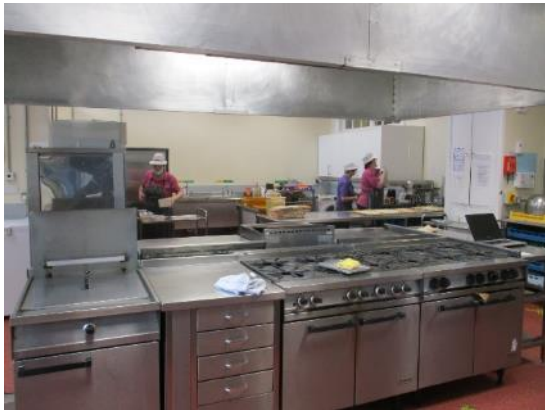
107. Stainless steel commercial kitchen

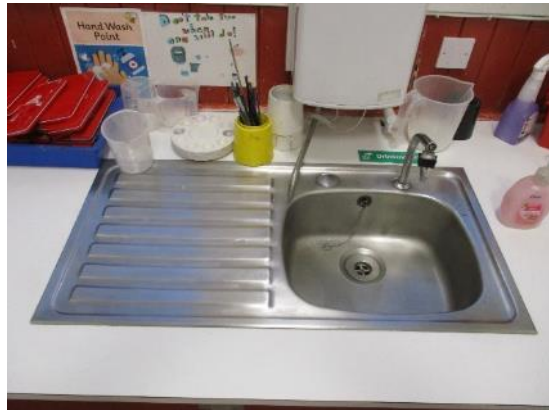
108. Classroom stainless steel sinks

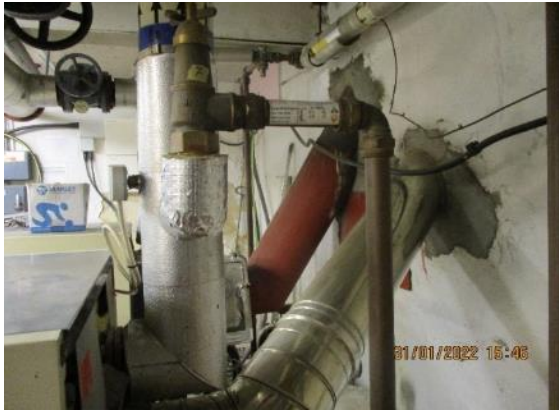
119. Boiler Flues and chimney

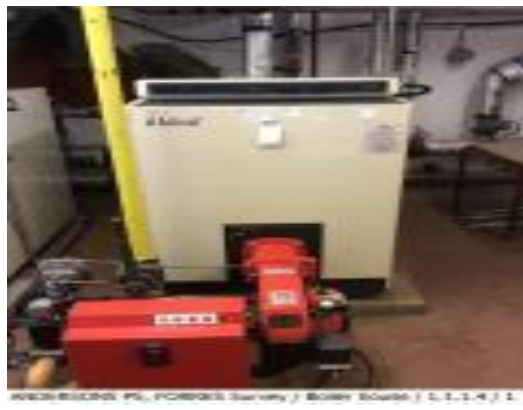
- A number of electrical distribution boards and consumer units are life expired and should be considered for replacement.
- The boilers and hot water storage tanks are reaching the end of their useful life and should be considered for upgrade, together with the plant room pipework and control system.

120. Cast iron sectional gas boiler 1 of 2

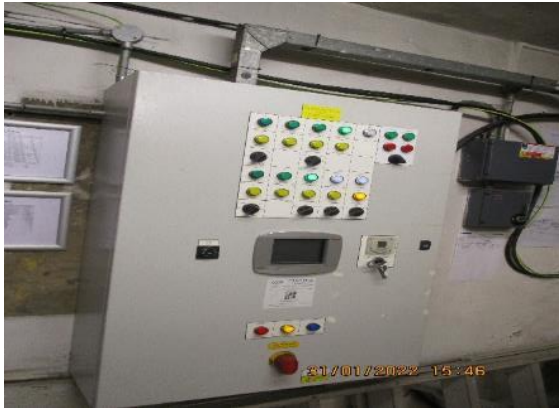
121. Plant BMS control panel and controller keypad

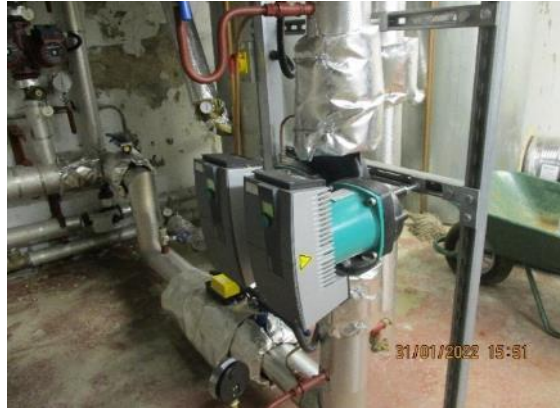
122. Plant room pumps and pipework

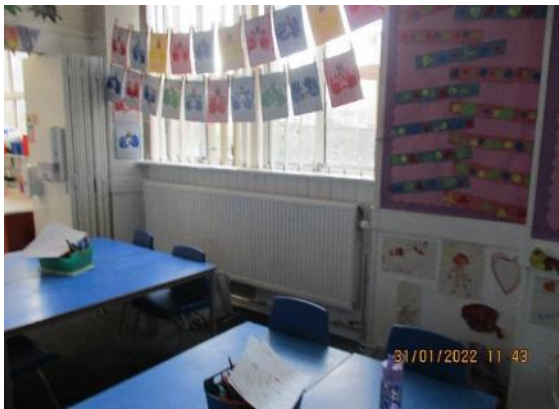
123. Typical heating system radiator

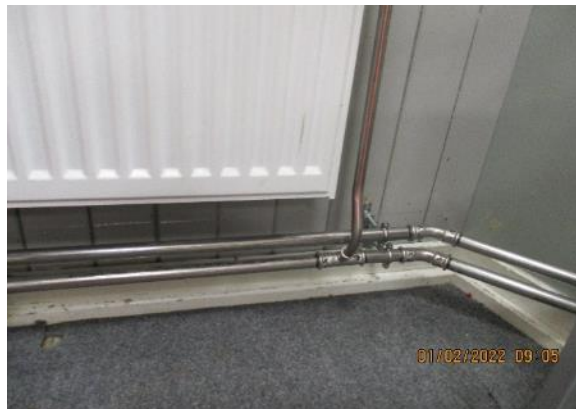
124. Heating system pipework

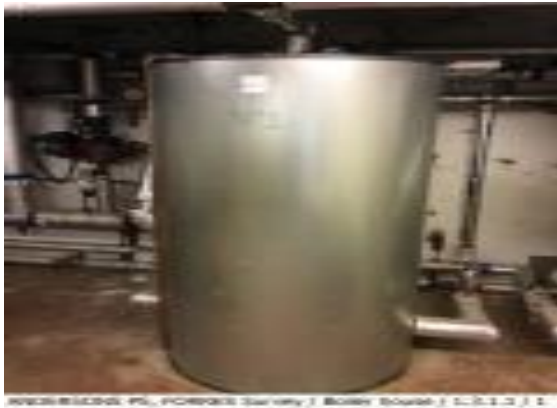
125. Hot water storage calorifier – 1 of 2 Plant room 0/29

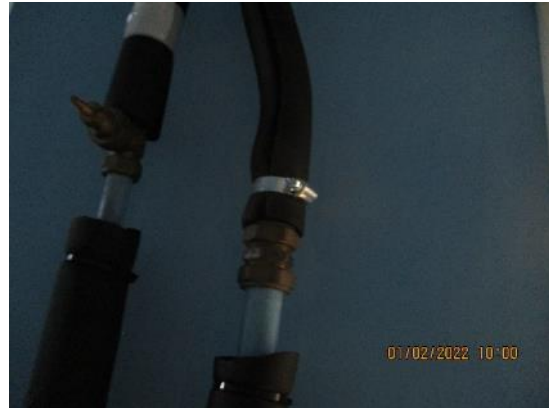
126. Hot water pipework within school building

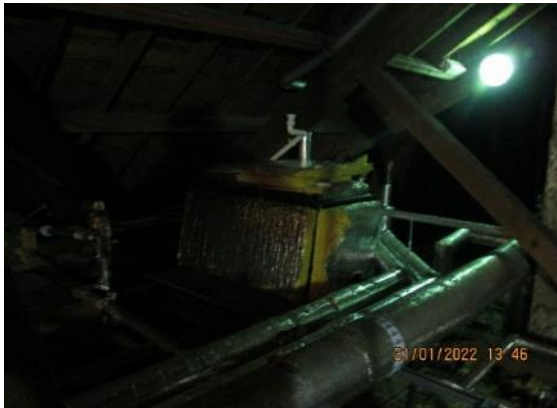
127. Cold water storage tank attic space

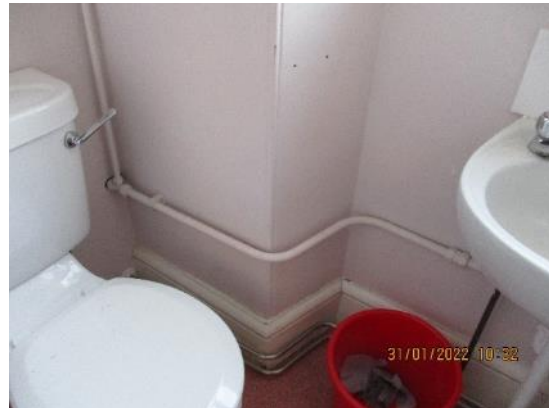
128. Cold water pipework within school building 1-36

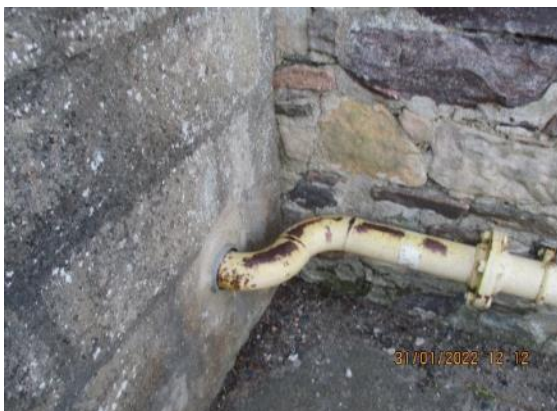
- Gate piers have exposed reinforcement and require repair (Cat B Listed).
- Perimeter wall surface cracking and efflorescence, cracked and broken coping stones.
- Gas supply pipe exiting the main gas meter has no mechanical protection and has evidence of being used to climb on.

129. Gas supply to plant room – external. Main gas meter

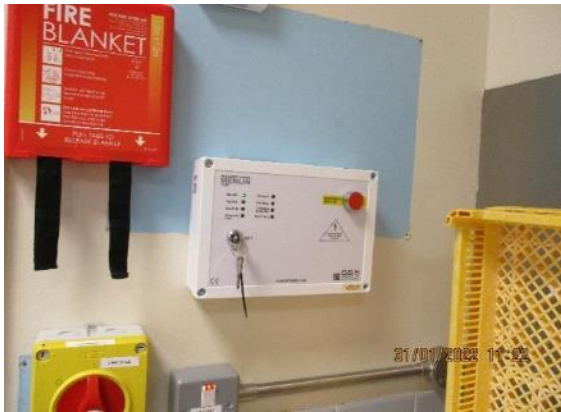
131. Automatic gas safety controls – Kitchen 1/11

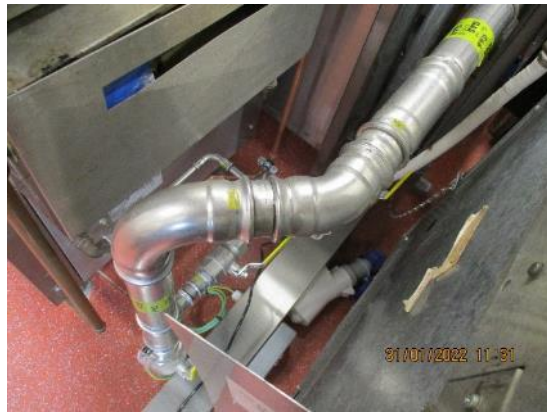
132. Gas pipework within kitchen to appliances 1/11

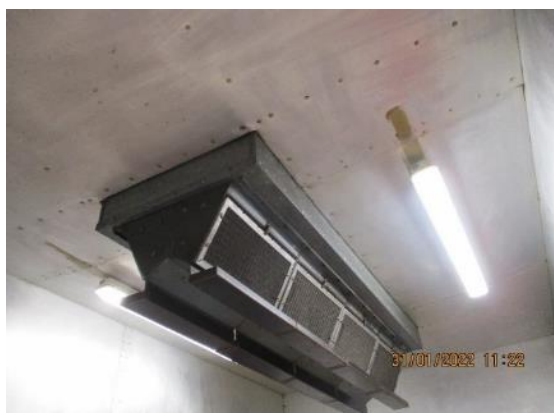
135. Specialist extract mechanical ventilation kitchen 1/11

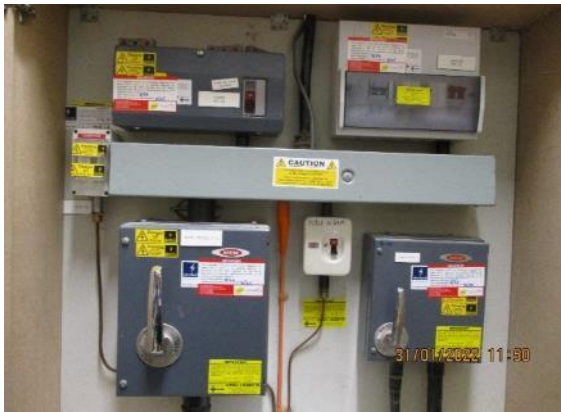
137. Electrical distribution boards and consumer unit

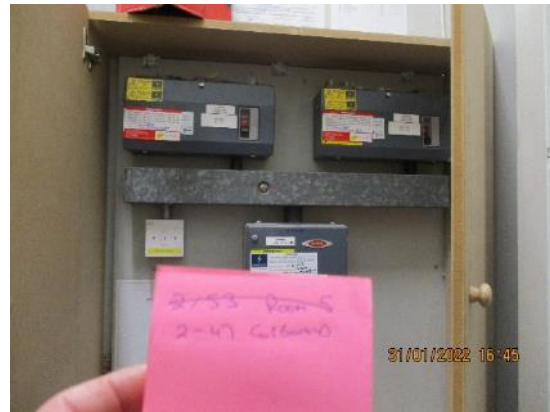
138. Electrical distribution boards

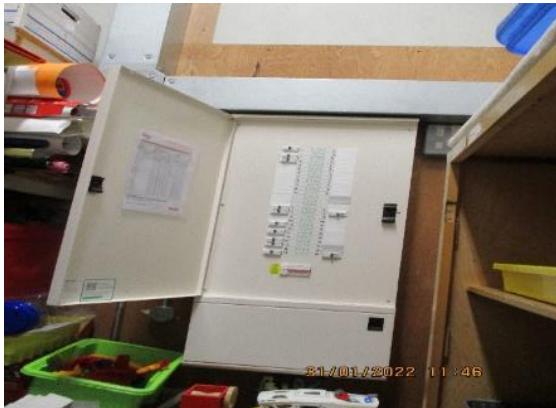
139. Electrical distribution board kitchen 1/11

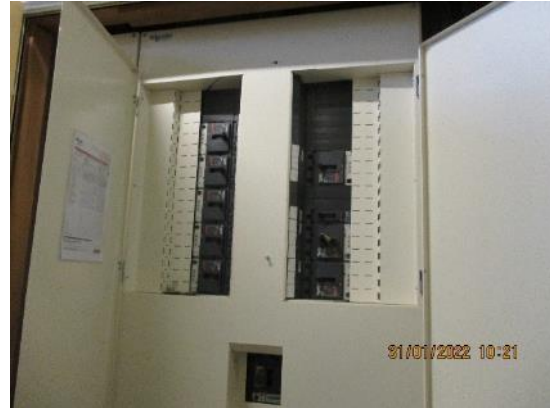
140. Electrical distribution board 2/47

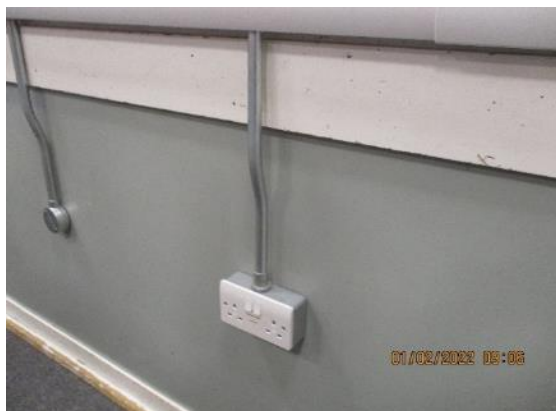
141. Wiring accessories and conduit and trunking-classroom

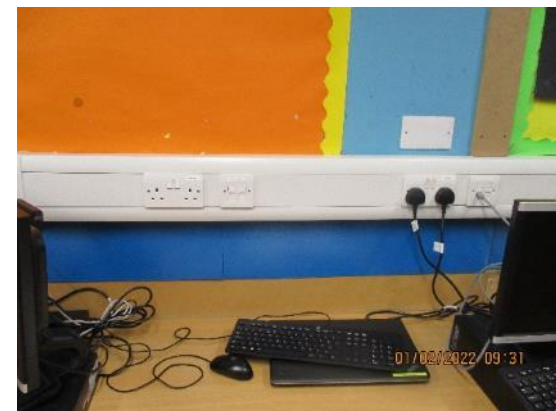
142. General wiring and dado trunking – class 2/30

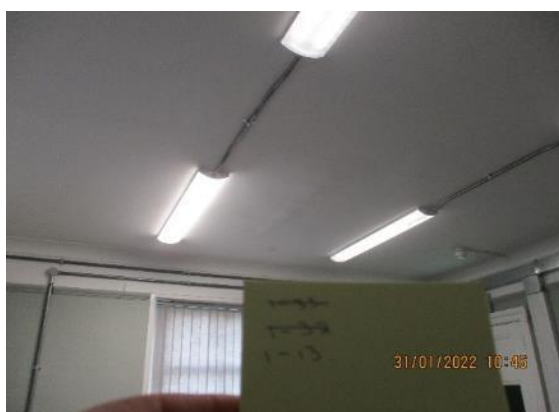
143. Office lighting HT – Room 1/13

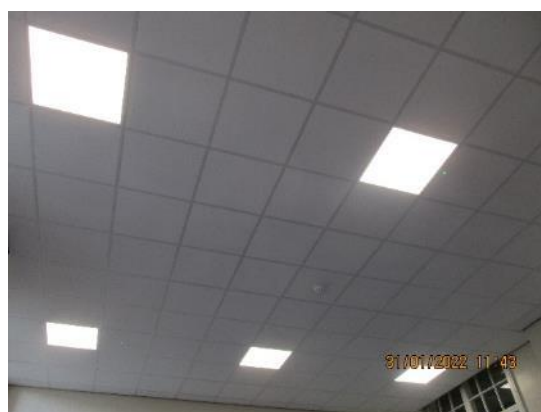
- A percentage of internal lighting is life expired.
- During upgrade or replacement of systems, all redundant systems should be removed or clearly labelled to state they are redundant and no longer live systems.

144. Classroom lighting room 1/14 / throughout.

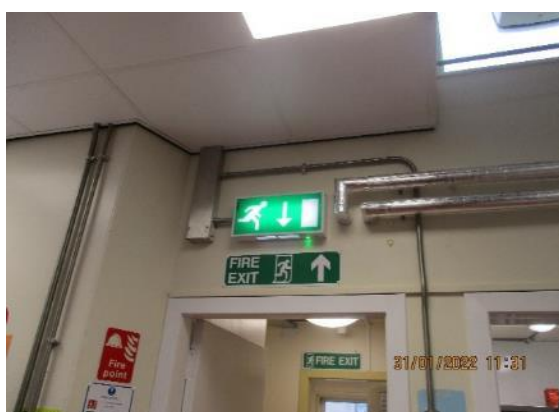
145. Emergency exit maintained lighting kitchen 1/11

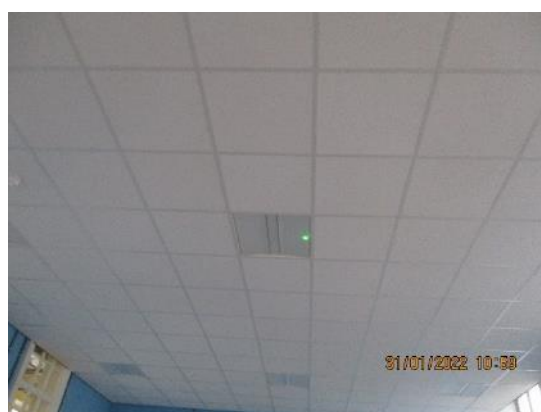
146. Emergency room lights. Non maintained Class

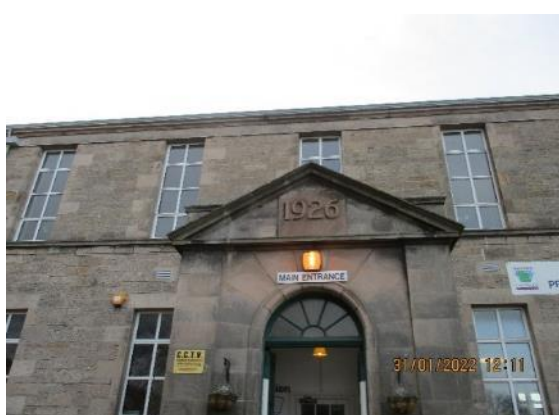
- External lighting is dated and in poor condition.
- The lightning conducting cable is inadequately secured to the building and a works order has been created to repair this.

147. External building lighting

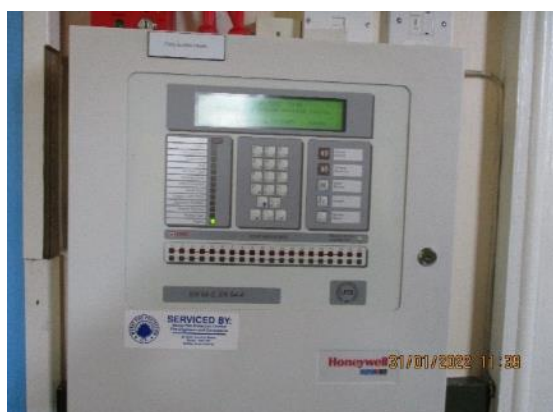
149. Fire alarm panel

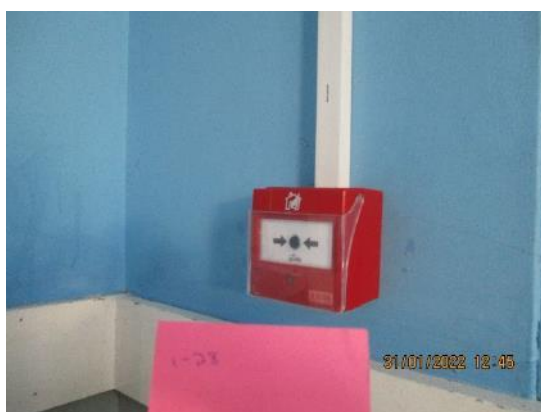
150. Fire alarm device

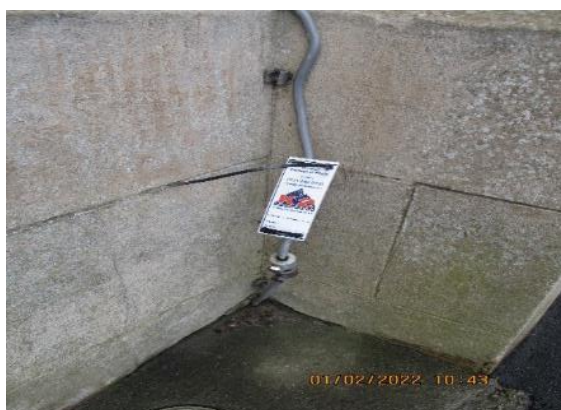
151. Lightning conductor cable ground level discharge

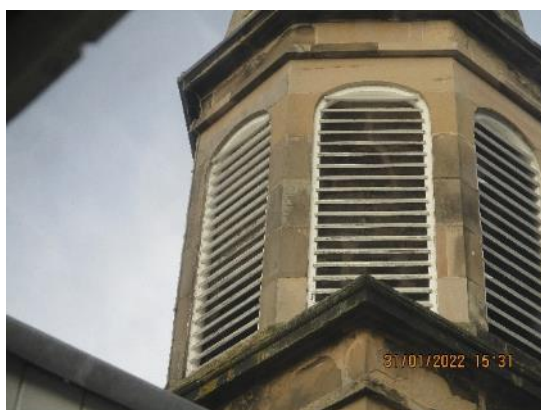
152. Lightning conductor cable clock tower

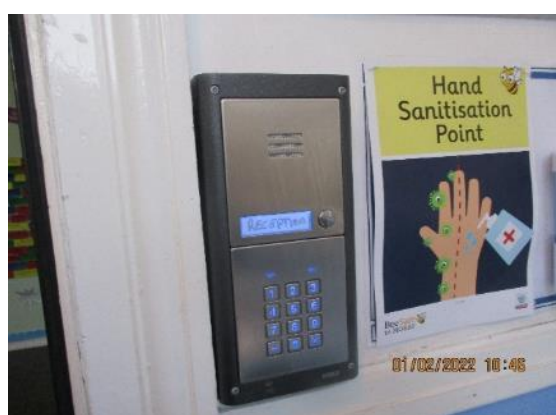
153. Door entry system

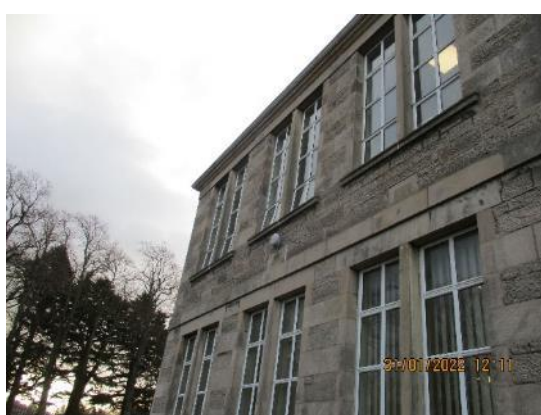
154. Period bell system (external bell)

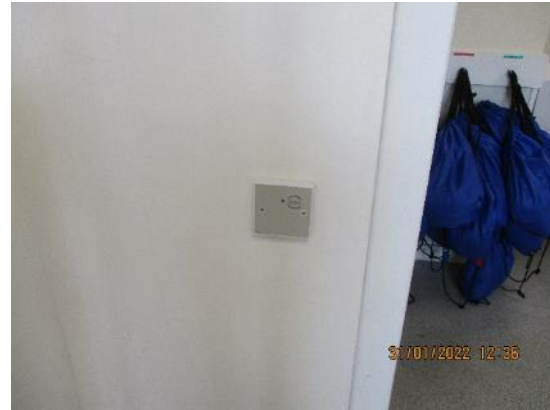
156. Disabled alarm system call point – access toilet

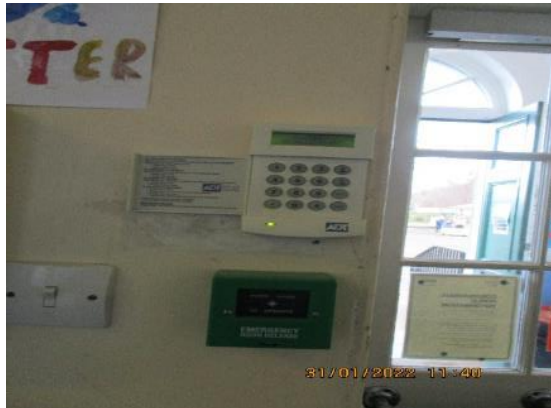
157. Intruder alarm panel – main entrance

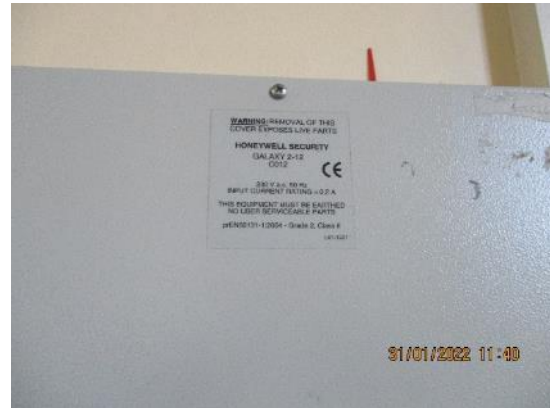
158. Intruder alarm panel main entrance

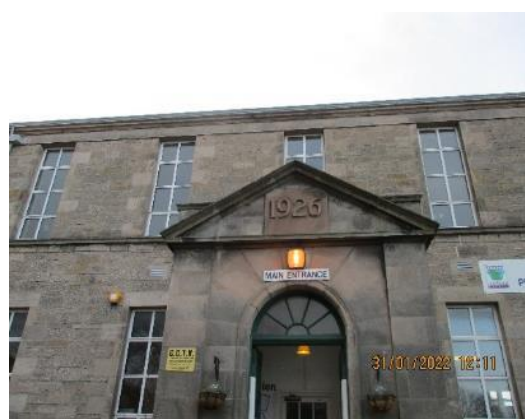
160. External CCTV camera main entrance

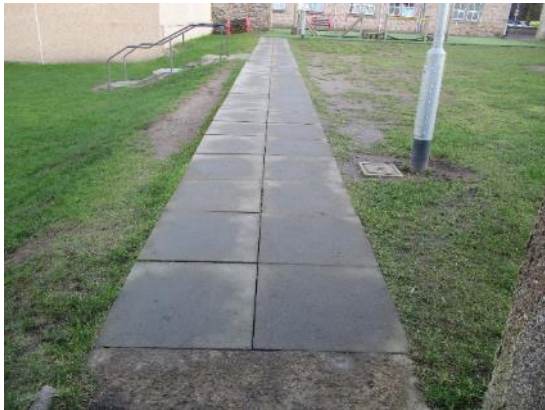
163. Paving slab footpath

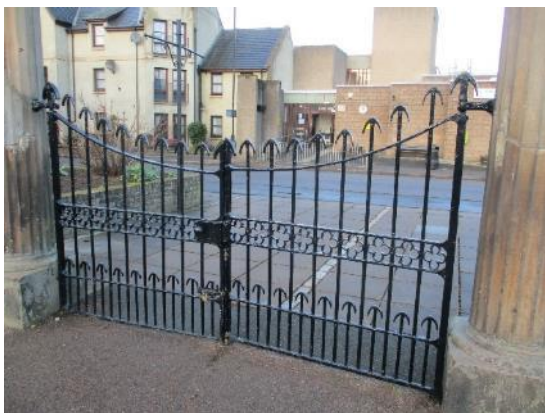
165. Cast iron gate (Listed)

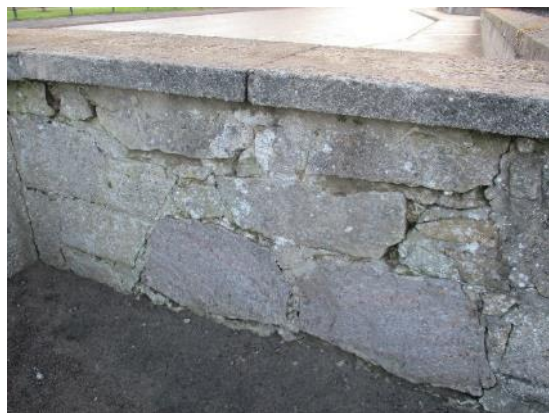
172. Perimeter wall pointing

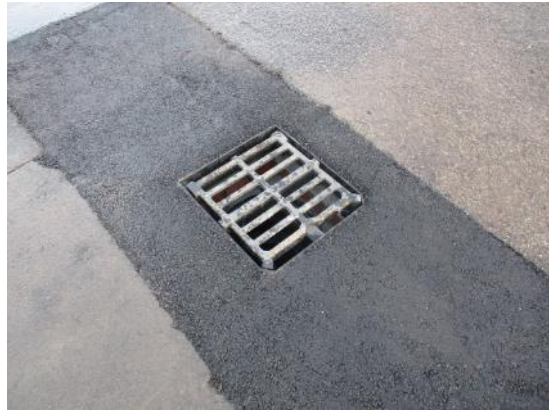
174. Surface water drainage
