# **Summary Building Condition Survey Report**

**Applegrove Primary School  
Orchard Road, Forres IV36 1PJ**

**21<sup>st</sup> & 22<sup>nd</sup> February 2022**

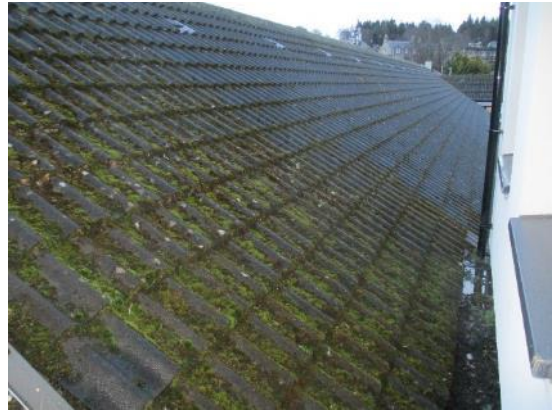
4. Tiled roof above SEN

- Concrete tile roofs are reaching the end of their useful life.
- Flat roofs are very slippery and require cleaning.
- Single ply membrane roof coverings are wrinkled and require monitoring.
- Rain water outlets to flat roofs are blocked and require clearing.
- Isolated areas of damage to external wall insulation.
- Watermarked ceilings require further investigation.
- The original internal doors are reaching the end of their useful life
- Carpets are soiled in a number of locations.
- Vinyl treads to internal stairs are soiled.

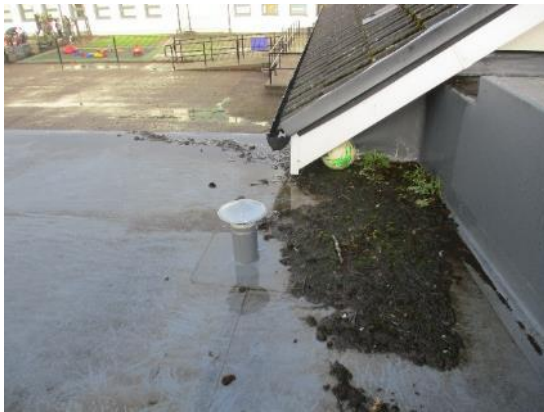
13. Debris and vegetation

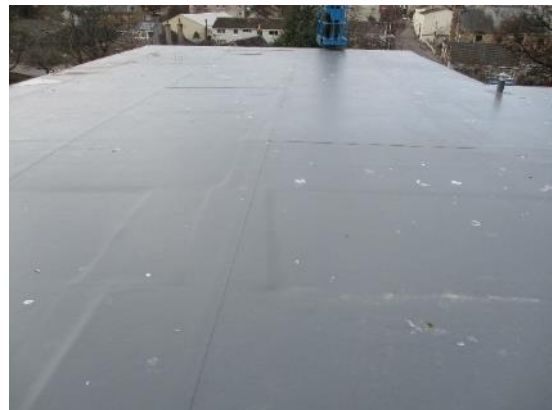
16. Insulation joints visible

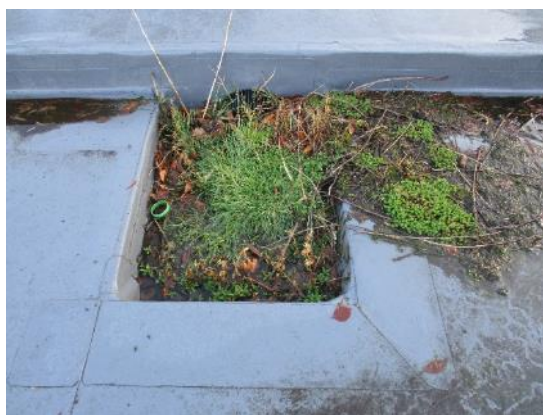
24. Blocked flat roof outlets

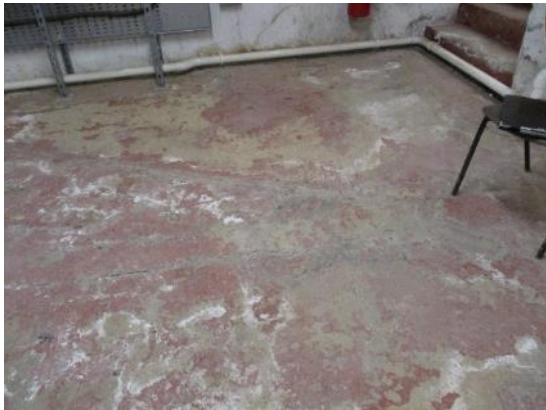
57. Painted concrete floor – Boiler House

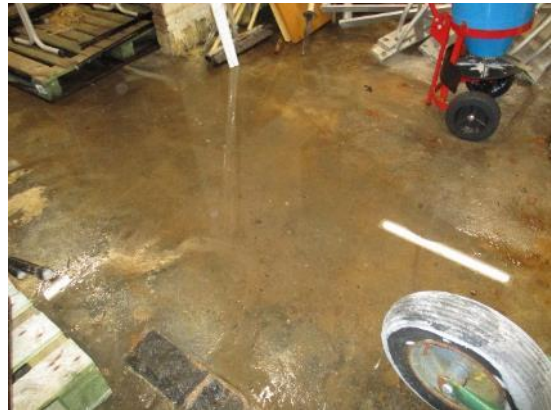
58. Concrete floor – Basement Store

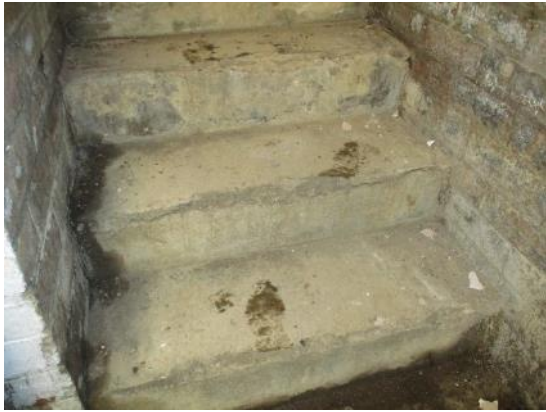
61. Concrete stairs to Basement Store

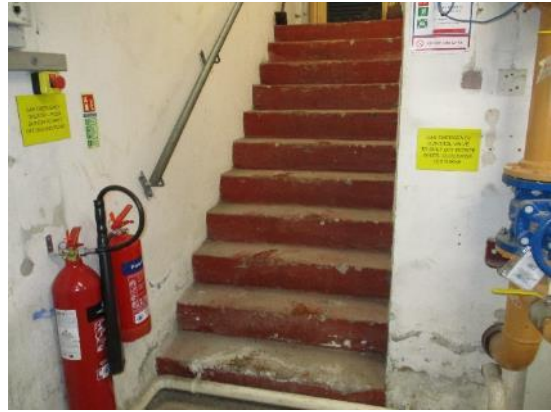
62. Concrete stairs to Boiler House

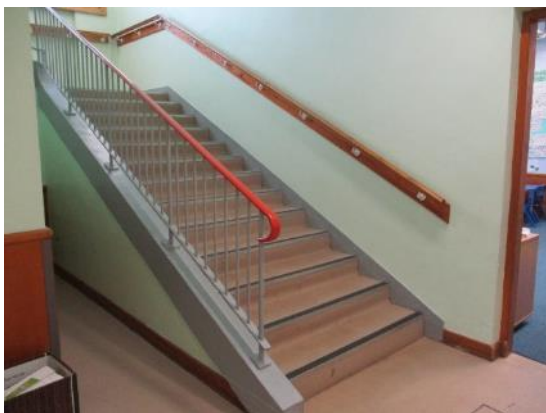
65. Timber and PVC handrails

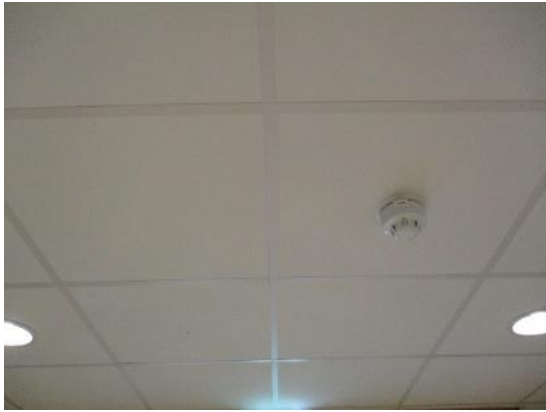
67. Suspended ceiling tiles

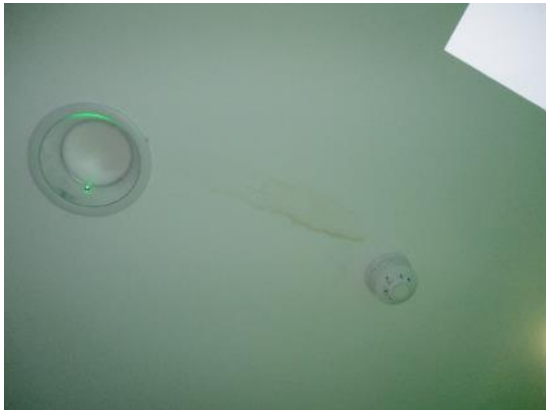
69. Water mark in Soft Play Room

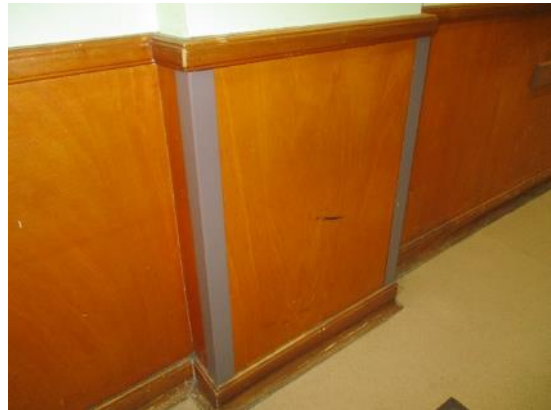
76. Timber panelling at low level

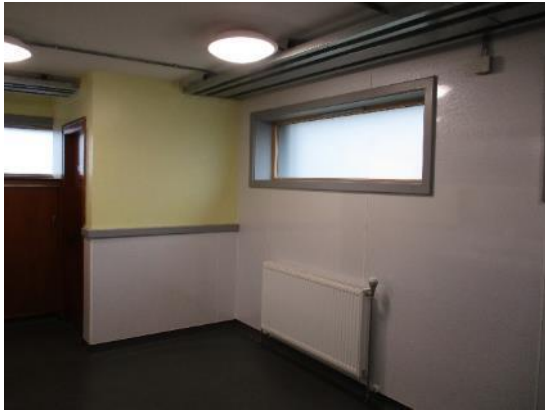
79. Wetwall in toilets

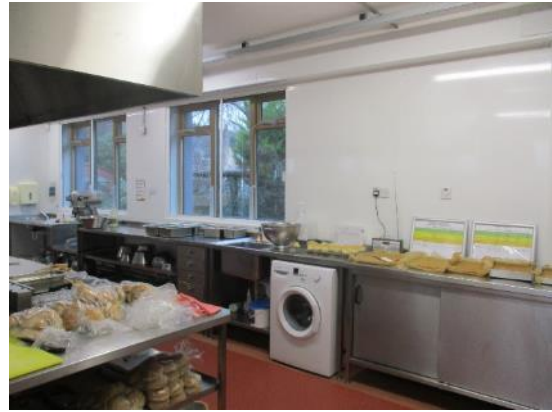
80. Wetwall in Kitchen

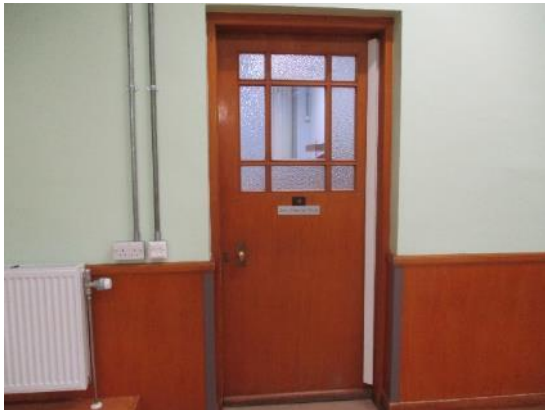
81. Original timber doors

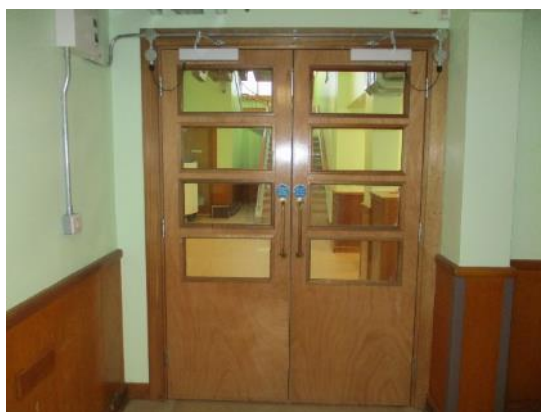
86. Replacement double doors

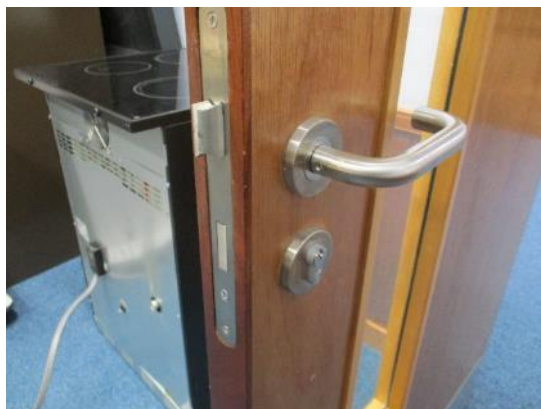
88. Replacement aluminium ironmongery

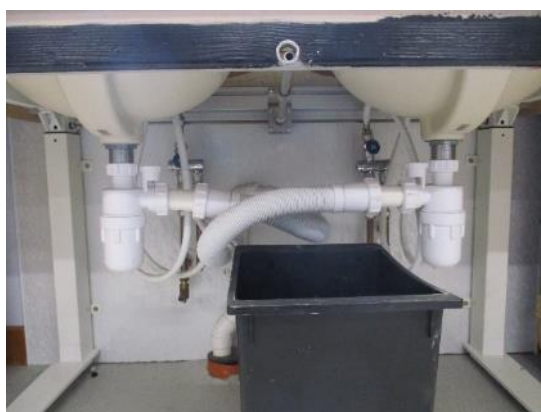
94. PVC waste pipes

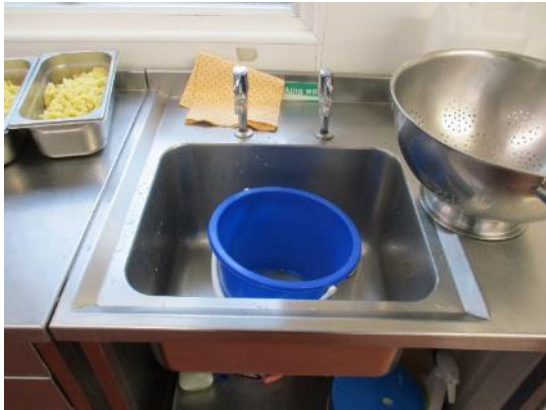
103. Commercial kitchen sink

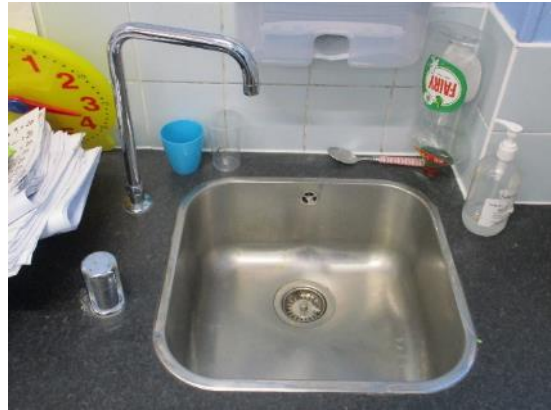
104. Classroom stainless steel sink

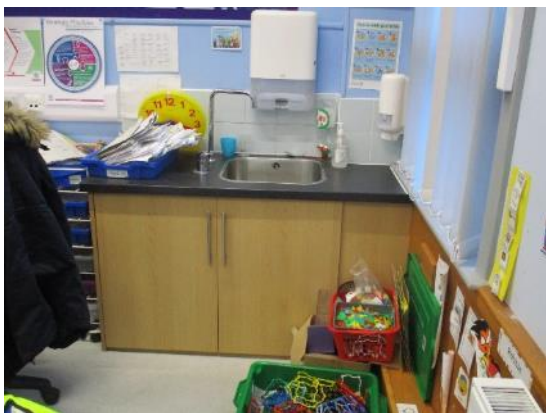
107. Classroom sink base unit

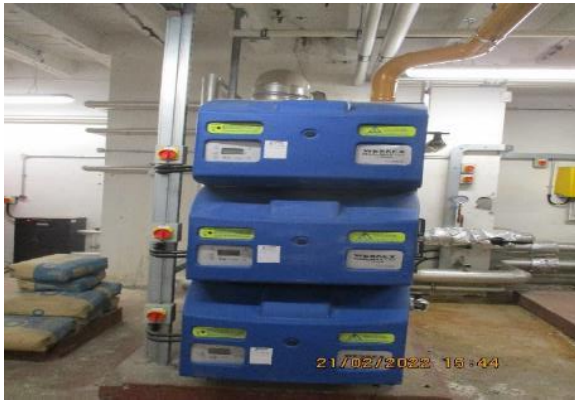
111. Gas boilers – Modular (3 of)

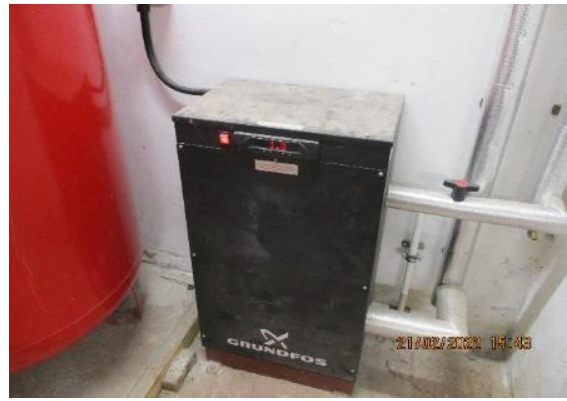
112. Pressurisation Unit – Heating system

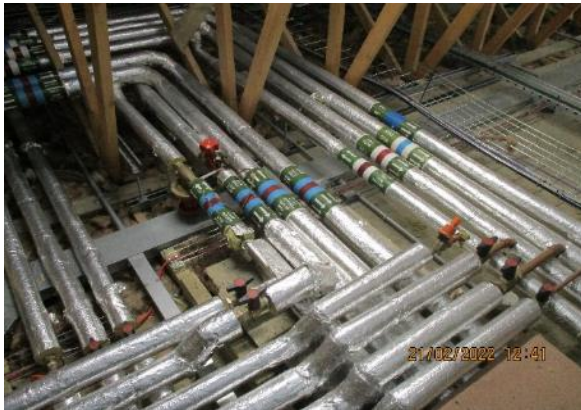
113. Heating pipework and insulation – attic space

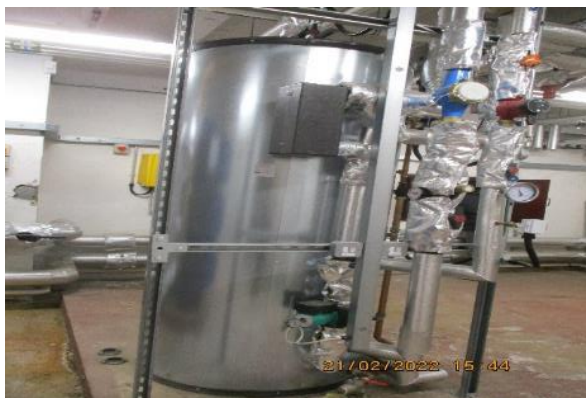
115. Hot water storage calorifier

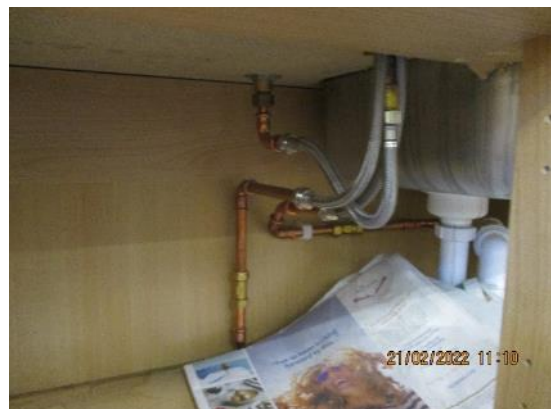
116. Hot water copper pipework classroom sink

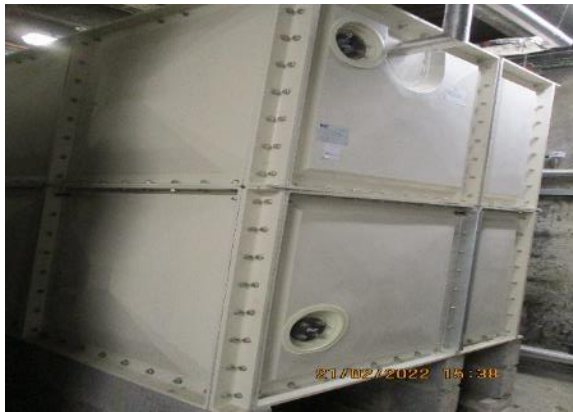
117. Cold water tank – plant room

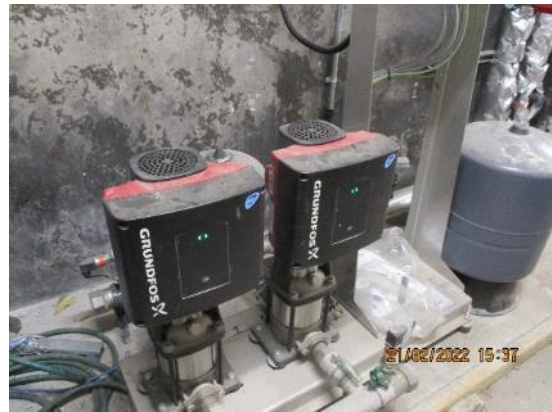
118. Cold water booster pump set.

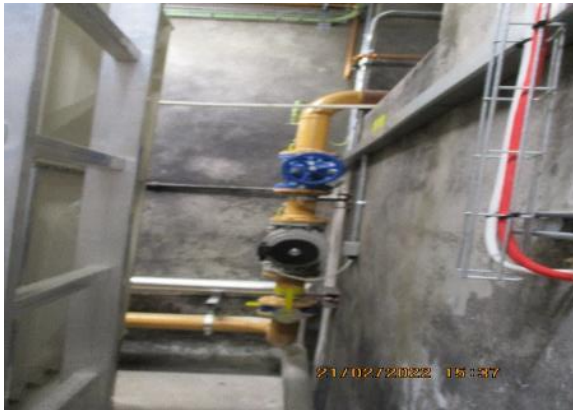
119. Gas supply pipework and electric solenoid control.

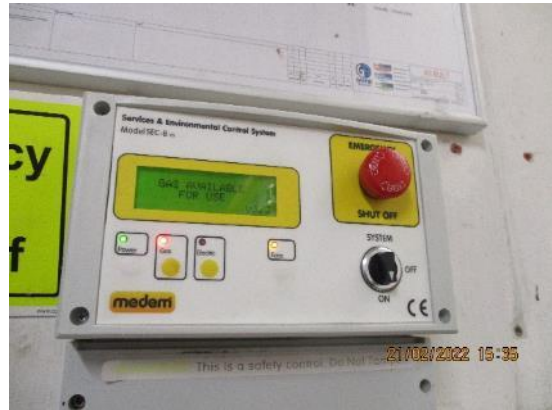
120. Gas safety auto shut down control panel

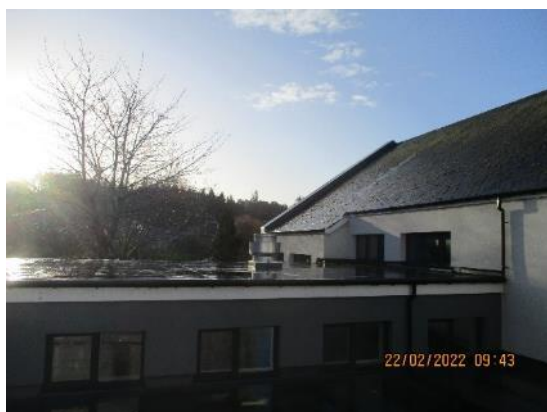
123. Specialist ventilation – kitchen canopy fan roof

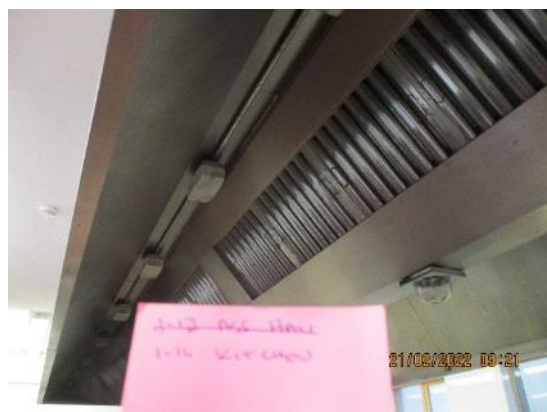
124. Specialist ventilation. Kitchen appliance canopy

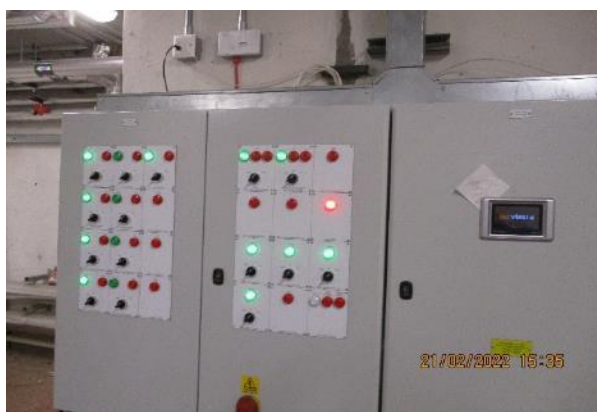
125. BMS control panel – Plant room

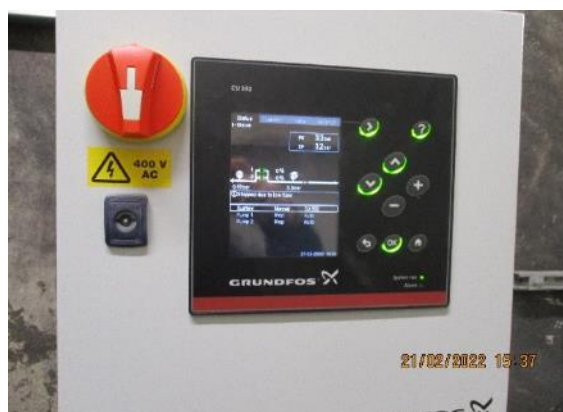
126. Control panel – cold water booster pump

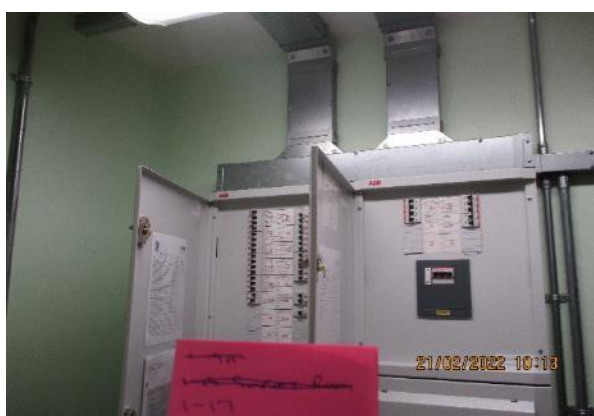
127. Distribution boards – lighting and power

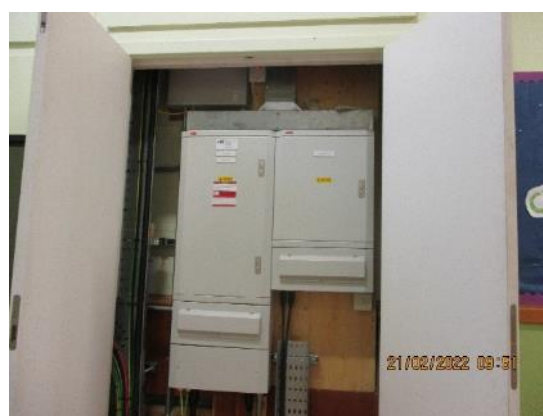
128. Distribution boards – lighting and power

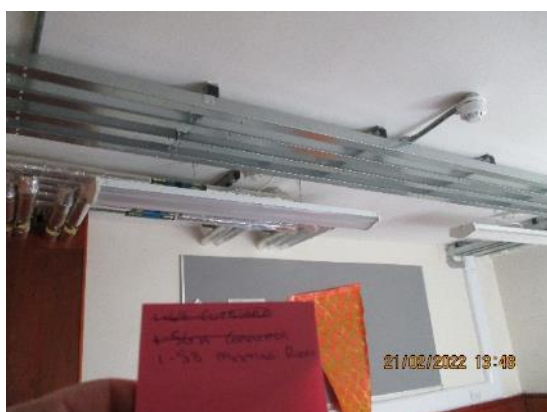
129. General wiring within metal protective trunking.

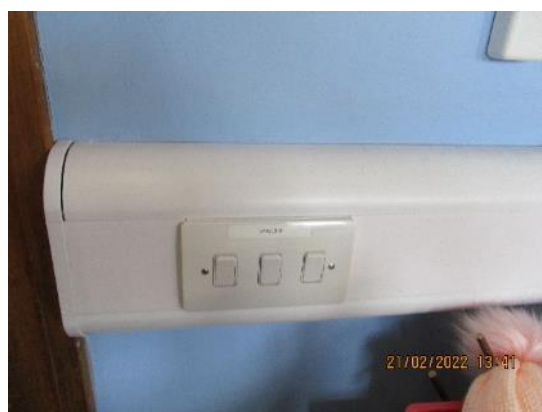
130. General wiring within protective plastic trunking.

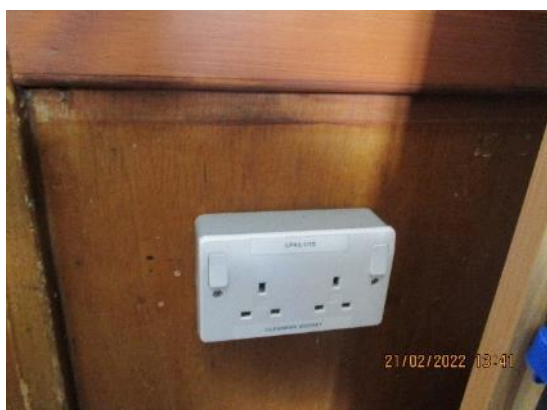
131. Wiring accessories. Surface socket metal back box.
