# **Summary Building Condition Survey Report**

**Dyke Primary School**

**Dyke IV36 2TF**

**5<sup>th</sup> October 2021**

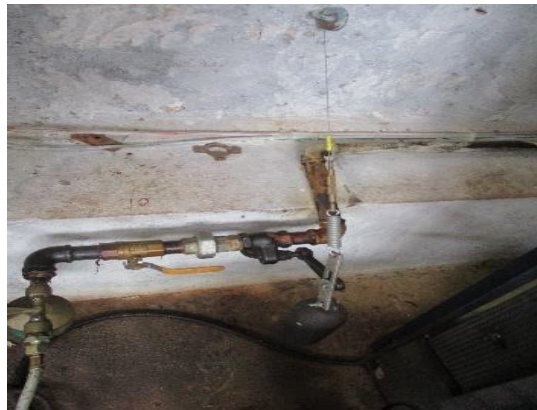
40. Oil supply pipework to boiler – Plant room

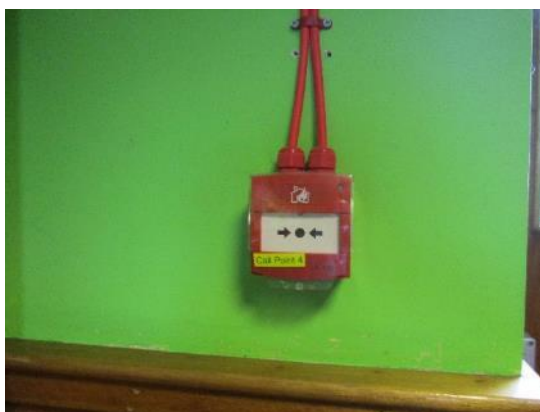
44. Fire alarm system device – call point main school.

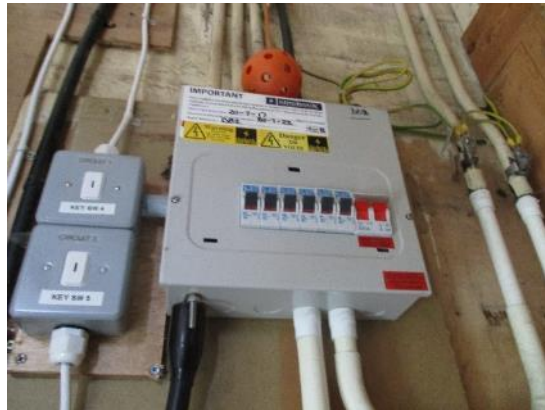
59. Horsa Hut distribution board.
